G1000 / GFC 700 System Maintenance Manual Hawker Beechcraft Model 300/B300 Series King Air

**Contains Instructions
For Continued Airworthiness
For STC SA01535WI-D**

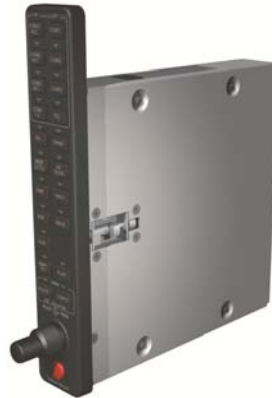
Figure 2-2, Audio Panel

The Garmin GMA 1347D Audio Panel integrates NAV/COM digital audio, intercom system and marker beacon controls. The 300/B300 installation includes two GMA 1347D panels. The GMA 1347D panels provide control of all cockpit intercom/mic systems as well as NAV/COM/ILS audio. The units also provide display reversion mode control through a large red button. Warning and alert audio received by the GMA 1347Ds is processed by and received from the GIA 63W Integrated Avionics Units (IAUs). Electrical power to GMA 1 is provided from No. 1 Triple Fed Bus. Electrical power to GMA 2 is provided from Left Gen Avionics Bus. GMA 1 will be powered immediately with external or aircraft power or battery operation. GMA 2 will operate after selecting Avionics Master on. The GMA 1347D units interface with the existing marker beacon antenna, as well as existing mic and phone jacks and oxygen mask mic.

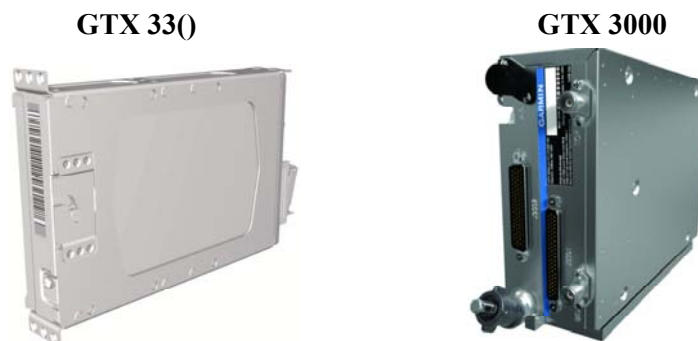
Figure 2-5, Transponder

The Garmin GTX 33() or GTX 3000 transponders communicates with the on-side GIA 63W through RS-232 digital interface. This STC installation allows for installation of two GTX 33 non-diversity transponders, two GTX 33D diversity transponders, or one of each type. This STC installation also allows for installation of two GTX 3000 diversity transponders. Mixing between the GTX 33 and GTX 3000 transponders is not permissible. Additionally, for TCAS II operations, the GTX 3000 transponder communicates with the GTS Processor through ARINC 429 digital interfaces (transmit and receive). The transponder units are mounted on the upper avionics equipment shelf in the tail section of the airplane.

Power is provided by the No. 1 GTX from Triple Fed Avionics Bus. The No. 2 GTX is powered from Left Gen Avionics Bus. All GTX transponders (non-diversity and diversity) interface with a transponder antenna mounted to the bottom of the fuselage. Each diversity transponder (GTX33D and GTX 3000) interfaces to a transponder antenna mounted to the top of the fuselage.

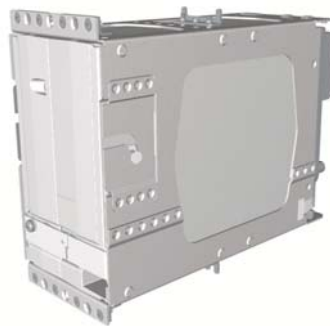
Figure 2-6, GIA unit

The GIA 63W #2 interfaces to the following additional equipment:

- GDC 7400 #2
- GTX 33() or GTX 3000 #2
- ADF (if installed)
- Stormscope (if installed)
- Radar Altimeter (if installed)

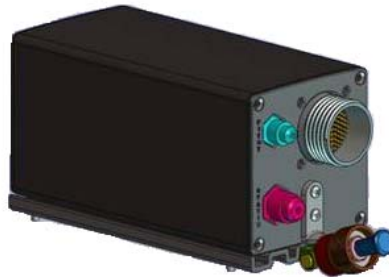
Figure 2-8, Air Data Computer

The Garmin GDC 7400 computers compile information from the pitot/static system and various outside air temperature (OAT) and awareness sensors and provide digital air data computations to the G1000 system. The GDC 7400 communicates with the GIA 63W, GDU 1040A, and GRS 77 using ARINC 429 digital interface. The unit is mounted behind the instrument panel. GDC 1 receives primary electrical power from No. 1 Triple Fed Bus and a secondary power supply from Center Bus. GDC 2 receives power from No. 3 Triple Fed Bus. GDC 1 and GDC 2 connect to existing pitot/static ports. Refer to Figure 2-24 for a schematic of the aircraft's pitot/static system and its connections to the G1000 STC installed equipment.

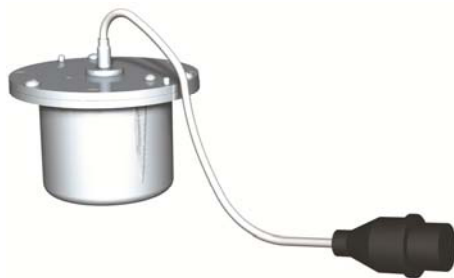
GMU 44 -20 Unit

The GMU 44 provides horizontal and vertical magnetic field information to the GRS AHRS. This allows heading to be calculated and provides assistance during AHRS alignment. The GMU 44 units are mounted in the tailcone or in the horizontal stabilizer. The 011-00870-20 GMU 44 units may only be installed in the horizontal stabilizer. The GMU 44 units were modified to account for low clearance installations and have a 90-degree pig-tail harness versus the straight harness on the 011-08870-10 GMU 44 units. The units receive power directly from the GRS units and communicate with the GRS units via RS-485 digital interface.

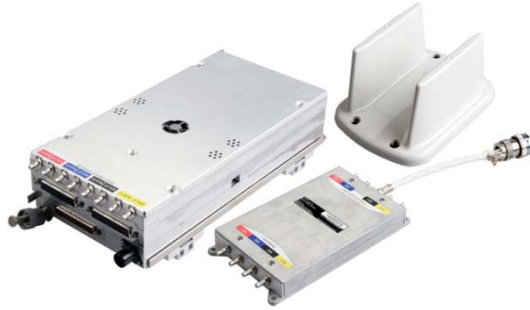
Figure 2-16, GTS 820/850 Traffic System

The GTS 820/850 is a traffic surveillance system that uses active interrogation of Mode S and Mode C transponders to provide traffic advisories to the pilot. The GTS 820 is a TAS unit; the GTS 850 is a TCAS I unit. The installation includes a top directional antenna (GA 58) paired with a GPA 65 power amplifier / low noise amplifier (PA/LNA) unit and a bottom, unamplified GA 58 antenna. The GTS 820/850 is located in the nose avionics bay on the top, left shelf. The GPA 65 is located in the left sidewall area, just in front of the most forward cabin window. The GTS 820/850 traffic system is powered from Right Gen Avionics Bus.

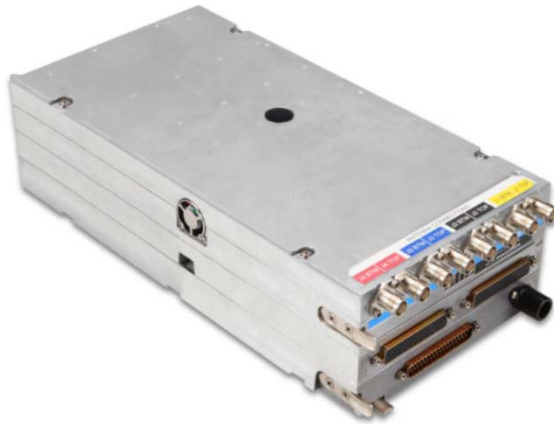
Figure 2-17, GTS Traffic Processor

The GTS Traffic Processor is a microprocessor-based Line Replaceable Unit that uses active interrogations of Mode S and Mode A/C transponders to provide Traffic Advisories and Resolution Advisories (GTS 8000 only) to the pilot. When installed, the GTS Processor can be configured as TAS (GTS 825), TCAS I (GTS 855), or TCAS II (GTS 8000). The GTS traffic processor is installed in the nose avionics bay. The GTS interfaces to the GA58 traffic antennas which are mounted on the upper and lower fuselage. The GTS traffic processor also interfaces with the GTX 3000 through ARINC 429 digital data lines. The GTS traffic processor is powered from the Right Gen Avionics Bus.

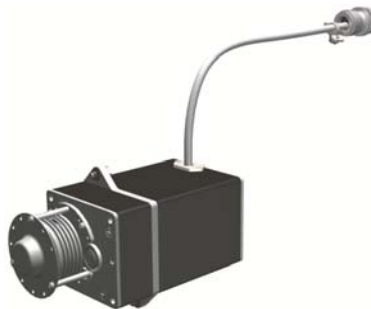
Figure 2-19, GSA 80 / GSM 86

The Garmin GFC 700 AFCS uses GSA 80 high torque servos to control aircraft pitch, pitch trim and roll. The pitch trim variant of the GSA 80 is a high speed servo actuator. The GSA 80 contains a motor-control and monitor circuit board, as well as a solenoid and a brushless DC motor. The GSA 80 servo receives serial RS-485 data packets from the GIA 63Ws. The roll servo is located in the forward cabin lower fuselage near the wing front spar. The pitch and pitch trim servos are located in the tail. Power to the servos is received from No. 2 Triple Fed Bus. All servos mount to Garmin GSM 86 Servo Gearboxes. The GSM 86 is responsible for transferring the output torque of the GSA 80 servo actuators to the mechanical flight control surface linkage.

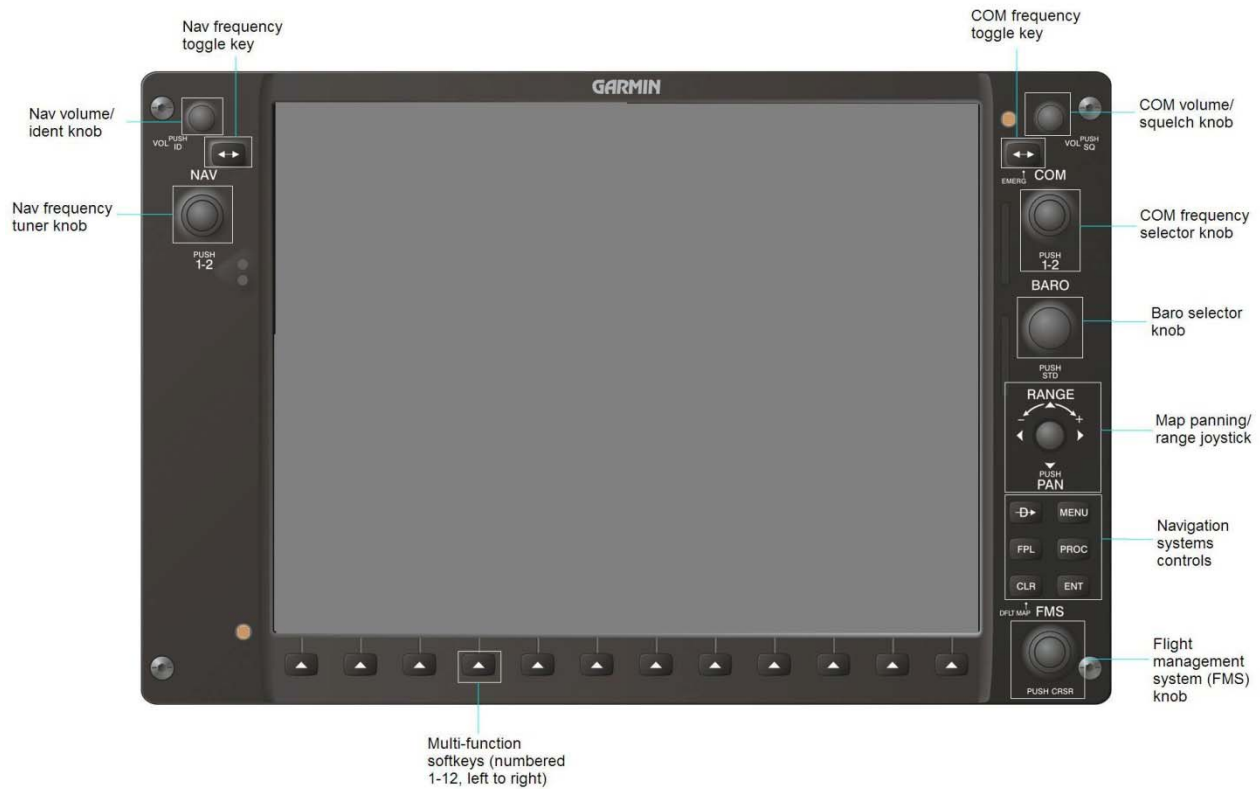
Figure 3-1, GDU 1040A Control Interface

Figure 3-1 and Figure 3-2 provide identification of the GDU 1040A PFD and GDU 1500 MFD controls.

All control and operation of G1000 equipment as normally used in flight occurs through the PFDs, MFD, GMC 710, GCU 477 and GMA 1347D audio panel. Figure 3-1 through Figure 3-6 identify various interface buttons for these units.

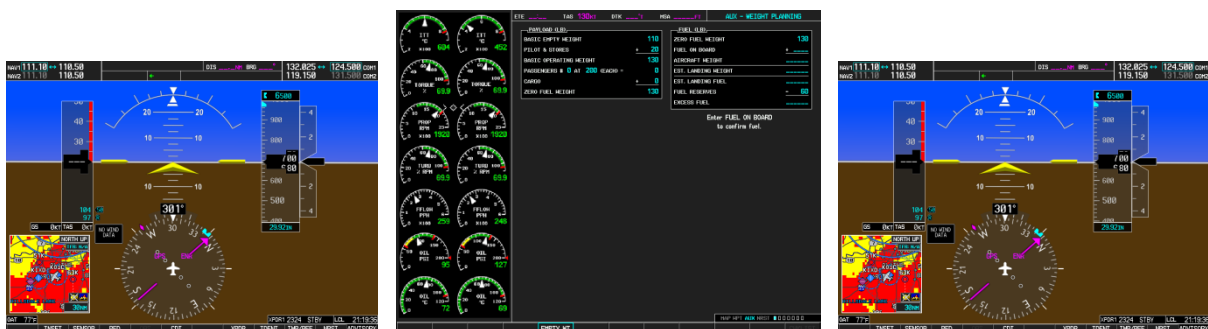
Figure 3-7, Normal Mode

The G1000 system is now powered in the normal mode. In the normal operating mode, data fields that are invalid have large red X's through them. A valid field does not display a red X. Allow the displays to initialize for approximately one minute. The GDC 7400s require a longer initialization period than do the other LRUs. During normal operation, this causes the airspeed, altitude, vertical speed, and OAT fields to be invalid during the first ~40-60 seconds of PFD power-up. The PFDs and MFD will function as specified in the G1000 300/B300 Series Cockpit Reference Guide when the system has been correctly installed and configured.

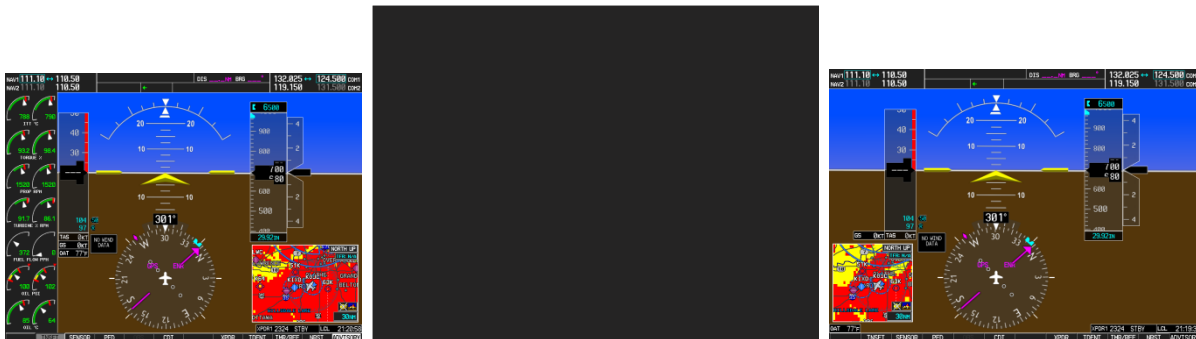
Figure 3-8, Automatic Reversion with MFD failure

Reversionary mode allows for display of information related to safe flight in the event of a display communication or hardware failure. The pilot's PFD automatically goes into reversionary mode when communication to the MFD is lost. Manual reversionary mode allows the operator to force the pilot or copilot's PFD into reversionary mode by pressing the large red button labeled 'DISPLAY BACKUP' on the respective GMA 1347D audio panel.

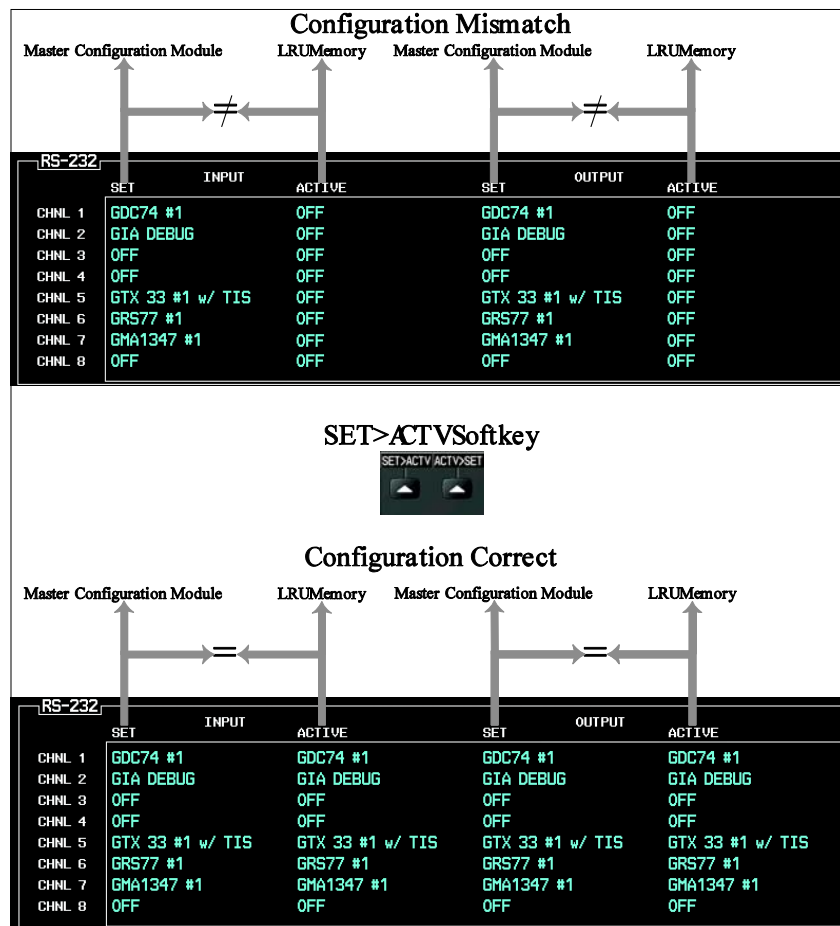
Figure 3-10, SET>ACTV Diagram

In the first example shown in Figure 3-10, the SET columns do not match the ACTIVE columns. The inequality between SET and ACTIVE indicates a configuration mismatch. By pressing the SET>ACTV softkey, this copies the SET column to the LRU unit’s configuration memory. The settings then become the ACTIVE settings for the LRU being configured.

When troubleshooting the system, technicians can look for inequalities between SET and ACTIVE columns. Certain problems can be resolved simply by pressing the SET>ACTV softkey, which reloads settings to the specific LRU from the PFD. (Note that this can also be accomplished by reloading the configuration files for the LRU. Section 7 describes this process for each LRU).

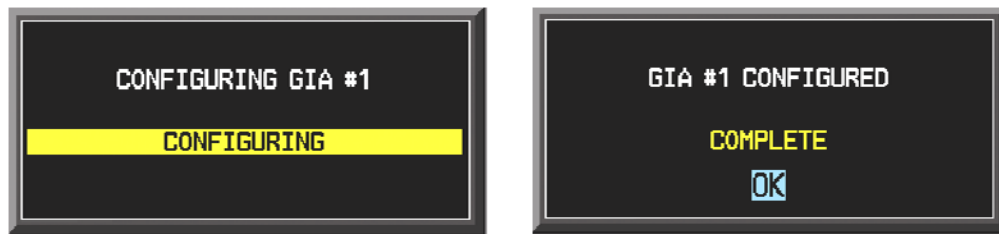
Figure 3-12, Configuration Status

When configuration settings are changed, the technician receives on-screen prompts and/or confirmations such as those shown in Figure 3-12. Section 7 shows other prompts encountered during the configuration process.

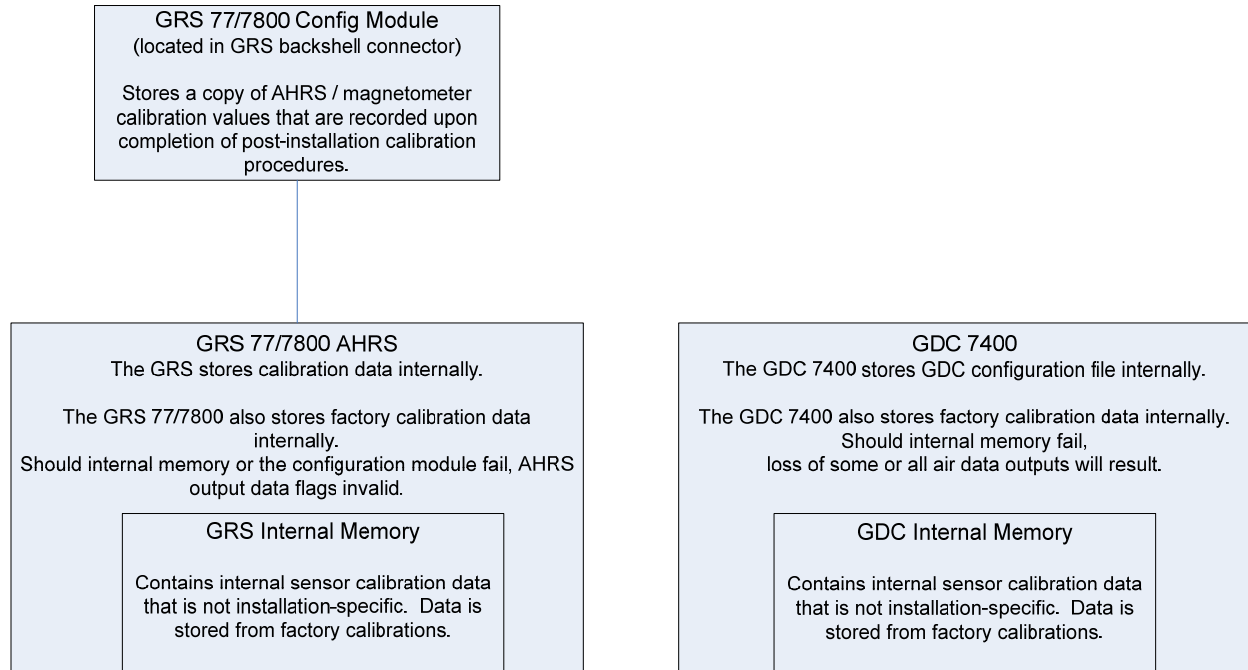
Figure 3-15, GRS/GDC Configuration Settings Storage

The GRS 77/7800, GMU 44 and GDC 7400 configuration/calibration (reference Figure 3-15) is different than the LRU's shown in Figure 3-14.

The GRS 77/7800 AHRS and GMU 44 Magnetometer do not have a configuration file. However, the GRS does store calibration data acquired during the post installation checkout, which are characteristic to the specific installation. A copy of this calibration data is stored in the GRS configuration module. While performing maintenance on these units, re-calibration may be required. See Section 7.7.1 for more information on re-calibration criteria.

The GDC 7400 air data computer configuration file is loaded directly to GDC 7400 internal memory and there is no configuration module for the GDC 7400.

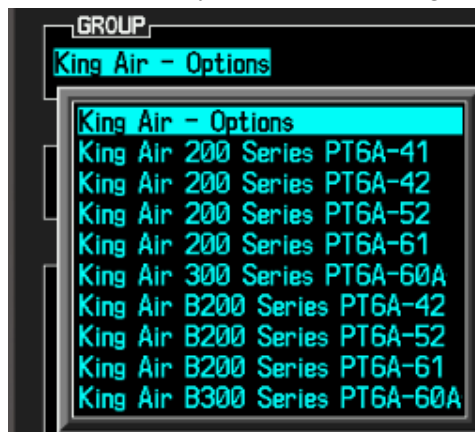
Figure 3-17, Airframe Options

1. Ensure loader card is inserted into top card slot of PFD1 and PFD1 is in configuration mode. On PFD1, select the “System Upload” page using the PFD1 small FMS knob.
2. Activate the cursor and use the PFD1 small FMS knob to highlight the GROUP field. Scroll small FMS knob to select the appropriate airframe (**King Air 300 Series PT6A-60A** or **King Air B300 Series PT6A-60A**). Press the PFD1 ENT key to select the configuration.

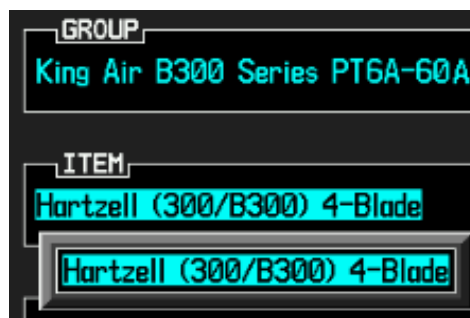
Figure 3-18, Propeller Options

3. Once an airframe type is selected the cursor moves to the ITEM window. Rotate the PFD1 small FMS knob to activate the drop-down menu. Move the cursor to highlight the appropriate propeller configuration for the aircraft and press ENT on PFD1.

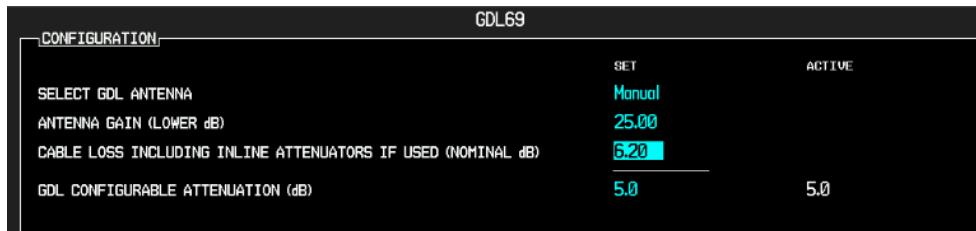
Figure 3-24, GDL 69 Cable Loss

3. Highlight the **CABLE LOSS INCLUDING INLINE ATTENUATORS IS USED (NOMINAL dB)** field.
4. Use the small FMS knob to select a value of 6.20, then press the **ENT** key on PFD1.

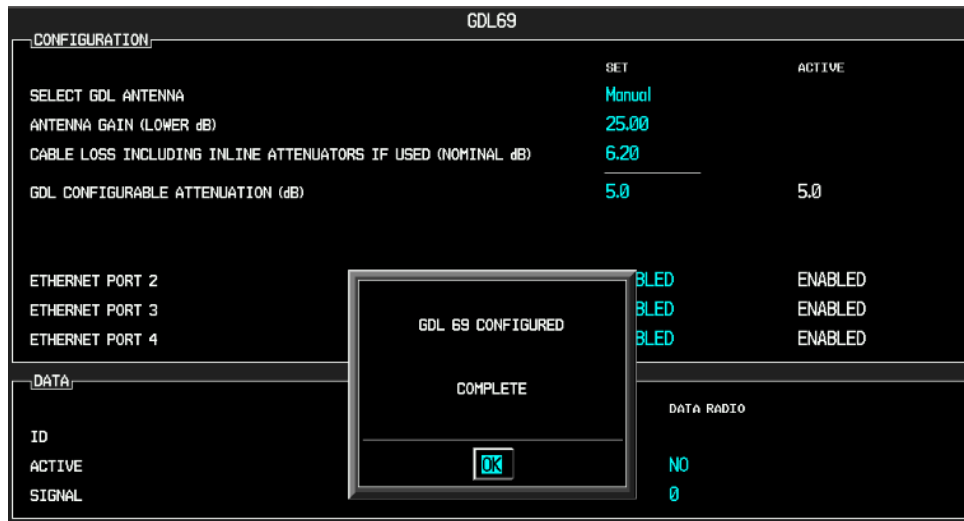
Figure 3-25, GDL 69 Cable Loss Configured

5. Verify GDL 69 is configured, then press the **ENT** key on PFD1 to acknowledge.

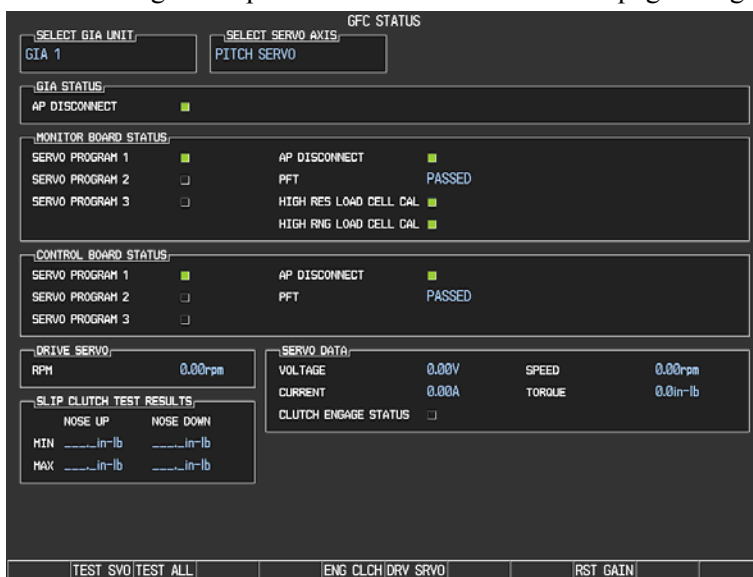
Figure 4-3, GFC Status Page

1. Power on the system with PFD1 in Configuration Mode and with PFD2 and MFD in normal mode.
2. Press the red DISPLAY BACKUP button on the pilot's GMA audio panel to place the MFD in reversion mode.
3. On PFD1, go to the GFC Page Group and select the GFC STATUS page using the FMS knobs.

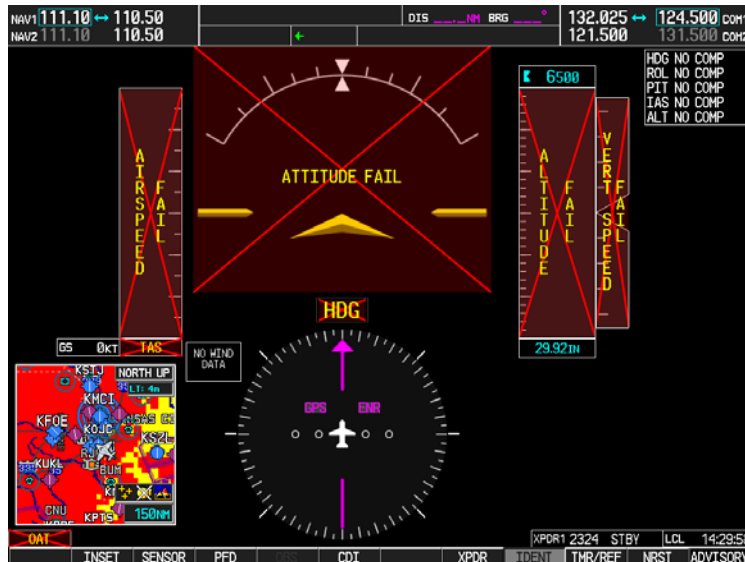
Figure 5-4, System Annunciations

If data fields become invalid due to an LRU failure, the PFD/MFD typically annunciates the failure with a large red X, as shown in Figure 5-4.

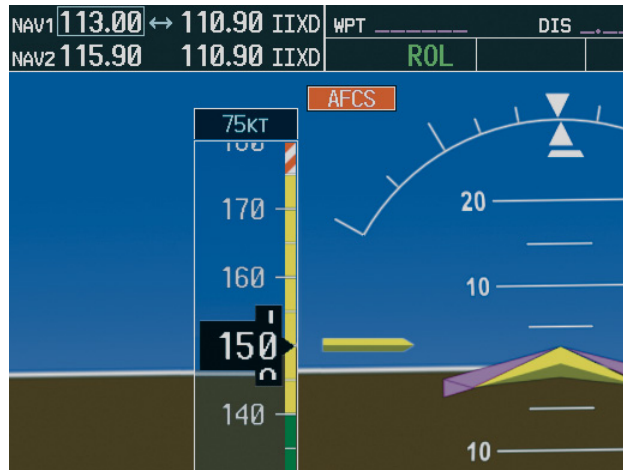
Figure 5-5, AFCS Annunciation Field

The GFC 700 AFCS Annunciation field is located above the airspeed tape on the PFD as shown:

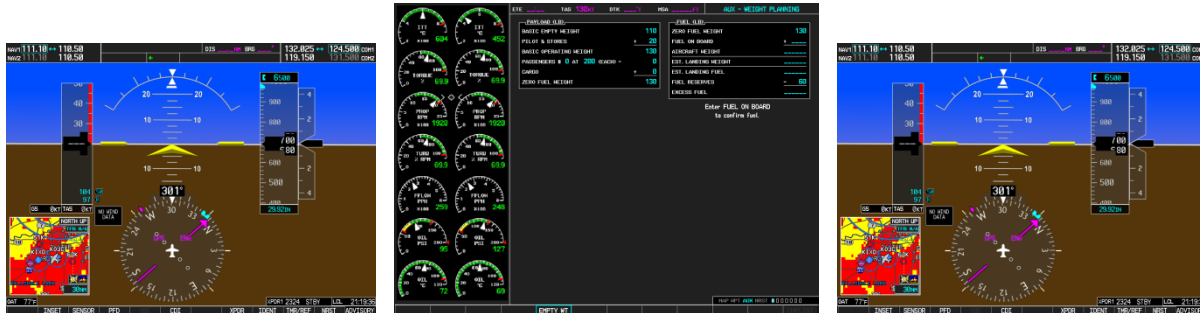
Figure 7-1, G1000 Normal Mode Check

1. Allow displays to initialize for ~1 minute.
2. Check that all COM/NAV display fields are valid in the top corners of both PFDs.
3. Check that attitude, heading, altitude, airspeed, vertical speed and OAT fields are valid within 2 minutes of power up on both PFDs.
4. Press the SENSOR softkey on each PFD and switch between ADC1 and ADC2. Verify that data from both GDC 7400s is valid on both displays.
5. Press the SENSOR softkey on each PFD and switch between AHRS1 and AHRS2. Verify that data from both GRS 77s is valid on both displays.
6. Check that the engine instrument fields are valid on the MFD.

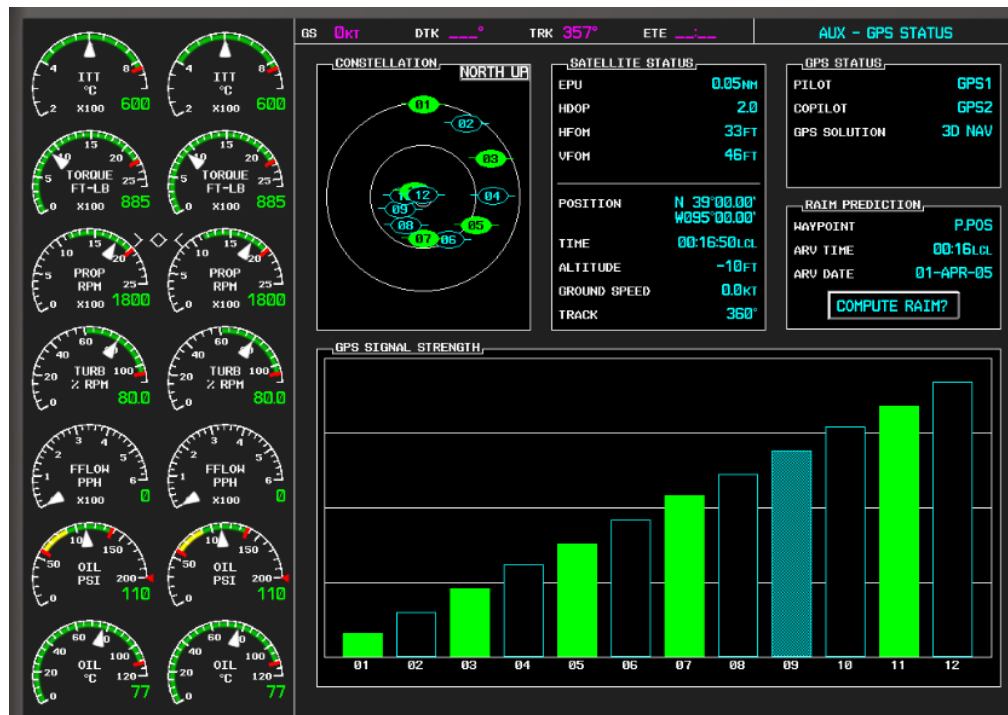
Figure 7-3, AUX – GPS STATUS Page (MFD)

The GIA 63W units should normally acquire a GPS navigation solution within 5 to 10 minutes of startup, provided the aircraft is outside (or indoors with a GPS repeater). Select the GPS STATUS page on the MFD (4th page in AUX group). Two softkeys on the bottom of the display allow the user to toggle between GPS 1 and GPS 2. Verify that both receivers show 3D DIFF NAV on the MFD.

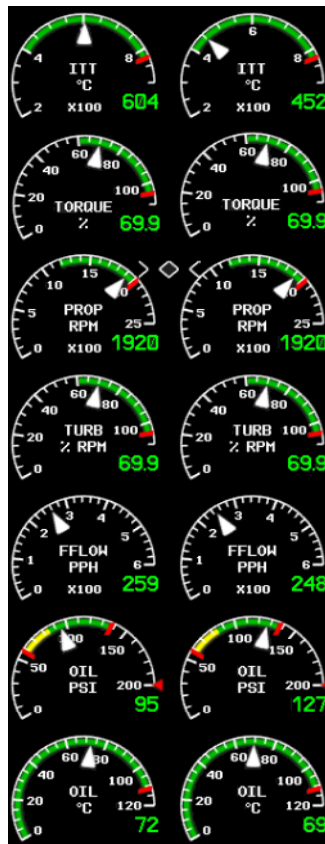
Figure 7-4, Normal Engine Instrument Markings (MFD)

In general, verify all engine and system instruments show valid static normal values and markings, with no red Xs or erratic indications. Reference Figure 7-4 for normal engine instrument markings (figure may not reflect actual aircraft installation). If necessary, reference Sections 7.4.2, 7.4.3 and 7.4.4 for additional tests to verify instrument readings.

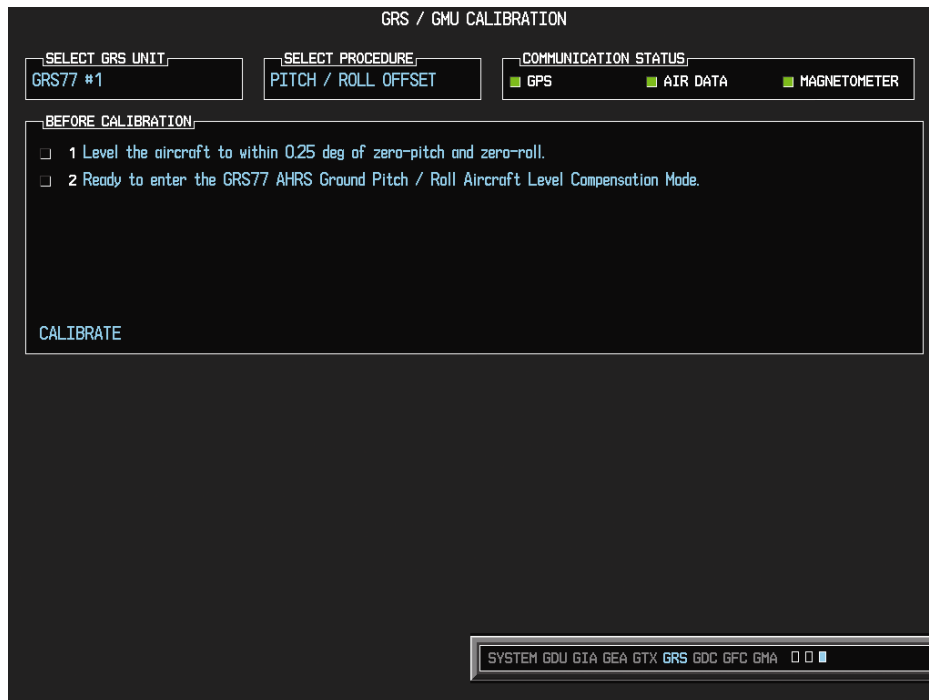
1. Level the aircraft to within $\pm 0.25^\circ$ of zero pitch and zero roll using a digital level. (Follow instructions in Super King Air 300 or B300 Maintenance Manual, listed in Table 1-2, for leveling)
2. Start PFD #1 in Configuration mode.
3. Go to the GRS Page Group and select the GRS/GMU Calibration page at the PFD. This page is protected and the following softkey password must be entered at the PFD to continue:
 - 9
 - 10
 - 11
 - 12 (Far Right softkey)

4. Ensure that the No. 1 GRS is selected in the SELECT GRS UNIT window on the PFD.
5. Activate the cursor and highlight the SELECT PROCEDURE window and select PITCH/ROLL OFFSET.

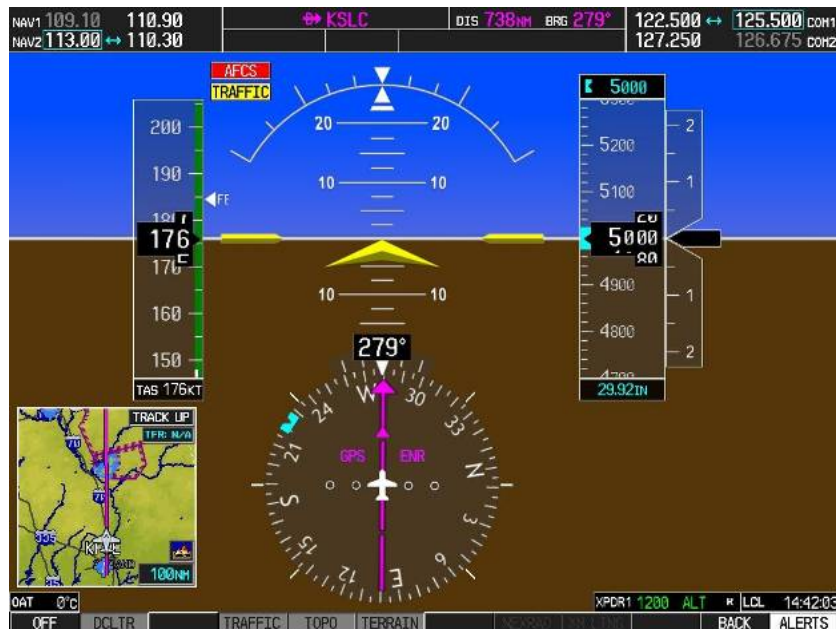
Figure 7-7, Normal Mode AHRS Check

The aircraft can now be taxied back and the engine can be shut down for final testing. Restart the displays in normal mode to conduct final system checks. When the PFDs power up in normal mode, the AHRS attitude and heading information displayed should become valid within 1 minute of power-up, as shown in Figure 7-7 (provided both GPS receivers have a valid position; if GPS is unavailable, AHRS initialization may take as long as 2 minutes).

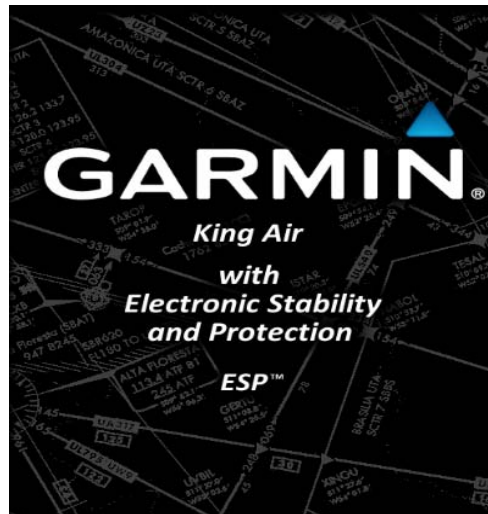
1. Apply power to the aircraft and avionics systems by setting the BAT, EXT PWR and AVIONICS MASTER PWR switches to ON. Ensure G1000 system and components are powered and operating normally.
2. Verify the DISPLAY BACKUP button on the audio panel is pushed in so that the GDUs will not operate in reversionary mode.
3. Verify no AHRS, ADC, Autopilot, PFD, AFCS Mode Controller, GCU alert messages or monitor flags (HDG MISCOMP etc) are present on PFD1 or PFD2.
4. On initial power up verify that the MFD splash screen includes the following graphic:

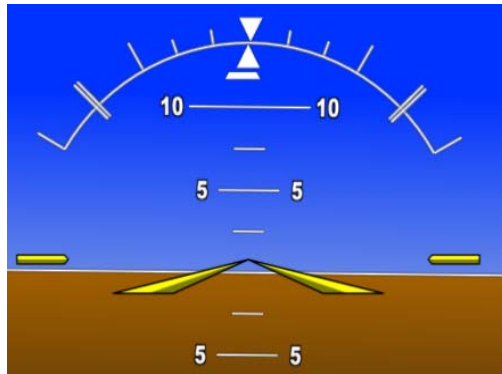
9. Verify on PFD 1 and PFD 2 that there are no “ESP FAIL”, “ESP OFF”, or “ESP DEGRADE” alert messages.
10. Cover both GPS1 and GPS2 antennas.
11. Verify on PFD 1 and PFD 2 the ESP Roll Indices are displayed at 45° on the roll indicator on the Attitude Display.

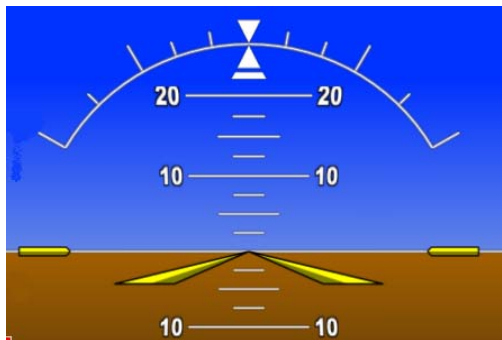
15. Verify on PFD 1 and PFD 2 the ESP Roll Indices are not displayed at 45° on the roll indicator on the Attitude Display.

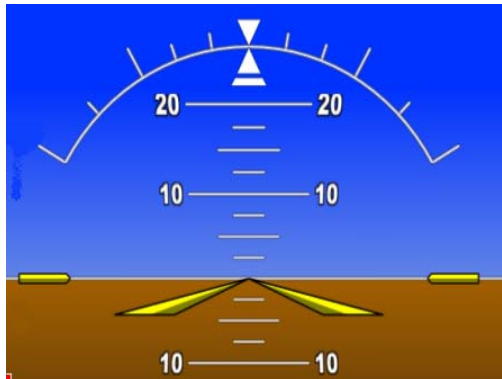
22. Once AFCS PFT is complete and GPS has acquired satellites, verify on PFD1 and PFD2 the ESP Roll Indices are not displayed at 45° on the roll indicator on the Attitude Display.

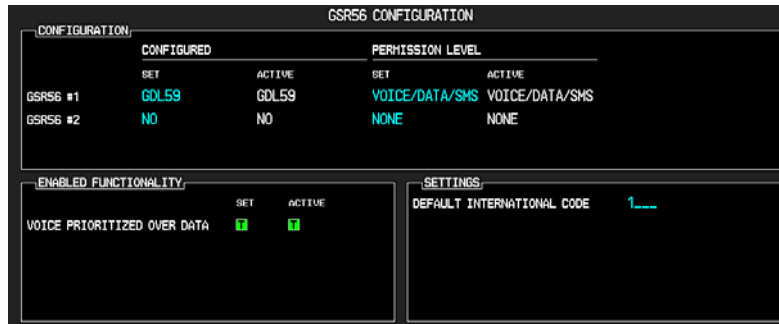
Figure 7-16, GSR56 Configuration Page

1. Power up the PFD1 in configuration mode.
2. On the PFD1, select GDL page group using the large FMS knob.
3. Using the small FMS knob select the GSR56 Configuration page. Verify the page can be displayed and information is available.

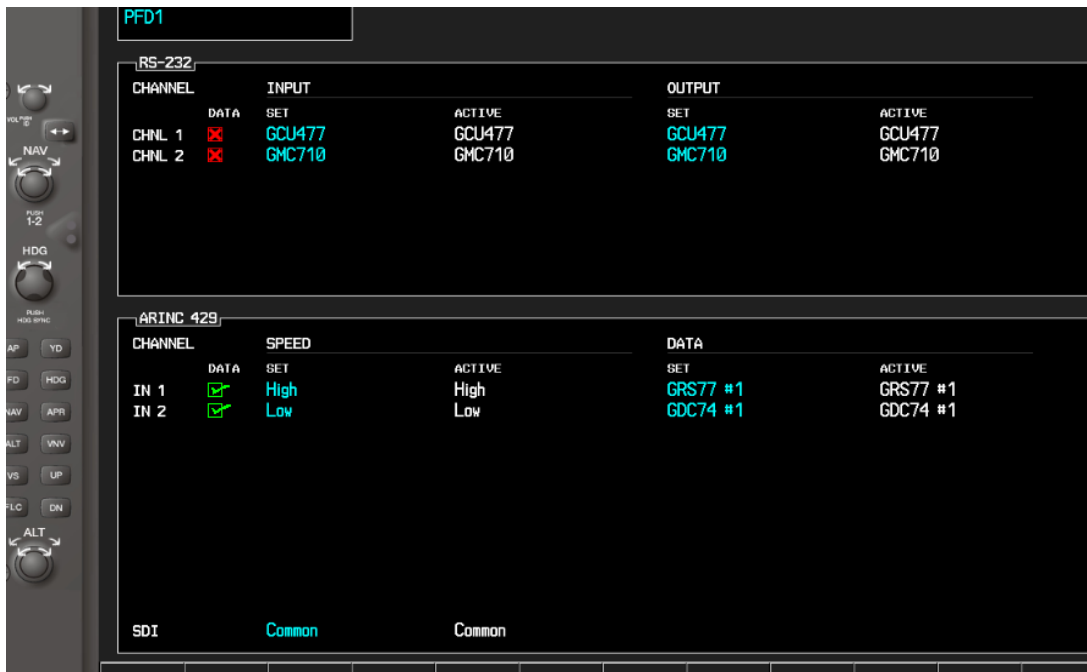
Figure 8-1, GDU Data Verification (ARINC 429)

1. With the G1000 in configuration mode, go to the GDU Page Group on PFD1.
2. On PFD1, activate the cursor and select PFD1 in the SELECT UNIT field and press ENT.
3. Observe the GRS 77 or GRS 7800 and GDC 74 DATA indicators in the ARINC 429 window.
4. Verify both indicators are GREEN, indicating the channels are receiving data as shown below:

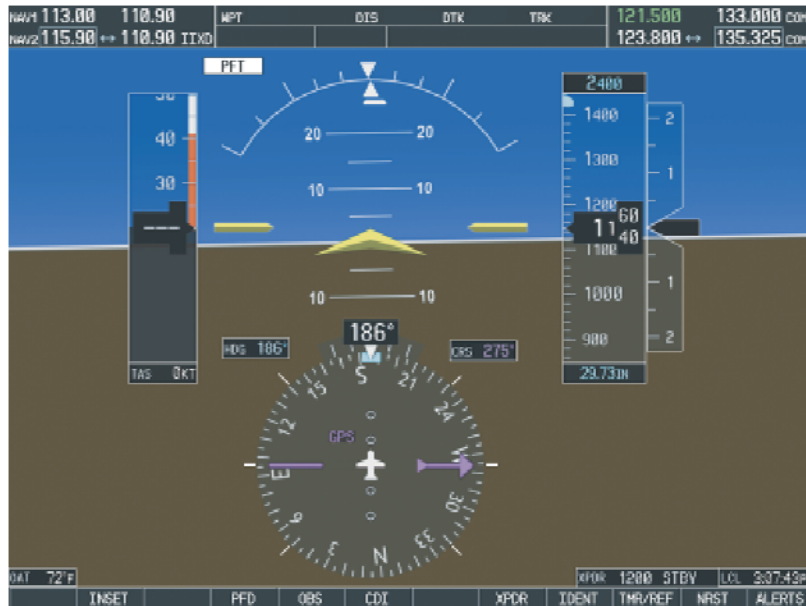
Figure 8-4, Pre-Flight Test

1. If selected ON, set the AVIONICS MASTER PWR and EXT PWR switches to OFF. After 30 seconds set the EXP PWR and AVIONICS MASTER PWR switches to ON. Verify the GFC 700 begins an automatic pre-flight test after AHRS and ADC parameters become valid.
2. Verify that a white 'PFT' annunciation is displayed on PFD1 and PFD2, as shown in Figure 8-4.

If the 'PFT' annunciation turns red, the test has failed. Return to Section 1 for troubleshooting.
