SCR331-DI OEM Integration Manual

The scope of this document is to explain the fine points of integrating the SCM SCR331-DI Rev 2.1b dual interface reader modules into other devices.

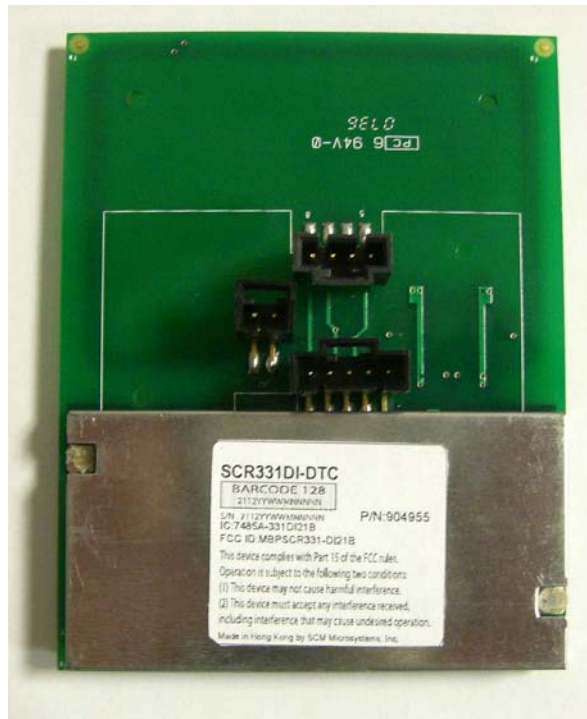
It is recommended that the module is mounted so that the antenna is parallel to the card placement position on the enclosure. The antenna area of the board has mounting holes. It is recommended to use nylon (non-metallic) screws in these mounting holes. It is also recommended that there is no metal in proximity of the antenna to ensure that signal strength is not degraded.

The board has four external connectors: one host USB header and three connectors for the optional smart card reader. The USB host connector can be found under the shield. The five pin header connects pins #1 thru #4 of the smart card connector while the four pin header connects pins #5 thru #8 of the smart card connector. The two pin header is connected to the card detect switch of the smart card connector. It is recommended that none of the cables pass over the antenna region.
