TABLE OF CONTENTS

VOL D01 M/T 3411 SERIAL 51051905

CARRL
CARRL
 Checks, Adjustments, Removals, Replacements, and Locations describes maintenance functions that can be performed on the 3410/3411 Tape Subsystem.

The 3410/3411 Magnetic Tape Subsystem consists of one or more IBM 3410 Magnetic Tape Units and an IBM 3411 Magnetic Tape Unit and Control. The major parts (tape unit and tape control) are functionally packaged (all controls used in performing a hardware function are located together) for quick isolation and replacement of a failing component. The circuitry within the subsystem (called the *attachment*), which adapts the subsystem to the I/O interface of the host system, must be considered in maintenance. Expanded sense data is provided to include more details of hardware failure than was furnished by most earlier tape subsystems.

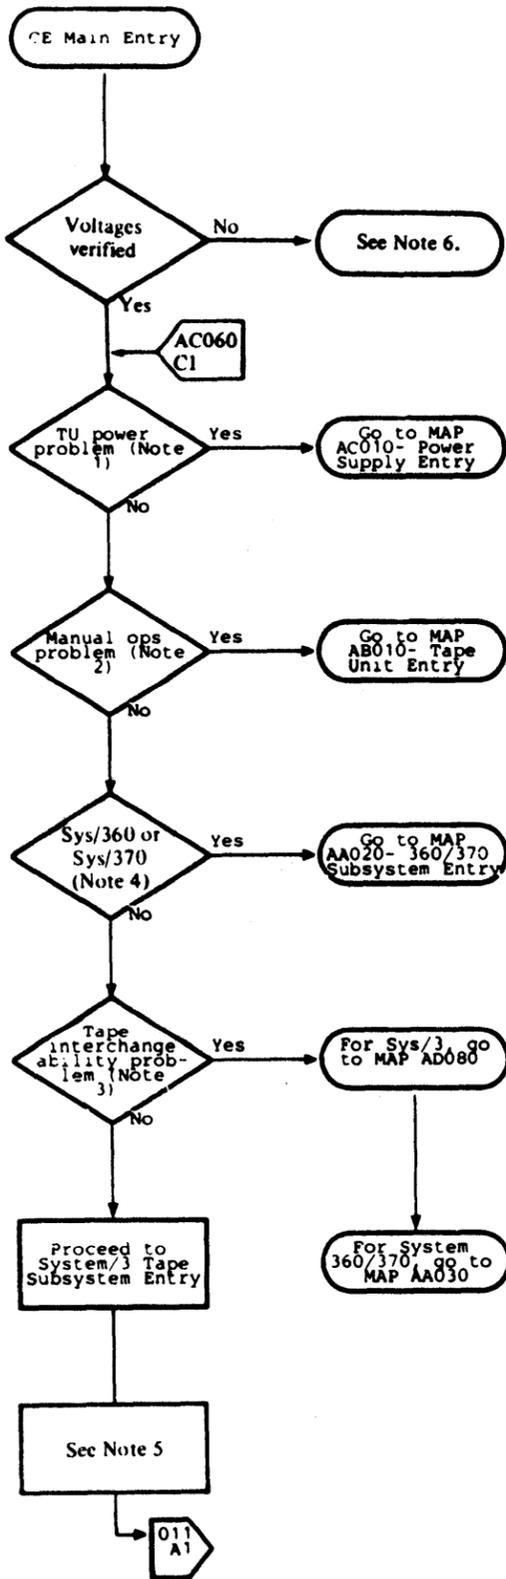
Tape Subsystem Main Entry

Discussion: This MAP is your entry point for all 3410/3411 tape subsystem problems. This, and subsequent MAPs, will help you isolate the problem; they will not direct you to any other I/O device. Make all entries from block A1 on this map.

Note 1: Power on indications are fans running and FILE PROTECT light on when tape unit is in NOT READY status.

Note 2: Manual operations include all the functions performed by use of the operator's panel and mechanical problems (such as broken cover parts, etc.)

Note 3: An interchangeability problem is the inability to read a tape on a tape unit other than the unit on which the tape was written. This problem could be caused by differences in tracking or skew between the tape units.

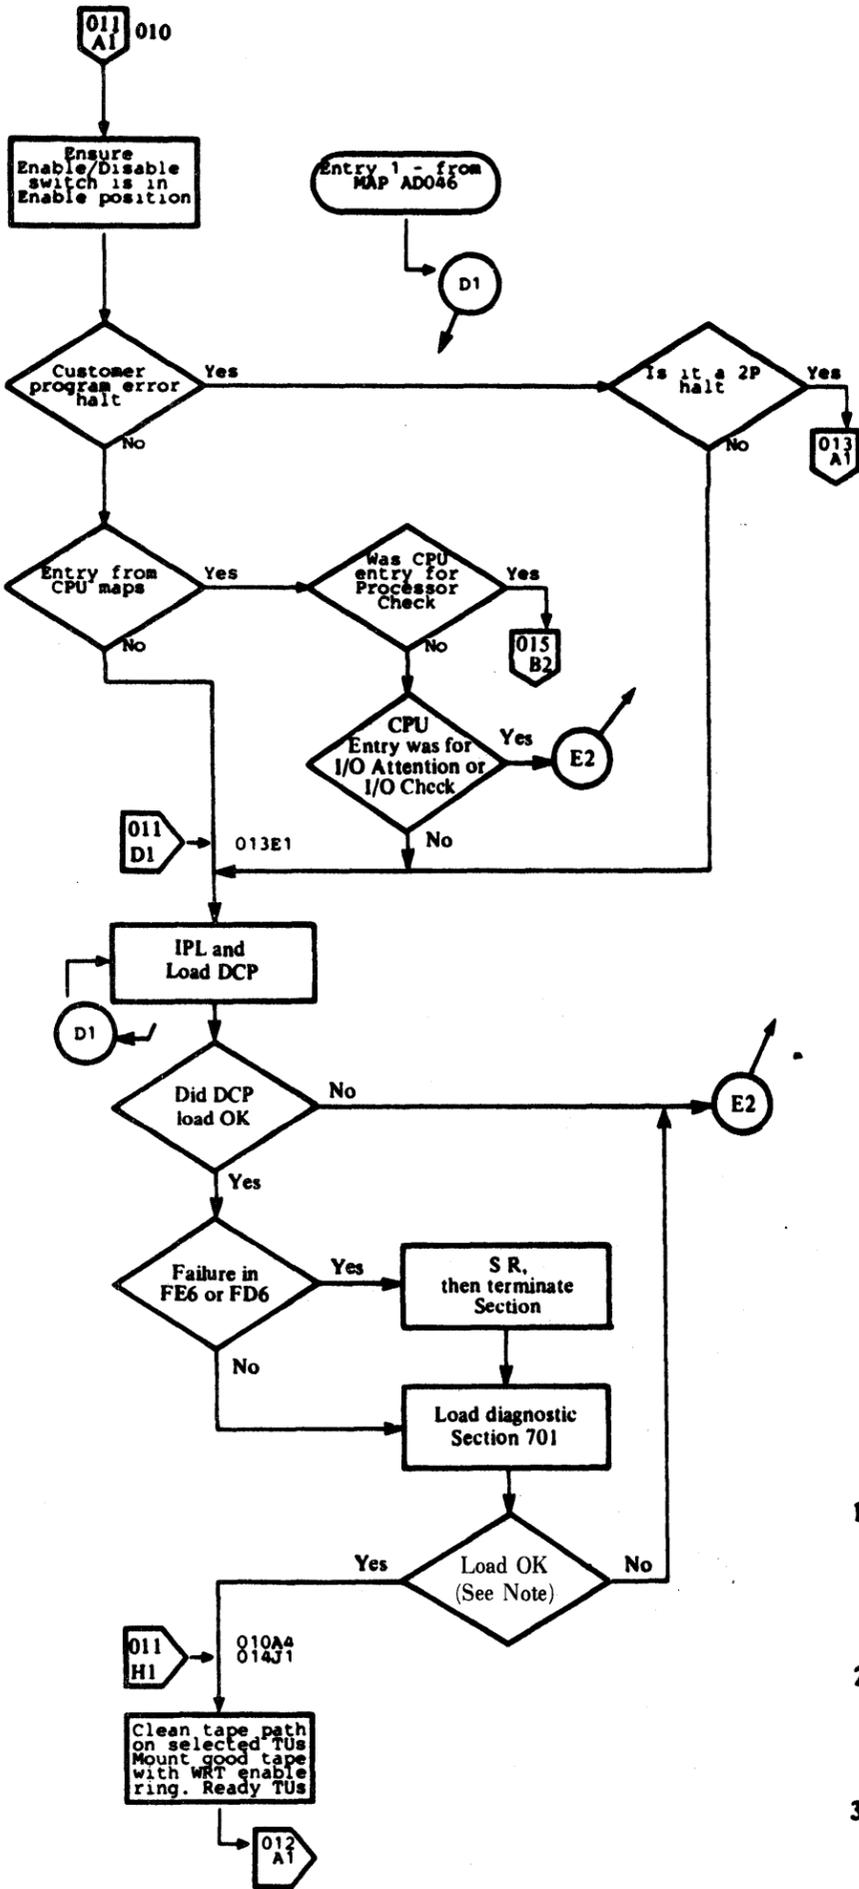
MAP AA010

Tape Subsystem Entry (System/3)

Note - Sense Switch Settings: Select desired tape units for test as follows:

SSW10	=	TU 0
SSW11	=	TU 1
SSW12	=	TU 2
SSW13	=	TU 3
SSW14	=	IF ON, Sense data will be printed on printer.

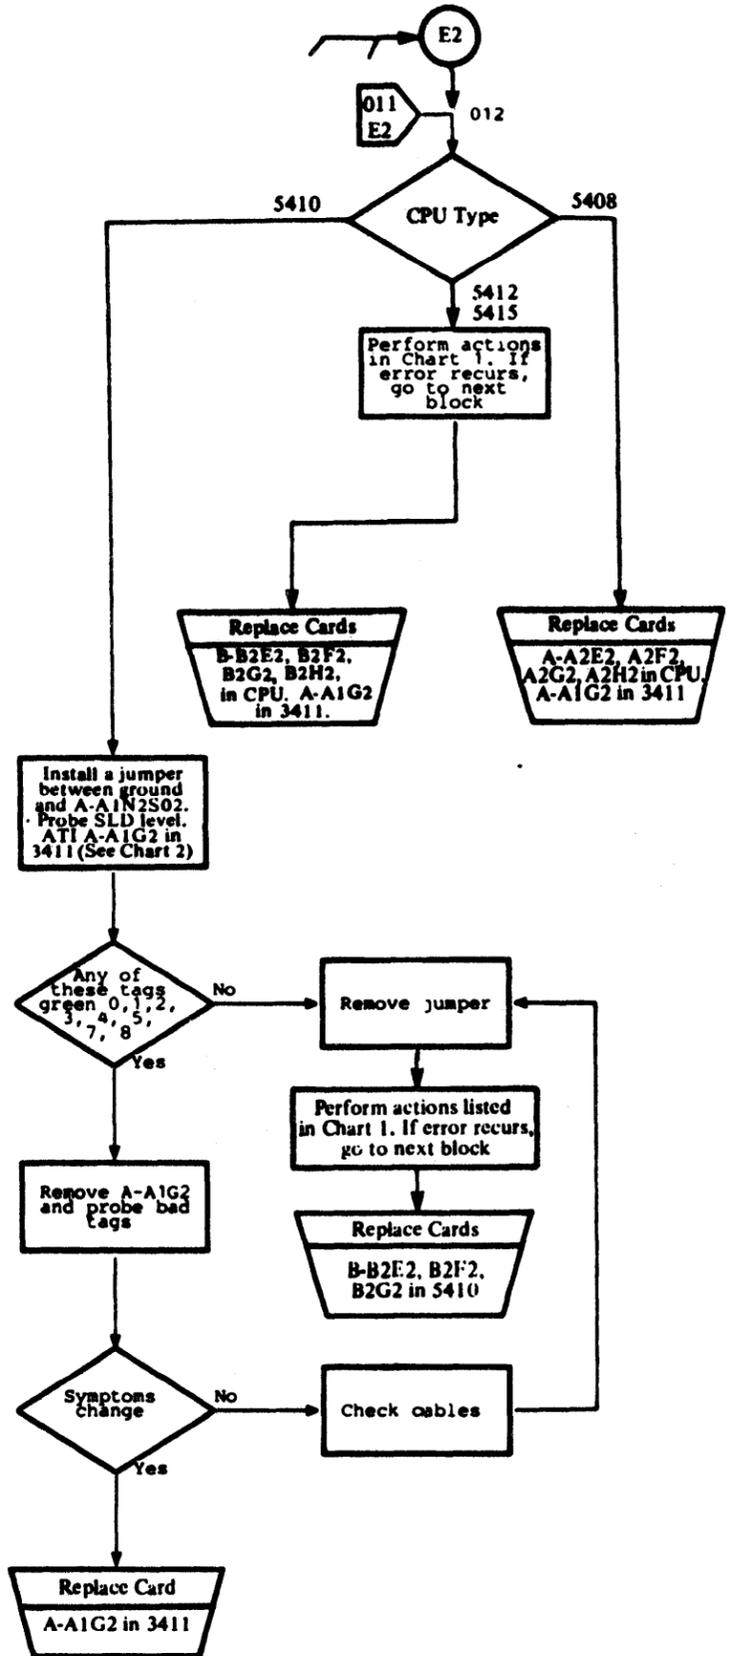
MAP AA011

Chart 1: System Reset and power down. Interchange the cards listed in the following three steps. Then power up, reload, and rerun failing routine.

If error changes or goes away, interchange the cards again but only two at a time to see which card causes the error to change.

Tape Subsystem Entry (System/3)

1. Pull A-B2C2.
Put A-B2D2 in A-B2C2
Put A-B2E2 in A-B2D2
Put A-B2F2 in A-B2E2
Put original A-B2C2 card in B2F2.
2. Pull A-B2E4.
Put A-B2F4 in A-B2E4
Put A-B2G4 in A-B2F4
Put original A-B2E4 in A-B2G4.
3. Interchange terminators that will be located on one of the following boards:
 - a. B-A2U2, B-A2U3
 - b. B-B2B2, B-B2B3
 - c. B-A1U2, B-A1U3
 - d. B-B1J2, B-B1J3

Check Bus In cables by using System pages: WB201, WB203, WB205, WB207

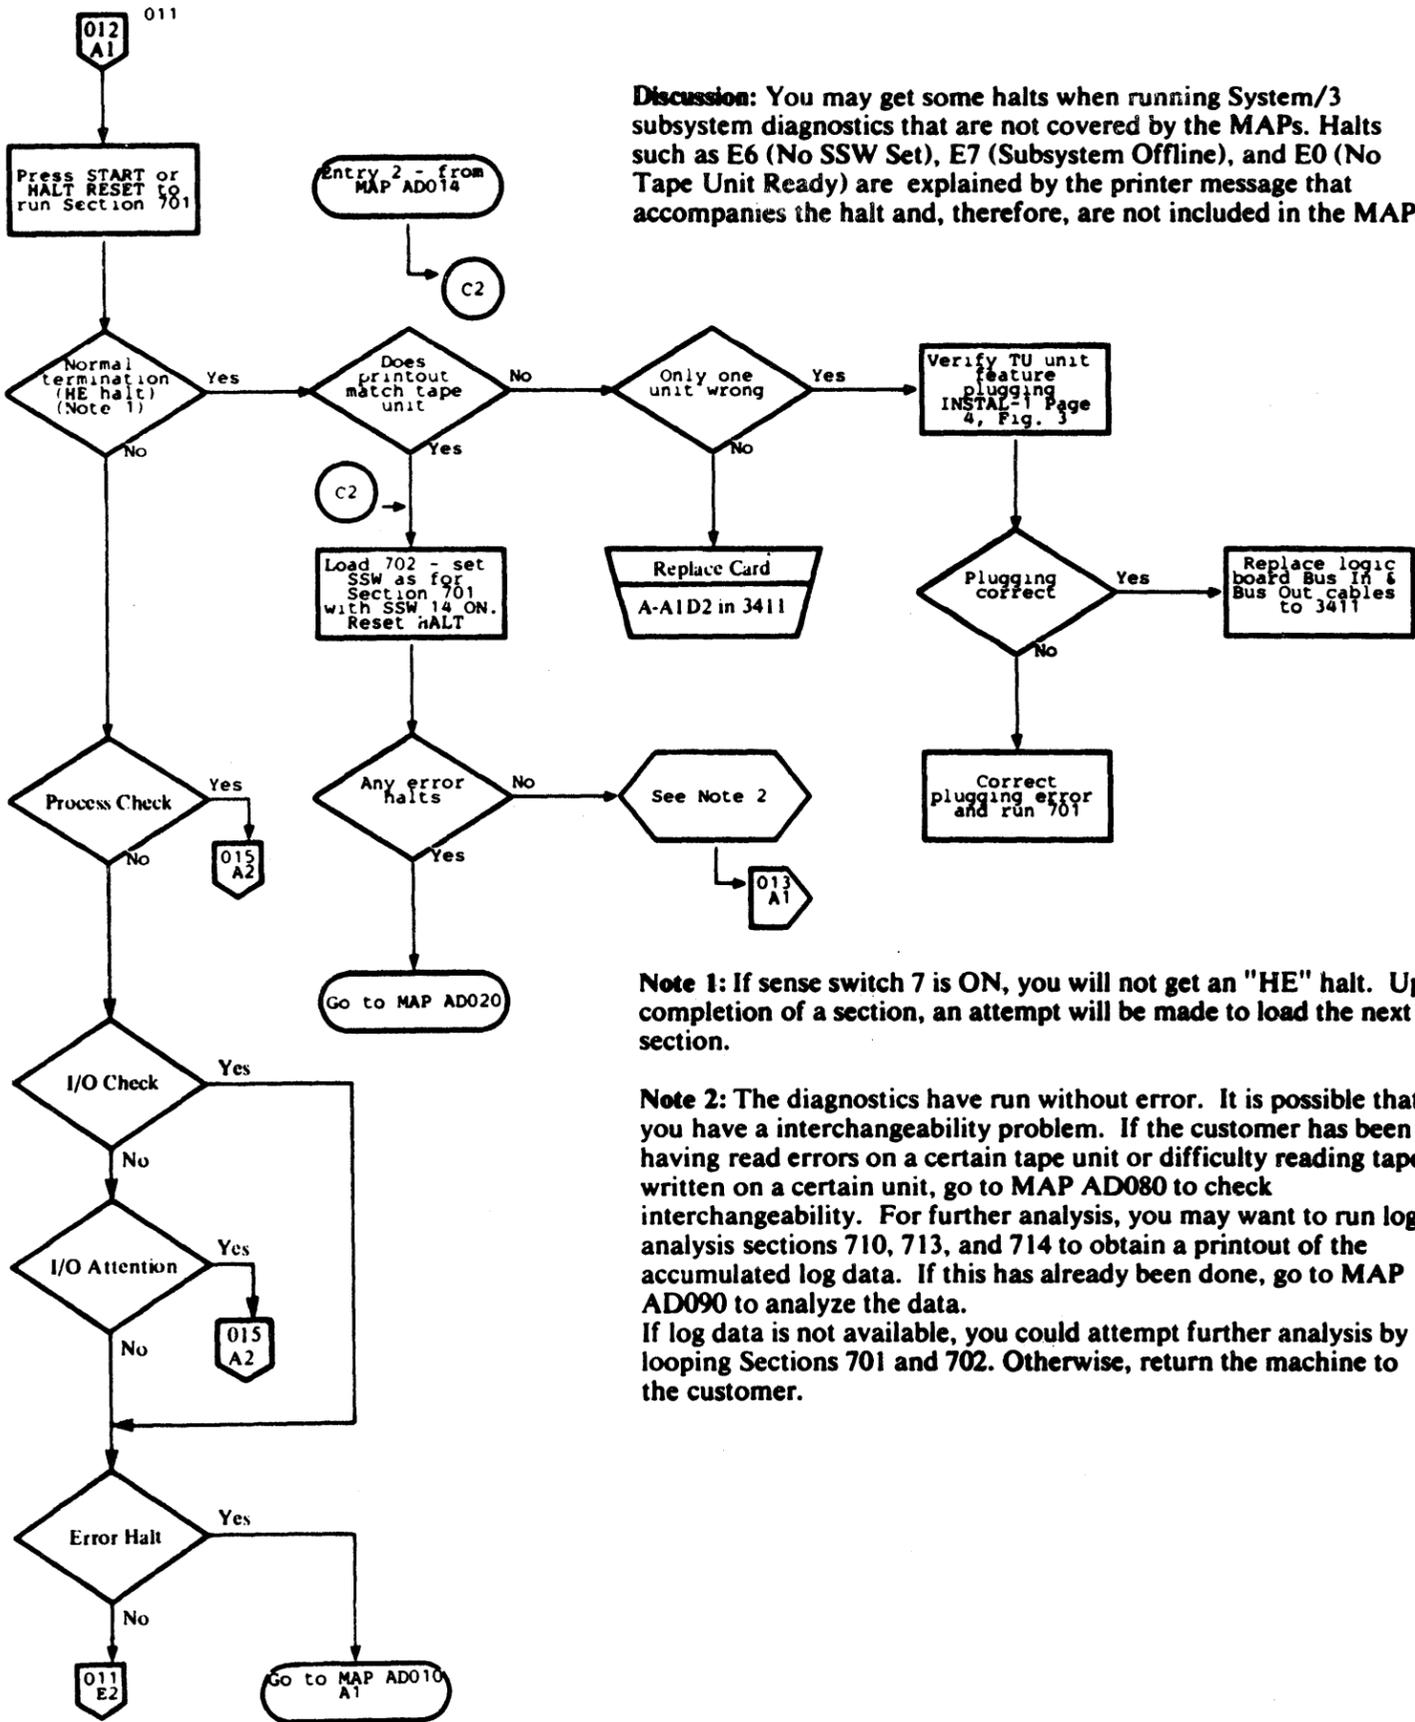
Tape Subsystem Entry (System/3)

Discussion: You may get some halts when running System/3 subsystem diagnostics that are not covered by the MAPs. Halts such as E6 (No SSW Set), E7 (Subsystem Offline), and E0 (No Tape Unit Ready) are explained by the printer message that accompanies the halt and, therefore, are not included in the MAPs.

Note 1: If sense switch 7 is ON, you will not get an "HE" halt. Upon completion of a section, an attempt will be made to load the next section.

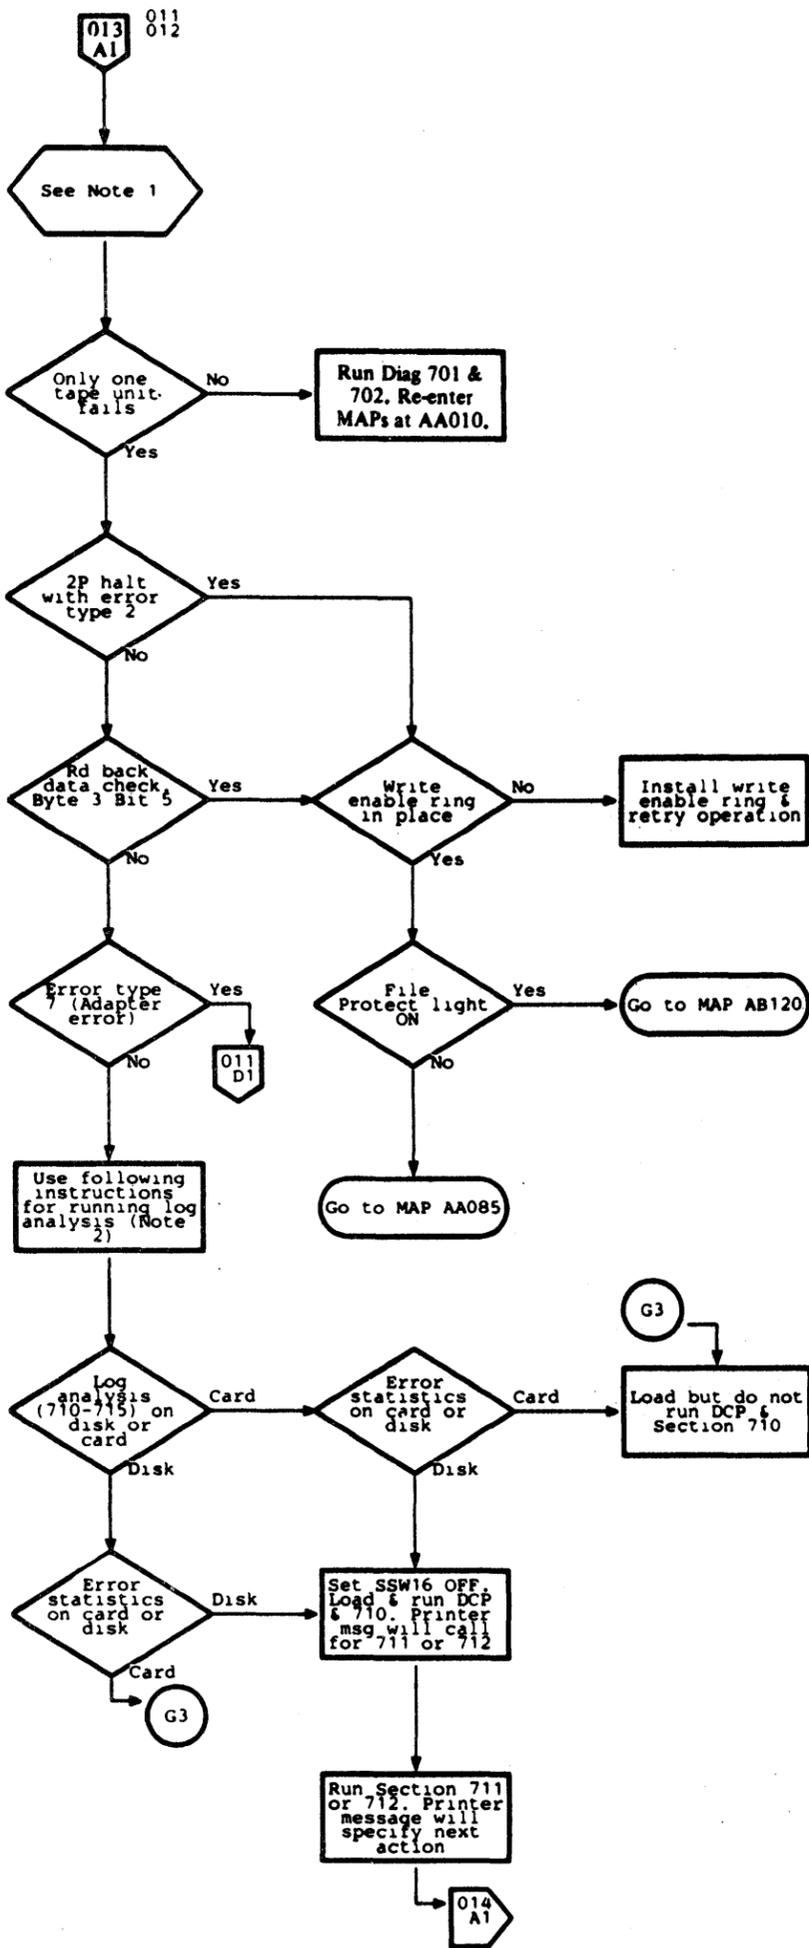
Tape Subsystem Entry (System/3)

Note 1: Determine if customer has a 2P halt; for any other halt, the customer should refer to the *System Control Program Halt Code Manual* for instructions. A 2P halt indicates a permanent tape error. The second byte of the halt code indicates the tape unit and type of error as follows:

Note 2 - Log Analysis: Log analysis is a diagnostic program used to analyze tape error statistics accumulated by the customer's IBM System Control Program. The disk system accumulates the statistics on the disk pack where they can be accessed by the log analysis program. The basic card system stores the statistics in core storage until the end of the job, when they can be punched into cards by the customer. If your customer is operating with the basic card system, and he has not punched out the error statistics or saved the cards, you must, when using log analysis, regenerate error log data.

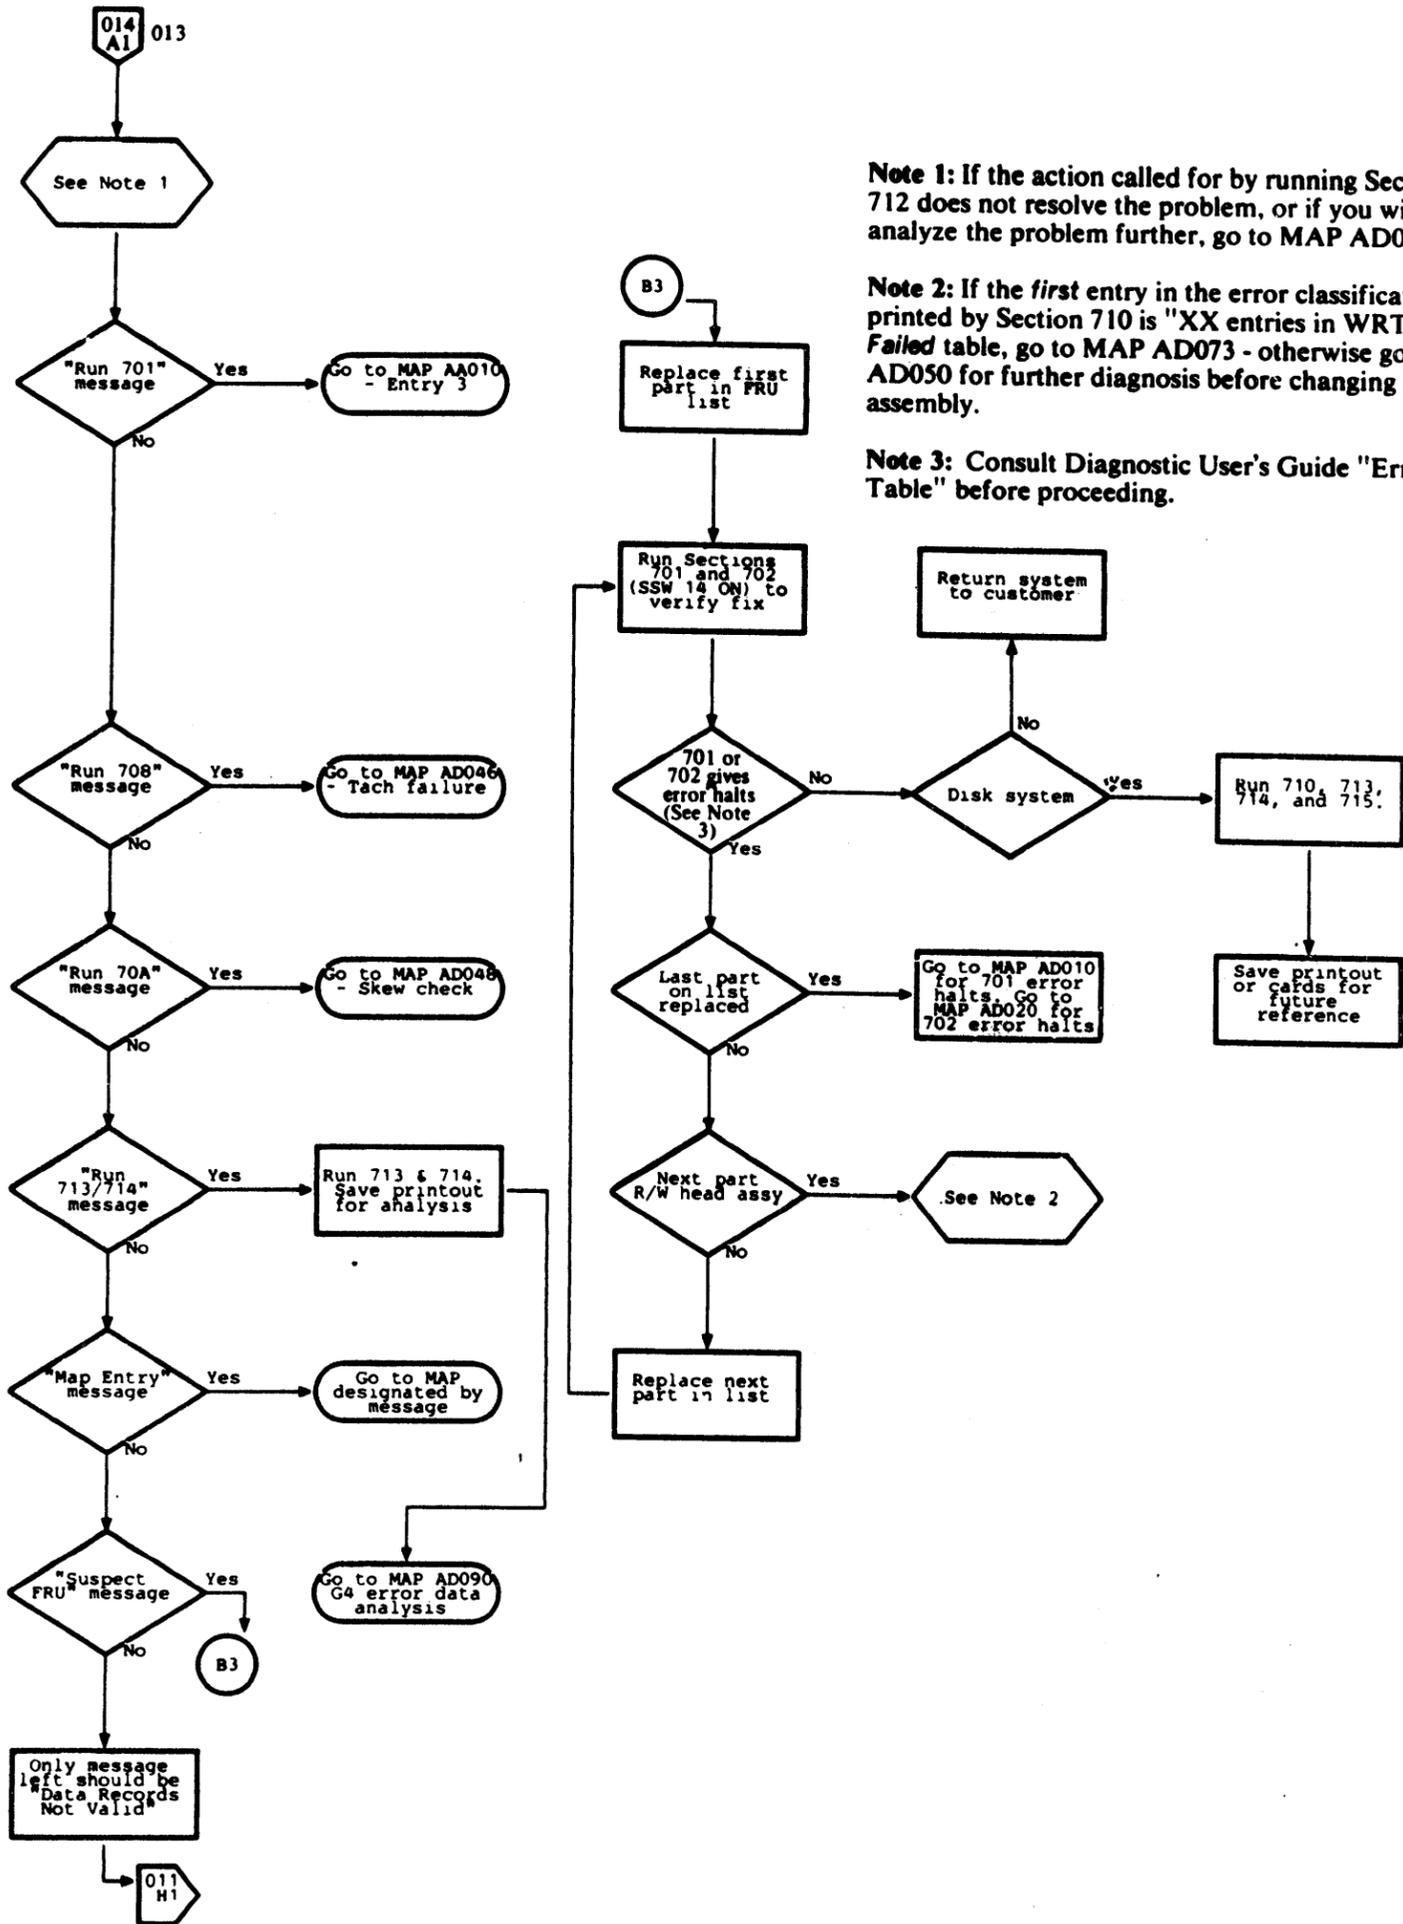
Tape Subsystem Entry (System/3)

Note 1: If the action called for by running Section 711 or 712 does not resolve the problem, or if you wish to analyze the problem further, go to MAP AD090 G4.

Note 2: If the first entry in the error classification table printed by Section 710 is "XX entries in WRT LWR" Failed table, go to MAP AD073 - otherwise go to MAP AD050 for further diagnosis before changing read/write assembly.

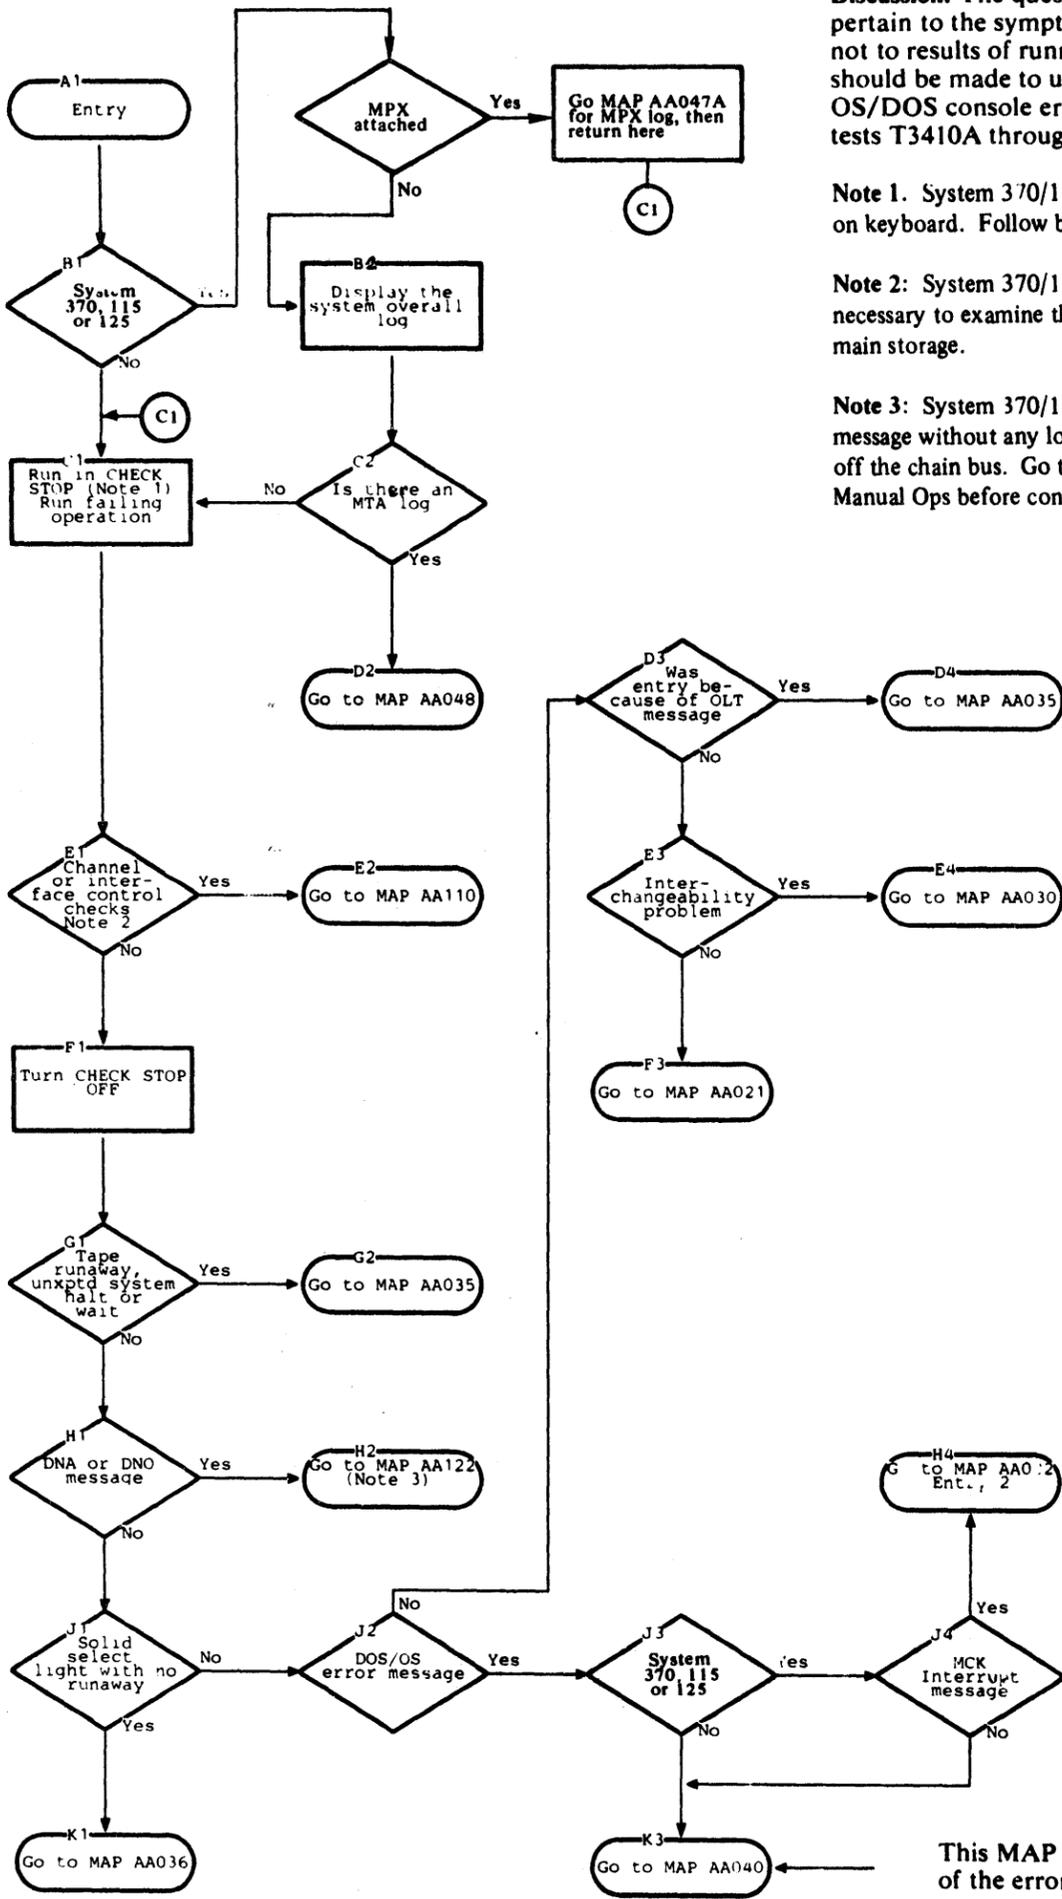
MAP AA016

Tape Subsystem Entry (System/360; System /370)

Discussion: The questions at the beginning of this MAP pertain to the symptoms reported by the customer and not to results of running the online tests. An attempt should be made to utilize the sense information in the OS/DOS console error message before running the online tests T3410A through O.

Note 1: System 370/115 and System 370/125, Mode Sel "K" on keyboard. Follow by running in "I/O STOP" mode.

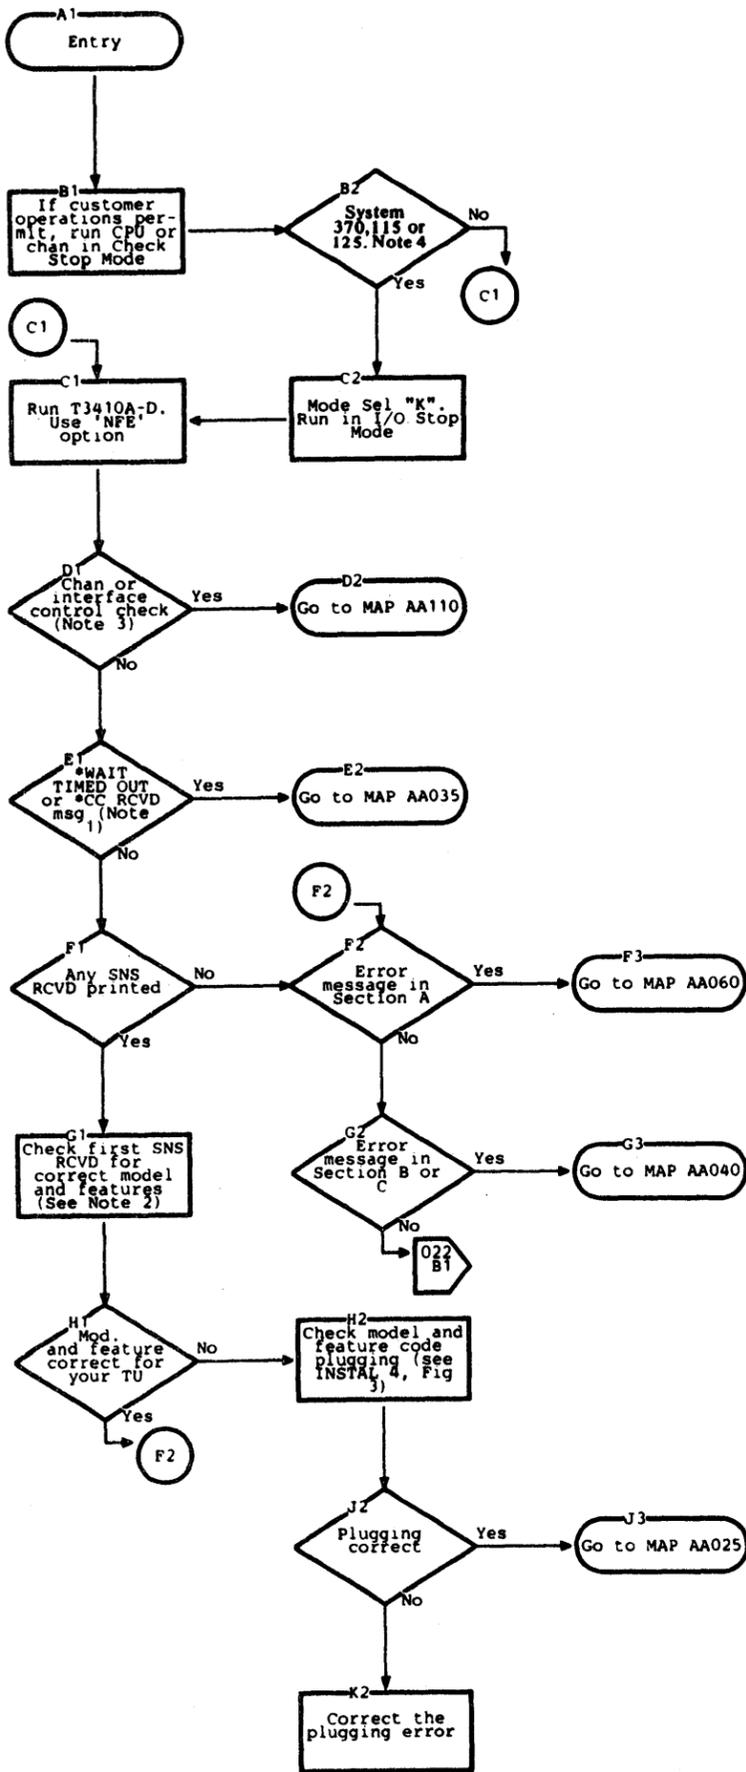
On Line Tests (OLTs)

Discussion: The OLT sections are called for in small groups by this MAP in an effort to reduce running time. Most solid failures will cause errors in Sections A through D. If you would rather run all sections at the same time, run A through O, take the printout, and answer the questions on this page. Always start with the first error message on the printout. If channel errors are suspected, run the OLTs with the channel in Check Stop Mode.

OLT Section D performs the LWR test and effectively checks the read chain from an addressed tape unit through the tape control detection. Errors only are indicated. The R/W head and shielded cable to the R/W logic board are not checked by this routine.

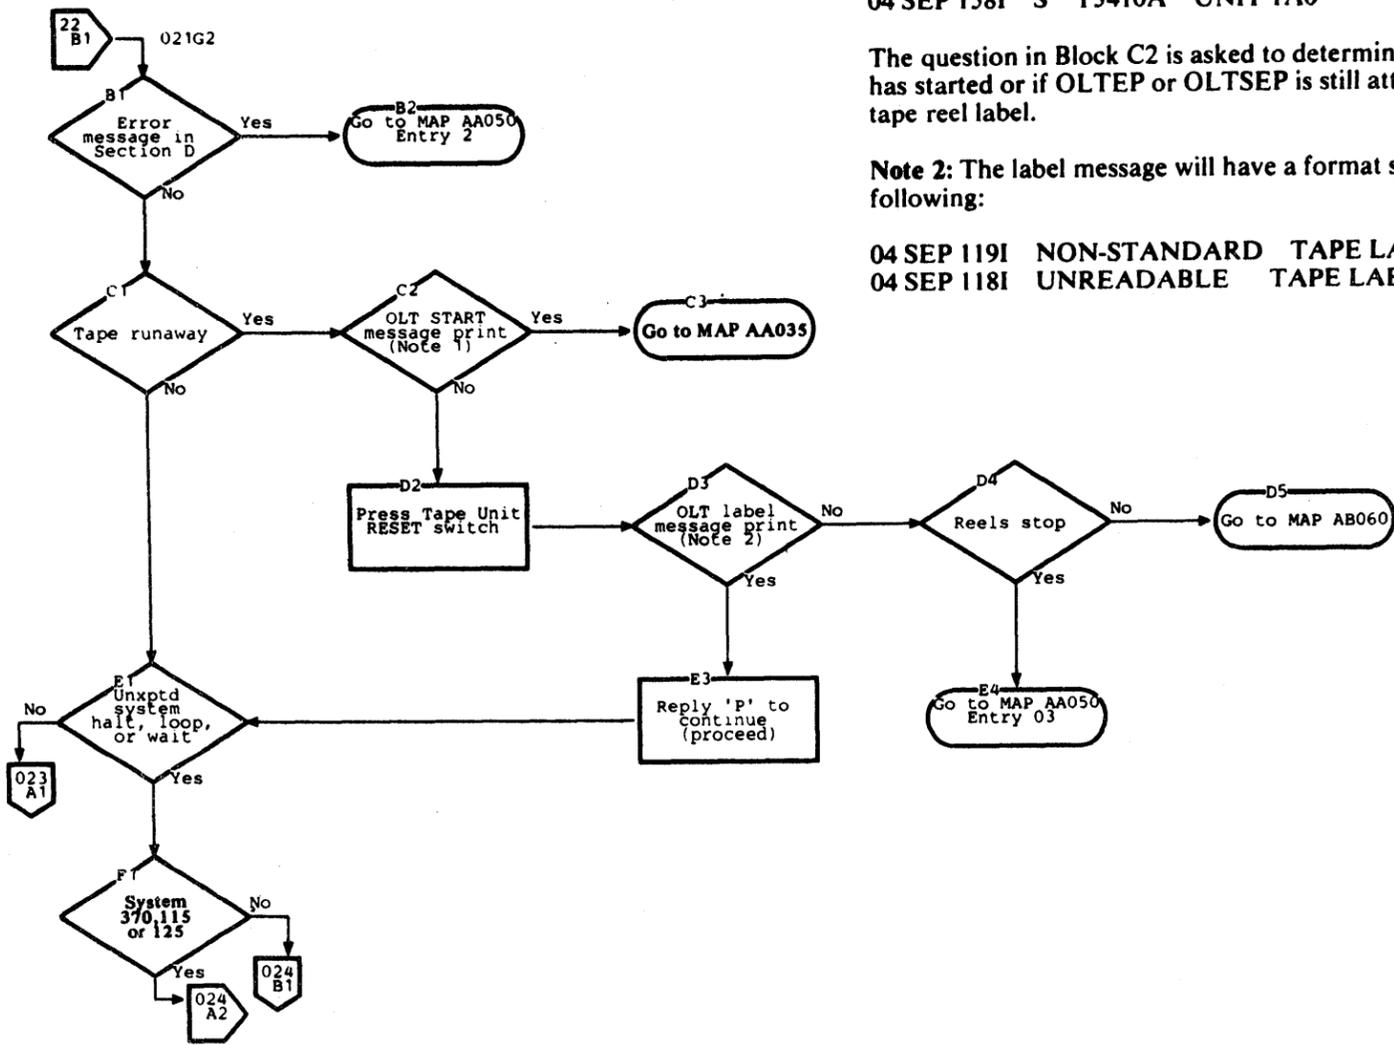
On Line Tests (OLTs)

Note 1: The start message will have a format similar to the following:

04 SEP 158I S T3410A UNIT 1A0

04 SEP 119I NON-STANDARD TAPE LABEL ON 01A0, or
04 SEP 118I UNREADABLE TAPE LABEL ON 01A0

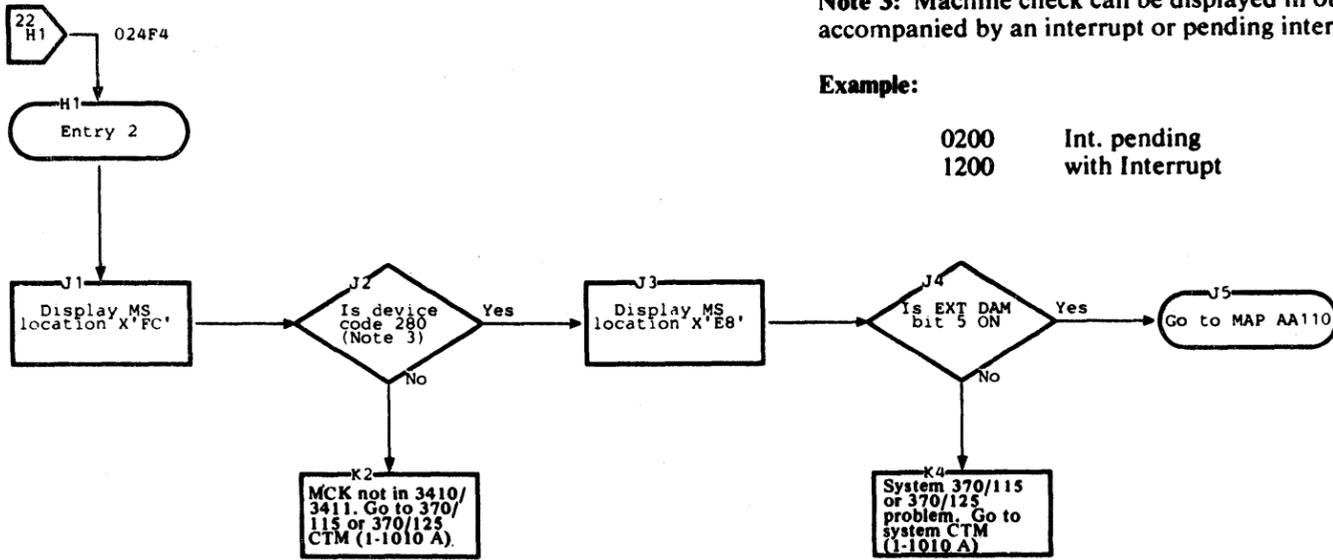
Machine Check Entry - System 370/115 or 370/125

Note 3: Machine check can be displayed in other forms if accompanied by an interrupt or pending interrupt.

Example:

0200 Int. pending
1200 with Interrupt

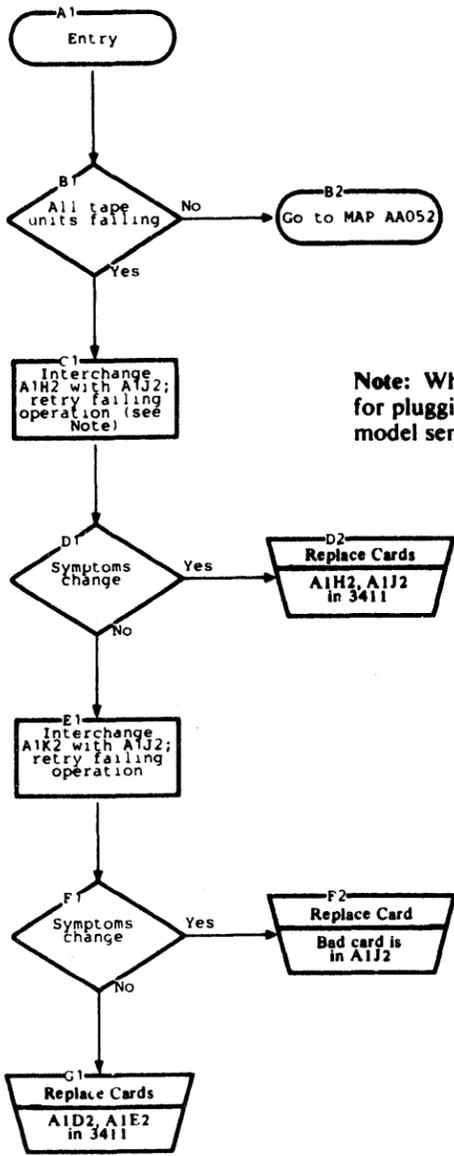
Tape Unit Sense Failure

Note: When interchanging A-A1H2, A-A1J2, and A-A1K2, refer to ALD page A6001 for plugging instructions. All three cards should be factory plugged as position "K" is model sensitive. If they are not plugged, refer to the above ALD page.

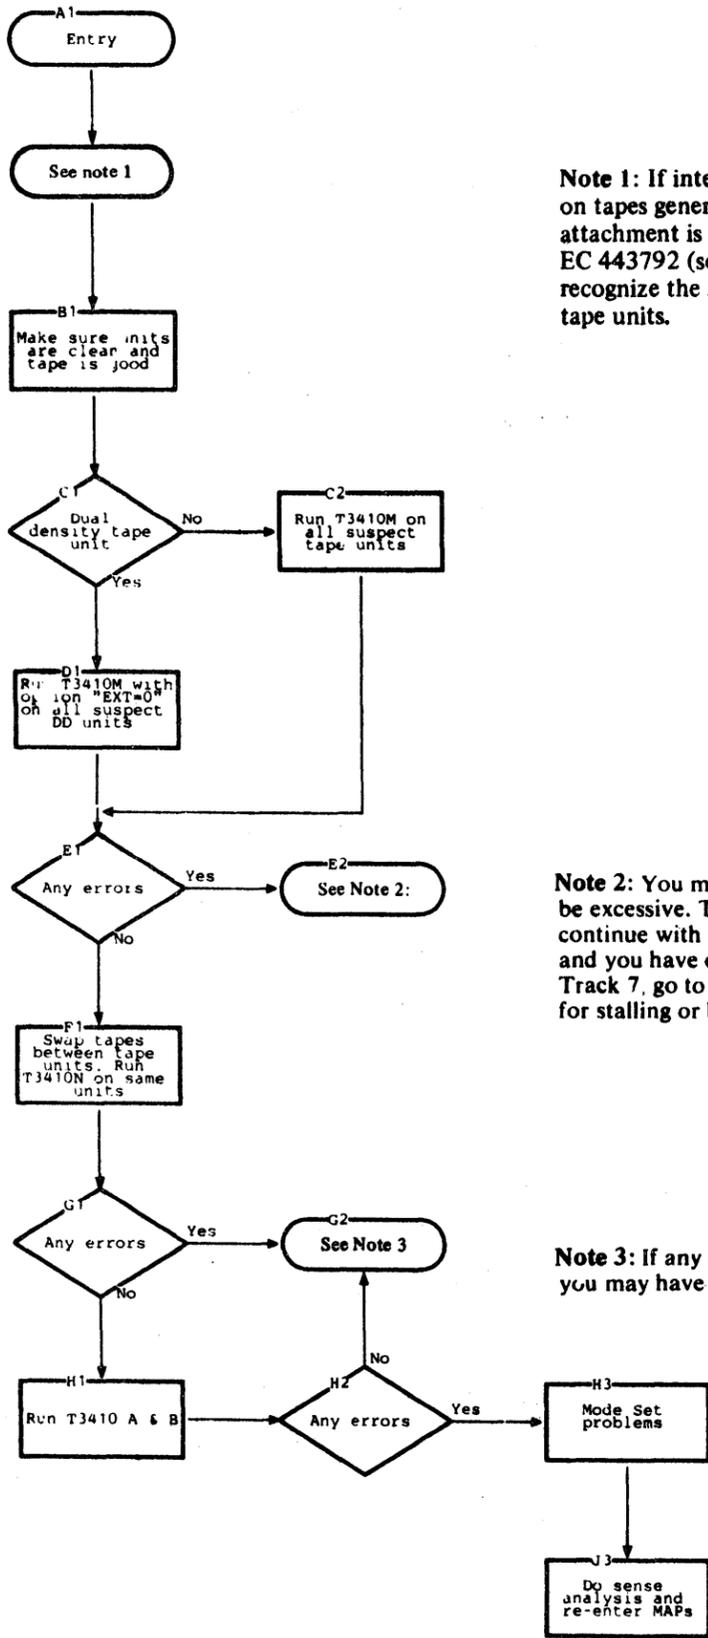
Interchangeability

Discussion: An interchangeability problem would be a failure of a tape volume to read on a unit other than the one on which it was written. This problem could be caused by skew or tracking "off" in one or both of the tape units.
 Failure to Mode Set correctly on dual density units may also lead to interchangeability problems. Sense analysis should indicate incorrect Mode Set.

Note 1: If interchange problems occur while reading tape marks on tapes generated by 24XX series tape units, and the 3411 attachment is a S/370 CPU Model 115 or 125 Model 3, install EC 443792 (see 3411 ECA 044). This EC allows the 3411 to recognize the 32 bit tape marks written on the 24XX series tape units.

Note 2: You may want to ignore write errors unless they appear to be excessive. To pursue write errors, go to MAP AA040; otherwise, continue with Block E1 on this page. If subsystem is a 3411 Mod 1 and you have excessive write errors, predominantly TIE Data Track 7, go to CARRL D 24 and check the lower left guide roller for stalling or binding.

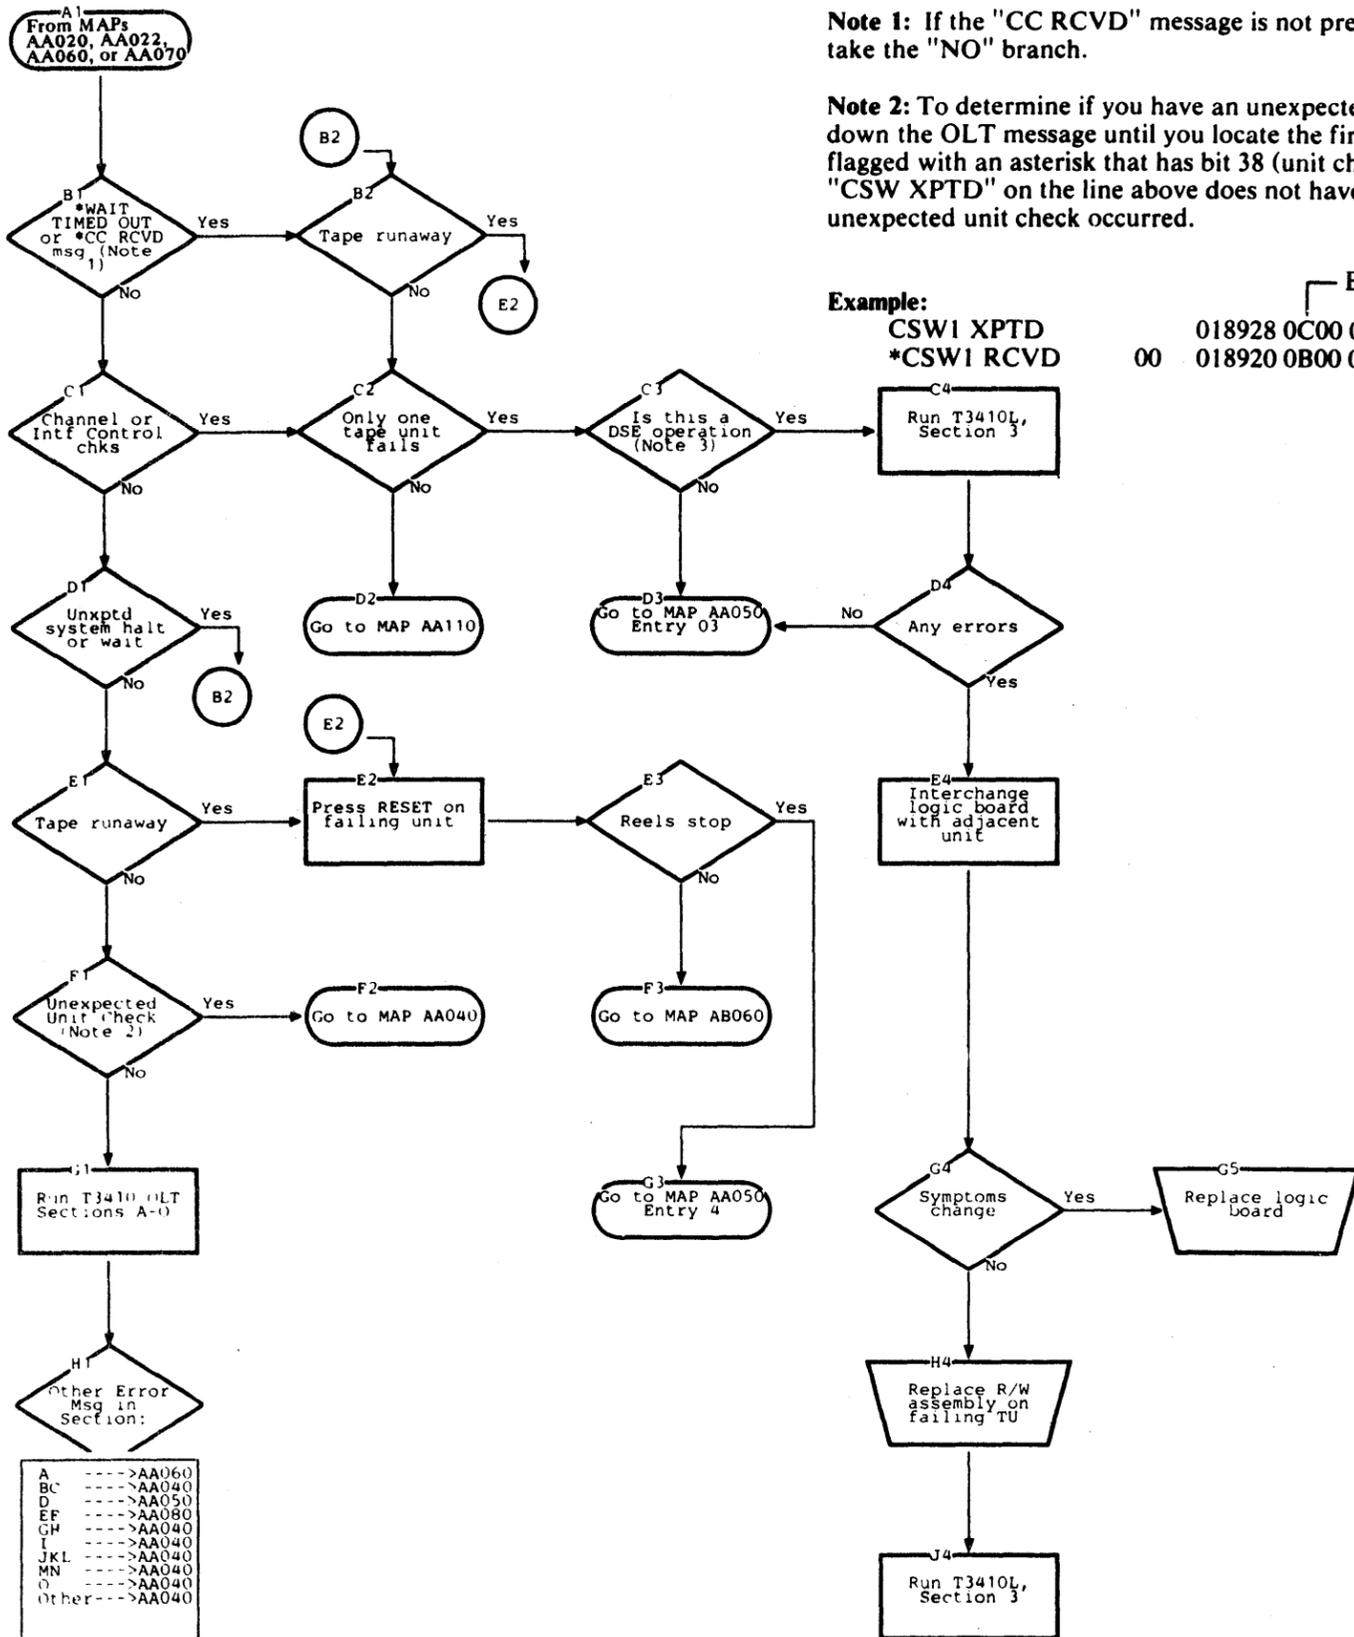
OLT Messages and Tape Subsystem Entry 360/370

Note 3: During a DSE operation, if all tape units fail T3410L Section 3, the problem is in 01A1N2, 01A1D2, or 01A1E2.
