TABLE OF CONTENTS

VOL D01 M/T 3411 SERIAL 51051905

CARRL
CARRL
 Checks, Adjustments, Removals, Replacements, and Locations describes maintenance functions that can be performed on the 3410/3411 Tape Subsystem.

The 3410/3411 Magnetic Tape Subsystem consists of one or more IBM 3410 Magnetic Tape Units and an IBM 3411 Magnetic Tape Unit and Control. The major parts (tape unit and tape control) are functionally packaged (all controls used in performing a hardware function are located together) for quick isolation and replacement of a failing component. The circuitry within the subsystem (called the *attachment*), which adapts the subsystem to the I/O interface of the host system, must be considered in maintenance. Expanded sense data is provided to include more details of hardware failure than was furnished by most earlier tape subsystems.

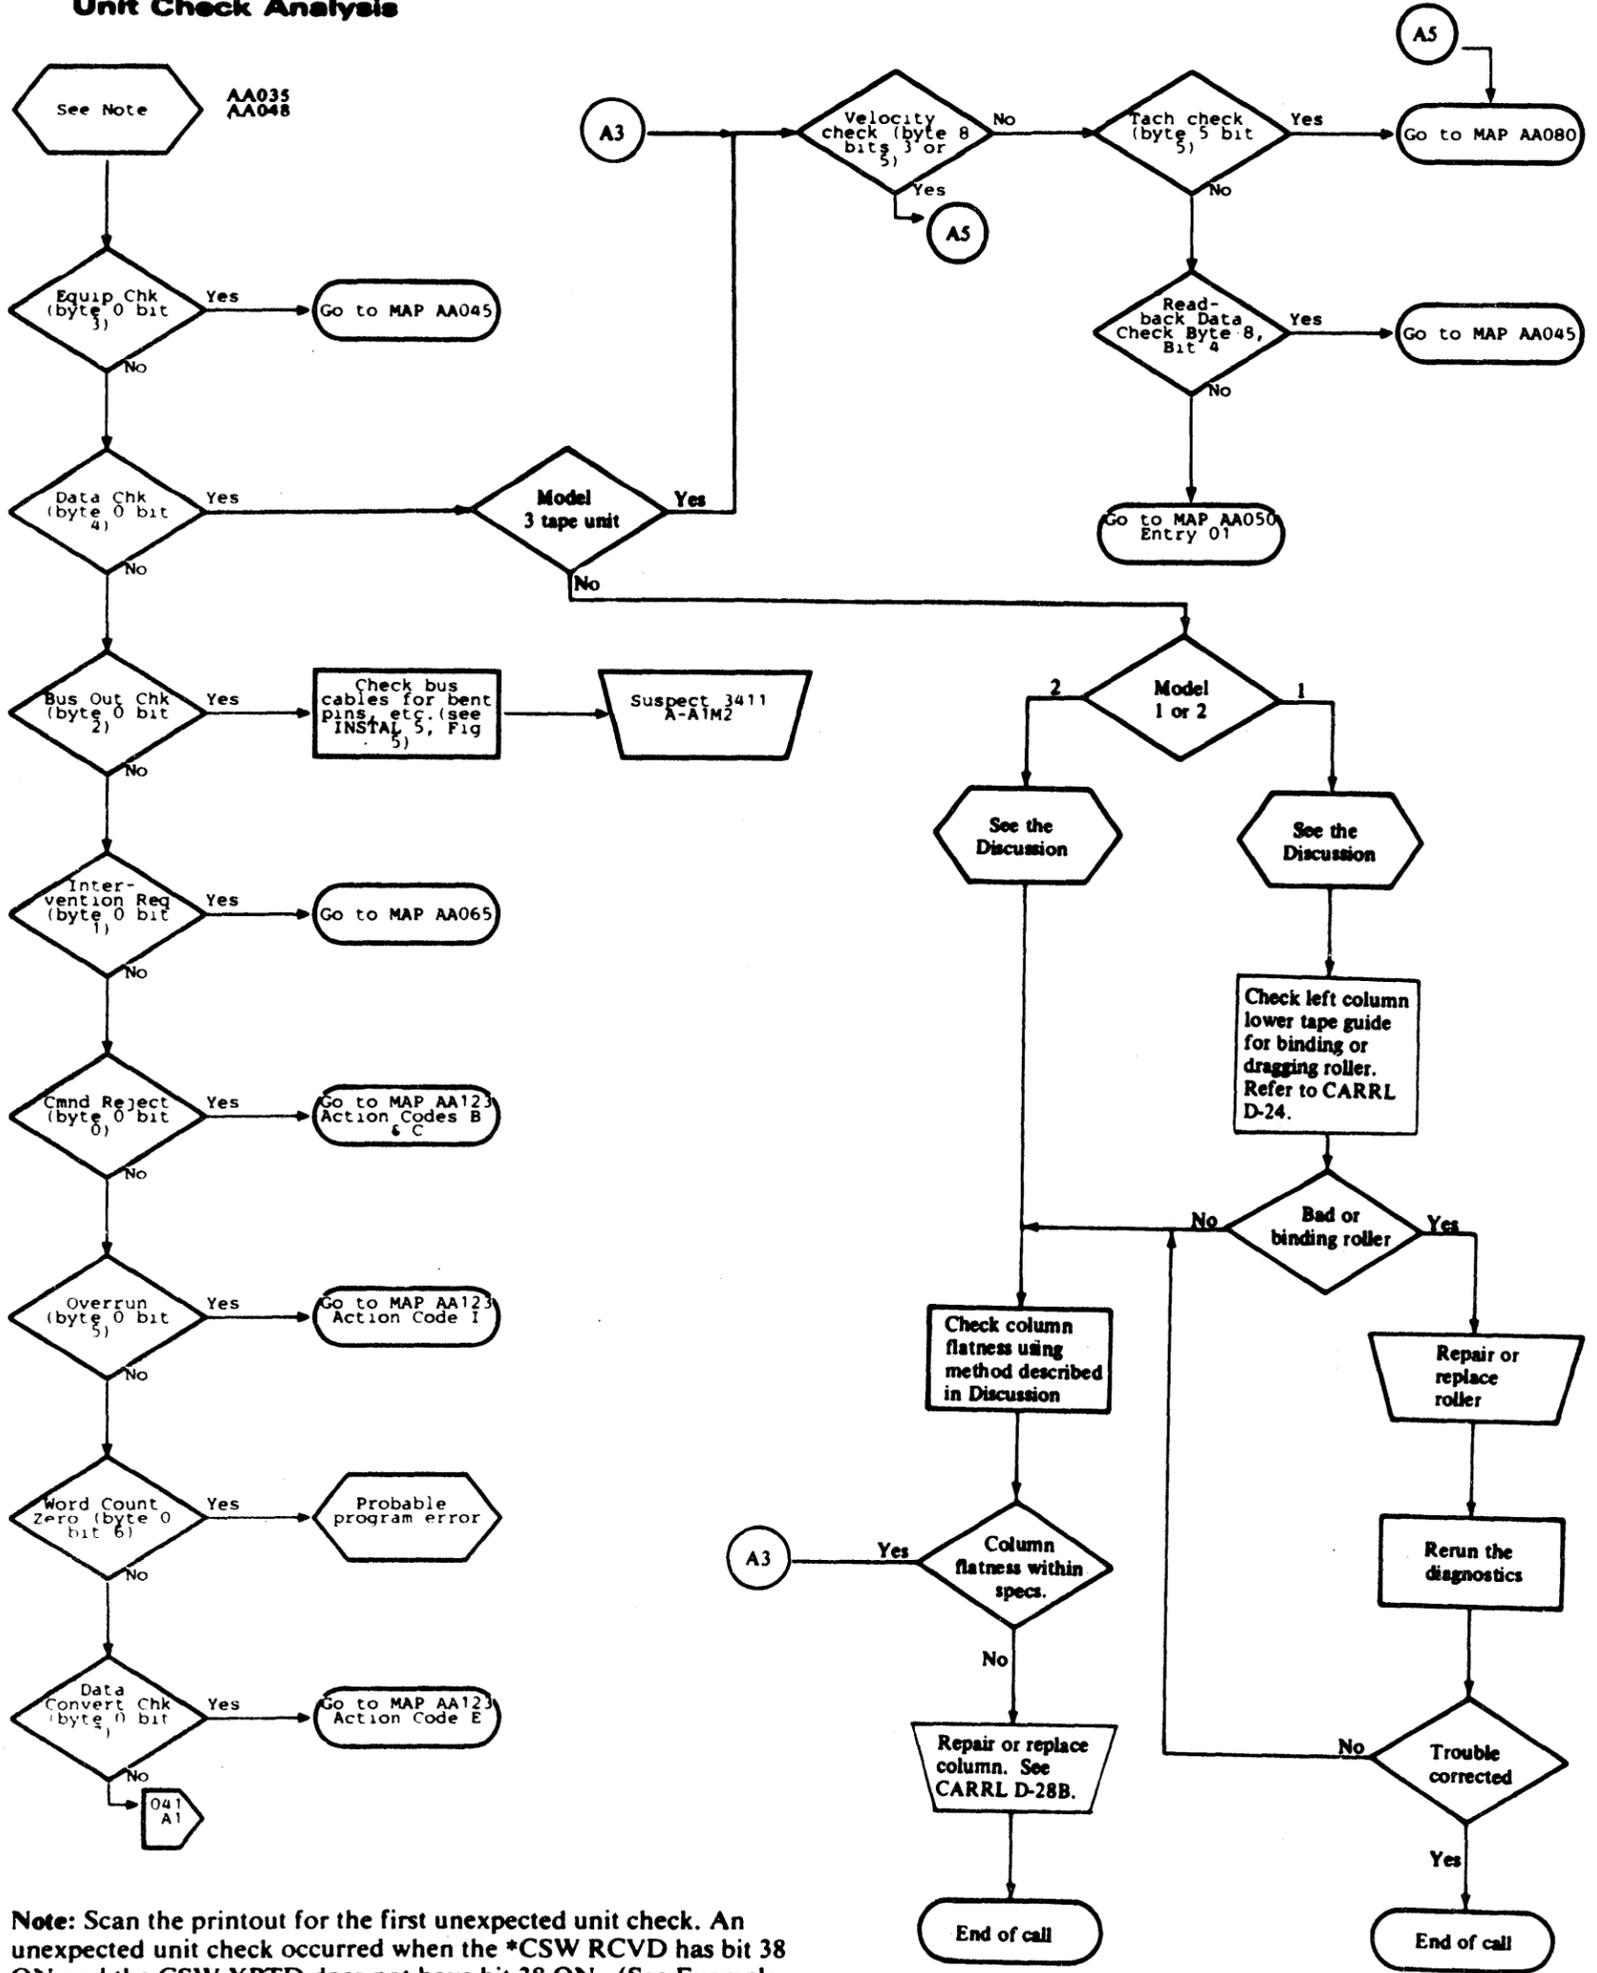
Unit Check Analysis

Note: Scan the printout for the first unexpected unit check. An unexpected unit check occurred when the *CSW RCVD has bit 38 ON and the CSW XPTD does not have bit 38 ON. (See Example 1.)

The byte and bit notation used in this MAP refers to the sense data printed out with the error message. In the case of OLT messages, the reference is to the sense received (SNS 00-08 RCVD) line of the message. Bits are counted 0-7, left to right. 3410/3411 sense bytes are numbered 0-8, left to right. (See Example 2.)

Common causes of a velocity rate change error are:

- 1- Lower tape guide in the left column (model 1 only) has a binding roller. Check the roller for free rotation. It is important that all washers and springs are properly installed. Refer to CARRL D-24 for correct installation.
- 2- Check for column flatness on models 1 and 2. Excessive warpage of the vacuum column can cause excessive vibration at the tape loop. Flatness of the vacuum column in the tape loop area should be checked using a straight edge. (The edge of the half column cover, PN 2517722, can be used for this measurement.) Column should be flat within 0.015 inches (0.381 mm) over the area below the BOT/EOT block the full width of the column.

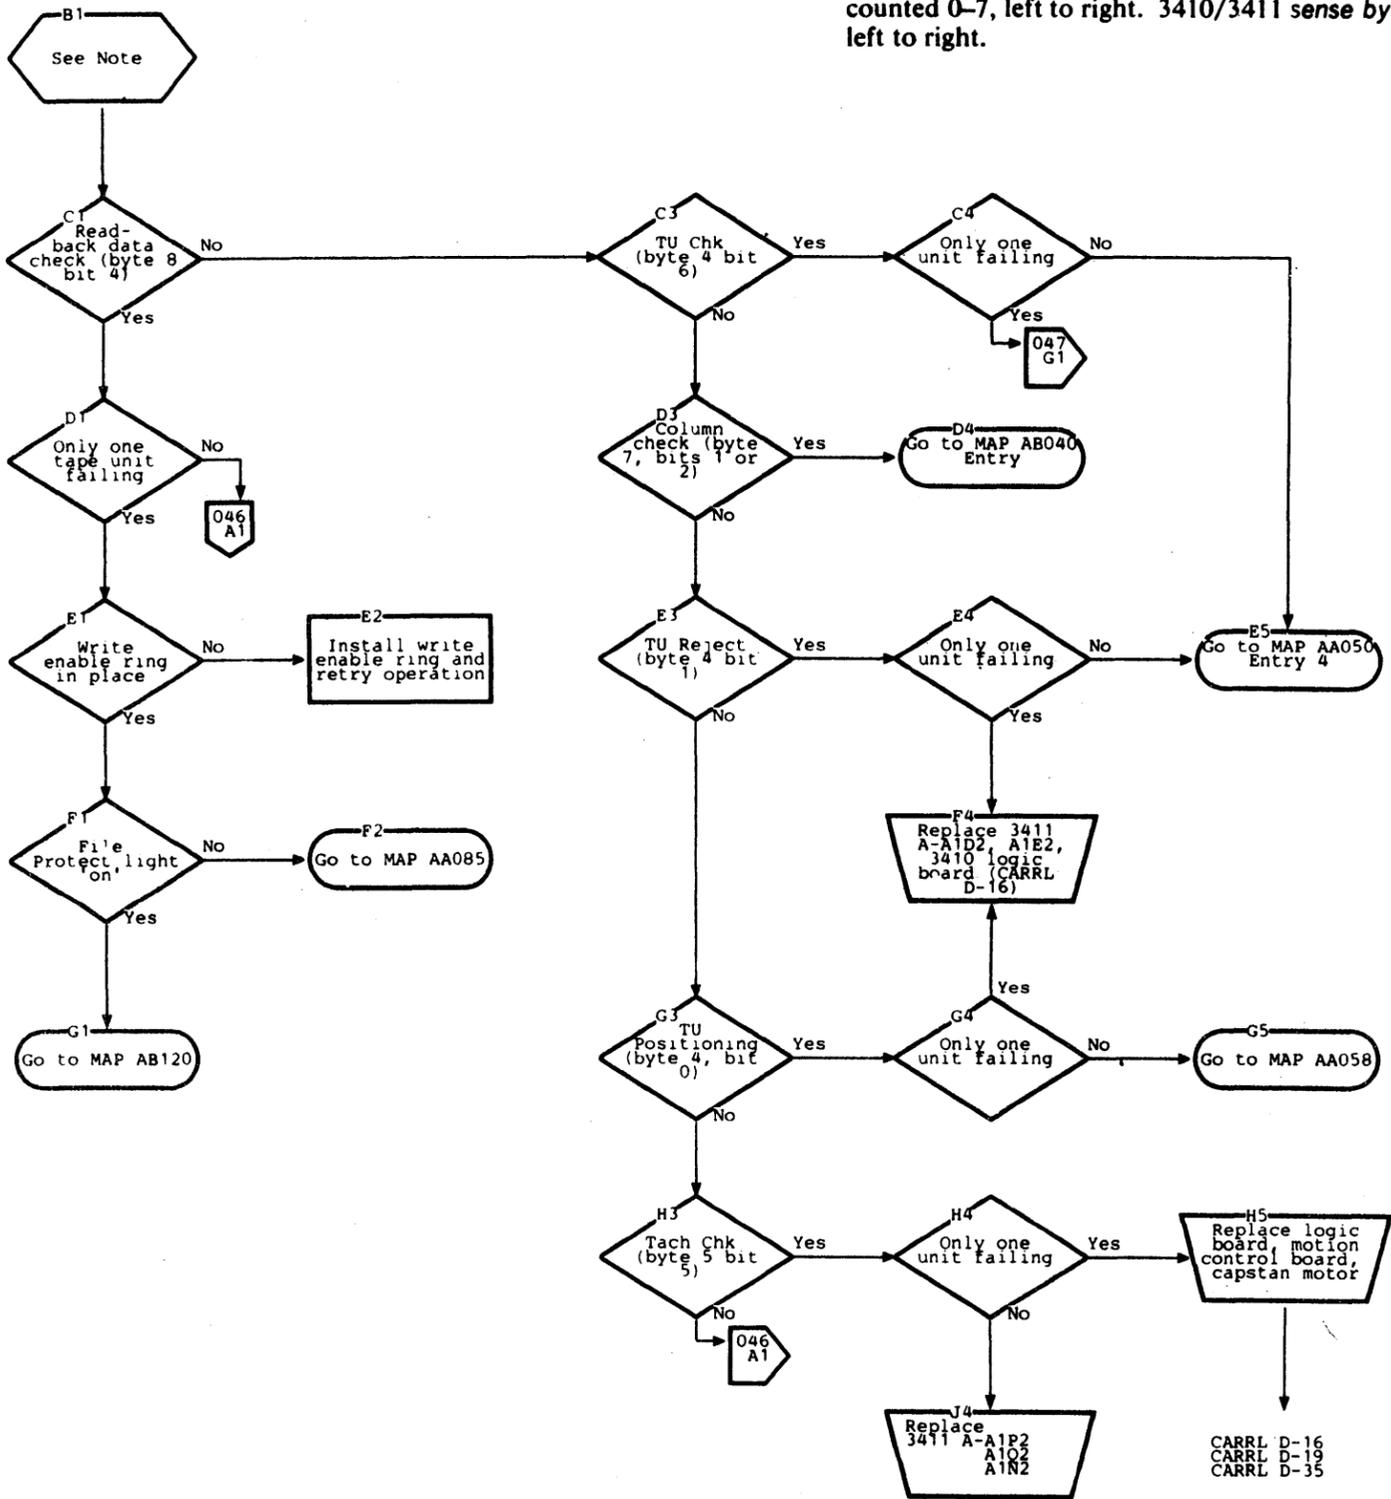
Equipment Check

Note: Enter this MAP if you have equipment checks. If the action called for by this MAP does not resolve the problem, go to MAP AA050 Entry 3 for further analysis. The byte and bit notation used in this MAP refers to the sense data printed out with the error message. In the case of OLT messages, the reference is to the sense received (SNS00-08 RCVD) line of the message. Bits are counted 0-7, left to right. 3410/3411 sense bytes are numbered 0-8, left to right.

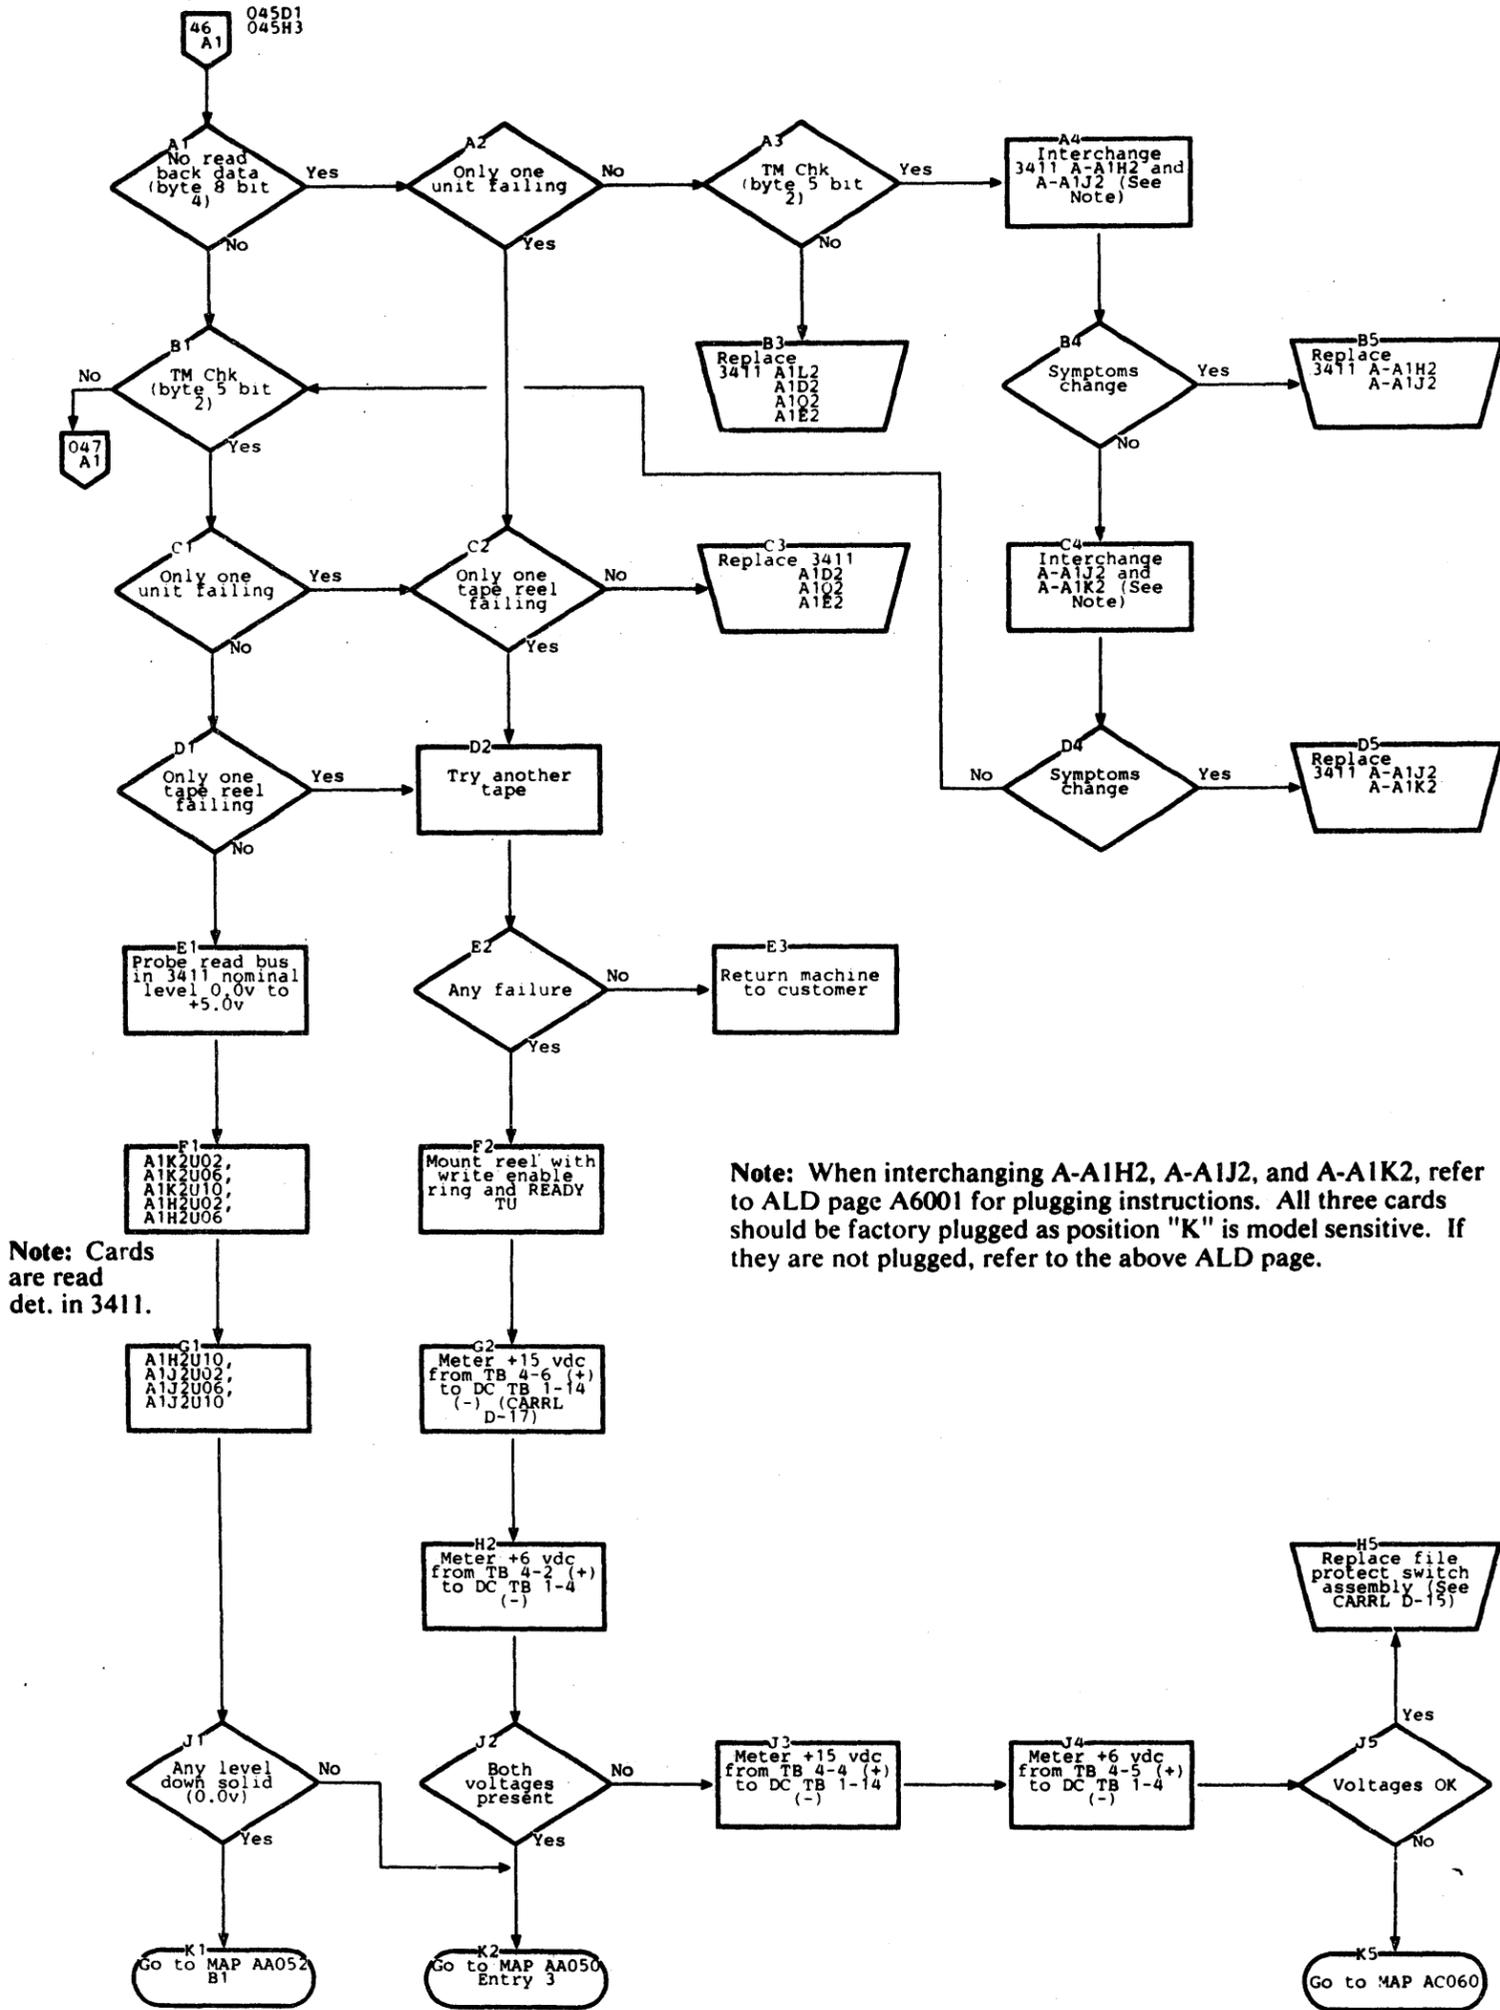
Equipment Check

Note: Cards are read det. in 3411.

Note: When interchanging A-A1H2, A-A1J2, and A-A1K2, refer to ALD page A6001 for plugging instructions. All three cards should be factory plugged as position "K" is model sensitive. If they are not plugged, refer to the above ALD page.

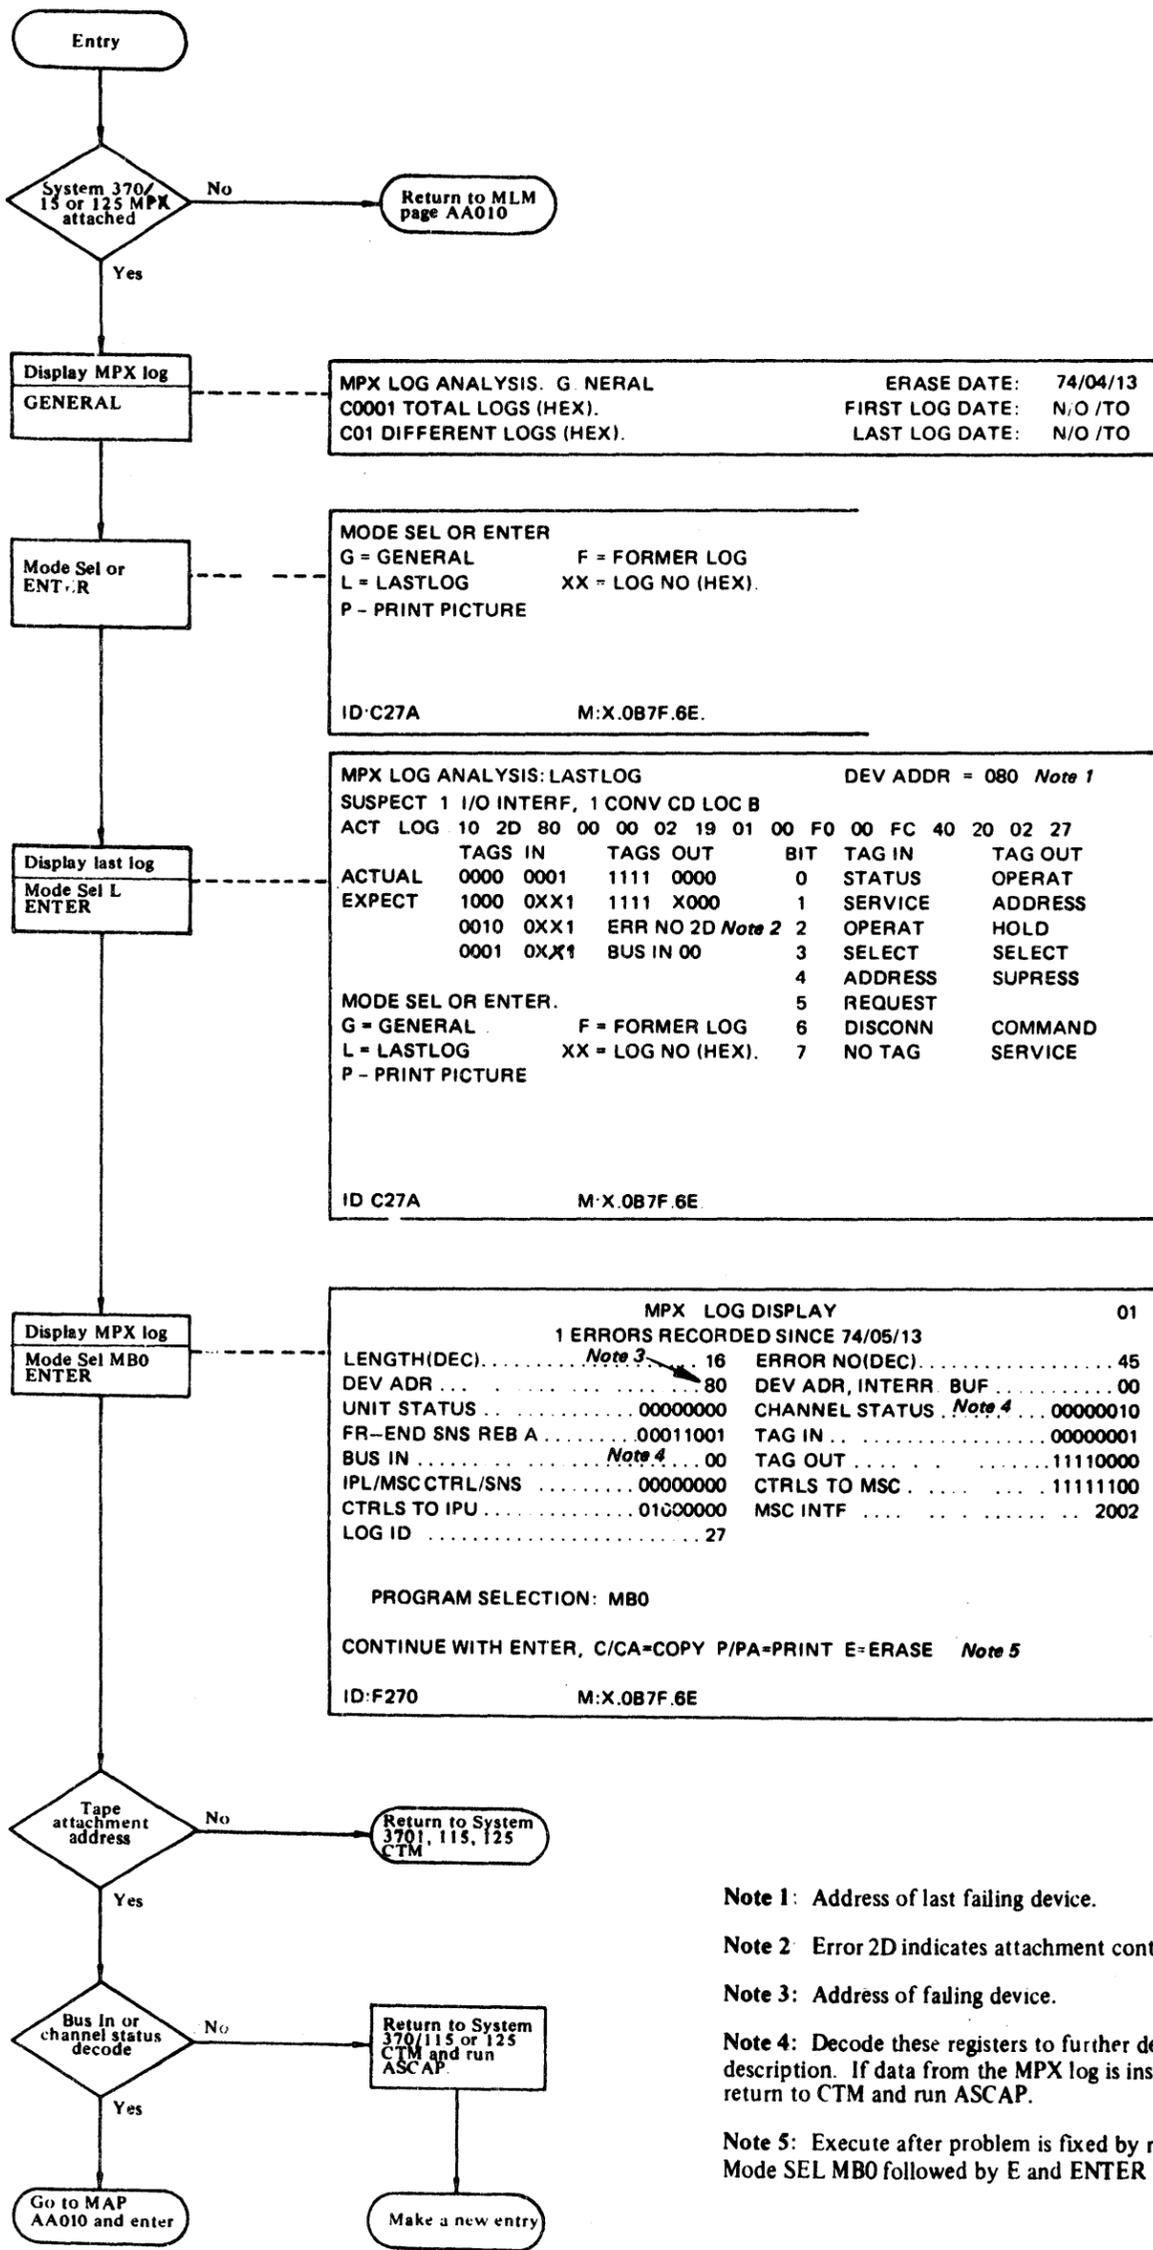
SYSTEM 370 MODELS 115 and 125 MPX LOG ANALYSIS

Note 1: Address of last failing device.
 Note 2: Error 2D indicates attachment controller as fault.
 Note 3: Address of failing device.
 Note 4: Decode these registers to further define error description. If data from the MPX log is insufficient, return to CTM and run ASCAP.
 Note 5: Execute after problem is fixed by returning to Mode SEL MBO followed by E and ENTER

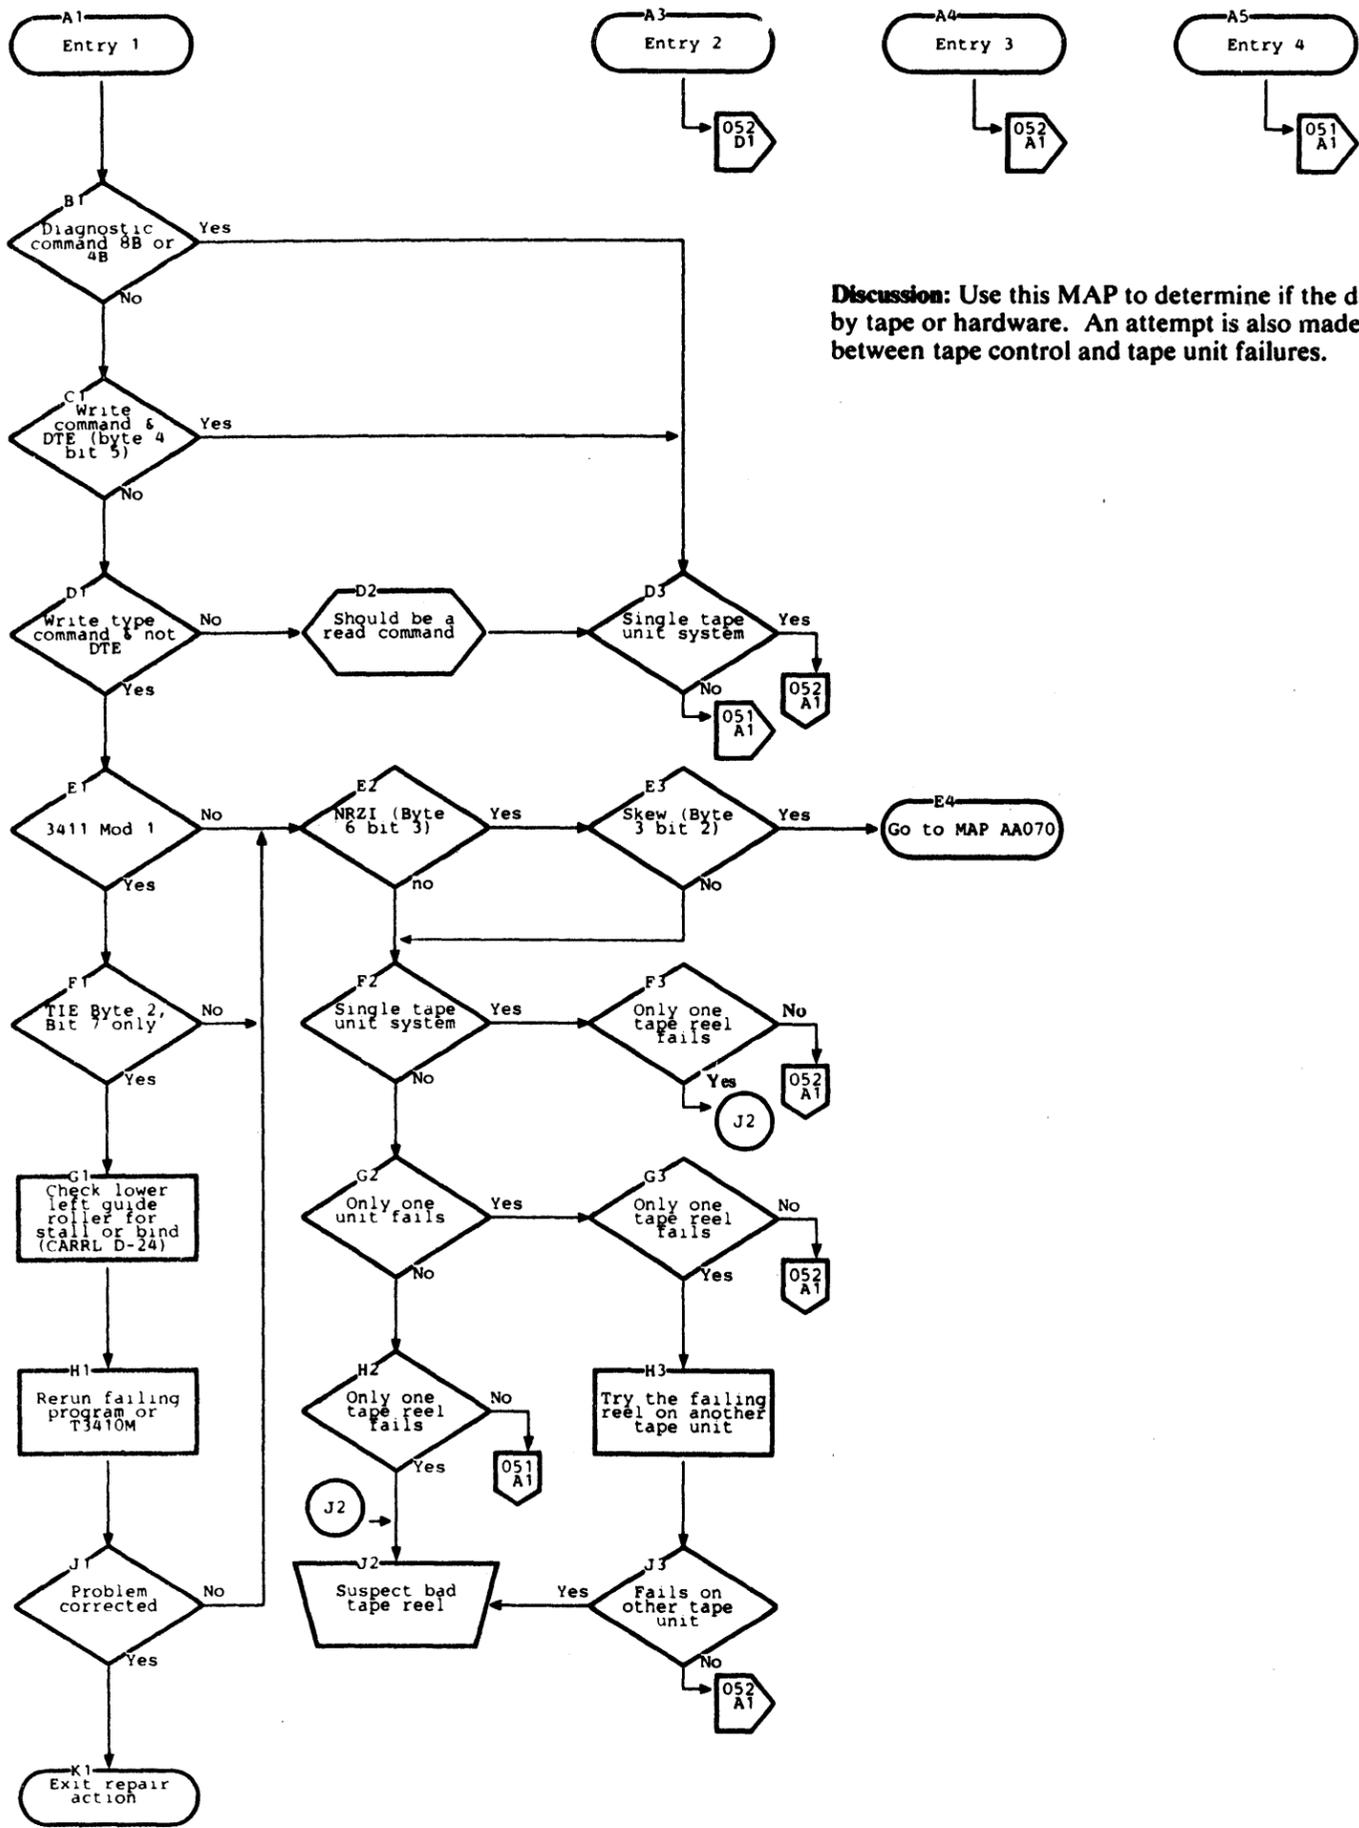
Data Check

Discussion: Use this MAP to determine if the data check is caused by tape or hardware. An attempt is also made to differentiate between tape control and tape unit failures.

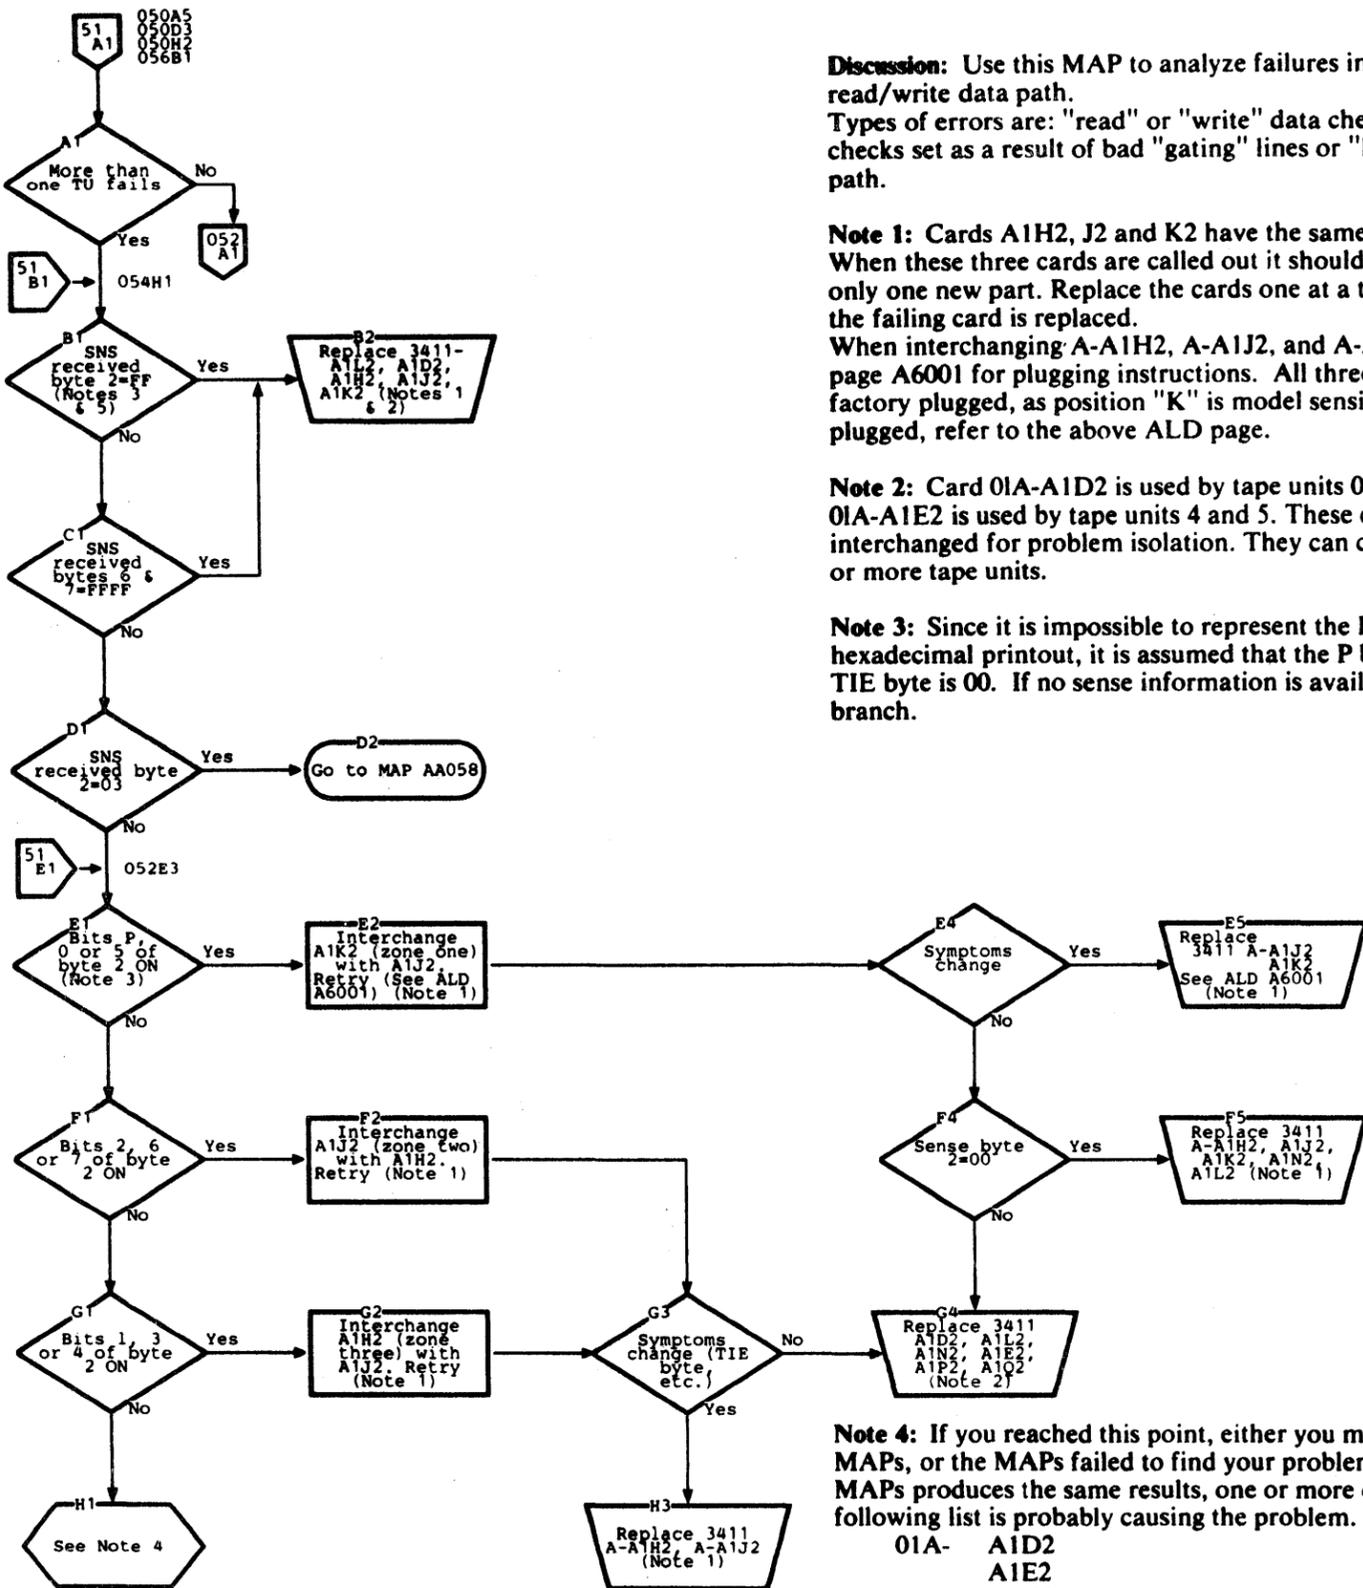
Data Check

Discussion: Use this MAP to analyze failures in the tape control read/write data path. Types of errors are: "read" or "write" data checks, and equipment checks set as a result of bad "gating" lines or "hot" bits in the data path.

Note 1: Cards A1H2, J2 and K2 have the same part number. When these three cards are called out it should be necessary to get only one new part. Replace the cards one at a time and retry until the failing card is replaced. When interchanging A-A1H2, A-A1J2, and A-A1K2, refer to ALD page A6001 for plugging instructions. All three cards should be factory plugged, as position "K" is model sensitive. If they are not plugged, refer to the above ALD page.

Note 2: Card 01A-A1D2 is used by tape units 0-3 and card 01A-A1E2 is used by tape units 4 and 5. These cards may be interchanged for problem isolation. They can cause failures on one or more tape units.

Note 4: If you reached this point, either you misinterpreted the MAPs, or the MAPs failed to find your problem. If re-entering MAPs produces the same results, one or more of the cards in following list is probably causing the problem.

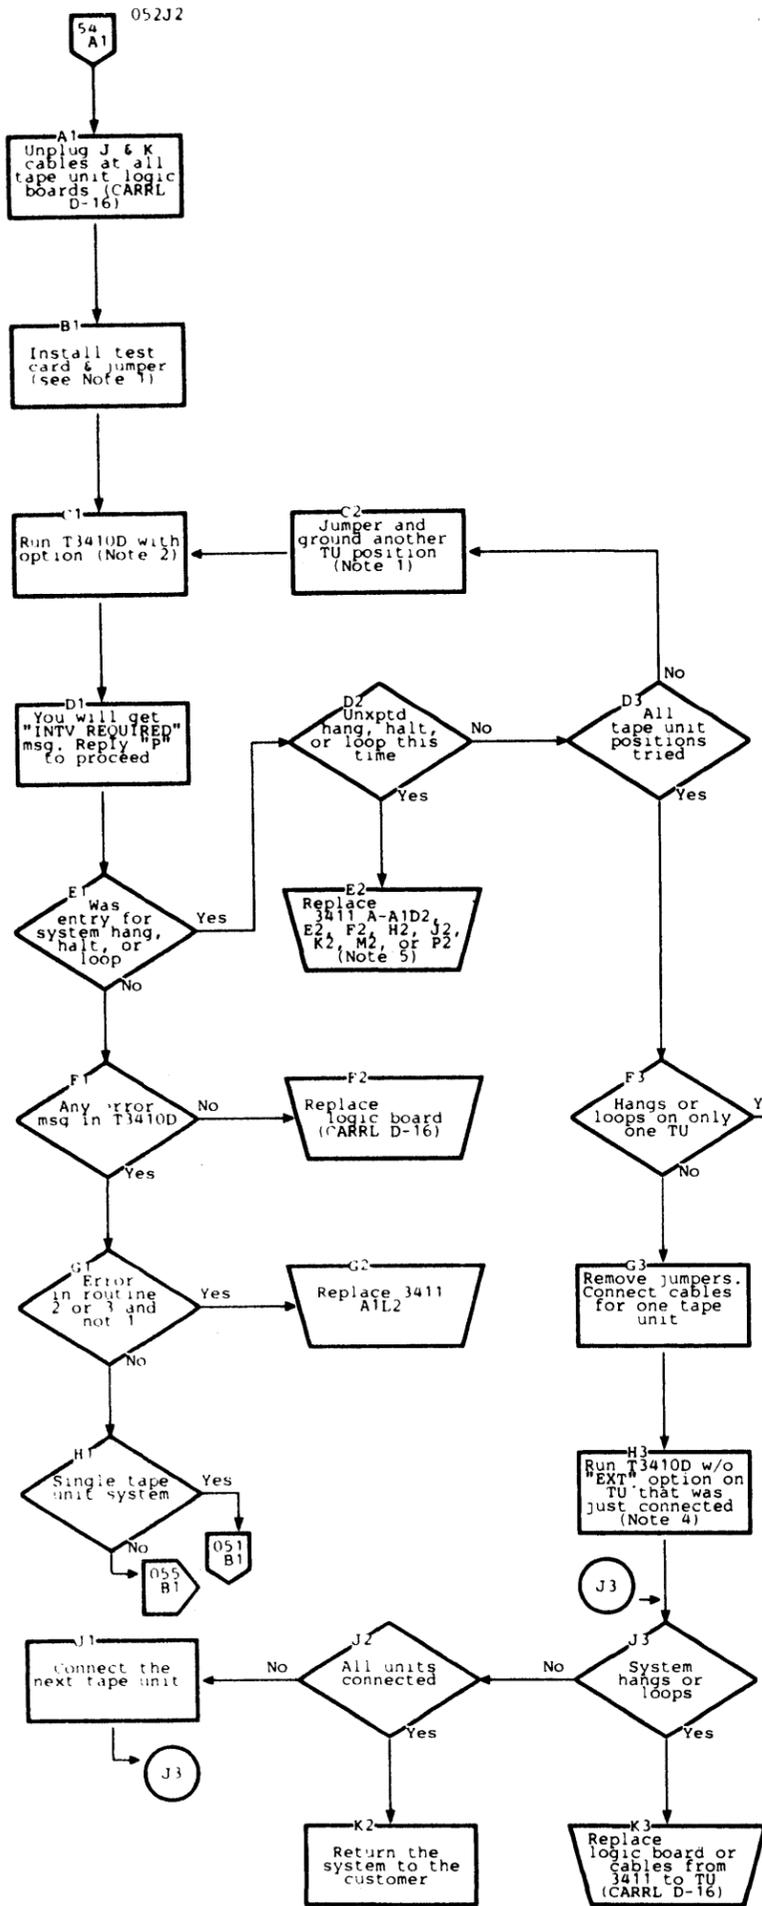
Data Check

Discussion: Use this MAP to diagnose tape-unit-caused unexpected system "hangs," halts, or "loops," and some data path problems.

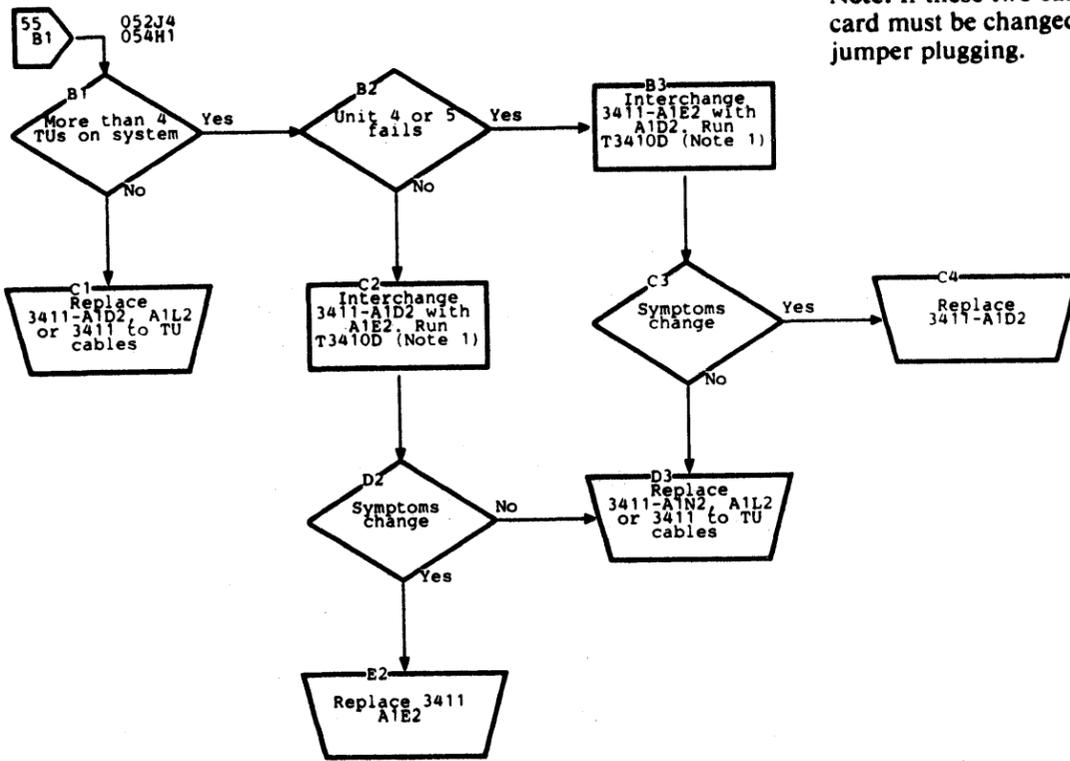
MAP AA055

Discussion: You have reached this MAP because only one tape unit failed while being looped back at the tape control.

Note: If these two cards are swapped, the jumper on each card must be changed. ALD pages JA101 & JA201 show jumper plugging.

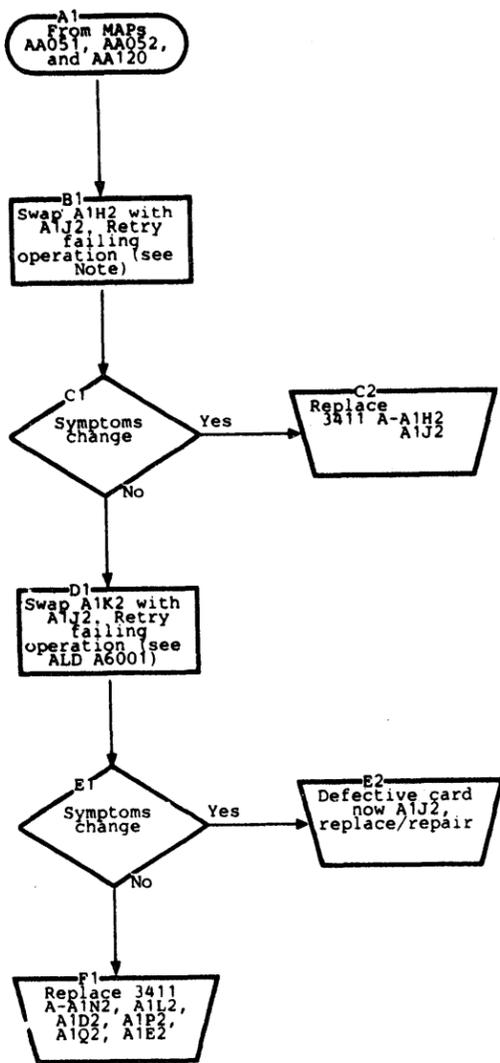
Zone Card Failures

Note: When interchanging A-A1H2, A-A1J2, and A-A1K2, refer to ALD page A6001 for plugging instructions. All three cards should be factory plugged, as position "K" is model sensitive. If they are not plugged, refer to the above ALD page.

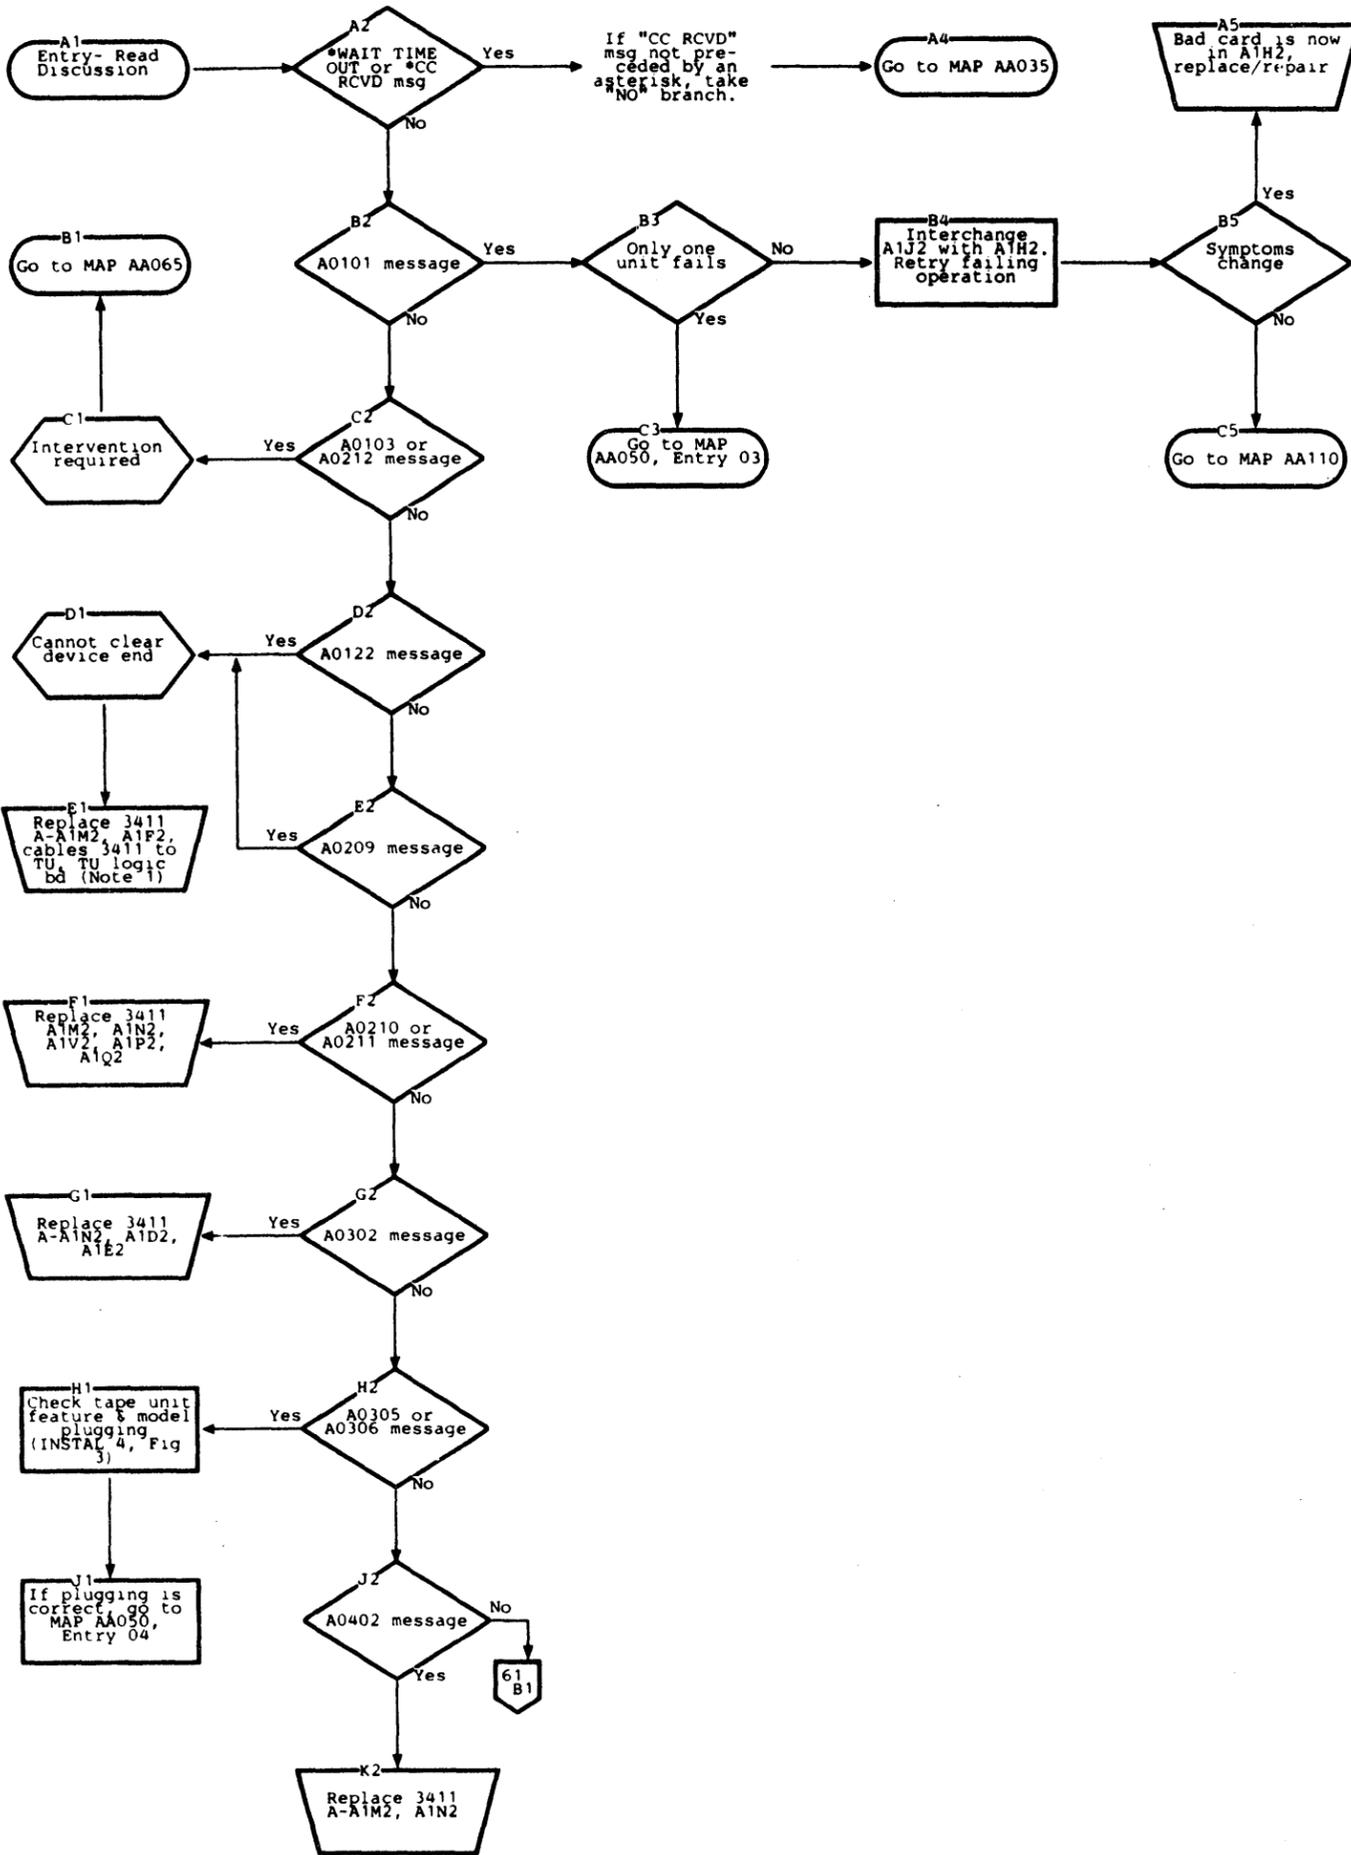
OLT Section A Messages

Discussion: The questions about message numbers on this MAP pertain to the first error message. You could have several of the messages listed here. Start with the first error message on your printout and answer the questions with regard to that message.

Note 1: System 370/115 or 370/125, AIM2 becomes AIG2 in the 3411 tape control and A-B1C2, A-B1D2 in the 3125 and AA1S2, AA1T2 in the 3115. Interface problems can also be caused by attachment cables. If MPX attached, the channel interface locations are: 370/115 and 370/125 - 01BA1B02.
