TABLE OF CONTENTS

VOL D01 M/T 3411 SERIAL 51051905

CARRL
CARRL
 Checks, Adjustments, Removals, Replacements, and Locations describes maintenance functions that can be performed on the 3410/3411 Tape Subsystem.

The 3410/3411 Magnetic Tape Subsystem consists of one or more IBM 3410 Magnetic Tape Units and an IBM 3411 Magnetic Tape Unit and Control. The major parts (tape unit and tape control) are functionally packaged (all controls used in performing a hardware function are located together) for quick isolation and replacement of a failing component. The circuitry within the subsystem (called the *attachment*), which adapts the subsystem to the I/O interface of the host system, must be considered in maintenance. Expanded sense data is provided to include more details of hardware failure than was furnished by most earlier tape subsystems.

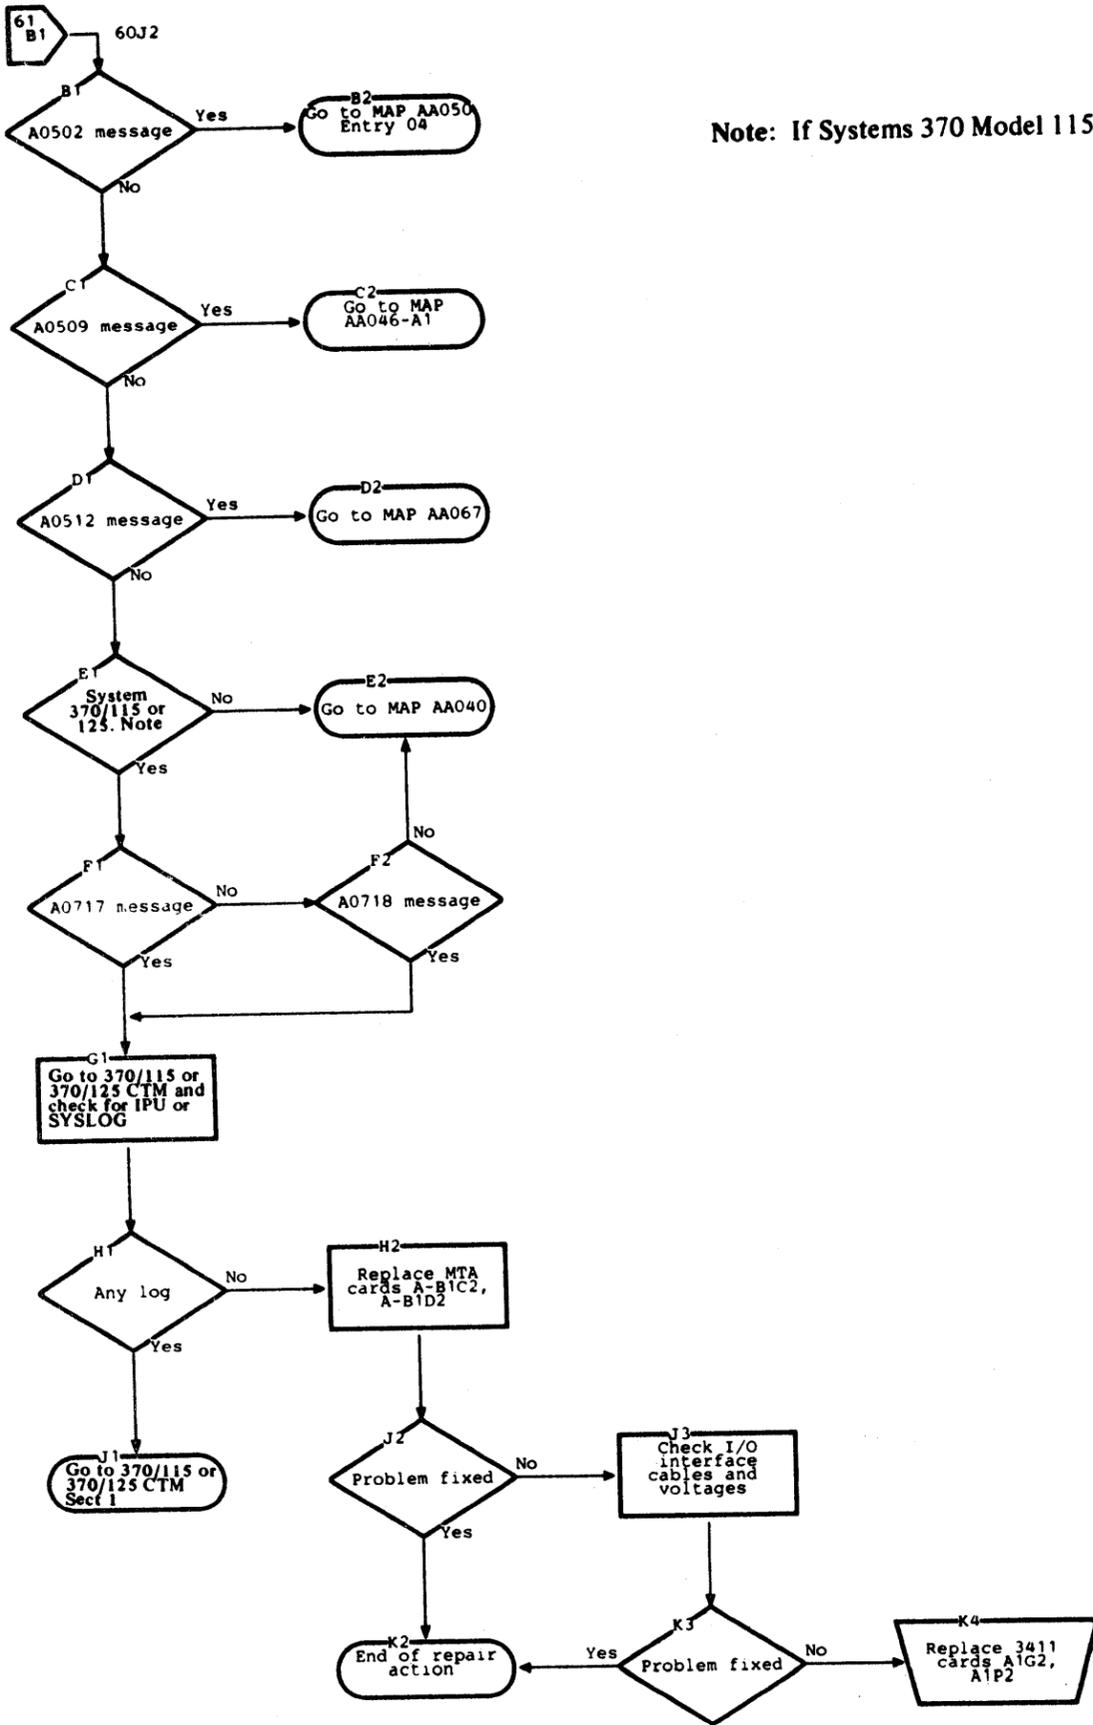
Intervention Required

Note: If Systems 370 Model 115 or 125 MPX attached, answer this block no.

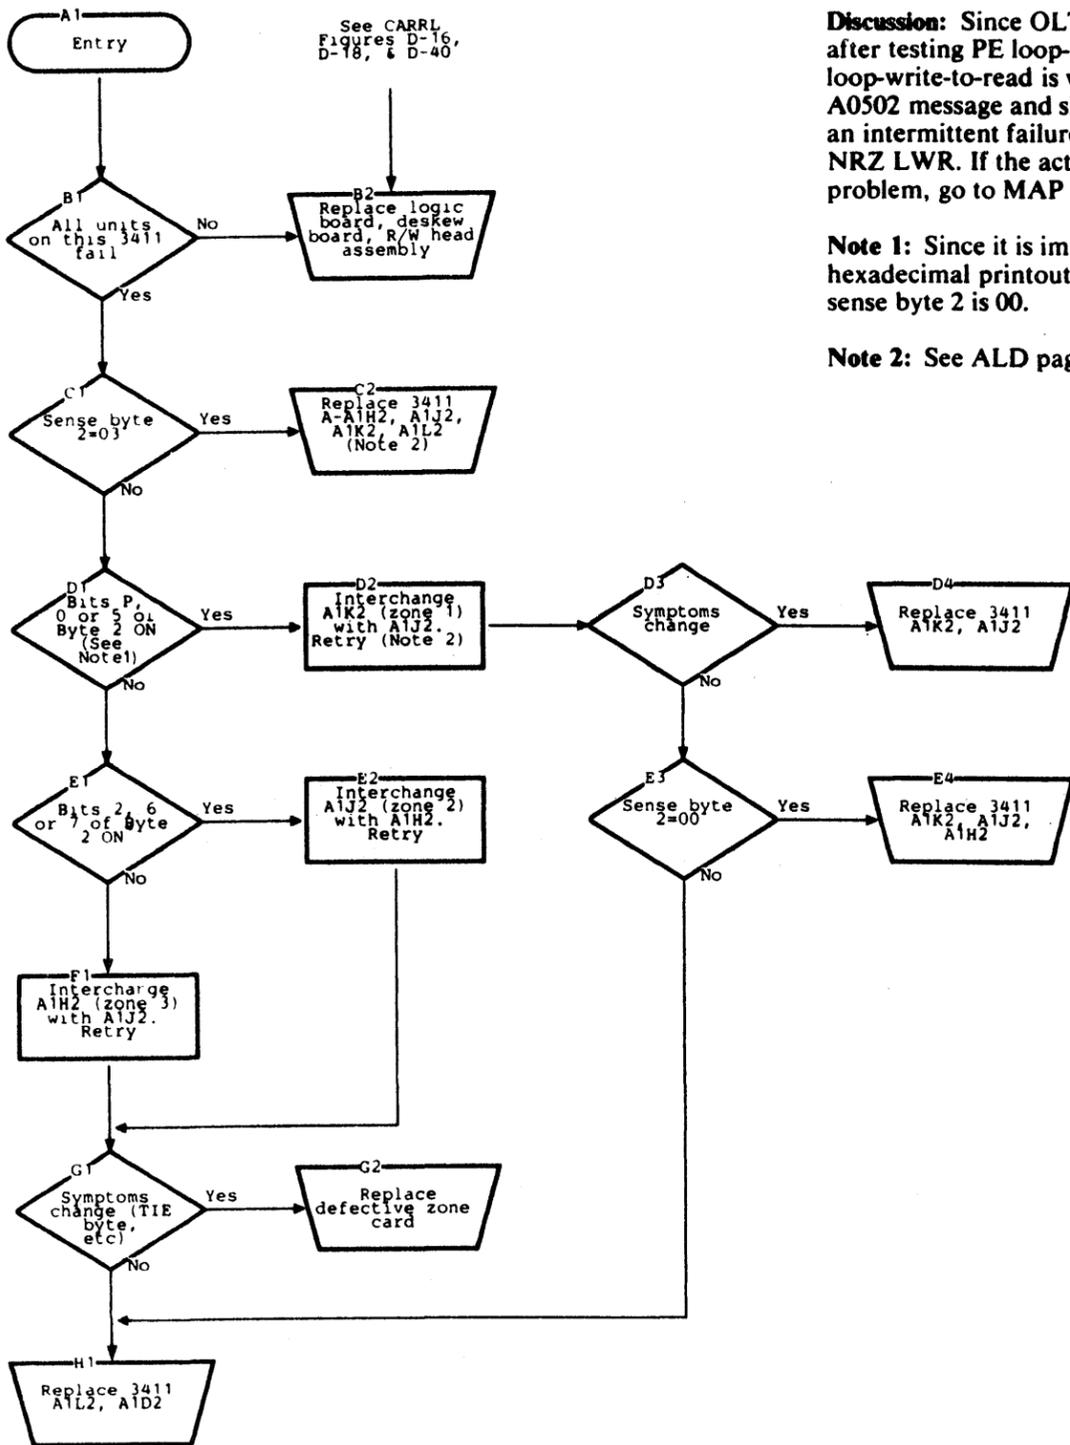
NRZI LWR Failure

Discussion: Since OLT Section "A" tests NRZI loop-write-to-read after testing PE loop-write-to-read, this MAP assumes that PE loop-write-to-read is working. If PE LWR failed, you would get an A0502 message and should go to MAP AA051. It is possible that an intermittent failure could have passed PE LWR and failed on NRZ LWR. If the action on this MAP does not resolve the problem, go to MAP AA051.

Note 1: Since it is impossible to represent the P bit in a hexadecimal printout, it is assumed that the P bit is ON when sense byte 2 is 00.

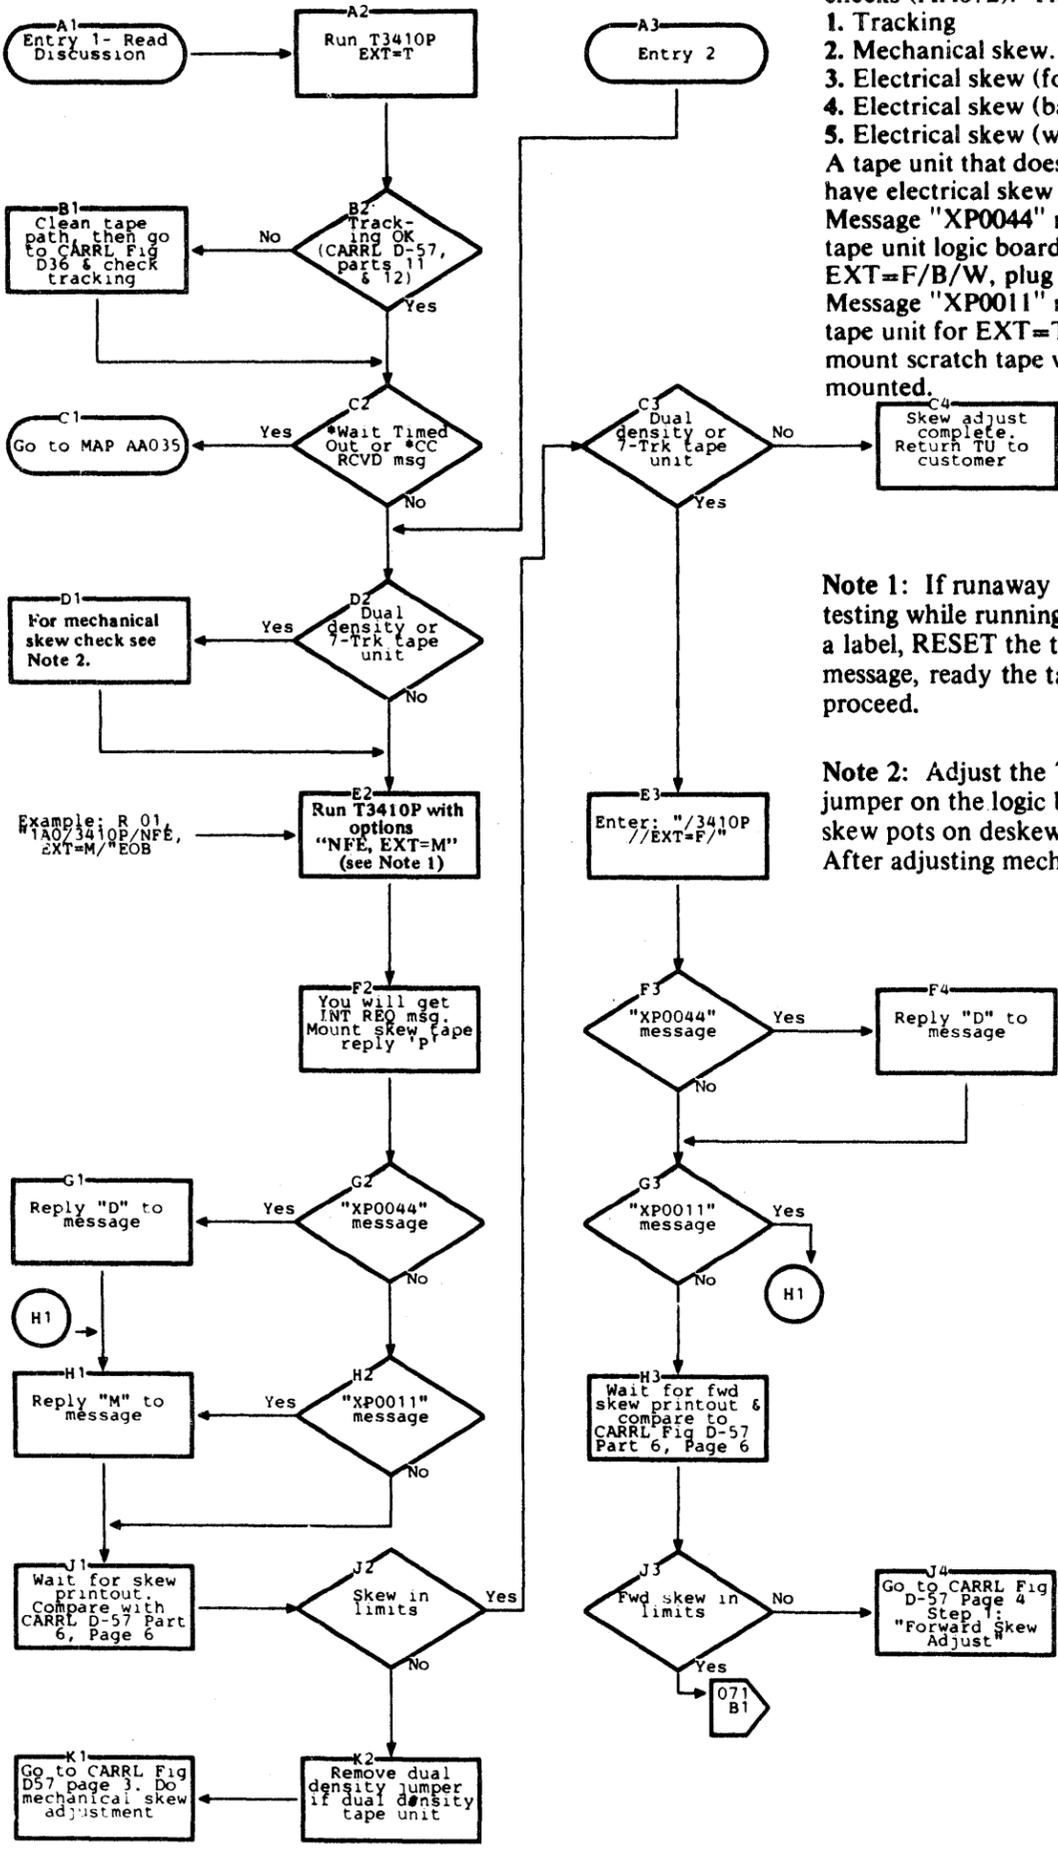
Skew Check and Adjust

Discussion: Since skew and tracking are interrelated, you are asked to verify that tracking is correct before proceeding with skew checks (AA072). The sequence is as follows:

- 1. Tracking FEXT=T
- 2. Mechanical skew. EXT=M T3410P
- 3. Electrical skew (forward). EXT=F EXTERNAL
- 4. Electrical skew (backward). EXT=B OPTIONS
- 5. Electrical skew (write). EXT=W

Note 2: Adjust the 7-track mechanical skew. Leave the 7-track jumper on the logic board and turn FWD and BKWD electrical skew pots on deskew board clockwise for minimum setting. After adjusting mechanical skew, readjust electrical skew.

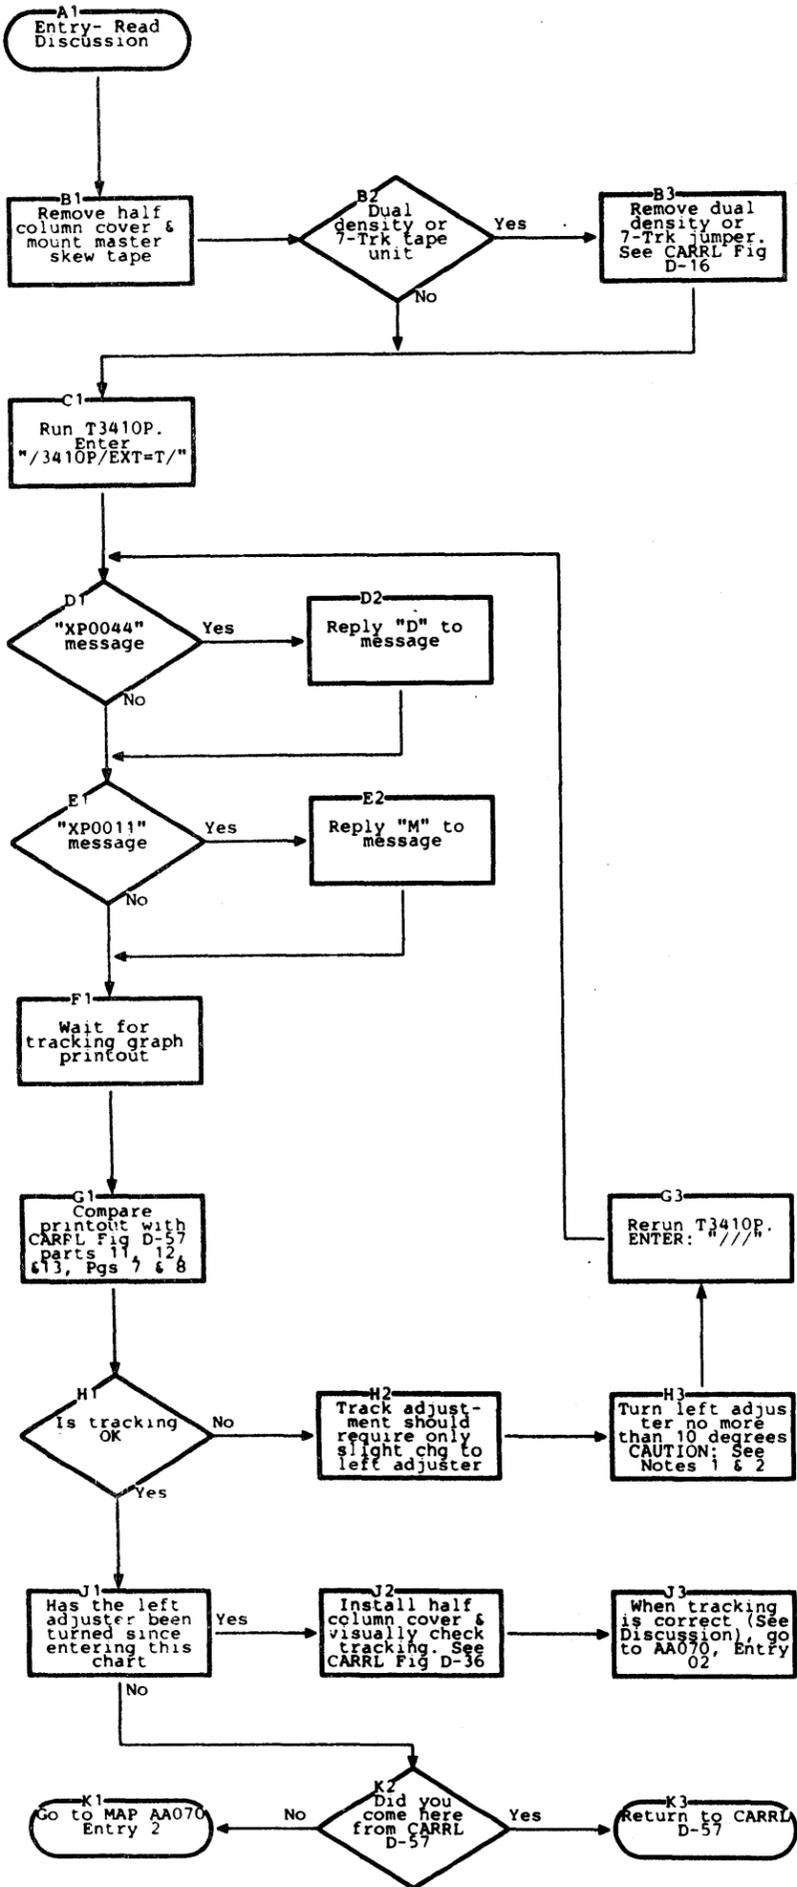
Tracking Check and Adjust

Discussion: Entry to this MAP assumes that a visual check of tracking has been made, using CARRL Figure D-36. The objective is to have tracking as specified by CARRL Figure D-36 Step 9 and to have the tracking printout of section T3410P indicate minimum tracking shift between forward and backward tape motion.

Note 1: If you are unable to obtain correct tracking after several tries, or if the printout shows no change between tries, go back to CARRL Figure D-36 and verify the visual check of tracking.

Note 2: If runaway occurs on the particular tape unit you are testing while running OLTs with OS or DOS and trying to read a label, RESET the tape unit. After "unreadable tape label" message, ready the tape unit, and continue by replying "P" for proceed.

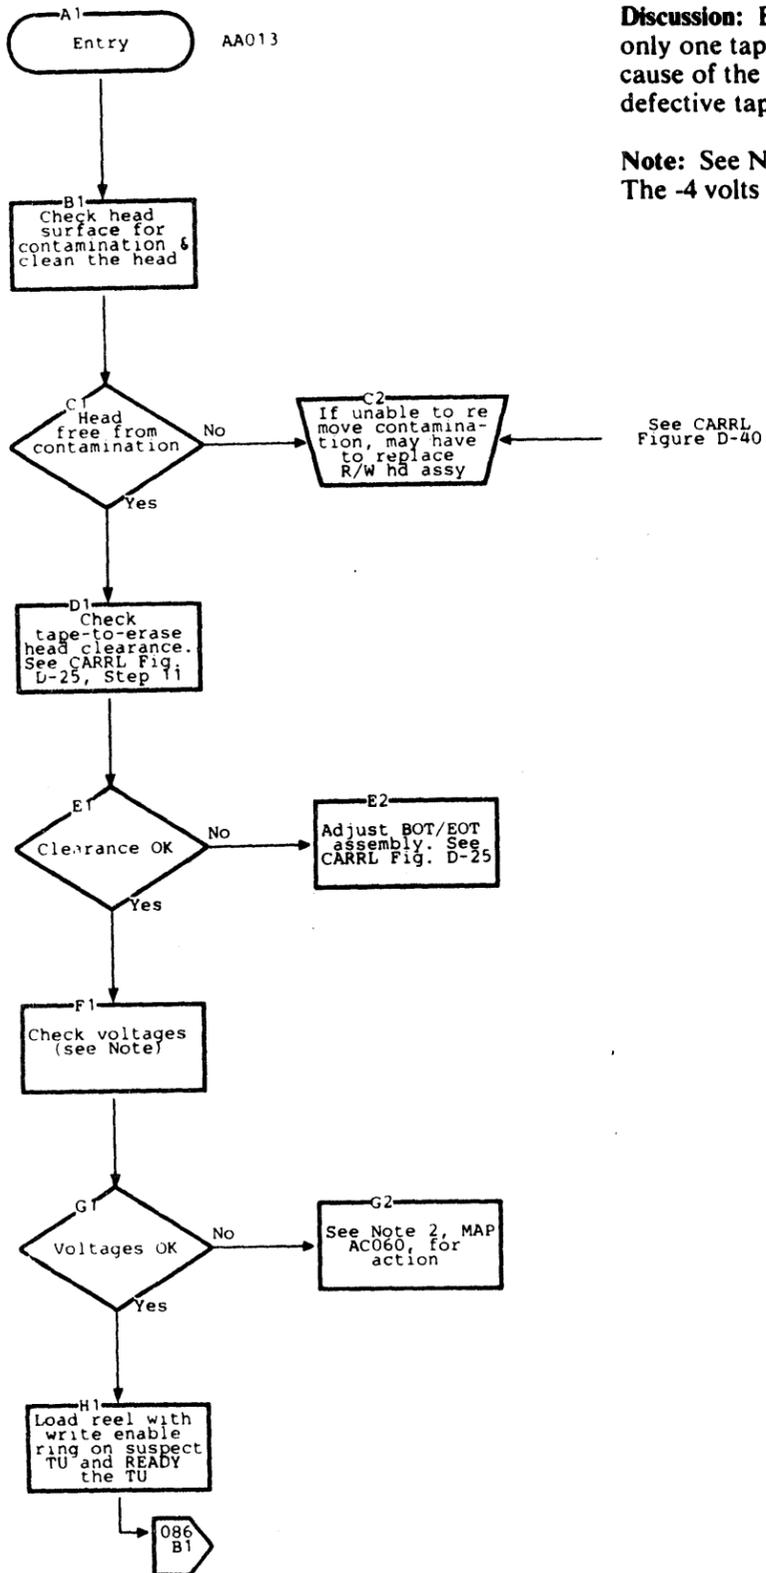
Read/Write Head Assembly

Discussion: Entry to this chart is for data checks that occur on only one tape unit and the R/W head assembly is suspected to be cause of the failure. Be sure the data check is not caused by defective tape. Try more than one tape reel.

Note: See Note 1 on MAP AC060 for voltage check procedure. The -4 volts need not be checked at this time.

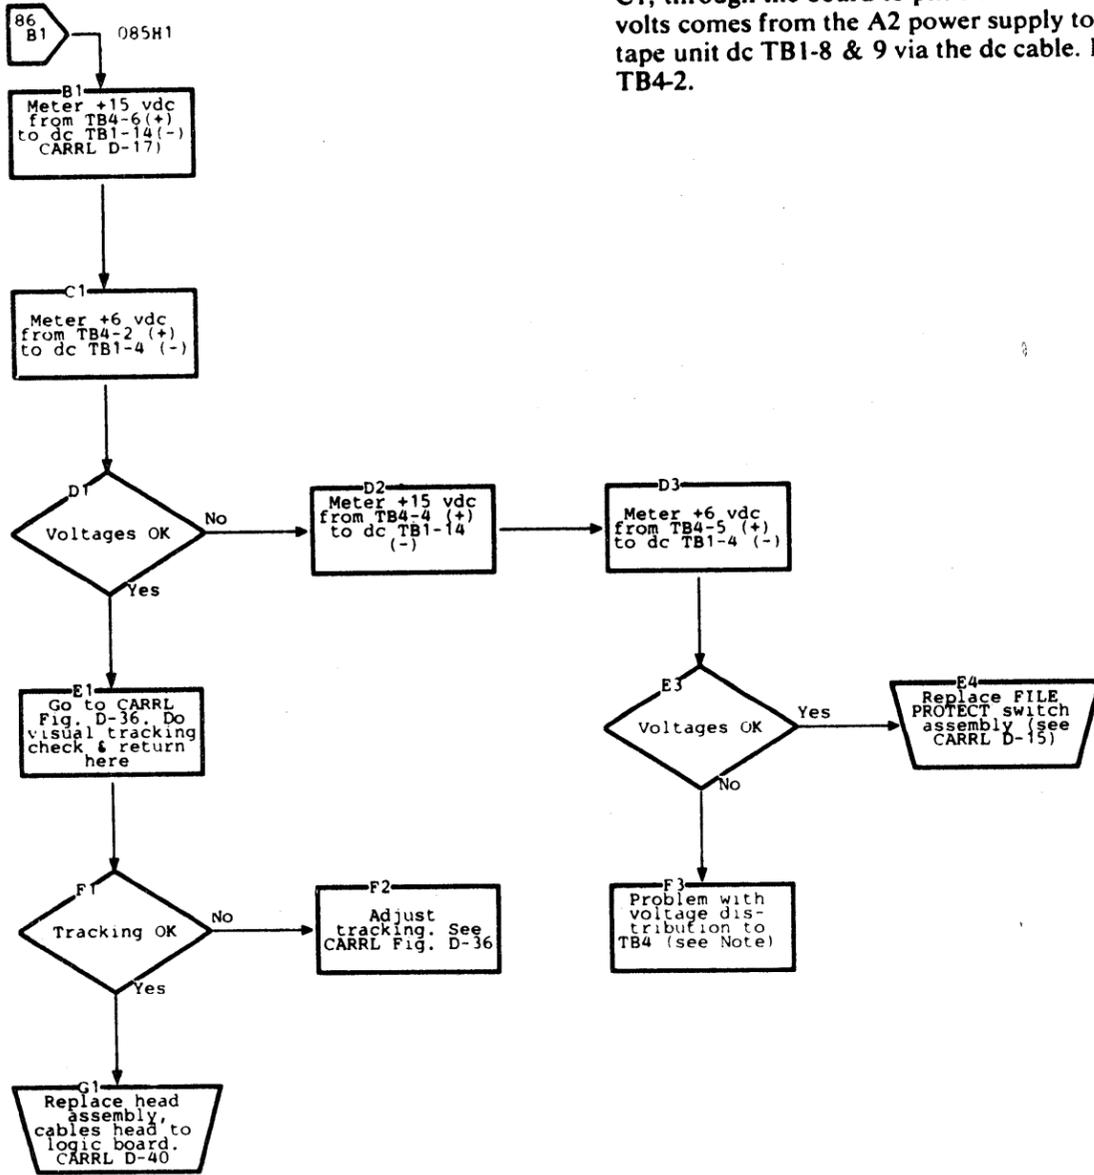
Read/Write Head Assembly

Note: The +15 volts comes from A2 TB1-16 (YG110) to J21-J26 (YG112) to the tape unit dc TB1-10 through 13 via the dc cable. From dc TB1-13, +15 volts dc goes to the motion control board pin C1, through the board to pin B14 and from there to TB4-6. The +6 volts comes from the A2 power supply to J21-J26 (YG112) to the tape unit dc TB1-8 & 9 via the dc cable. From dc TB1-8, it goes to TB4-2.

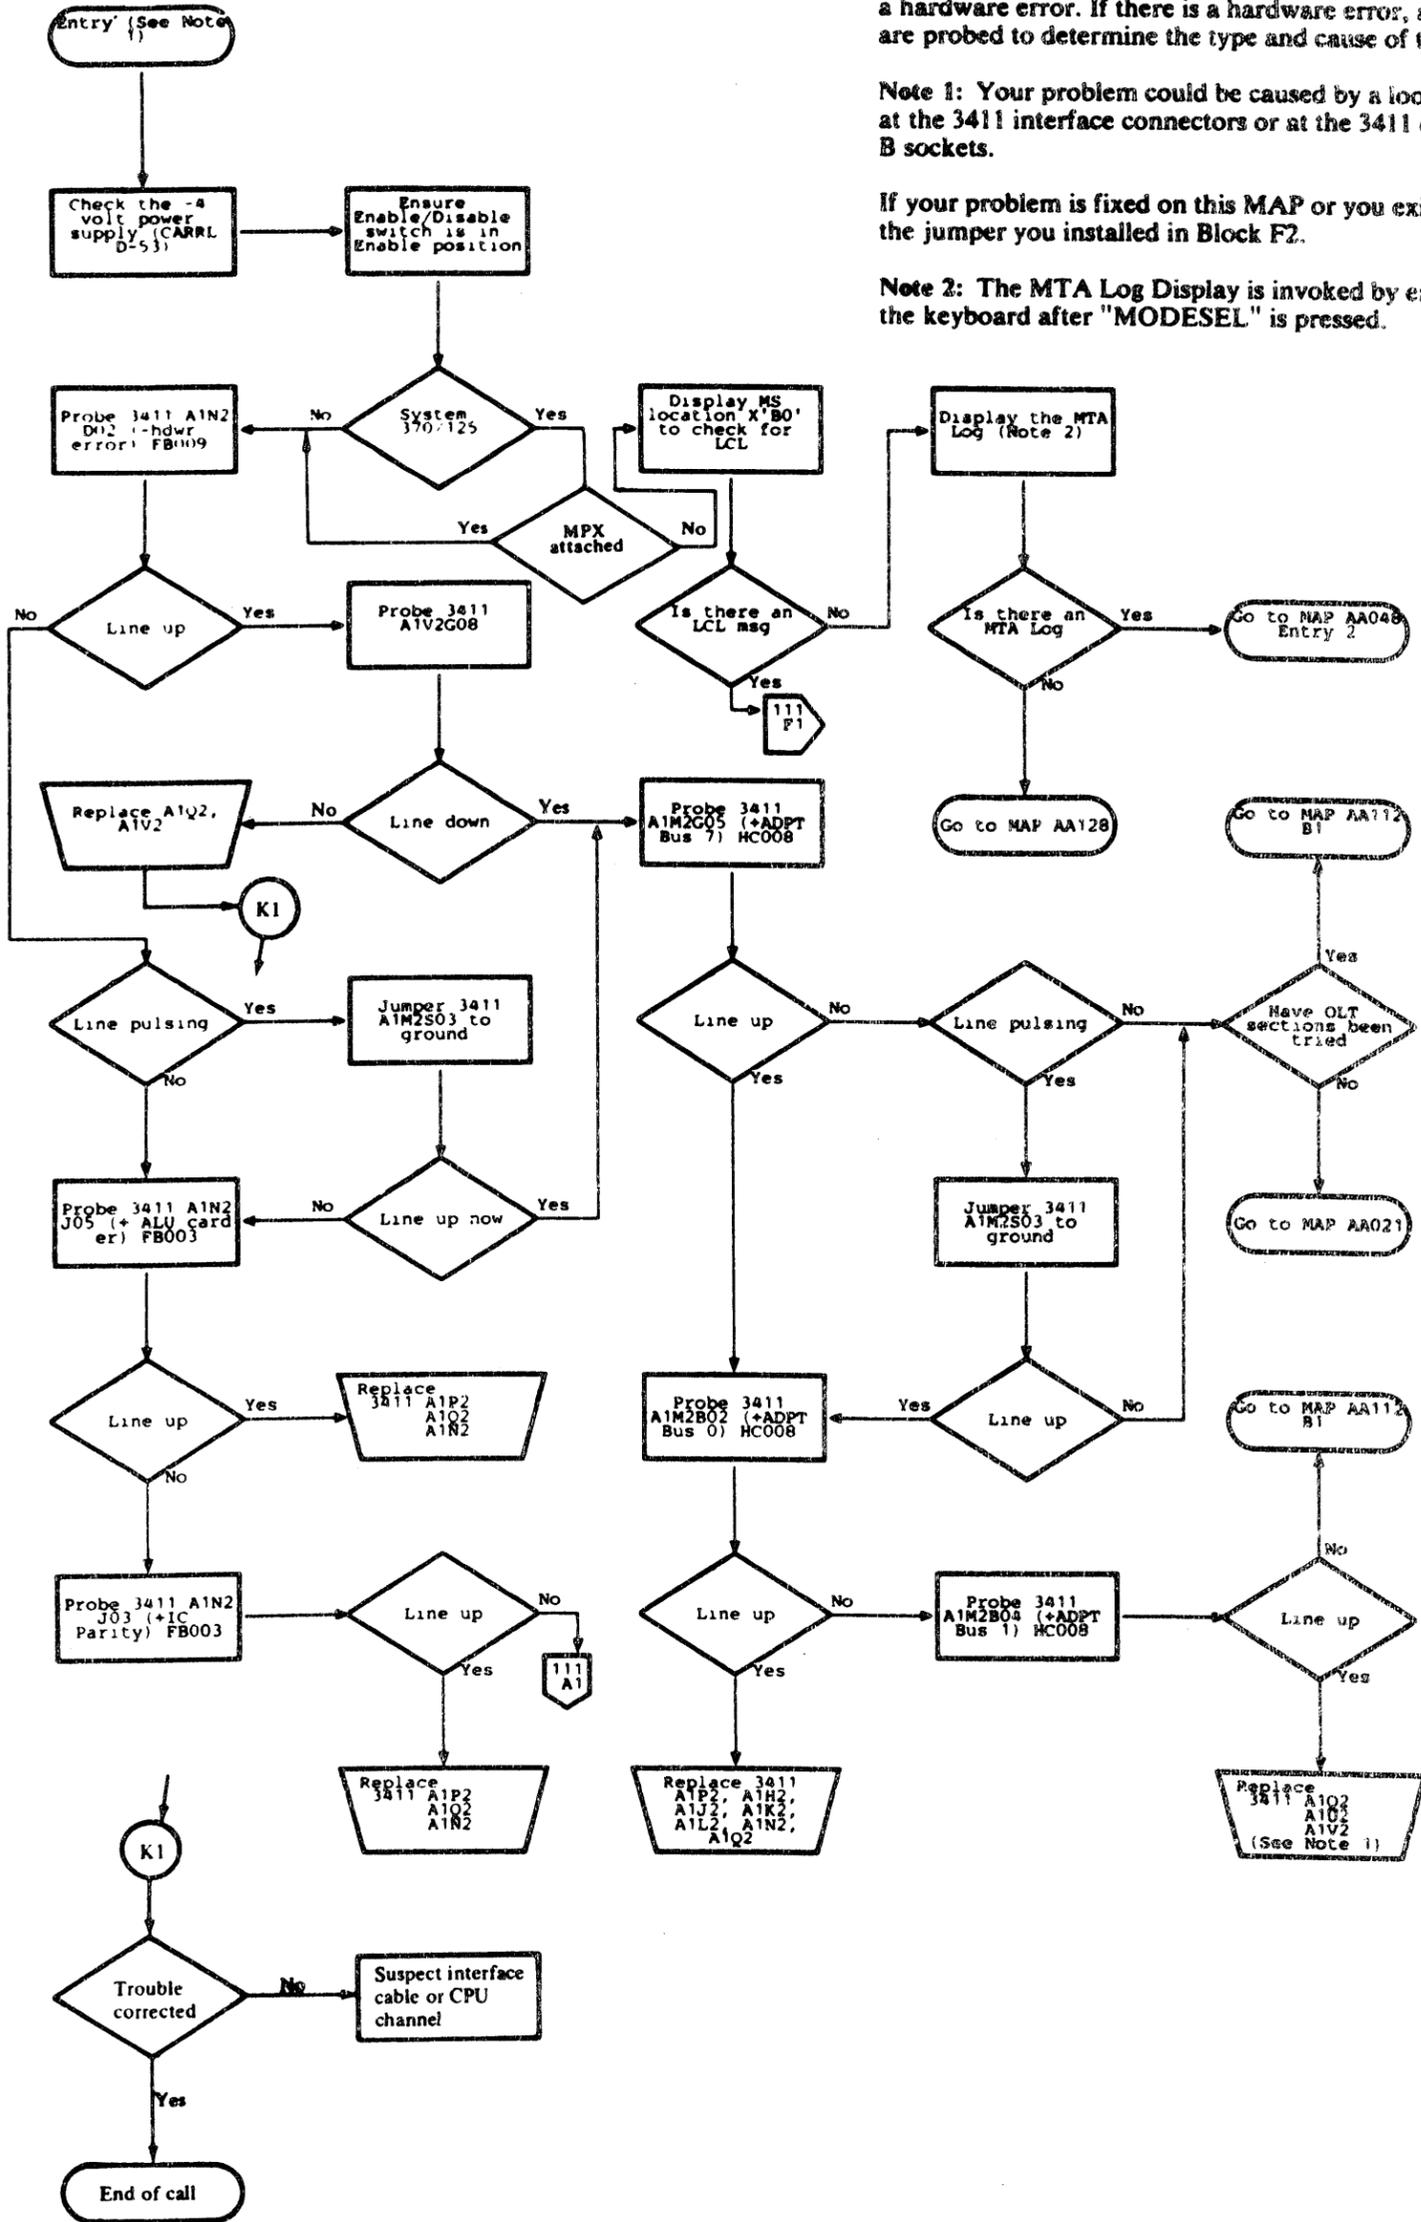
Hardware Error (System/360; System/370)

Discussion: Hardware errors in the 3411 will freeze the microprogram so it is not possible to get sense information to the CPU. This chart calls for probing of points to determine if there is a hardware error. If there is a hardware error, additional points are probed to determine the type and cause of the error.

Note 1: Your problem could be caused by a loose or failing cable at the 3411 interface connectors or at the 3411 circuit board A and B sockets.

If your problem is fixed on this MAP or you exit this page, remove the jumper you installed in Block F2.

Note 2: The MTA Log Display is invoked by entering "MBK" on the keyboard after "MODESEL" is pressed.

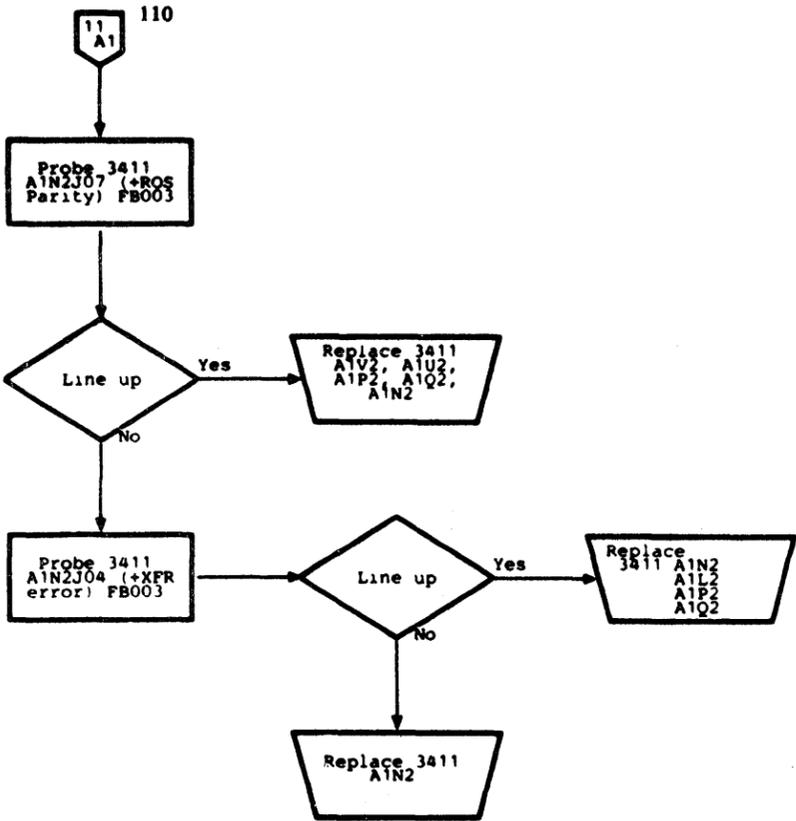
MAP AA110

Note: If machine still fails check -4 volts at A1Q2M06(-) to A1Q2P08(+). Voltage should be -4 volts ± 1%. Check +6 volts at A1K2S11(+) to A1K2U08(-). Voltage should be +6 ± 4%. If volts not correct, go to MAP AC060 Note 2.

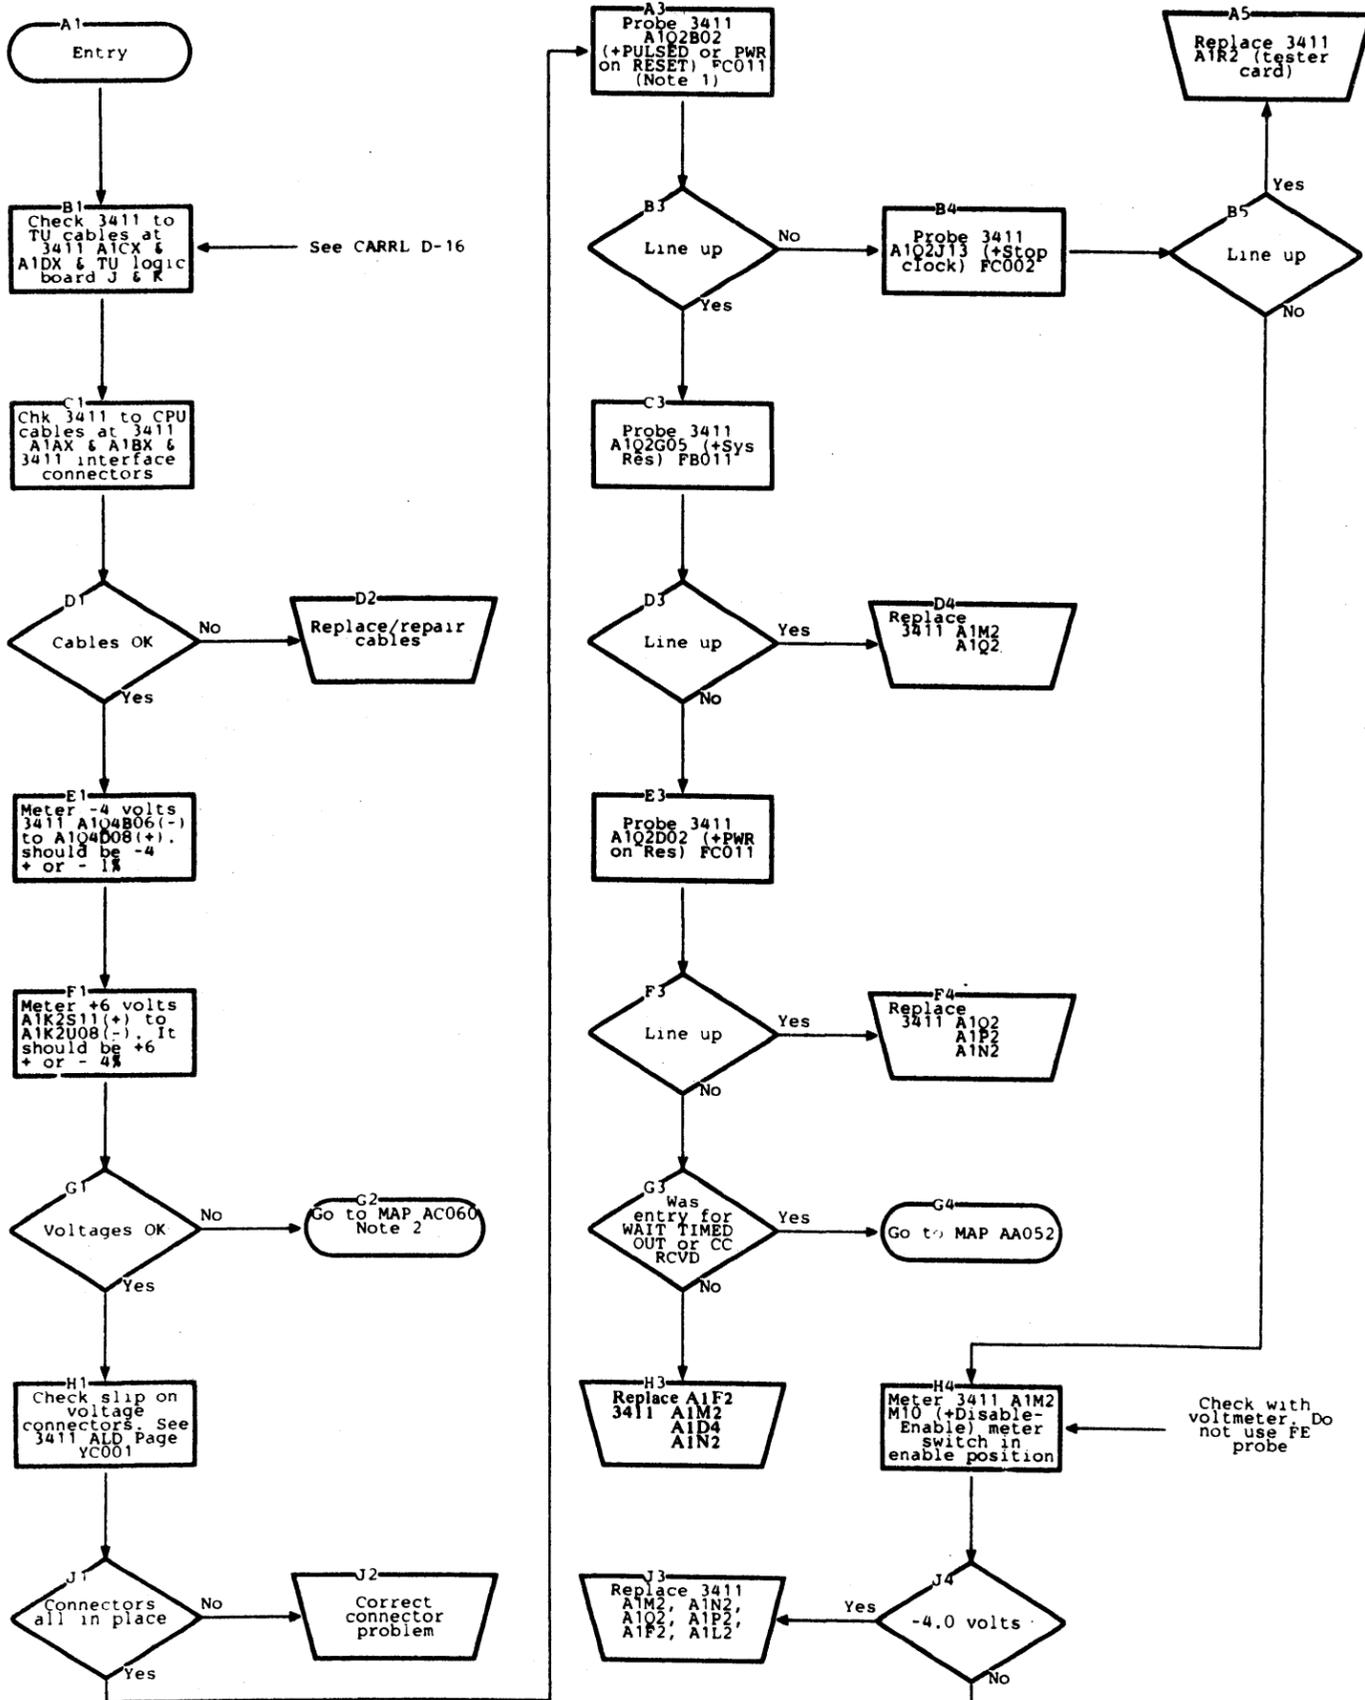
Channel Problems

Note 1: Refer to SER 3 for functional description of FE Diagnostic Probe. You must understand probe response to "Line Up," "Line Down," and "Line Pulsing."

You have a defective Enable/Disable switch or defective wiring to the switch. The switch is wired from TB2-6 (ground) through the switch to TB2-12 and then to A1G2P13. A1G2P13 connects to A1M2M10.

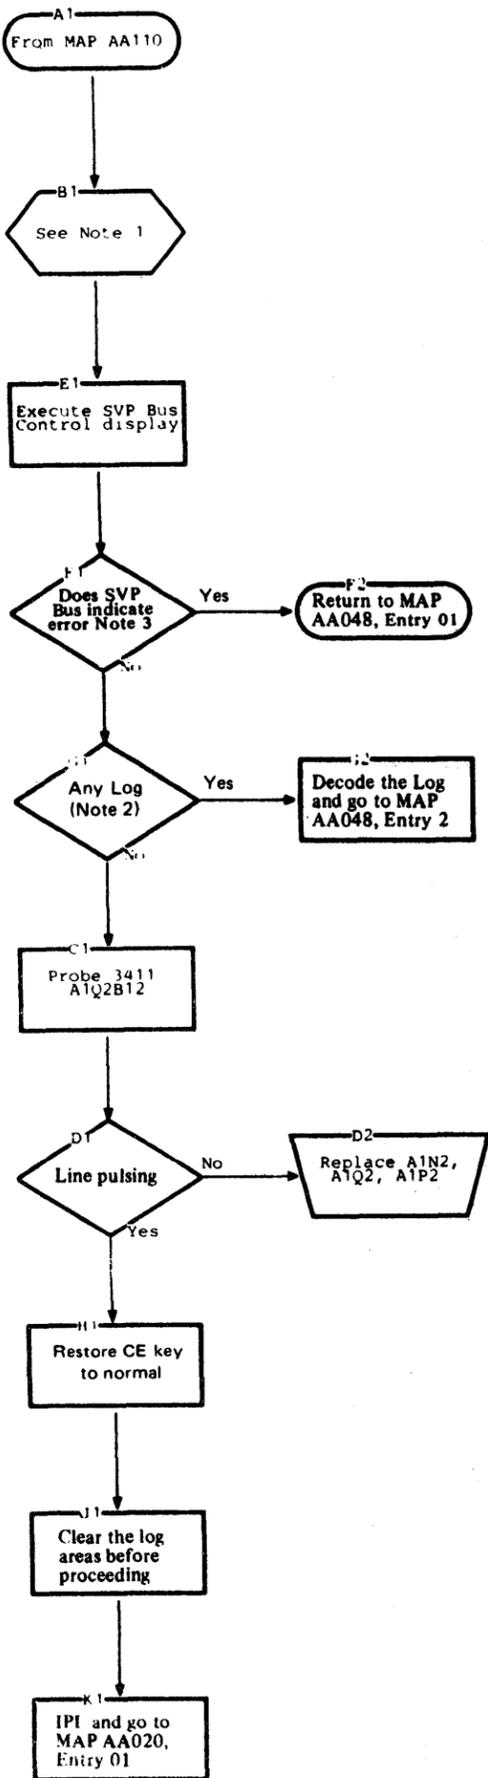
Note 1: Entry to this MAP assumes that you have no LCL or MTA Log entered and you have a system hang or channel/interface control check condition.

Note 2: Any Log means any MTA Log, LCL, or SVP Bus Control Sense Byte 8.

Note 3: Hex '48' on SVP Bus is valid and indicates a non-error condition. Go to MAP AA065 if this status is presented.

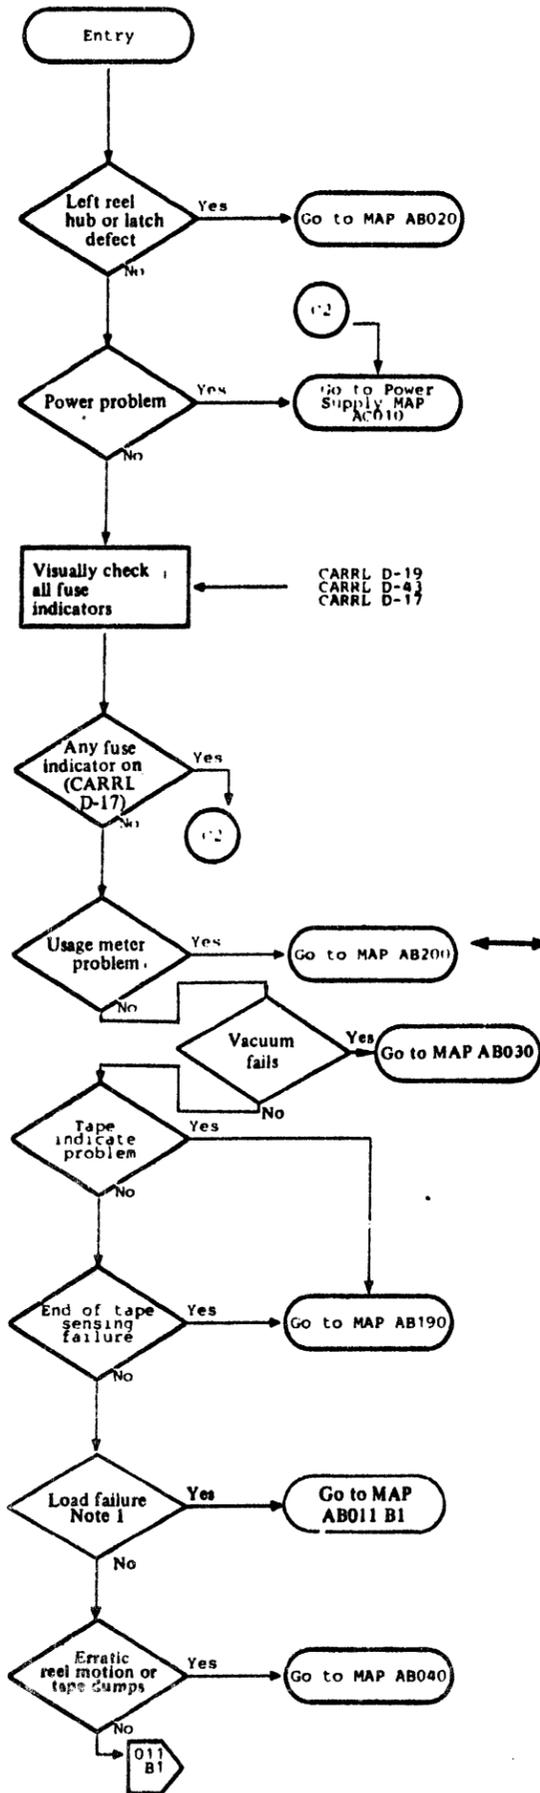
Tape Unit Entry

ENABLE/DISABLE

This switch allows the subsystem to be taken offline for maintenance. The switch setting can be changed at any time, but the subsystem changes status only when the system is stopped. The switch must be set to the DISABLE position to take the subsystem offline. A disabled subsystem is non-existent to the system program.

Note 1: A loaded condition is tape looped in both columns without dumping. Following loading, the tape unit automatically initiates a load point search by moving tape to the right until the beginning of tape (BOT) marker is sensed by the BOT photocell or until the RESET switch is pressed.

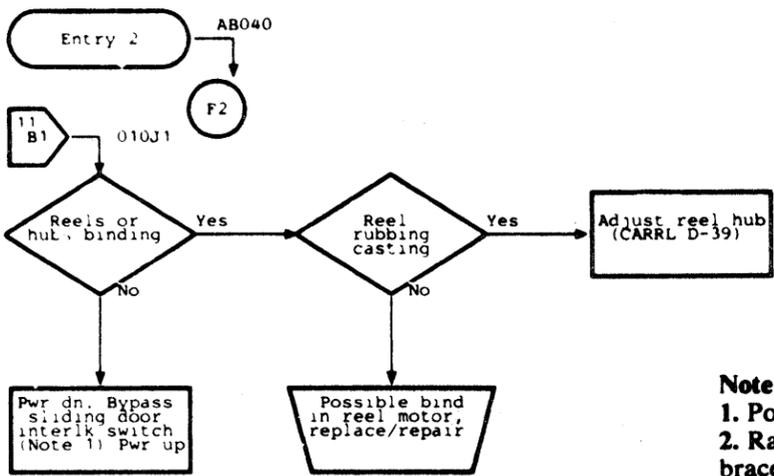
Tape Unit Entry

Note 1: To bypass the interlock switch:

1. Power down.
2. Raise the transport assembly (ensure that both stay braces latch).
3. Reach up behind the right reel motor through a hole in the casting to locate the switch.
4. Push the switch interlocking plunger to the right. The plunger will release if you close the sliding door.

Note 3: A loaded condition is tape looped in both columns without dumping. Following loading, the tape unit automatically initiates a load point search by moving tape to the right until the beginning tape (BOT) marker is sensed by the BOT photocell or until the RESET switch is pressed.

Note 4: BOT leader should be 16 ft. ± 2 ft. long.

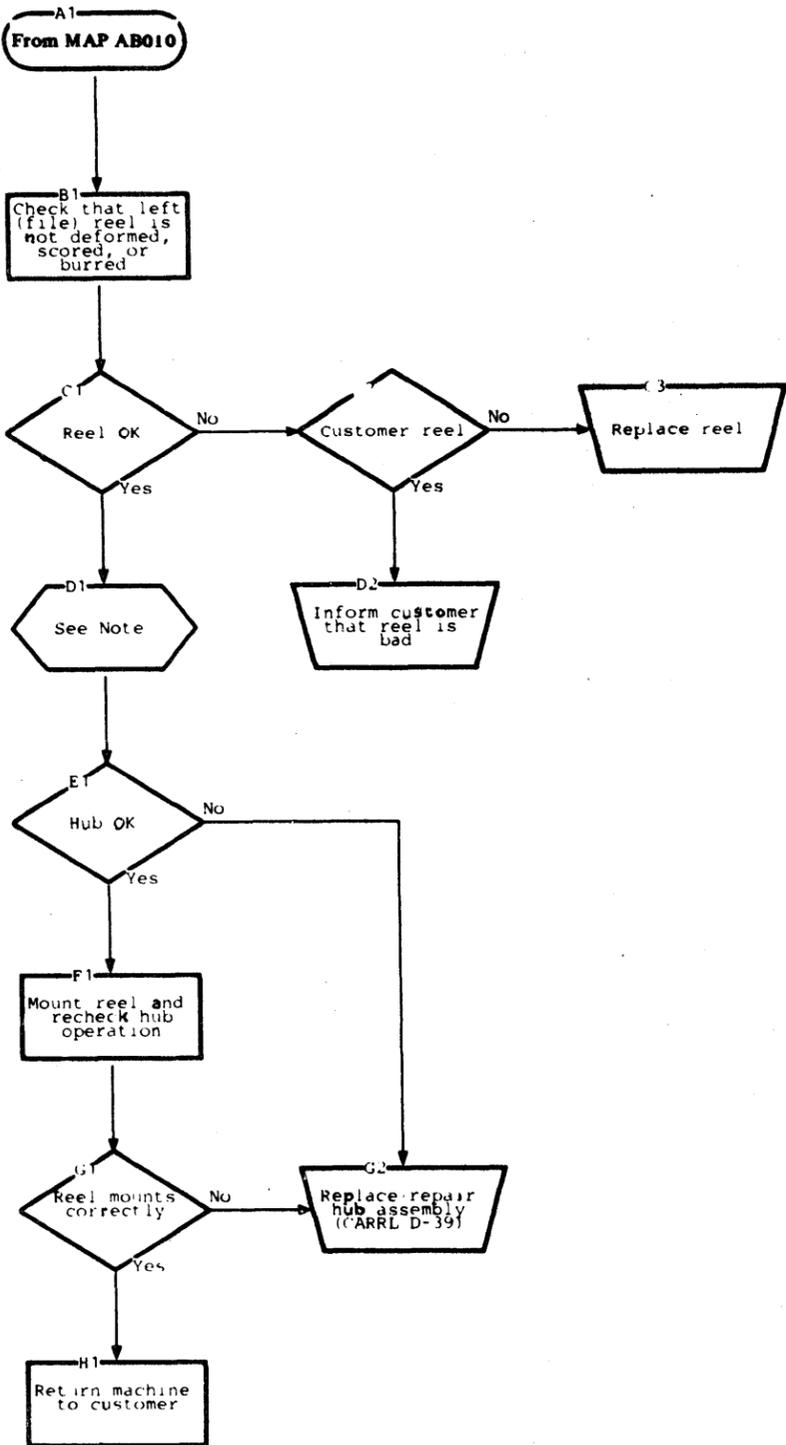
Left Reel Hub and Latch Mechanism

Discussion: Entry to this MAP assumes you had trouble mounting the left (file) reel

- A. Check that the hub is free from obvious physical defects such as broken parts or contamination.
- B. With the center of the hub depressed, check that:
 1. Both "O" rings protrude at three points directly under the lugs.
 2. The three locking lugs extend from the hub.
- C. With the center of the hub released, check that:
 1. The center of the hub extends automatically when no tape reel is mounted.
 2. The "O" rings and the three locking lugs retract flush with the hub.

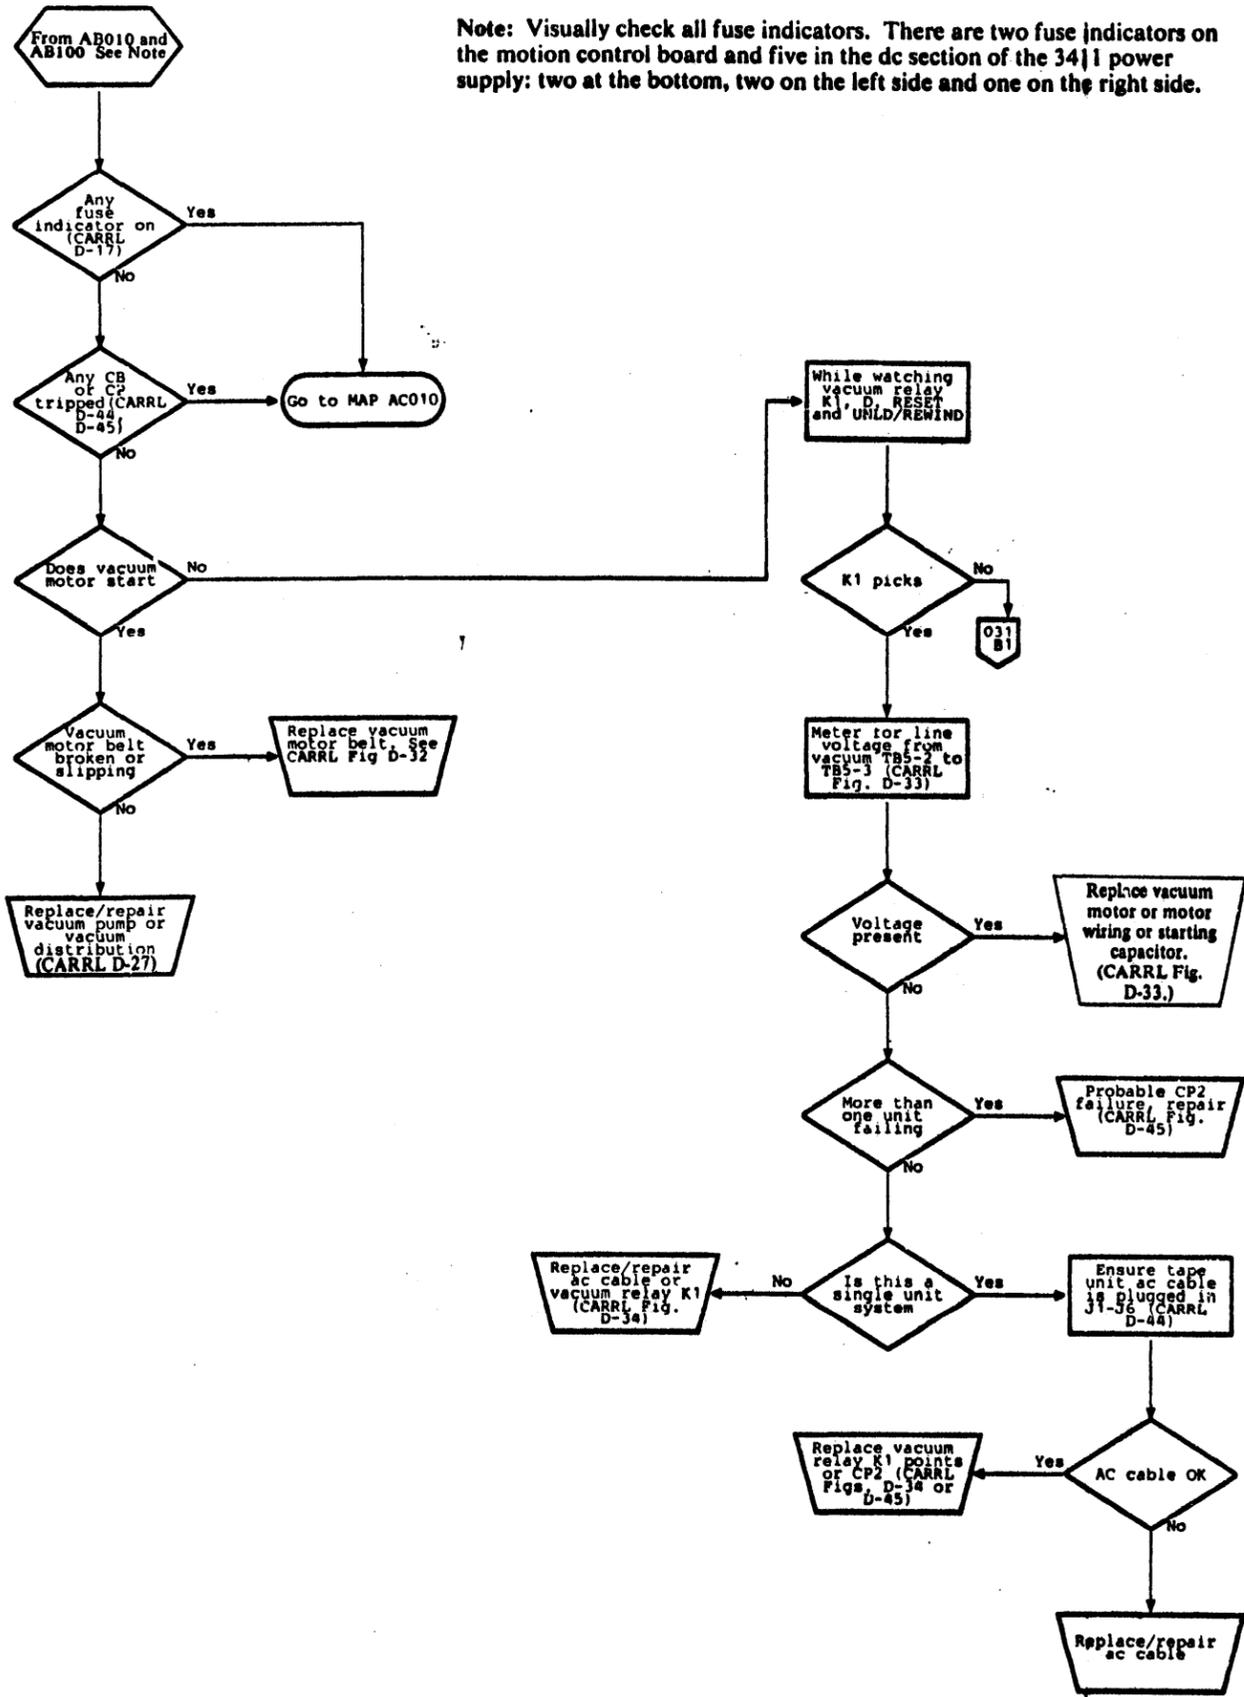
Vacuum Failures

Note: Visually check all fuse indicators. There are two fuse indicators on the motion control board and five in the dc section of the 3411 power supply: two at the bottom, two on the left side and one on the right side.
