TABLE OF CONTENTS

VOL D01 M/T 3411 SERIAL 51051905

CARRL
CARRL
 Checks, Adjustments, Removals, Replacements, and Locations describes maintenance functions that can be performed on the 3410/3411 Tape Subsystem.

The 3410/3411 Magnetic Tape Subsystem consists of one or more IBM 3410 Magnetic Tape Units and an IBM 3411 Magnetic Tape Unit and Control. The major parts (tape unit and tape control) are functionally packaged (all controls used in performing a hardware function are located together) for quick isolation and replacement of a failing component. The circuitry within the subsystem (called the *attachment*), which adapts the subsystem to the I/O interface of the host system, must be considered in maintenance. Expanded sense data is provided to include more details of hardware failure than was furnished by most earlier tape subsystems.

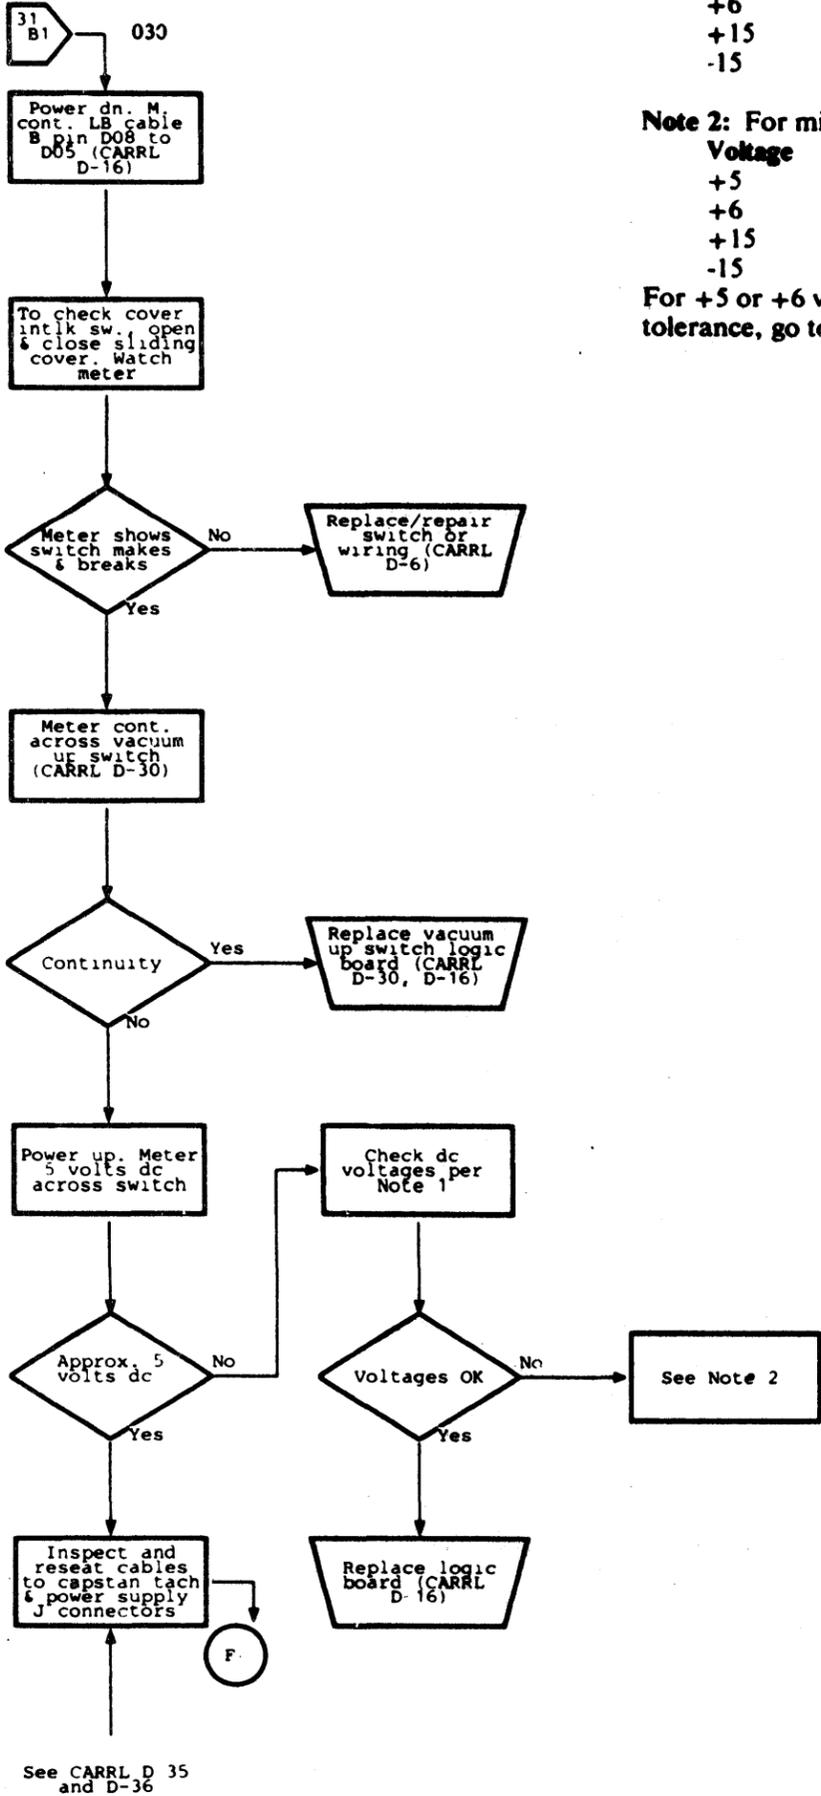
Vacuum Failures

Note 1: Measure voltages in the failing tape unit at the following points on DC TB1:

Voltage	Measure at	Tolerance
+5	TB1-1 (+) to 1-4 (-)	+4.90 to +5.10
+6	TB1-9 (+) to 1-4 (-)	+5.99 to +6.01
+15	TB1-11 (+) to 1-14 (-)	+13.5 to +17.15
-15	TB1-17 (-) to 1-14 (+)	-13.5 to -17.15

Note 2: For missing dc voltage, go to the MAP listed below:

Voltage	MAP
+5	AC090
+6	AC100
+15	AC130
-15	AC130

For +5 or +6 volts out of tolerance, go to MAP AC120. For +15 or -15 volts out of tolerance, go to MAP AC134.

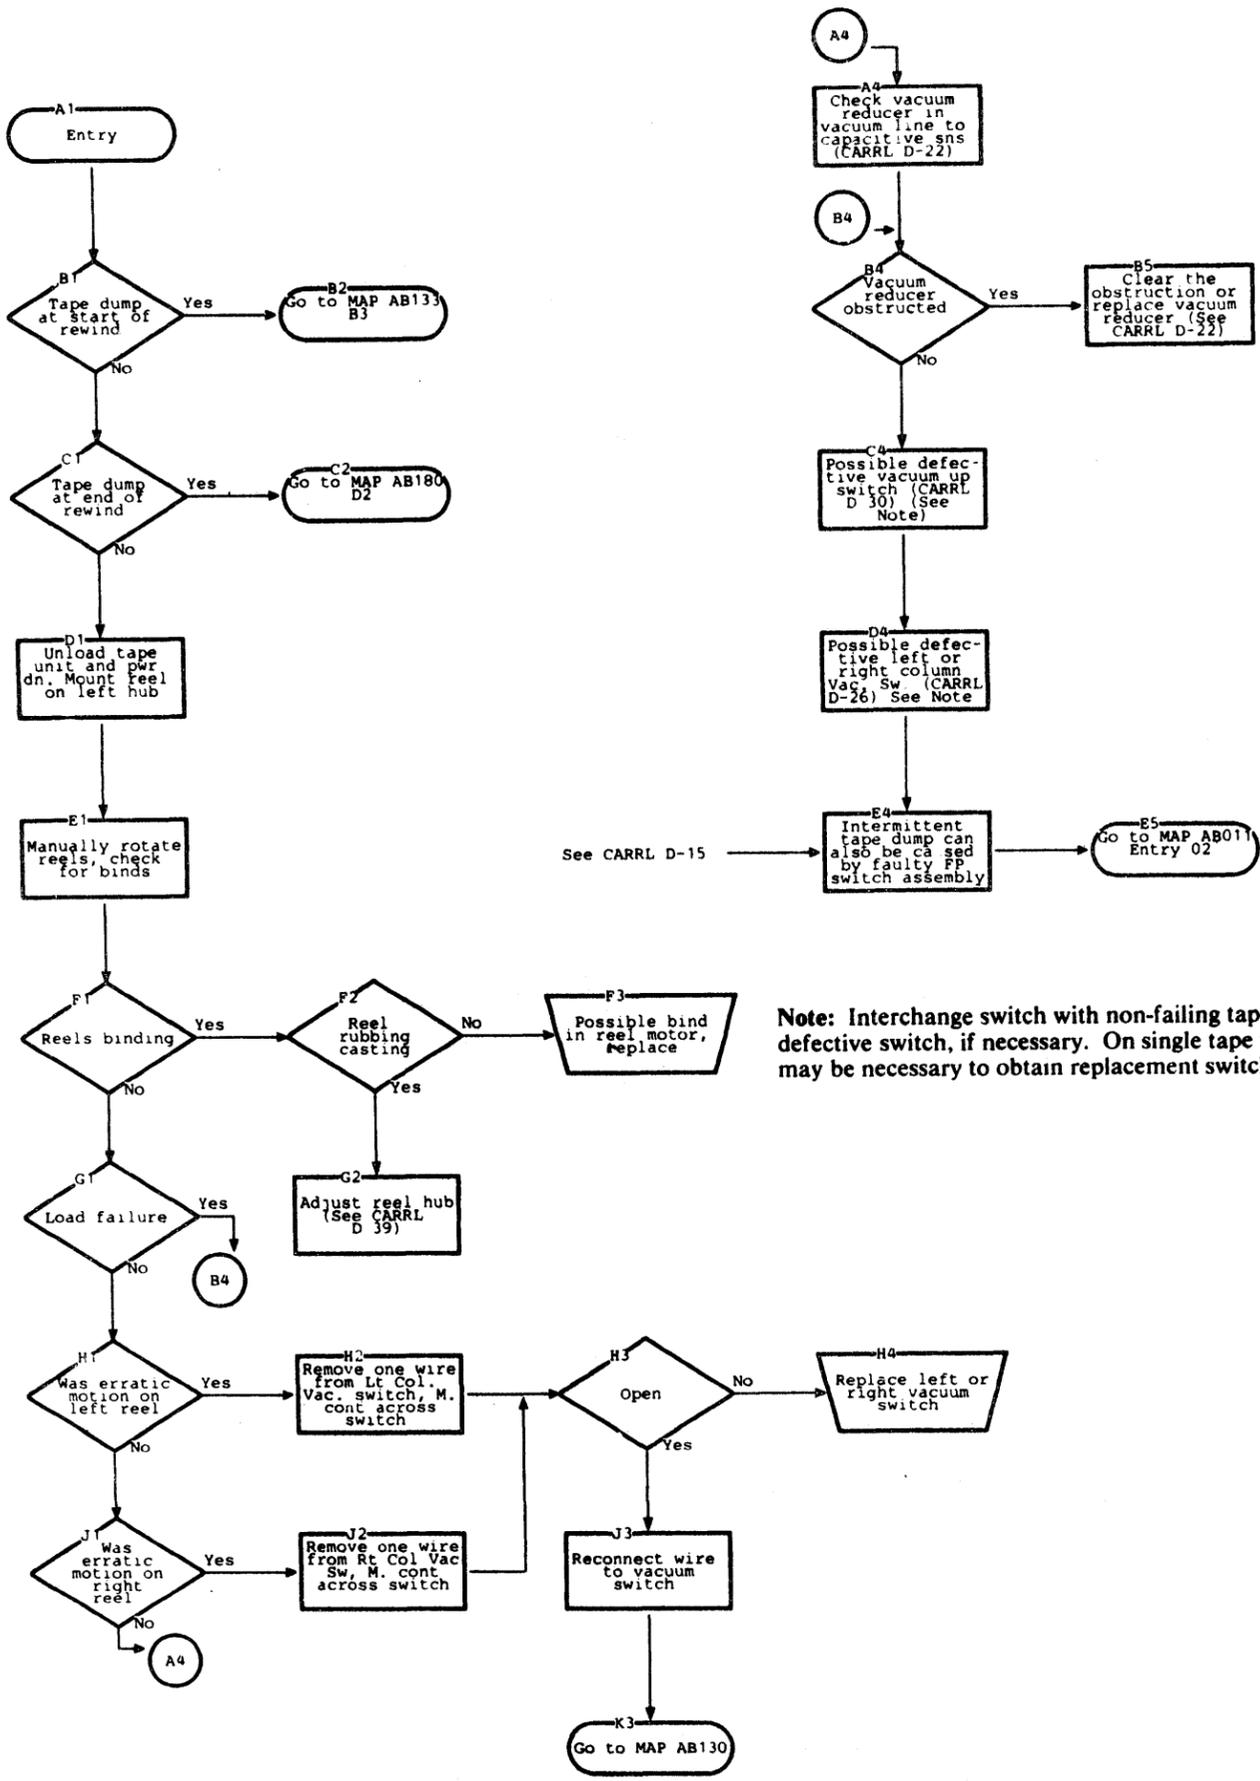
Erratic Reel Motion and Intermittent Tape Dump

Note: Interchange switch with non-failing tape unit. Replace defective switch, if necessary. On single tape unit subsystems, it may be necessary to obtain replacement switches.

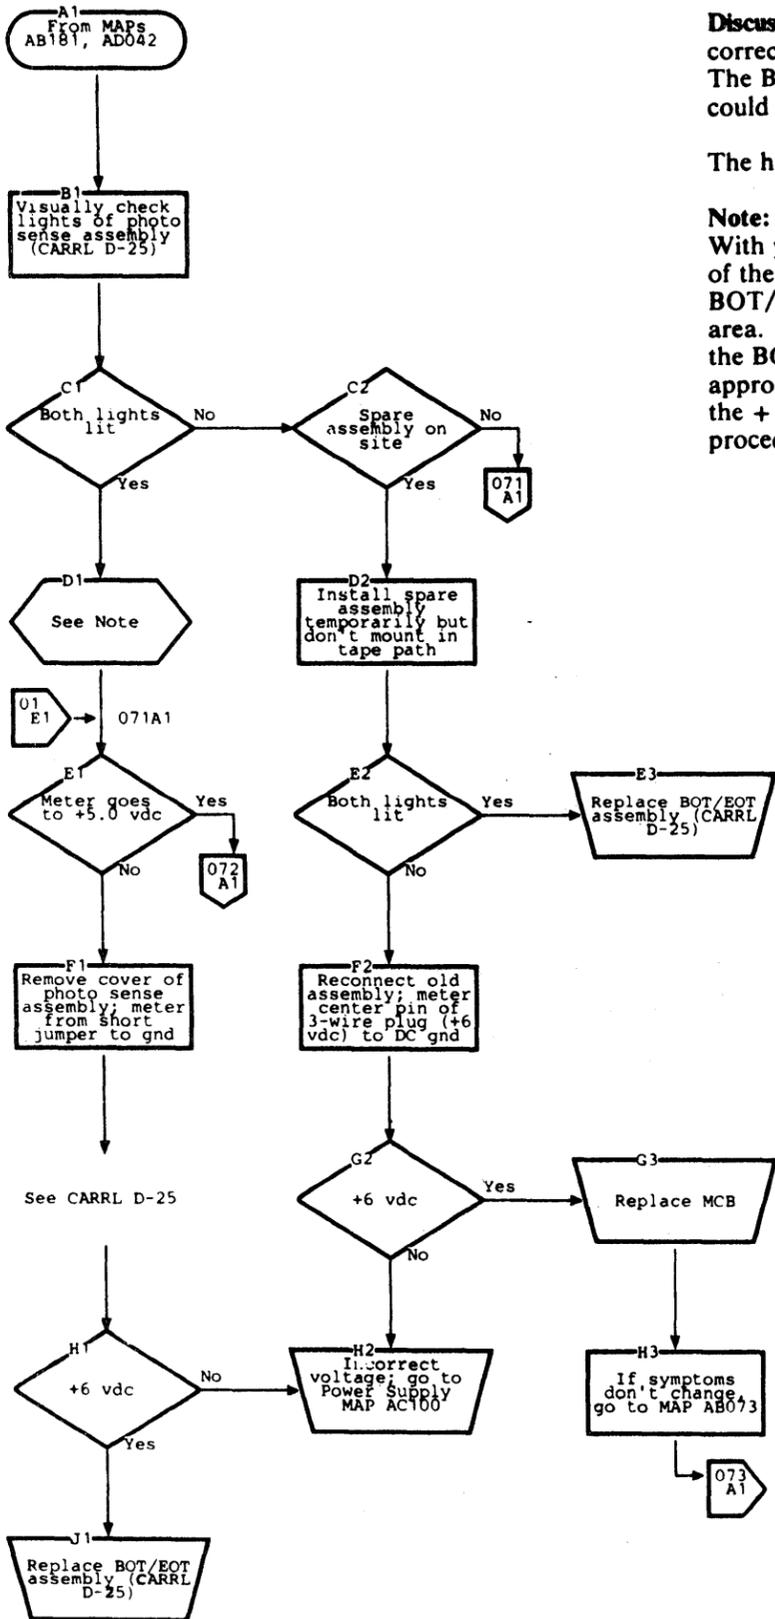
BOT Sense Failure

Discussion: Entry to this MAP assumes that the tape unit loads correctly, but fails to recognize a correctly installed BOT marker. The BOT/EOT sensing assembly or motion control board (MCB) could be defective.

The half-column cover must be in place when using this MAP.

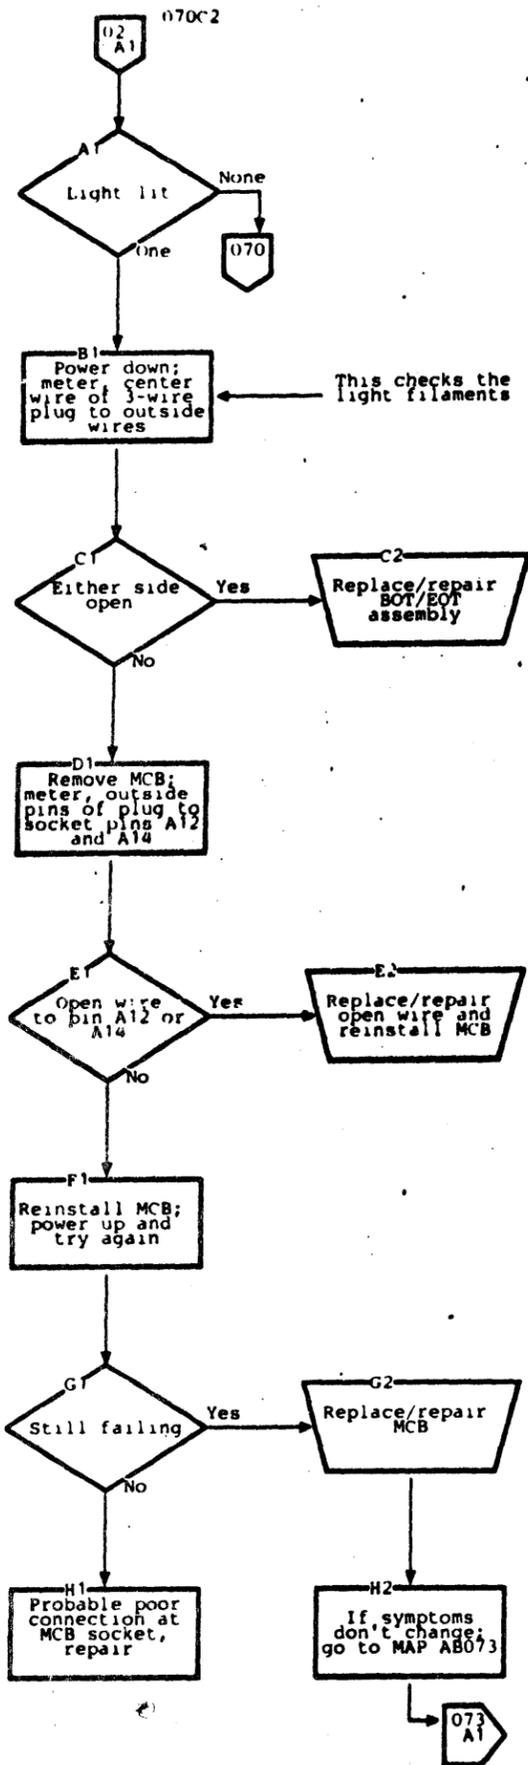
BOT Sense Failure

Note: Disconnect the two-wire plug from the BOT/EOT assembly. With your meter on the 15 volt dc scale, connect + lead to either pin of the wire plug and - lead to DC TB1-4. Hold the tape over the BOT/EOT assembly with the BOT marker just outside the sensing area. The meter should read approximately 3.5 volts. Now move the BOT marker into the sensing area; the meter should now read approximately 5.0 volts. If the voltage does not change, connect the + lead to the other pin of the two-wire plug and repeat the procedure.

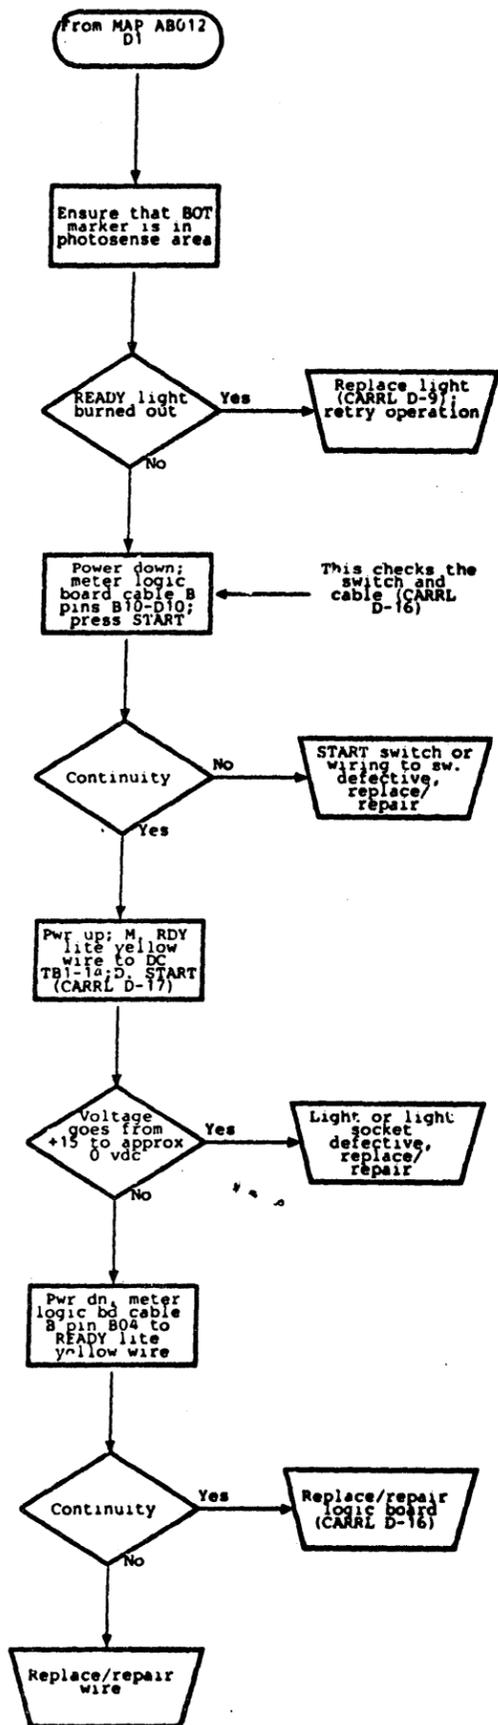
START Switch Failure

Discussion: Entry to this MAP assumes that tape loads correctly and stops with the BOT marker in the BOT sensing area, but READY light doesn't come on when START switch is pressed. The START switch, READY light, or logic board could be defective.

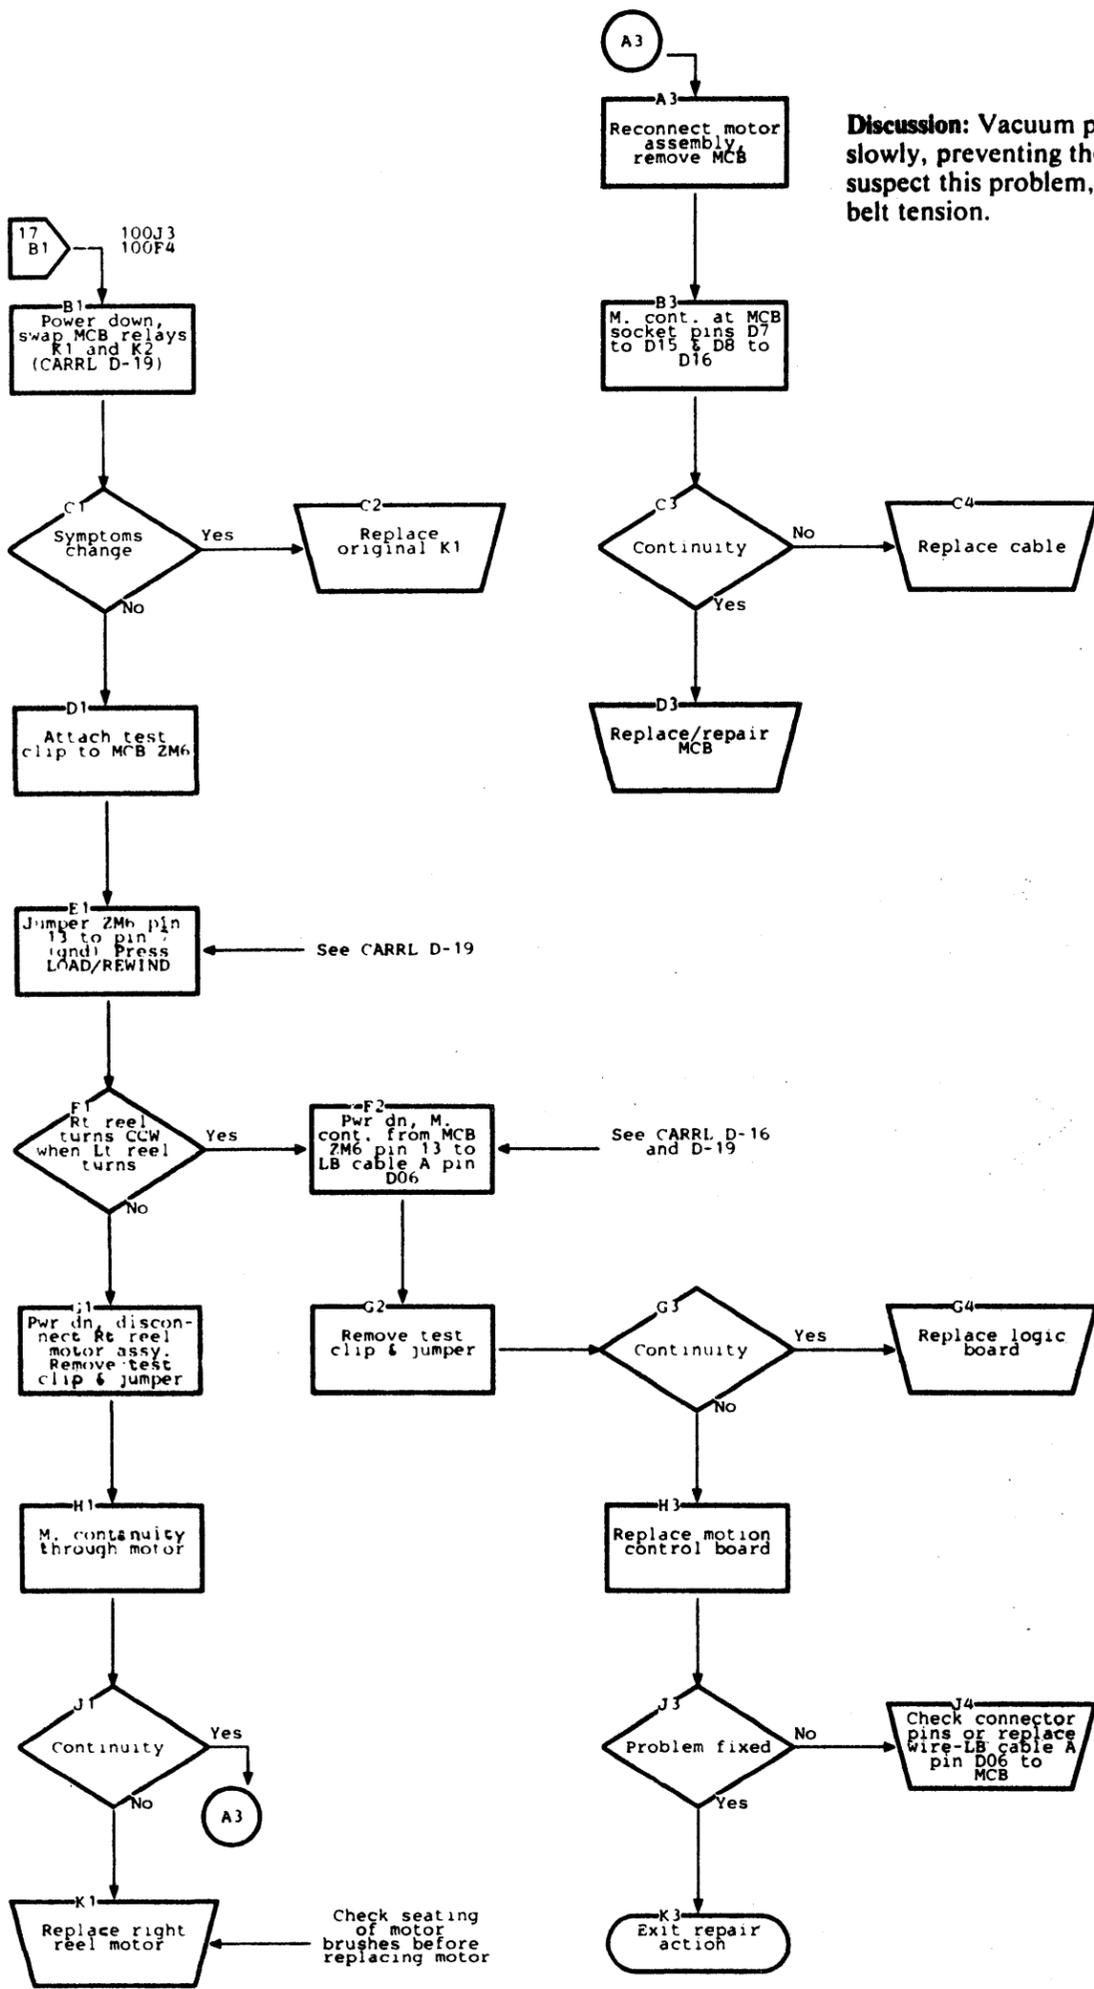
Load/Unload Reel Control Check

Discussion: Vacuum pump may attain vacuum level slowly, preventing the right reel from loading. If you suspect this problem, check vacuum pump pulley and belt tension.

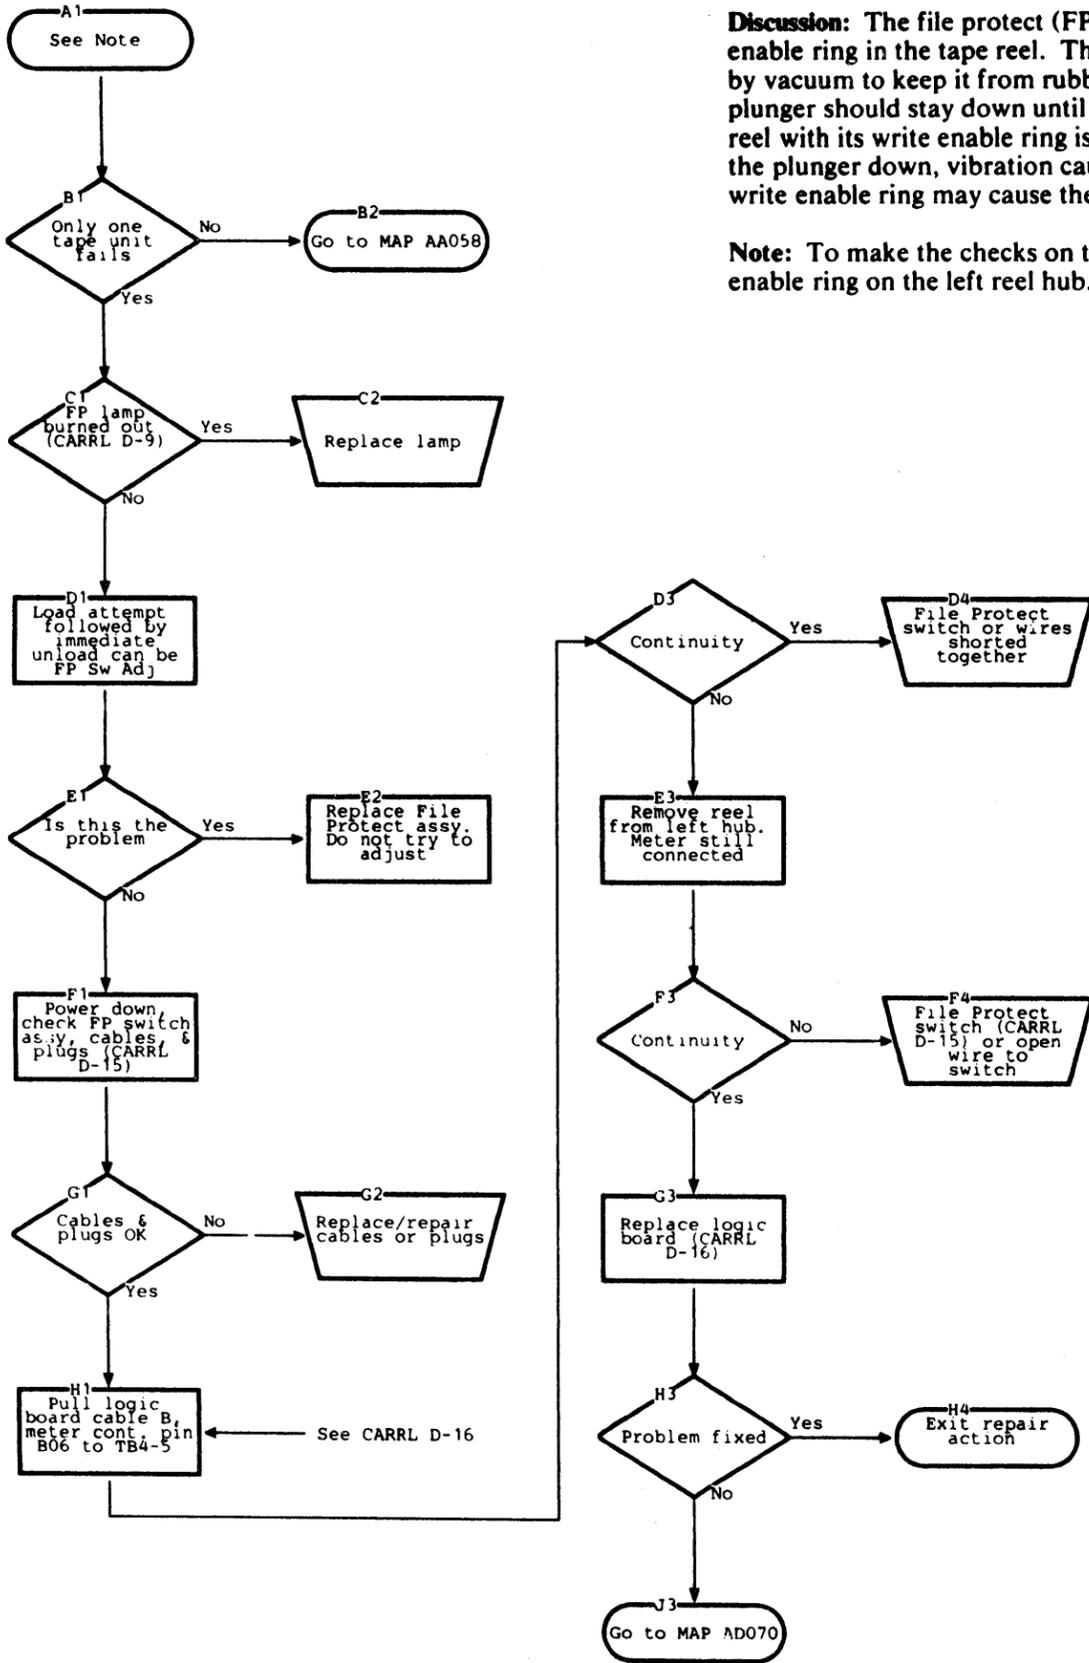
File Protect Failure

Discussion: The file protect (FP) switch is actuated by the write enable ring in the tape reel. The switch plunger is then held down by vacuum to keep it from rubbing on the write enable ring. The plunger should stay down until the vacuum pump stops, even if the reel with its write enable ring is removed. If vacuum does not hold the plunger down, vibration caused by the plunger rubbing on the write enable ring may cause the switch to transfer intermittently.

Note: To make the checks on this MAP, mount a reel with a write enable ring on the left reel hub. Do not load the tape unit.

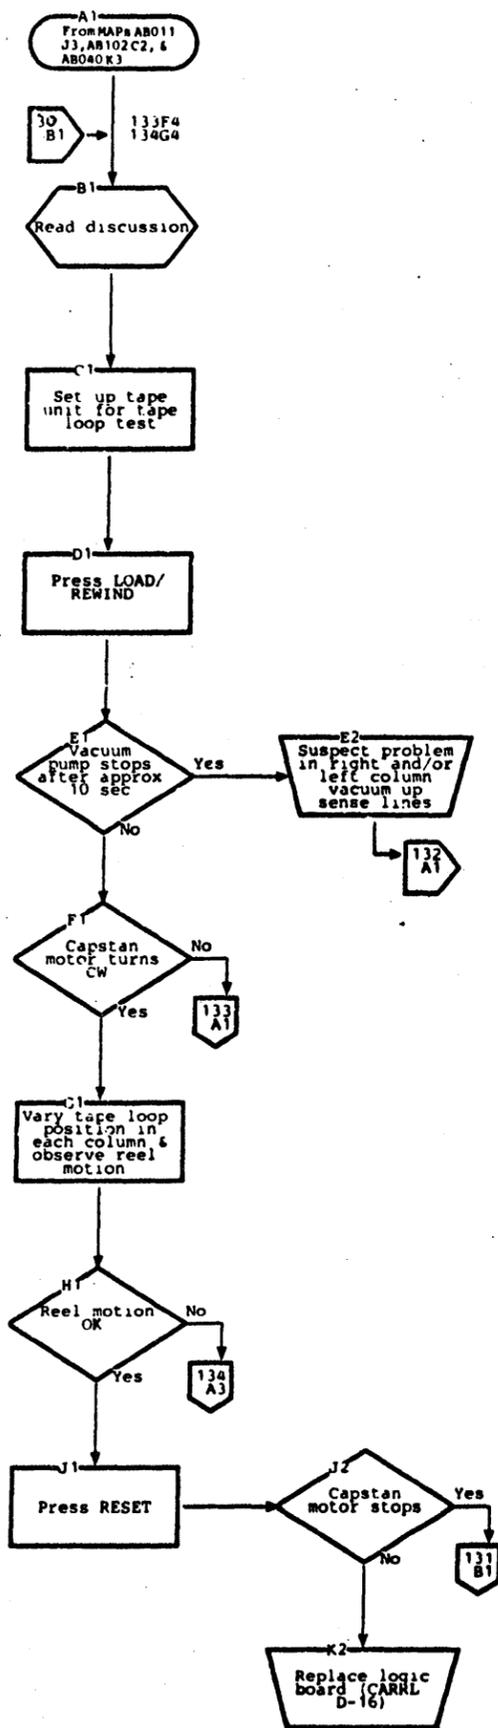
Discussion: Read the Tape Loop Check procedure in CARRL Figure D-3 before starting this MAP. Keep the CARRL section open to Figure D-3 for reference to this MAP to perform the tape loop check. If the completion of "Load Op" is unsuccessful and tape dump has occurred in the right column, check the capstan for proper sequencing including LP search. If capstan appears to run away in a forward direction, go to MAP AB131-A2 and check the tachometer. If tachometer is OK, return here and continue on this MAP. If it is not OK, take the corrective action indicated on MAP AB131.

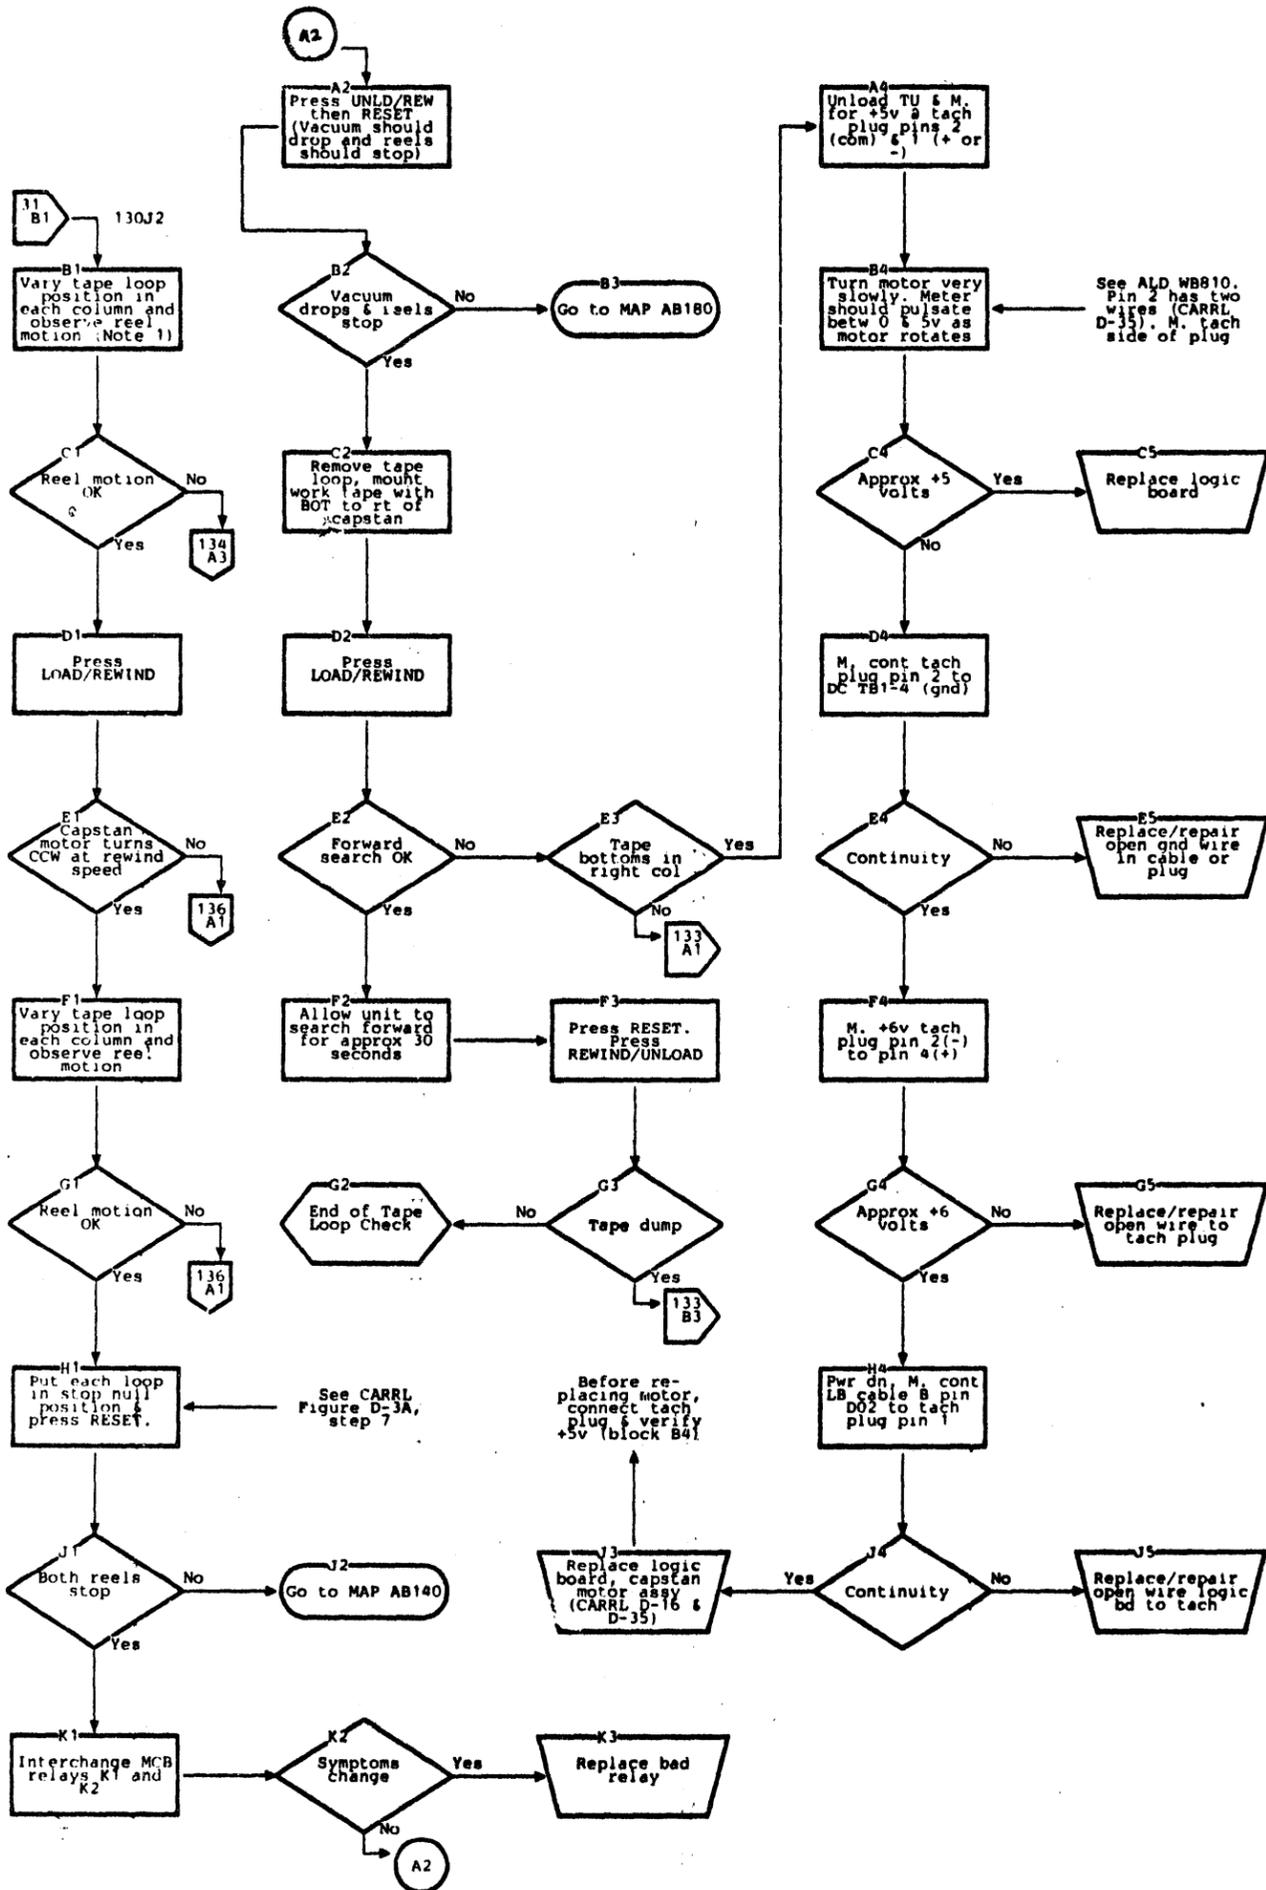
Tape Loop Check

Note 1: Read CARRL D-3 for instructions for mounting work tape or 8 ft. loop.

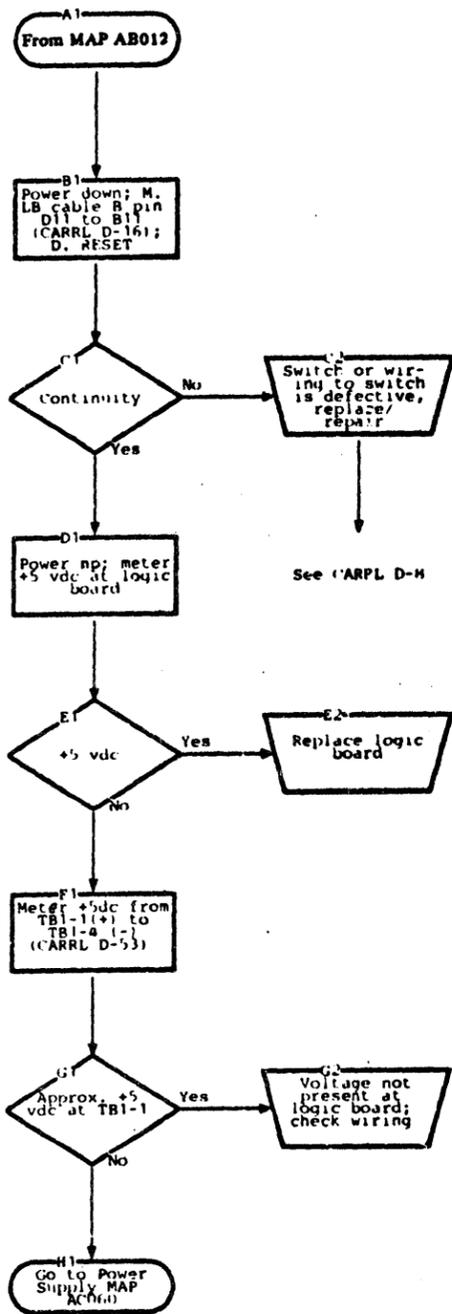
Reset Problems

Discussion: Entry to this MAP assumes that the READY light remains on when the RESET button is pressed. This condition could be caused by a faulty switch or wire, or a power supply problem.

Note: The tape control can cause a hang-up condition that disables the RESET switch.

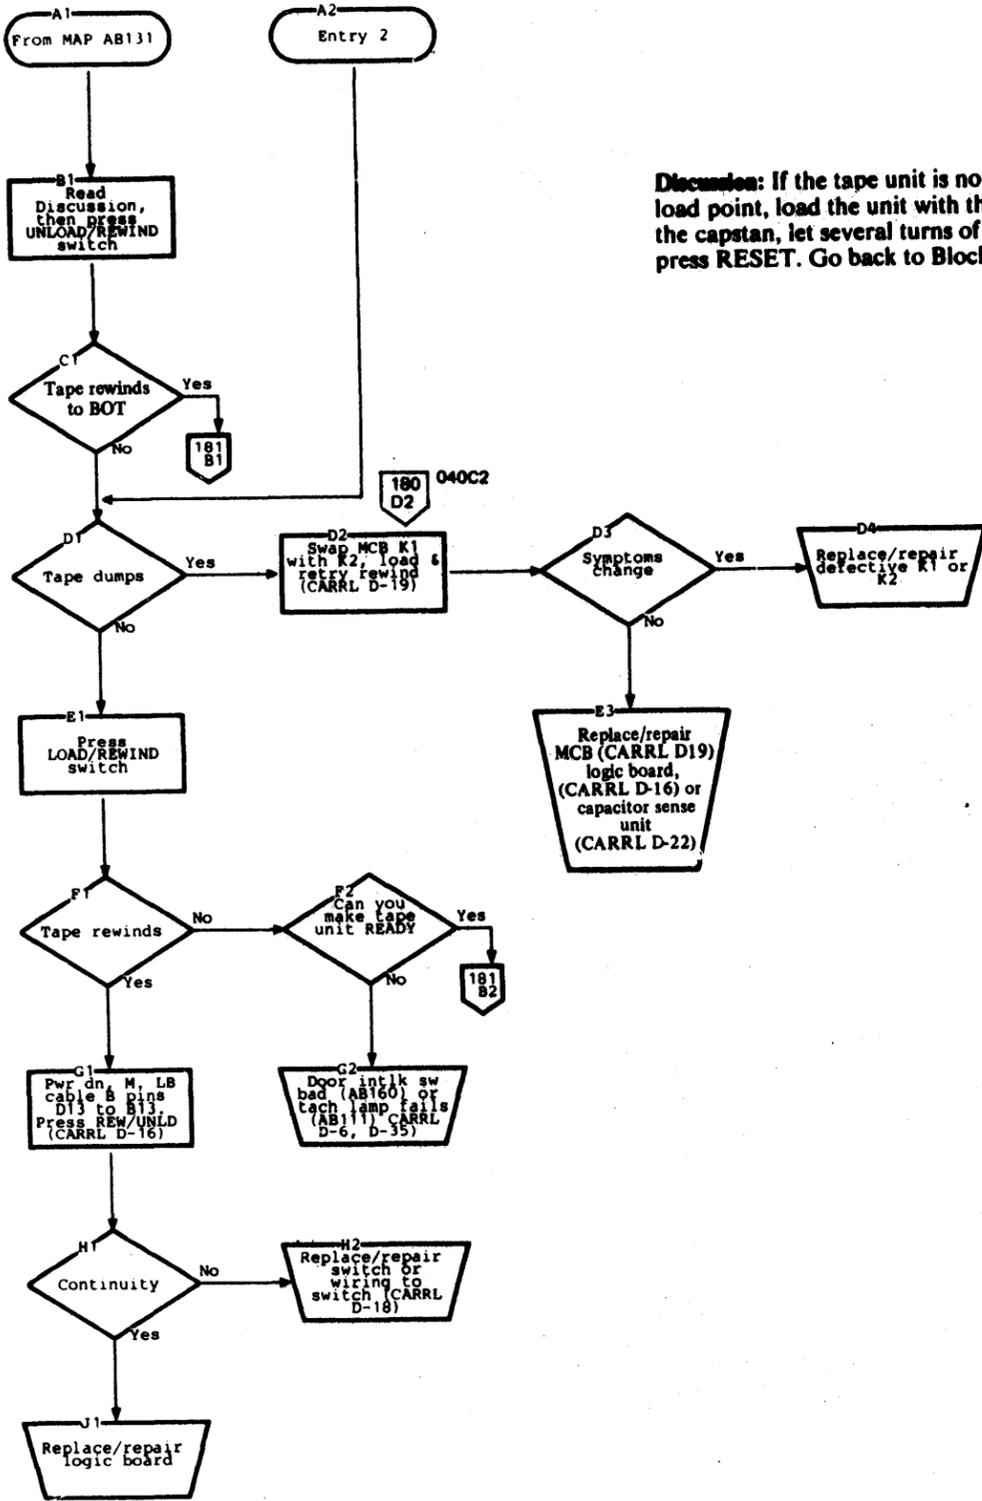
Unload/Rewind Failures

Discussion: If the tape unit is not already loaded and away from load point, load the unit with the BOT marker on the right side of the capstan, let several turns of tape wind onto the right reel, and press RESET. Go back to Block B1.

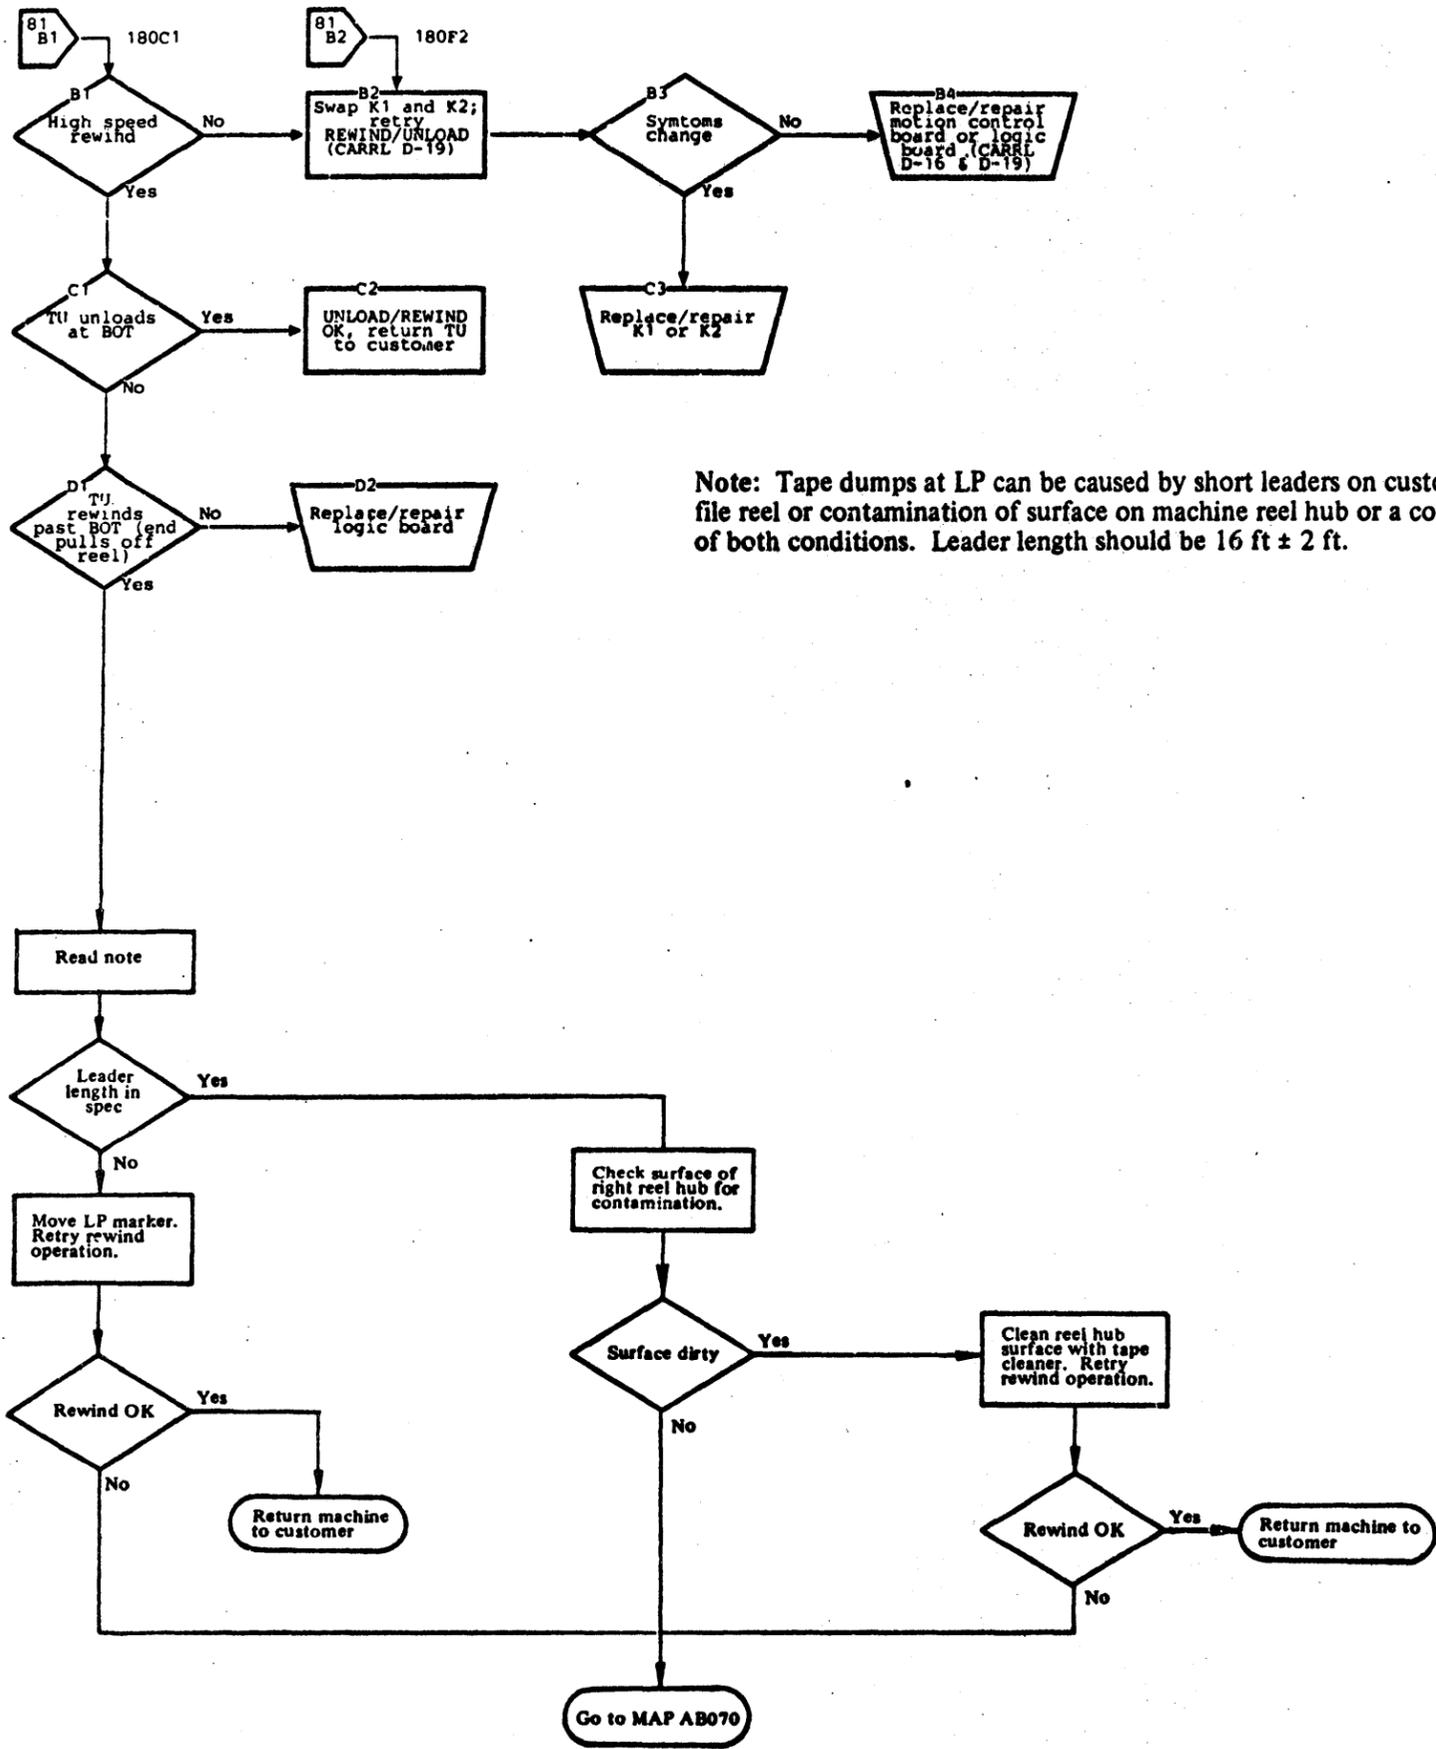
Unload/Rewind Failures

Note: Tape dumps at LP can be caused by short leaders on customer file reel or contamination of surface on machine reel hub or a combination of both conditions. Leader length should be 16 ft ± 2 ft.

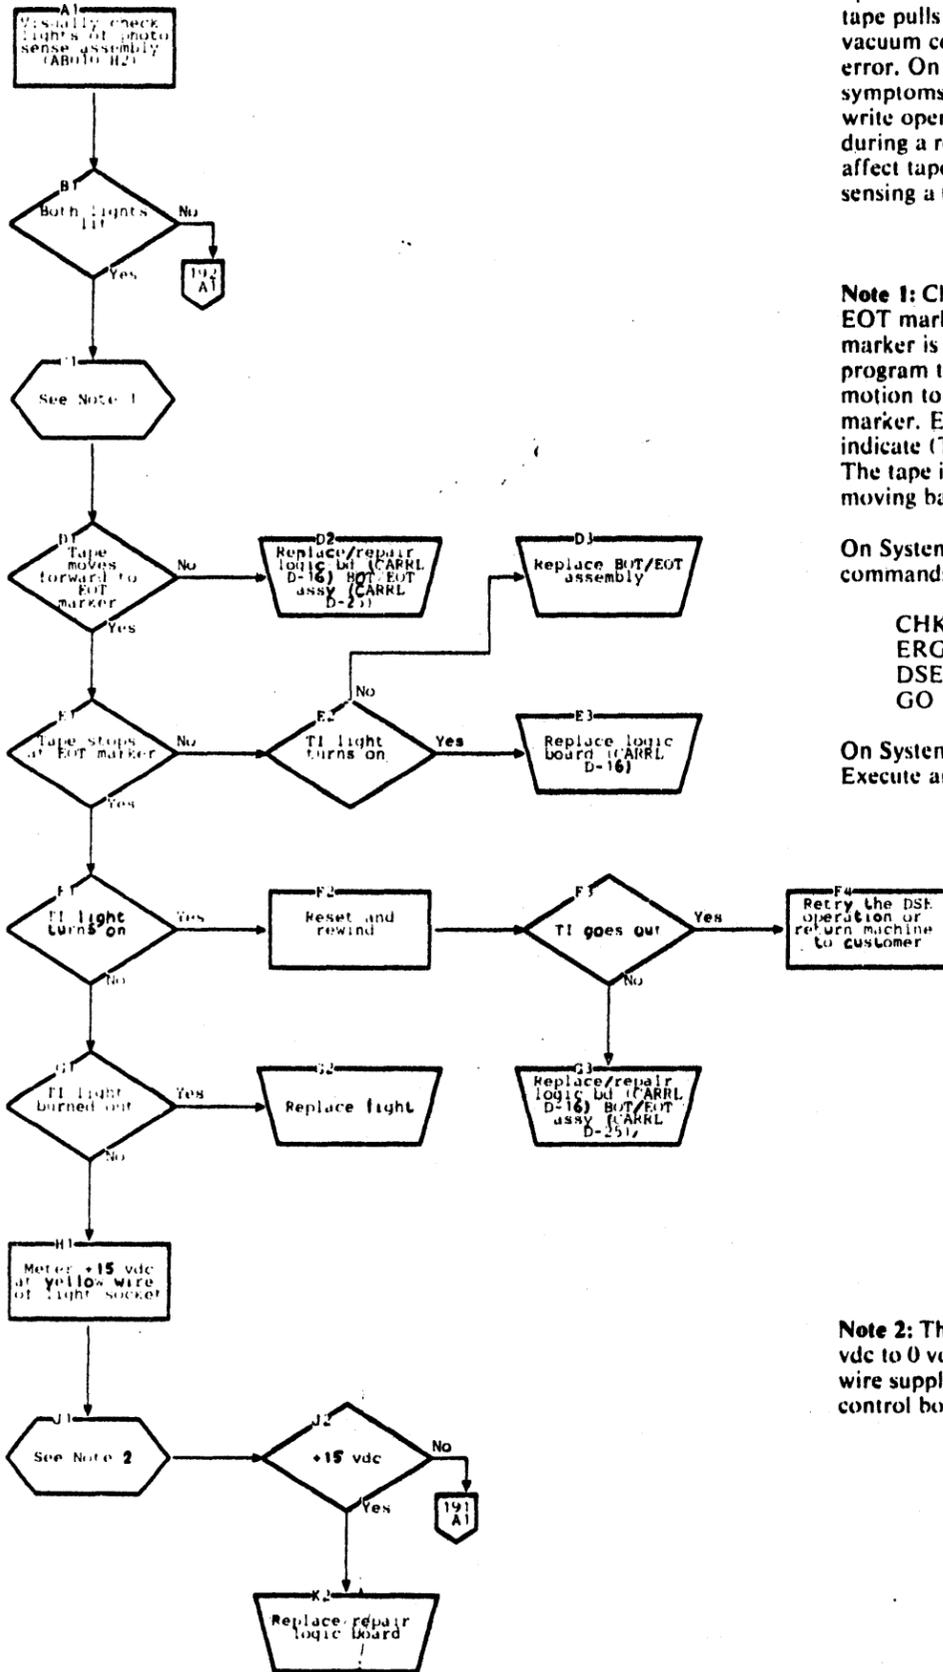
EOT Sense Problems

Discussion: Failure to sense end of tape during a write operation allows the tape unit to continue writing until tape pulls off the file reel. Tape then bottoms in the vacuum column, which drops READY and signals an error. On operations such as data security erase, the symptoms are similar to those encountered during a write operation. Failure to sense EOT reflective marker during a read or forward space operation doesn't usually affect tape unit operation since the program relies on sensing a tape mark block to indicate end of tape.

Note 1: Check EOT sensing with a work tape that has an EOT marker about two feet from the BOT. The EOT marker is on the lower or back edge of the tape. Run a program that executes a DSE command and observe tape motion to see if the tape unit is failing to sense the EOT marker. Each time the EOT marker is sensed, the tape indicate (TI) light should turn on and tape should stop. The tape indicate light should turn off when tape starts moving backward.
