TABLE OF CONTENTS

VOL D01 M/T 3411 SERIAL 51051905

CARRL
CARRL
 Checks, Adjustments, Removals, Replacements, and Locations describes maintenance functions that can be performed on the 3410/3411 Tape Subsystem.

The 3410/3411 Magnetic Tape Subsystem consists of one or more IBM 3410 Magnetic Tape Units and an IBM 3411 Magnetic Tape Unit and Control. The major parts (tape unit and tape control) are functionally packaged (all controls used in performing a hardware function are located together) for quick isolation and replacement of a failing component. The circuitry within the subsystem (called the *attachment*), which adapts the subsystem to the I/O interface of the host system, must be considered in maintenance. Expanded sense data is provided to include more details of hardware failure than was furnished by most earlier tape subsystems.

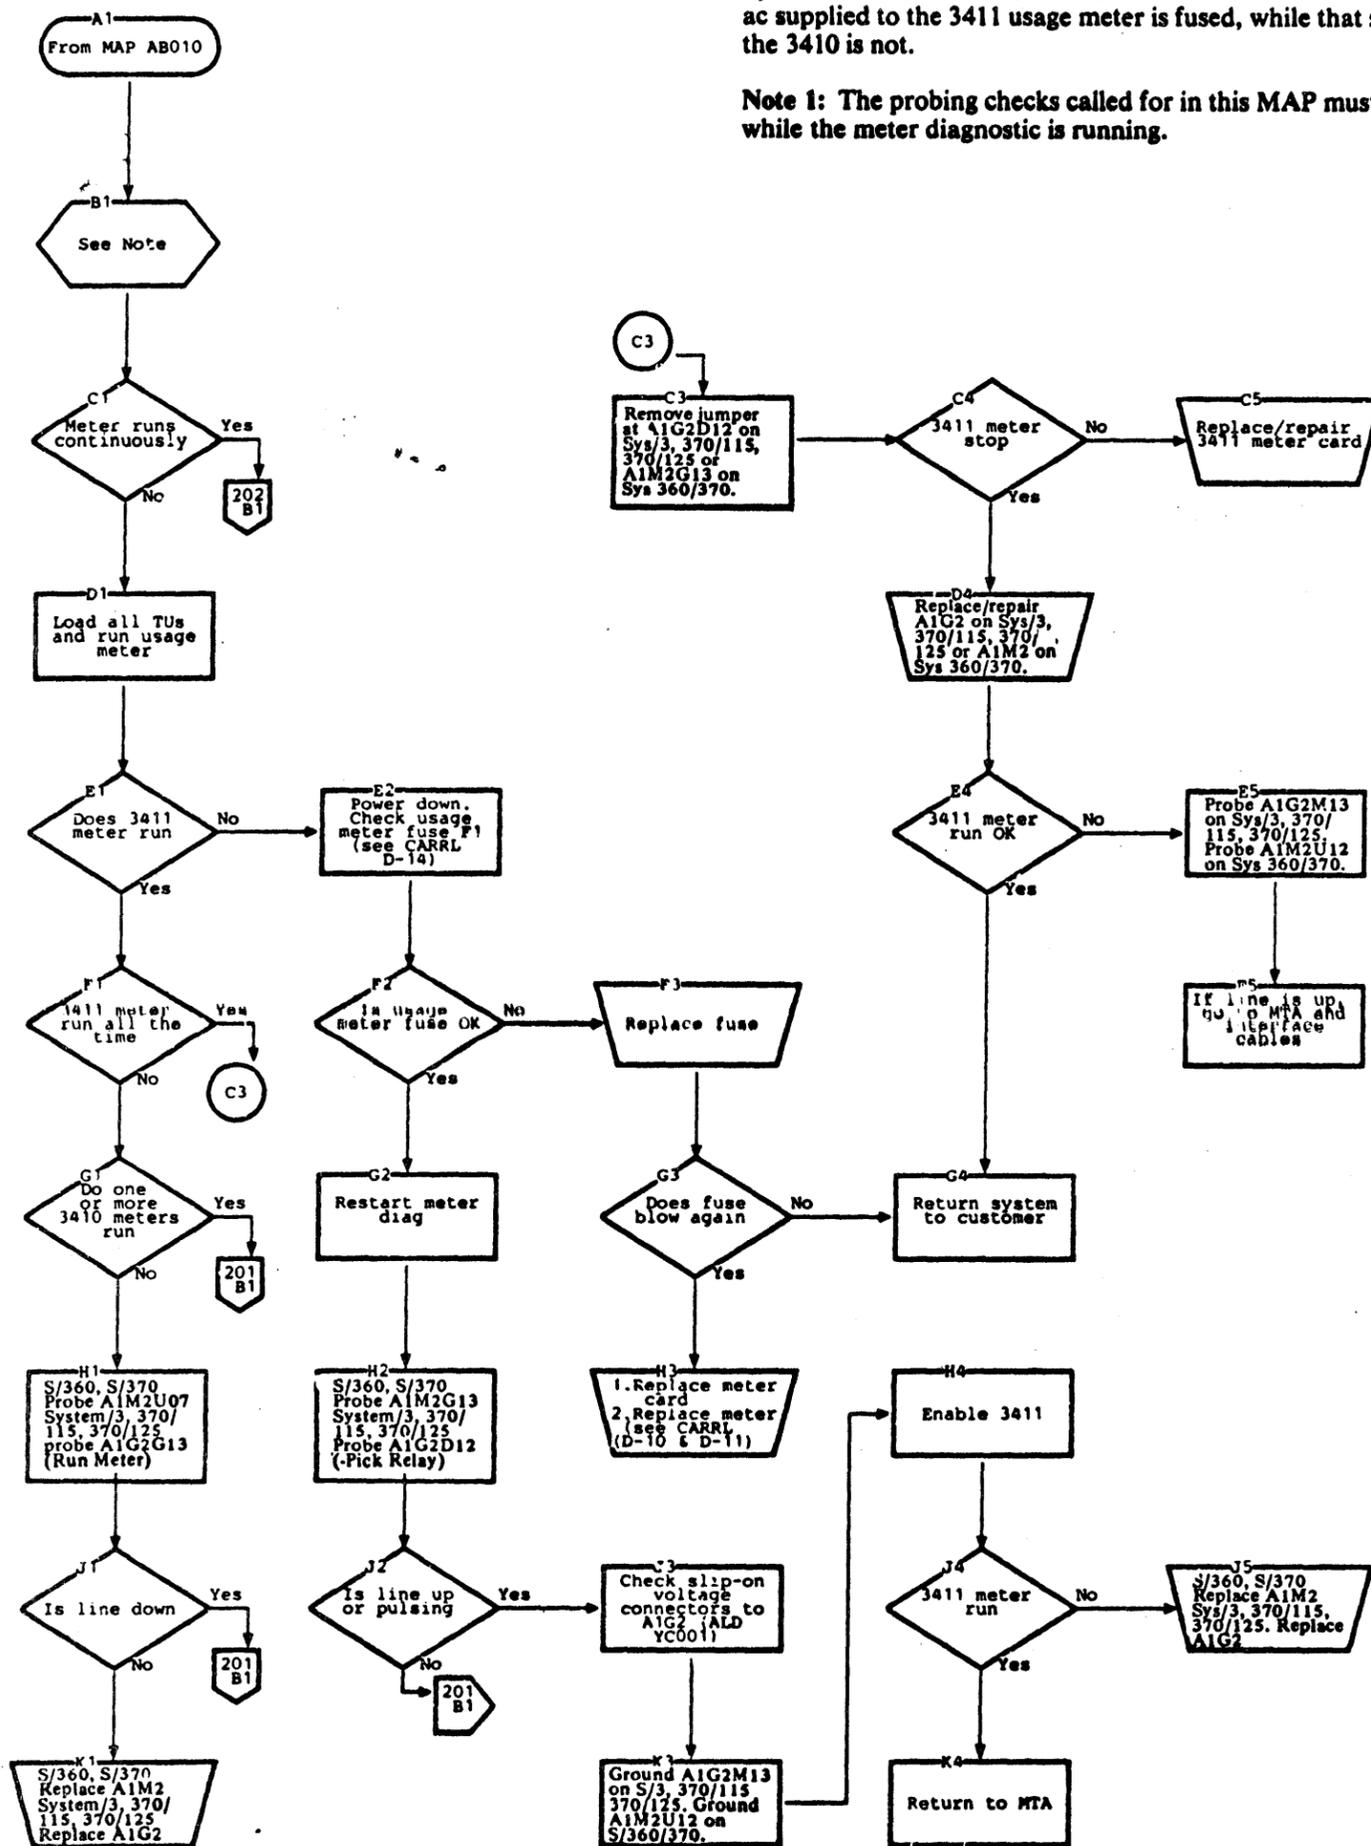
Usage Meter Problems

Discussion: The 41 volts ac for the 3411 usage meter is supplied by transformer T1. The voltage for the 3410 usage meter is supplied by a small transformer mounted on the lower left side frame. The ac supplied to the 3411 usage meter is fused, while that supplied to the 3410 is not.

Note 1: The probing checks called for in this MAP must be made while the meter diagnostic is running.

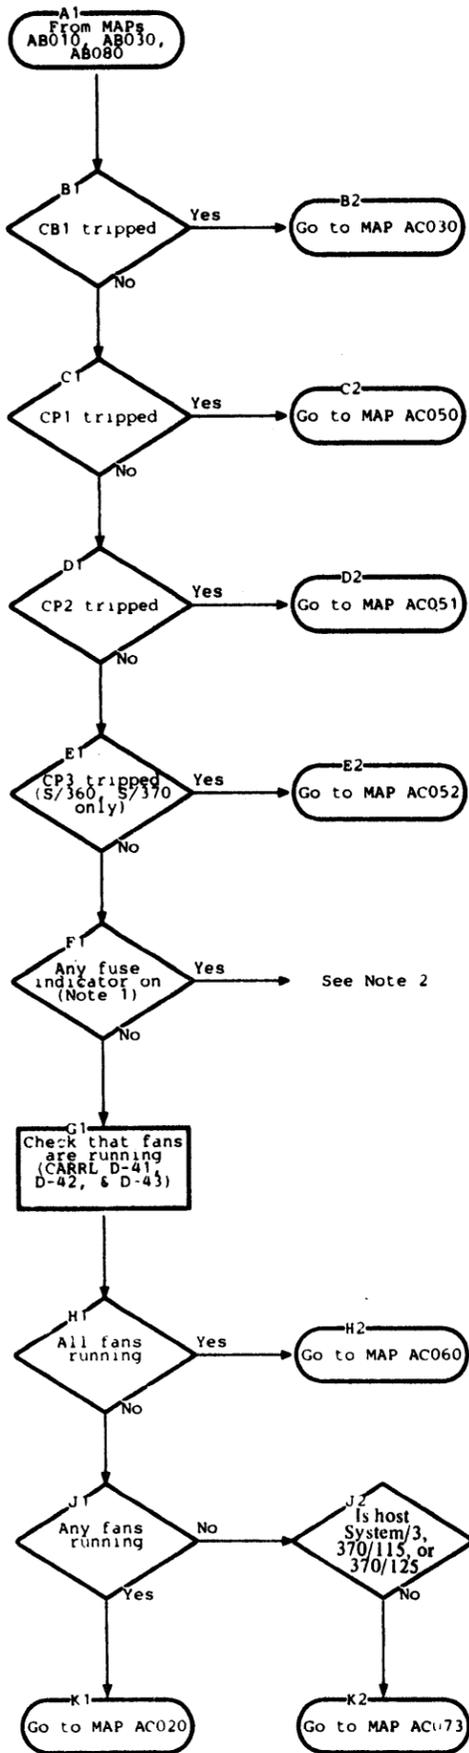
Power Supply Entry

Discussion: This MAP is the general entry for all power supply problems. It lists symptoms and routes you to the appropriate MAP or diagnostic for further analysis. Approach power supply problems from this MAP unless directed to a different MAP by another MAP or diagnostic printout.

Note 1: There are two fuse indicators on the motion control board, and five in the dc section of the 3411 power supply. In the dc section of the 3411 power supply, two indicators are located at the bottom, two on the left side, and one on the right side.

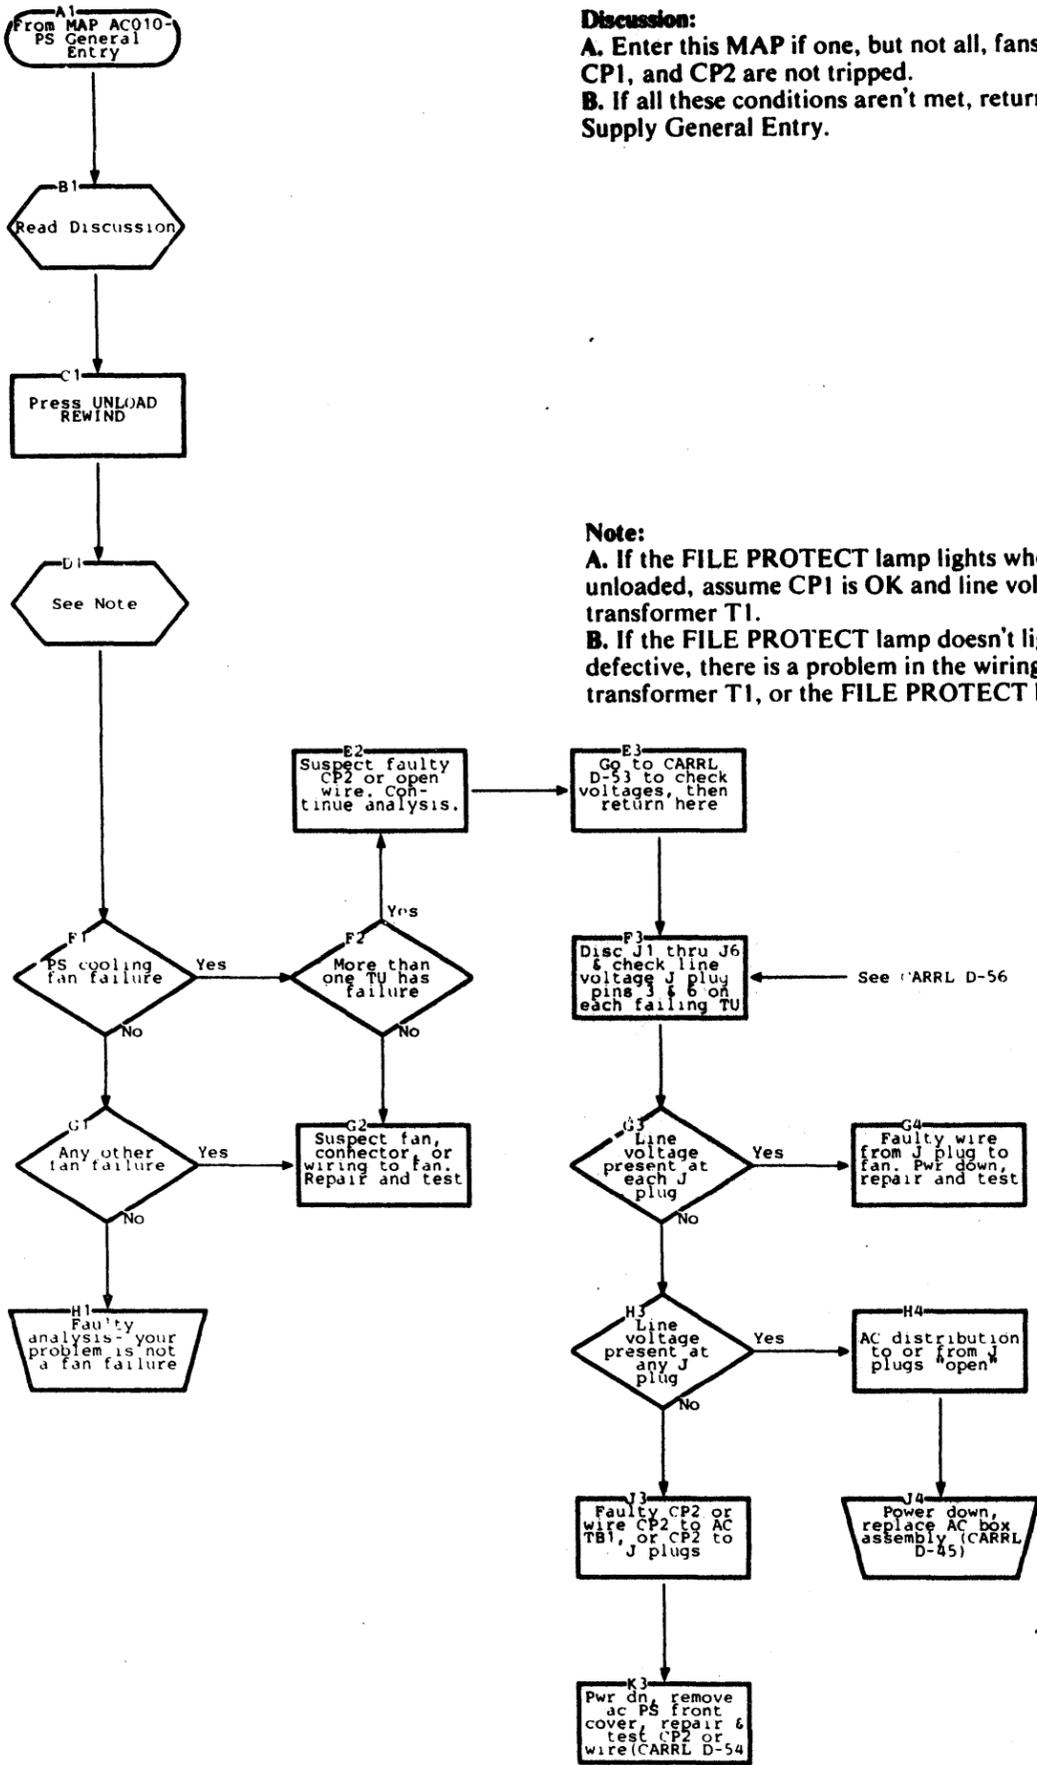
Fan Failure

- A. Enter this MAP if one, but not all, fans are running, and CB1, CP1, and CP2 are not tripped.
- B. If all these conditions aren't met, return to MAP AC010, Power Supply General Entry.

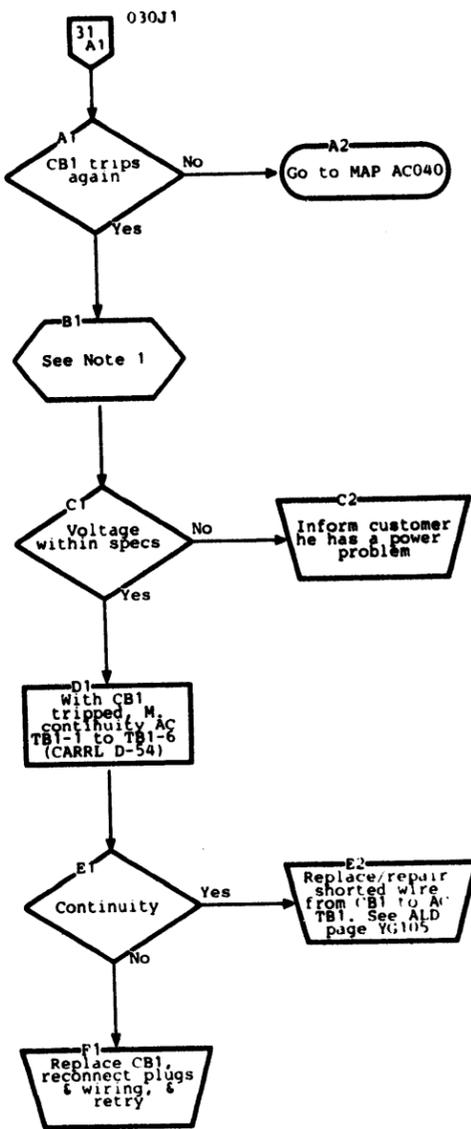
CB1 Tripped

Note 1: Measure input line voltage at AC TB1. Input voltage should be 200, 208, or 230 vac $\pm 10\%$. Check input connections on ALD page YG105 and make sure that AC TB1-3, -4, and -5 are wired correctly. The wires disconnected at block AC030 J1 will still be disconnected and J1-J6 will still be unplugged. Do not reconnect them at this time.

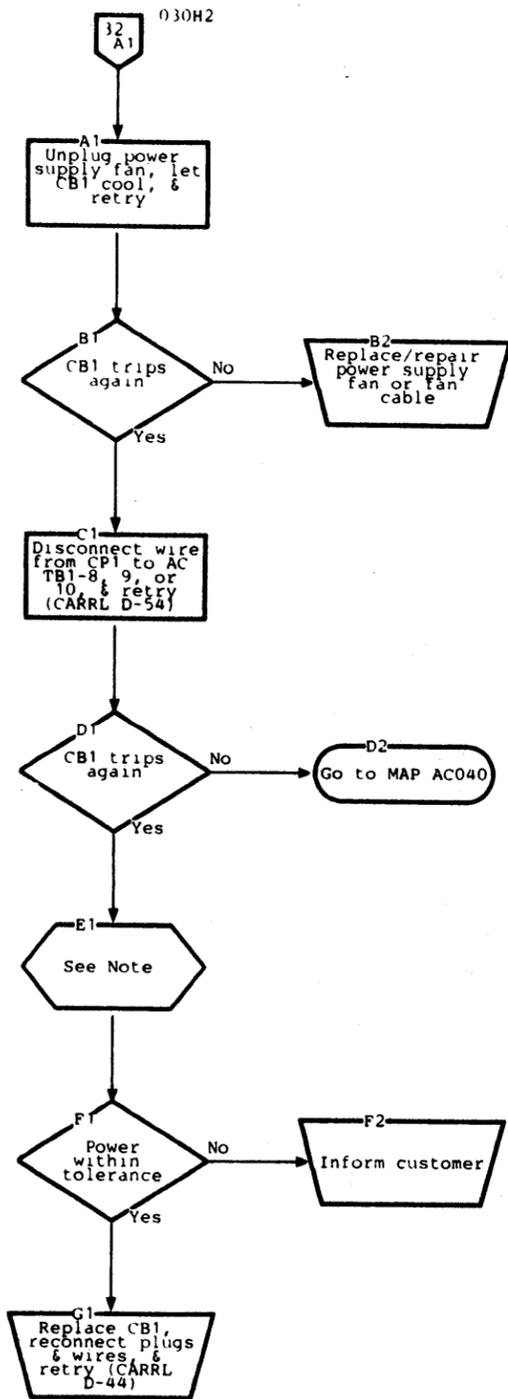
CB1 Tripped

Note: Disconnect power cable from wall and measure input line voltage. Input voltage should be 200, 208 or 230 vac $\pm 10\%$ for 60 Hz machines, and 200, 220, 235, 380, or 408 vac $\pm 10\%$ for 50 Hz machines.

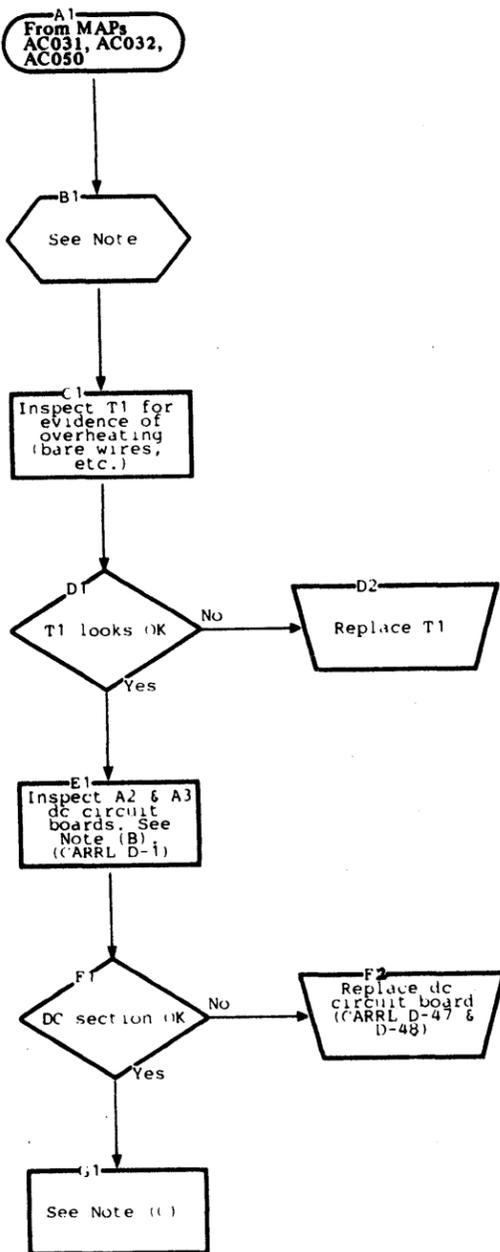
Transformer T1 Overload

Discussion: Entry to this MAP assumes that either CBI or CPI keeps tripping, and following MAP AC030, AC032, or AC050 hasn't corrected the problem. A defective transformer (T1), or a faulty dc power supply could cause this condition.

Note: Your problem appears to be caused by overloading transformer T1. Since diagnosis from this point may be difficult, you should probably call for assistance, and check the following while waiting for help:

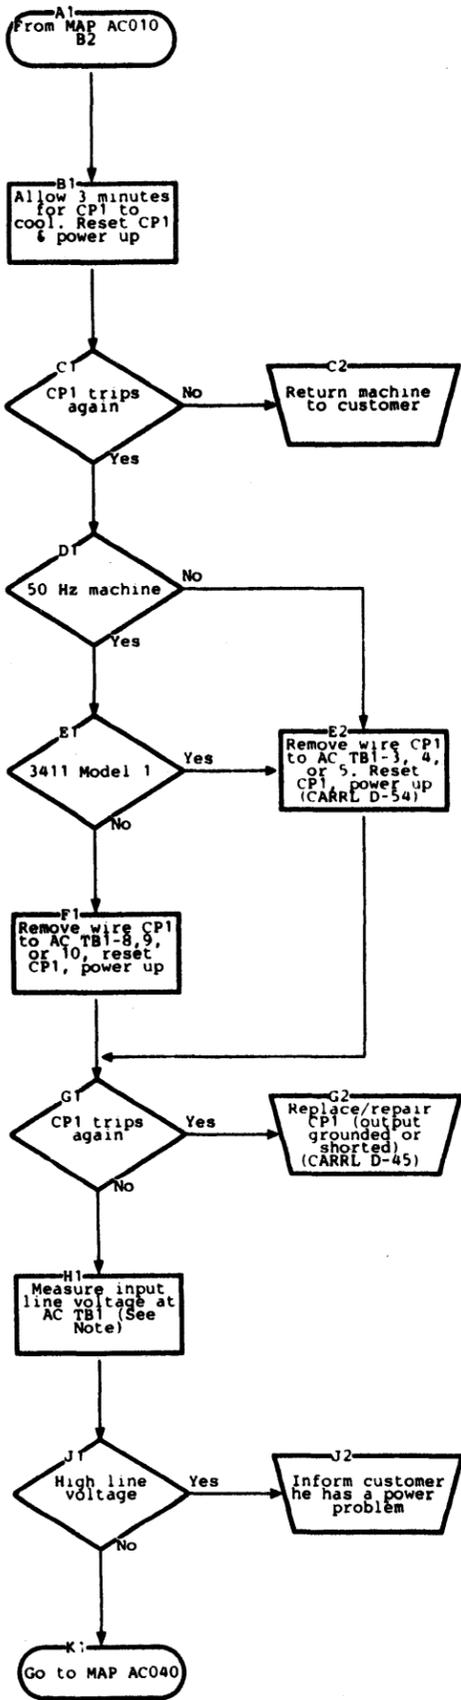
CP1 Tripped

Discussion: Entry to this MAP assumes that CP1 is tripped. CP1 protects the ac distribution to the primary side of transformer T1.

Note-Input Voltage: Input voltage should be 200, 208, or 230 vac \pm 10% for 60 Hz machines, and 200, 220, 235, 380, or 408 vac \pm 10% for 50 Hz machines.

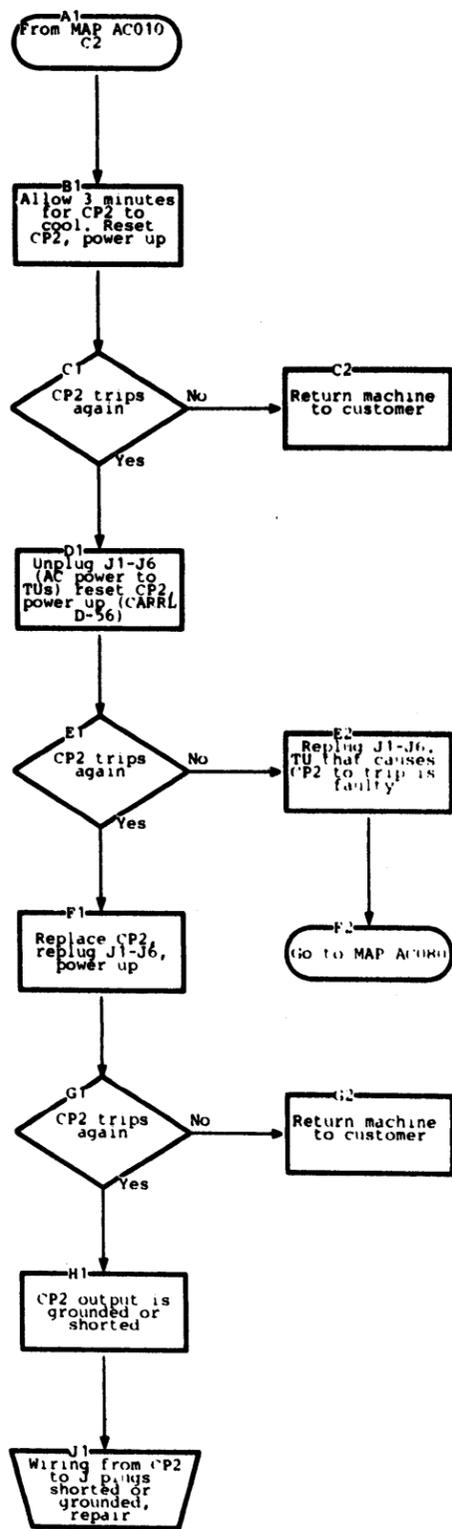
MAP AC050

CP2 Tripped

Discussion: Entry to this MAP assumes that CP2 is tripped. CP2 protects the ac distribution to the tape units. When CP2 trips, it interrupts the ac to J1-J6.

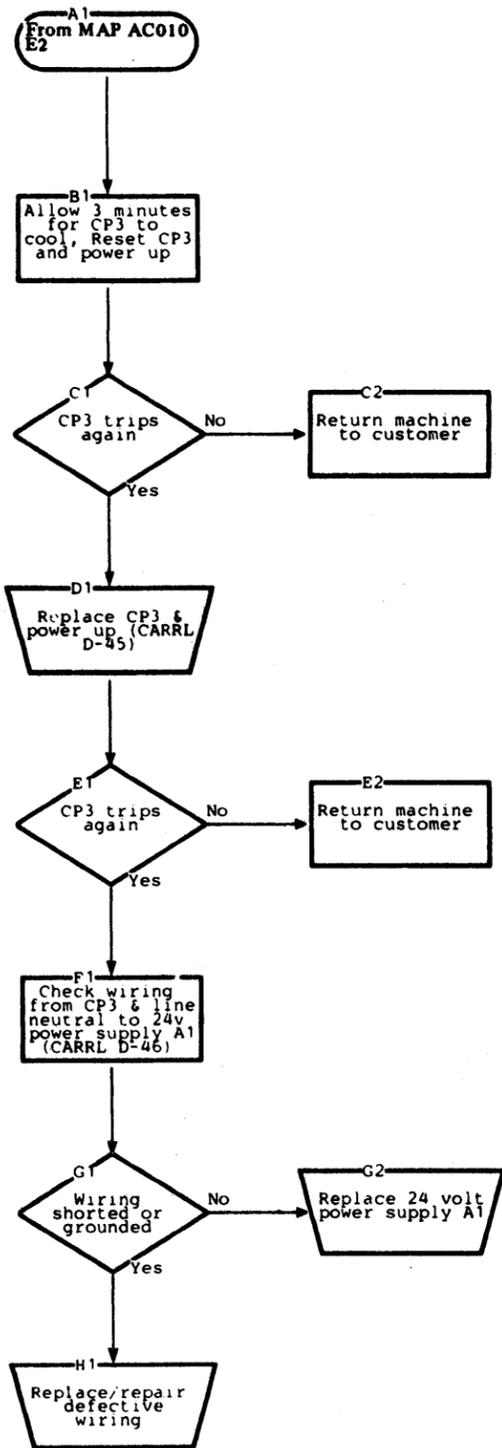
CP3 Tripped

Discussion: Entry to this MAP assumes that CP3 is tripped. CP3 protects the 24-volt ac power supply A1. This power supply activates the tape control power-on circuitry when the subsystem is attached to a System/360 or System/370.

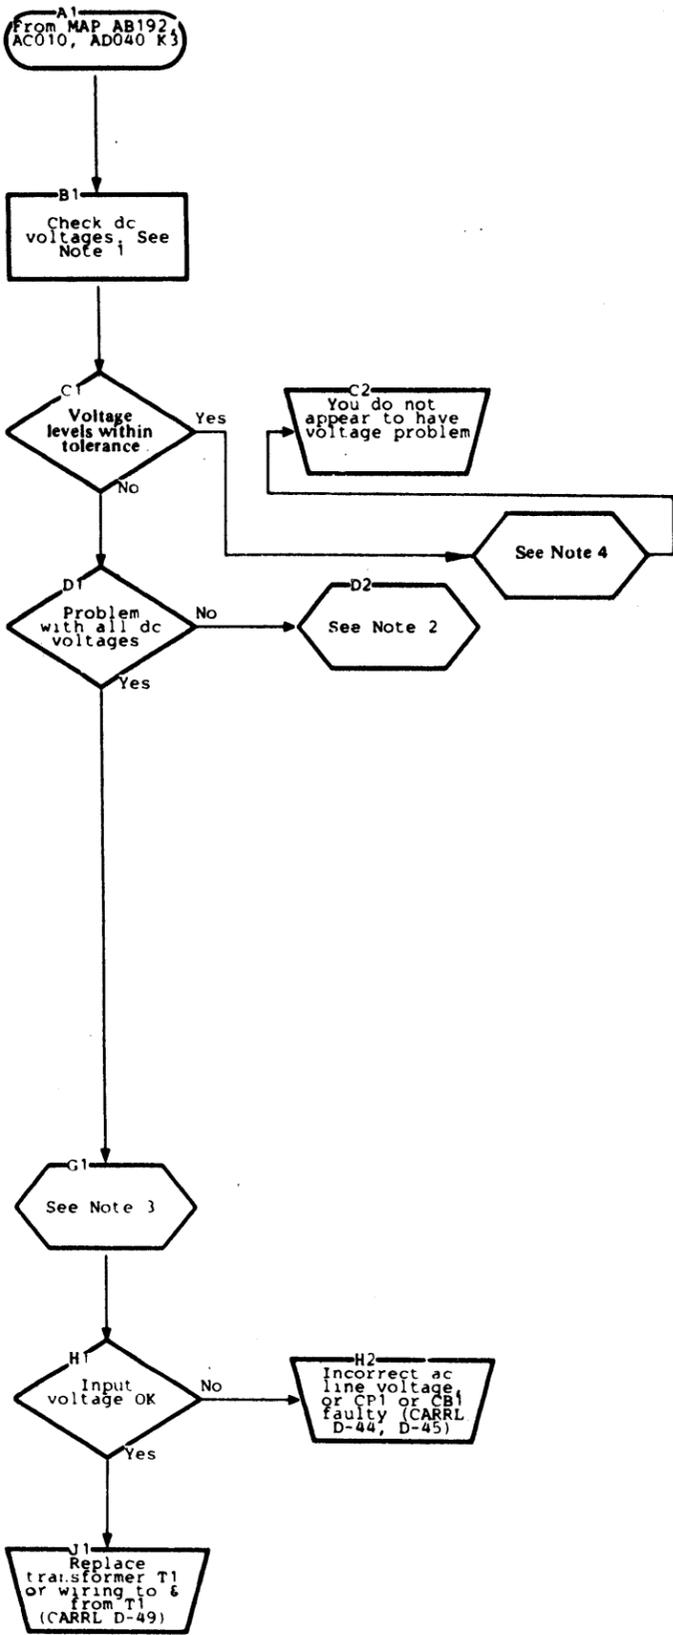
DC Voltage Settings

Discussion: Enter this MAP if ac voltages are present but you suspect a dc voltage is outside allowable limits or missing.

Note 1: Measure power supply output voltages at the following test points on DC TB1 (see CARRL D-17):

If -4v, +5v, or +6v is missing, check for a defective regulator card by swapping regulator cards to see if the symptoms change. Do not adjust any voltages while making this check, and be sure to return the cards to their correct sockets when the check is completed. If you decide that the problem is a defective regulator card, see CARRL Figure D-53 for replacement and adjustment procedures. If this check does not isolate your problem or if your problem is with the ± 15 volt supply, go to the following MAP:

Note 4: If entry to this page was due to clock stoppage, intermittent, or unrelated failures, check -4, +5, and +6 voltages for ripple. Use an oscilloscope grounded to dc common and check for ripple or noise with all tape units loaded. It should not exceed $\pm 2.5\%$ or a total of 5%. If ripple exceeds tolerance, replace the power supply (see CARRL D-47 and D-48).

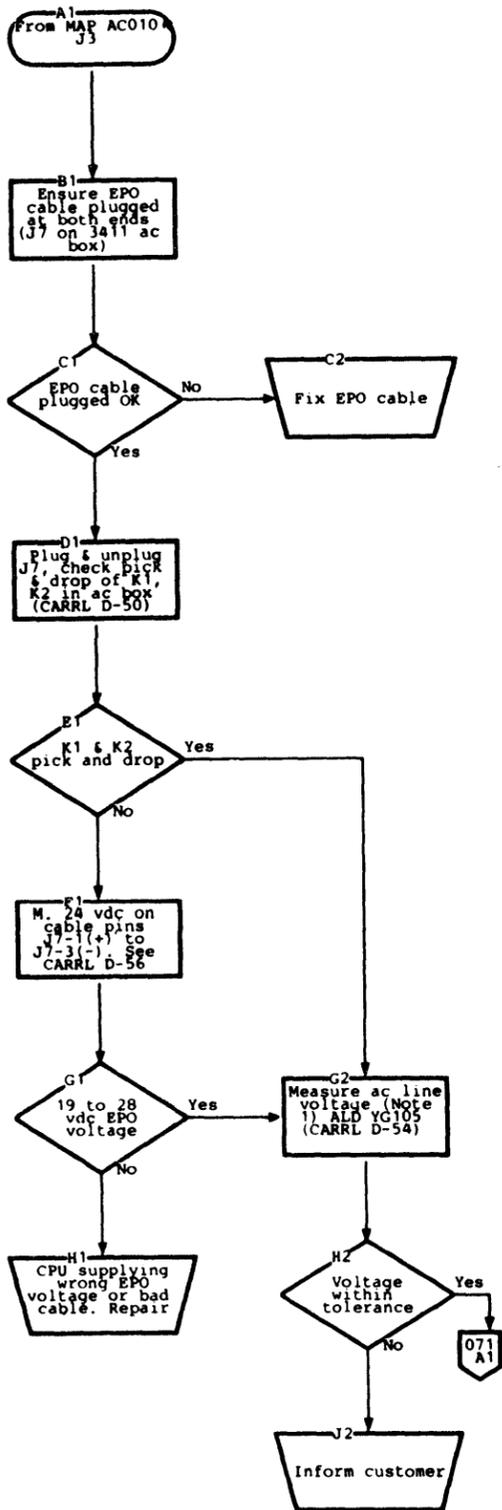
System/3 Power-On Sequencing

Discussion: Entry to this MAP assumes you have power-on sequencing problems when attached to a System/3 "host" system.

Note 1-Input Voltage: Input voltage should be 200, 208, or 230 vac $\pm 10\%$ for 60 Hz machines, and 200, 220, 235, 380, or 408 vac $\pm 10\%$ for 50 Hz machines. Ensure that primary input voltage is present at subsystem from main CB, if possible.

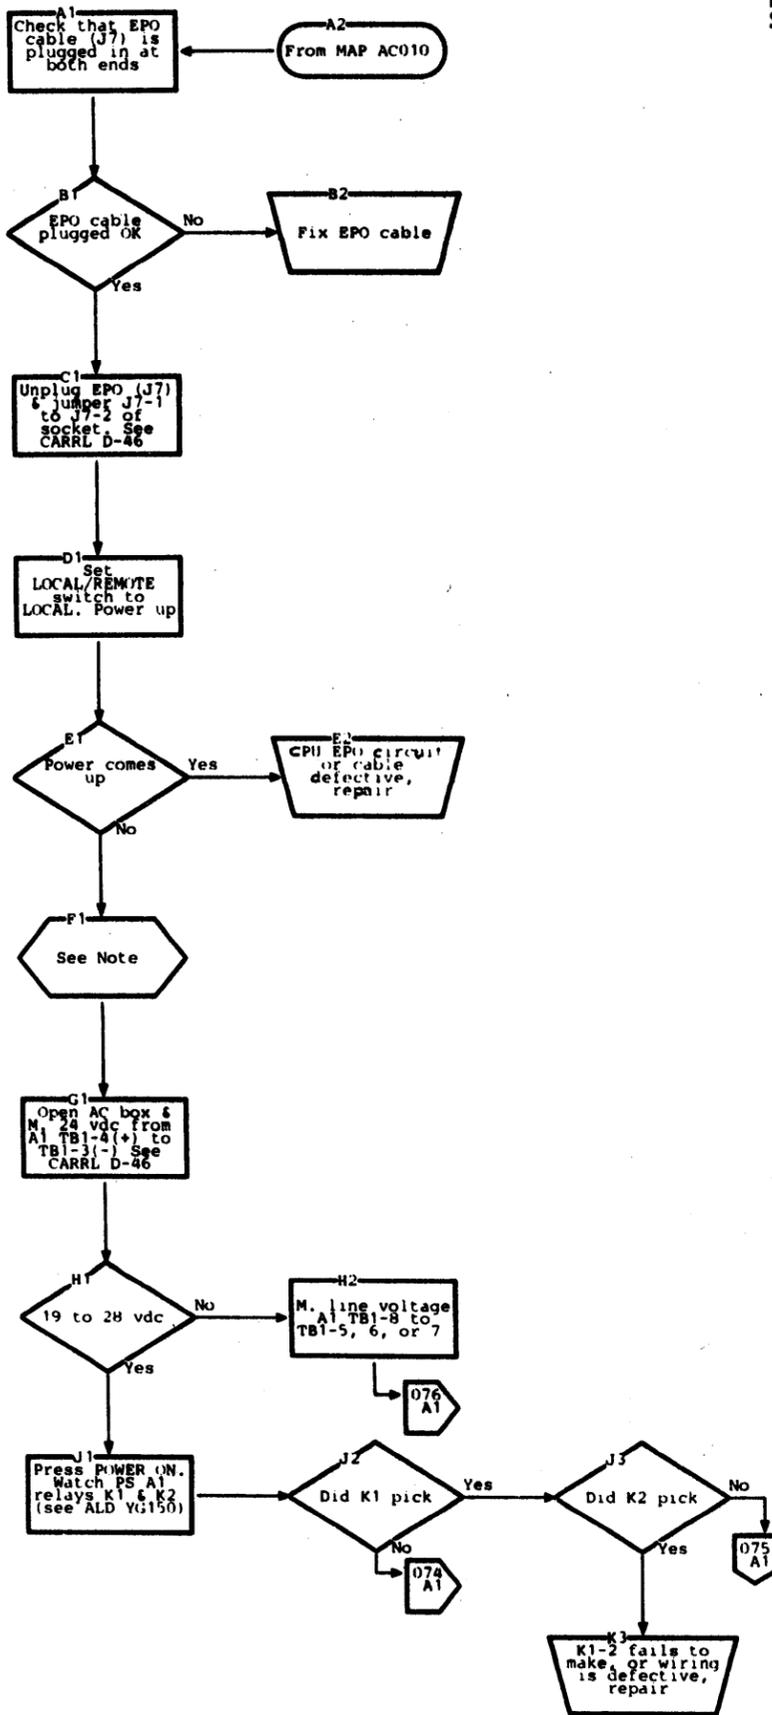
System/360 and System/370 Power-On Sequencing

Discussion: Entry to this MAP assumes you have power-on sequencing problems when attached to a System/360 or System/370 "host" system.

- A. ALD page YG108 is a circuit diagram of the 24V supply A1.
- B. ALD page YG150 view AA is a location diagram that will help you locate components of power supply A1.
- C. If K1 or K2 relay points fail, replace the relay.
- D. Attempts to clean or adjust the relay points will not result in permanent fixes.

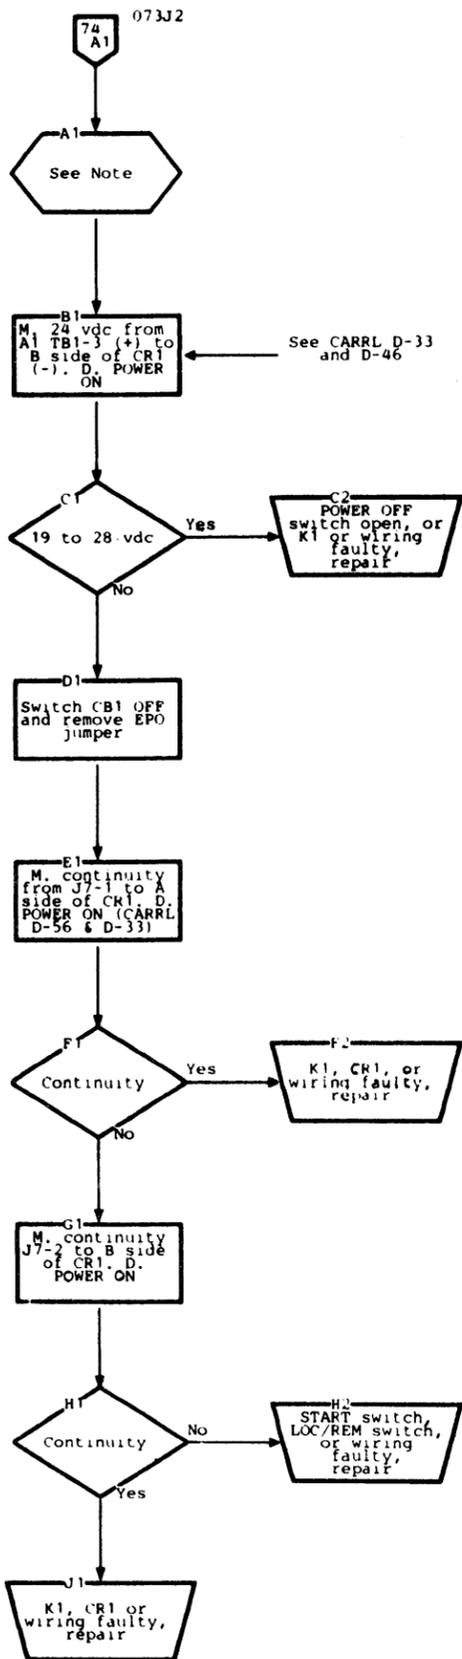
System/360 and System/370 Power-On Sequencing

- A. See ALD page YG108 for circuit diagram of the 24 volt supply A1.
- B. See YG150 for component location chart for power supply A1.
- C. If the POWER ON, POWER OFF, or LOCAL/REMOTE switch is defective, the A1 power supply circuit board must be replaced.

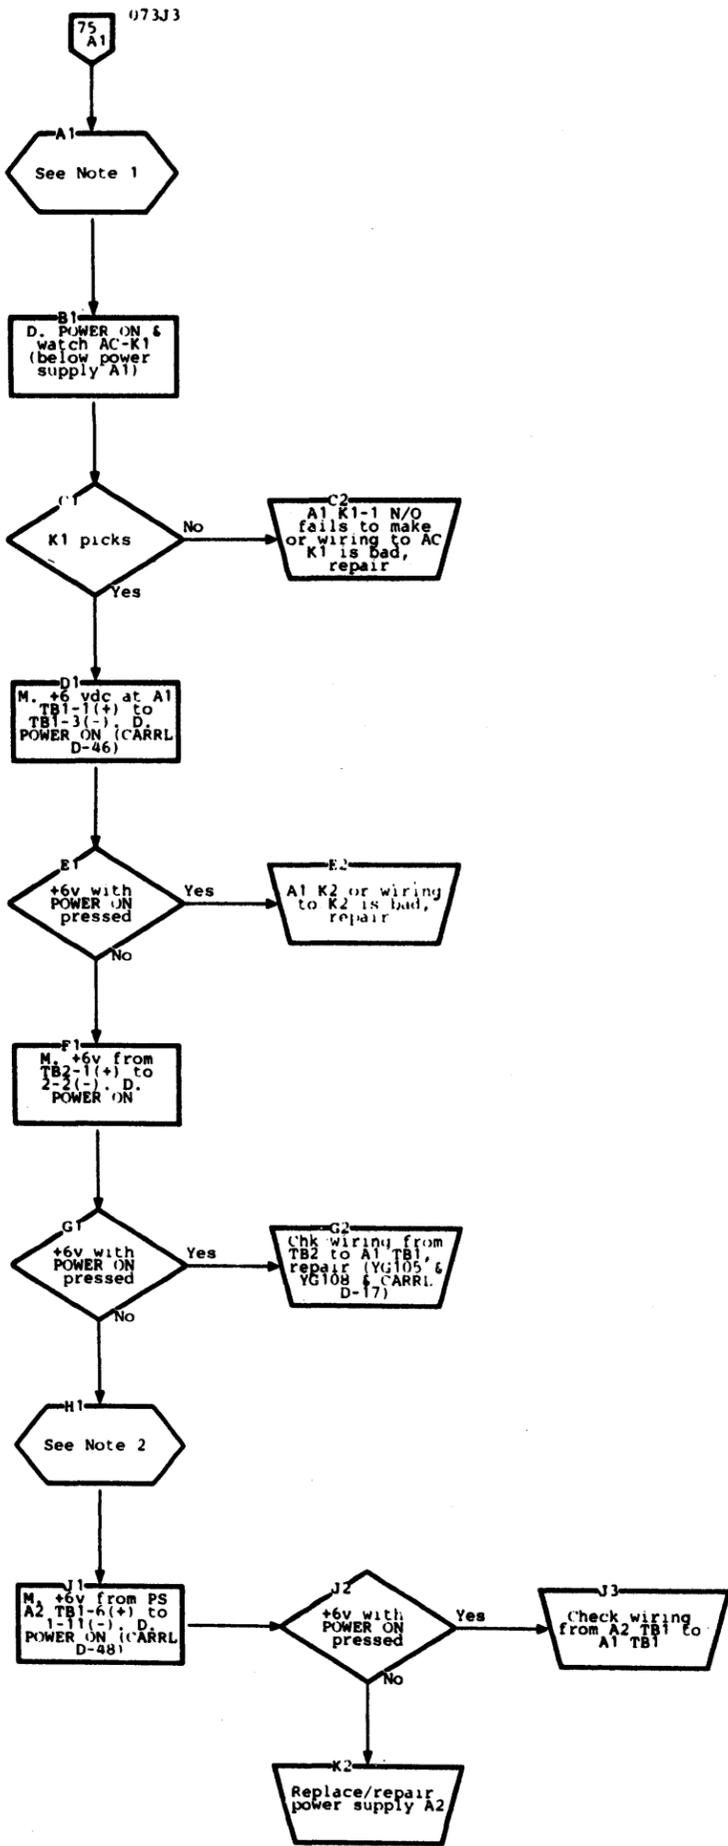
System/360 and System/370 Power-On Sequencing

- A. See ALD page YG108 for 24 volt supply A1 circuit diagram.
- B. See YG150 for component location chart for power supply A1.
- C. If K1 or K2 relay points are failing, replace the relay. Attempts to adjust or clean relay points will not result in permanent fixes.

- A. Power supply A2 is the large circuit board on the left side of the dc section.
- B. TB1 is at the rear of the board, with terminal 1 at the top.
- C. See ALD page YG160, section A-A.
- D. Power supply A2 circuit diagram is on ALD logic page YG110.

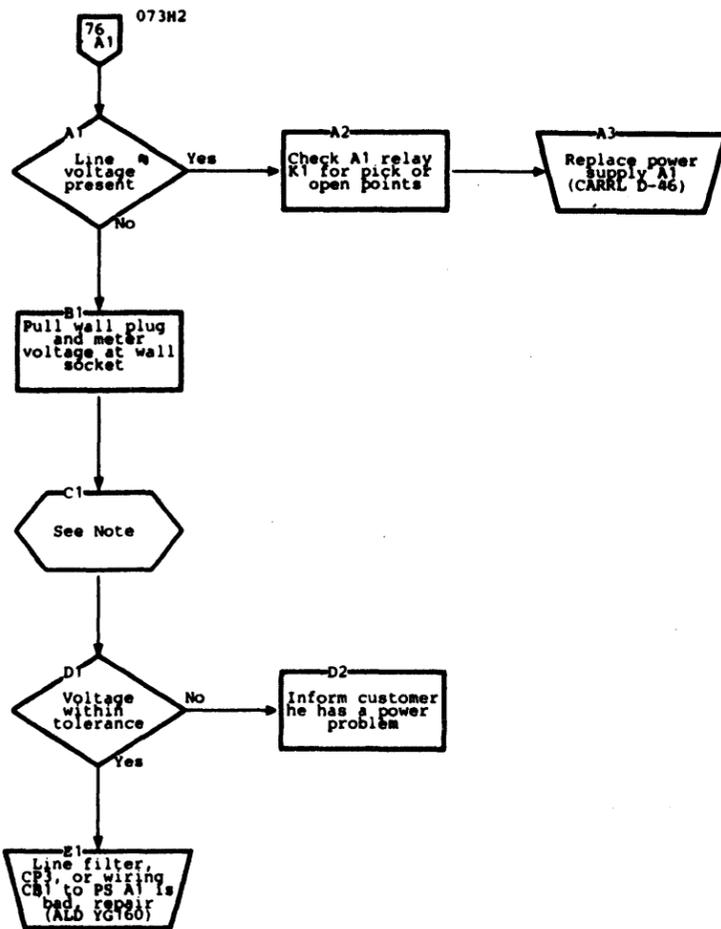
System/360 and System/370 Power-On Sequencing

Note:
A. Input voltage should be 200, 208, or 230 vac $\pm 10\%$ for all 60 Hz machines and for 3411 Model 1 (50 Hz).
B. Input voltage should be 200, 220, 235, 380, or 408 vac $\pm 10\%$ for 3411 Models 2 and 3 (50 Hz).
C. See ALD page YG105 for input connections chart.

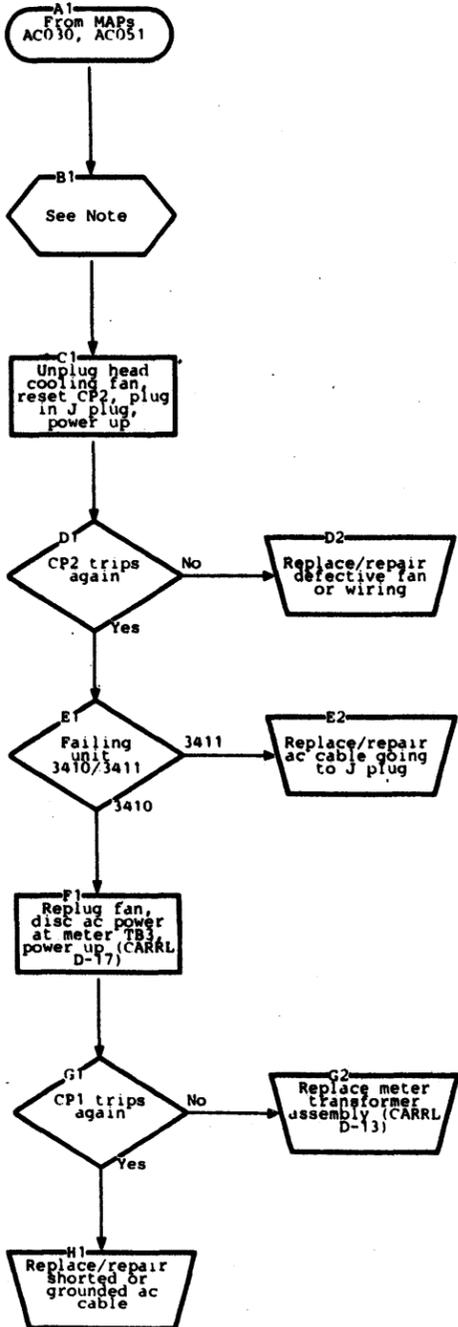
3410 AC Distribution

Discussion: Entry to this MAP assumes you have ac distribution problems in one of the tape units, causing CP2 to trip. In the tape units, ac is distributed to the head cooling fan and the pneumatic motor, and to the 3410 usage meter transformer.

Note: AC is distributed to the tape units (including the one in the 3411) via connectors J1-J6, located near the bottom of the 3411 ac section. Make the tests and observations called for in this MAP on the tape unit that is causing CP2 to trip.

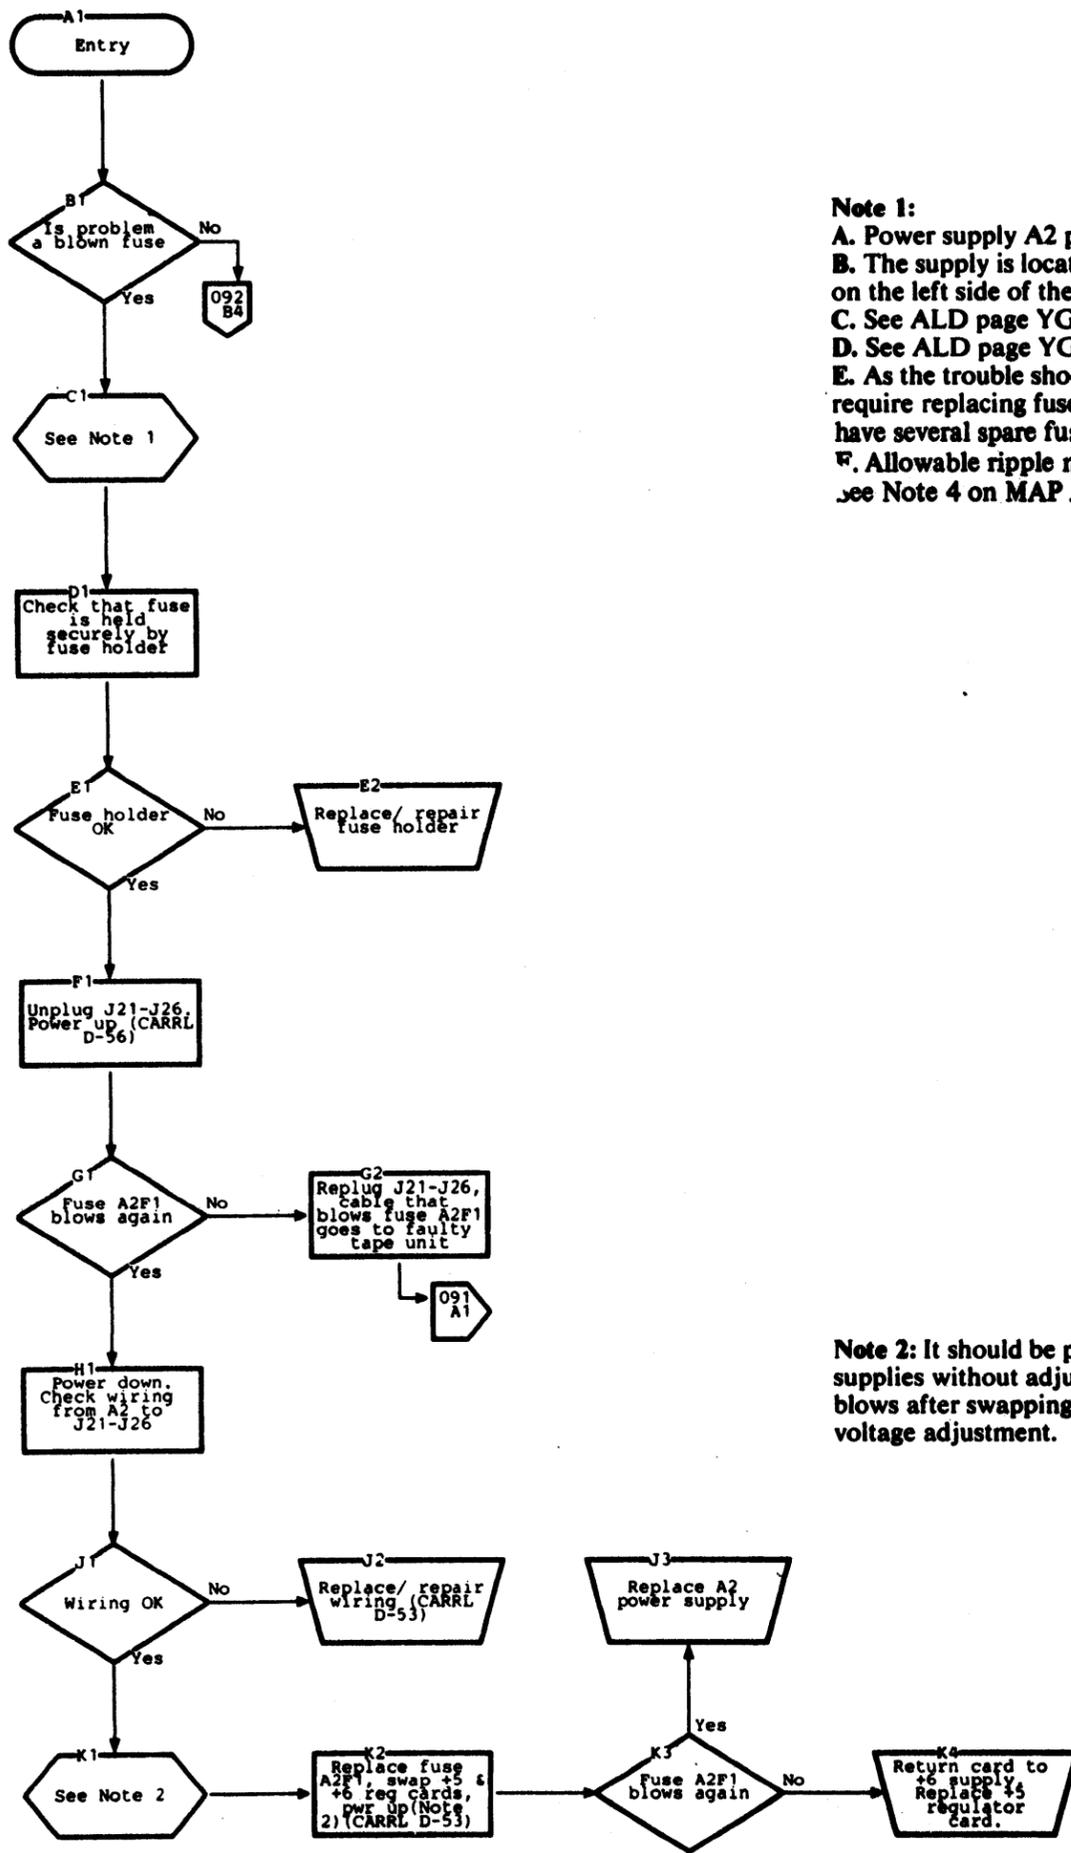
+5 Volt Power Supply Failures

- A. Power supply A2 provides both +5 vdc and +6 vdc.
 - B. The supply is located on a large printed circuit board on the left side of the dc section.
 - C. See ALD page YG160 for the location diagram.
 - D. See ALD page YG110 for the circuit diagram.
 - E. As the trouble shooting procedure outlined here may require replacing fuse A2F1 several times, you should have several spare fuses on hand.
 - F. Allowable ripple must not exceed ±2.5%.
- See Note 4 on MAP AC060.

Note 2: It should be possible to swap cards between supplies without adjusting the voltage. If fuse A2F1 blows after swapping cards, it is not due to improper voltage adjustment.

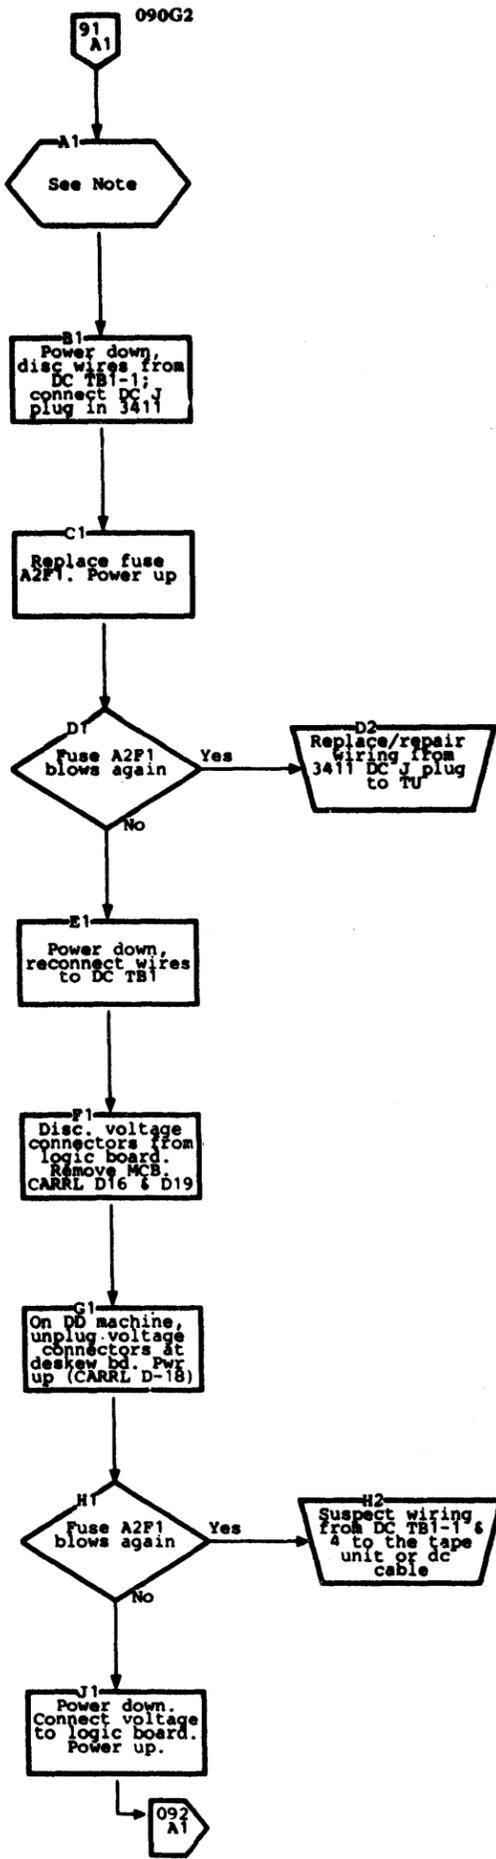
+5 Volt Power Supply Failures

- A. Make the tests and observations called for in this MAP on the tape unit that caused fuse A2F1 to blow.
- B. The +5 volts is distributed through the cable from the 3411 J plug to tape unit DC TB1-1 (+5) and 1-4 (-). It is then distributed to the motion control board, the logic board and (if the NRZI feature is installed) to the skew board.
- C. The +5 volts is supplied to the vacuum column switches from MCB pins A16 and B1.
- D. See ALD pages YG112 and YG125 for voltage distribution diagrams.
