TABLE OF CONTENTS

VOL D01 M/T 3411 SERIAL 51051905

CARRL
CARRL
 Checks, Adjustments, Removals, Replacements, and Locations describes maintenance functions that can be performed on the 3410/3411 Tape Subsystem.

The 3410/3411 Magnetic Tape Subsystem consists of one or more IBM 3410 Magnetic Tape Units and an IBM 3411 Magnetic Tape Unit and Control. The major parts (tape unit and tape control) are functionally packaged (all controls used in performing a hardware function are located together) for quick isolation and replacement of a failing component. The circuitry within the subsystem (called the *attachment*), which adapts the subsystem to the I/O interface of the host system, must be considered in maintenance. Expanded sense data is provided to include more details of hardware failure than was furnished by most earlier tape subsystems.

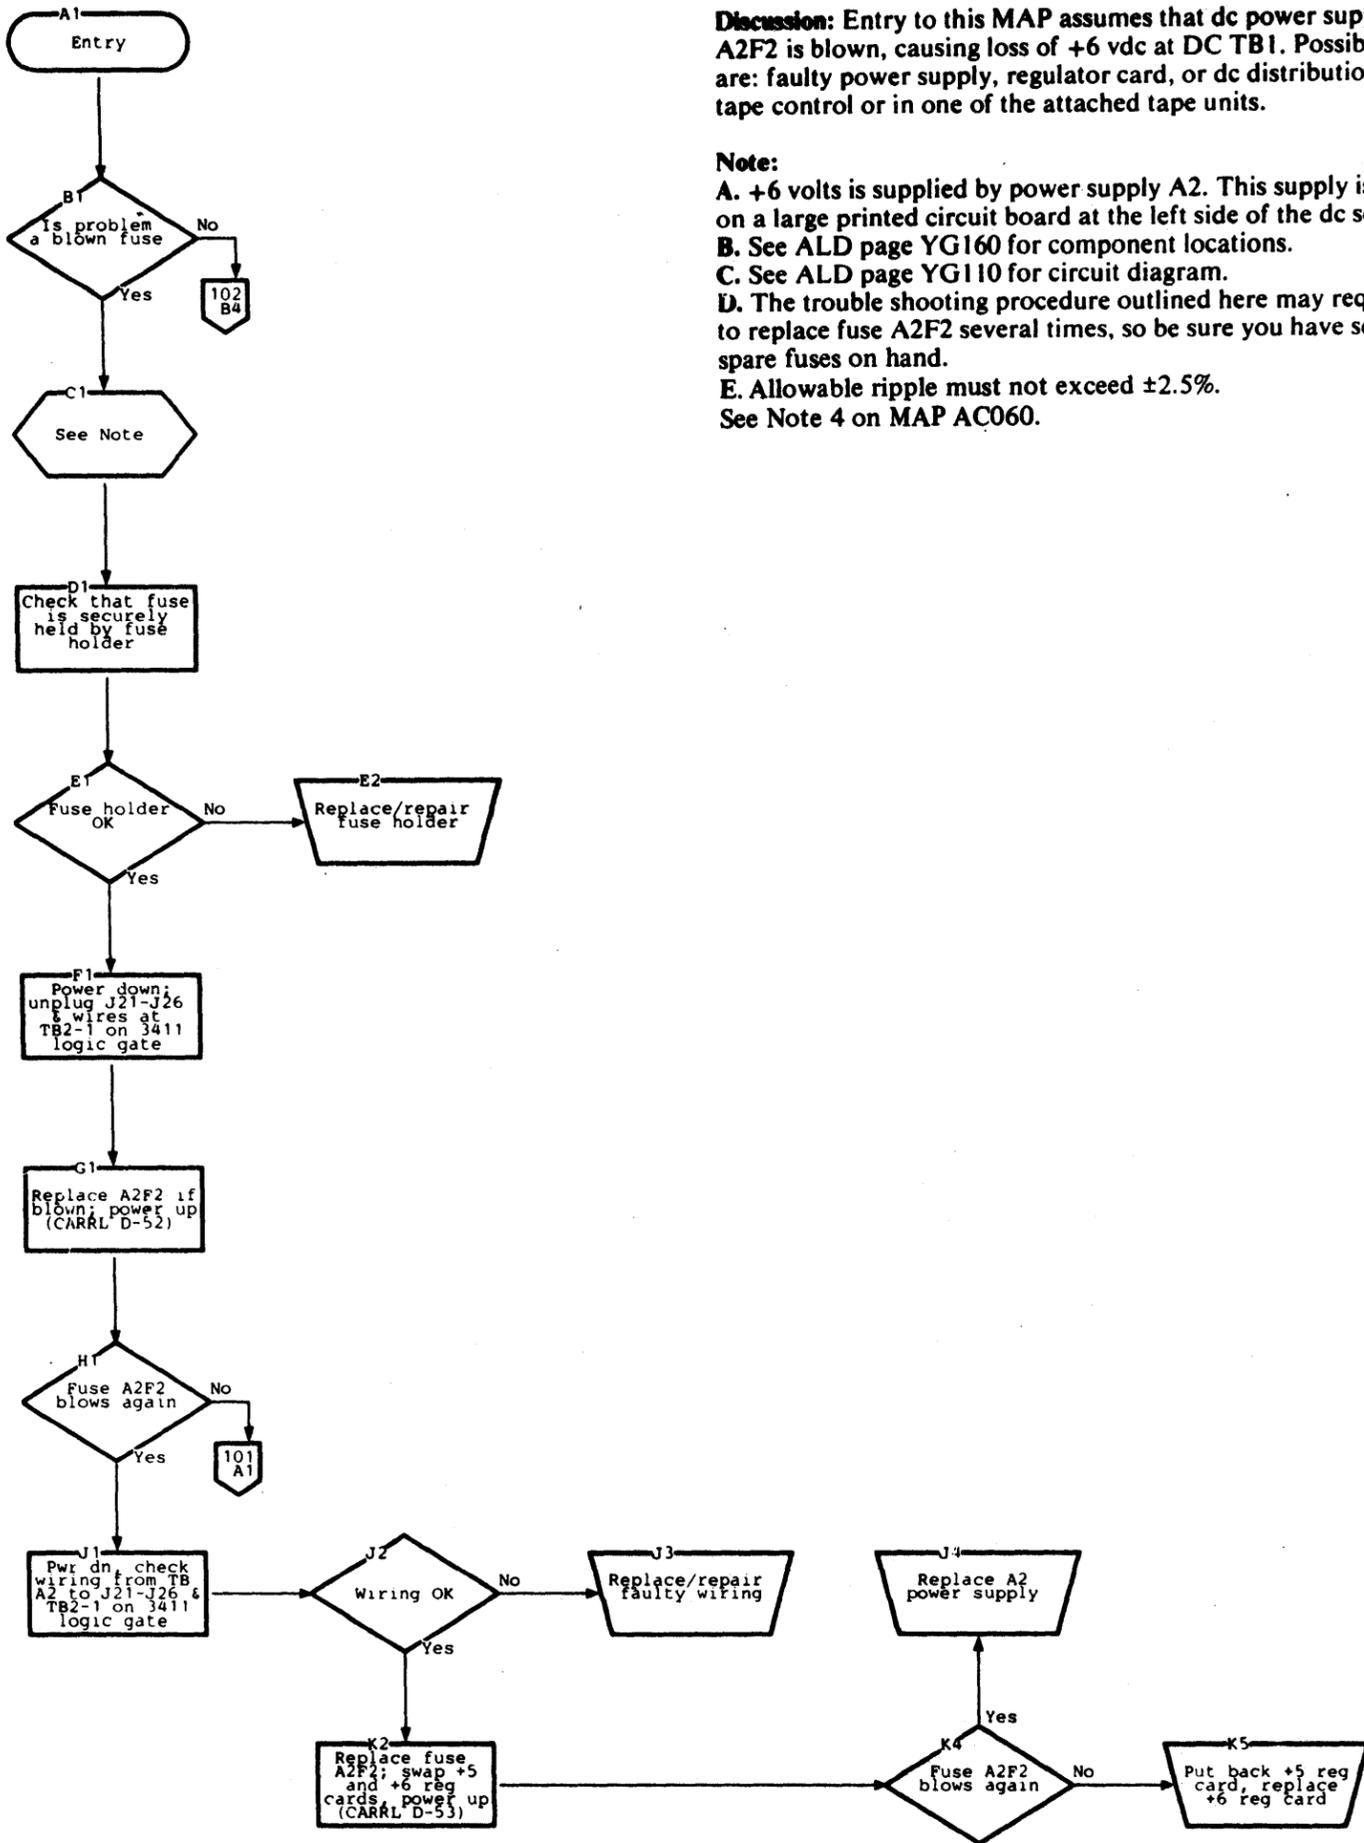
+6 Volt Power Supply Failures

Discussion: Entry to this MAP assumes that dc power supply fuse A2F2 is blown, causing loss of +6 vdc at DC TB1. Possible causes are: faulty power supply, regulator card, or dc distribution in the tape control or in one of the attached tape units.

- A. +6 volts is supplied by power supply A2. This supply is located on a large printed circuit board at the left side of the dc section.
 - B. See ALD page YG160 for component locations.
 - C. See ALD page YG110 for circuit diagram.
 - D. The trouble shooting procedure outlined here may require you to replace fuse A2F2 several times, so be sure you have several spare fuses on hand.
 - E. Allowable ripple must not exceed $\pm 2.5\%$.
- See Note 4 on MAP AC060.

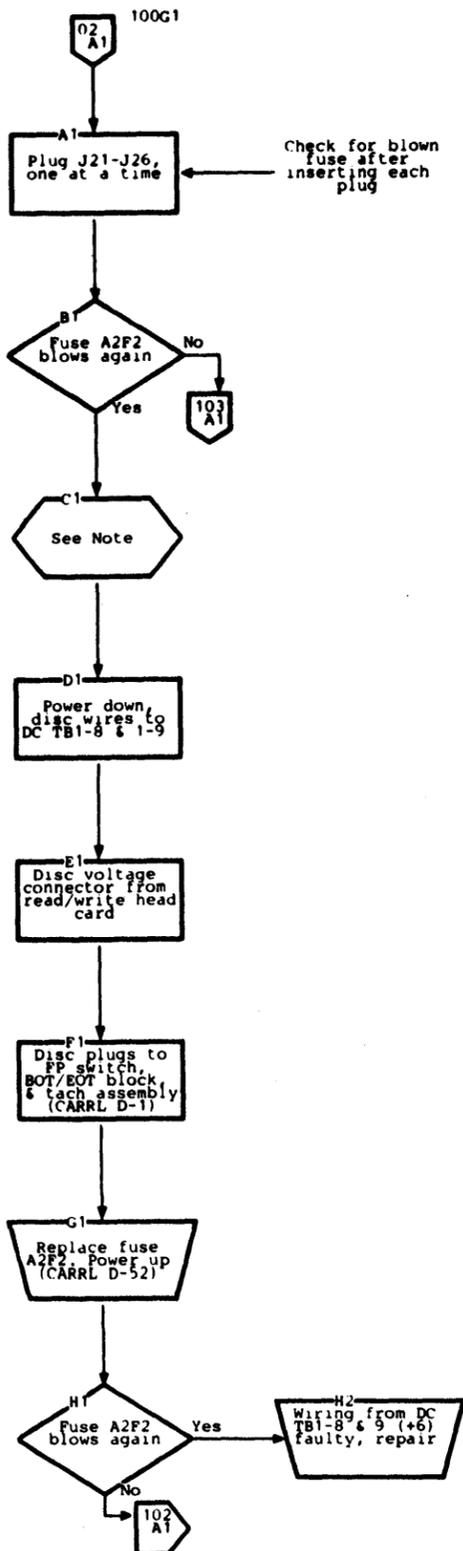
+6 Volt Power Supply Failures

- A.** Make the checks called for in this MAP on the tape unit that caused fuse A2F2 to blow.
- B.** The +6 volts in the tape unit is distributed from the 3411 J plug to DC TB 1-9 (+6) and TB1-4 (dc common).
- C.** From DC TB1-9 +6 volts goes to the capstan tachometer assembly, the BOT/EOT block, and TB4-5. (TB4 is below the upper base, to the right of the capstan motor).
- D.** TB4 terminals are numbered front-to-back.
- E.** +6 volts goes to TB4-5, then to the file protect switch and, in the 3410, to the meter relay card (adjacent to the meter). In the 3411 the +6 to the meter relay card comes from tape control TB2-2.
- F.** When the FP plunger is pressed, +6 volts is applied to TB4-2, and from there to the head read/write head card.

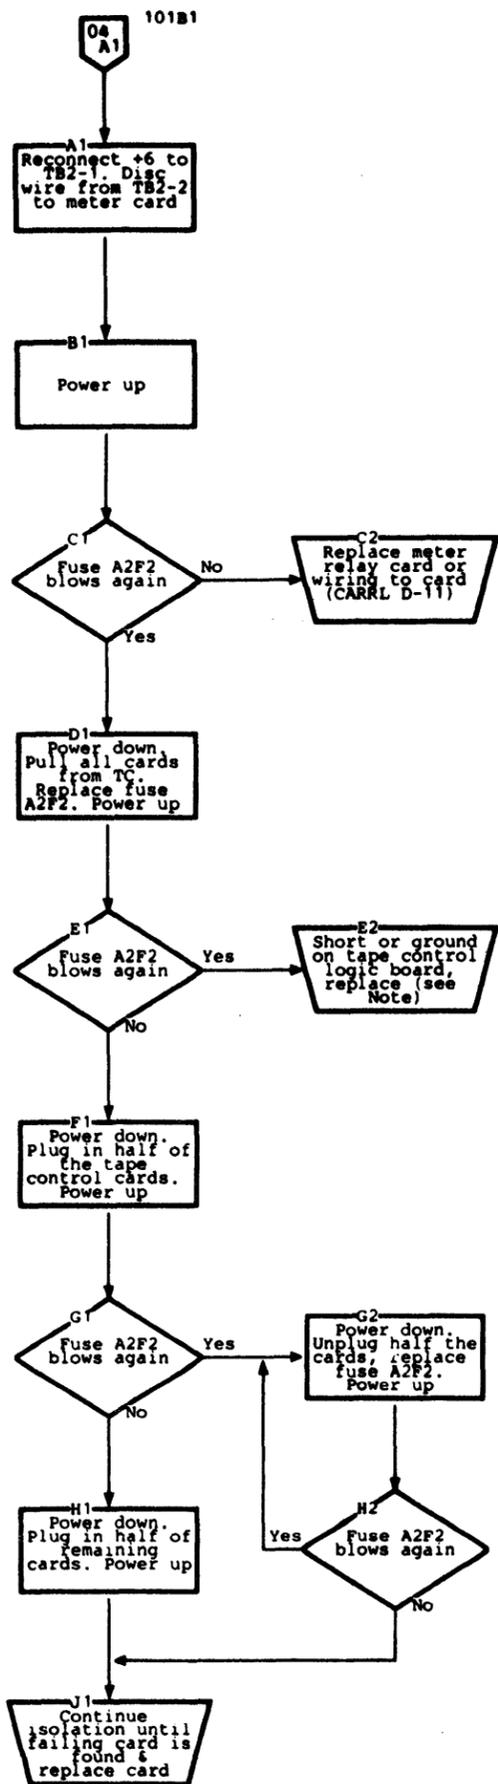
+6 Volt Power Supply Failures

- A. Carefully inspect TB2 for shorts.
- B. Inspect the pin side of the board for any pieces of wire or other foreign matter that might cause shorts.
- C. Look for signs of overheating of wires and board land patterns.
- D. Look for shorted pins on the card side.
- E. It may be necessary to replace the board.

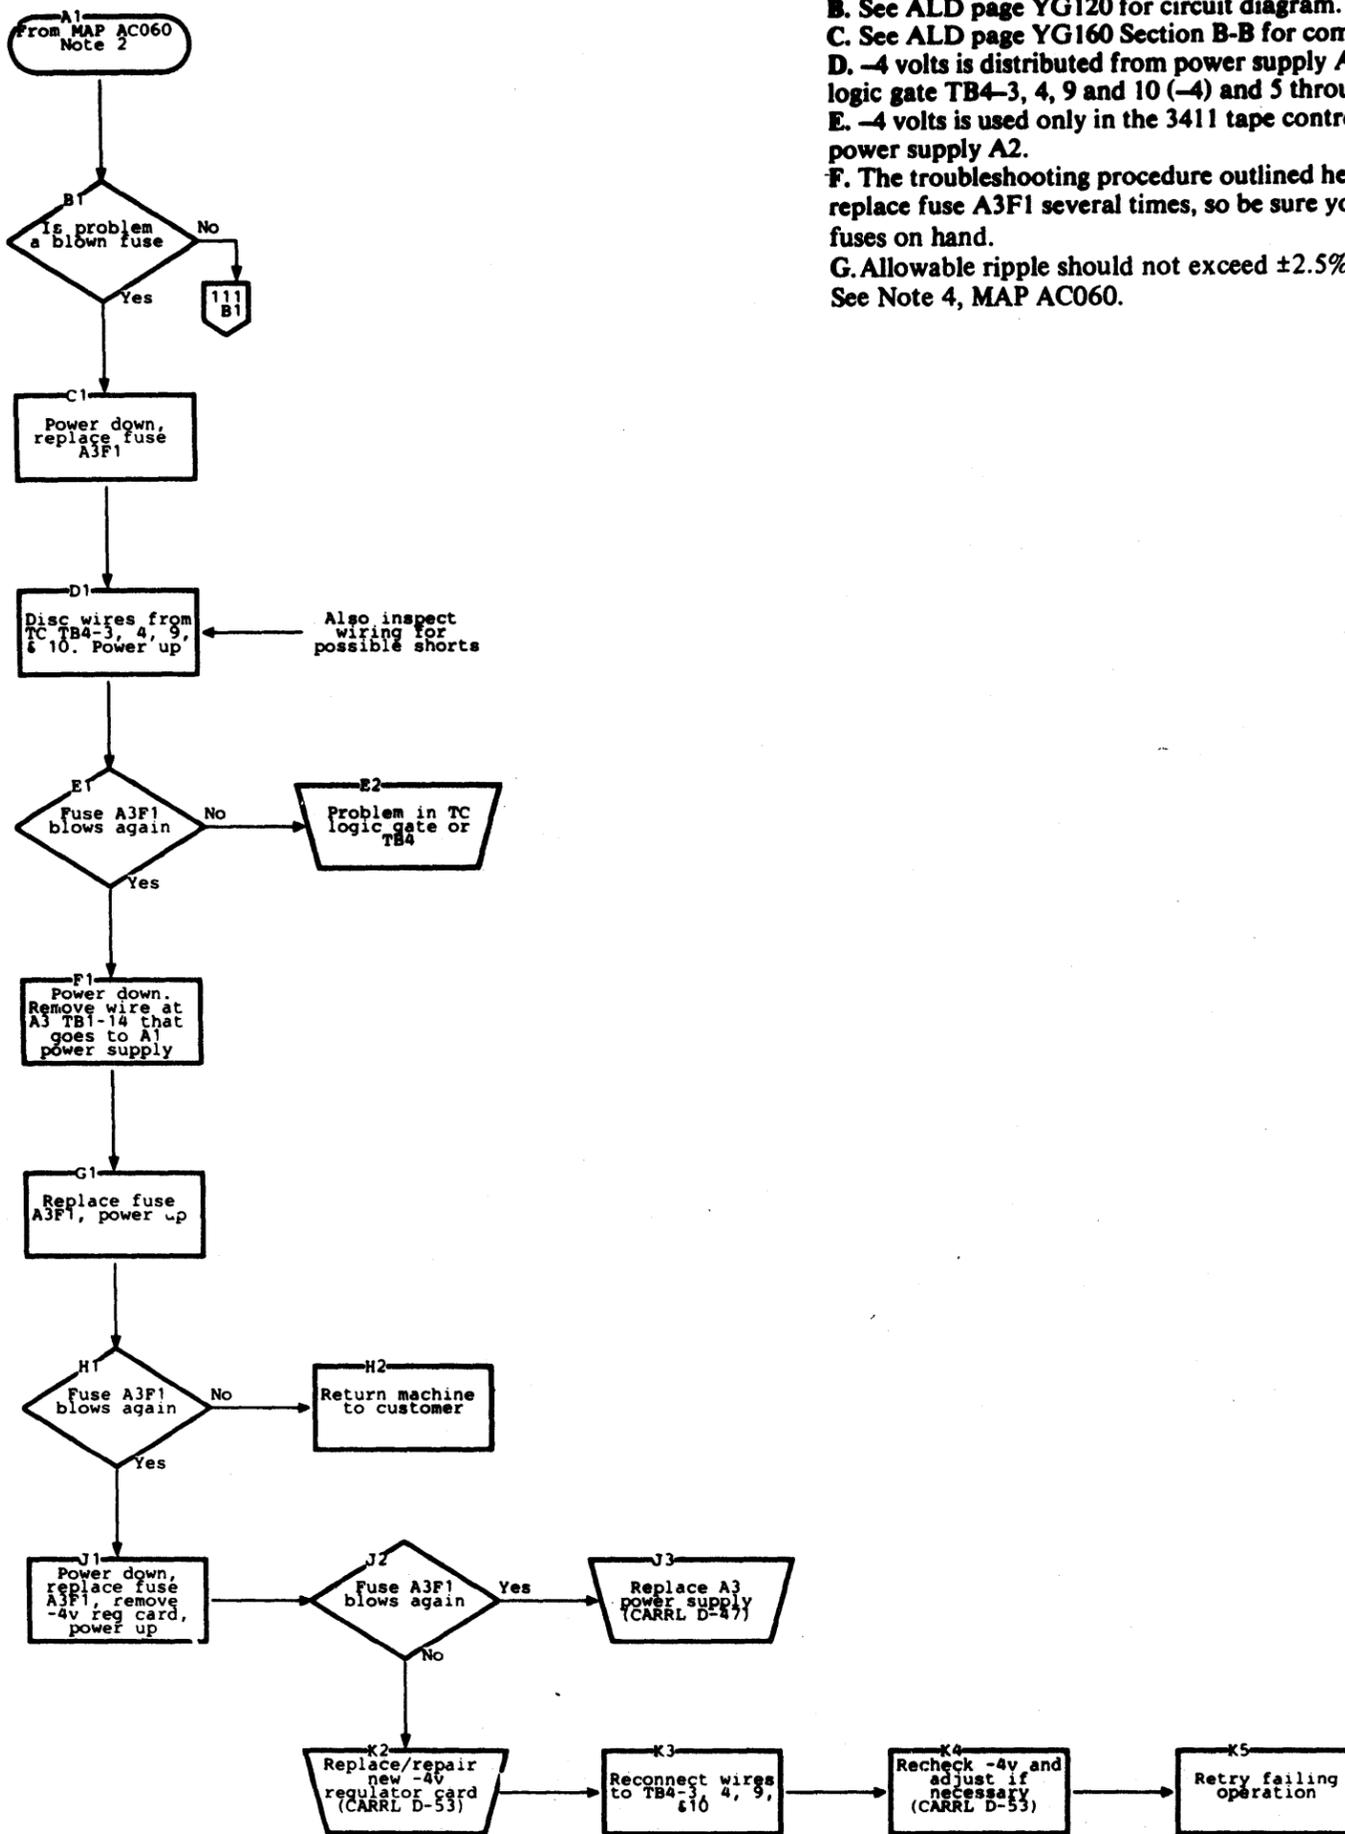
-4 Volt Power Supply Failures

- A. -4 volts is supplied by power supply A3, which is located on a large printed circuit board on the right side of the dc section.
 - B. See ALD page YG120 for circuit diagram.
 - C. See ALD page YG160 Section B-B for component locations.
 - D. -4 volts is distributed from power supply A3 to the tape control logic gate TB4-3, 4, 9 and 10 (-4) and 5 through 8 (ground return).
 - E. -4 volts is used only in the 3411 tape control logic gate and in power supply A2.
 - F. The troubleshooting procedure outlined here may require you to replace fuse A3F1 several times, so be sure you have several spare fuses on hand.
 - G. Allowable ripple should not exceed $\pm 2.5\%$.
- See Note 4, MAP AC060.

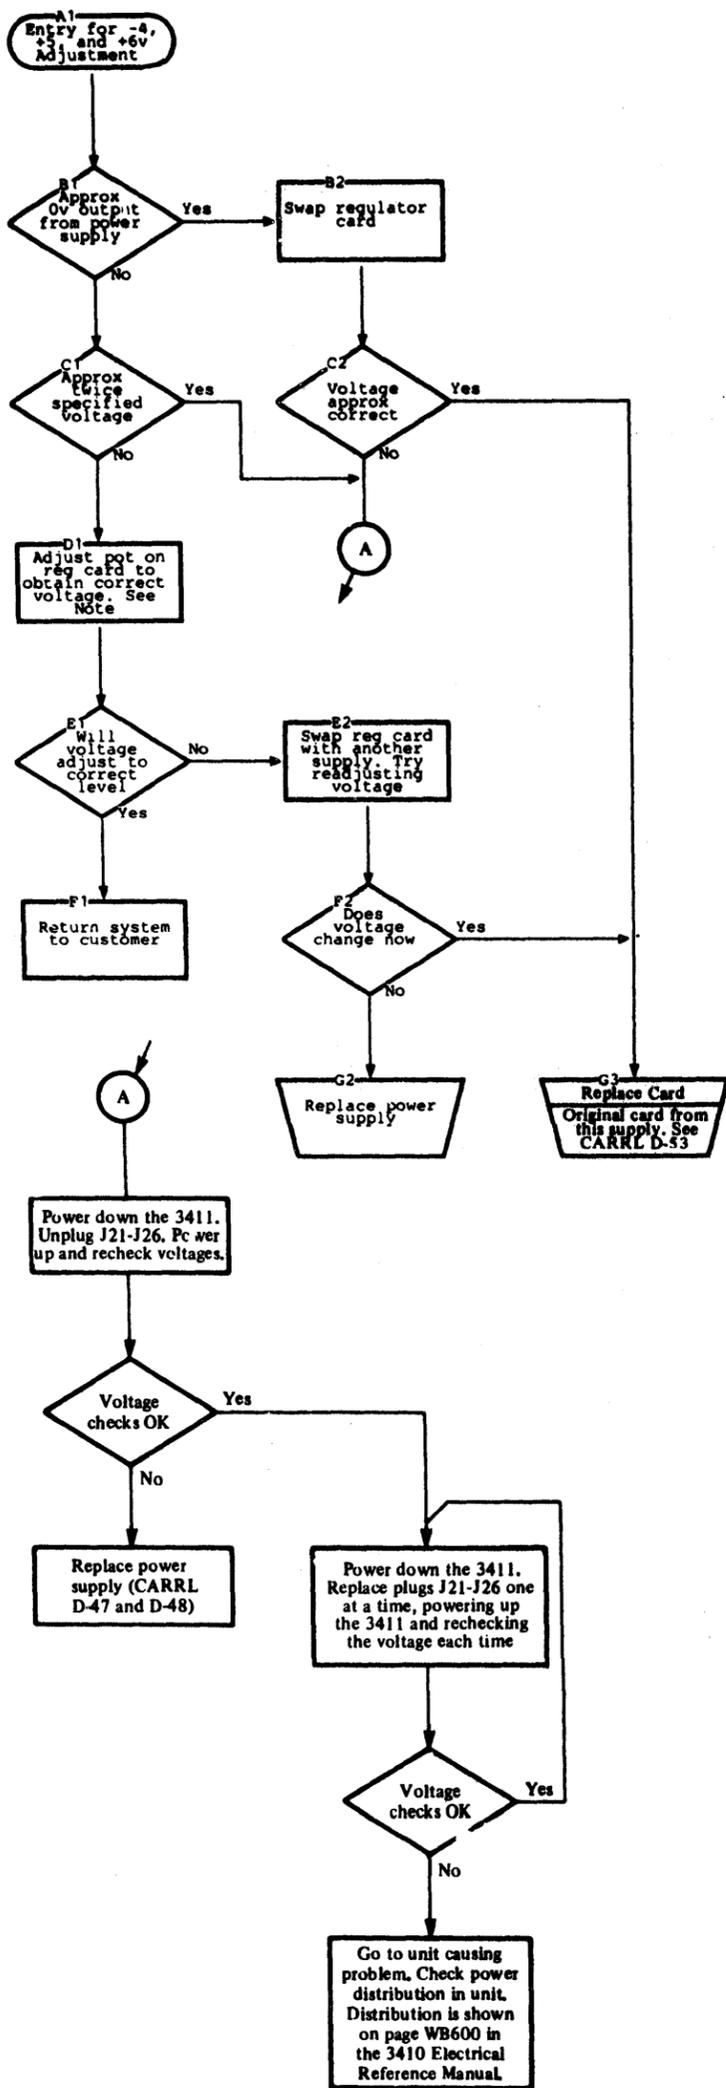
-4, +5, and +6 Volt Power Supply Adjustments

Discussion: Entry to this MAP assumes you found the -4, +5, or +6 volts dc outside allowable limits. Your problem could be a defective power supply or regulator card, or incorrect regulator card adjustment.

Note: Measure power supply output voltages at DC TB1:

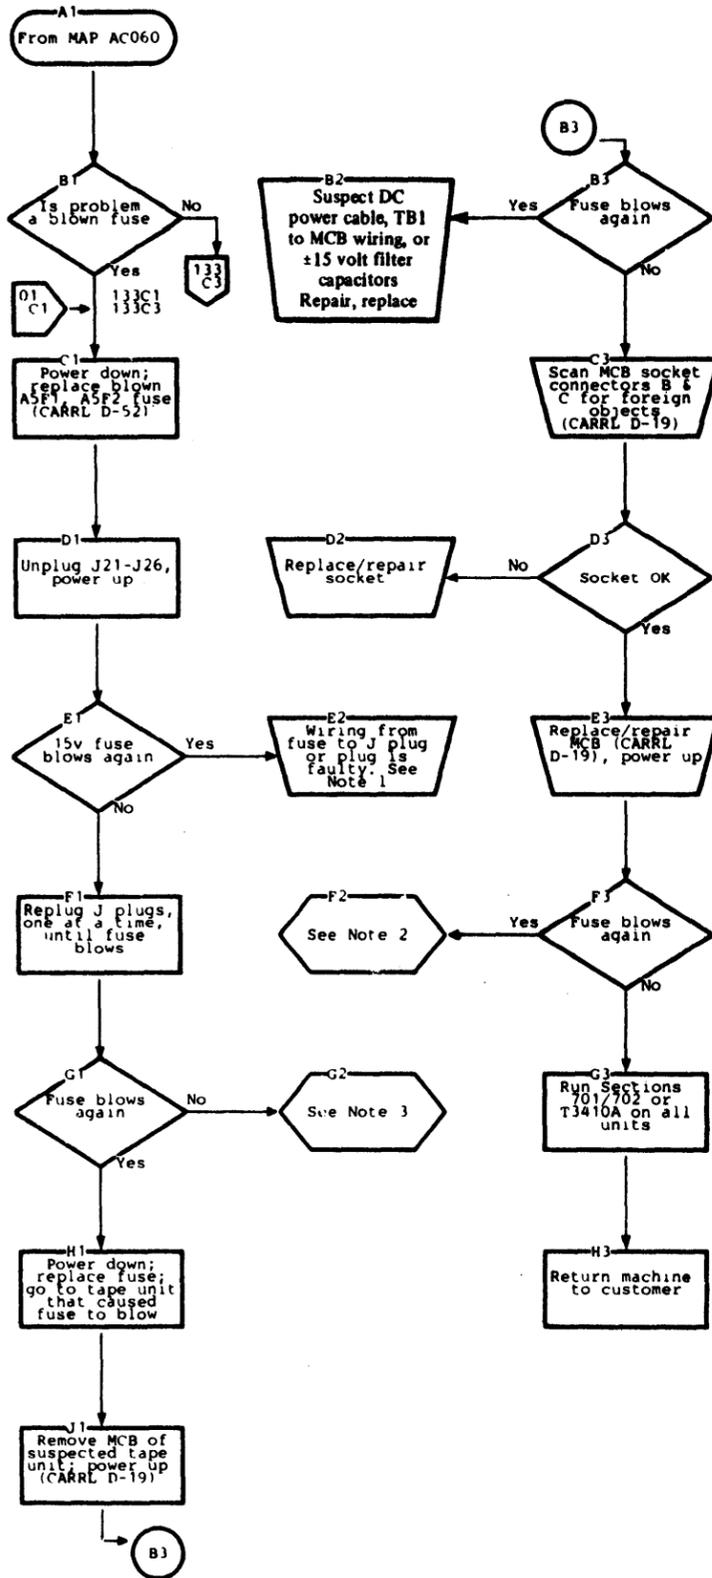
+15 and -15 Volt Power Supply Out of Tolerance

Discussion: Entry to this MAP assumes that one of the 15 volt dc power supply fuses is blown, causing loss of +15 vdc or -15 vdc at DC TB1. Possible causes are a faulty power supply, or dc distribution in the attached tape units.
A. 15 vdc is supplied through the fuses to J21-J26, then through the dc cables to the DC TB in each tape unit.
B. In each tape unit, the voltage is filtered by two large capacitors, C4 and C5.
C. Voltage then goes to the motion control board.
D. See ALD pages YG110, YG112; and YG125 for wiring diagrams.
E. See ALD pages YG135 and YG160 for component locations.

Note 1:
A. The wires from F1 go to J plug, pins 7 and 8.
B. From F2, the wires go to J plug pins 9 and 10.
C. The J plug pins are numbered 1 through 12, top to bottom.
Note 2:
A. Check for loose connections at power supply A2TB1 (see YG150 and YG160 for location).
B. Check diodes CR5-CR14 (YG110 and YG160). Failure of one of the diodes affects the 15 volt supply; if one is defective, power supply A2 must be replaced.

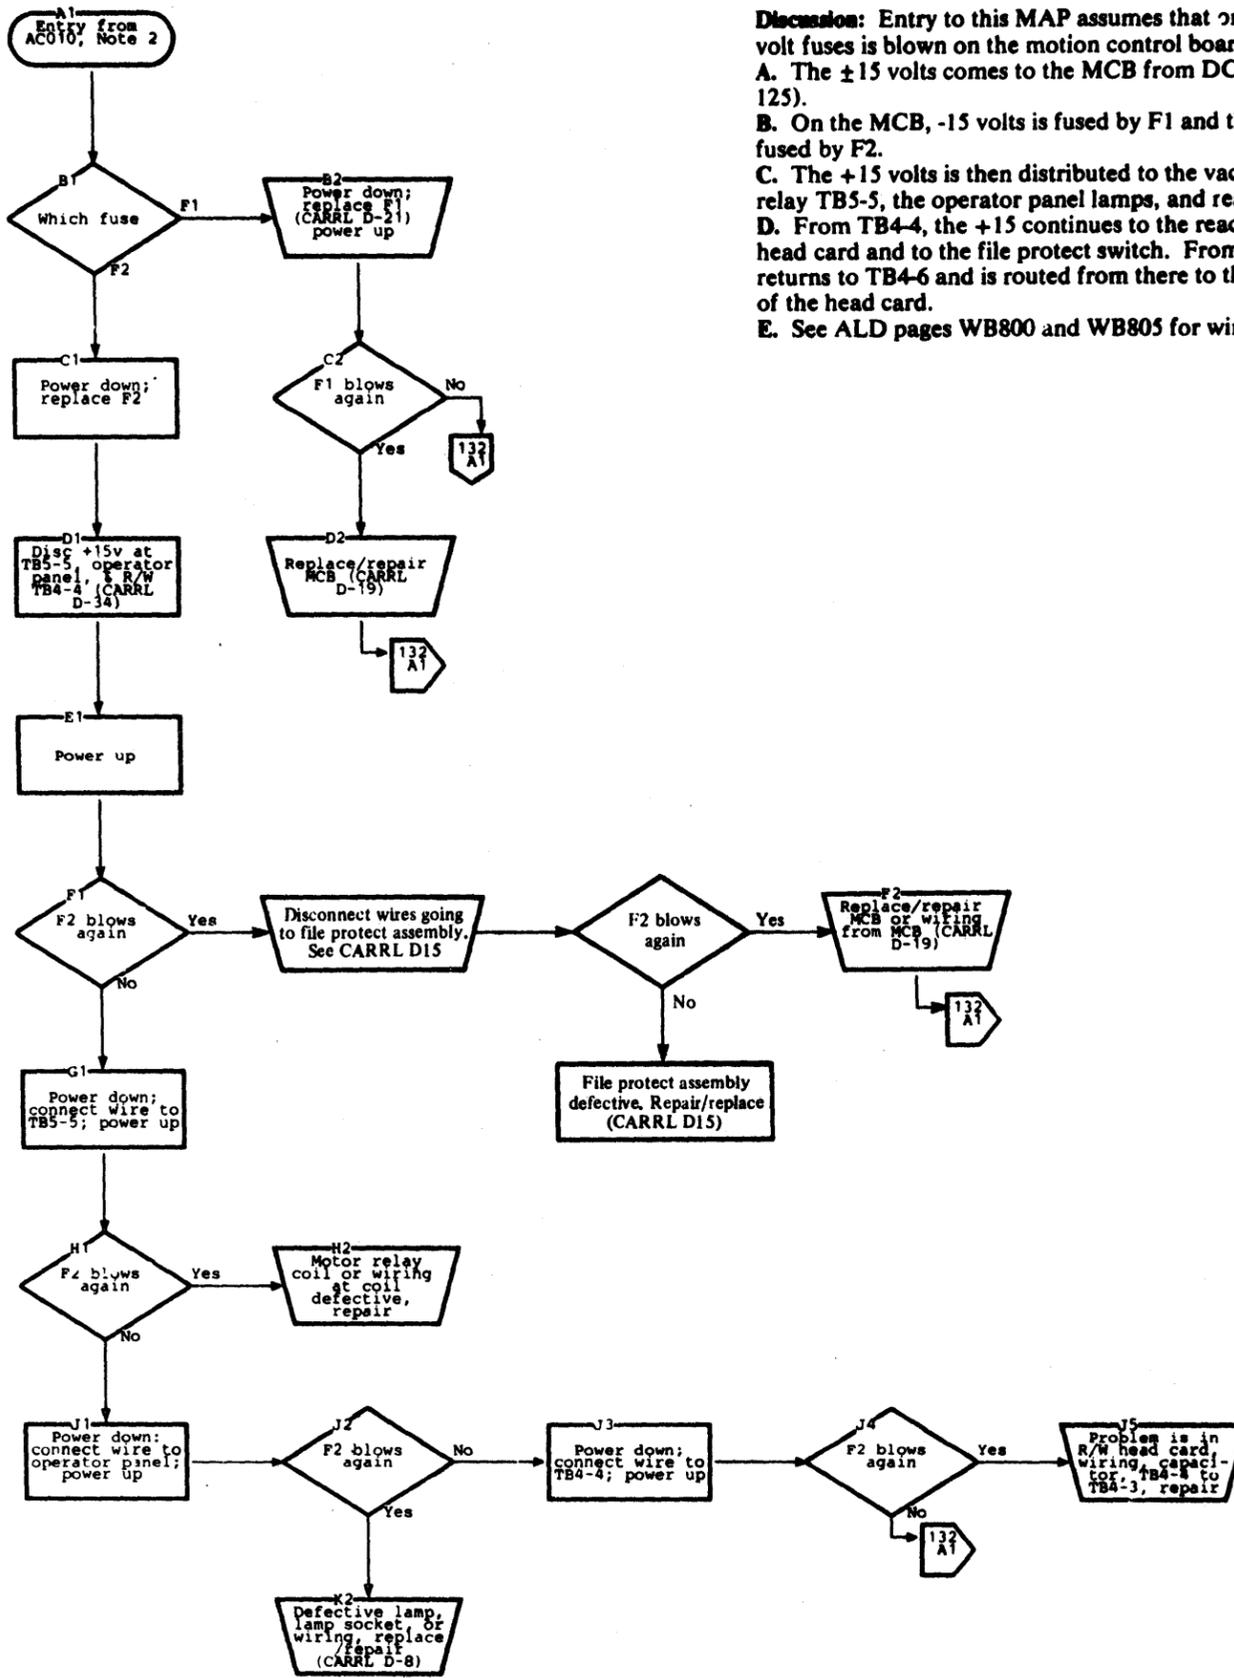
+15 and -15 Volt Power Supply Out of Tolerance

Discussion: Entry to this MAP assumes that one of the 15 volt fuses is blown on the motion control board.
A. The ± 15 volts comes to the MCB from DCTB1 (Ref. YG 125).
B. On the MCB, -15 volts is fused by F1 and the +15 volts is fused by F2.
C. The +15 volts is then distributed to the vacuum motor relay TB5-5, the operator panel lamps, and read/write TB4-4.
D. From TB4-4, the +15 continues to the read side of the head card and to the file protect switch. From the switch, it returns to TB4-6 and is routed from there to the write side of the head card.
E. See ALD pages WB800 and WB805 for wiring.

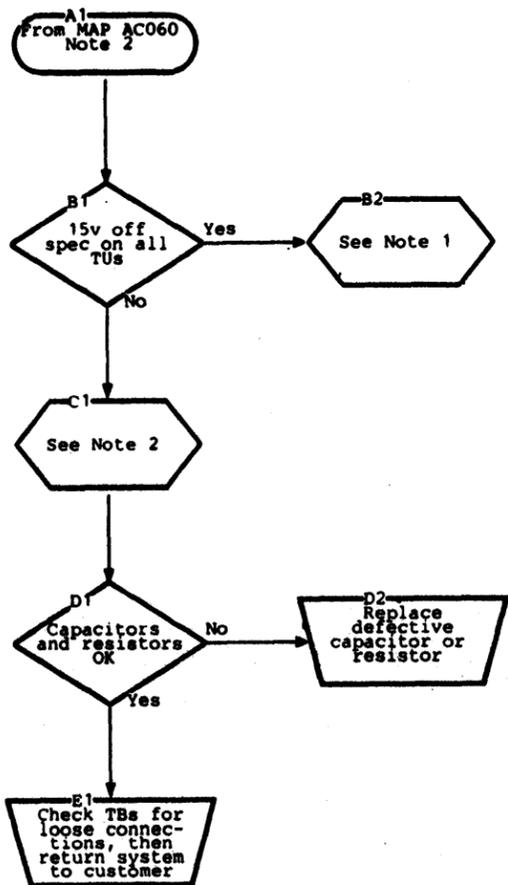
MAP AC132

+15 and -15 Volt Power Supply Out of Tolerance

- A. Check for loose connections at power supply A2 TB1 (see YG150 and YG160 for location).
- B. Check diodes CR5-CR14 (YG110 and YG160). Failure of one of the diodes affects the 15v supply; if one is defective, power supply A2 must be replaced.

- A. Examine capacitors C4 and C5 in the failing tape unit for swelling of the can or the safety vent.
- B. See CARRL Figure D-51 for locations of C4 and C5.
- C. Examine the resistors on C4 and C5 for signs of shorting.
- D. C4 filters the +15 volts, and C5 filters the -15 volts.

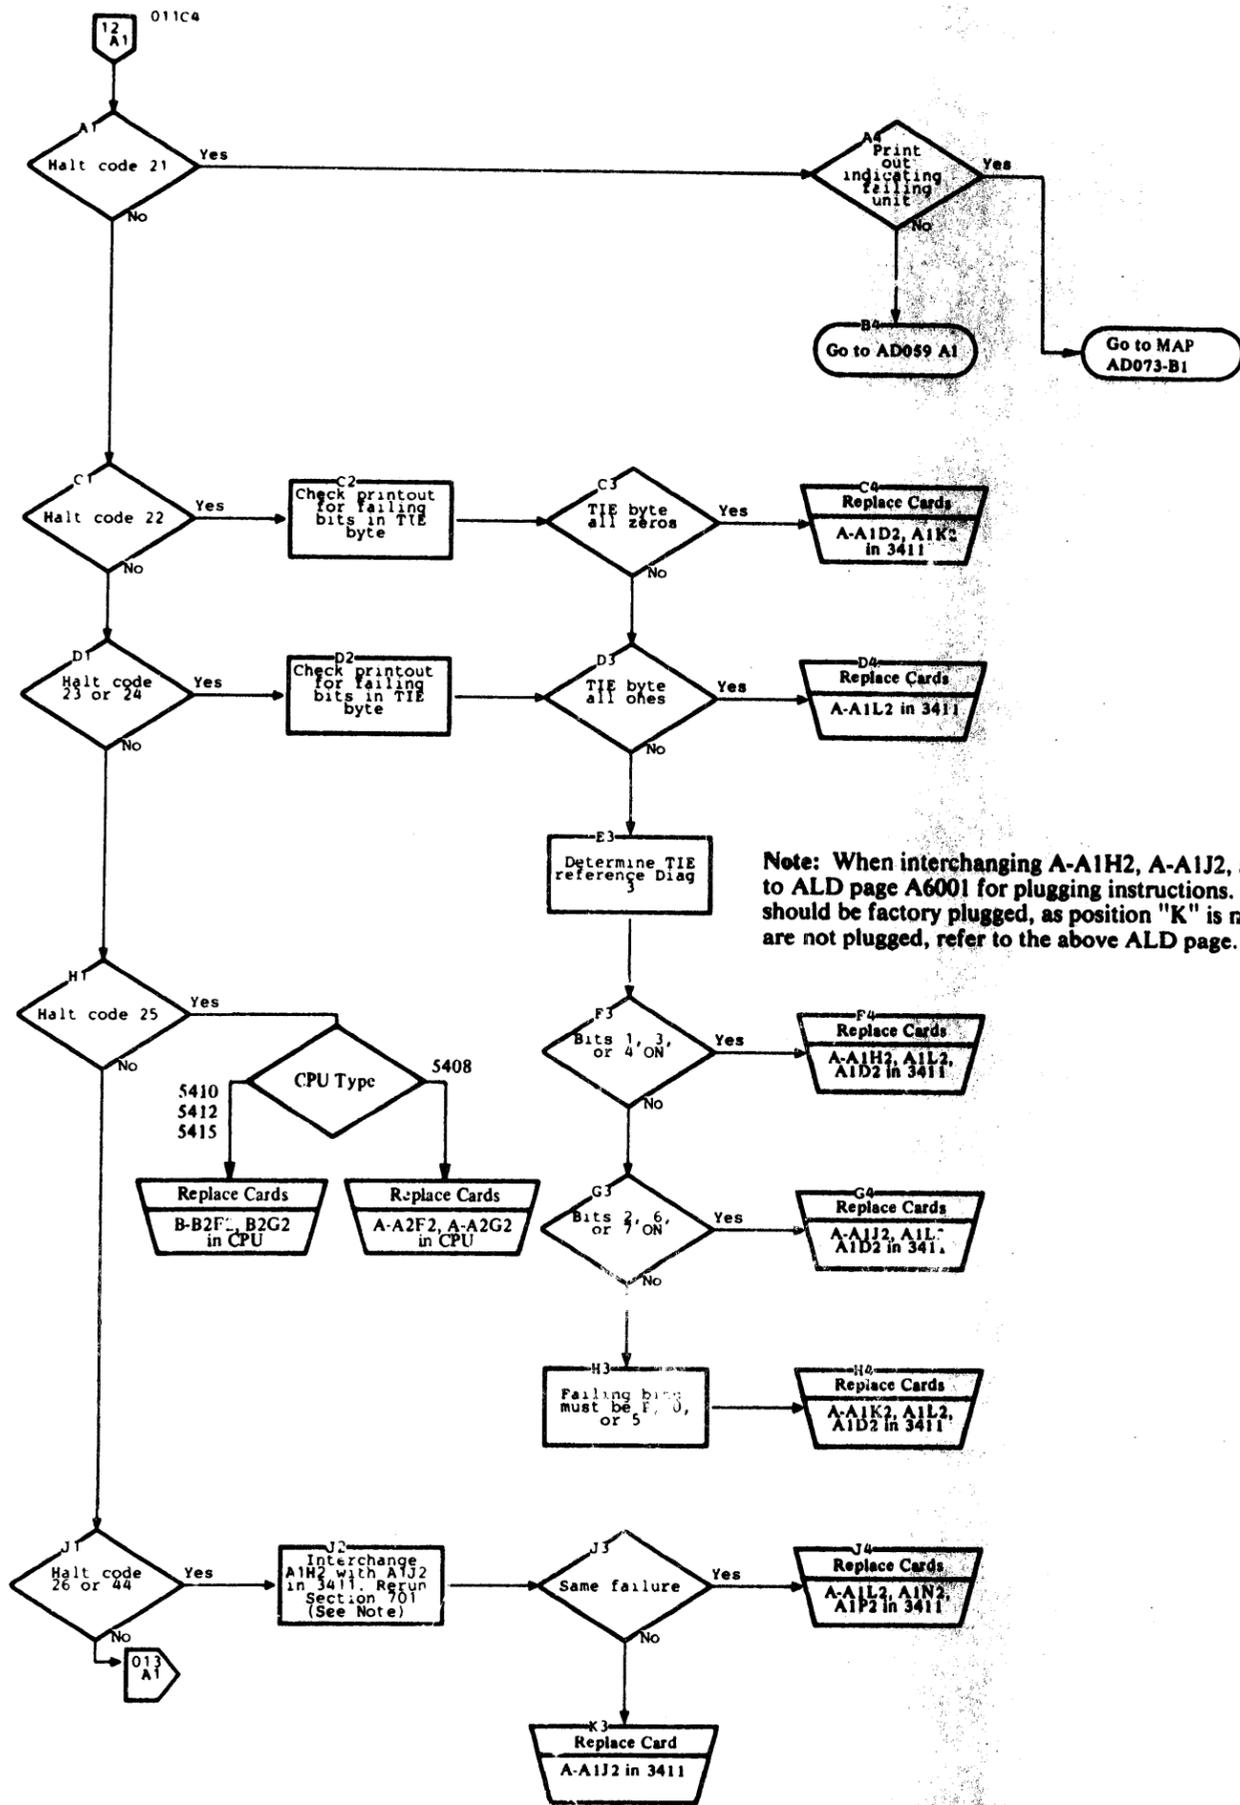
701 Halt Analysis

Note: When interchanging A-A1H2, A-A1J2, and A-A1K2, refer to ALD page A6001 for plugging instructions. All three cards should be factory plugged, as position "K" is model sensitive. If they are not plugged, refer to the above ALD page.

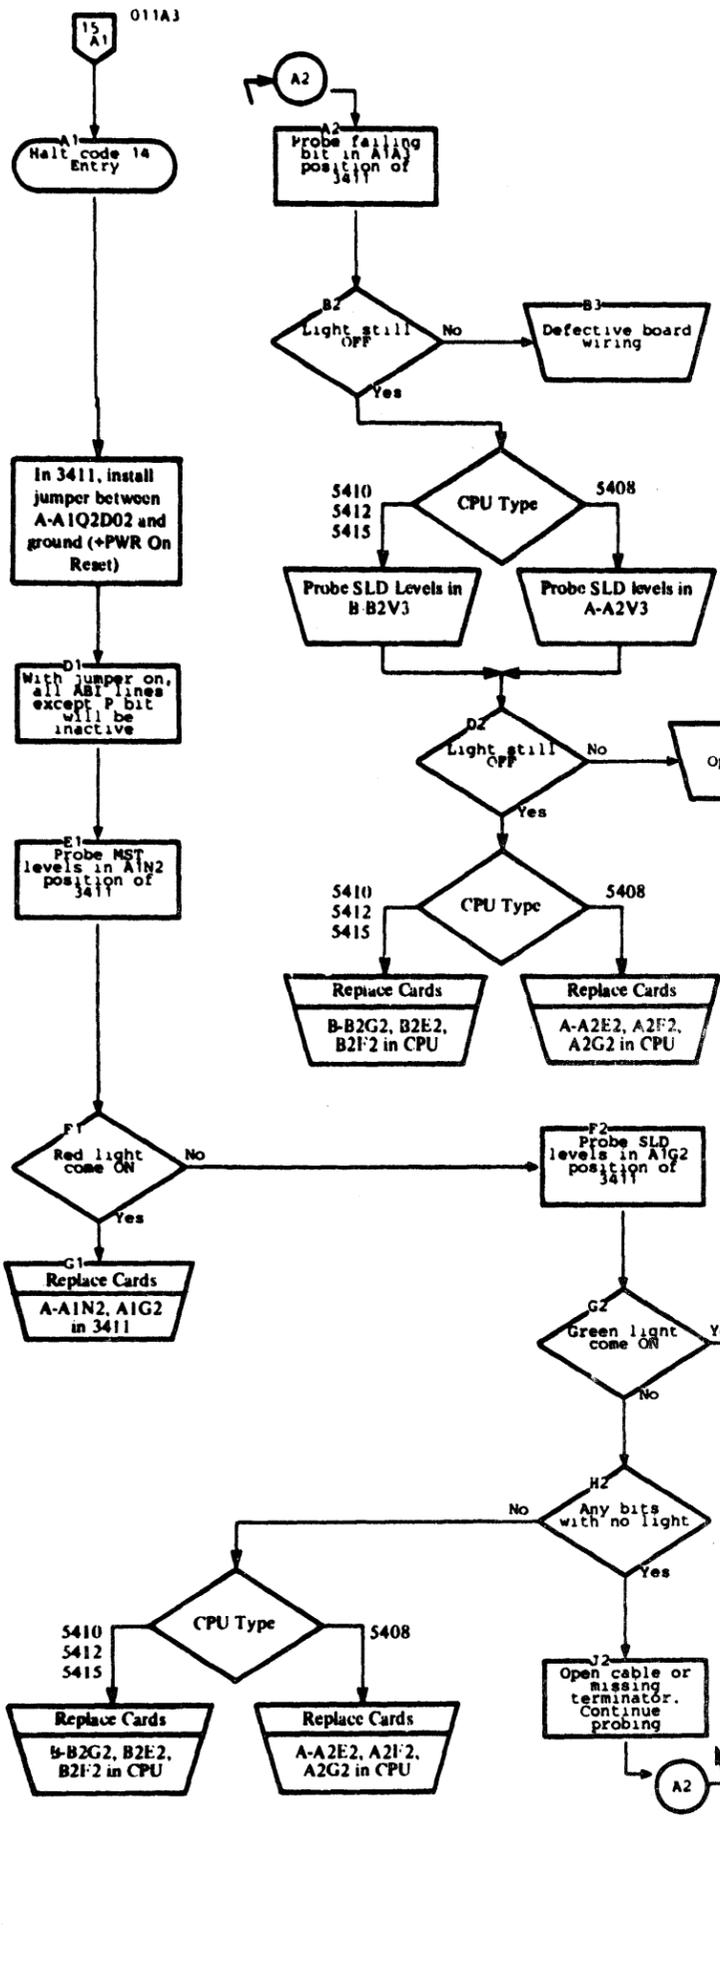
701 Halt Analysis

ABI Lines from 3411 to 5408, 5410, 5412, or 5415					
3411 Panel A-A1			5408 = Panel A-A2 5410 } = Panel B-B2 5412 } 5415 }		
MST Level	SLD Level		SLD Level		
0	N2J02	G2J03	A3B04	V3B07	G2D12
1	N2J03	G2J04	A3D05	V3D05	G2D13
2	N2J04	G2J05	A3B06	V3B06	G2J02
3	N2J05	G2J06	A3B08	V3B08	G2J03
4	N2J06	G2J07	A3D09	V3D09	G2J04
5	N2J07	G2J09	A3B10	V3B10	G2J05
6	N2J09	G2J10	A3D11	V3D11	G2J06
7	N2J10	G2J11	A3B12	V3B12	G2J07
P	N2J11

Note: See SER 3 for diagnostic probe and switching levels.

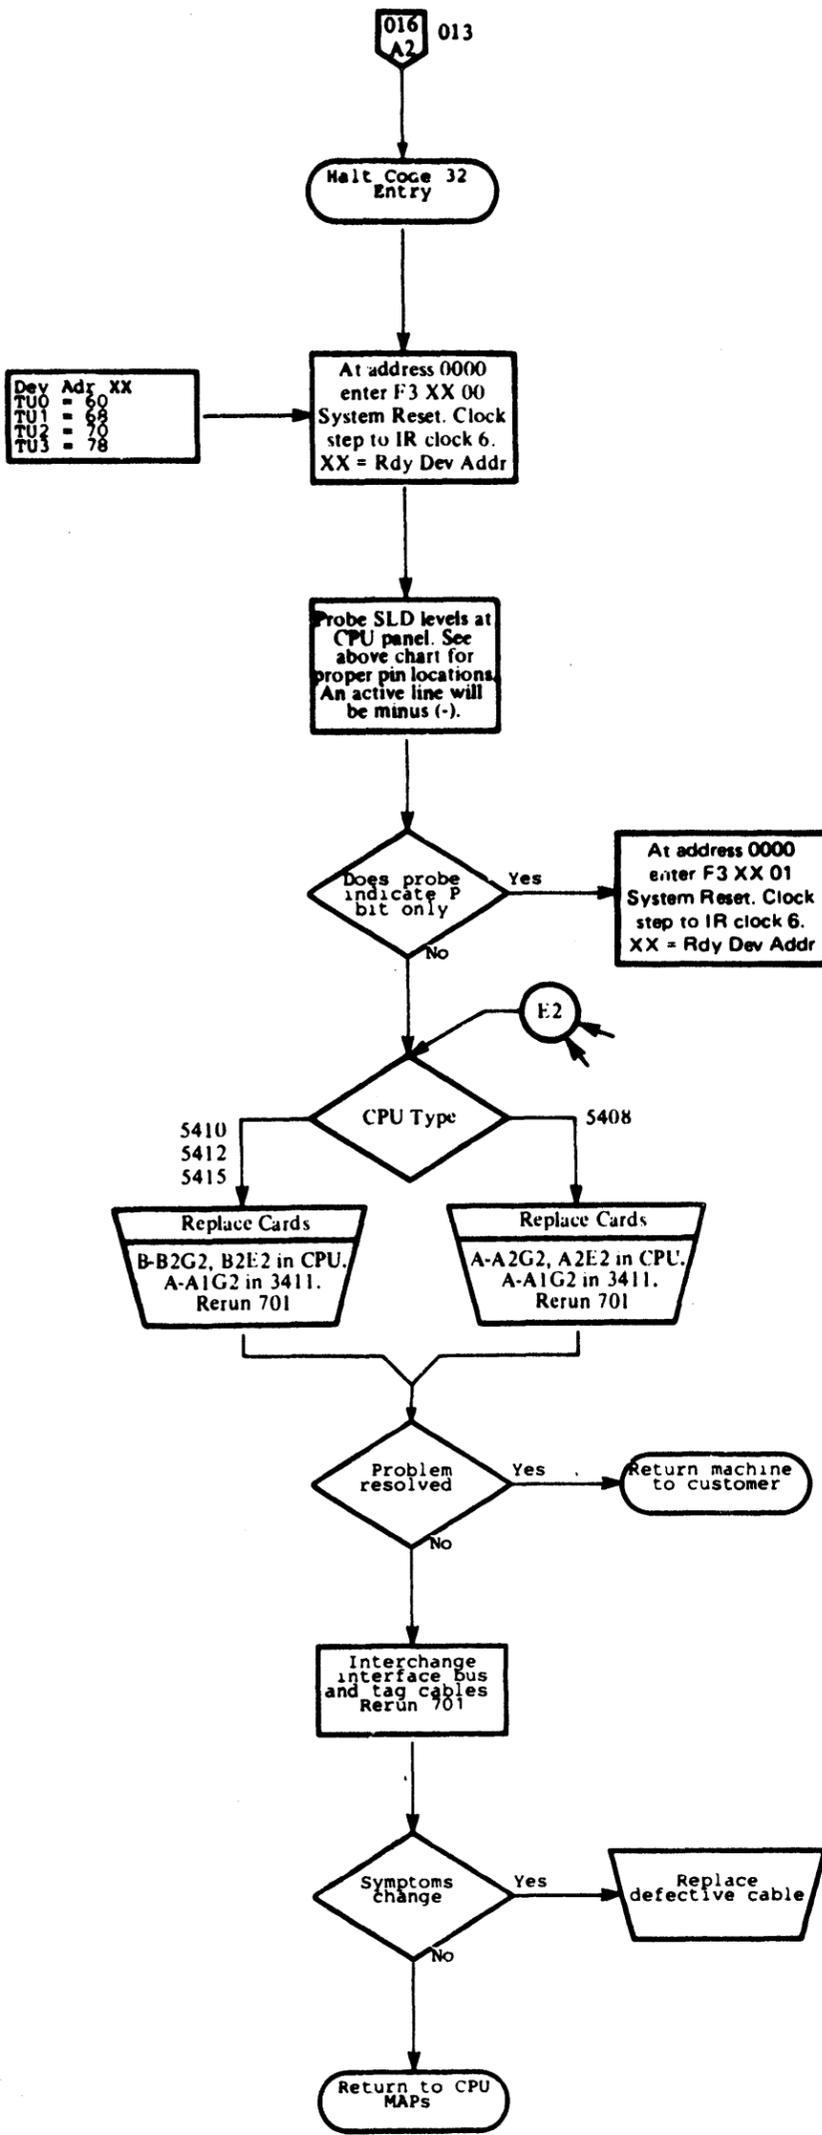
Dev	Adr	XX
TU0	=	60
TU1	=	68
TU2	=	70
TU3	=	78

ABO Lines from 5408, 5410, 5412, or 5415 to 3411					
5408 = Panel A-A2 5410, 5412, 5415 = Panel B-B2			3411 = Panel A-A1		
	SLD Level		SLD Level	MST Level	
P	G2B13	V2D03	A2D03	G2D02	G2B13
0	G2B02	V2B04	A2B04	G2D03	G2B02
1	G2B03	V2D05	A2D05	G2D04	G2B03
2	G2B04	V2B06	A2B06	G2D05	G2B04
3	G2B05	V2B08	A2B08	G2D06	G2B05
4	G2B07	V2D09	A2D09	G2D07	G2B07
5	G2B09	V2B10	A2B10	G2D09	G2B09
6	G2B10	V2D11	A2D11	G2D10	G2B10
7	G2B12	V2B12	A2B12	G2D11	G2B12

Note: See SER 3 for diagnostic probe and switching levels.

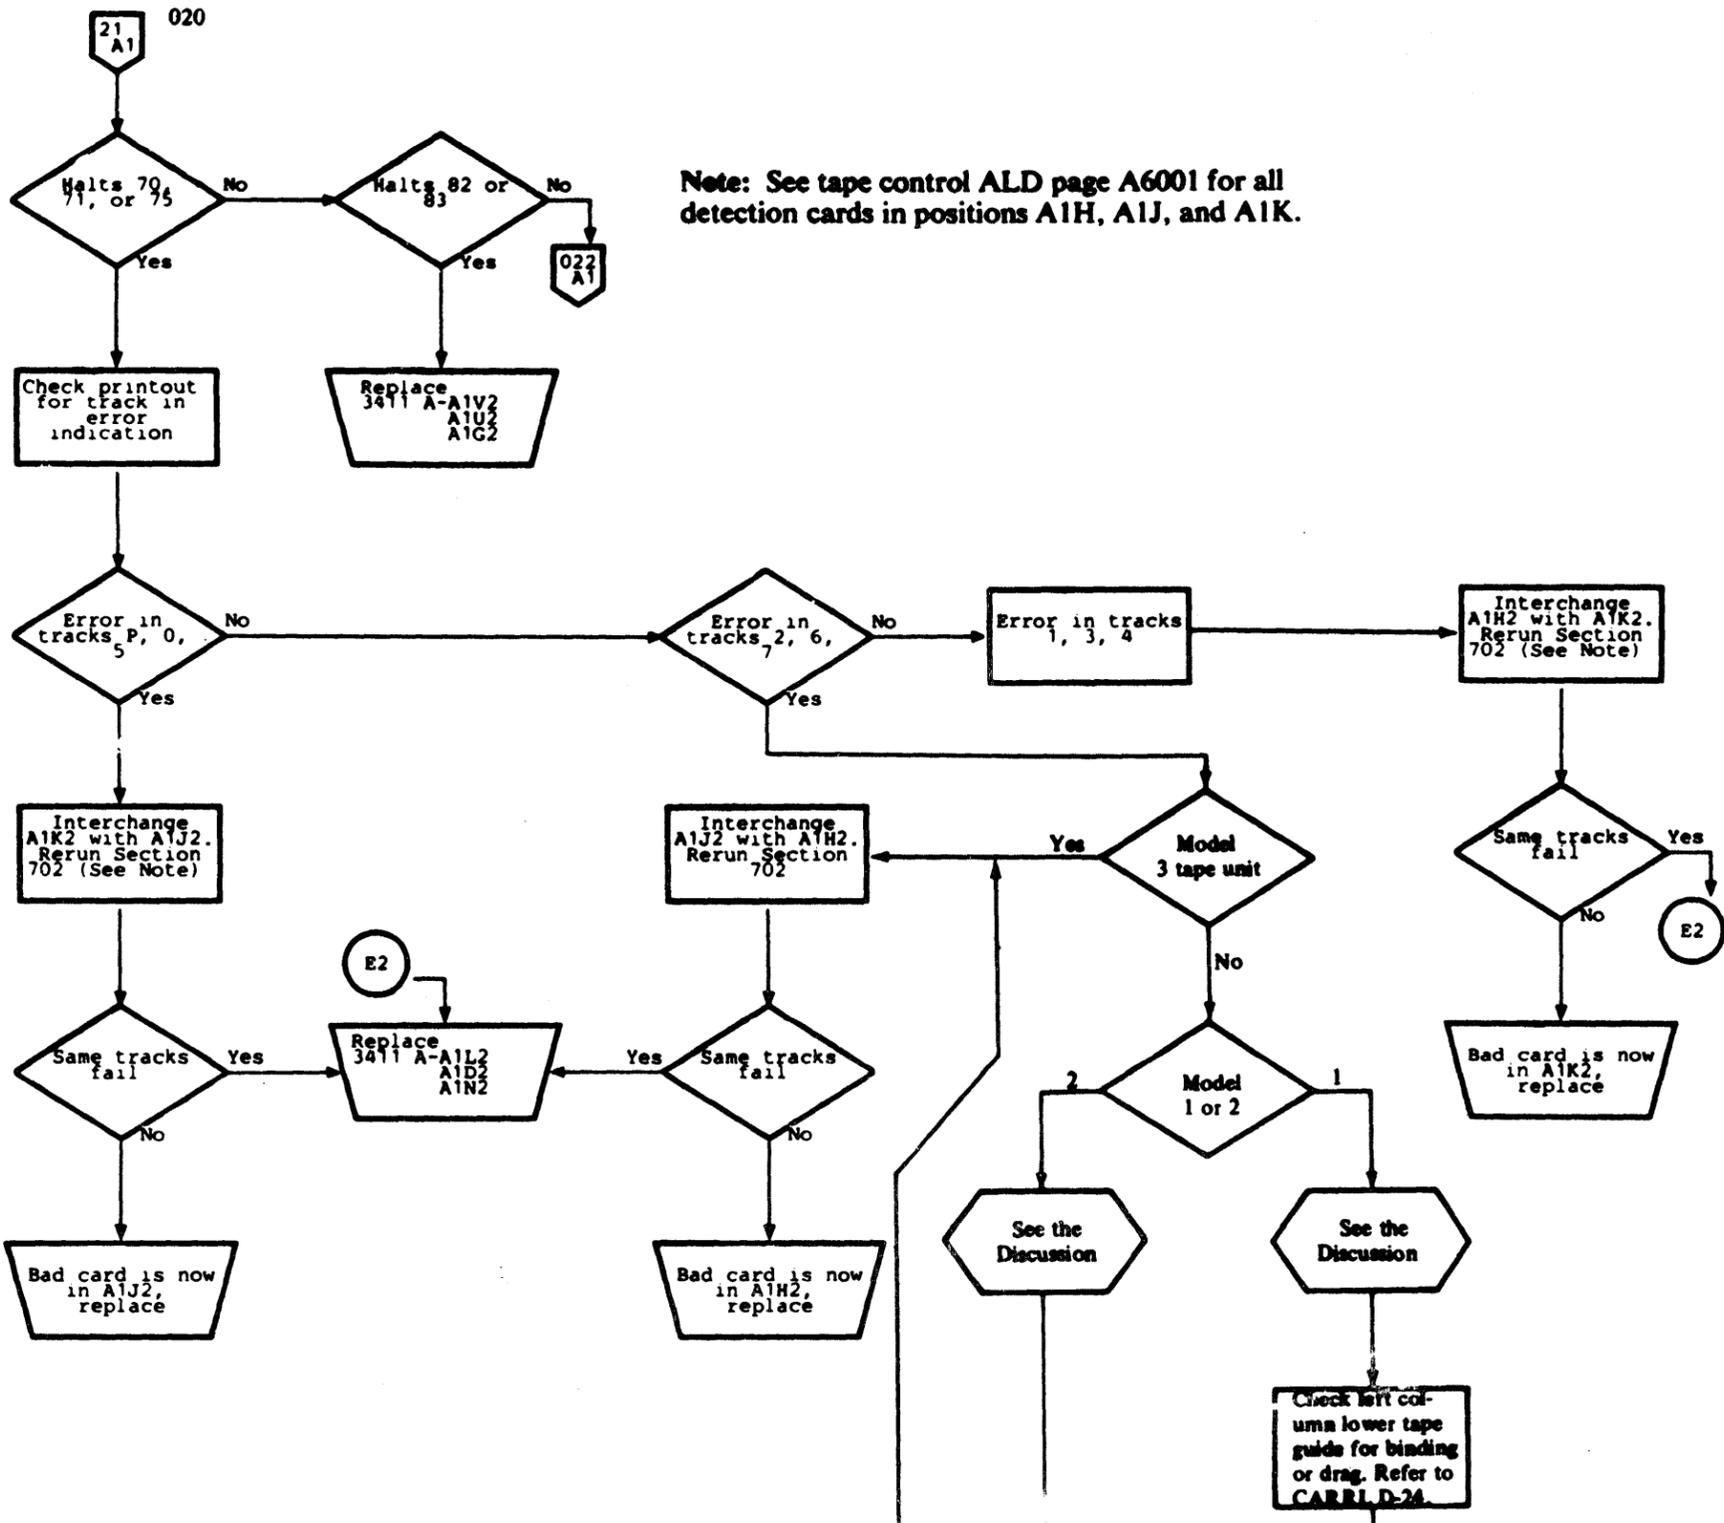
702 Diagnostic Entry (Dead Track Failure)

Note: See tape control ALD page A6001 for all detection cards in positions A1H, A1J, and A1K.

Discussion: To prevent the creation of tapes that may not be interchangeable with 24xx series tape units, the 3411 models 1 and 2 are equipped with a velocity rate of change per bit detection circuit. This circuit is active only in the PE mode during a write operation.

Common causes of a velocity rate change error are:

- 1 - Lower tape guide in the left column (model 1 only) has a binding roller. Check the roller for free rotation. It is important that all washers and springs are properly installed. Refer to CARRL D-24 for correct installation.
- 2 - Check for column flatness on models 1 and 2. Excessive warpage of the vacuum column can cause excessive vibration at the tape loop. Flatness of the vacuum column in the tape loop area should be checked using a straight edge. (The edge of the half column cover, PN 2517722, can be used for this measurement.) Column should be flat within 0.015 inches (0.381 mm) over the area below the BOT/EOT block the full width of the column.

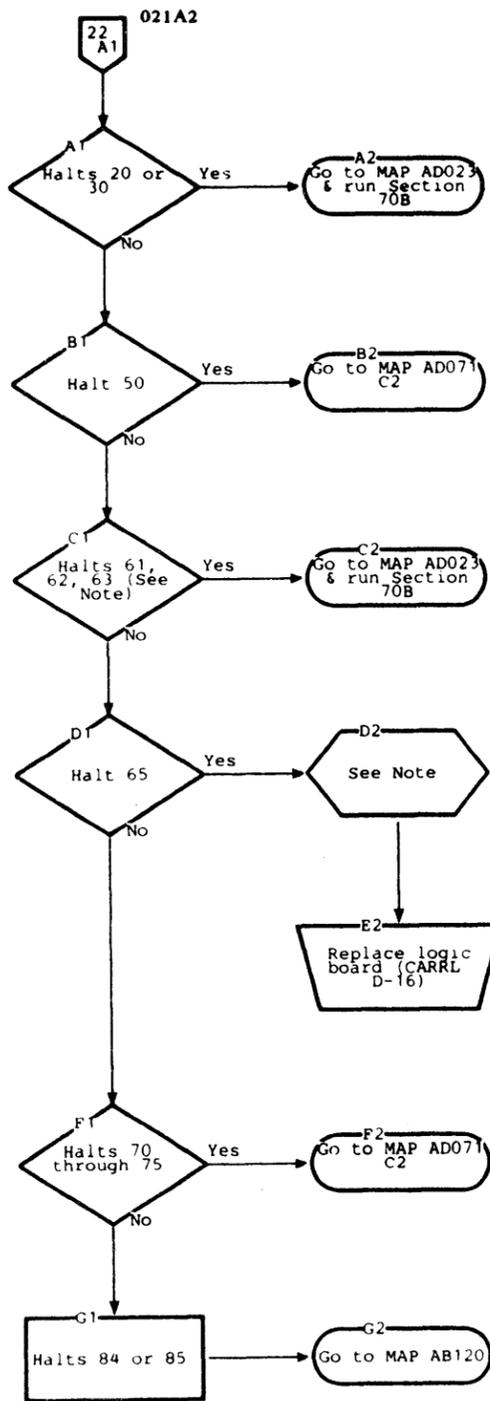
702 Diagnostic Entry (Tape Analysis Chart)

Note: Halts 61, 62, 63 and 65 indicate an erase head failure. Before replacing the head assembly:
 A. Check that the erase head leads are connected.
 B. Check tape-to-erase-head clearance (See CARRL Figure D-25, step 11).
 C. Unload tape unit. Turn power off.
 D. Check continuity of erase head (16-25 ohms).
