TABLE OF CONTENTS

VOL D01 M/T 3411 SERIAL 51051905

CARRL
CARRL
 Checks, Adjustments, Removals, Replacements, and Locations describes maintenance functions that can be performed on the 3410/3411 Tape Subsystem.

The 3410/3411 Magnetic Tape Subsystem consists of one or more IBM 3410 Magnetic Tape Units and an IBM 3411 Magnetic Tape Unit and Control. The major parts (tape unit and tape control) are functionally packaged (all controls used in performing a hardware function are located together) for quick isolation and replacement of a failing component. The circuitry within the subsystem (called the *attachment*), which adapts the subsystem to the I/O interface of the host system, must be considered in maintenance. Expanded sense data is provided to include more details of hardware failure than was furnished by most earlier tape subsystems.

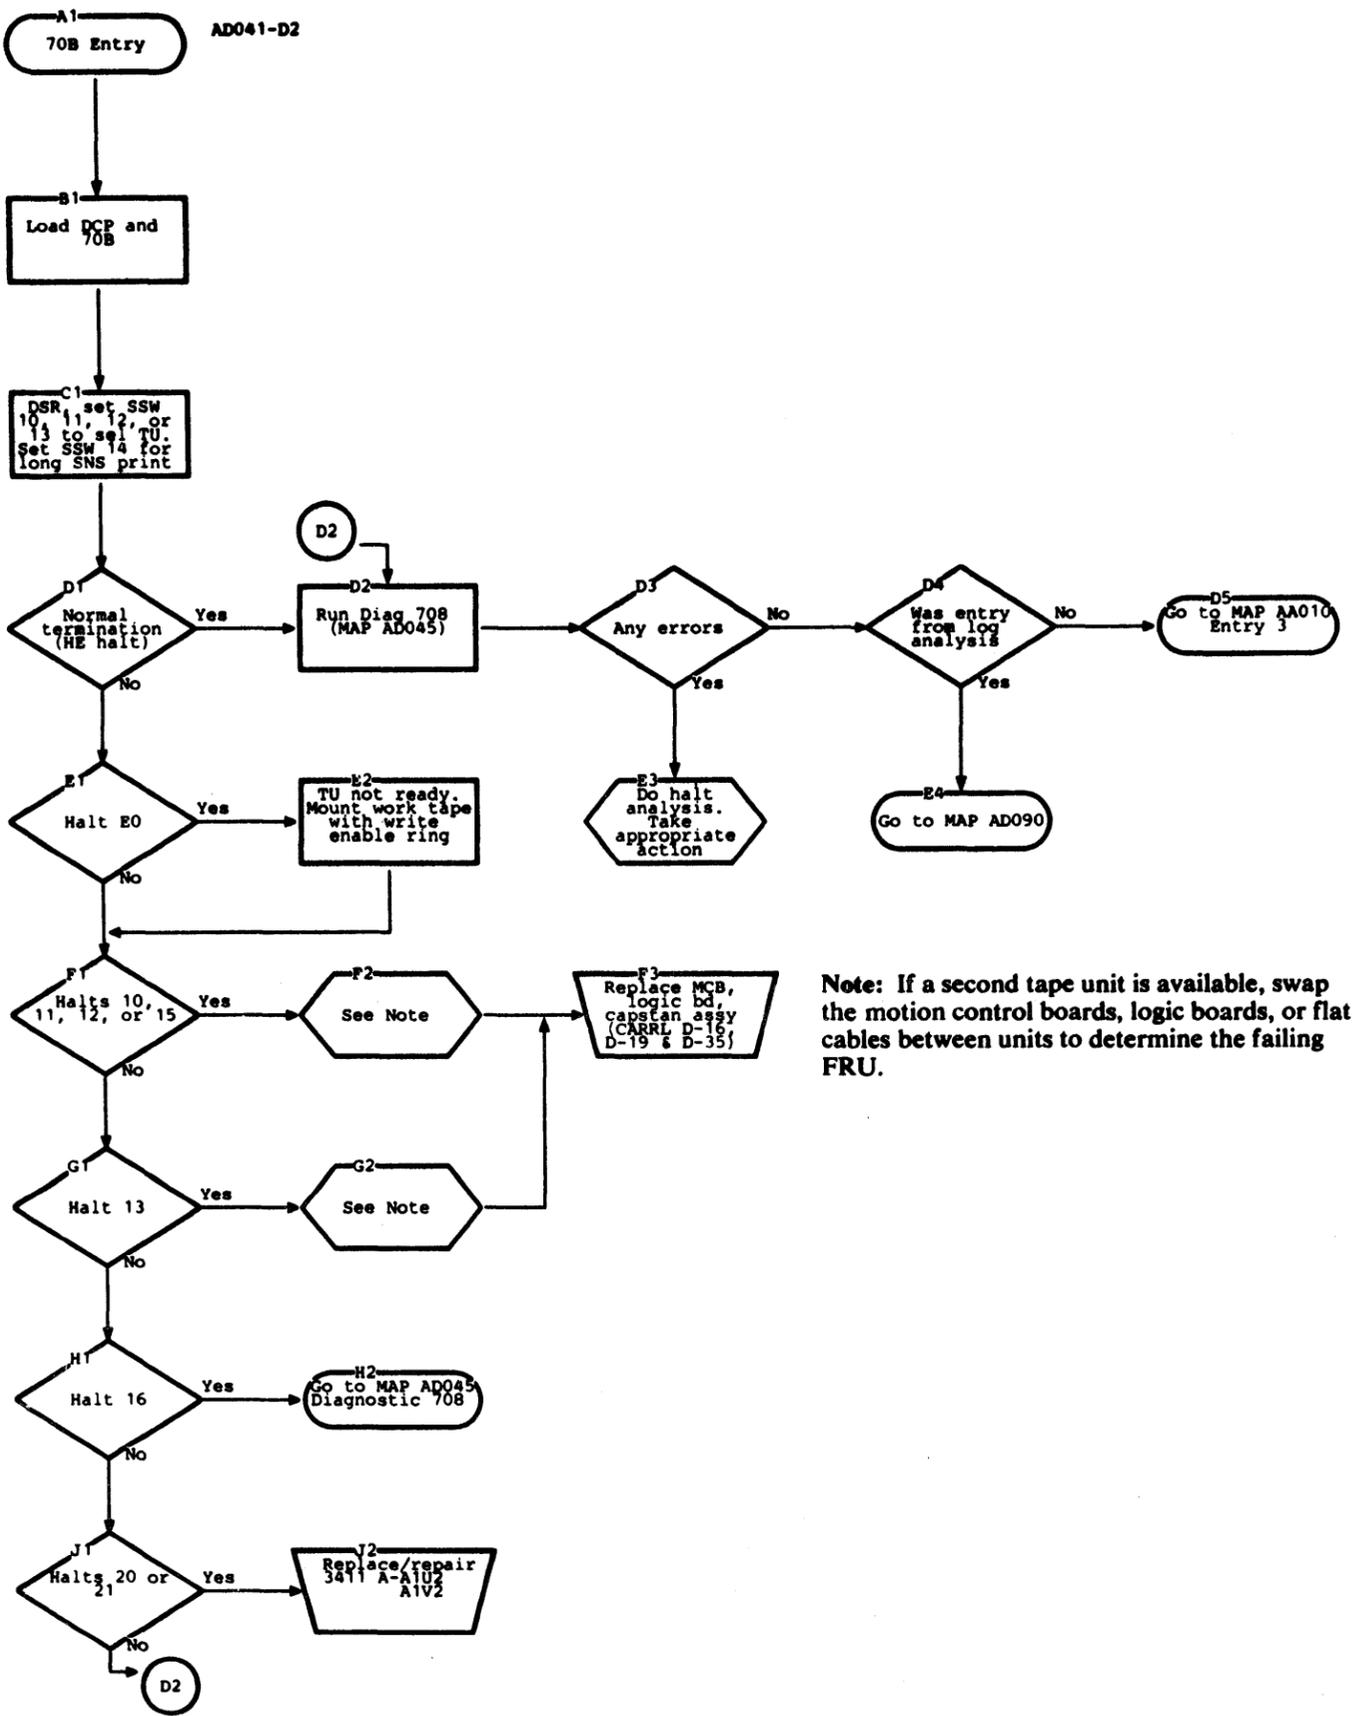
70B Tachometer Check

Note: If a second tape unit is available, swap the motion control boards, logic boards, or flat cables between units to determine the failing FRU.

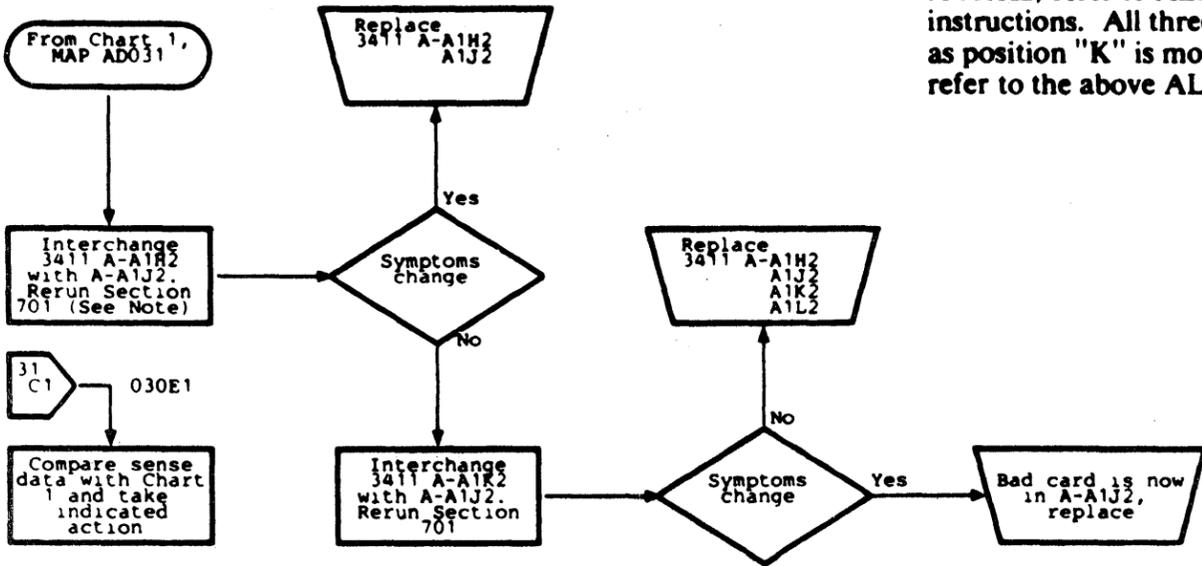
701 Halt 02 Analysis

Note: When interchanging A-A1H2, A-A1J2, and A-A1K2, refer to ALD page A6001 for plugging instructions. All three cards should be factory plugged, as position "K" is model sensitive. If they are not plugged, refer to the above ALD page.

CHART NO. 1: 701 HALT 02 DATA CHECK												
MODE		TIE DATA	SENSE BITS									ACTION: Replace card(s) indicated or go the MAP chart indicated
PE	NRZI		MTE	END DATA	ENV CHK	FALSE END	PEID BURST	VRC ER	LRCR	TIME ER	CR CR	
X		FF	X	X	X							3411 A-A1L2 A-A1P2
X		01			X			X				Suspect A-A1J2. Go to MAP AD031 A1. Refer to Discussion on AD021.
X		02			X			X				Go to MAP AD031 A1
X		08			X			X				Suspect A-A1H2 Go to MAP AD031 A1
X		40			X			X				Suspect A-A1H2 Go to MAP AD031 A1
X		80			X			X				Suspect A-A1K2 Go to MAP AD031 A1
X		EF	X		X			X				3411 A-A1L2
X		FF	X	X	X			X				Go to MAP AD032 A1
X		03								X		3411 A-A1L2 A-A1P2
X		03				X						Go to MAP AD032 A3
X		03				X		X				3411 A-A1L2 A-A1P2
X		00					X					Go to MAP AD032 E3
X		03						X				3411 A-A1N2
	X	03		X				X		X		Suspect A-A1K2 Go to MAP AD031 A1
	X	03						X		X	X	Suspect A-A1H2 Go to MAP AD031 A1
	X	03	X					X		X		Suspect A-A1H2 Go to MAP AD031 A1

X	03							X			Go to MAP AD031 A1
	X	03						X	X	X		Go to MAP AD031 A1
	X	03						X	X			Go to MAP AD032 A1
	X	03						X			X	Suspect A-A1K2 Go to MAP AD031 A1
	X	03									X	3411 A-A1Q2
Any combination not shown												Go to MAP AD033 A1

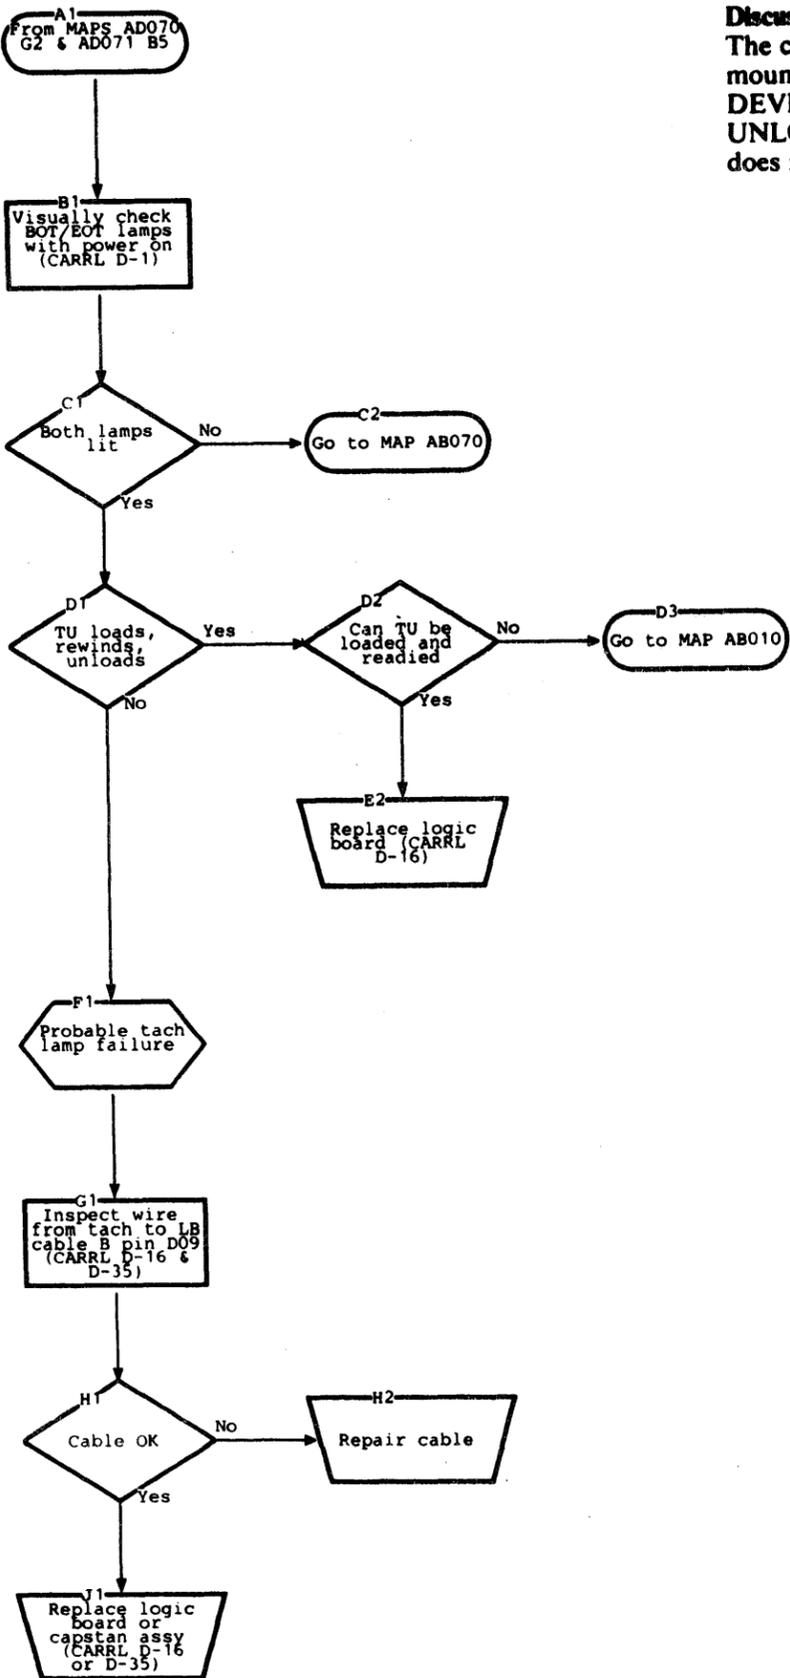
Lamp Check

Discussion: The BOT and EOT lamps can be checked visually. The capstan tach lamp is more difficult to check since it is mounted on the capstan motor. A tach lamp failure brings up DEVICE RESET which disables the LOAD, REWIND, and UNLOAD functions of the tape unit. A BOT or EOT lamp failure does not force DEVICE RESET.

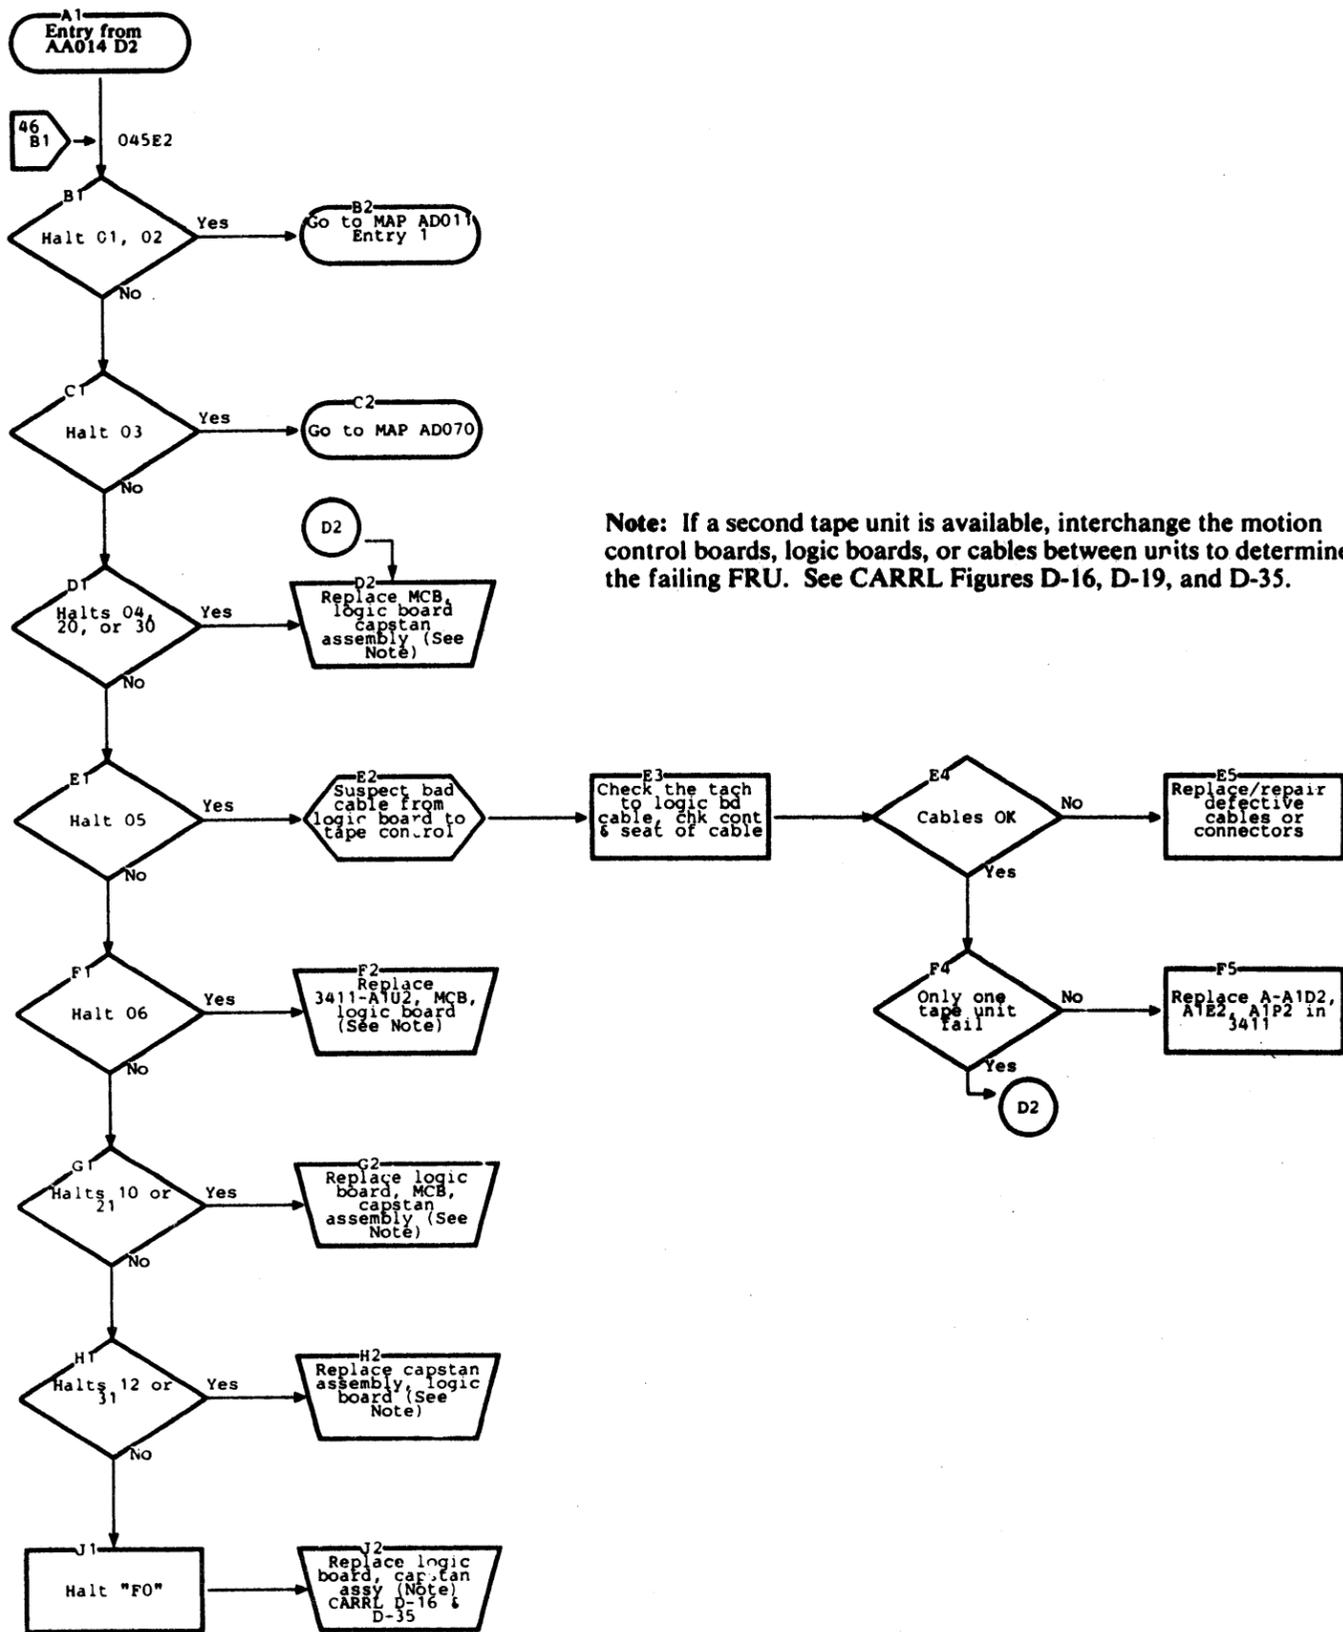
708 Tachometer Failure

Note: If a second tape unit is available, interchange the motion control boards, logic boards, or cables between units to determine the failing FRU. See CARRL Figures D-16, D-19, and D-35.

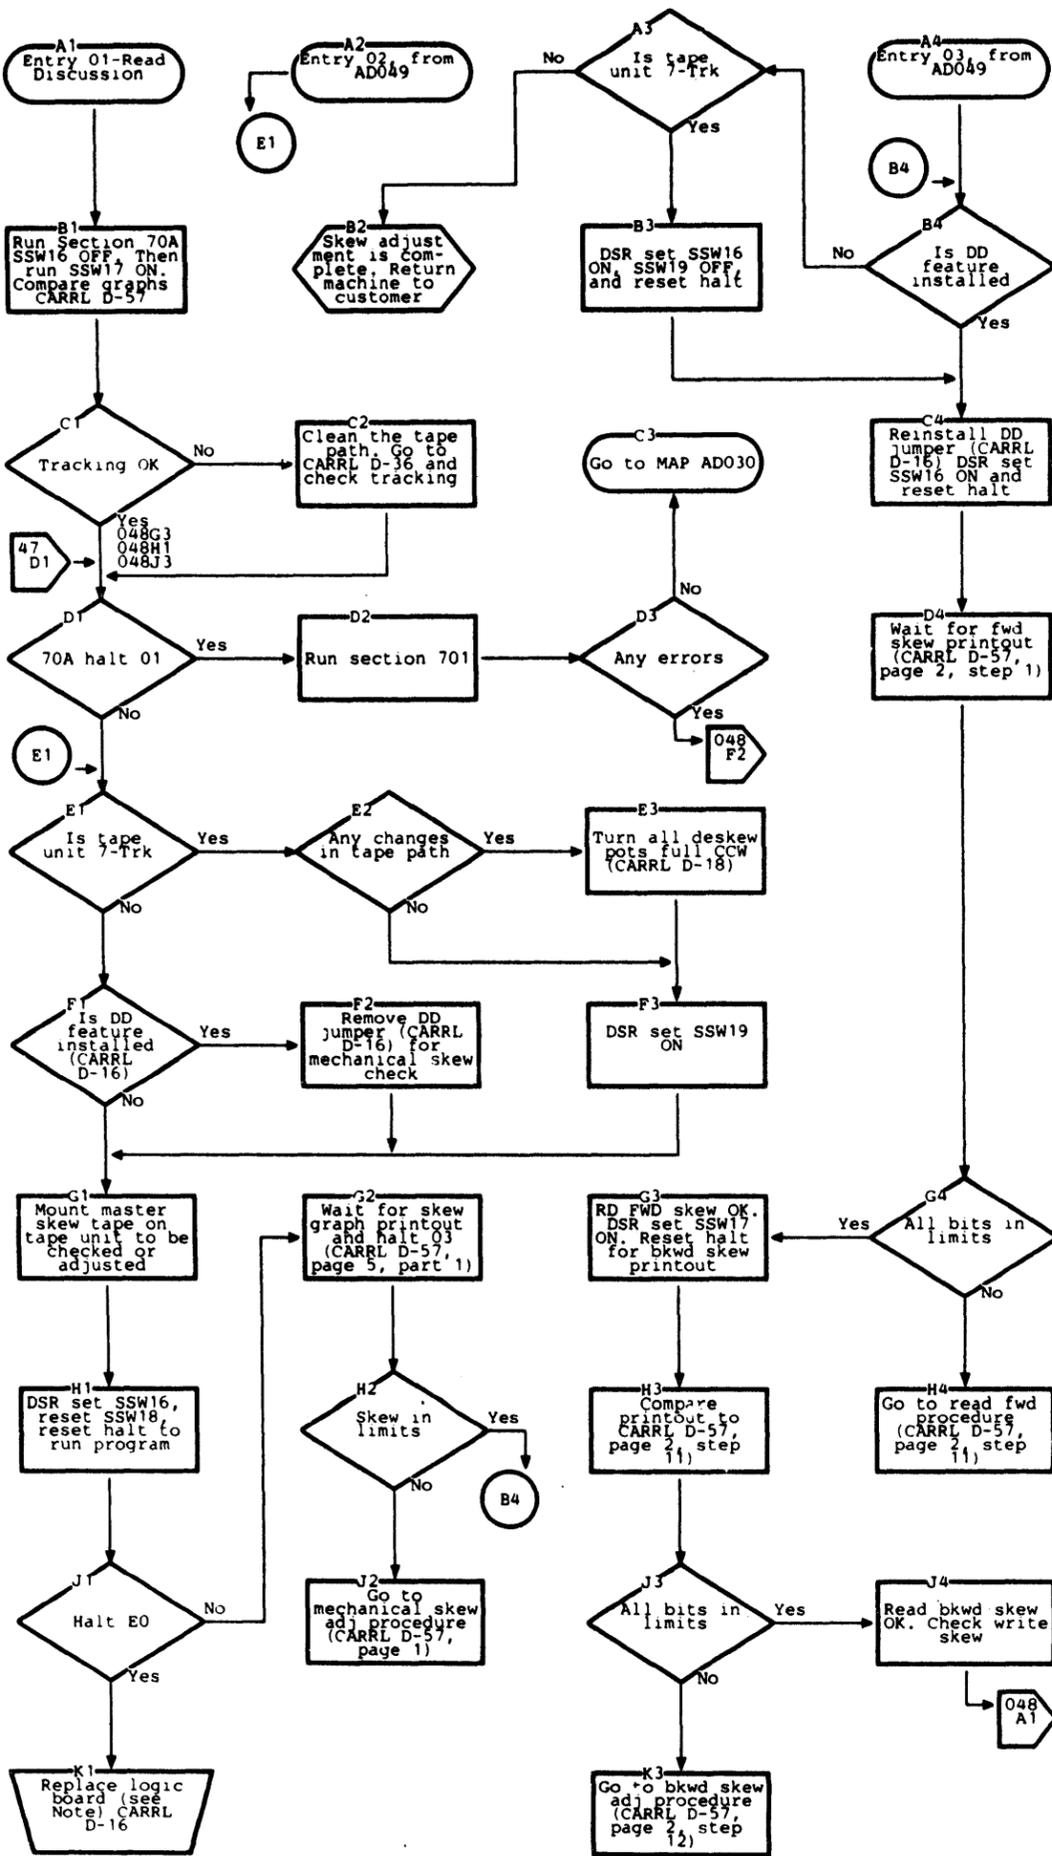
Tracking and Skew Checks and Adjustments

Discussion: Tracking and skew adjustment must be made if the read/write head assembly, columns, or guides are replaced. Order of adjustment is: tracking, mechanical skew, read forward skew, read backward skew, and write skew. Clean the tape path and column cover before making skew checks and adjustments.

CAUTION: Do not attempt to adjust skew unless you are sure tracking is correct. Reference MAP AD049 for tracking.

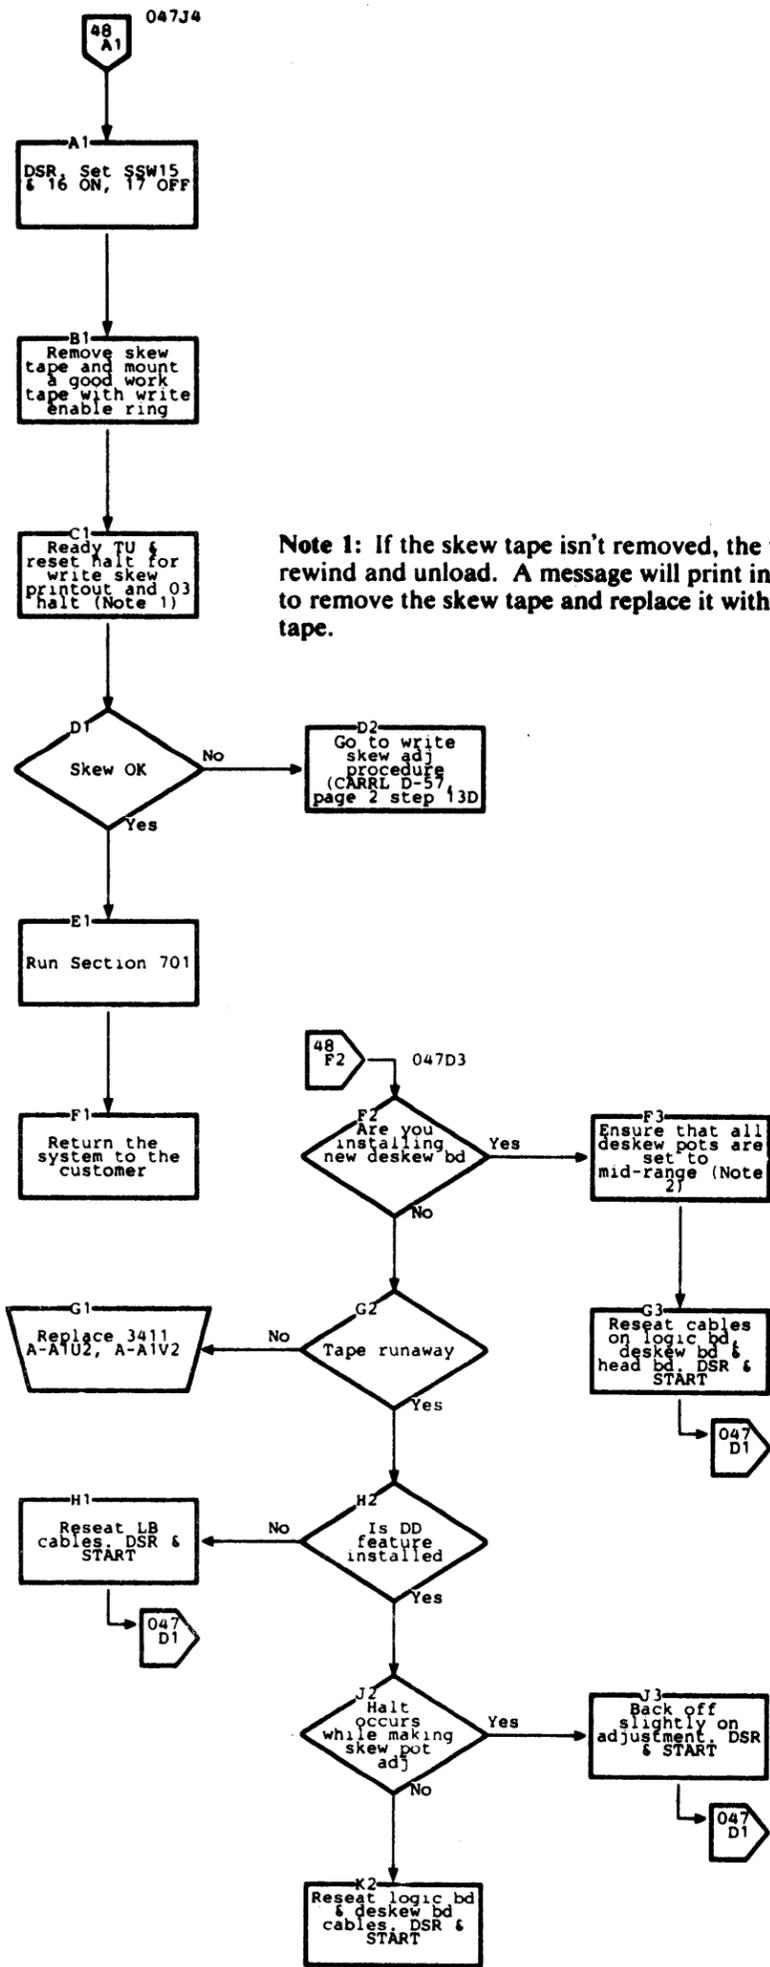
Tracking and Skew Checks and Adjustments

Note 1: If the skew tape isn't removed, the tape unit will rewind and unload. A message will print instructing you to remove the skew tape and replace it with a good work tape.

Note 2: If 7-Track, set all deskew pots fully CW.

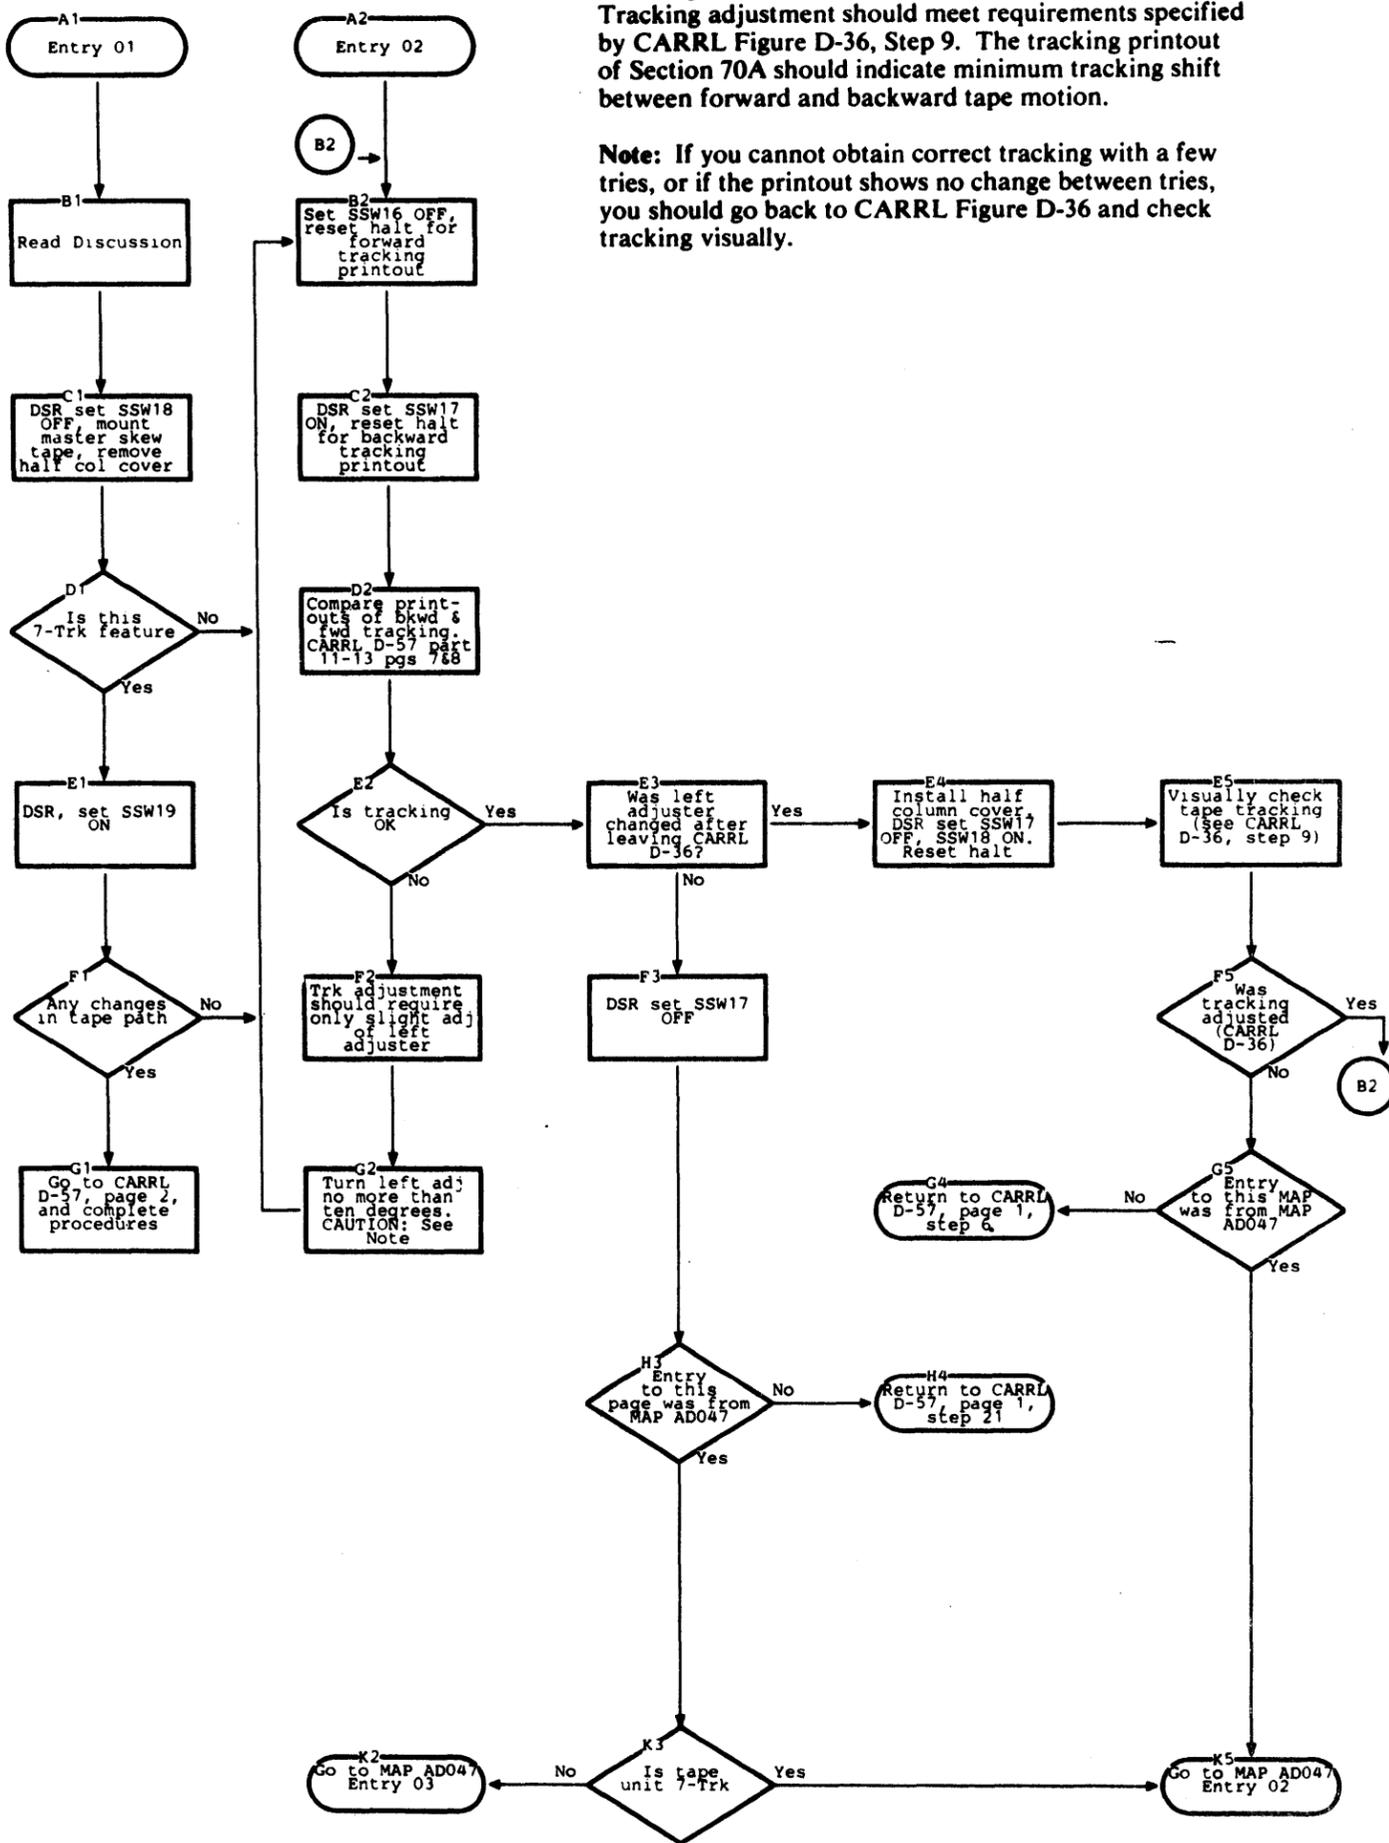
Tracking Check

Discussion: Entry to this MAP assumes that you have checked tracking visually (see CARRL Figure D-36) and that diagnostic section 70A is loaded and ready to run. Tracking adjustment should meet requirements specified by CARRL Figure D-36, Step 9. The tracking printout of Section 70A should indicate minimum tracking shift between forward and backward tape motion.

Note: If you cannot obtain correct tracking with a few tries, or if the printout shows no change between tries, you should go back to CARRL Figure D-36 and check tracking visually.

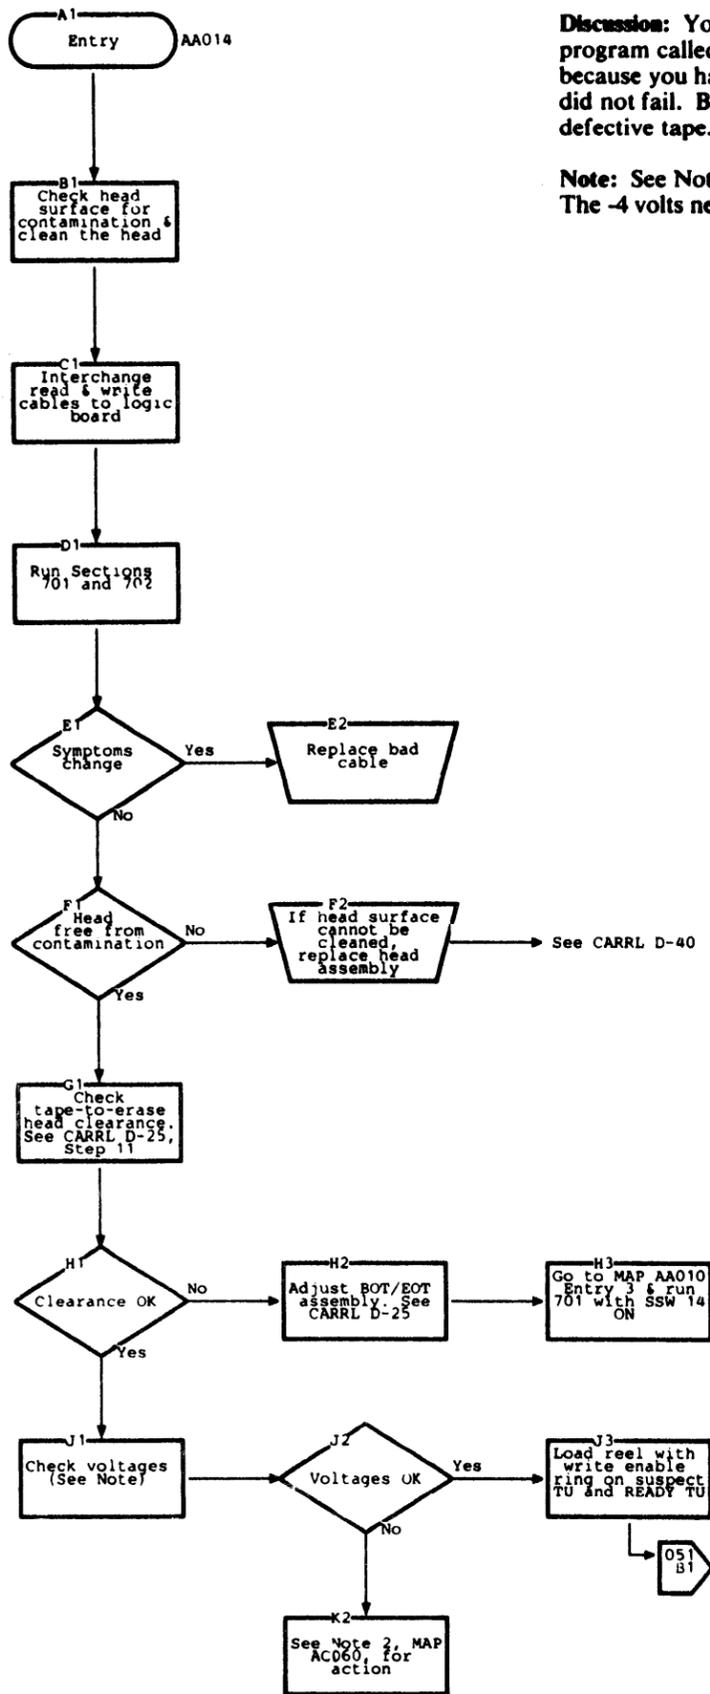
Read/Write Head Assembly

Discussion: You should enter this MAP if the Log Analysis program called out the read/write head assembly as suspect, or because you had a data check and a loop-write-to-read command did not fail. Be sure that the data check was not caused by defective tape. Try more than one tape reel.

Note: See Note 1 on MAP AC060 for voltage check procedure. The -4 volts need not be checked at this time.

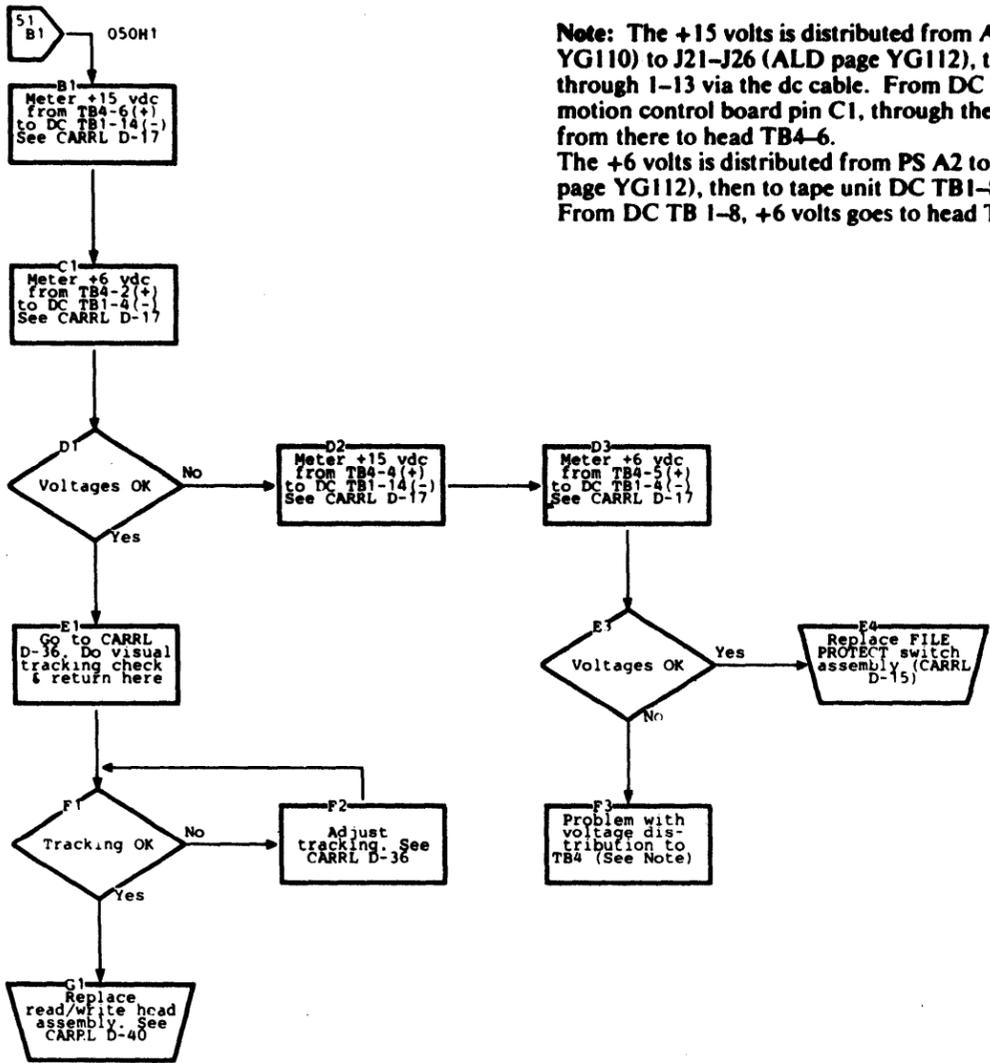
Read/Write Head Assembly

Note: The +15 volts is distributed from A2 TB1-16 (ALD page YG110) to J21-J26 (ALD page YG112), then to tape unit DC TB1-10 through 1-13 via the dc cable. From DC TB1-13, +15 volts goes to motion control board pin C1, through the board to pin B14, and from there to head TB4-6. The +6 volts is distributed from PS A2 to connectors J21-J26 (ALD page YG112), then to tape unit DC TB1-8 and 1-9 via the dc cable. From DC TB 1-8, +6 volts goes to head TB4-2.

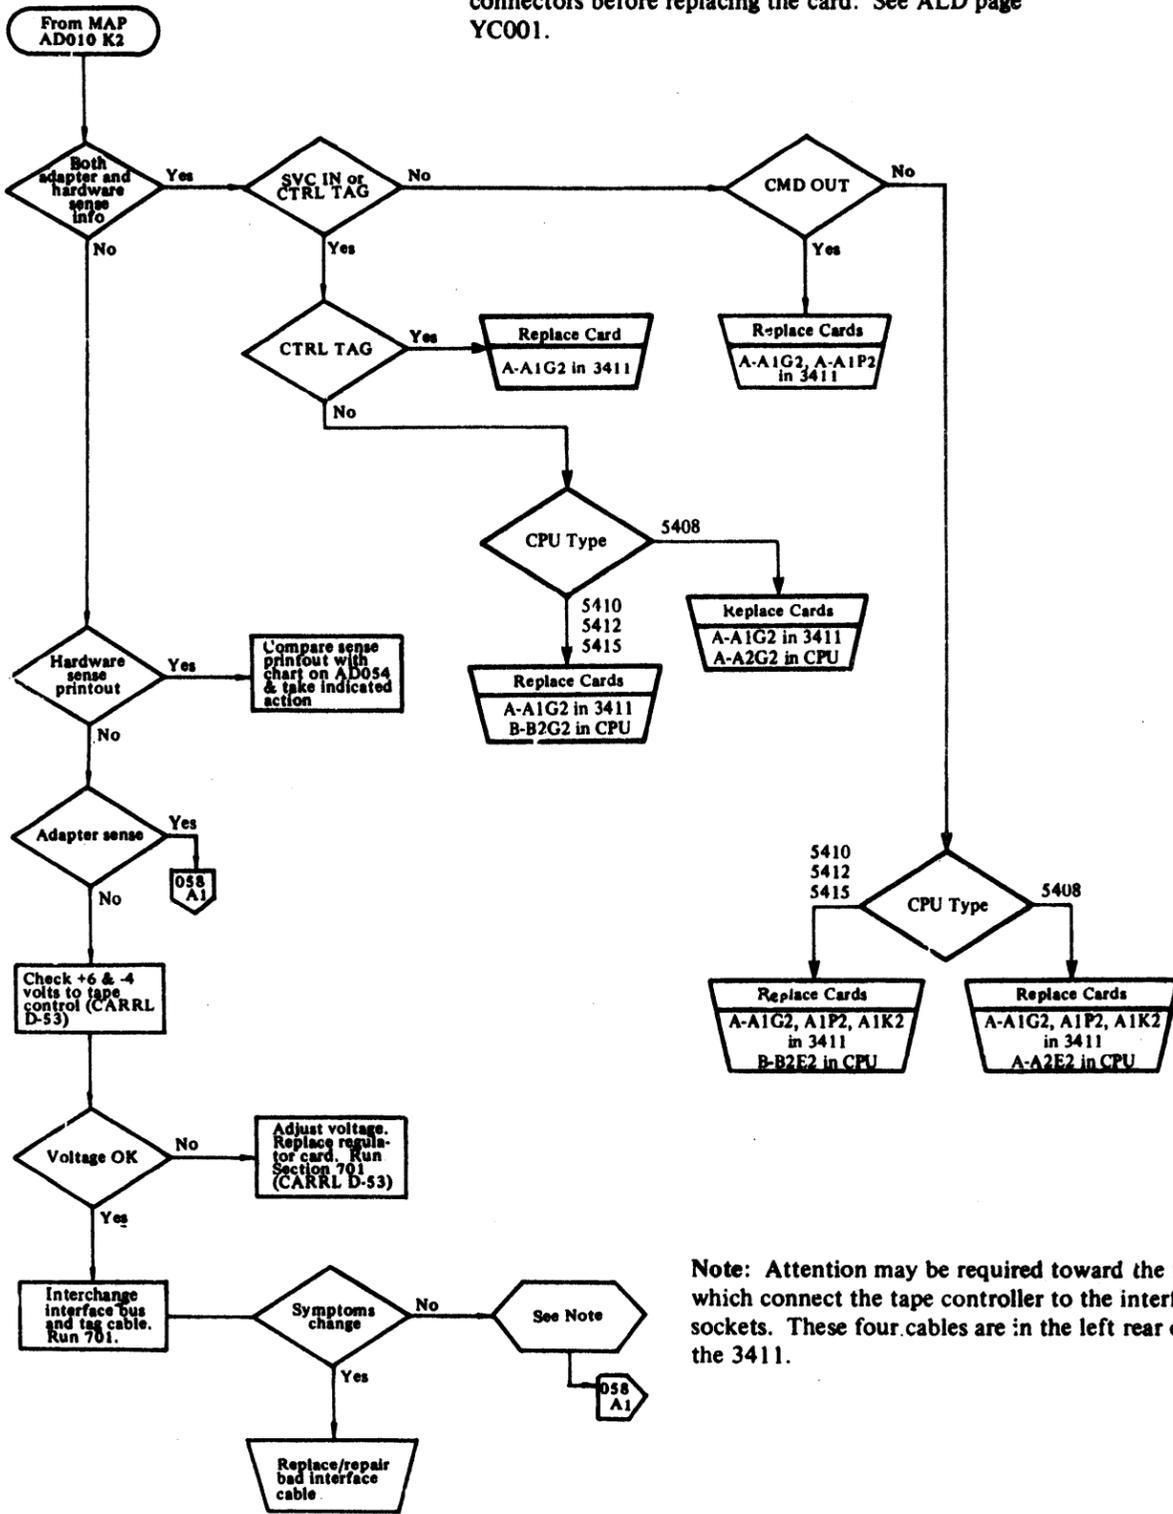
701 Halt 01 Analysis
MAP AD054

Discussion: Whenever you are instructed to replace/repair card A1G2, check the slip-on voltage connectors before replacing the card. See ALD page YC001.

Note: Attention may be required toward the flat cables which connect the tape controller to the interface sockets. These four cables are in the left rear corner of the 3411.

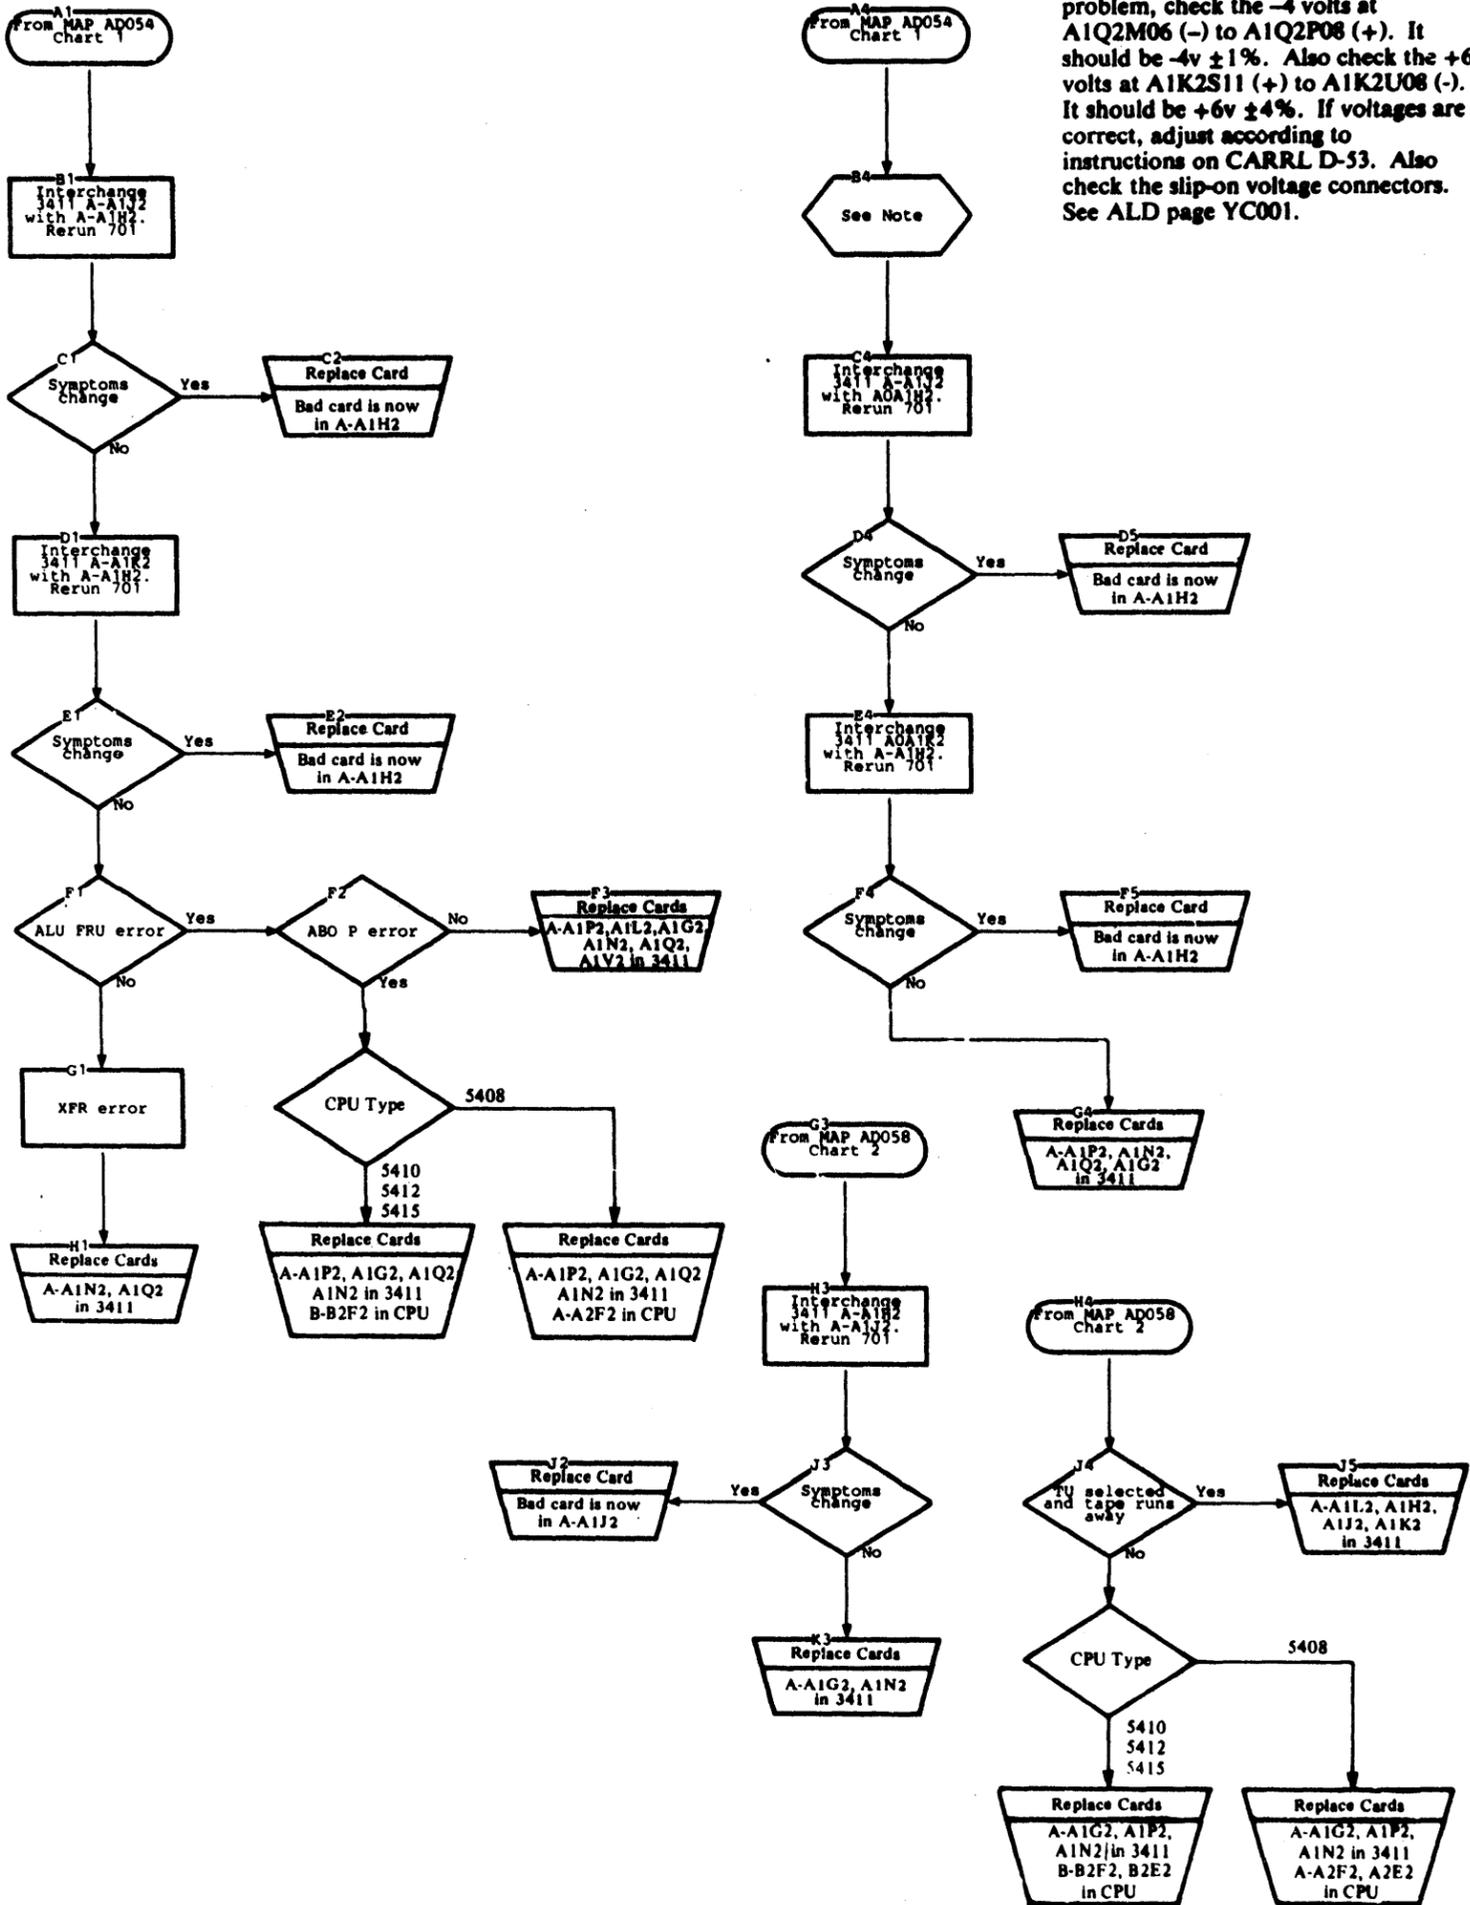
701 Halt 01 Analysis

Note: If replacing the cards called out in this MAP does not fix the problem, check the -4 volts at AIQ2M06 (-) to AIQ2P08 (+). It should be $-4v \pm 1\%$. Also check the +6 volts at AIK2S11 (+) to AIK2U08 (-). It should be $+6v \pm 4\%$. If voltages are not correct, adjust according to instructions on CARRL D-53. Also check the slip-on voltage connectors. See ALD page YC001.

CHART NO. 1: 701 HALT 01 HARDWARE ERRORS									
HARDWARE SENSE BITS									ACTION: Replace card(s) indicated or go to MAP chart indicated
ALU FRU	IC CHECK	ABO P ERROR	CTRL TAG	INST TAG	ALU ERROR	ROS P ERROR	XFR ERROR	WRT CLK	
									Go to MAP AD056 A1
X									Go MAP AD057 A1
X	X								3411: A-A1P2 A-A1G2 A-A1H2 A-A1J2 A-A1K2
X			X						Go to MAP AD056 G3
X				X					Go to MAP AD056 G1
X	X	X							3411: A-A1G2
X	X	X	X						3411: A-A1G2
X		X							Go to MAP AD057 B1
	X								3411: A-A1Q2 A-A1P2
	X				X	X			3411: A-A1P2
		X							3411: A-A1G2, A1P2, A1Q2 5408: A-A2E2, A2G2 5410/12/15: B-B2E2, B2G2 Cables attached to CU.
							X		Go to MAP AD057 B1
		X		X					Go to MAP AD056 B3
			X						3411: A-A1G2, A1N2 5408: A-A2E2, A2F2, A2G2 5410/12/15: B-B2E2, B2F2, B2G2
					X				3411: A-A1P2 A-A1Q2 A-A1D2 A-A1L2 A-A1N2
				X					3411: A-A1G2
						X			3411: A-A1U2 A-A1V2 A-A1N2 A-A1P2
	X					X			3411: A-A1U2 A-A1V2 A-A1Q2

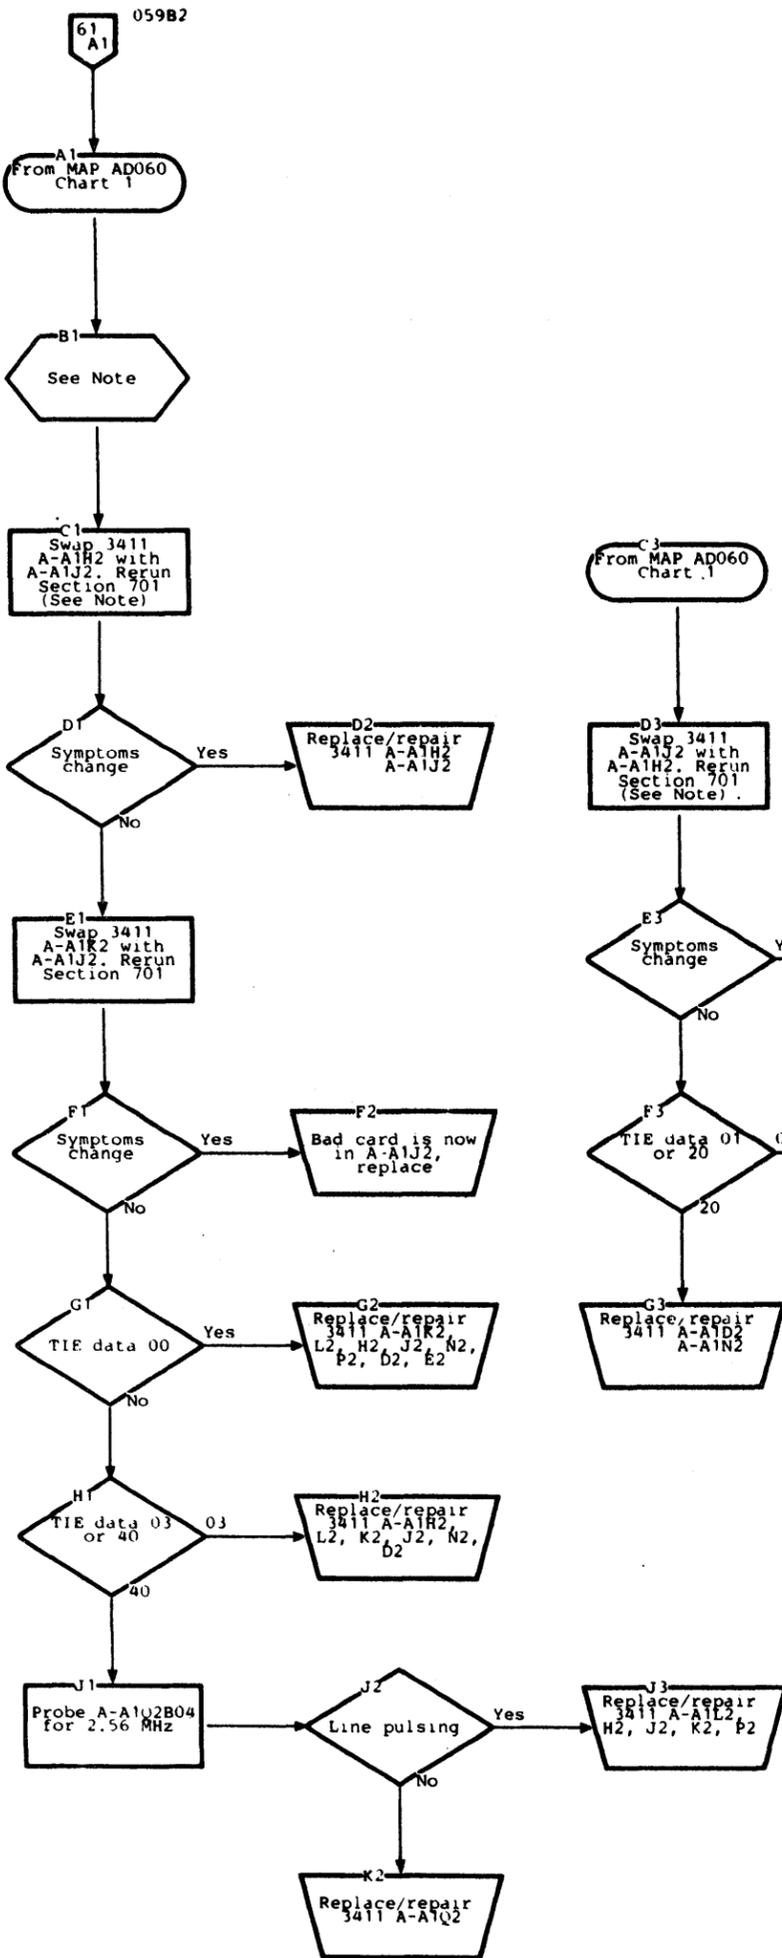
701 Halt 21 Analysis

Note: When interchanging A-A1H2, A-A1J2, and A-A1K2, refer to ALD page A6001 for plugging instructions. All three cards should be factory plugged, as position "K" is model sensitive. If they are not plugged, refer to the above ALD page.

CHART NO. 1: 701 HALT 21 ANALYSIS					
TIE DATA	SENSE BITS				ACTION: Replace card(s) indicated or go the MAP indicated. NOTE: If this is a single tape unit system and the MAP called out doesn't correct the problem, go to MAP AD070, entry 1.
	START KEY	TU CHK	RDY RESET	EQUIP CHK	
00	X				Go to MAP AD061 A1
00	X	X	X		Go to MAP AD062 A1
00		X	X		Go to MAP AD062 A1
01	X				Go to MAP AD061 C3
02	X				Single tape unit system, go to MAP AD062 A3. More than one tape unit, change 3411: A-A1J2.
02		X	X		Single tape unit system, go to MAP AD062 A3. Otherwise, change 3411: A-A1J2.
02	X	X			Single tape unit system, go to MAP AS062 A3. Otherwise, change 3411: A-A1J2.
03	X				Go to MAP AD061 A1
03		X	X		Go to MAP AD063 A1
04	X				Go to MAP AD064 F3
04		X	X		Single tape unit system, go to MAP AD063 A3. Otherwise, change 3411: A-A1K2.
04	X	X	X		3411: A-A1N2 (see Note)
08	X				Go to MAP AD063 E1
08		X	X		Go to MAP AD063 E3
