TABLE OF CONTENTS

VOL D01 M/T 3411 SERIAL 51051905

CARRL
CARRL
 Checks, Adjustments, Removals, Replacements, and Locations describes maintenance functions that can be performed on the 3410/3411 Tape Subsystem.

The 3410/3411 Magnetic Tape Subsystem consists of one or more IBM 3410 Magnetic Tape Units and an IBM 3411 Magnetic Tape Unit and Control. The major parts (tape unit and tape control) are functionally packaged (all controls used in performing a hardware function are located together) for quick isolation and replacement of a failing component. The circuitry within the subsystem (called the *attachment*), which adapts the subsystem to the I/O interface of the host system, must be considered in maintenance. Expanded sense data is provided to include more details of hardware failure than was furnished by most earlier tape subsystems.

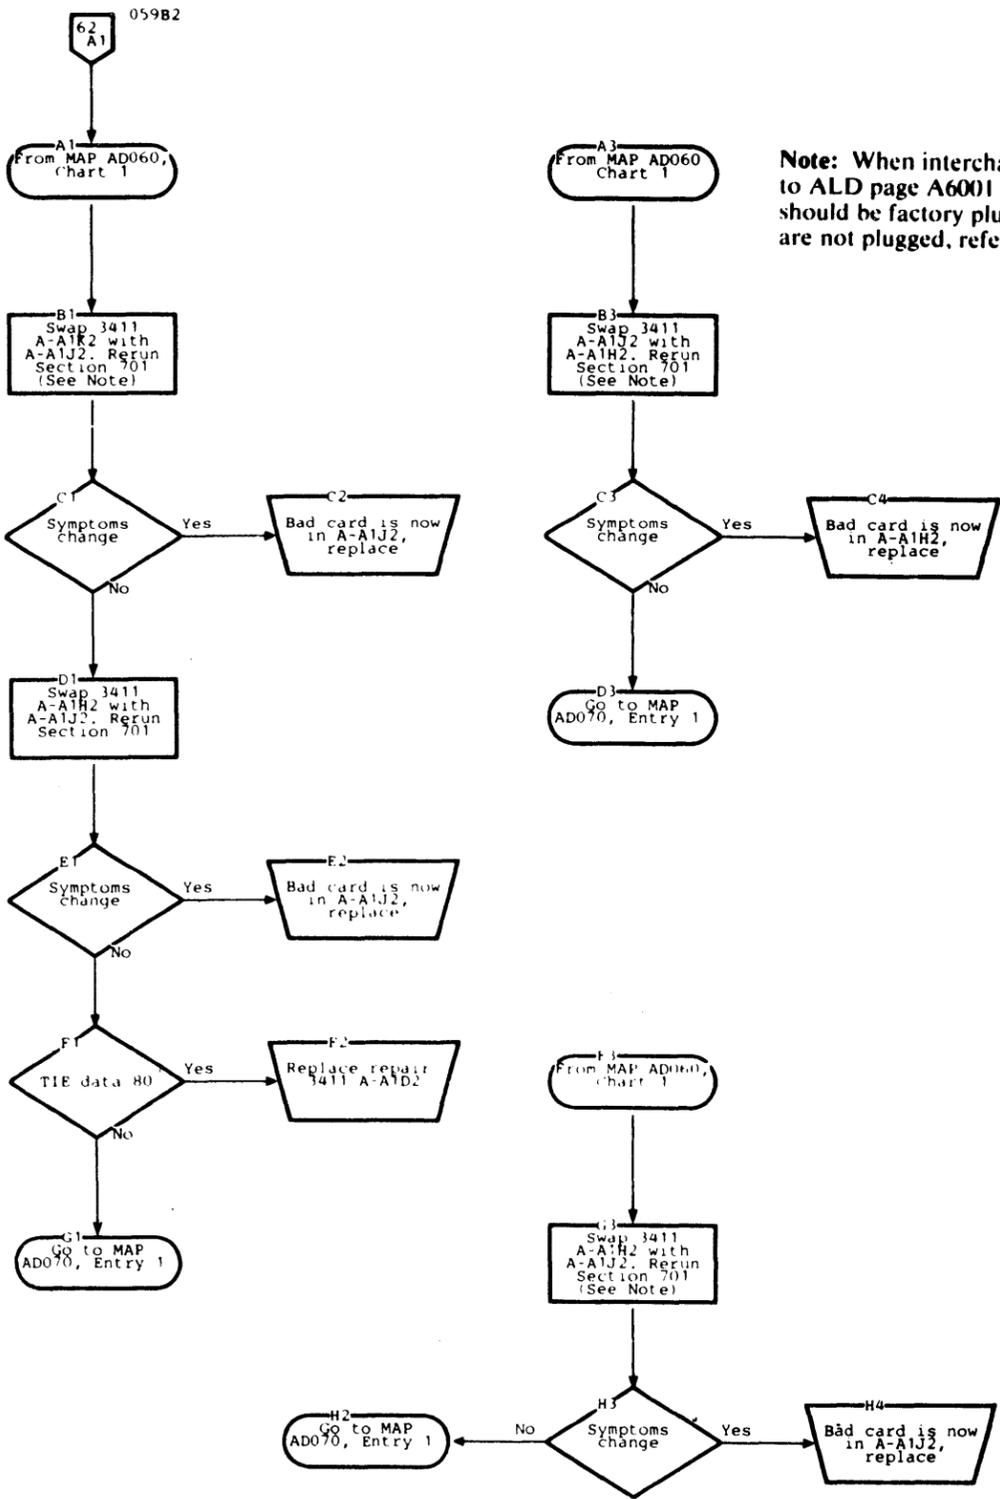
701 Halt 21 Analysis

Note: When interchanging A-A1H2, A-A1J2, and A-A1K2, refer to ALD page A6001 for plugging instructions. All three cards should be factory plugged, as position "K" is model sensitive. If they are not plugged, refer to the above ALD page.

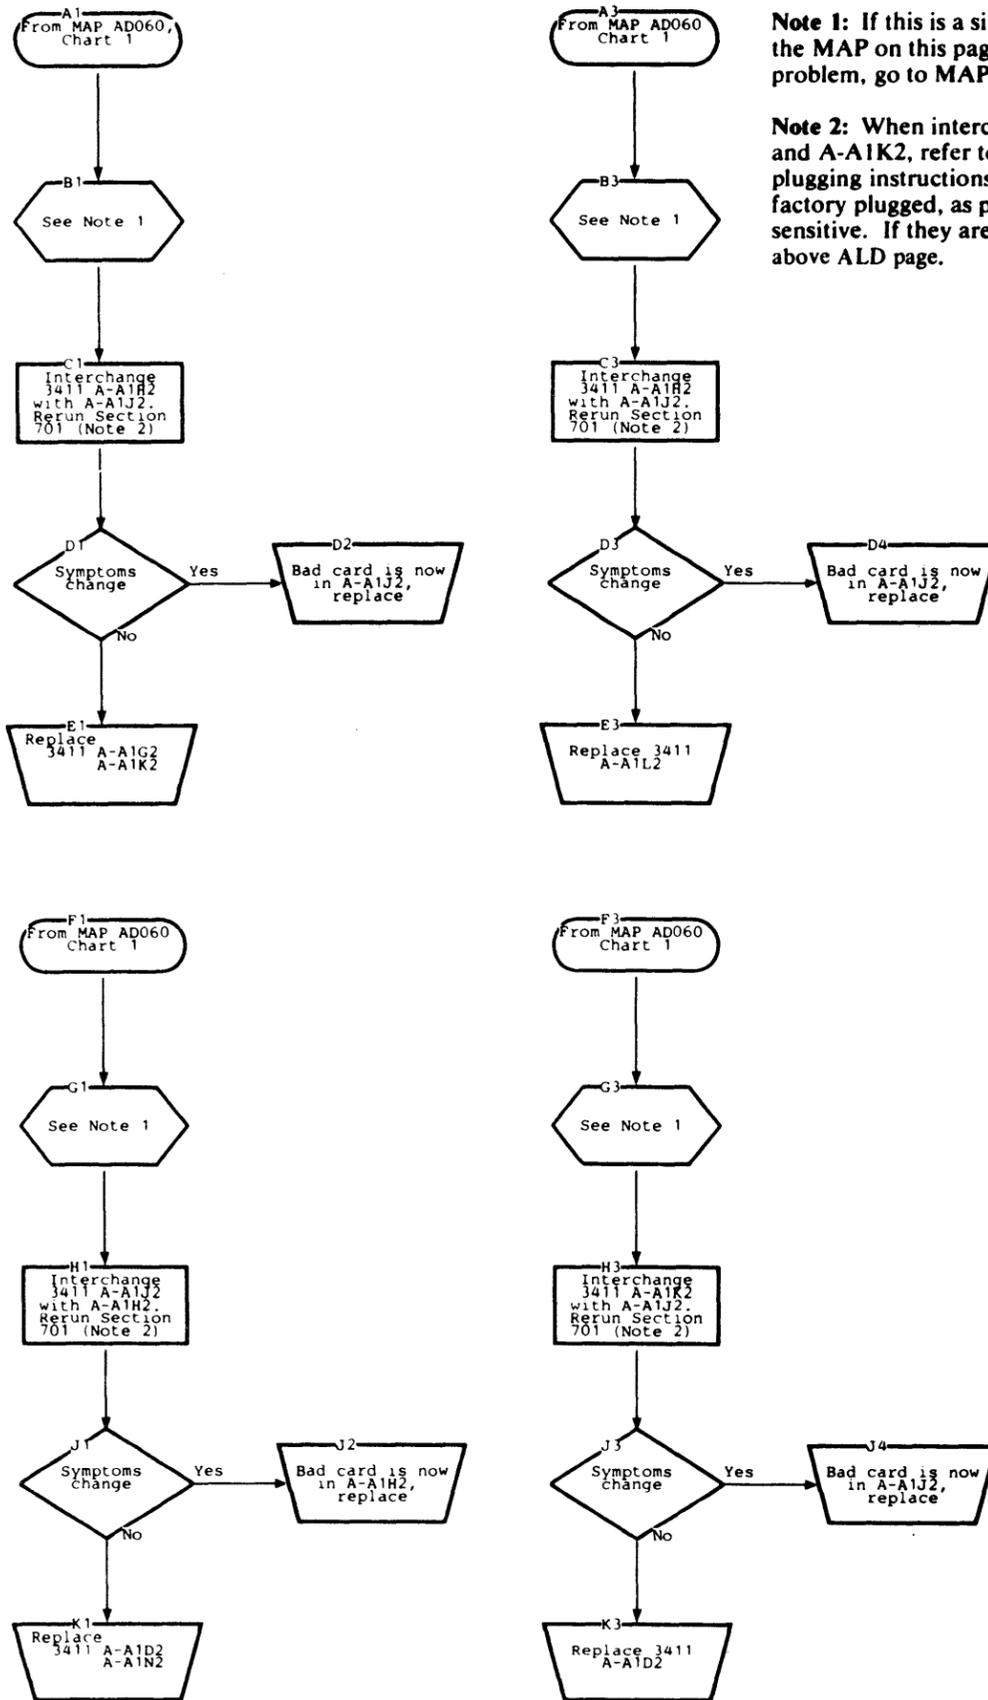
701 Halt 21 Analysis

Note 1: If this is a single tape unit system and the MAP on this page doesn't correct your problem, go to MAP AD070, Entry 1.

Note 2: When interchanging A-A1H2, A-A1J2, and A-A1K2, refer to ALD page A6001 for plugging instructions. All three cards should be factory plugged, as position "K" is model sensitive. If they are not plugged, refer to the above ALD page.

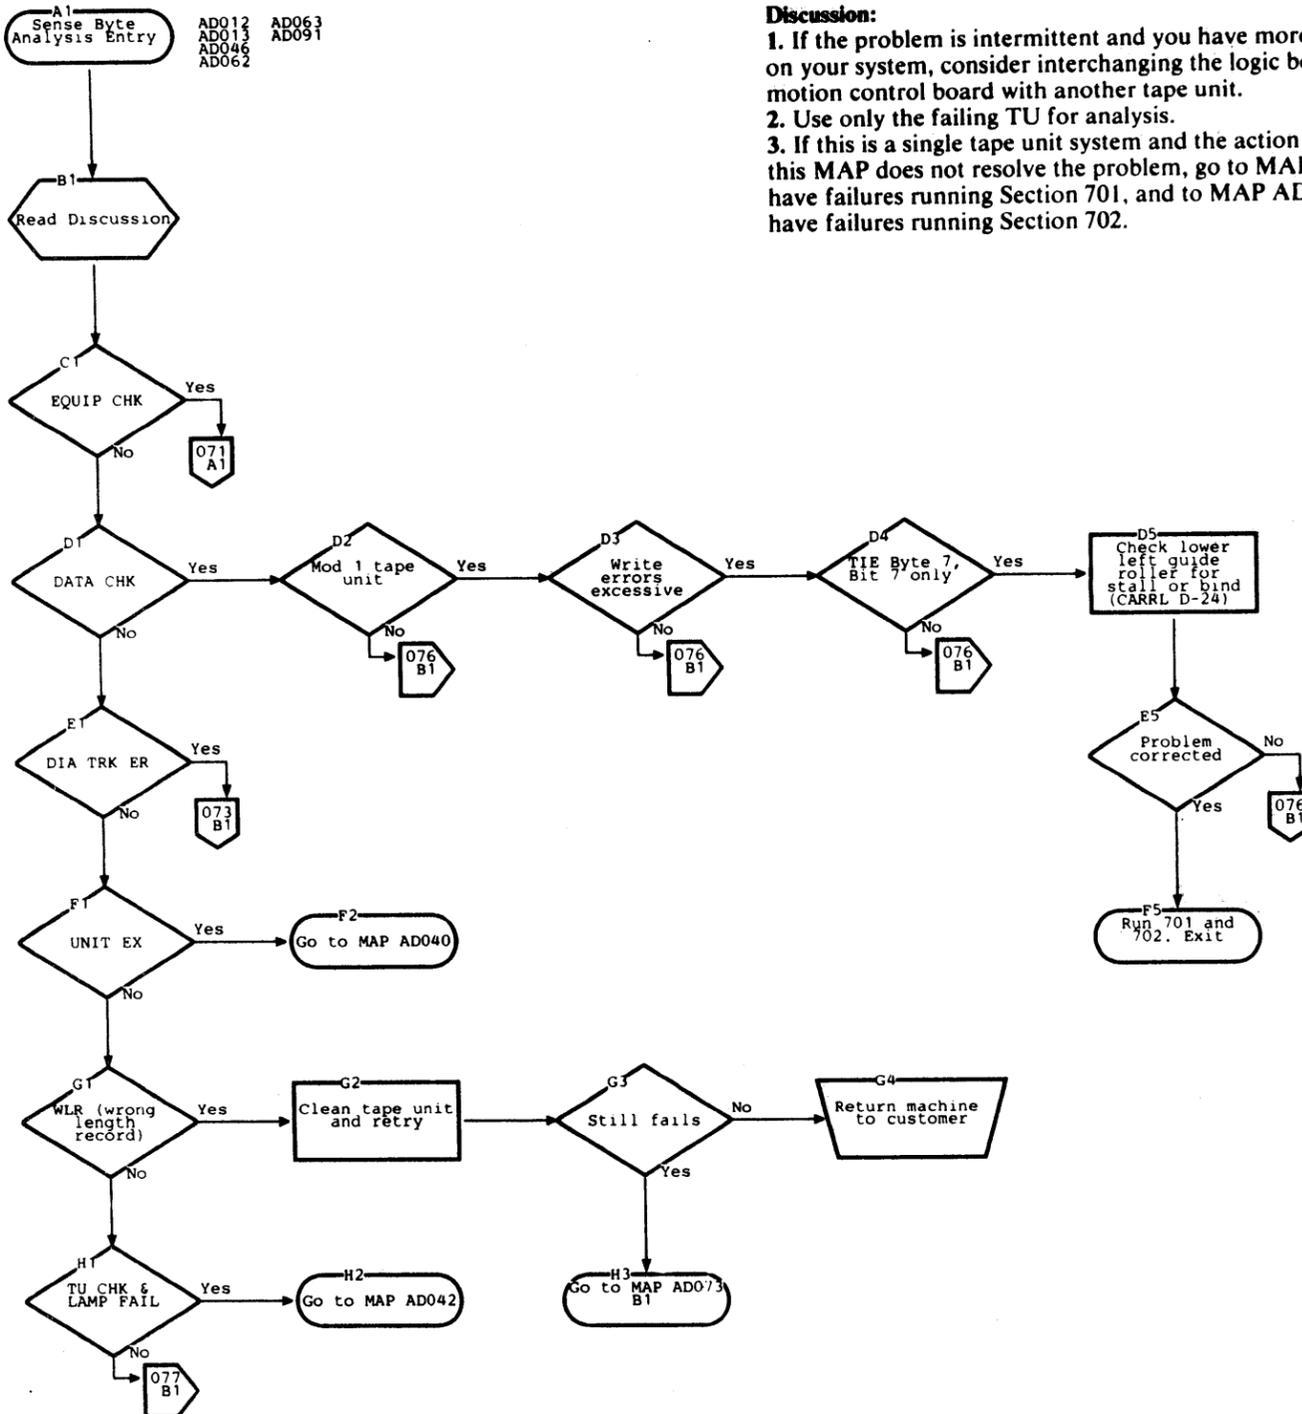
Sense Byte Analysis

1. If the problem is intermittent and you have more than one TU on your system, consider interchanging the logic board and/or motion control board with another tape unit.
2. Use only the failing TU for analysis.
3. If this is a single tape unit system and the action called for by this MAP does not resolve the problem, go to MAP AD010 if you have failures running Section 701, and to MAP AD020 C1 if you have failures running Section 702.

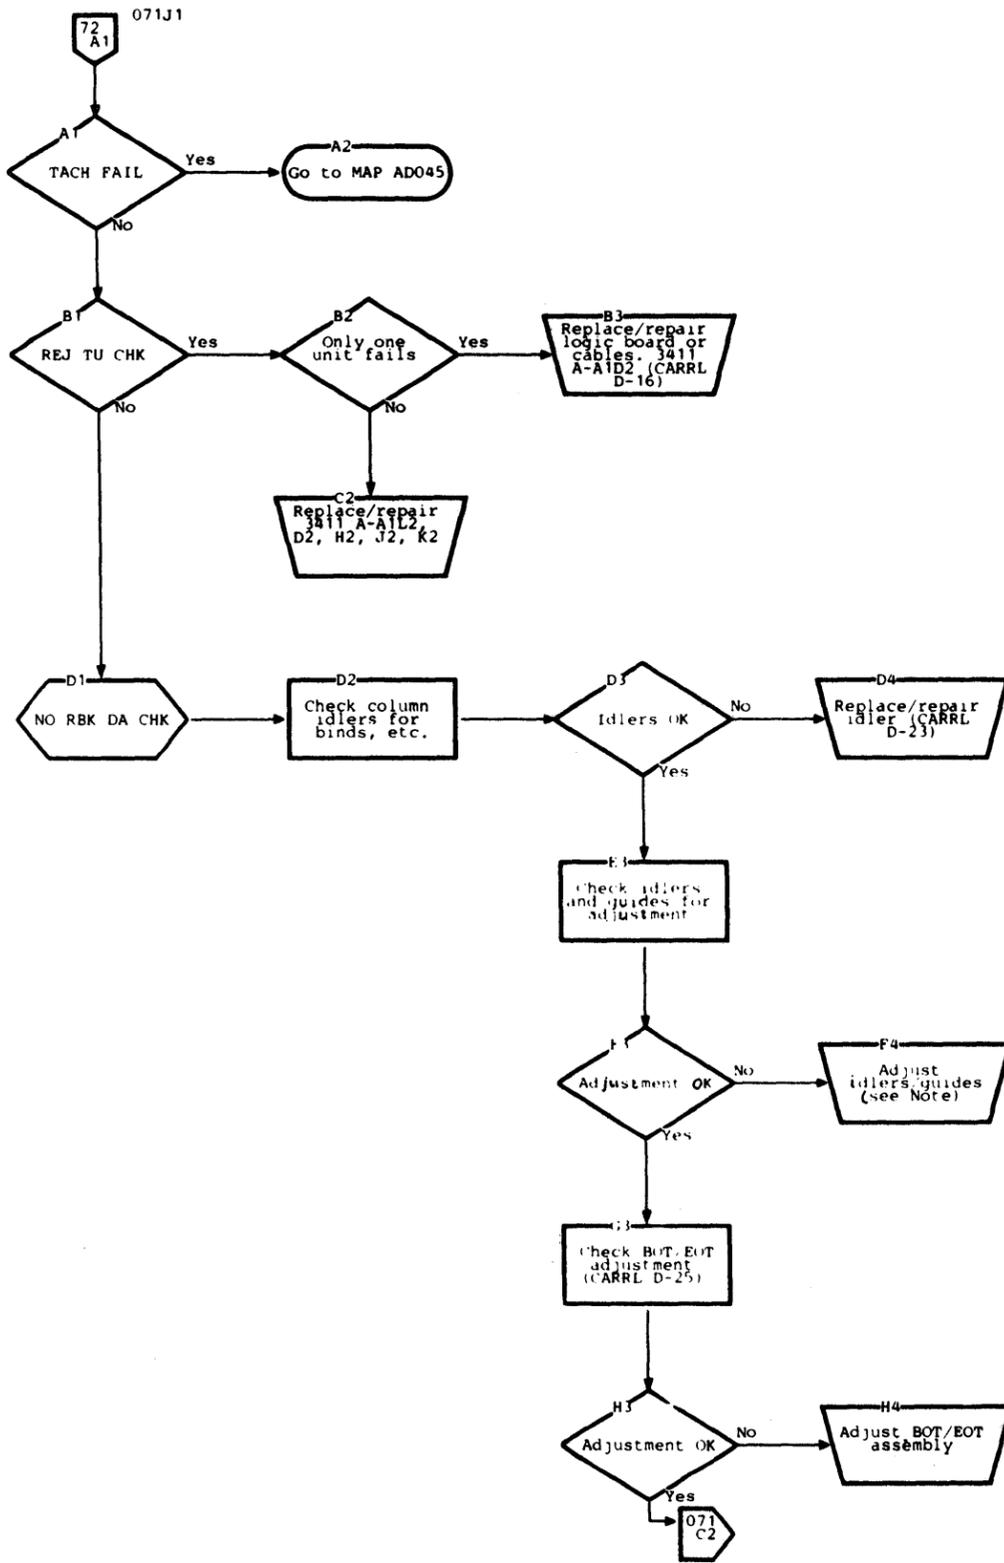
Sense Byte Analysis

Note: If you adjust the guides, you must recheck tracking and skew.

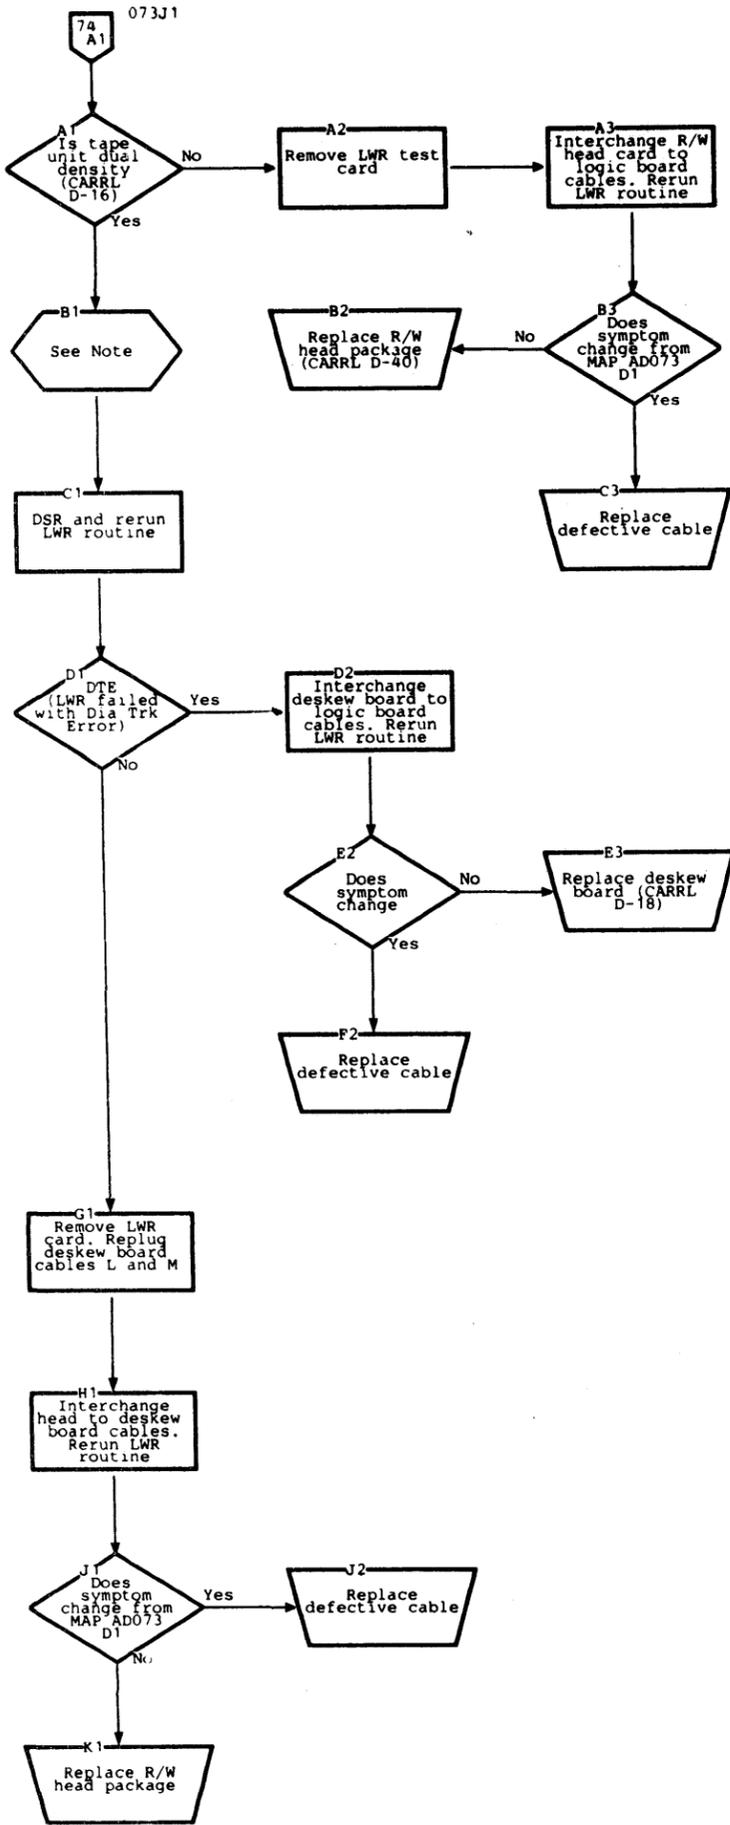
Sense Byte Analysis

Discussion: When interchanging cables, be sure cables are returned to their original positions after the analysis is completed.

- Note:**
1. Remove the LWR test card from the logic board.
 2. Replug logic board cables L & M.
 3. Unplug deskew board cables L & M (the top two cables).
 4. Plug the LWR test card into these two sockets.

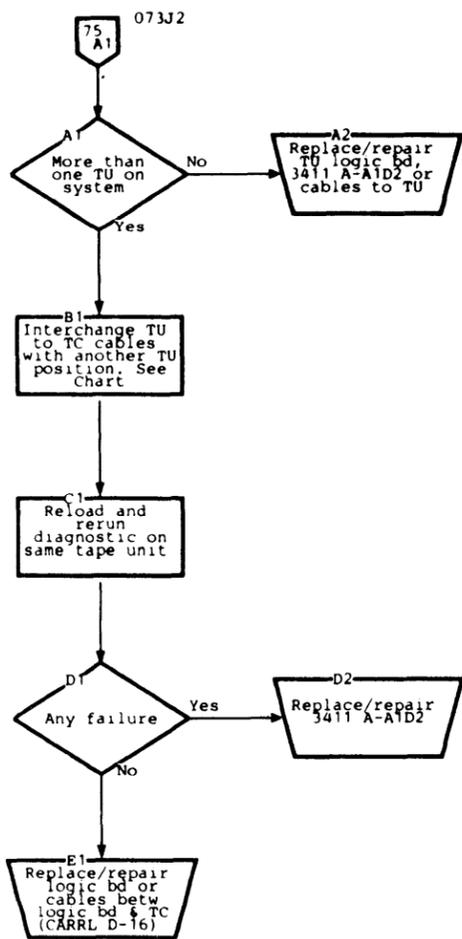
Sense Byte Analysis

CHART		
TAPE UNIT POSITION FOR:	TAPE CONTROL CABLES	
	TO TC	FROM TC
TU 60	A-A1C2	A-A1D2
TU 68	A-A1C3	A-A1D3
TU 70	A-A1C4	A-A1D4
TU 78	A-A1C5	A-A1D5

Example:
Failure on tape unit 60
Move cable at C2 to C3
Move cable at D2 to D3

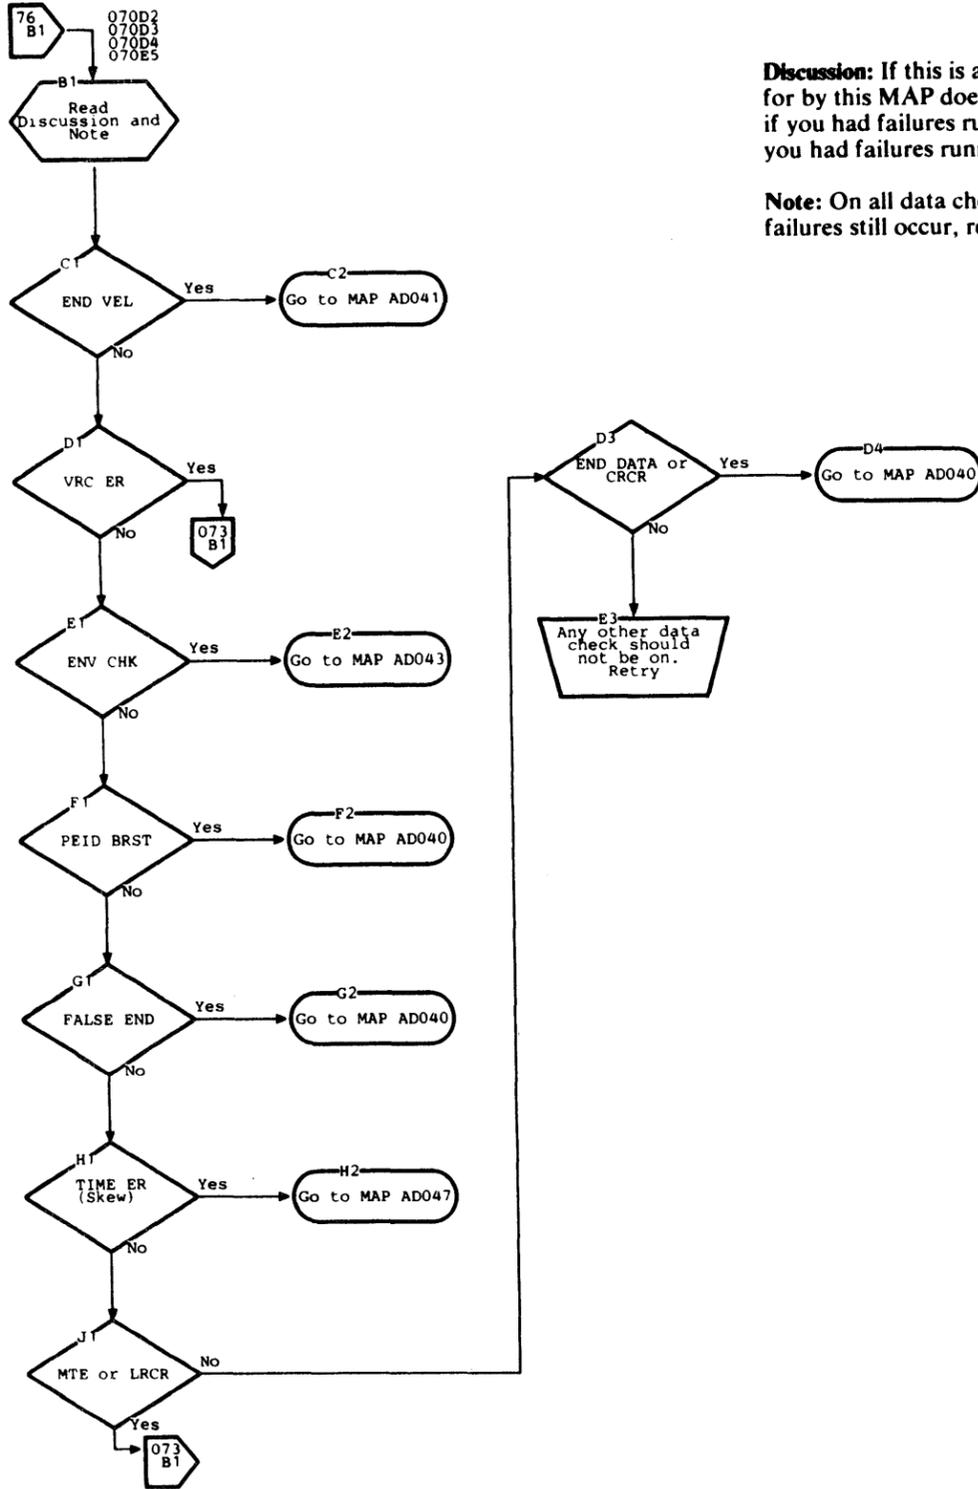
Sense Byte Analysis

Discussion: If this is a single tape unit system and the action called for by this MAP does not resolve the problem, go to MAP AD010 if you had failures running Section 701 and to MAP AD020 C1 if you had failures running Section 702.

Note: On all data checks, clean the failing tape unit and retry. If failures still occur, retry operation with a different reel of tape.

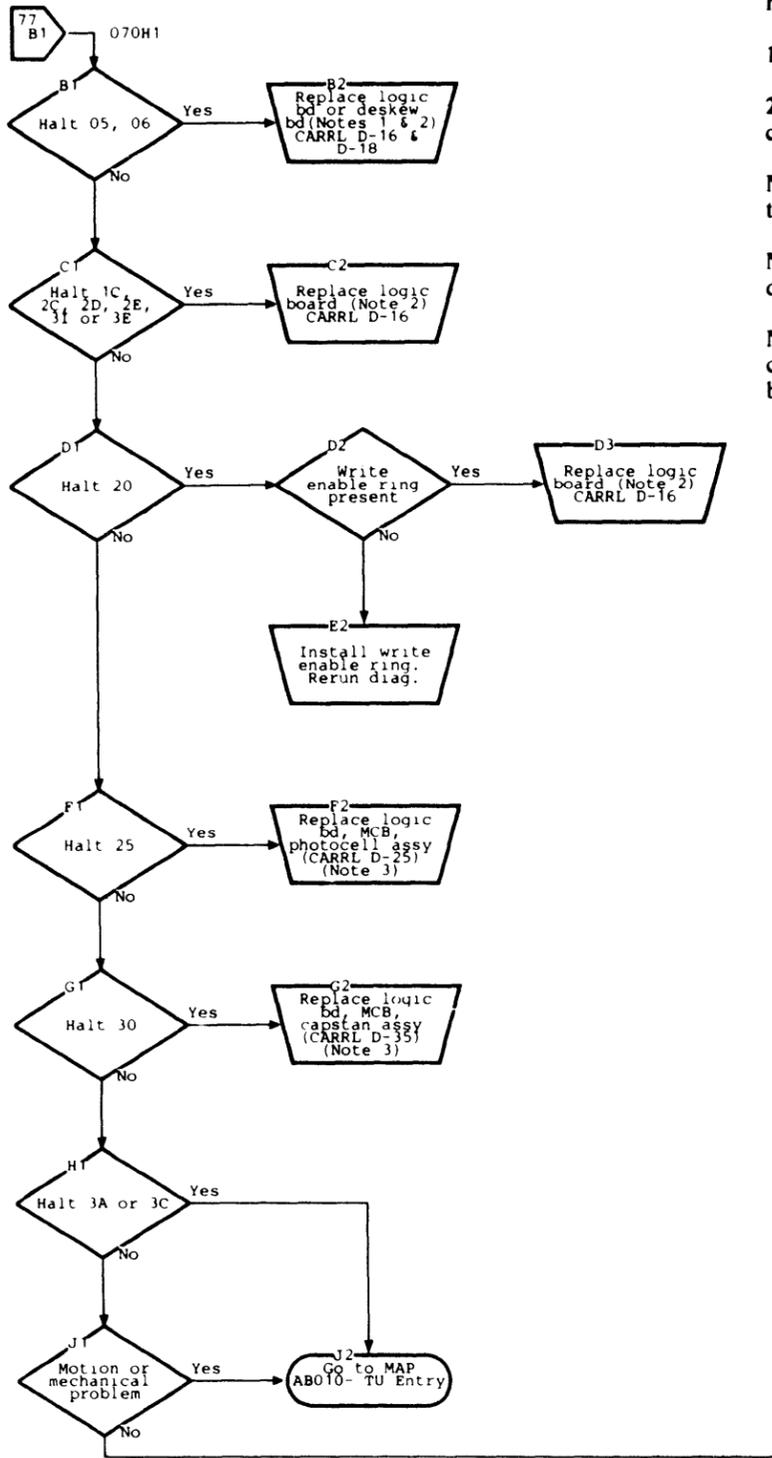
Sense Byte Analysis

Discussion: If this is a single unit tape system and the action called for by this MAP does not resolve the problem, go to MAP AD010 if you have failures with Section 701 and to MAP AD020 C1 if you have failures with Section 702.

1. When interchanging FRUs, be sure their E/C levels are the same.
2. When interchanging logic boards, be sure jumpers are plugged correctly.

Note 2: Reseat cables from logic board to read/write head card, deskew board, motion control board, and tape control.

Note 3: Interchange logic board (CARRL D-16) and motion control board (CARRL D-19) with logic board and motion control board from another tape unit if available, and rerun diagnostic.

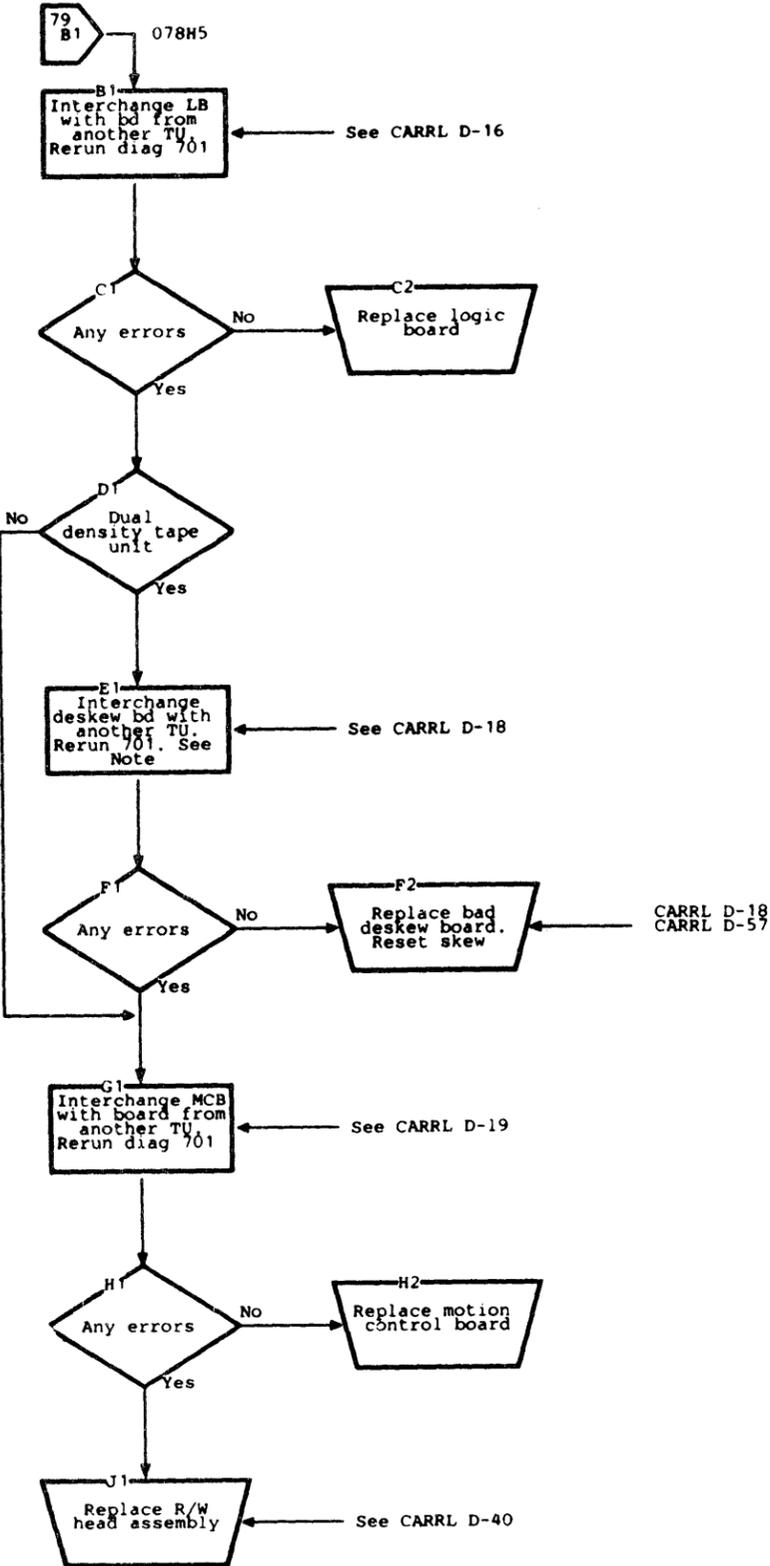
1. When interchanging FRUs, be sure their E/C levels are the same.
2. When interchanging logic boards, be sure jumpers are plugged correctly.
3. A model 3 logic board cannot be interchanged with a model 1 or 2 logic board.

Note: If this is a single tape unit subsystem, transfer the deskew board cables in locations J, K, L, and M to the corresponding locations on the tape unit logic board. You must temporarily remove the short crossover cables in positions L and M to do this. Run the tape unit in PE Mode. If no errors occur, the deskew board is bad or read detention cards H, J, or K are bad. If errors still occur, continue from block D1 on this MAP.

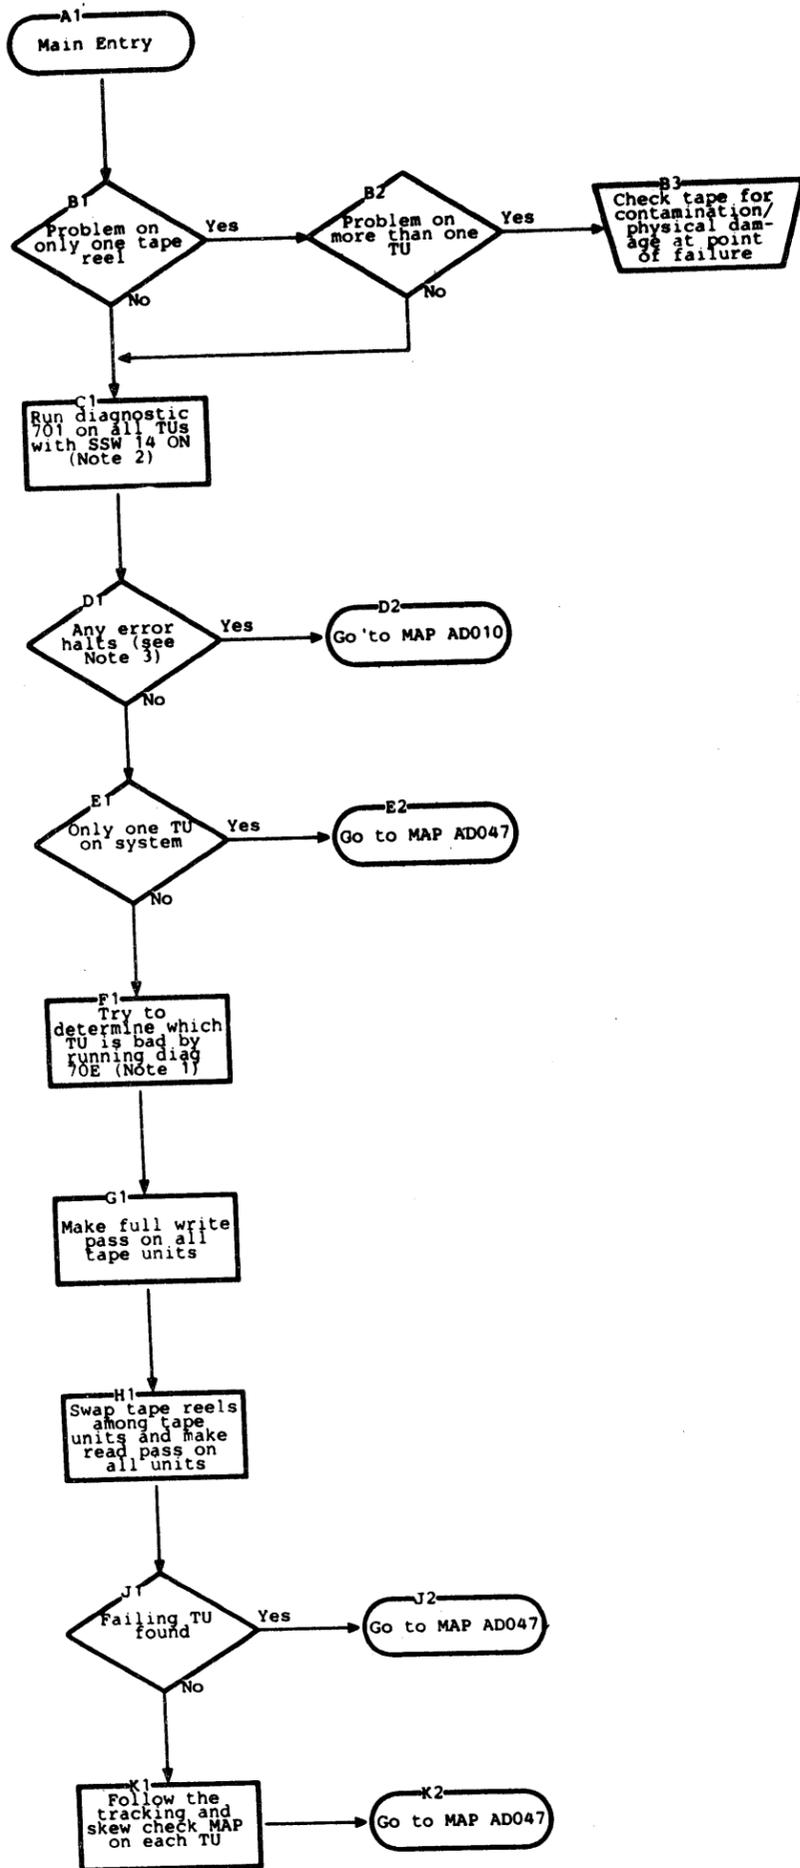
Interchangeability

Note 2: Common problems on dual density tape units which cause interchange problems are failure to mode set properly, failure to erase LP area, or incompatible skew setting between tape units.

Note 3: If subsystem is a Mod 1, check for excessive write errors on TIE Data track 7. If excessive and predominantly this track, go to CARRL D-24 and check the lower left guide roller for stall or bind.

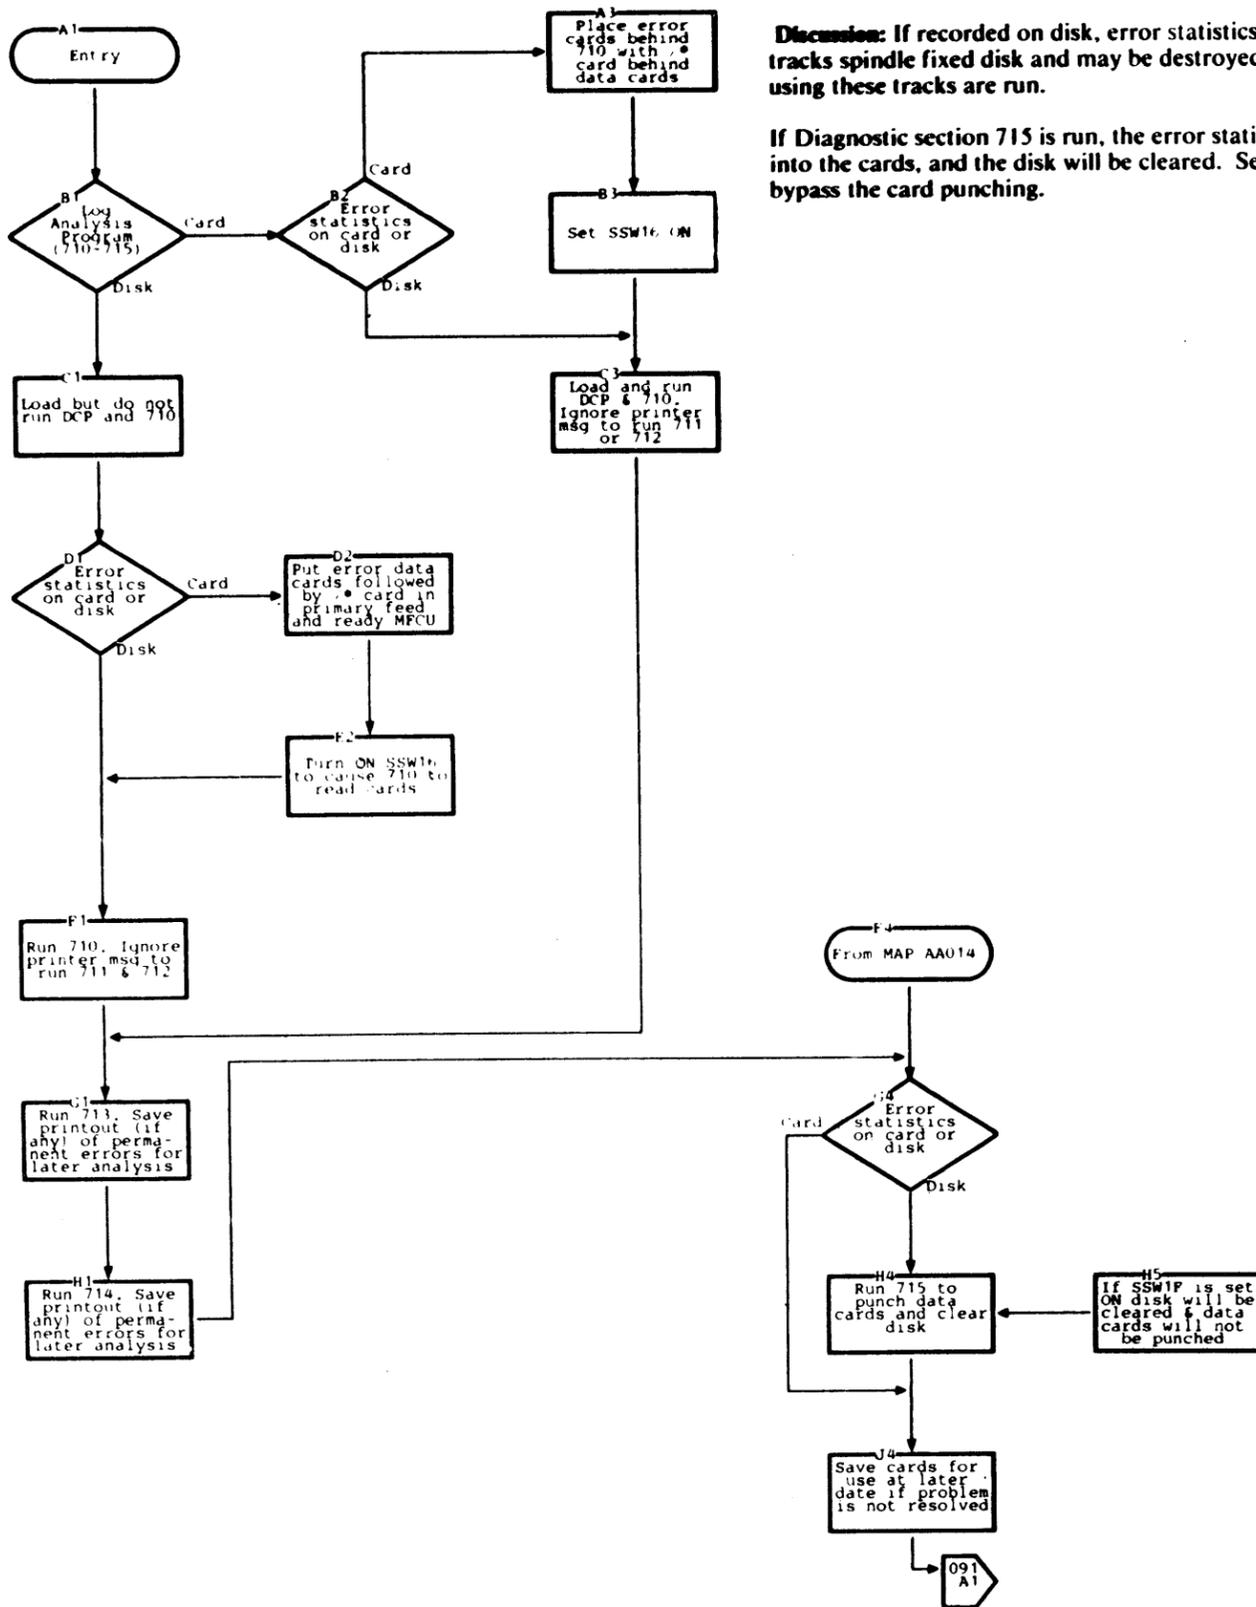
Tape Error Statistics Analysis

Discussion: If recorded on disk, error statistics reside on the CE tracks spindle fixed disk and may be destroyed if any programs using these tracks are run.

If Diagnostic section 715 is run, the error statistics will be punched into the cards, and the disk will be cleared. Set SSWIF ON to bypass the card punching.

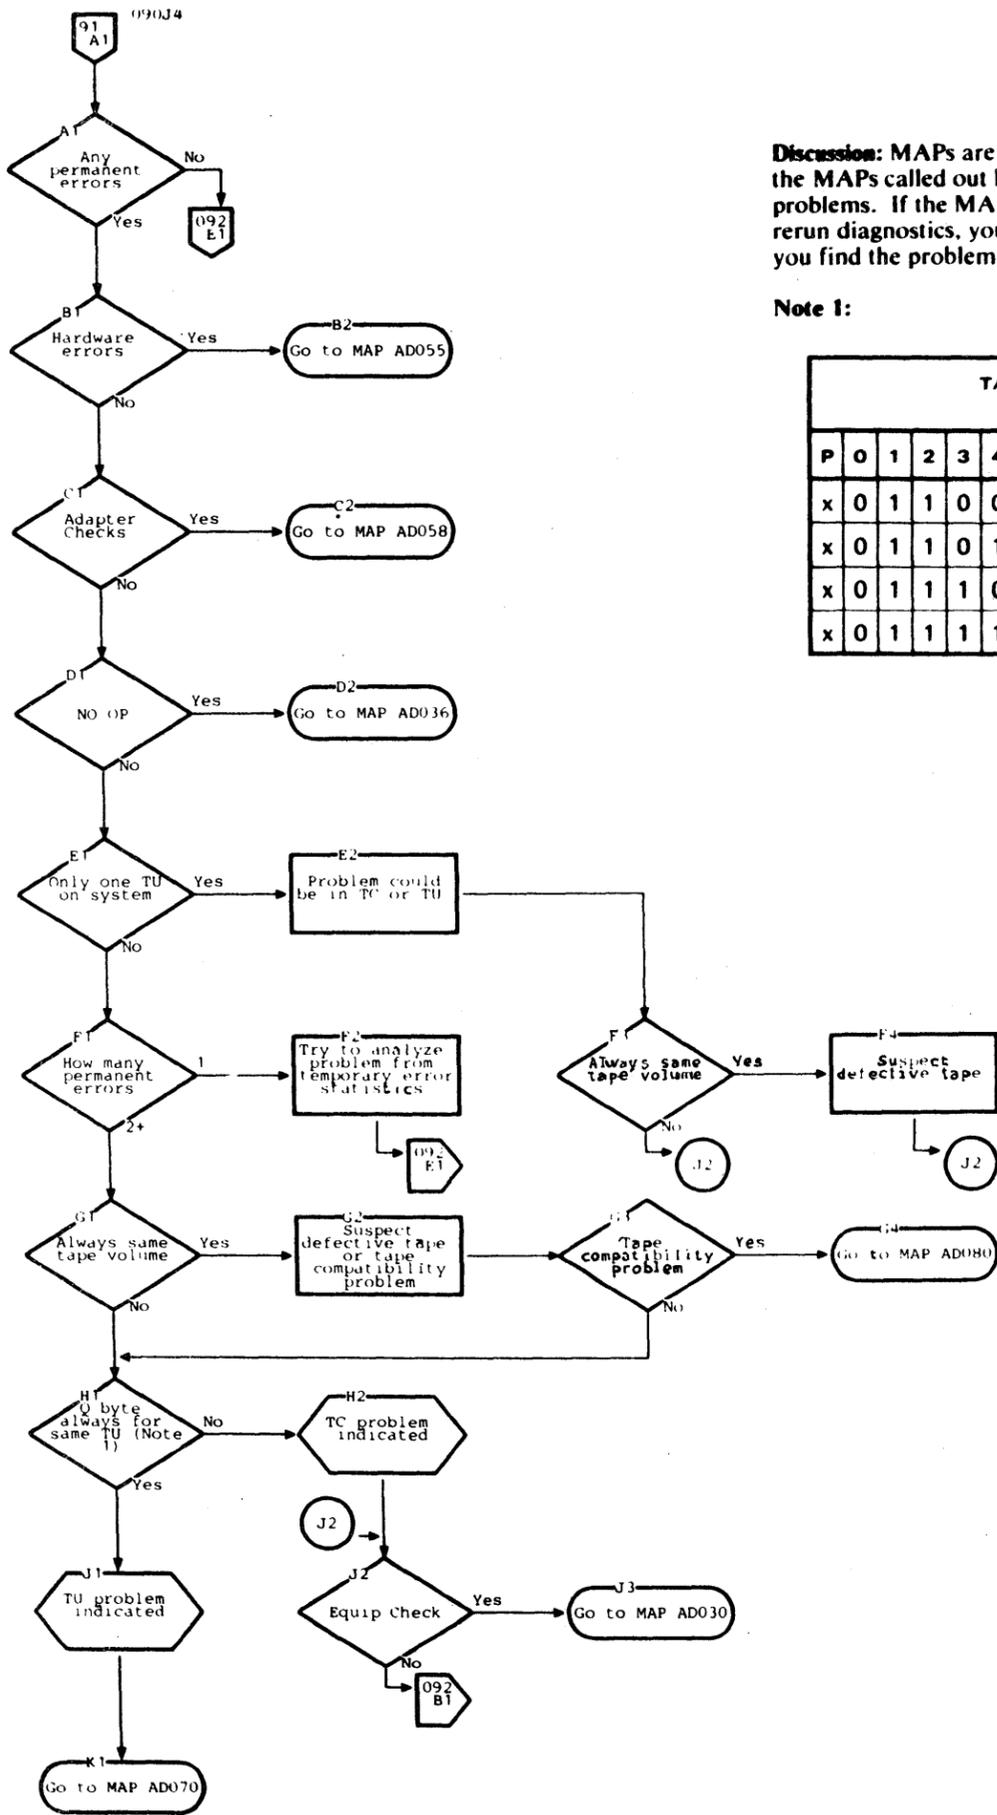
Tape Error Statistics Analysis

Discussion: MAPs are designed to detect solid failures; however, the MAPs called out here may be helpful in analyzing intermittent problems. If the MAPs ask you to swap cables, FRUs, etc., and rerun diagnostics, you must decide whether such action will help you find the problem. Ignore instructions to try log analysis.

TAPE UNIT ADDRESSING Q BYTE									
P	0	1	2	3	4	5	6	7	TAPE UNIT
x	0	1	1	0	0	x	x	x	0
x	0	1	1	0	1	x	x	x	1
x	0	1	1	1	0	x	x	x	2
x	0	1	1	1	1	x	x	x	3
