IBM 3420/3803

Magnetic Tape Subsystem

Reference Guide

This reference guide was created by FE Service Planning to assist in maintaining the 3420/3803 magnetic tape subsystem. It is divided into sections for each major topic. Reference is made to the 3420/3803 MLM, and other publications that are required for effective 3420/3803 maintenance.

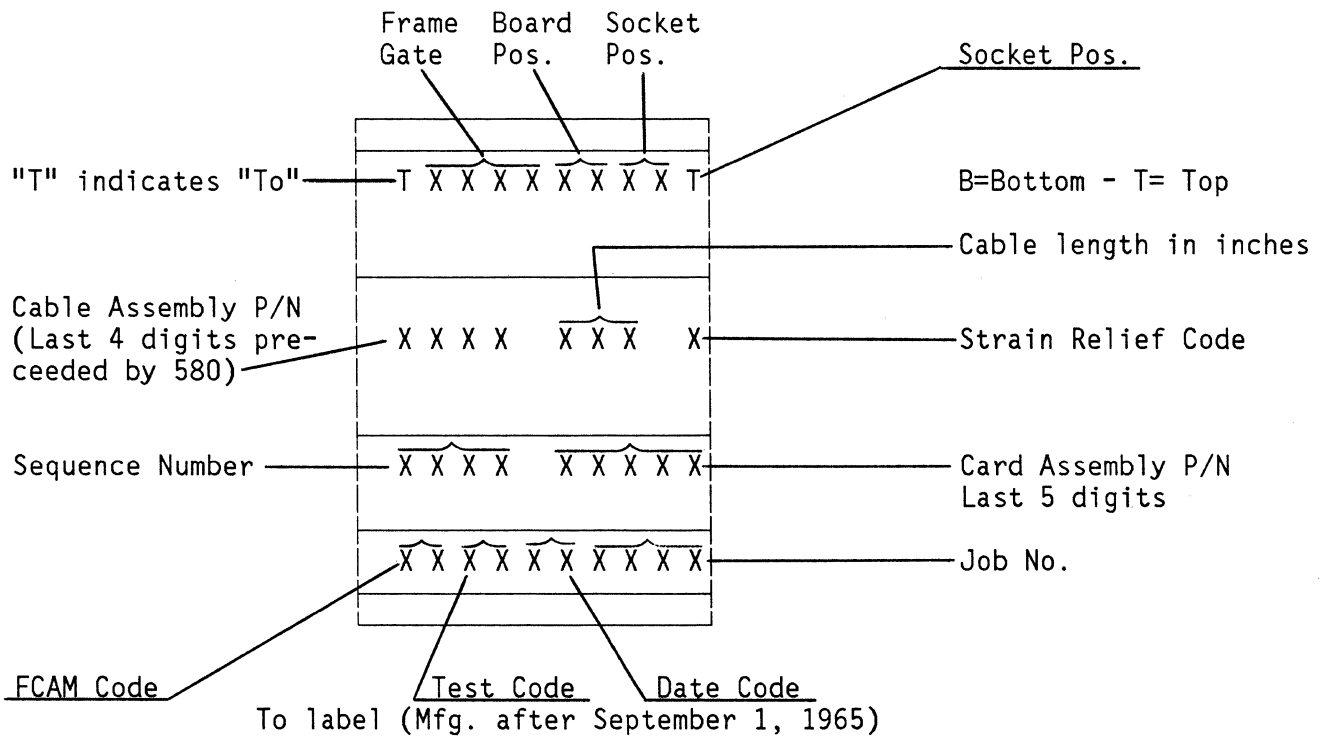
LABEL IDENTIFICATION

The following figures describe the information contained on the labels.

Note: The Test Code and/or Date Code may be missing on cables made between September 1, 1965 and September 18, 1968.

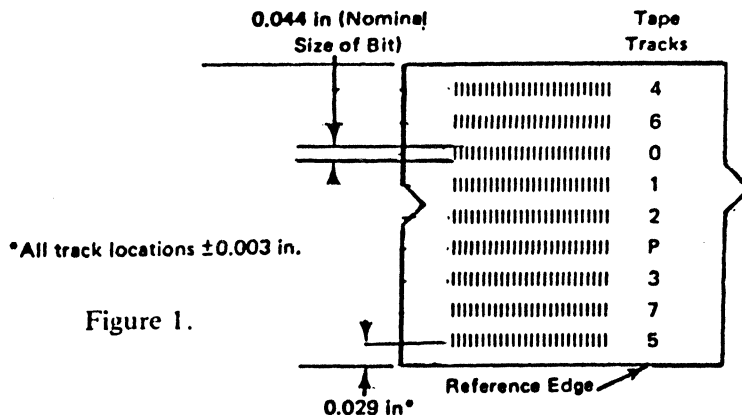
Figure 1.

*Note: The engineering specification for track spacing measures the distance from the front edge to the center of the "5"-track. (See Figure 1). This distance is $.029 + .003$. If the media width and the head tracks are within tolerance, then the outside tracks will appear equidistant.

BIT POSITIONING - The two outside tracks, tracks 4 and 5 in PE, should be equidistant* from their respective edges. Improper bit positioning can be caused by capstan tracking and/or improper skew plate alignment. Failures can appear as system abends and tape mark recognition problems. Replacing the R/W head will appear to fix the problem for a very short time.
