SmartZone 3.4.1 (Adding Support for the C110 Access Point)

Release Notes

Part Number: 800-71414-001 Rev A
Published: 02 December 2016

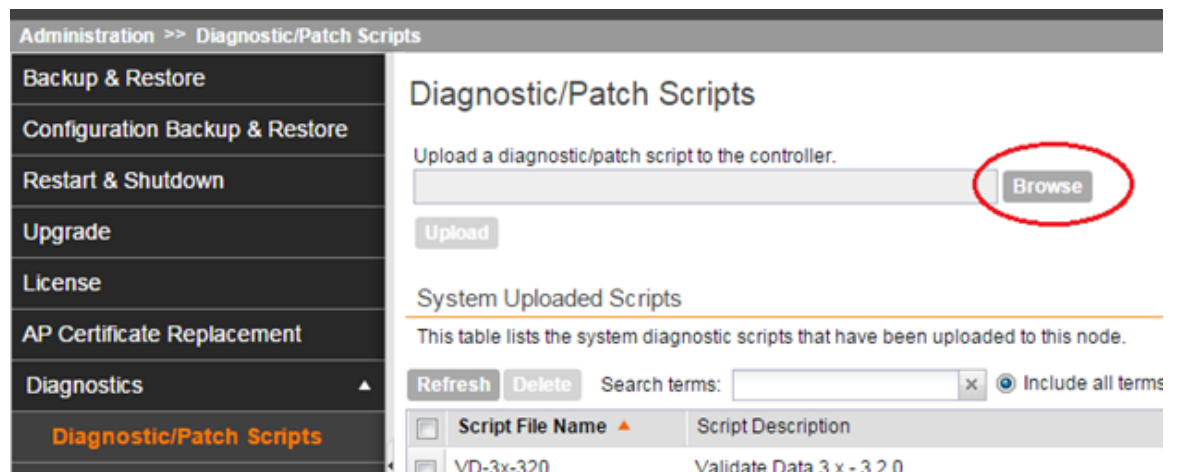
1. Download the KSP file from the Support website to your computer. The file name is `extendPrecheckTimeout_0.ksp`.
2. Log on to the controller, and then go to **Administration > Diagnostics > Diagnostic/Patch Scripts**.
3. Click **Browse**, and select the KSP file that you downloaded.

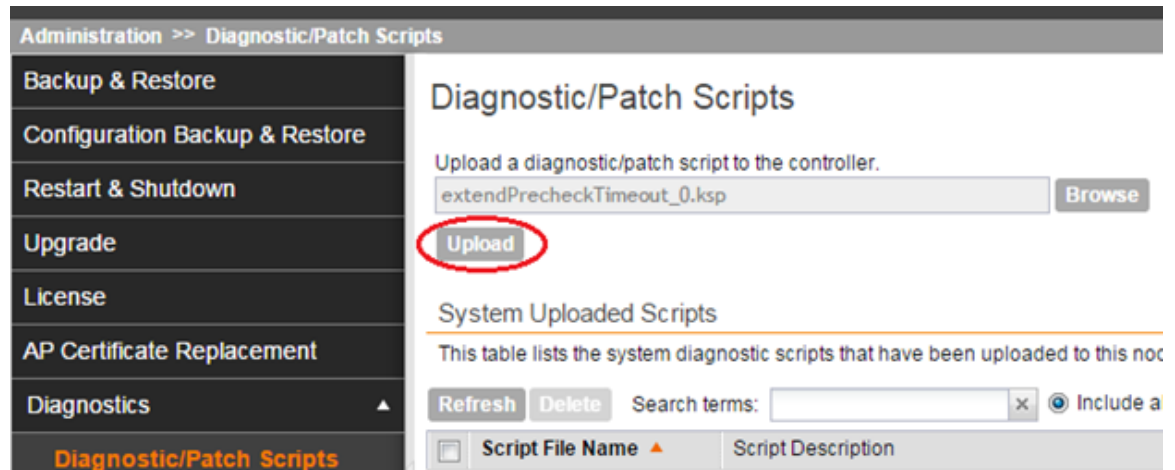
4. Click **Upload**.

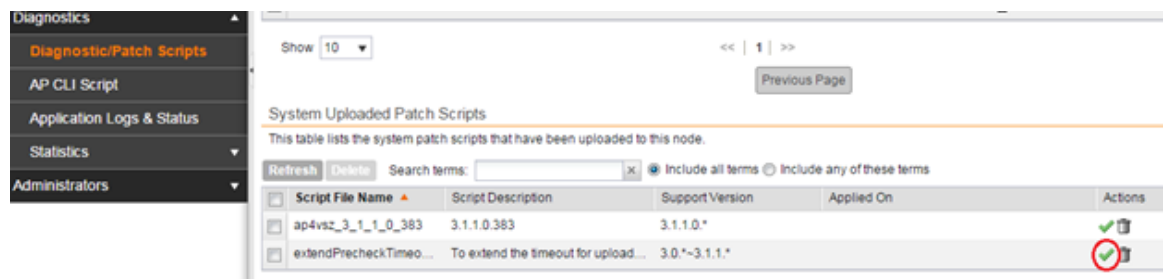
- When the KSP file appears on the list of available scripts, click the green check mark under the **Actions** column.

After the KSP script is applied, upload the upgrade image file, and then upgrade the controller to this release.
