TECHNICOLOR COM1000/COM2000 System Training Workshop

COM1000/COM2000 System Troubleshooting

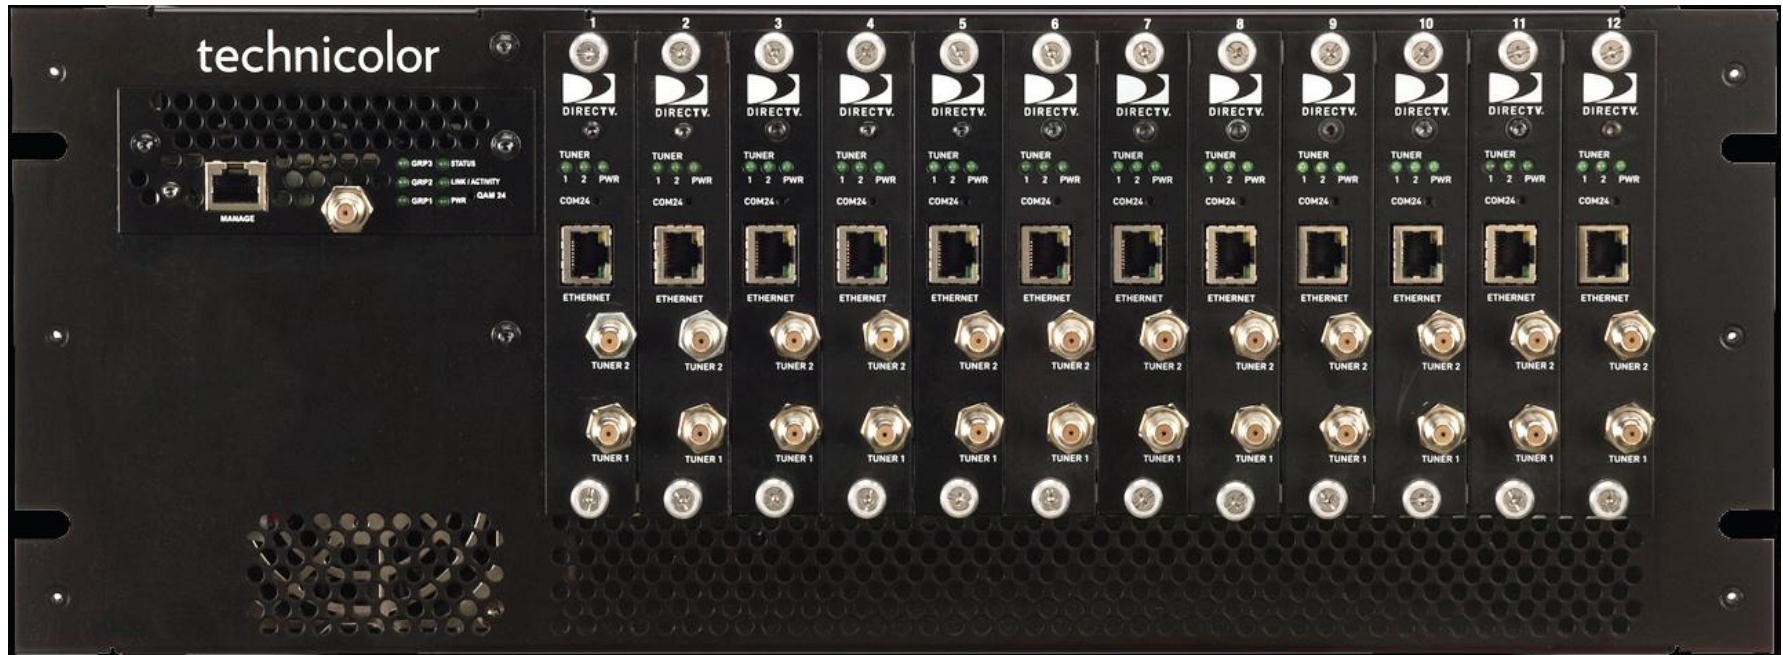
Front view of a COM200 chassis with 12 COM24 cards and a QAM6 installed

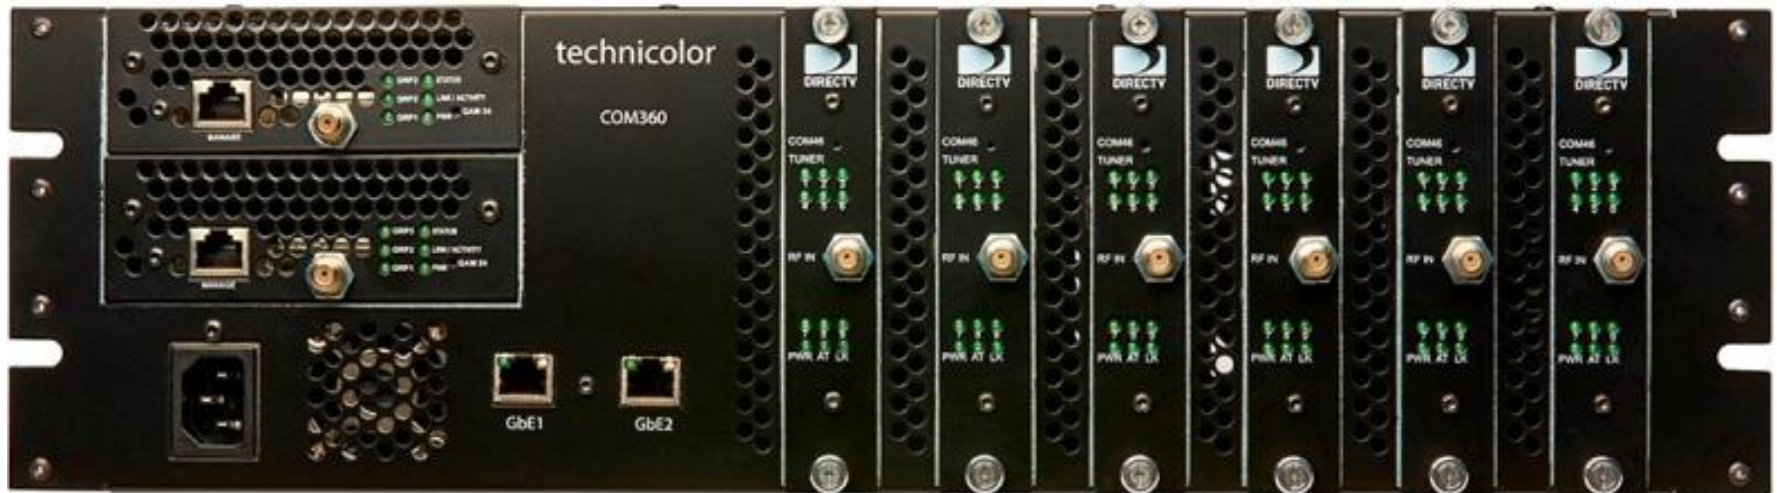
Front view of a COM360 with six COM46 Cards and QAMS

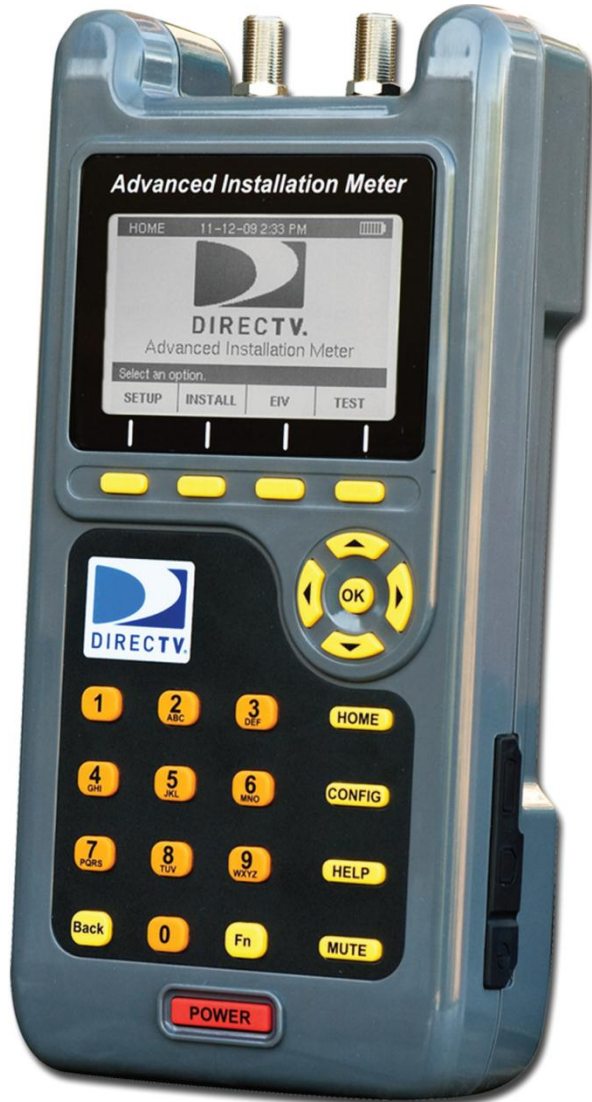
The DIRECTV Advanced Installation Meter

This device should be used for all aspects of the installation, verification and troubleshooting of the RF plant

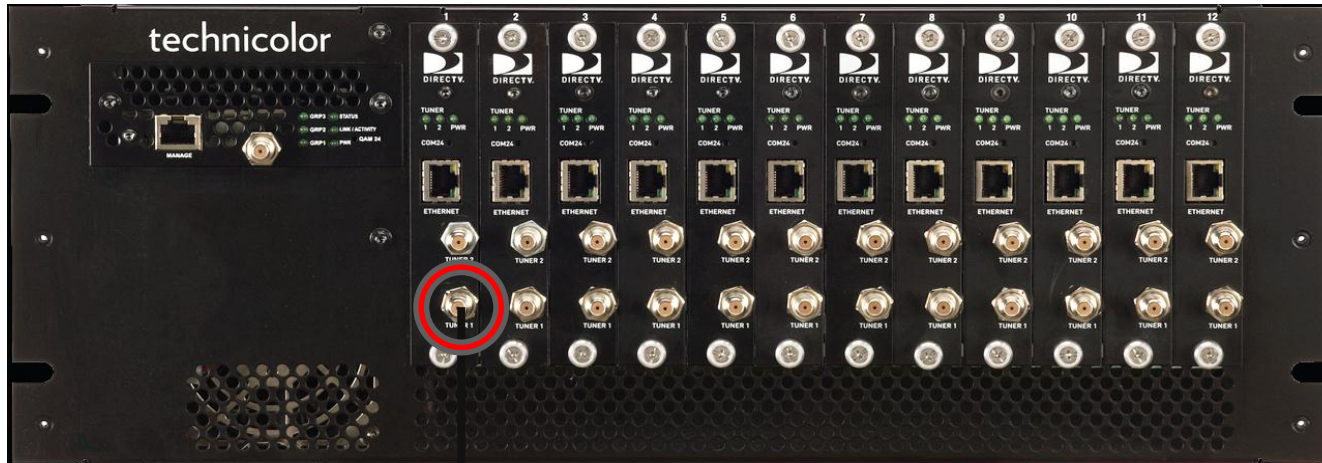
SWM or Multi-Switch RF
Conditioning and
Distribution

When testing the RF plant connect the AIM to F connector on the cable feeding the COM24 card.

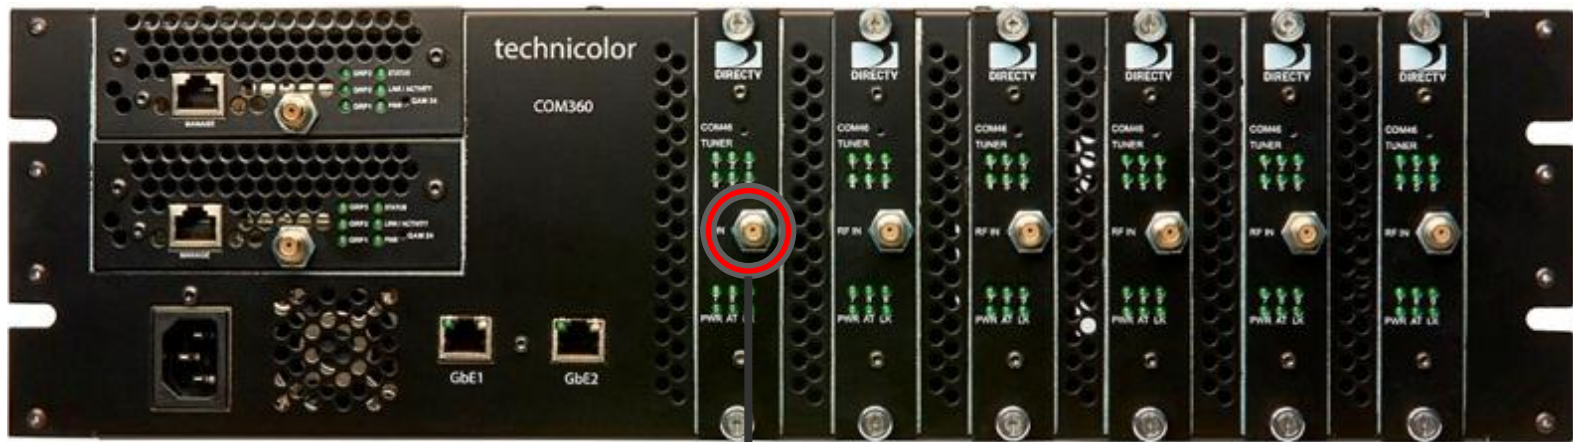
SWM RF Conditioning
and Distribution

When testing the RF plant connect the AIM to F connector on the cable feeding the COM46 card.

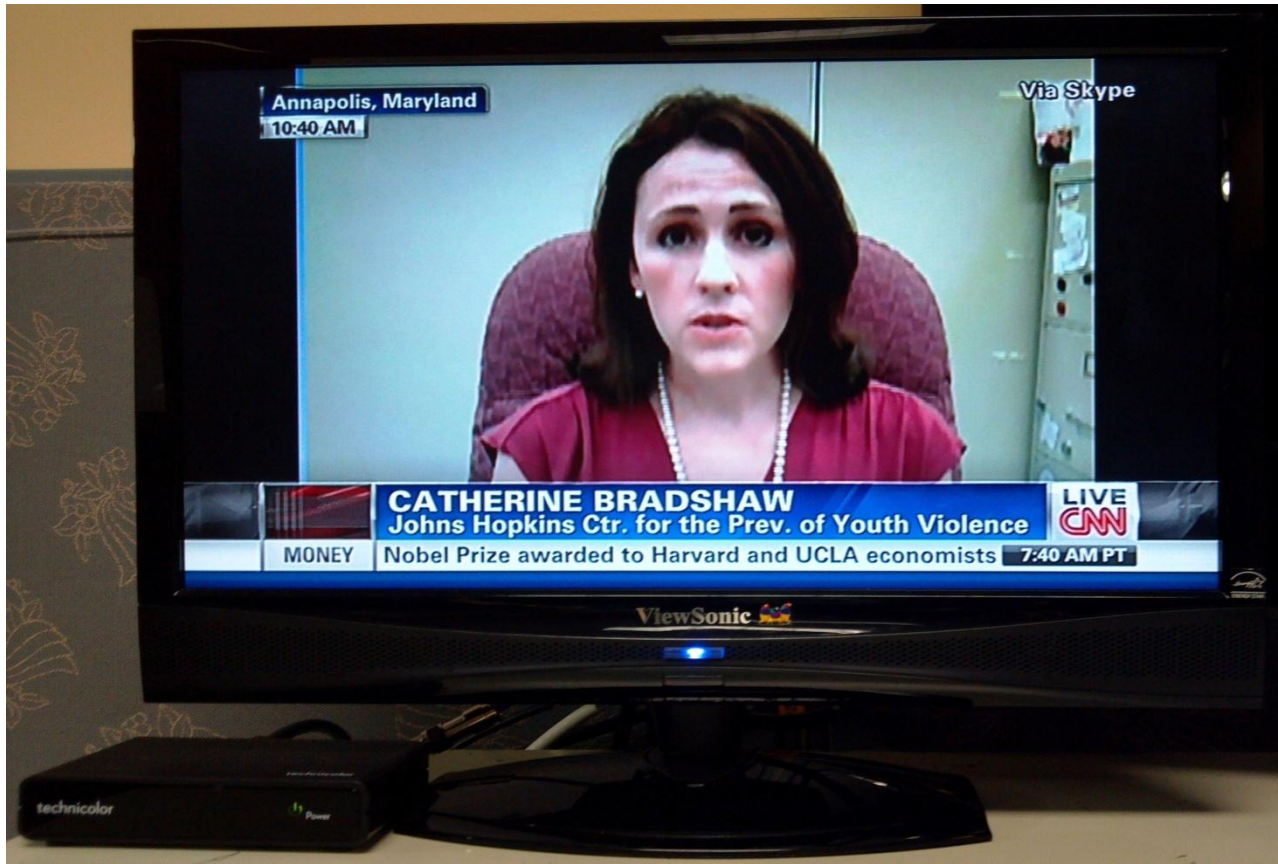
A DCI401MCS and a small television monitor with RF and HDMI inputs make an ideal troubleshooting tool for an RF based distribution network

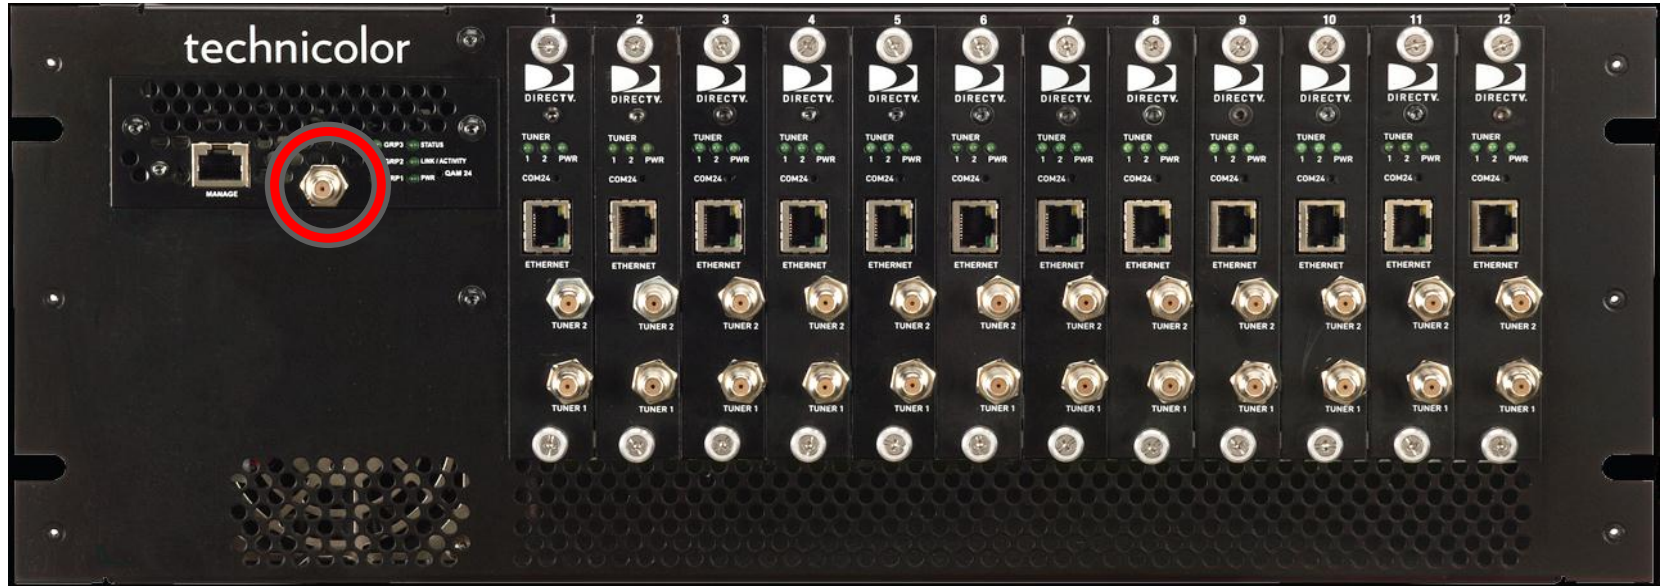
COM200 Chassis

The output of the QAM is checked at the F connector on the front of the QAM module

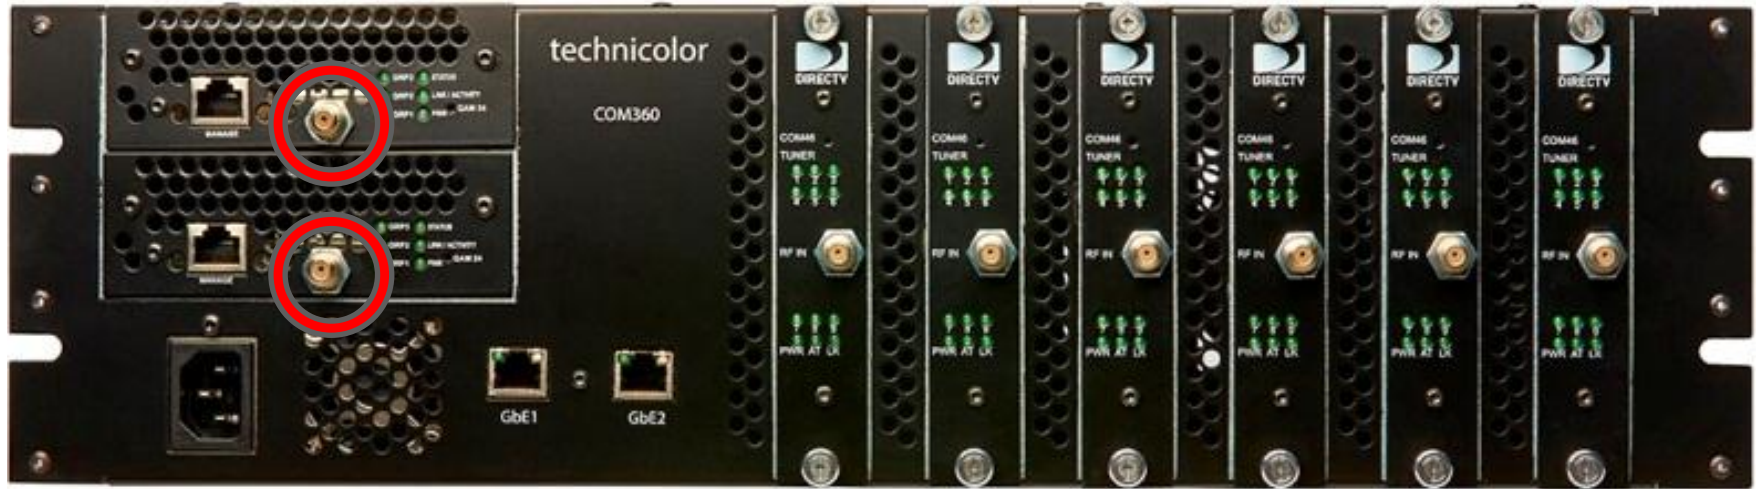
COM360 Chassis

The output of the QAM is checked at the F connector on the front of the QAM module(s)

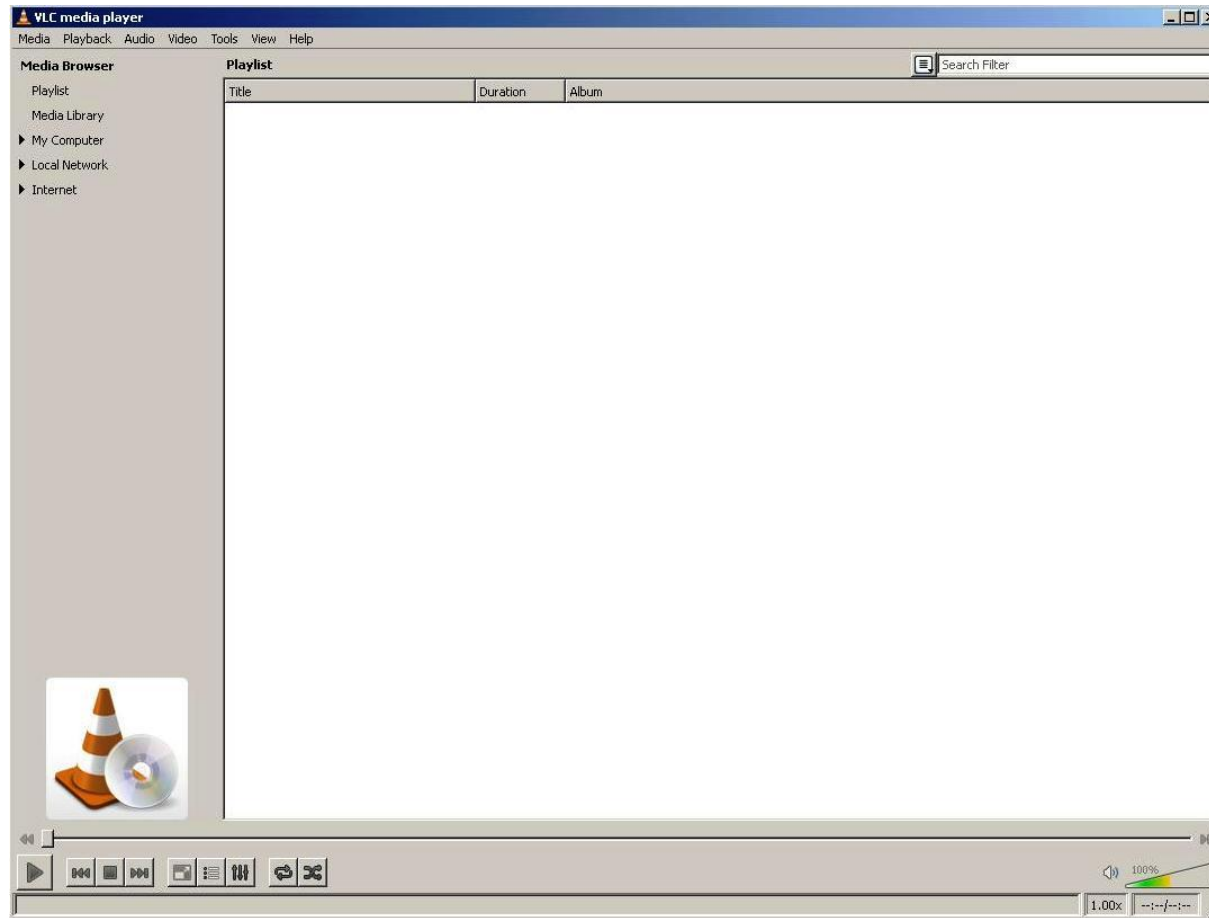
The VLC media player is an excellent tool for verification of an IP stream coming from a COM1000 system

To play a multicast stream with VLC select the Media pull down then select Open Network Stream and enter UDP://@225.0.0.1:123

To play a unicast stream with VLC select the Media pull down then select Open Network Stream and enter UDP://@10.0.0.1:123

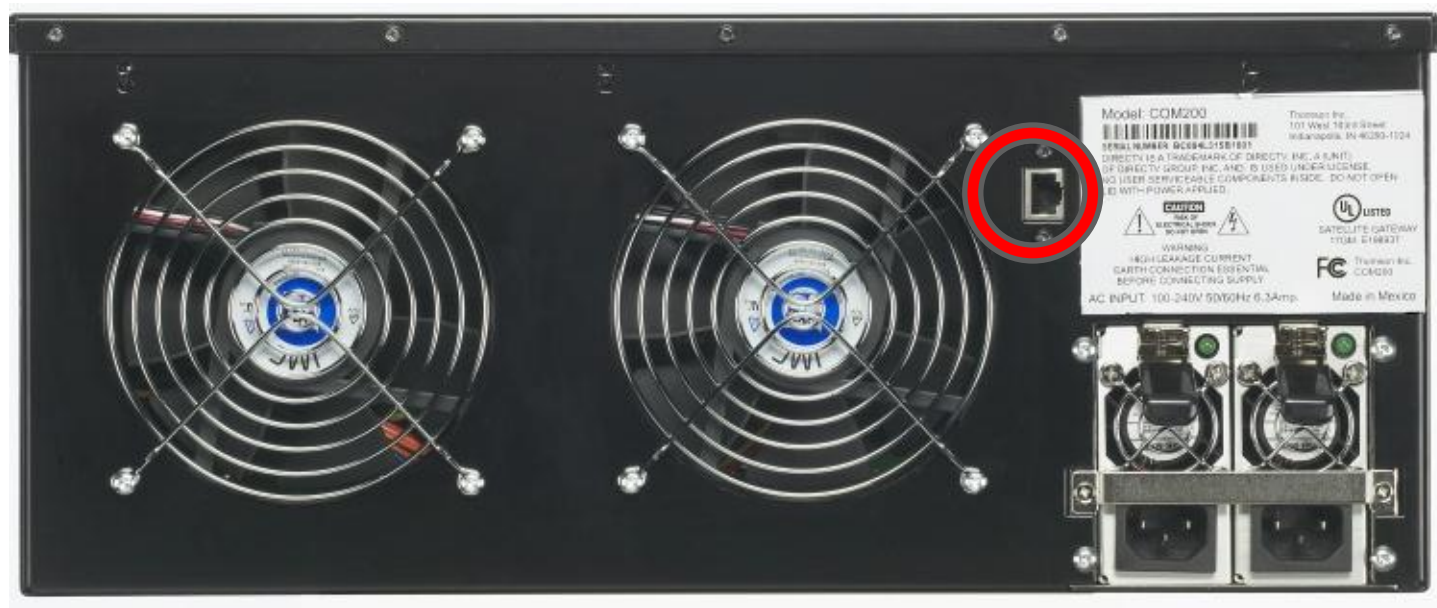
The IP output of the chassis is verified at the Gigabit Ethernet connector located on the rear of the COM200 chassis

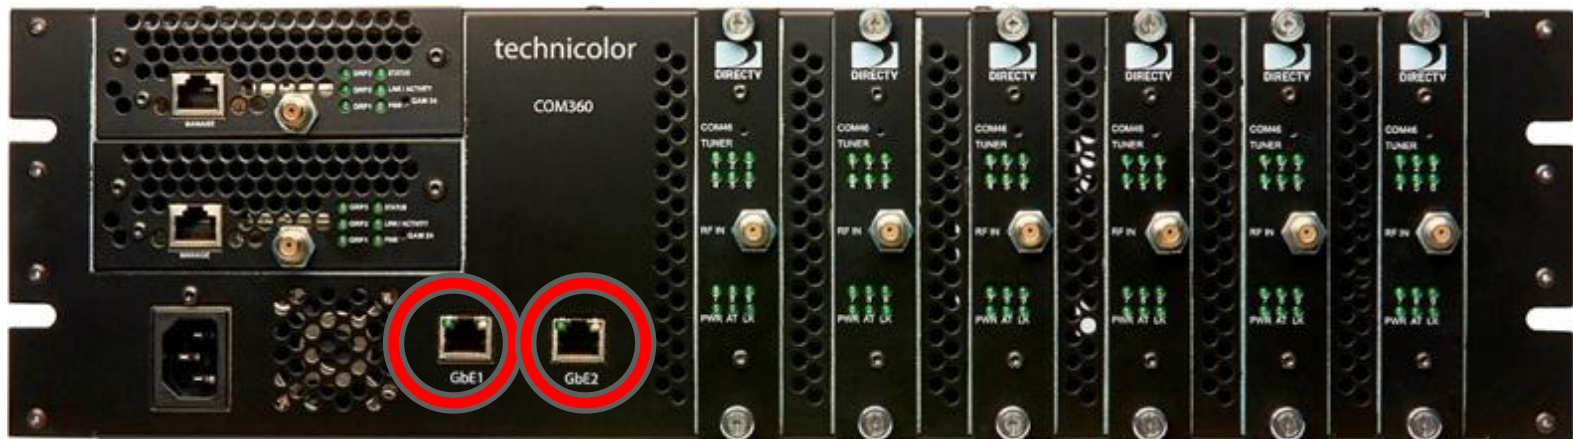
The IP output of the chassis is verified on the Gigabit Ethernet connectors located on the front of the COM360 chassis
