# Entune Audio Head Unit Software Update (Panasonic)

YEAR(S)	MODEL(S)	ADDITIONAL INFORMATION
2018 - 2019	Camry, Camry HV, Sienna

A software update is now available to address these conditions. Follow the Software Update Procedure in this bulletin to update the software.

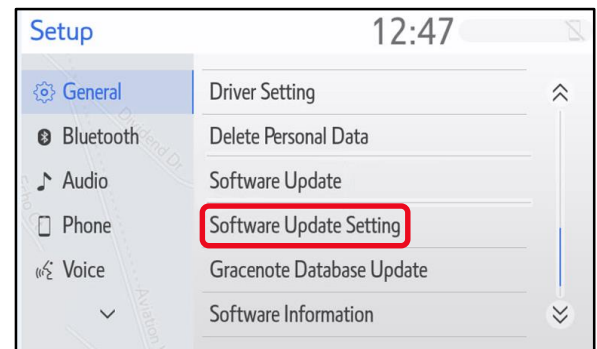
**Figure 3.**

5. Scroll down to Software Update Setting, then turn Automatic Update Check OFF.

7. Perform steps 3 and 4 again.

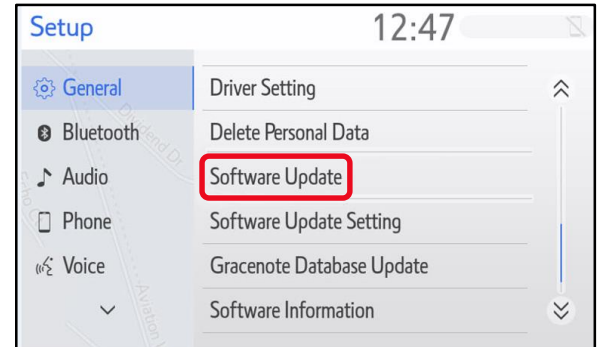
Figure 4.

8. Scroll down to and select Software Update.

22. Perform steps 3, 4, and 8 of the Software Update Procedure to re-enter the Software Update screen.

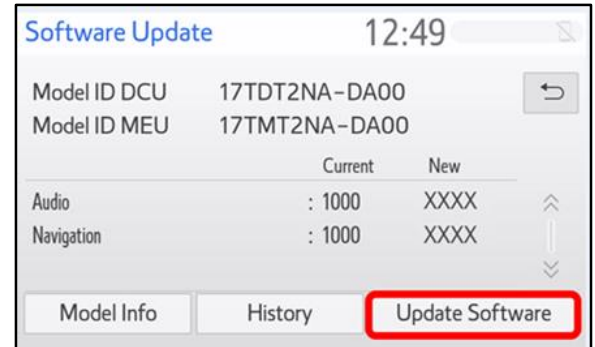
**Figure 7.**

14. Press the Update Software button in the lower right-hand corner.

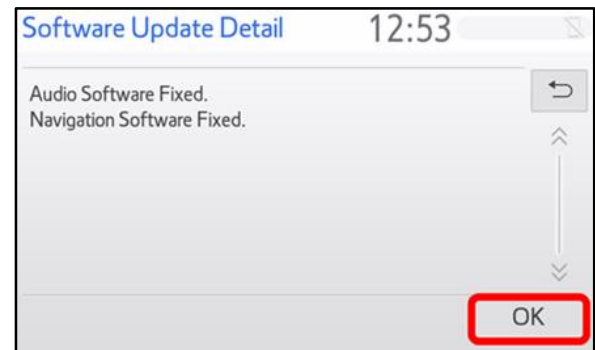
**Figure 8.**

15. Select OK on the Software Update Detail screen.

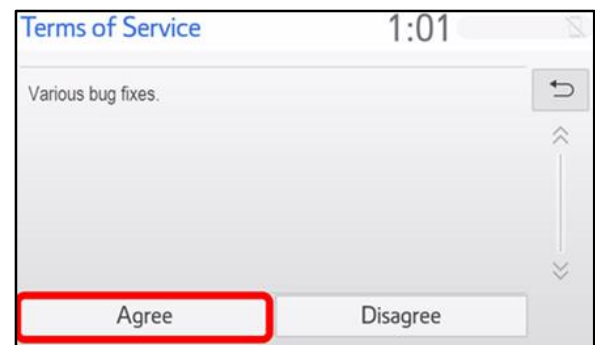
**Figure 9.**

16. Select Agree on the Terms of Service screen.

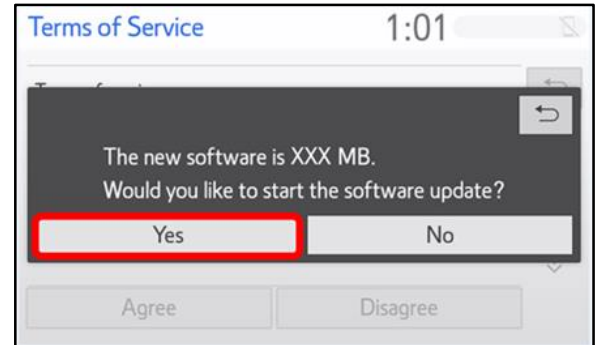
**Figure 10.**

17. Select Yes on the “Would you like to start the software update?” pop-up.

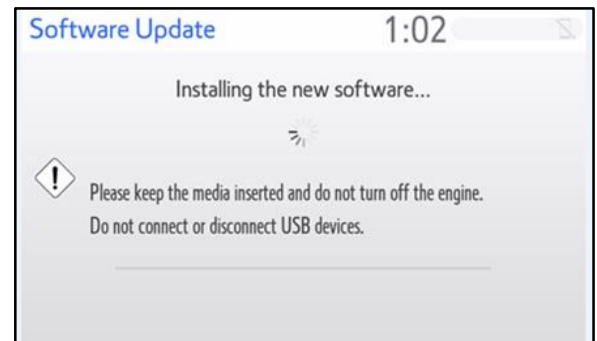
**Figure 11.**

18. The head unit begins installation. The update will take about 10 minutes.

- Do NOT turn OFF the engine or ACC BEFORE the software is ready for updating.
- Do NOT remove the USB flash drive until instructed in step 21.

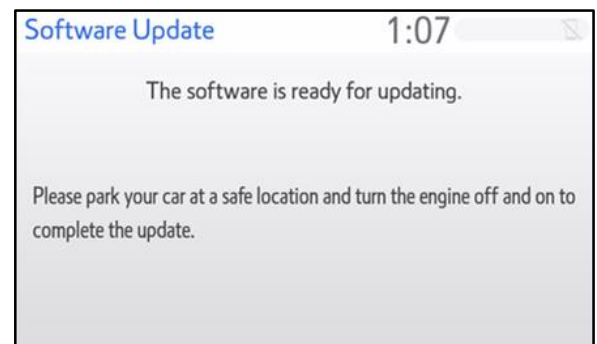
**Figure 12.**

19. When “The software is ready for updating” screen appears, turn the vehicle OFF.
