# ControlLogix Enhanced Redundancy System, Revision 16.081\_kit5

These release notes describe enhancements, corrected anomalies, and known anomalies specific to redundancy system firmware revision 16.081\_kit5 or earlier.

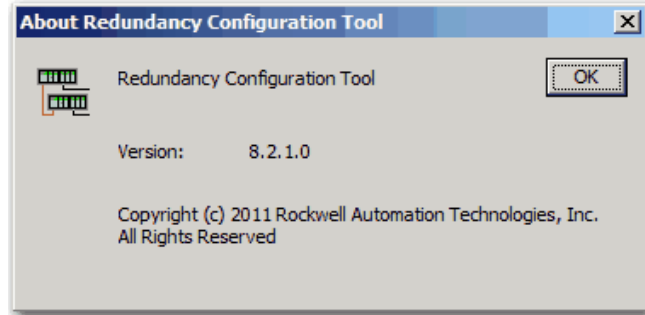
This enhanced redundancy system revision requires the RMCT, version 8.02.01 that is packaged with this enhanced redundancy system revision bundle. The About screen for the RMCT displays 8.2.1.0 but it's the correct version.

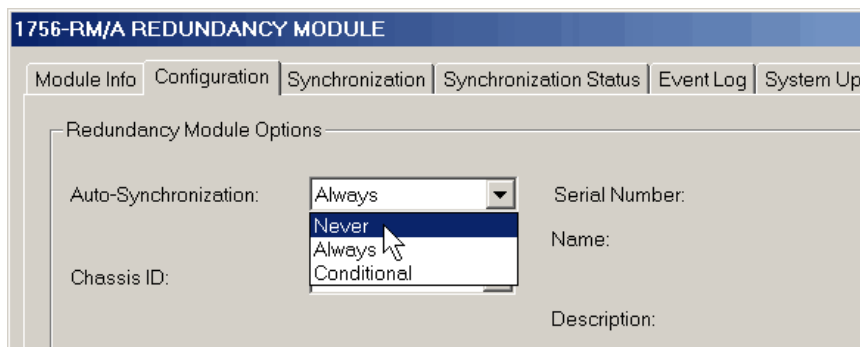
3. Click the Configuration tab in RMCT.
4. From the Auto-Synchronization pull-down menu, choose Never.

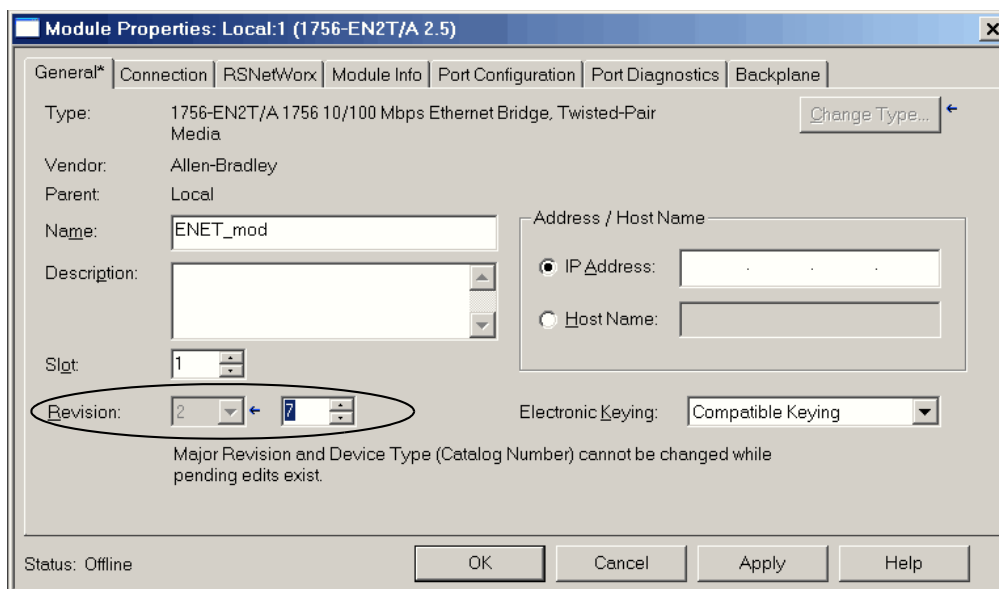
13. Access the Module Properties for each communication module in the chassis and specify the module firmware revision you are upgrading to.

If you are unable to specify the new revision, you may need to change the Electronic Keying parameter to Compatible Keying (recommended) or Disable Keying.

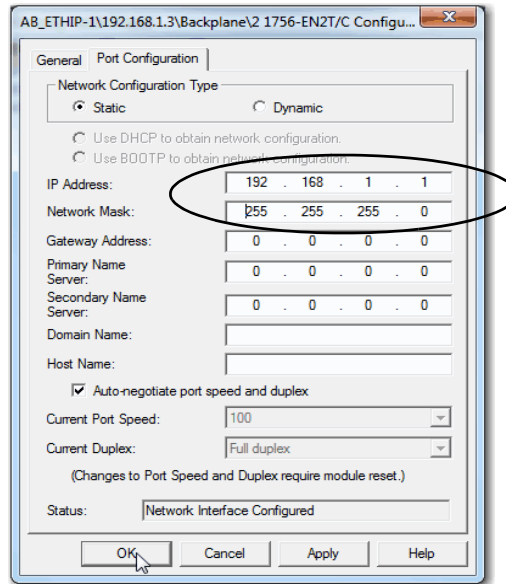
- b. On the Port Configuration tab, enter the desired IP address, Network Mask (if not entered automatically), and click OK.

This example uses the values in the following screen capture.

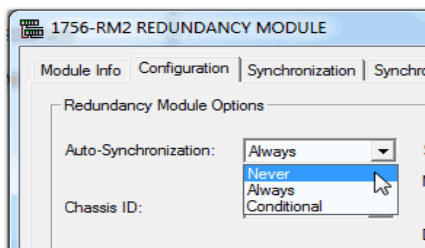
- On the Configuration tab, from the Auto-Synchronization pull-down menu, choose Never.

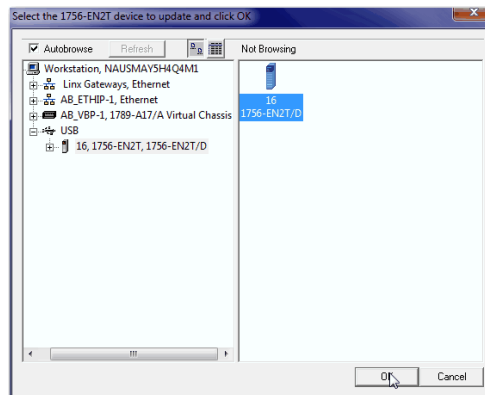
- c. Browse to the 1756-EN2T/D module.

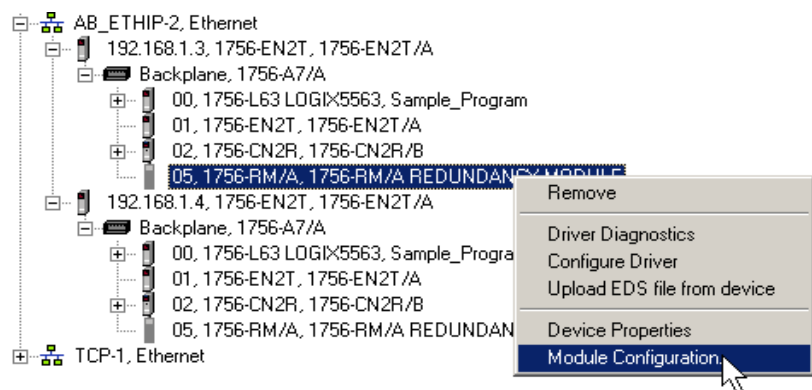
2. In the RSLinx Classic software, start the RMCT for the 1756-RM module in the primary chassis.
