Product Safety Recall

15047 Front Passenger Air Bag Inflator

Release Date: January 2020

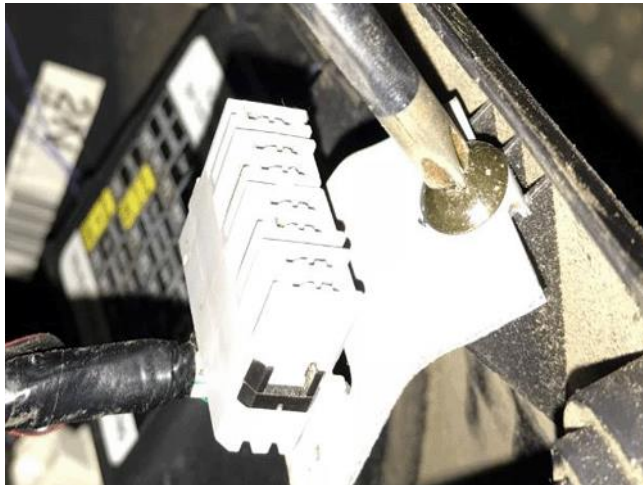
5145814

- 1.5 Carefully rotate the panel counter-clockwise to remove the B79 Check Connector screw. Leave the OBDII connector attached to the panel.

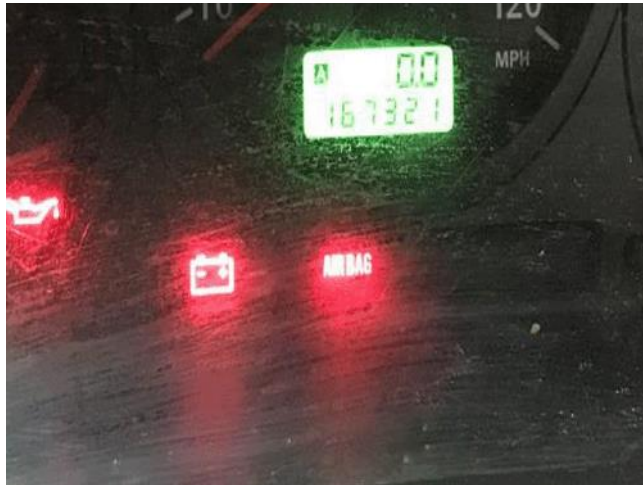
5145828

- 1.4 Watch the “AIRBAG” warning light in the cluster. It will begin to blink.
- 1.5 The long segments (1.2 seconds on) indicates a “ten”, and the short segment (0.3 seconds on) indicates a “one”. The warning light flashes a code corresponding to the fault.
- 1.6 There will be a brief pause approximately 6 seconds long between each DTC (No Light).
- 1.7 Read all codes until they begin to repeat. Write down all the codes.
- 1.8 See **DTC Code Listing chart – Table 1** at bottom of document for DTC code descriptions.

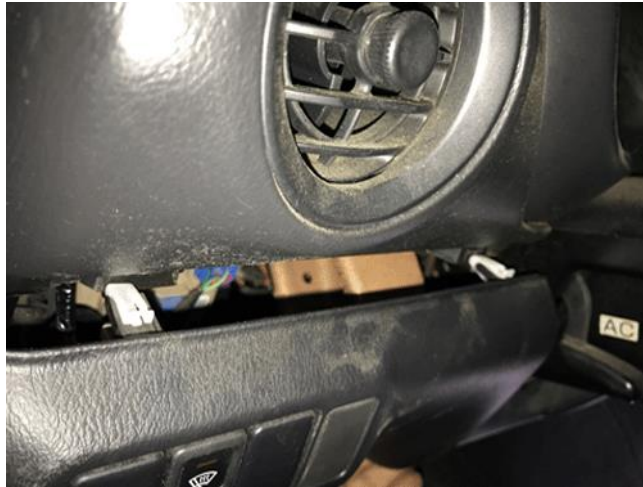
5145832

- 1.7 Rotate panel back to correct orientation.
- 1.8 Carefully line up the 3 upper clips that hold the panel on.

- 1.9 Snap the trim panel back into place.
- 1.10 Reinstall the 3 Phillips screws.
- 1.11 Turn Ignition Switch on.
- 1.12 Verify that the "AIRBAG" warning light comes on for 3 seconds and then goes out.

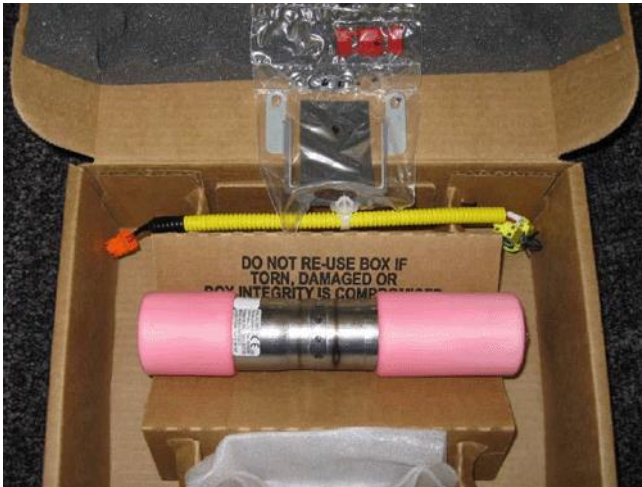
5145838

6. Open the front passenger air bag inflator kit box and confirm all the necessary components are included:
- 4 Self-Locking nuts
 - New Type 2 Inflator (pink collars on each end identify it as the replacement part)
 - New Inflator Harness
 - New Stopper Plate
 - Electro-Tap (red shorting crimp connector)
 - 1 ½" X 2 ¼" piece of self-adhesive Sponge Tape
 - Shipping Documentation and Instructions

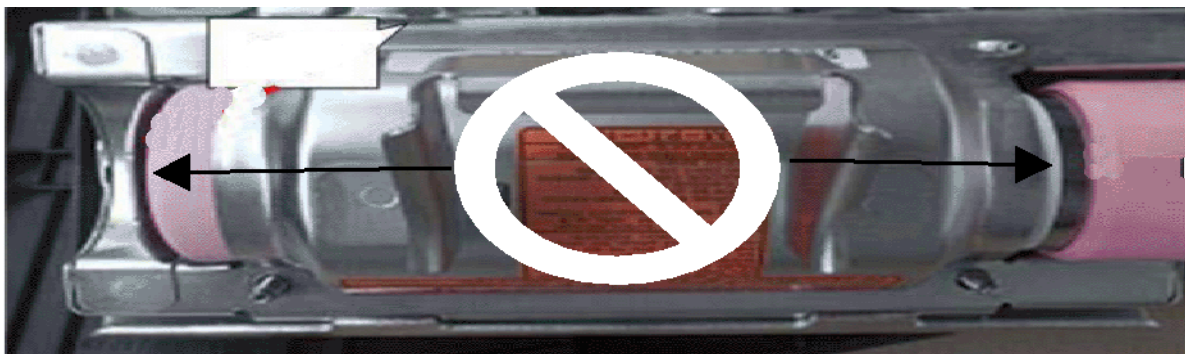
5145858

15. Inspect the new **Type 2** inflator to confirm the locating protrusions on each of the pink-collar portions are aligned as shown below. The “short” collar can be rotated as needed to align it with the protrusion on the “long” collar if necessary.

NOTE: The Type 2 inflator is installed in the opposite direction of the original. This change puts the connector on the other end. The new harness has been extended approximately 2” to compensate.

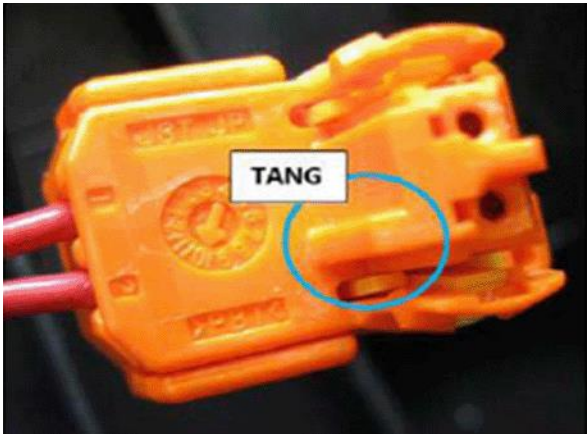
5145867

19. Peel off the white dust cover and **CAREFULLY** align the tang of the new harness connector with the receiving slot in the inflator connector. This assures proper routing of the harness in relation to the air bag assembly mounting brackets.

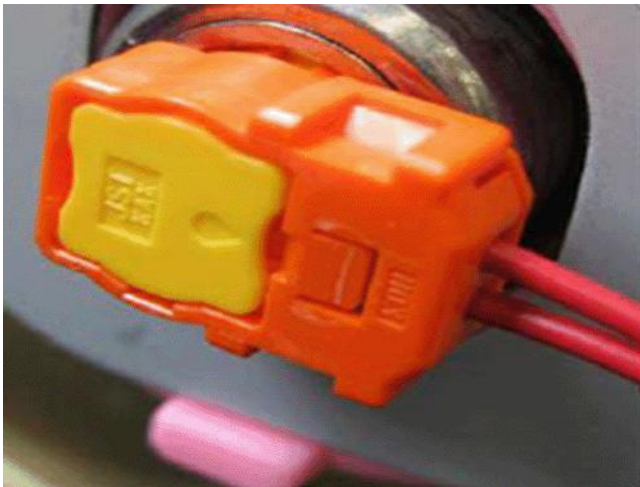
5145869

20. Once alignment is confirmed, push down firmly to engage the connector. When fully seated, press down on the yellow tab locking the connector to the inflator.

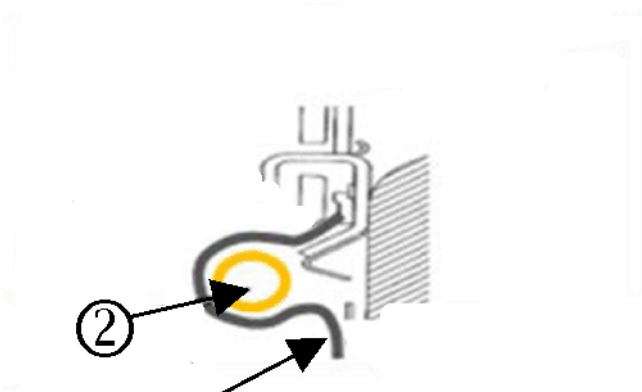
5145875

IMPORTANT: Cross section of the sponge tape installation. The sponge tape (1) must be installed more than half way around the yellow harness tube (2).
