# Agilent 2200 TapeStation System

## Troubleshooting Manual

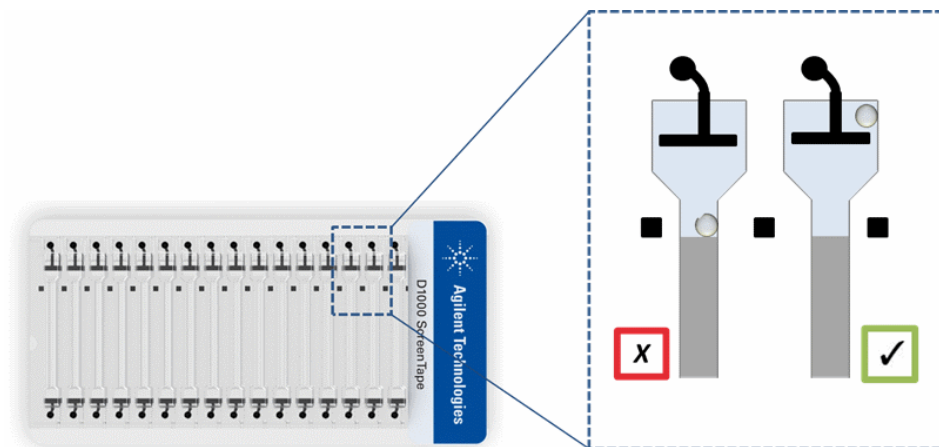
**Figure 2** Flicking the ScreenTape consumable removes bubbles from the gel interface

- Details and specifications for each assay are available in the 2200 TapeStation User Manual, the specific assay quick guide, and online [www.agilent.com/genomics/tapestation](http://www.agilent.com/genomics/tapestation)
- Protect the gel lanes of the ScreenTape from excessive force – do not bend or flex the ScreenTape
- Store the ScreenTape in the provided packaging between 2 – 8 °C
- ScreenTape can be used straight from the fridge with no equilibration time
- Handle ScreenTape carefully to avoid fingerprints or fibers, which can affect imaging
- Ensure that ScreenTape is *flicked* gently before inserting into the instrument, if there are any small bubbles present then this will move them to the top of the chamber, see [Figure 2](#) on page 14.

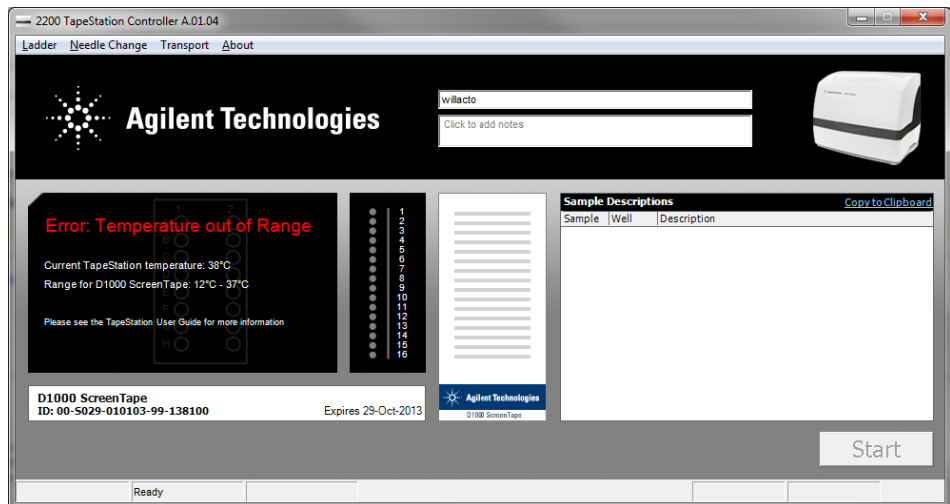
If the instrument is out of the recommended temperature range for the ScreenTape inserted, the following error message will appear in the controller software:

**Figure 3 Error: Temperature out of Range**

If the quoted current temperature is above the specified range, please move the system out of direct sunlight and away from any windows. Check that any air conditioning is functioning.

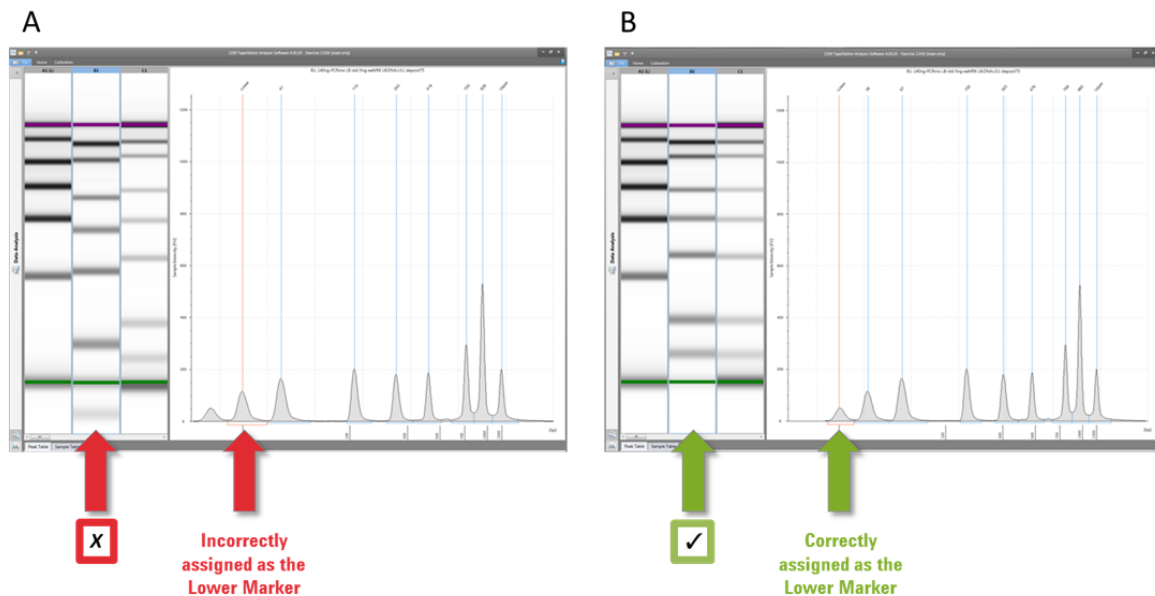
- 1 Turn Alignment off, by pressing the **Aligned** button.
- 2 Un-aligning the gel image shows the run distance of each band, uncorrected by known marker sizes. In a fully functional file, markers will migrate to a similar position and have a similar shape.  
Check the gel image to identify which bands are the correct upper and lower markers.

**Figure 4** Manual lower marker assignment in the TapeStation Analysis Software. First identify the correct marker.

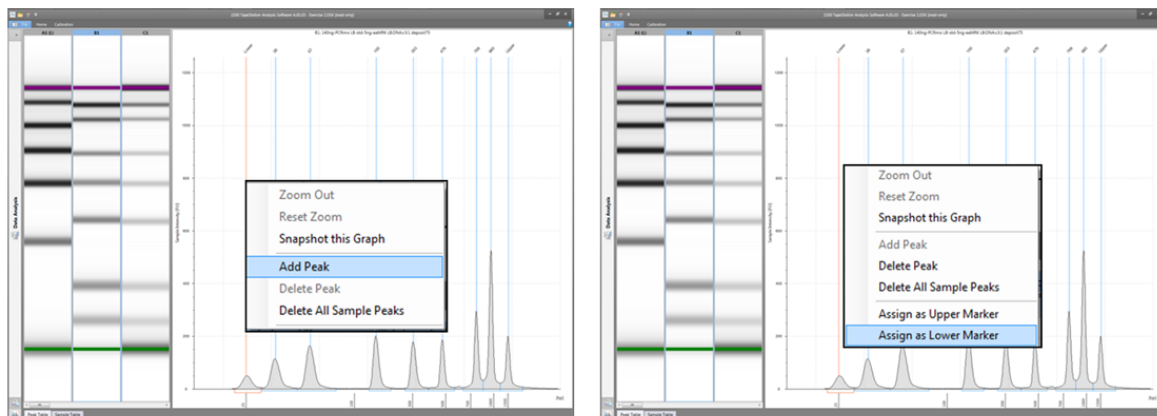
- Next, assign the correct Marker peak by right clicking, and selecting **Assign as Upper Marker/Assign as Lower Marker** as shown in Figure 5 on page 20 .

**Figure 5** Manual lower marker assignment in the TapeStation Analysis Software. Assign the correct marker by right clicking.

- 3 To add a Peak assignment, hover the mouse pointer above the unassigned peak, and right click. Then select **Add Peak** as shown in [Figure 5](#) on page 20.

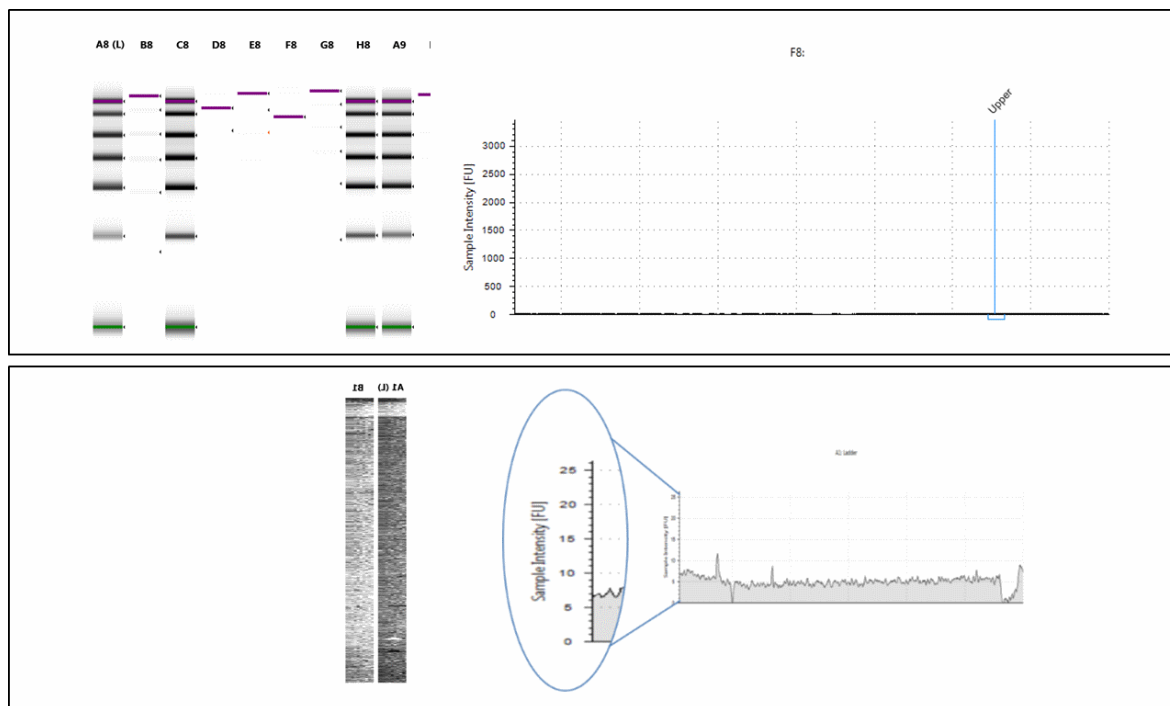
**Figure 6** Examples of blank lanes in the TapeStation Analysis Software

Blank lanes can appear in either of the ways shown above. As a white lane with no visible peaks, or as a black grainy lane. A black lane happens when there is very little sample signal, causing any background noise to appear higher than normal. In these cases the sample intensity scale shows very small values.

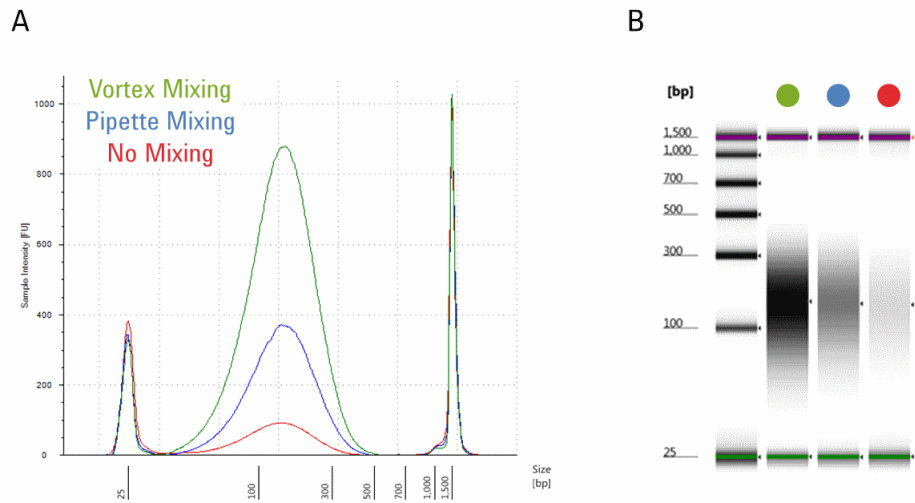
**Figure 7** The electropherogram (A) and the gel image (B) of the ScreenTape mixing tests. In both panels the green trace shows the recommended protocol of vortex mixing using the IKA vortexer and adaptor at 2,000 rpm for 1 minute followed by brief centrifugation. Blue shows results for pipette mixing only. Red shows the effect of no mixing. Images were taken from the Agilent TapeStation Analysis Software

- Sample and sample buffer must be vortex mixed according to protocol, followed by centrifugation to remove any bubbles.
- Insufficient mixing can cause discrepancies in quantification.
- The effects of insufficient mixing were investigated using D1000 ScreenTape and reagents, and results are presented in [Figure 7](#) on page 41 and [Figure 8](#) on page 42, as well as [Table 3](#) on page 42.
- Poor mixing dramatically affects the reported sample concentration. Following the recommended procedure is the best way to attain accurate quantification results.
- Please see “[Mixing recommendations](#)” on page 10, or the appropriate assay Quick Guide for more details.

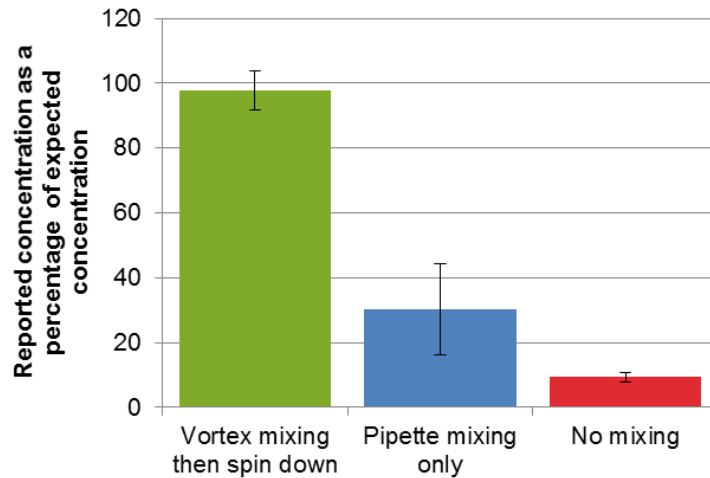
**Figure 8** Chart of reported concentrations for the ScreenTape mixing tests, using the D1000 Assay. Concentrations are expressed as a percentage of the theoretical for the three mixing methods. As above, the green bar represents the recommended protocol of vortex mixing using the IKA vortexer and adaptor at 2,000 rpm for 1 minute followed by brief centrifugation; blue - pipette mixing only; red - no mixing.

**Table 3** ScreenTape Reagent mixing tests. Quantification values obtained from the TapeStation Analysis Software and the Agilent D1000 ScreenTape Assay when using the correct protocol (vortex mix followed by brief centrifugation) and two incorrect mixing protocols (pipette mixing only and no mixing) as illustrated above

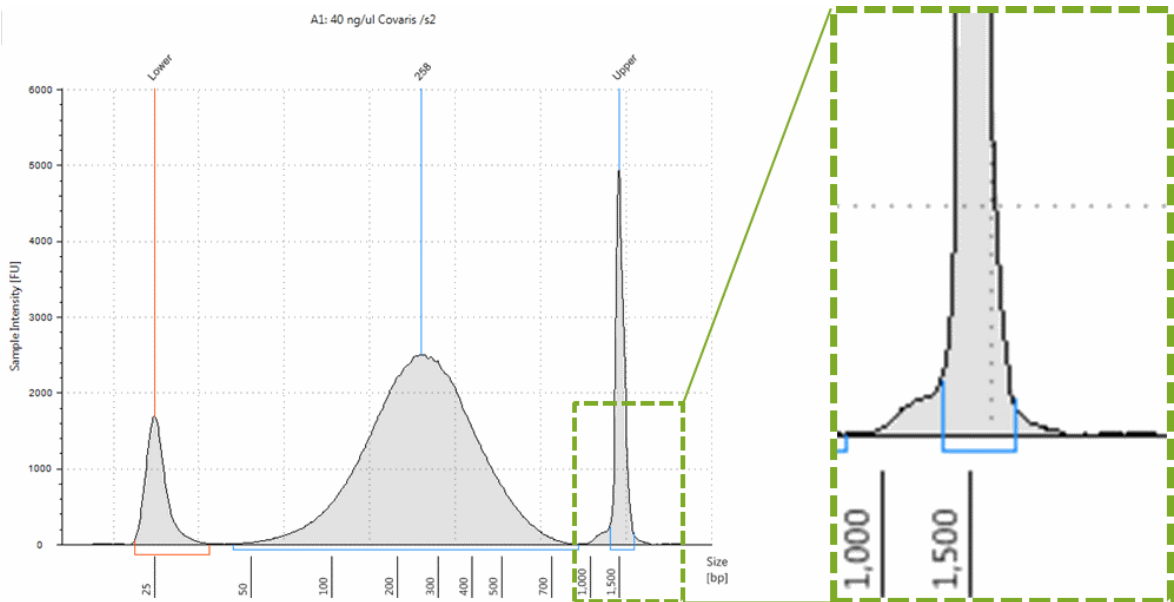
**Figure 9** Correct upper marker integration for the 2200 TapeStation DNA Assays. Figure shows D1000 ScreenTape Assay.

The user must ensure that both marker and sample peaks are properly integrated, by manually adjusting the peak when necessary. [Figure 9](#) on page 43 shows examples of correct upper marker peak integration.

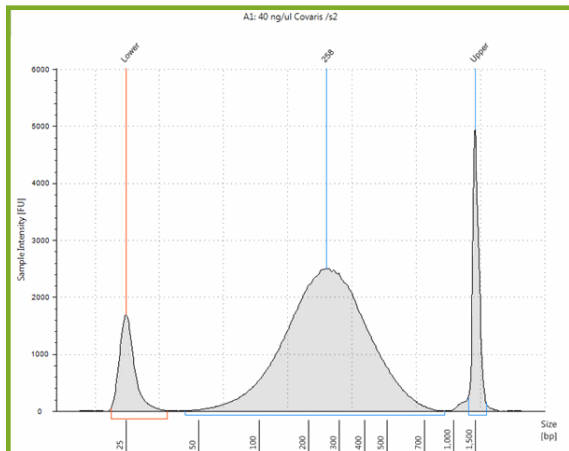
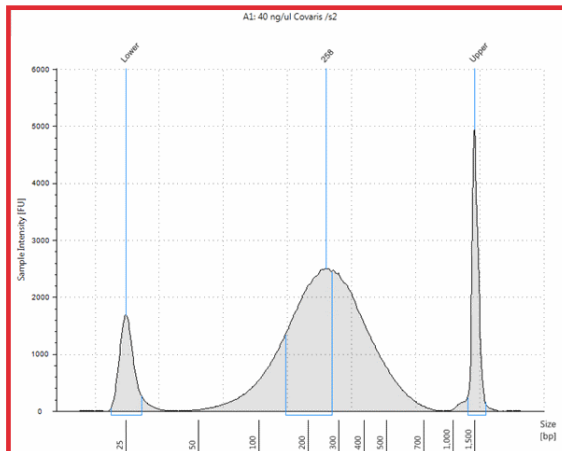
**Correct peak integration**  
Concentration: 41.2 ng/μL

**Incorrect peak integration**  
Concentration: 14.9 ng/μL

**Figure 10** Example of correct (A) and incorrect (B) sample peak integration, and their effect on reported sample concentration.

Figure 10 on page 44 demonstrates the effect of peak integration on the quantitative results. Incorrect peak integration can significantly bias the determined DNA sample concentration.

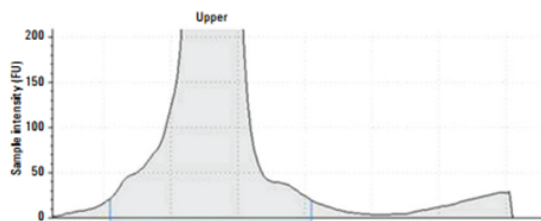
**Figure 11**    Enlarged image of the upper marker showing additional signal from AMPure beads.

The 2200 TapeStation system has been verified for use within the Agilent Sure Select protocol. During the purification step however, residual AMPure XP beads can give signal which runs with the upper marker (See [Figure 11](#) on page 46).

- Any signal under the upper marker causes a lower reported value of sample concentration.
- This artifact can be avoided by increasing the time for which the samples are incubated on the magnetic plate to 10 minutes, thereby removing a higher percentage of the beads.

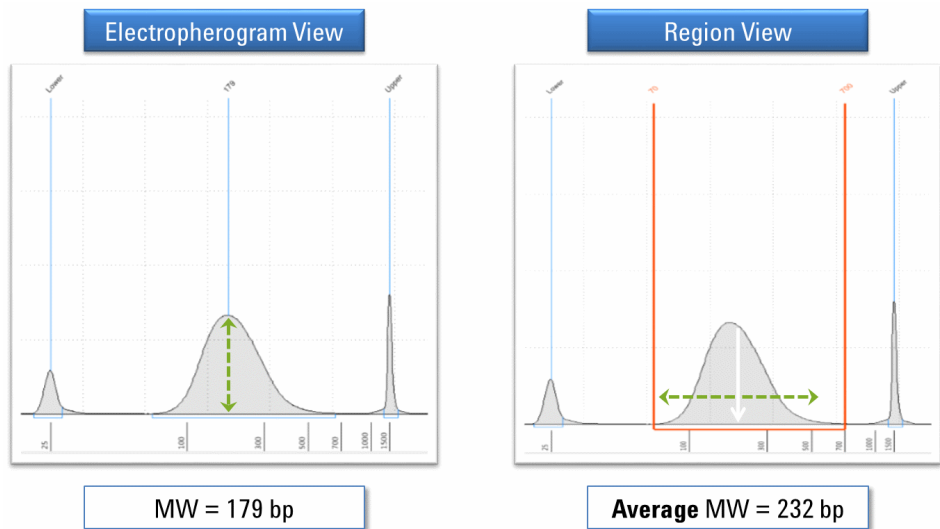
**Figure 12** The sizing data obtained in Electropherogram and Region views of the Agilent TapeStation Analysis Software.

Within the 2200 TapeStation analysis software, sizing can be found in both electropherogram and region mode. The sizing information presented in these modes will be different.

**Electropherogram view** is designed for use with discrete peaks, and the default size reported is that of the highest point of the peak.

**Region view** calculates data over a whole smear or region (for example NGS libraries), and reports size as that of the center of the regions' mass. This gives the user an idea of the distribution of sizes within that sample.

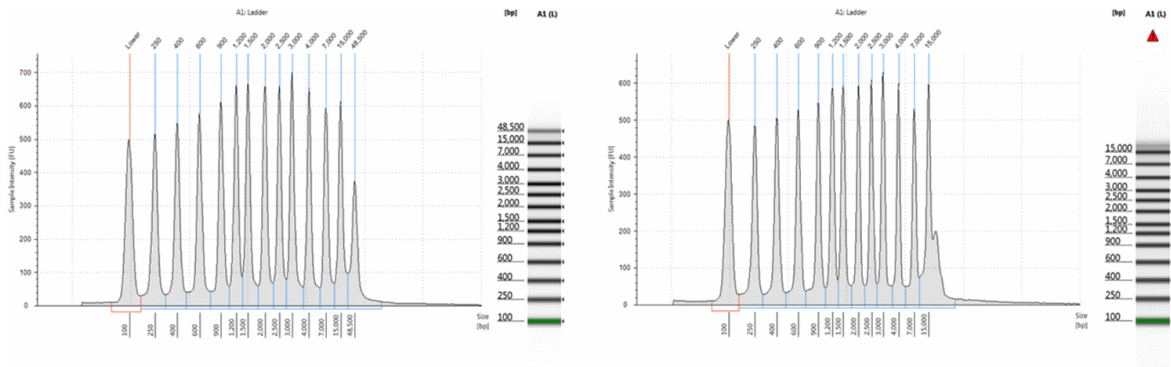
**Figure 13** The effect of shaking the Genomic DNA Ladder. A) Genomic DNA Ladder has been vortex mixed for 5 seconds prior to analysis on the Genomic DNA ScreenTape assay. B) The Genomic DNA Ladder vial was shaken by manually inverting the tube 30 times. Degradation of the top fragment (48,500 bp) is clearly shown.

- Shaking the Genomic DNA ladder vial can degrade the top fragment (See [Figure 13](#) on page 51).
- This can result in inaccurate sizing results
- Where the degradation has resulted in failure of the software to assign the top ladder fragment, no DIN scores will be presented for the lanes in this file
- Prior to addition with sample buffer the ladder vial should be handled carefully
- Once mixed with sample buffer, the ladder should be gently vortexed for 5 seconds as normal.

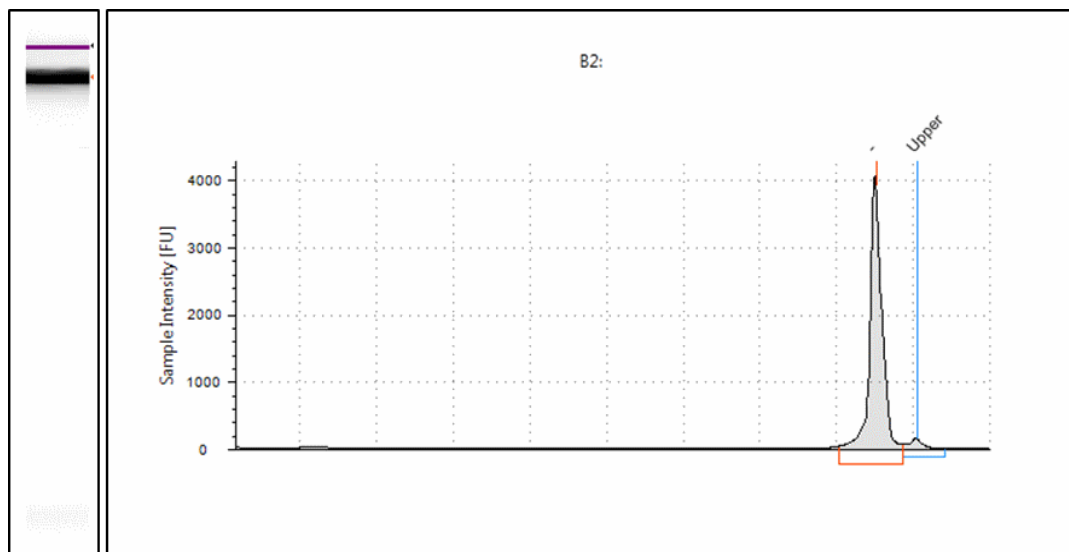
**Figure 14** Example of missing marker peak

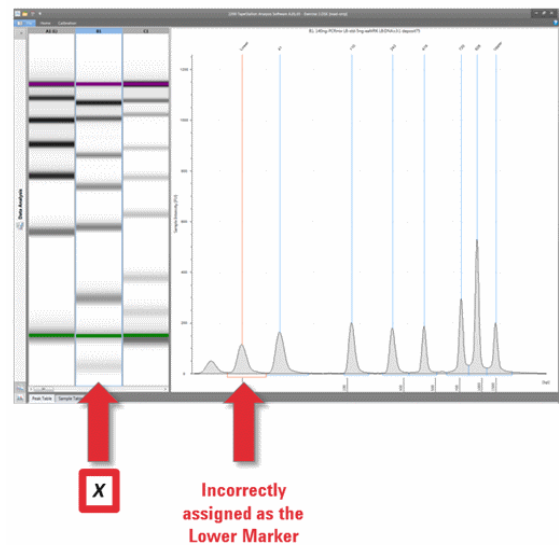
**Figure 15** Identifying the correct lower marker

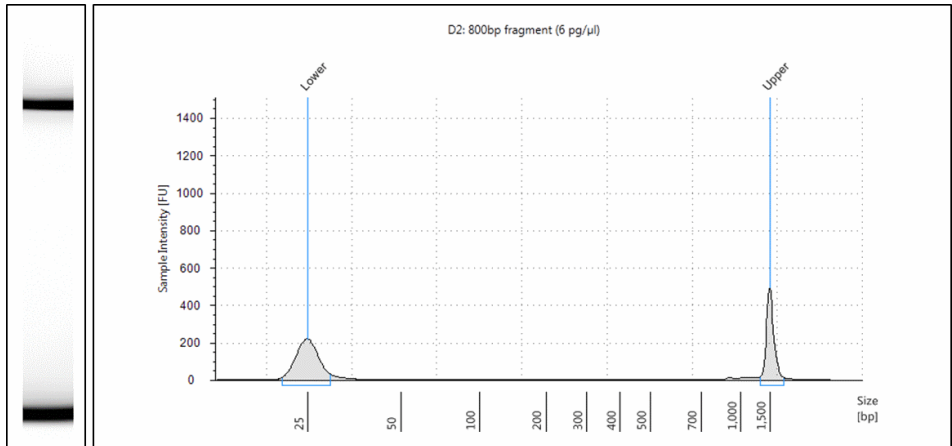
**Figure 17** Example of missing sample peak

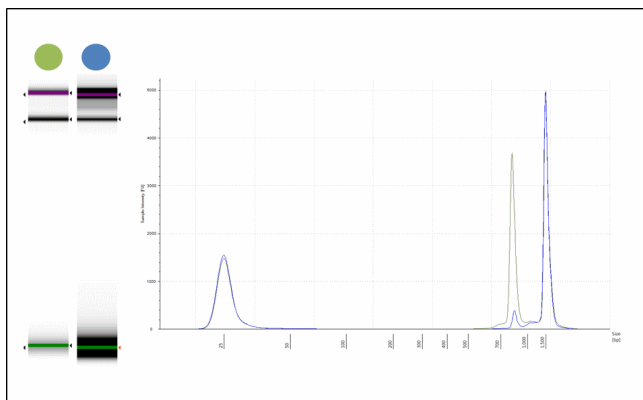
**Figure 18** Example of intense upper and lower markers seen in the blue gel image. Lower markers are normalised in electropherogram view and appear identical in signal.

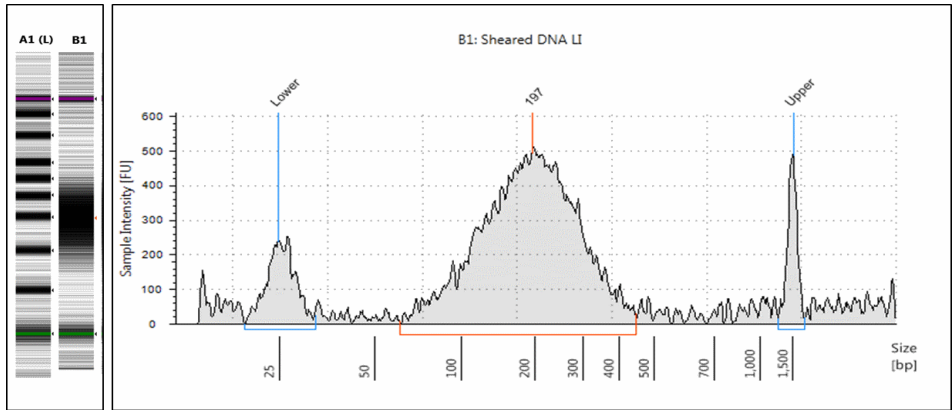
**Figure 19** Example of high background noise

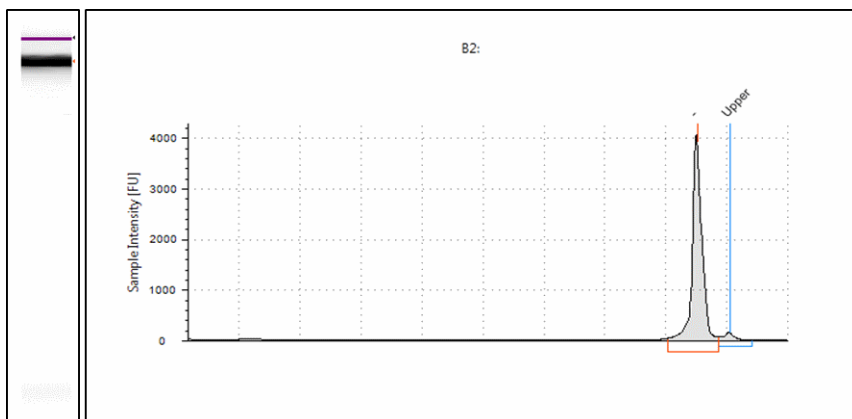
**Figure 20** Example of low signal intensity of the marker peaks

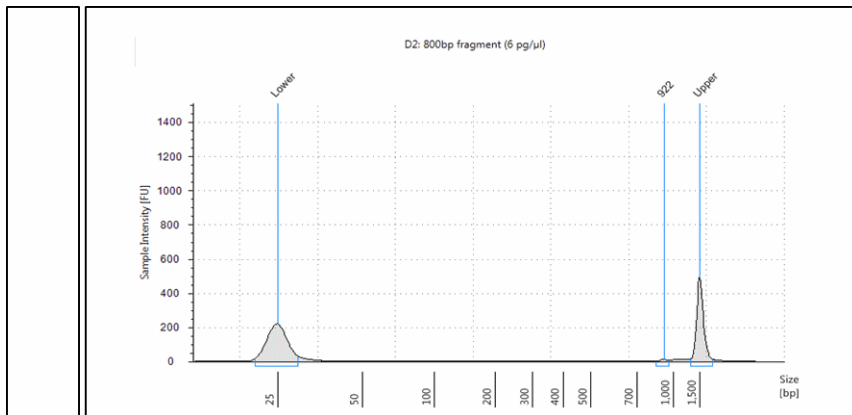
**Figure 21** Example of low signal intensity of the sample peaks

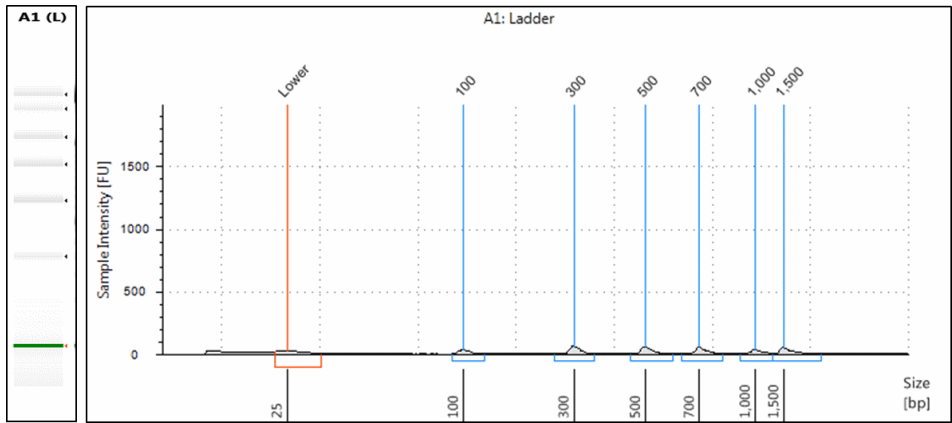
**Figure 22** Example of low signal intensity in the High Sensitivity D1000 Ladder

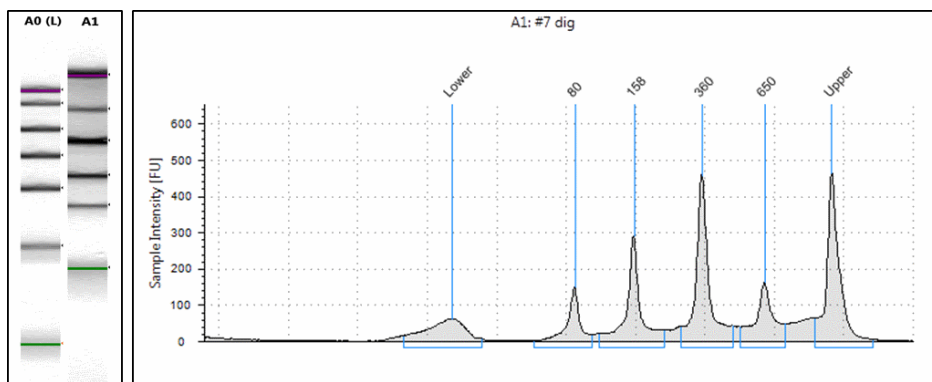
**Figure 23** Example of shortened migration caused by high salt concentration

| Problem | Likely Cause | Solution |
|---|---|---|
| Incorrect migration - samples have not reached the lower end of the gel lane | Salt concentration | <p>Unalign the image using the <b>Aligned</b> button in the TapeStation Analysis Software. This will show the true position of all peaks present.</p> <p>High salt concentrations can cause short running within the gel lane which can cause incorrect identification of Lower marker peaks.</p> <p>Please refer to the salt tolerance guidelines for the assay.</p> |

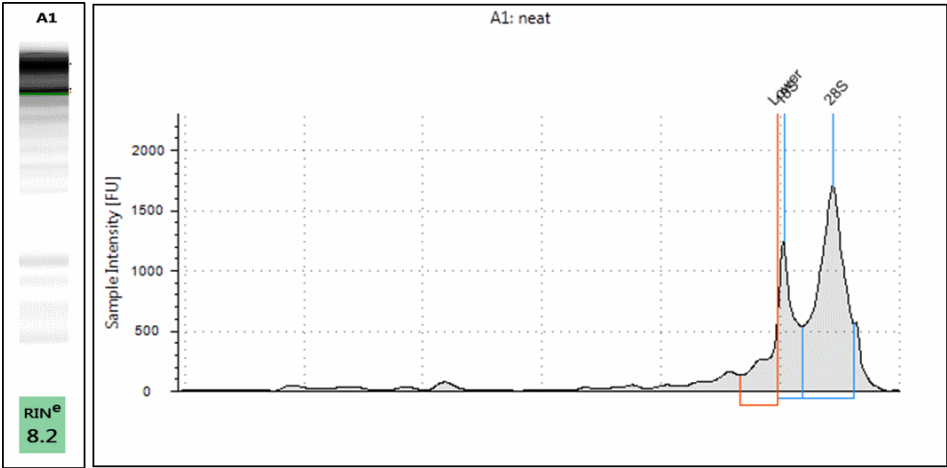
**Figure 24** Example of missing marker peaks in an RNA assay

**Table 11** RNA - Possible causes of missing marker peaks. In order of probability.

| Cause | Solution |
|---|---|
| Insufficient Mixing | Ensure correct mixing, see <a href="#">"Mixing recommendations"</a> on page 10 |
| Sample concentration outside recommended range for application | Either dilute or concentrate your sample until it is within the recommended range for the application as seen in the appropriate assay Quick Guide, then prepare a new run. |

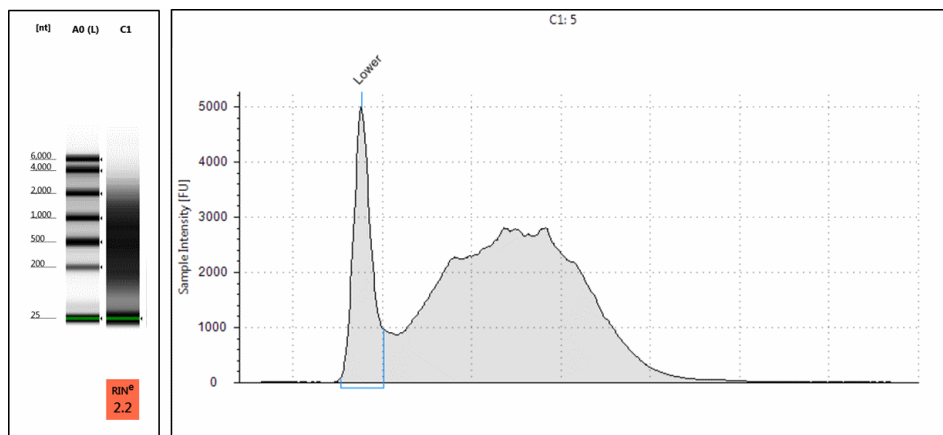
**Figure 25** Example of degraded RNA resulting in missing peak identification.

**Table 12** RNA - Possible causes of degraded sample in order of probability.

| Cause | Solution |
|---|---|
| Incorrect heating step | Ensure the correct heating recommendations for the assay are followed as described in the User Manual and appropriate Quick Guide |

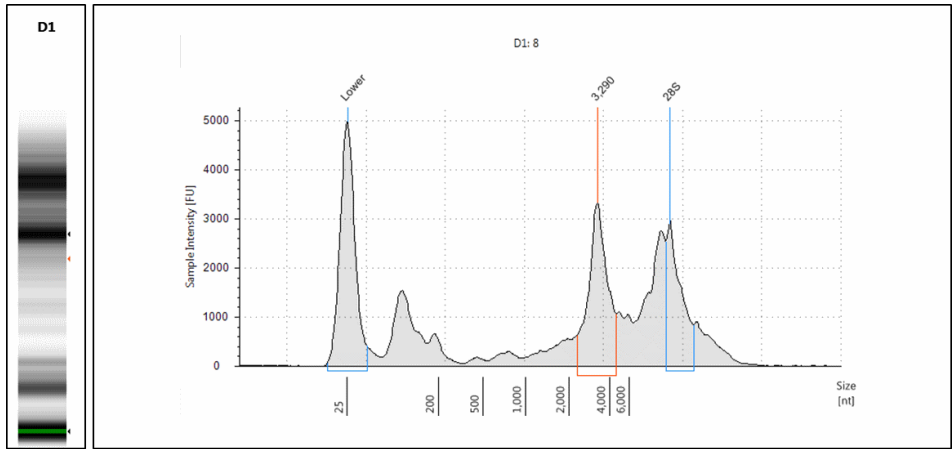
**Figure 26** Example of extra peaks being picked up at the 28S position

| Problem | Likely Cause | Solution |
|---|---|---|
| There are two bands evident in the 28S peak opposition | The 28S peak may have partially reverted back to its original, non-denatured conformation | There may have been insufficient sample denaturation prior to ScreenTape analysis.<br>Ensure the correct denaturation conditions during RNA sample preparation.<br>Samples should be kept on ice, and run within 2 hours of denaturation. |
| There are two bands present at the 18 or 28S peak position | The peak may have partially reverted back to its original, non-denatured conformation | There may have been insufficient sample denaturation prior to ScreenTape analysis.<br>Ensure the correct denaturation conditions during RNA sample preparation.<br>Samples should be kept on ice, and run within 2 hours of denaturation. |

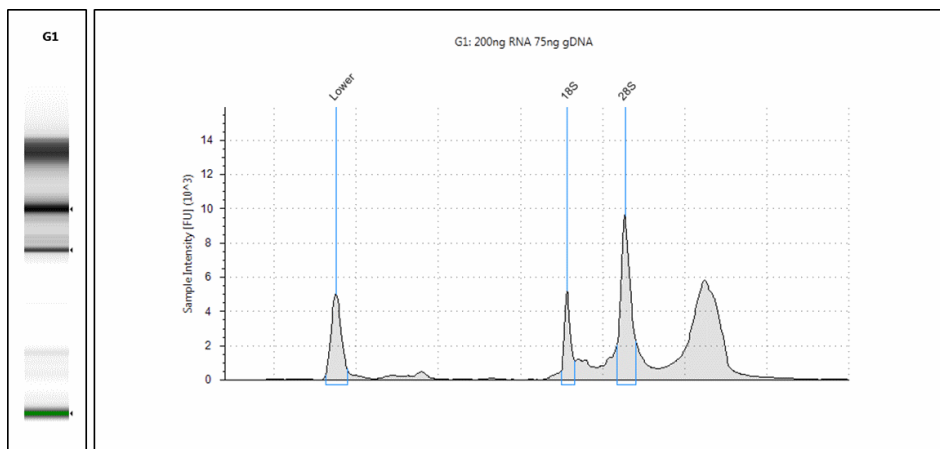
**Figure 27** Example of genomic DNA contamination of RNA sample

| Problem | Likely Cause | Solution |
|---|---|---|
| Additional bands are present in the region of the 18 and 28S peak | Genomic DNA contamination | Samples contaminated with genomic DNA contain a third peak which migrates in the region of the 18 and 28S. Occasionally this peak can be mistaken for the 18 or 28S peak. Ensure that all peaks are annotated correctly. Treat samples with DNase to eliminate the genomic DNA peak then prepare a new run. |

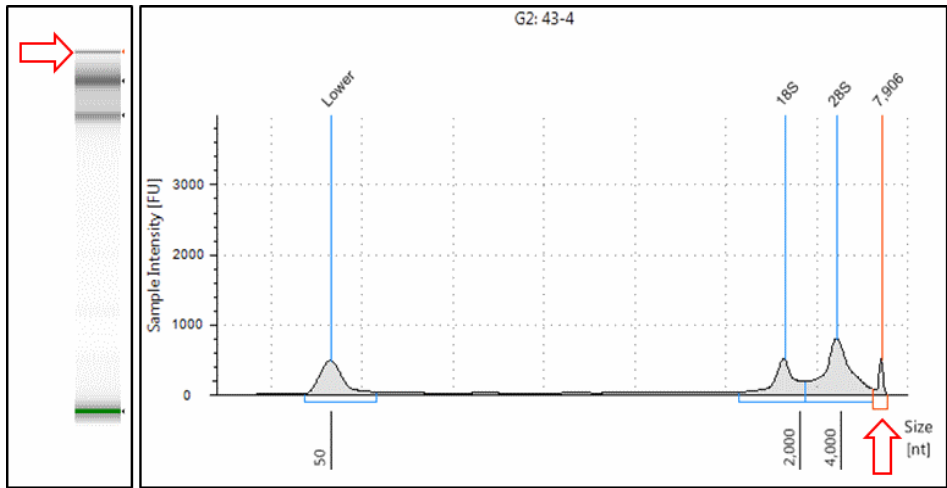
**Figure 28** Example of highly concentrated RNA sample presenting as additional bands (presented with arrows) above the 28S peak

| Problem | Likely Cause | Solution |
|---|---|---|
| Additional bands are present at the top of the gel image | The sample may be too concentrated for the application | Dilute or concentrate your sample until it is within the recommended range for the application, then prepare the sample again and rerun on ScreenTape. If necessary, use the High Sensitivity RNA ScreenTape assay. |

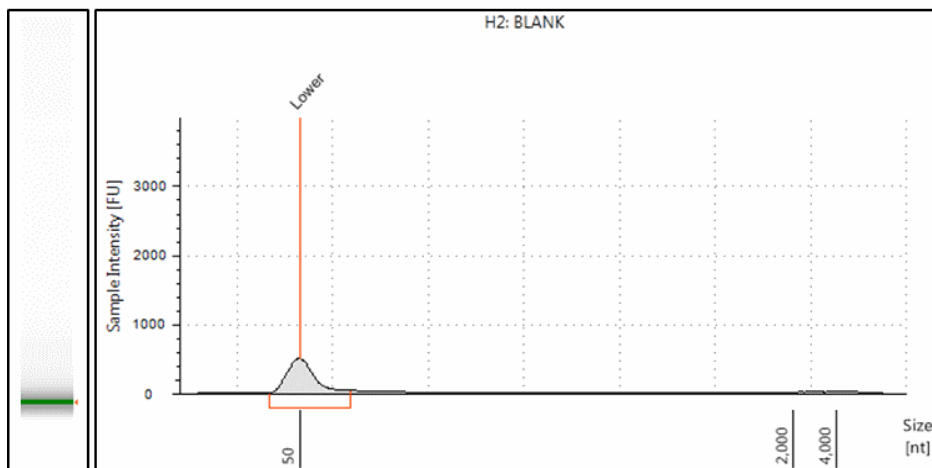
**Figure 29** Example of missing sample peaks in an RNA run

| Problem | Likely Cause | Solution |
|---|---|---|
| The markers have appeared in the sample lane, but the sample has not | The sample may be too dilute for the application | Concentrate your sample until it is within the recommended range for application, then prepare the sample again and rerun on ScreenTape |
| | Insufficient Mixing | Ensure correct mixing by reading the “ <a href="#">Mixing recommendations</a> ” on page 10 |

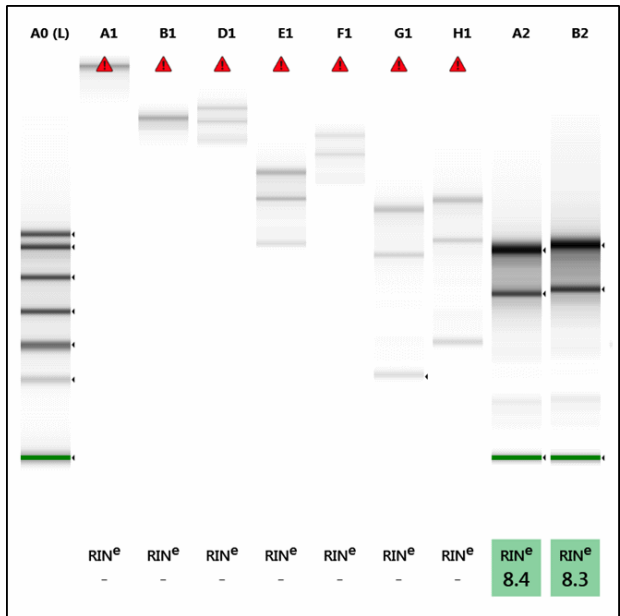
**Figure 30** Example of short migration caused by high salt concentration. Lanes A1- B2 show the same sample in buffers of decreasing salt concentrations, allowing migration further through the gel lane.

| Problem | Likely Cause | Solution |
|---|---|---|
| Incorrect migration - samples have not reached the lower end of the gel lane | Insufficient migration due to presence of salt | Dilute your samples to ensure low levels of buffer salt<br>True migration profiles can be seen by unaligning your gel image as described in <a href="#">“Manual Marker Assignment”</a> on page 18 |

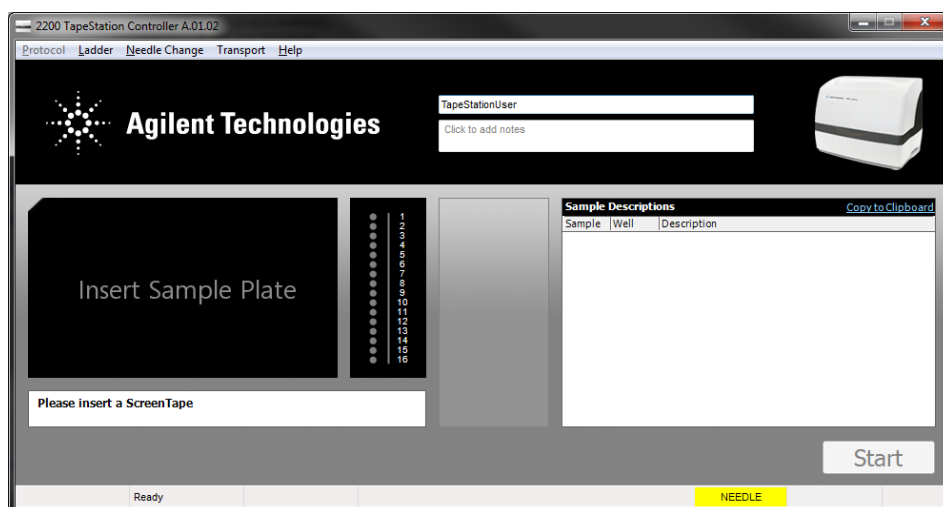
**Figure 31** Controller software indicating a **Needle** change is recommended

- After 7680 lanes (3840 pierces in a Single loading system), the controller software will inform the user that a needle change is pending. The word **Needle** will appear in the bottom of the controller software inside a yellow box.
- After 8320 lanes (4160 pierces in a Single loading system), a needle change is recommended. The box around the word **Needle** will change from yellow to red.
- After 8960 lanes (4480 pierces in a Single loading system), the needle has completed its lifetime and must be changed before the TapeStation will start.

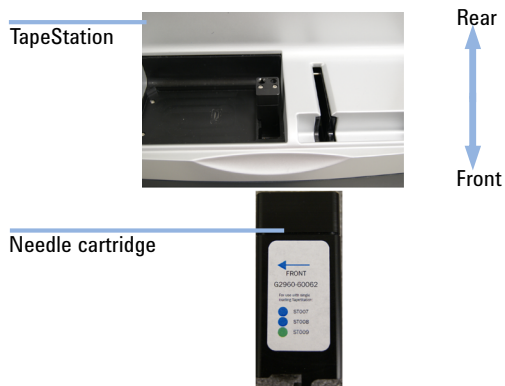
- 3 Insert the needle cartridge into the tip holder space, using the label for orientation. The cartridge should be placed so that the label faces to the right, and the printed arrow points to the front of the TapeStation.

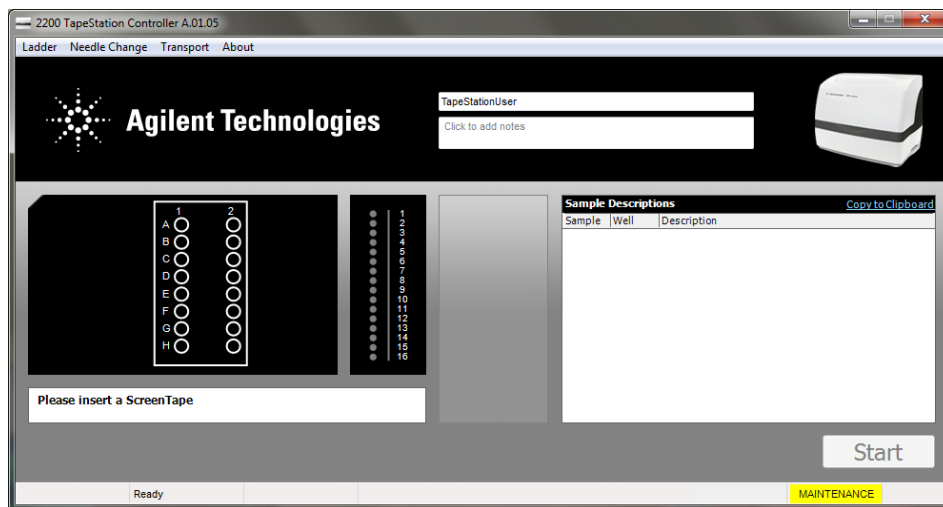
**Figure 32** Controller software indicating a Preventative Maintenance is due

After 16000 samples, the controller software will inform the user that Preventative Maintenance is required. The word **Maintenance** will appear in the bottom of the controller software inside a yellow box. The Preventative Maintenance service must be performed by a trained Agilent Field Service Engineer and can be scheduled by contacting your local Agilent Service representative.

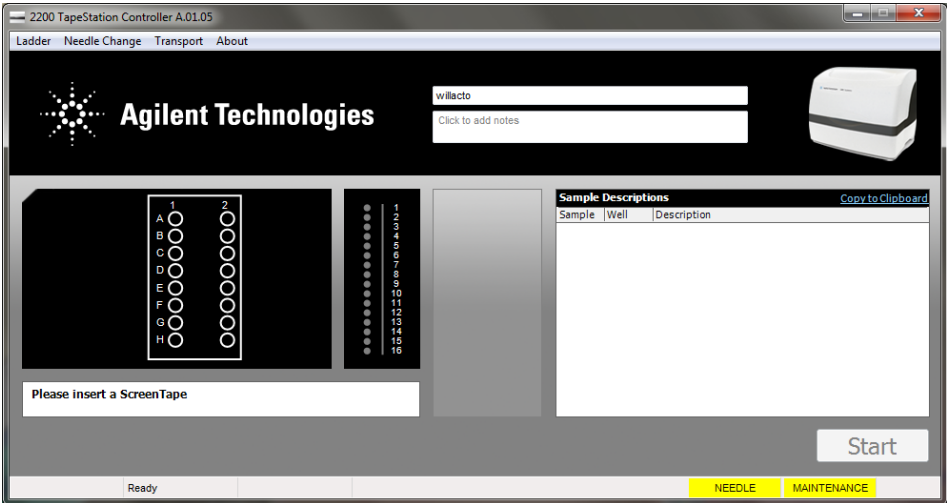
**Figure 33** Controller software indicating a Preventative Maintenance is due. Schedule Preventative Maintenance, do not perform a Needle Change

If both the **Maintenance** message and the **Needle** message are being displayed simultaneously then only a Preventative Maintenance should be performed. The Preventative Maintenance procedure includes a Needle Change and following PM service both messages will disappear.
