**Firmware Version:** V1.60.012  
**Prom Code Version:** V1.00.016  
**Published:** 2018/11/5

These release notes include important information about D-Link DGS-1510 Series firmware revisions. Please verify that these release notes are correct for your switch:

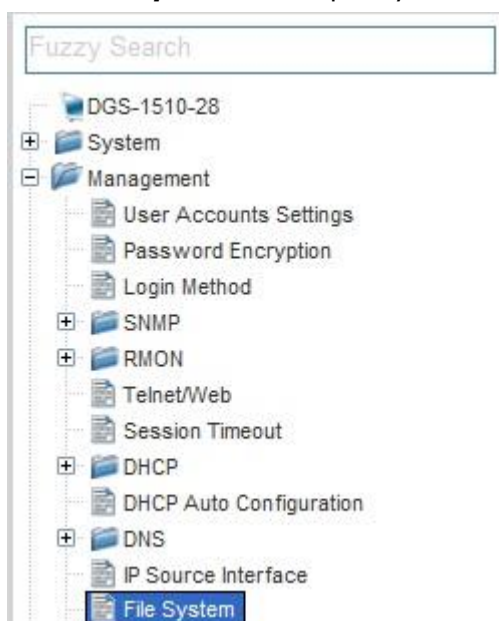
14. To select the boot up image used for next reboot, click **Management > Flash System** in the function tree and then click the **C:** drive name. When you see the files list, click corresponding **Boot Up** button to specify the firmware that will be used for next and subsequent boot up.

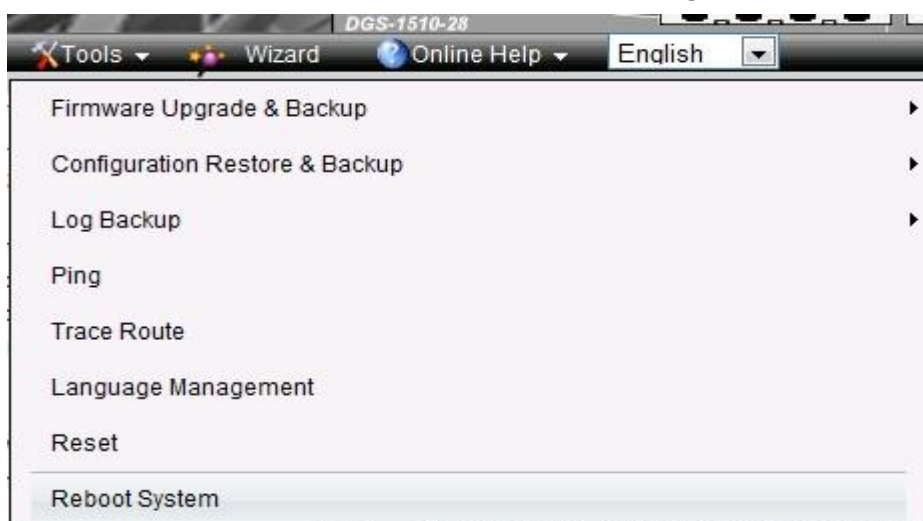
15. To reboot the switch, select **Tools > Reboot System** from the banner.
