EL18-023c

ITB18-040c

SOFTWARE UPDATES FOR INFOTAINMENT ISSUES

APPLIED VEHICLES: 2016-2018 Q50 (V37) 2017-2018 QX30 (H15)
2016-2018 Q50 Hybrid (V37) 2017-2018 QX60 (L50)
2017-2018 Q60 (V37) 2017-2018 QX60 Hybrid (L50)
2018 Q70 (Y51) 2018 QX80 (Z62)
2018 Q70 Hybrid (Y51)

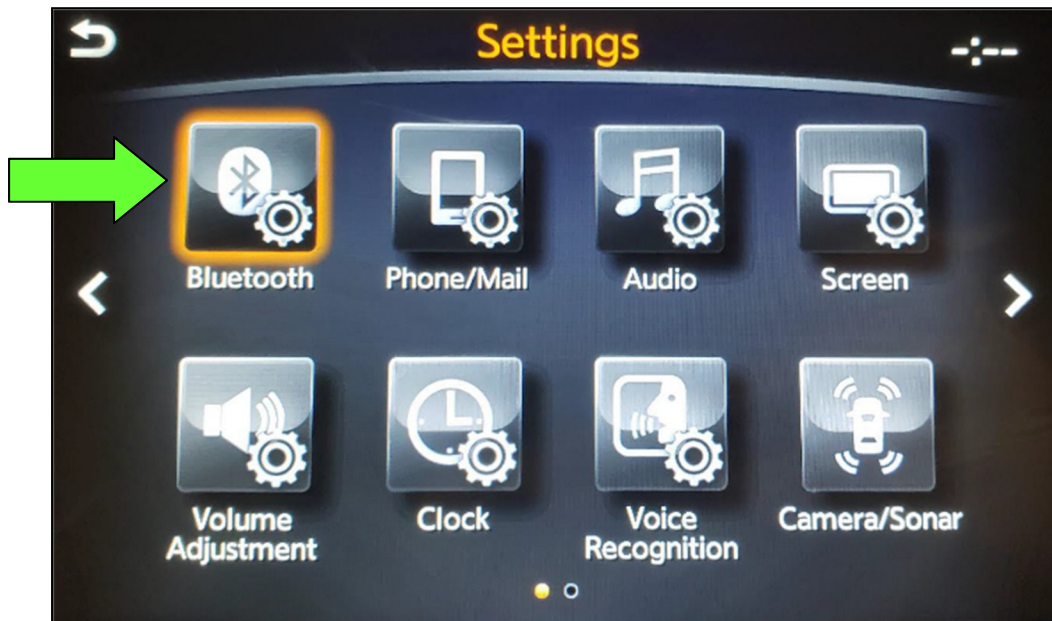
Figure 9

19. Open the Settings Menu, and then select **Bluetooth**.

- The **Settings** menu is accessed with the hard button located under the display.

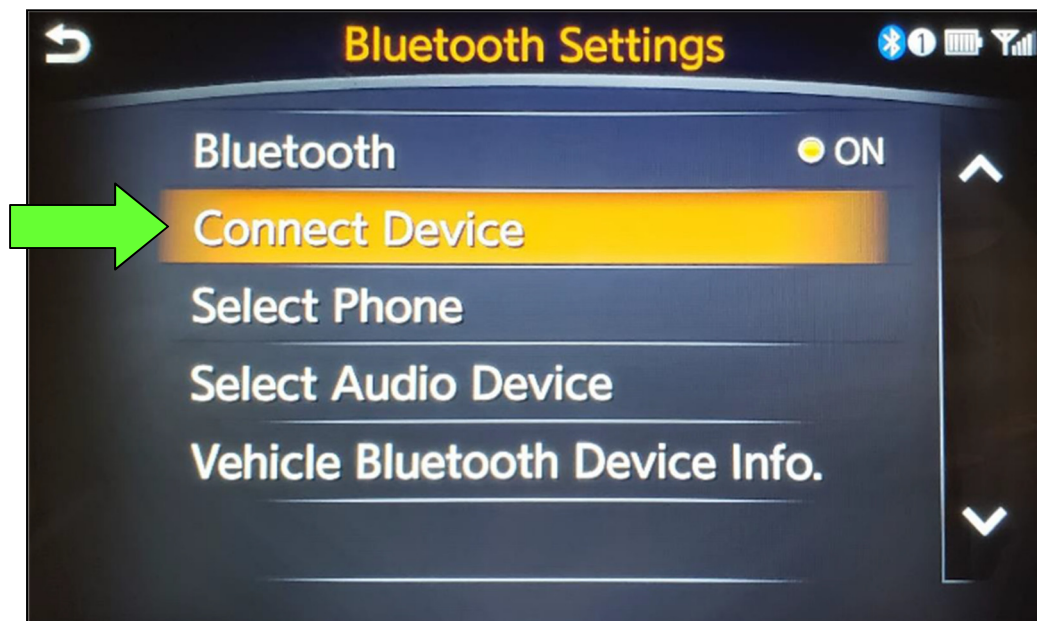
Figure 10

20. Select **Connect Device** from the **Bluetooth Settings** menu.

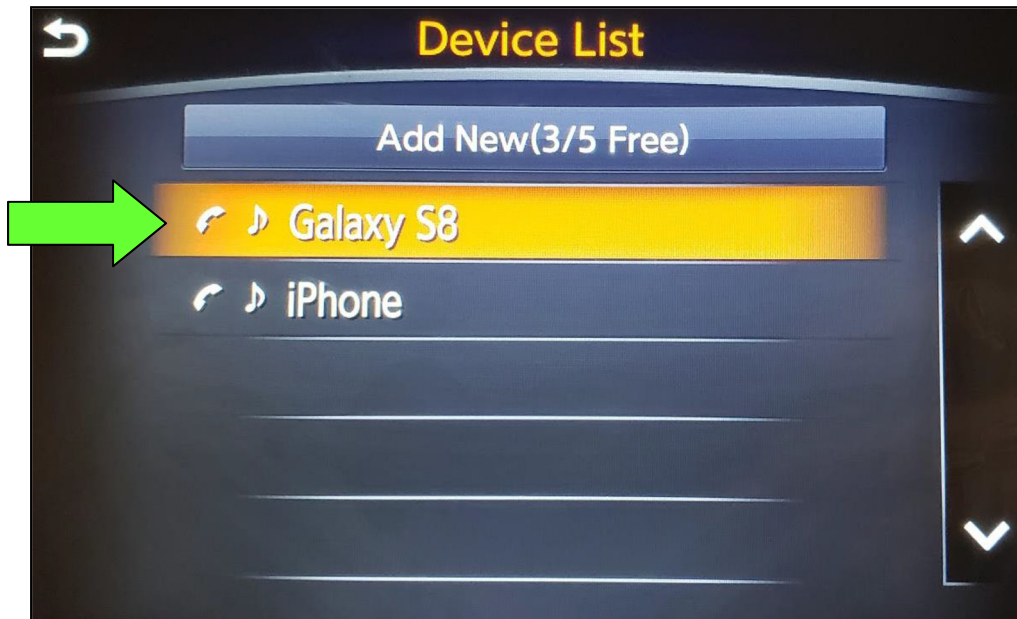
Figure 11

21. Check for devices in the **Device List**:

- **YES**, one or more devices are listed: Select a device, and then proceed to step 22.
- **NO**, there are no listed devices: Skip to step 24.

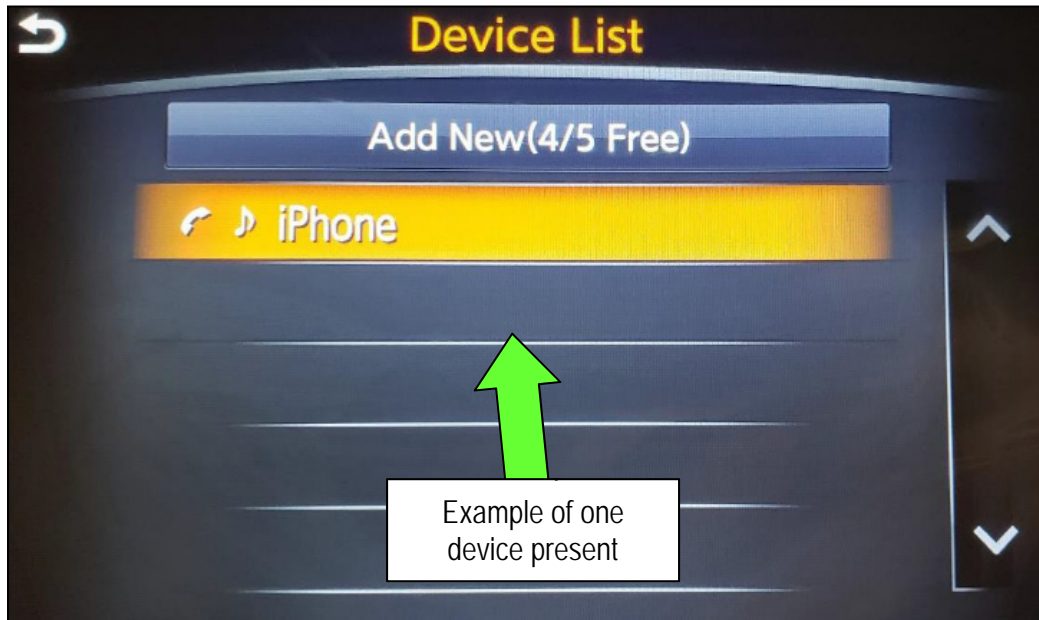
Figure 15

23. Check for additional devices in the **Device List**:

- **YES**, there are more listed devices: Perform steps 21 and 22 until all listed devices are deleted.
- **NO**, there are no listed devices: Proceed to step 24.
