# Safety Recall

## Code: 45F2

| Subject | ABS Control Module Software |
| Corrective Action | Update the ABS control module software with improved diagnostic capability to detect insufficient PCU ground connection. ABS modules with insufficient ground connections will be replaced. |

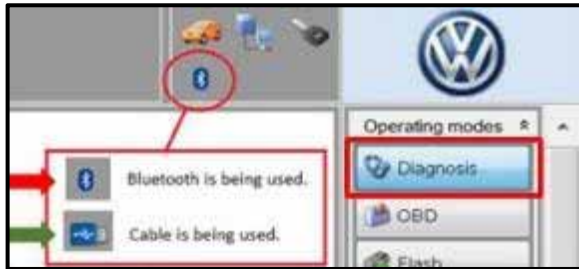
- Open the hood.
- Open the battery cover.
- Attach the GRX3000VAS Tester/Charger (or equivalent) to the vehicle battery.
- Switch the ignition on.
- Apply the parking brake.
- Turn off all consumers; headlights heated seats, etc.
- Connect the VAS6150D Diagnostic Tester (or equivalent) to the vehicle.
- Start the ODIS program.
- Confirm that scan tool is communicating with the diagnostic head by USB <Green Arrow>.
- If the Bluetooth symbol is shown <Red Arrow> then disconnect the diagnostic head from the vehicle and reconnect the USB cable to the diagnostic head and then reattach to the vehicle.
- Upon ODIS startup, verify the "Diagnosis" operating mode is selected <as shown>.
- Select "Starting Diagnosis" and perform a GFF scan of the vehicle.

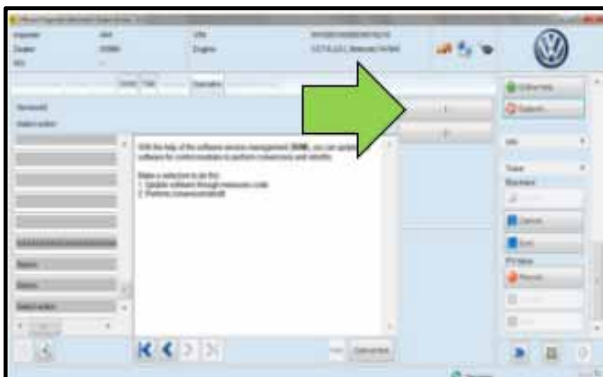
- Select the appropriate option to update "**through measures code**" <arrow>.

Read this screen carefully. The option to update software through measures code is **NOT** always selection #1 on this screen.

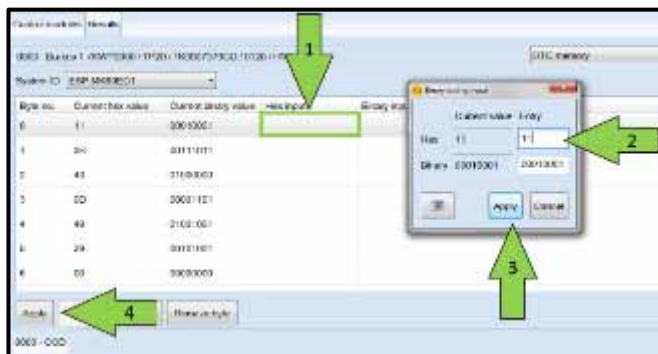
- Enter the previously recorded coding:
  1. Left click on the empty box in the Hex Input column <arrow 1> for the appropriate coding byte.
  2. Enter the previously recorded Hex value <arrow 2>.
  3. Select Apply <arrow 3>.
  4. Repeat for each coding byte.
  5. Once all coding bytes have been entered, select Apply in the bottom left <arrow 4>.
- After coding is complete, an ignition cycle will need to be performed.
- Clear the coding fault stored in the ABS Control Module.
