# Orthopantomograph® OP200 & OP200 D Orthoceph® OC200 & OC200 D Troubleshooting Manual

200214 rev 3

Code: 200214 rev 3 Date: 22 May 2008  
Document code: D500211 rev 3

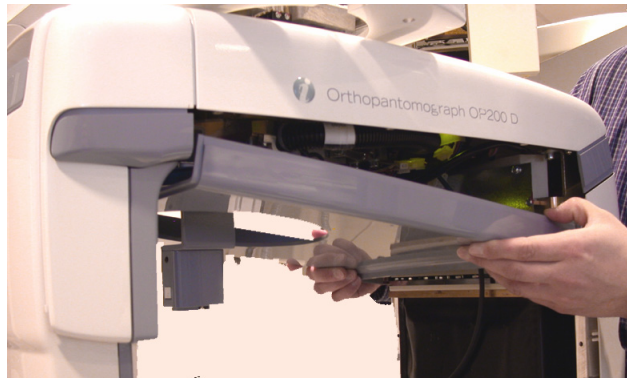
### 3.2.4 PAN AEC Terminal board (60247) leds status check

| Led/signal | Status Color | Unit Ready | During Panoramic Exposure |
| H1 (+2.5V) | green | ON | ON |
