Liebert® IntelliSlot™ Unity Card

Version 8.0.0.1_00101 Firmware

December 11th, 2020

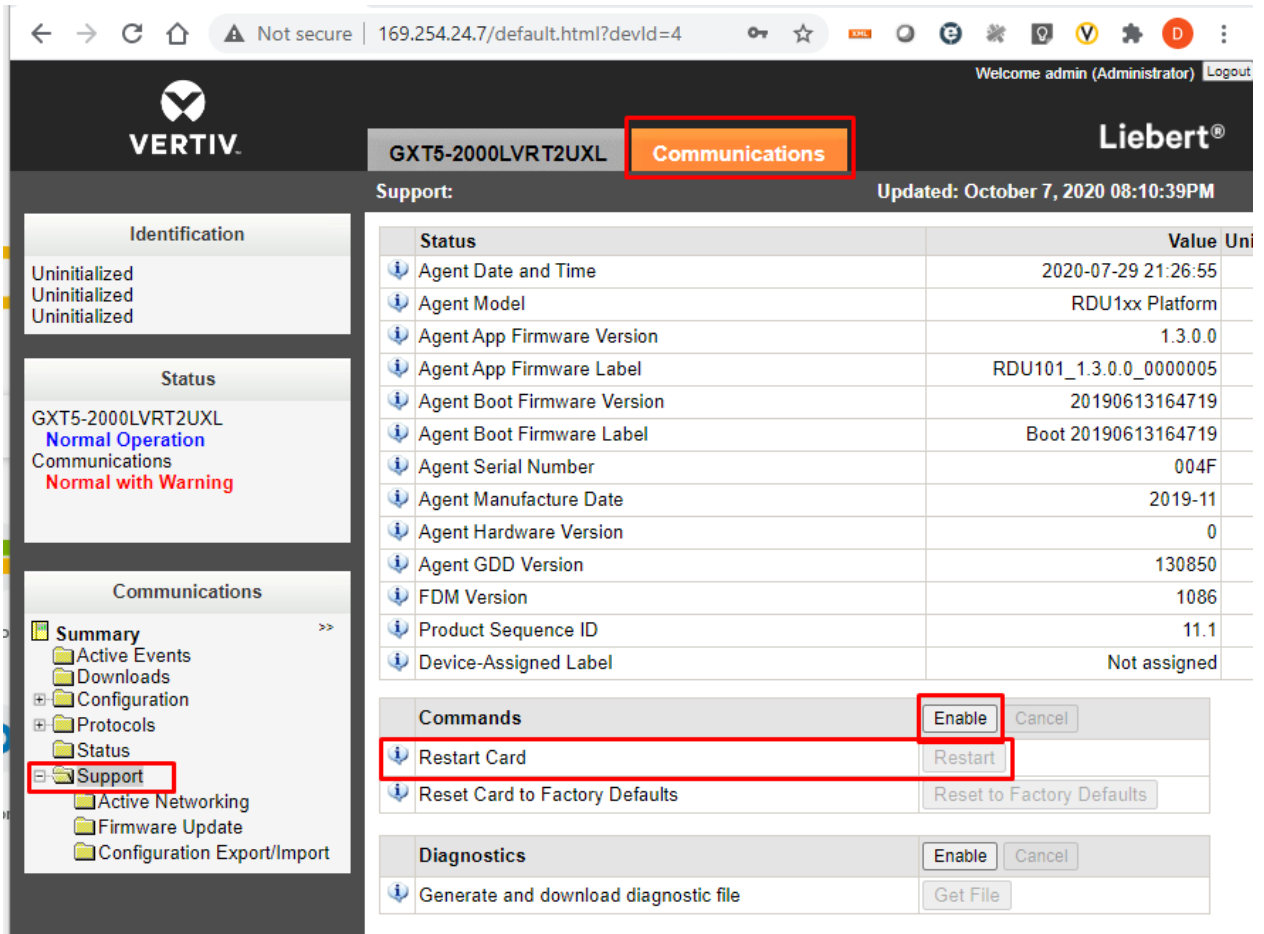
15) The **Normal with Warning** message can be cleared by **Restarting** the card.

Navigate to:

- a. "Communications" tab
- b. "Support" folder
- c. Click "Enable"
- d. Click "restart"
- e. Click "OK" in the browser pop-up dialogue
