Architectural Design and Construction

Instructor's Manual

DEPARTMENT OF HEALTH AND HUMAN SERVICES
Centers for Disease Control and Prevention
National Institute for Occupational Safety and Health

DHHS (NIOSH) Publication No. 2013-133

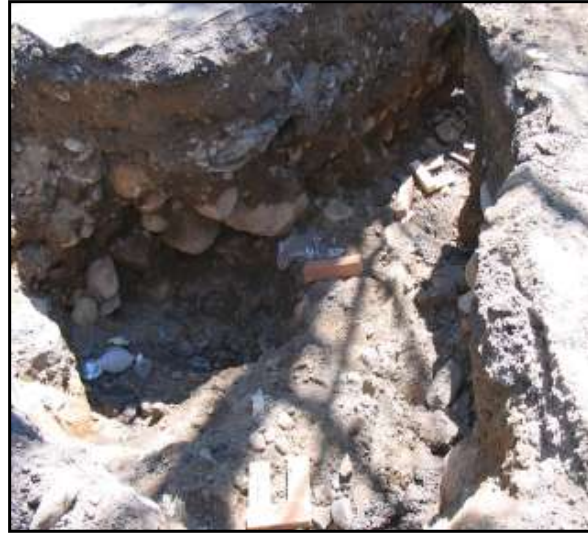
*Figure 4: Area of trench collapse
Note the large boulders hanging from the excavation faces and undermined areas on the edge of the trench (courtesy of OSHA)*

The OSHA investigation resulted in findings that the trench section that collapsed was a triangular shaped area at the northwest corner of the excavation, approximately 5 feet 1 inch (5' 1") in length, 4 feet (4') wide, and 6-7 feet (6-7') deep. Multiple hazards were present, but had not been identified and remediated. The W side of the excavation collapsed and pieces of asphalt paving and rock fatally crushed the victim while he was making the sewer tap (Figures 3 and 4).

The key to preventing a trench accident is not to enter an unprotected trench. When the walls of a trench collapse or cave in, the results are entrapment or struck-by incidents to anyone caught inside, accidents which can occur in seconds. Many workers in a trench are in a kneeling or squatting position that results in little opportunity for an escape. Victims do not need to be completely covered in soil. Even with partial covering, enough pressure is created for mechanical asphyxia in which the weight of the dirt and soil compresses the chest. One cubic yard of soil has an average weight of 2500 pounds (Figure 4), but can vary due to the composition and moisture content.

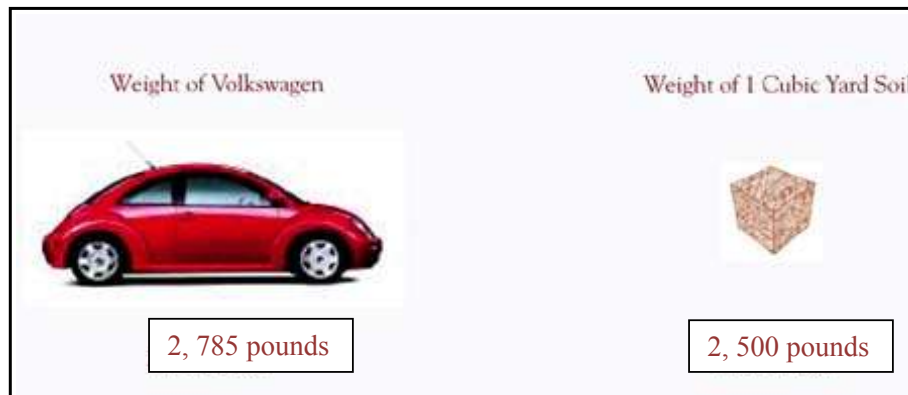
Figure 5: Weight of one cubic yard of soil (courtesy of “Weights of Building Materials, Agricultural Commodities, and Floor Loads for Buildings” standard reference)

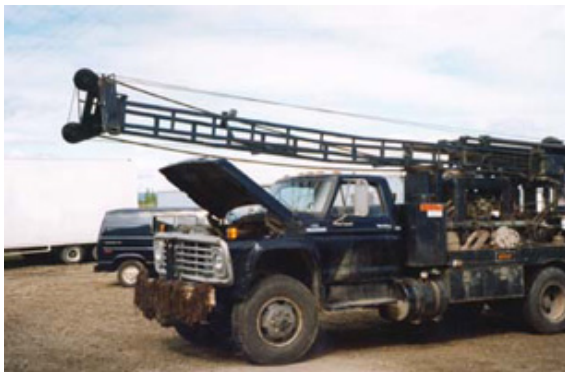
Figure 2a. View of drill rig, front driver's side

The equipment involved in the incident was a 1979 auger (mechanical rotary drill) mounted to a truck bed ([Figure 2a and 2b](#)). The truck was equipped with three outriggers: one at the front, mid-distance from both side; and two at the rear. The master derrick (or mast) was approximately 27 feet long with a maximum vertical rotation of 90 degrees from a rear pivot point 3½ feet from the end of the mast. The mast's pivot point was 8 feet above ground level. The height of the mast when fully raised was 31½ feet. All mast, drill, and pump controls were located at the rear of the truck. The control panel was in poor condition with worn and weathered labels ([Figure 2c](#)). An operator's platform consisted of a small metal grate attached to the rear of the truck below the control panel ([Figure 2d](#)).

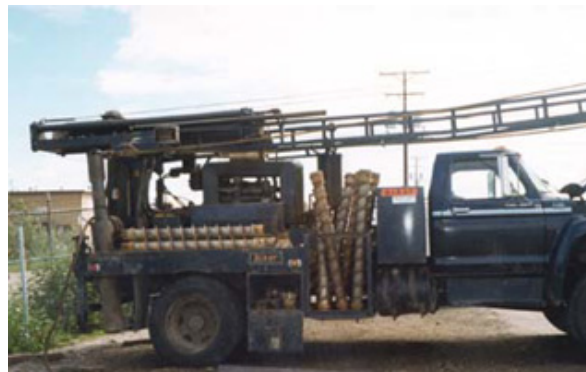
Figure 2b. View of drill rig, passenger side

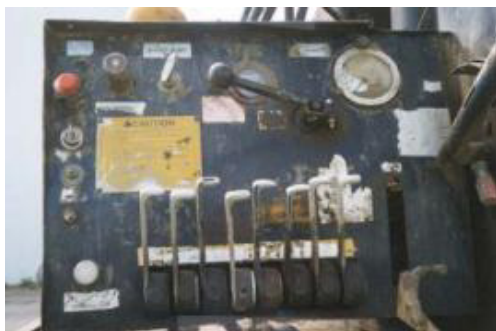
Figure 2c. Control Panel

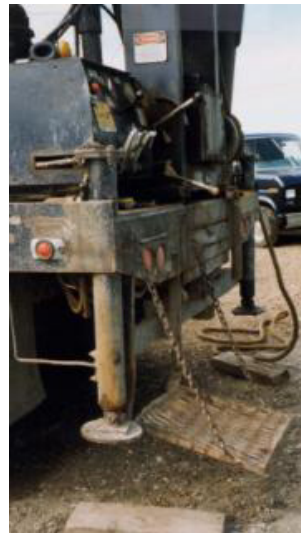
Figure 2d. Control Panel and operator's platform

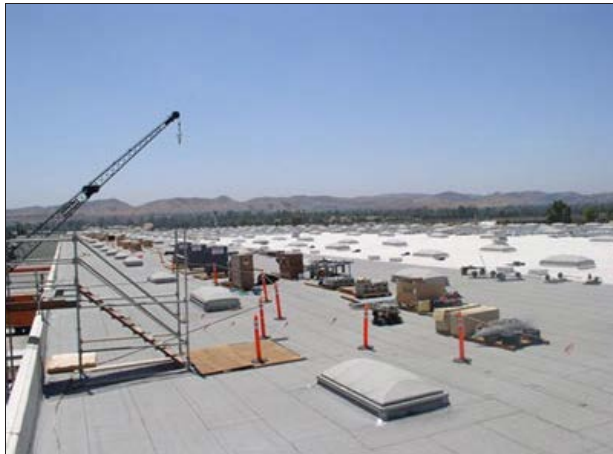
Exhibit 1. The rooftop looking south.

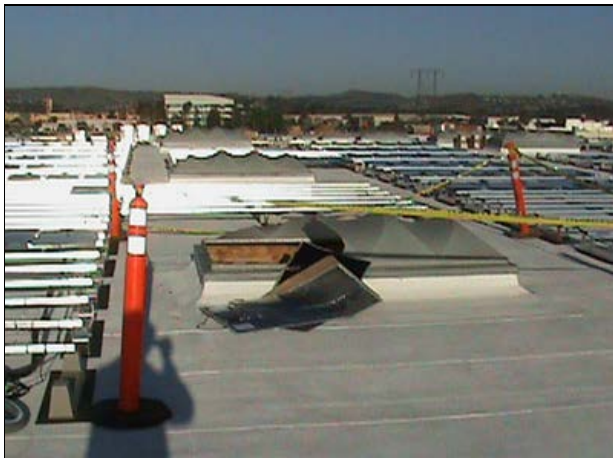
Exhibit 5. A view of the incident scene and the base foundations for the solar panels.

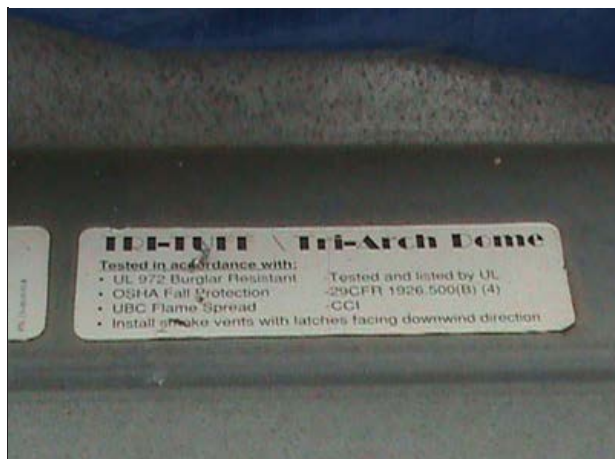
Exhibit 6. The identification tab on the skylight the victim fell through.

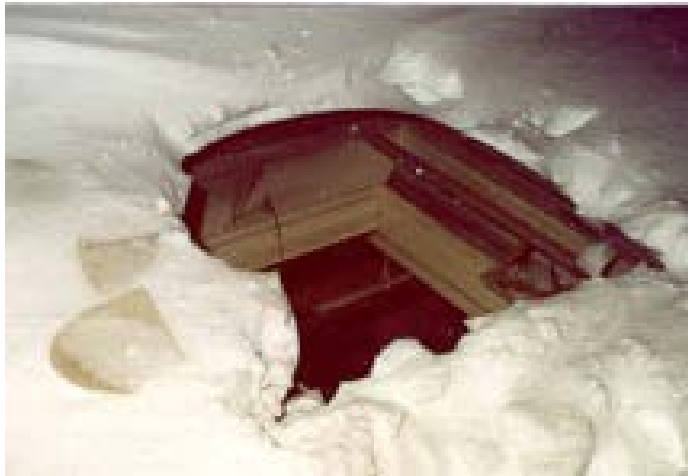
Unguarded Flat Skylight

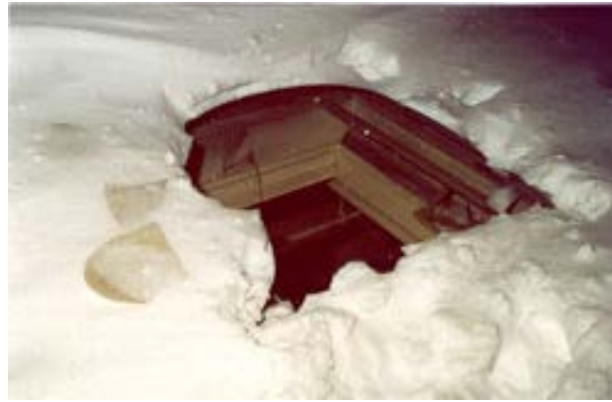
Figure 1. This picture shows the broken skylight where victim fell.

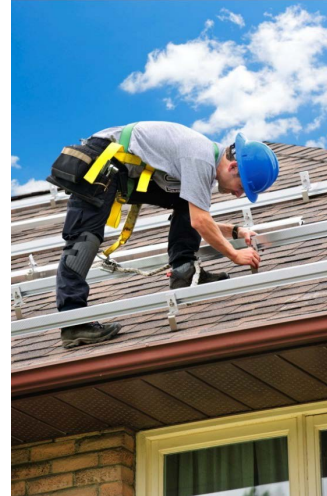
Installing Rails for Solar Panels

How could this man work safer?
