RECORD OF REVISIONS

Section 5: G1000 Equipment Removal & Replacement

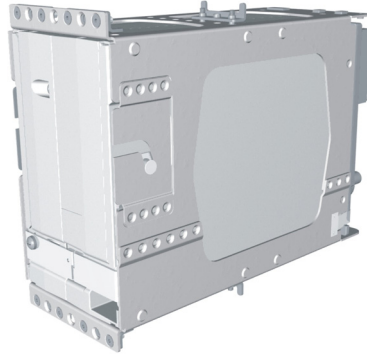
Figure 2-2. GIA 63 Integrated Avionics Unit

Two Garmin GIA 63 IAUs provide VHF COM, VHF NAV, GPS NAV and other various navigation functions, as well as control logic for the Garmin GFC 700 autopilot. GIAs provide communication interface to all other G1000 LRUs in the system. Both GIAs are located directly behind the MFD, installed into their respective LRU racks. The #1 GIA is powered through the essential bus and immediately powers up when the left battery or right battery master switch is turned on. The #2 GIA receives power through the Avionics bus and powers up when the avionics master switch is turned on. Both GIA 63s interface to the following equipment:

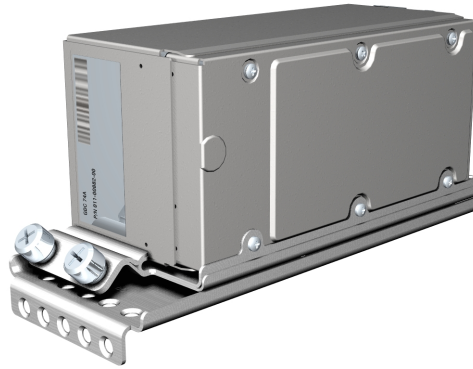
Figure 2-5. GDC 74A Air Data Computer

The Garmin GDC 74A provides digital air data to the G1000 system. The unit is mounted to its rack directly behind the PFD. Power is received from the Essential Bus. The GDC 74A connects to existing pitot/static ports. Air data is sent to the PFD for display. Four redundant data paths exist to the PFD, MFD, and both GIAs.

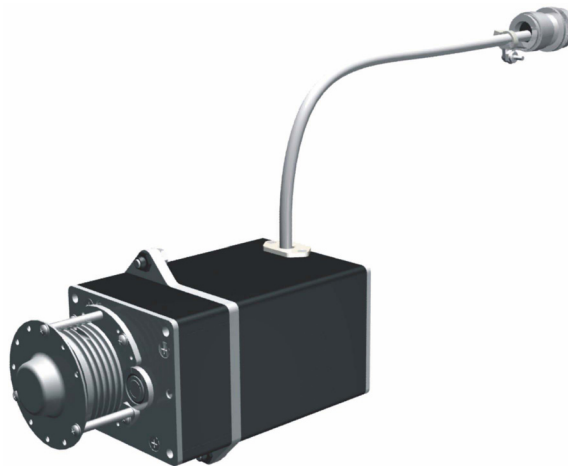
Figure 2-8. GSA 81 Servo and GSM 85 Servo Mount

The GSA 81 is mated to the GSM 85 Servo Mount to form a single servo unit. There are two servo units in this installation:

The design of the servo assembly allows the servo portion (GSA 81) to be removed from the capstan (GSM 85) without the need to de-rig the aircraft control cables. The roll servo is located beneath the rear passenger seats, and the pitch servo is located beneath the aft baggage area.

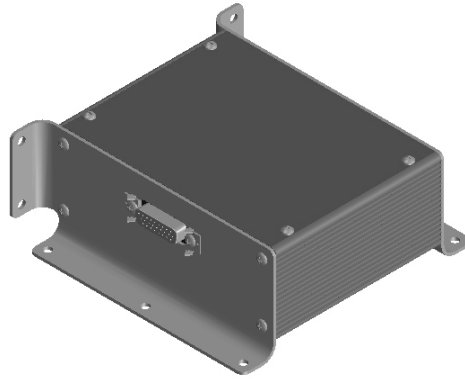
Figure 2-9. GTA 82 Pitch Trim Adapter

The Garmin GTA 82 Trim Adapter is a remote mounted device that is used to allow the GFC 700 to drive a pitch trim actuator provided by the airframe manufacturer. The GTA 82 adapter is located under the instrument panel on the pilot side beneath the standby instruments. The trim adapter is powered by the Essential Bus and interfaces with two GIA 63 Integrated Avionics units through serial communication on separate RS-485 ports.

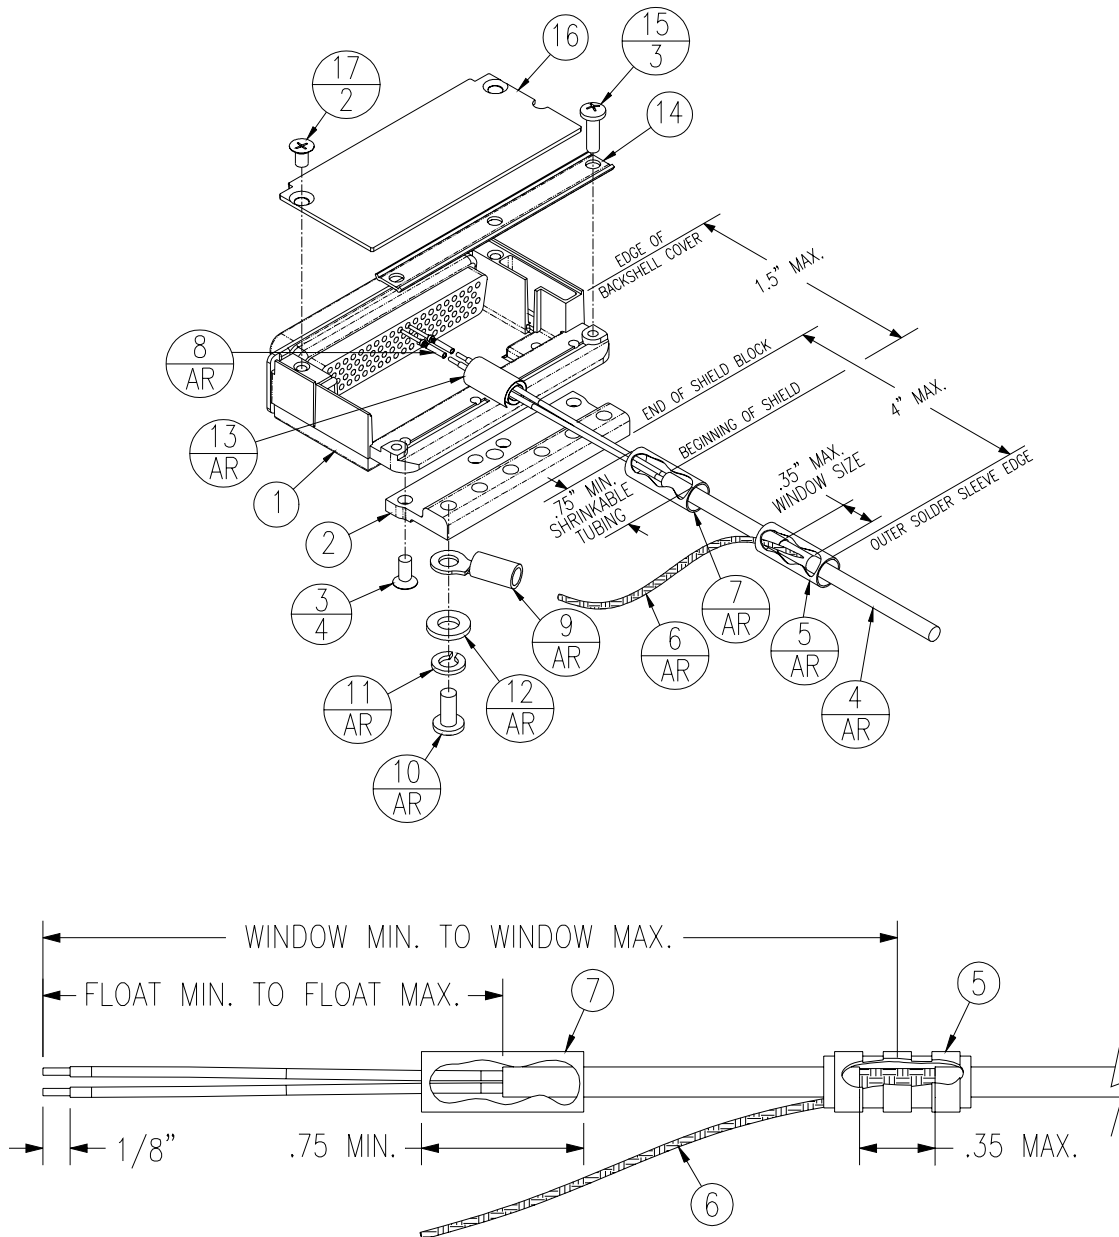
Most G1000 connectors employ a shield block grounding system to provide necessary ground reference to shielding and/or transducers.

Figure 2-12. Shield Block Installation to Backshell (78-pin Connector Example)

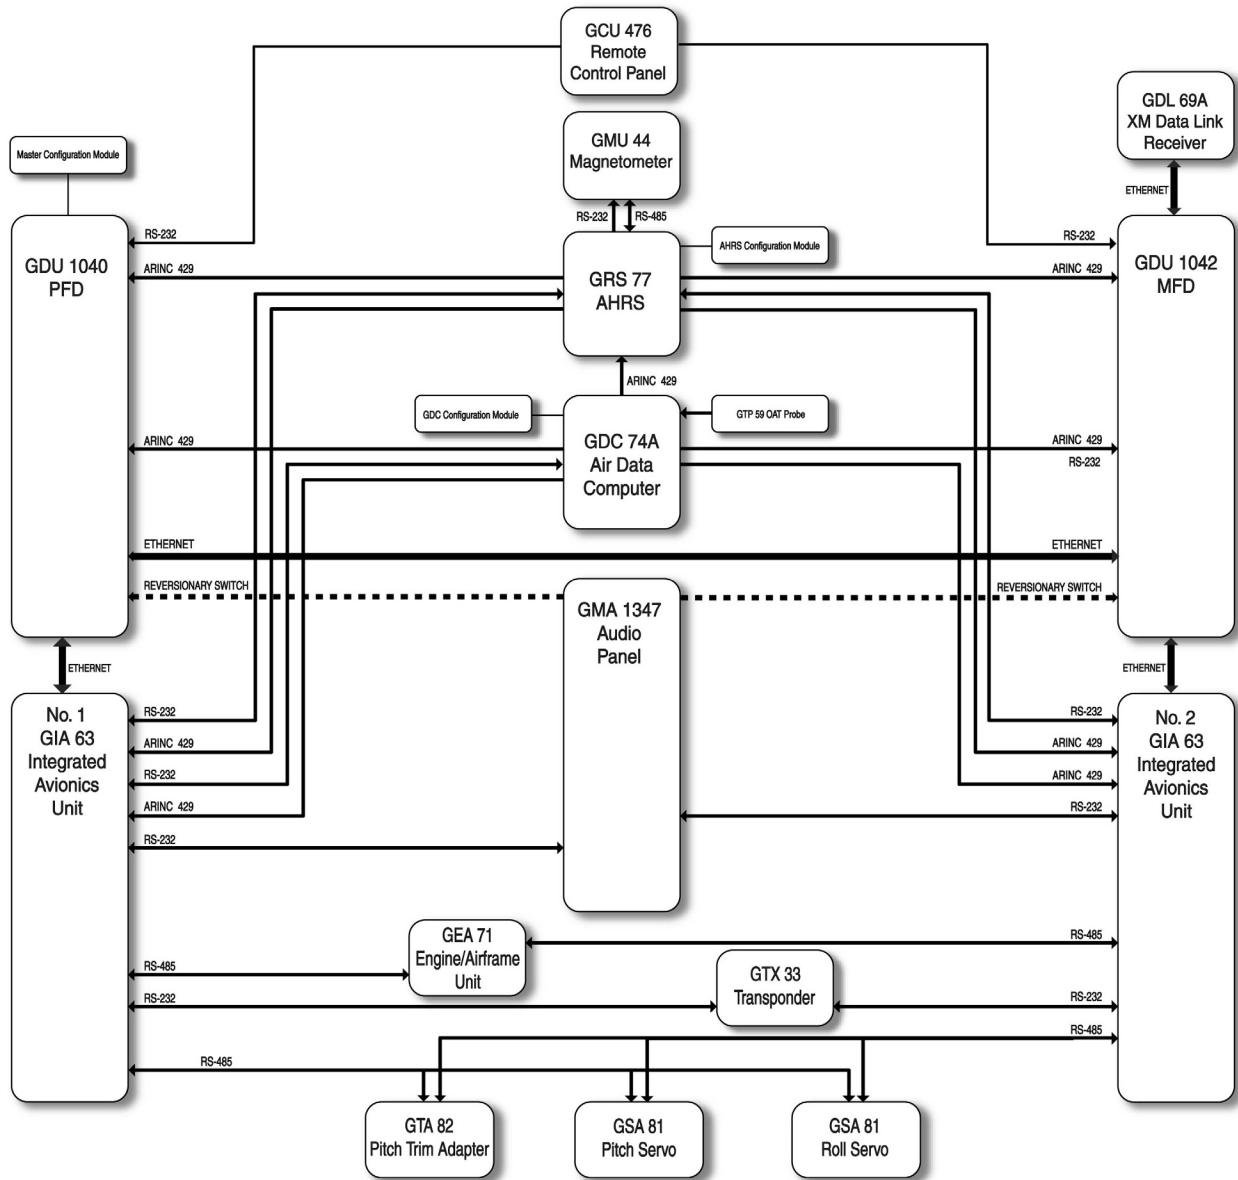
Figure 2-13. G1000 System Interface

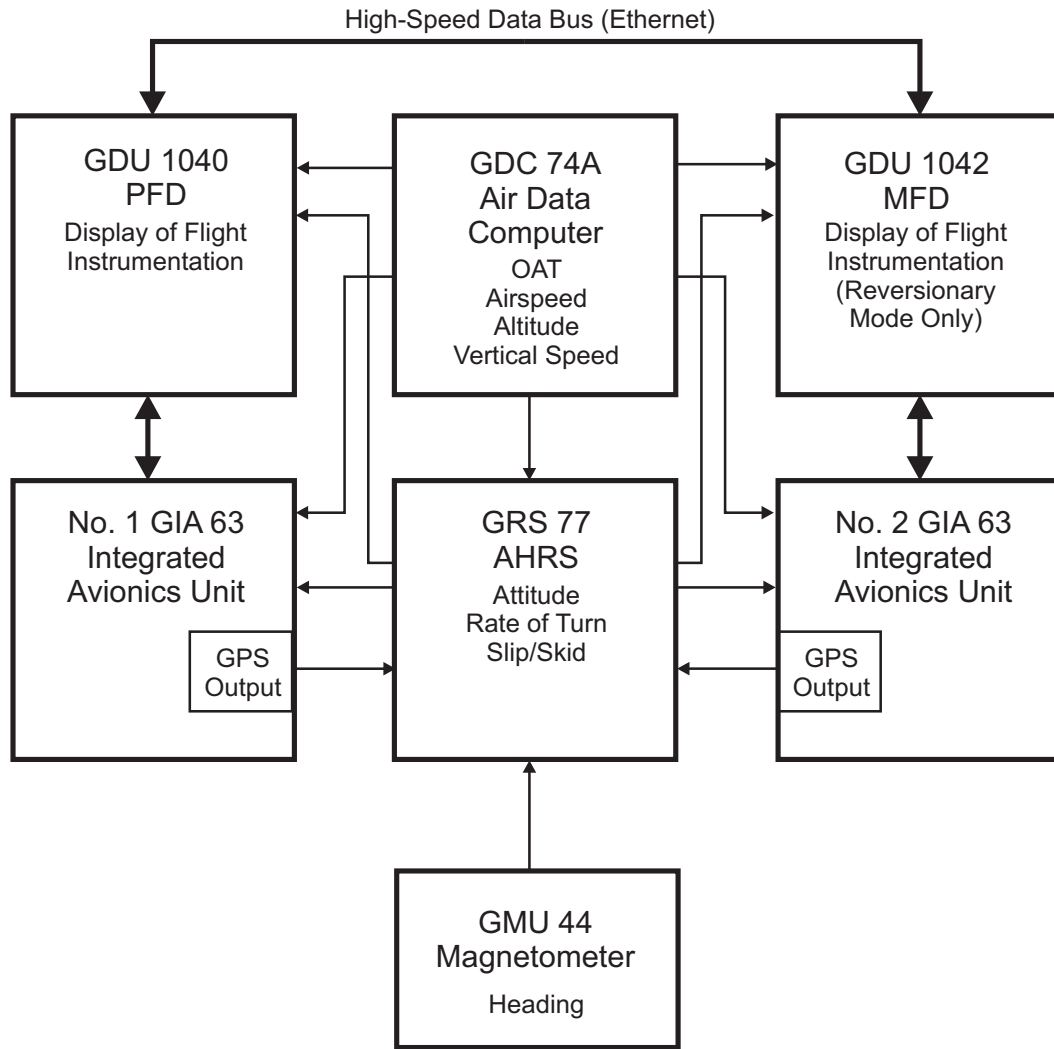
The GRS 77 AHRS, GDC 74A Air Data Computer, and GMU 44 Magnetometer are responsible for providing the G1000 system with flight instrumentation (refer to Figure 2-14). Data consists of aircraft attitude, heading, altitude, airspeed, vertical speed, and outside air temperature information, all displayed on the PFD (data is displayed on the MFD in reversionary mode only).

Primary data outputs from the GRS and GDC are sent directly to the PFD via ARINC 429. Secondary data paths connect the GRS and GDC to the MFD. Additional communications paths connect the GRS and GDC to both GIA 63 units, providing quadruple redundant interface.

The GRS 77 receives GPS data from both GIAs, airspeed data from the GDC, and magnetic heading from the GMU. Using these three external sources, combined with internal sensor data, the GRS accurately calculates aircraft attitude and heading.

Figure 2-14. Flight Instrumentation Interface

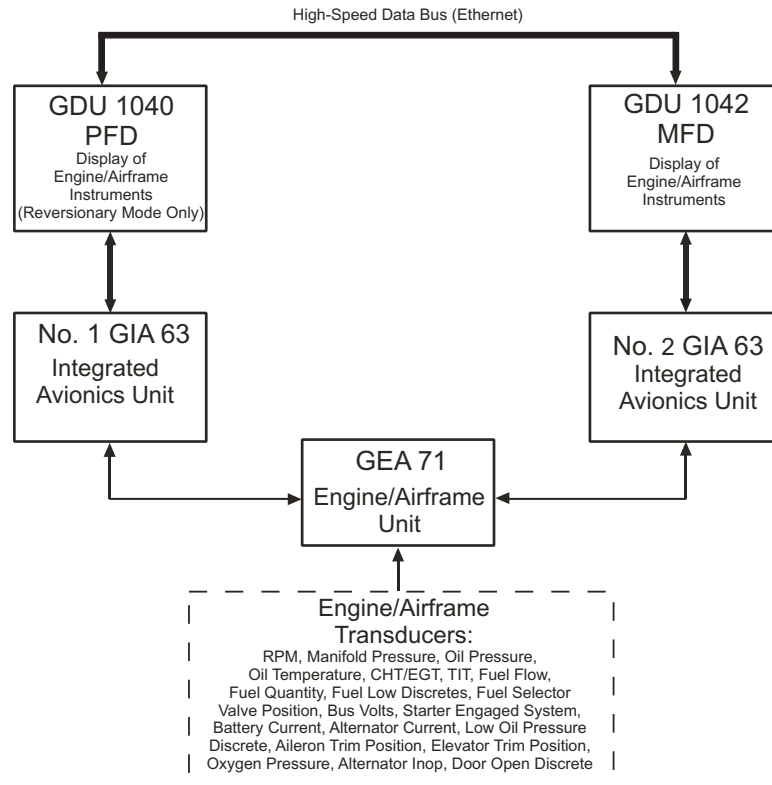
The GEA 71 provides engine/airframe data to the G1000 system. The unit interfaces to transducers shown in Figure 2-15. Analog data is received from the transducers and is converted to a digital signal by the GEA 71. Digital information is then sent through the primary RS-485 serial path to the #1 GIA 63. From the GIA, data is sent through the HSDB connection to the PFD, then on to the MFD for display. A backup data path from the GEA to the #2 GIA 63, then on to the MFD, exists in the event the primary path fails.

Figure 2-15. G1000 Engine/Airframe Interface

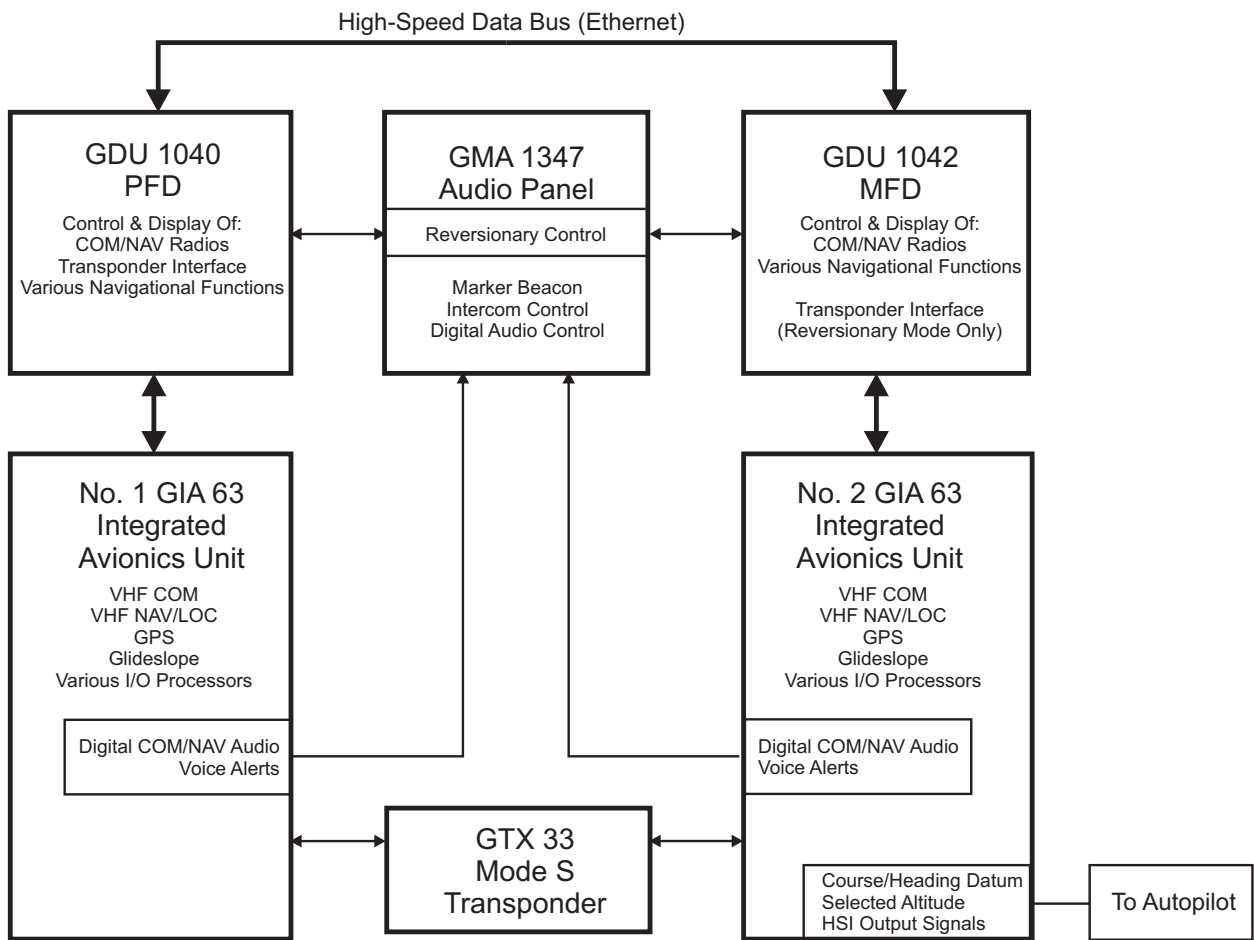
The GTX 33 Mode S Transponder communicates with both GIAs. Transponder data is sent from the GIAs to the PFD where control and operation occurs.

The GMA 1347 Audio Panel controls the display reversionary mode.

Figure 2-16. G1000 Navigation/Communications

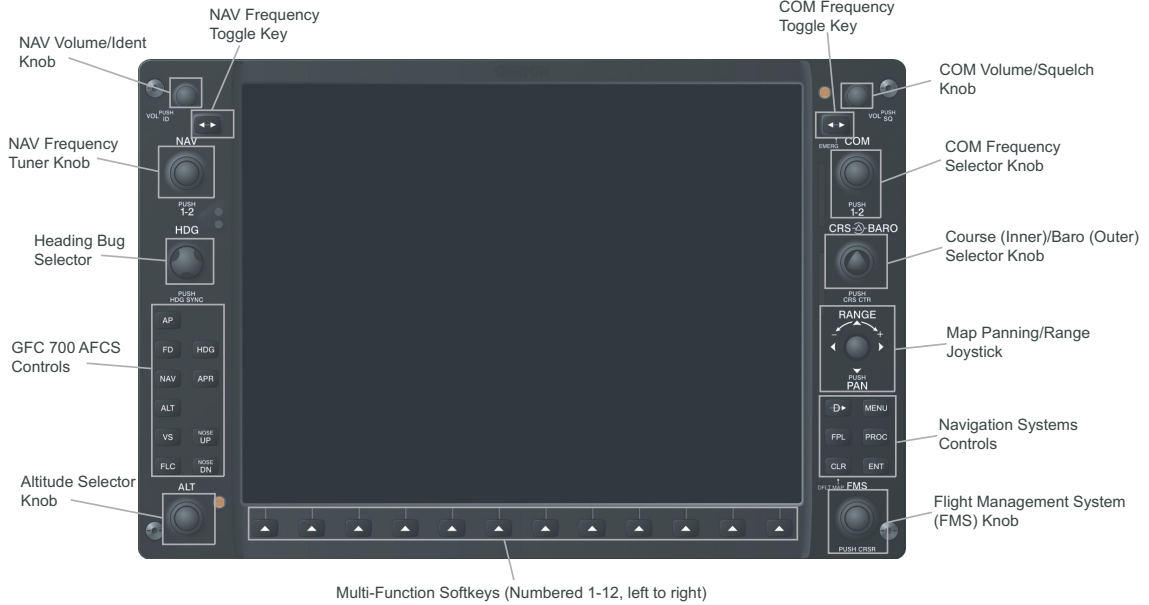
Figure 3-1. GDU 1040/1042 Control Interface

All control and operation of G1000 equipment as normally used in flight occurs through the PFD, MFD, GCU 476 Remote Keypad and GMA 1347 audio panel. Figure 3-1 identifies various GDU 1040/1042 buttons. Figure 3-2 identifies the GCU 476 buttons. Figure 3-3 identifies various GMA 1347 buttons.

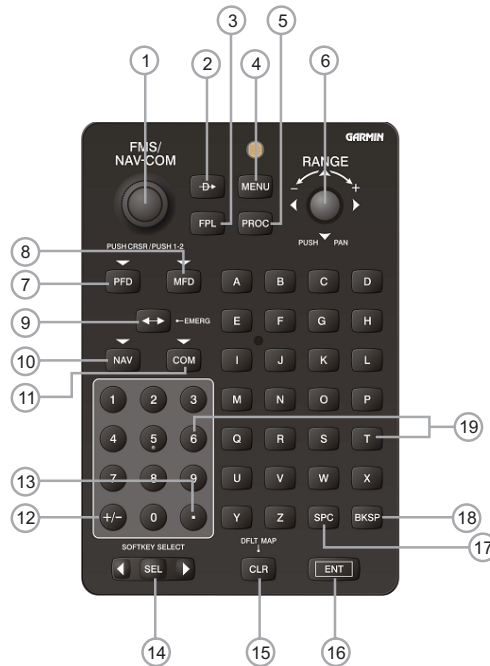
| 1. Dual FMS/NAV Knob | 7. PFD Key | 13. Decimal (.) Key |

Figure 3-2. GCU 476 Controls

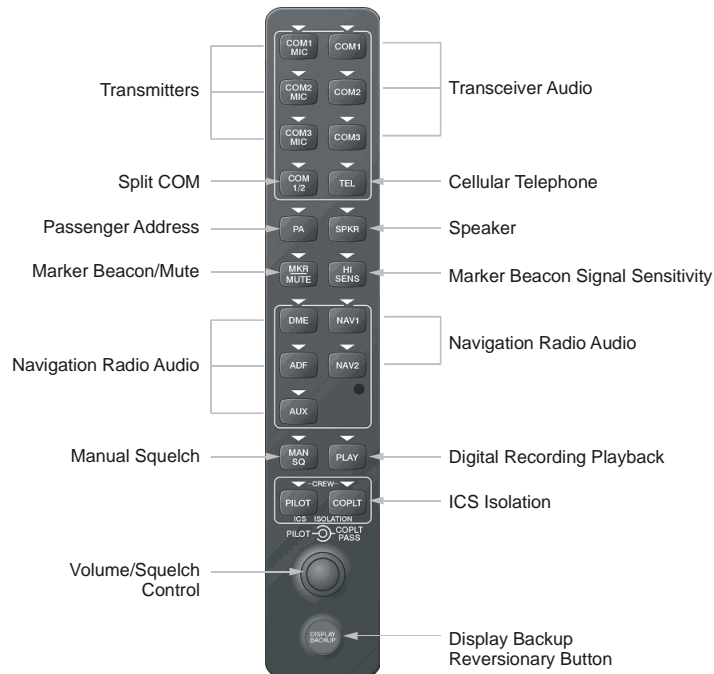
Figure 3-3. GMA 1347 Controls

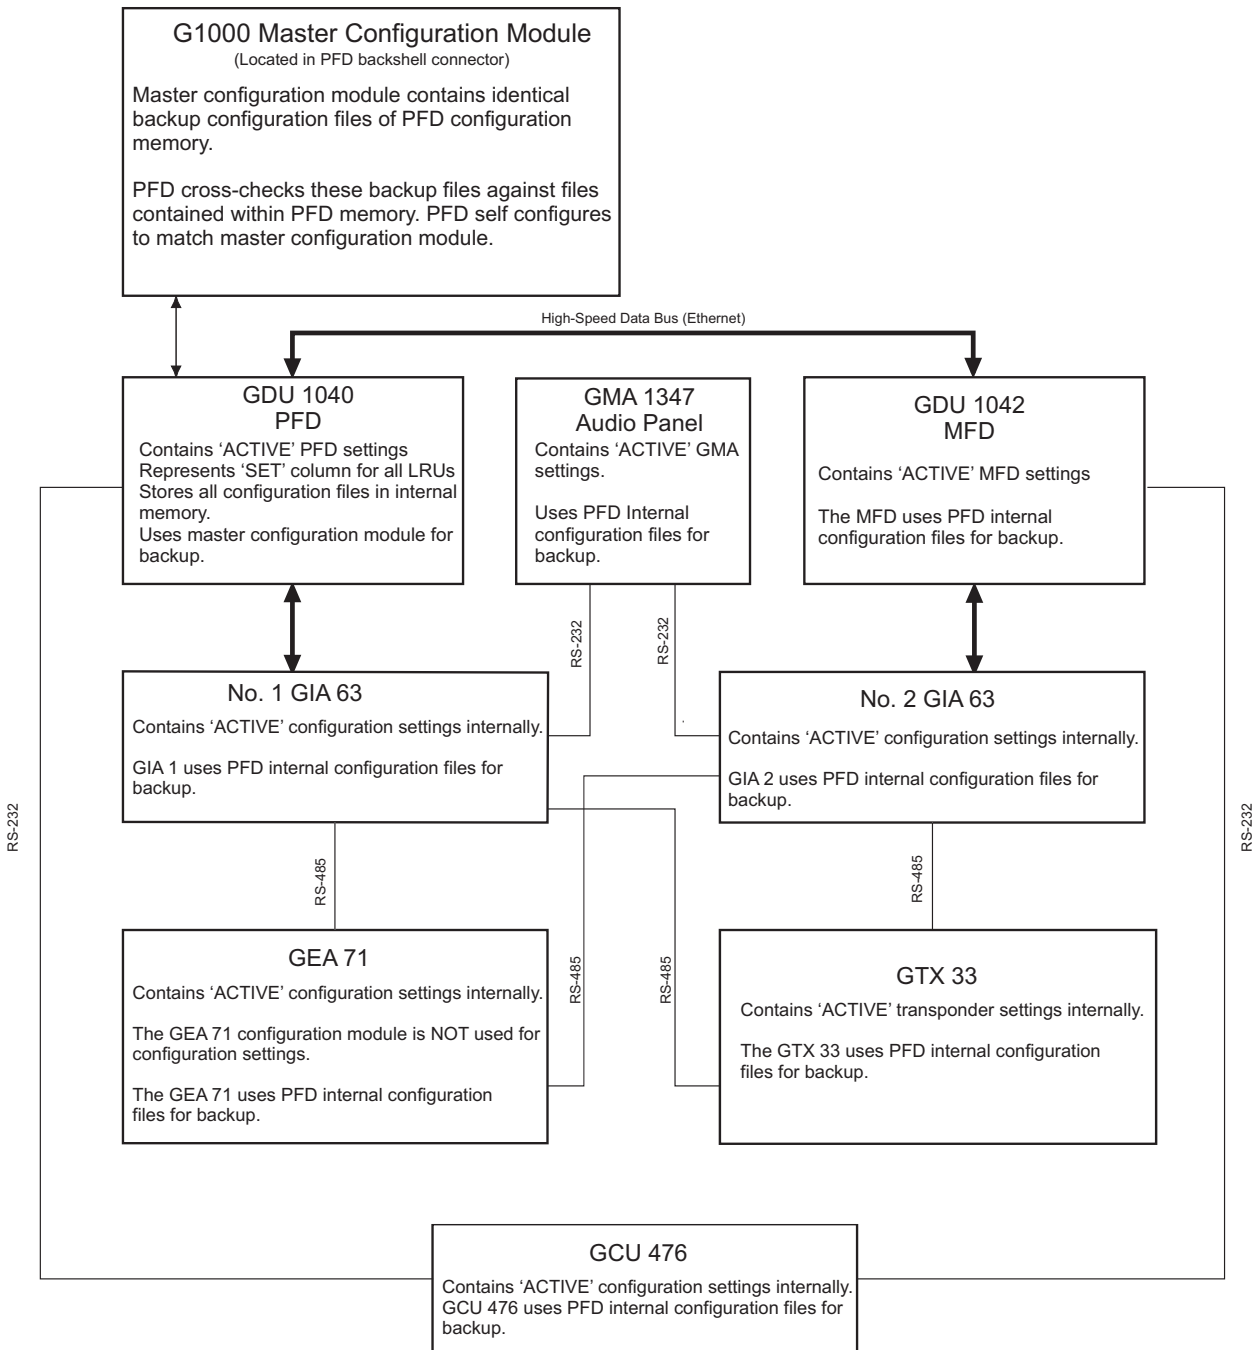
The G1000 system is designed to store all configuration settings in various places so that the configuration is retained in the aircraft during maintenance of units. Figure 3-9 and Figure 3-10 illustrate where the various configuration files are stored.

Figure 3-9. G1000 LRU Configuration File Storage

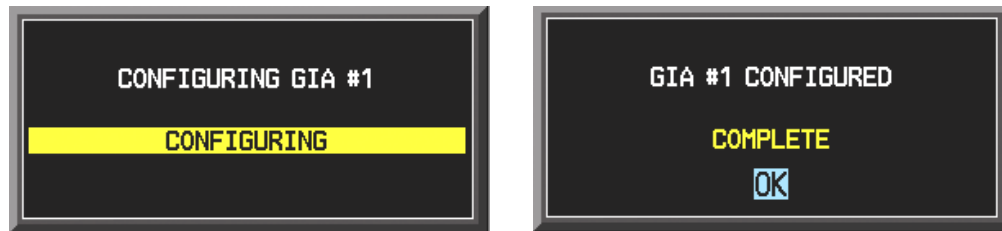
When configuration settings are changed, the technician receives on-screen prompts and/or confirmations such as those shown in Figure 3-13.

Figure 3-13. Configuration Status

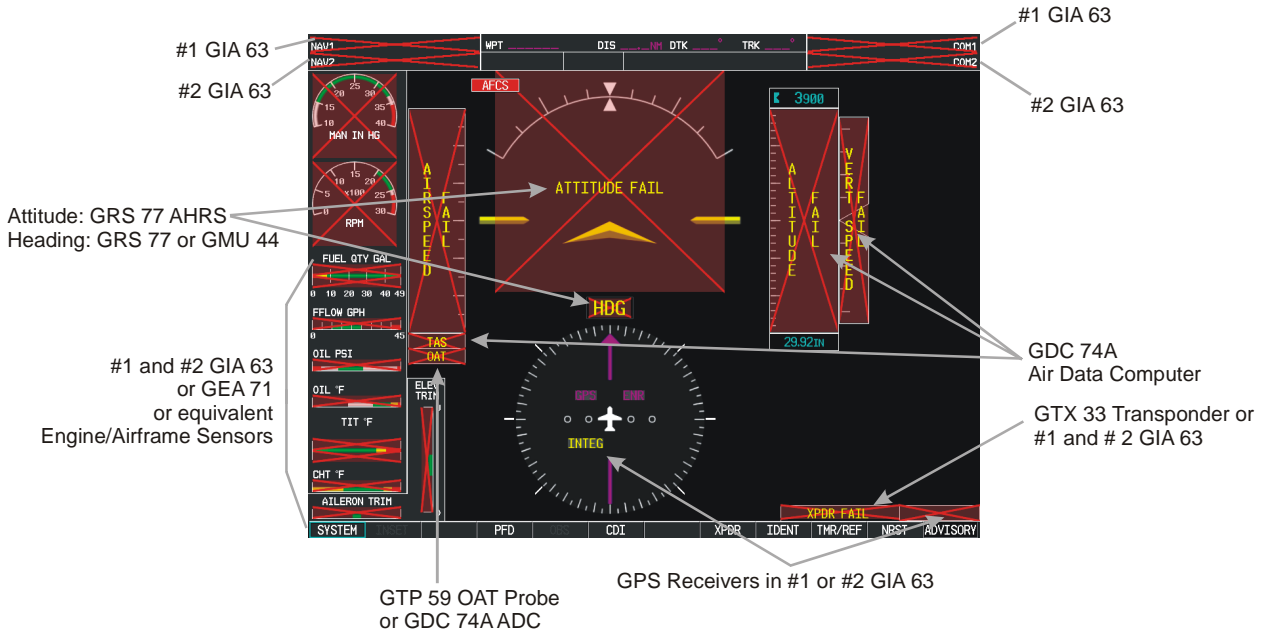
Figure 4-6. System Annunciations

If data fields become invalid due to an LRU failure, the PFD/MFD typically annunciates the failure with a large red X, as shown in the figure below.

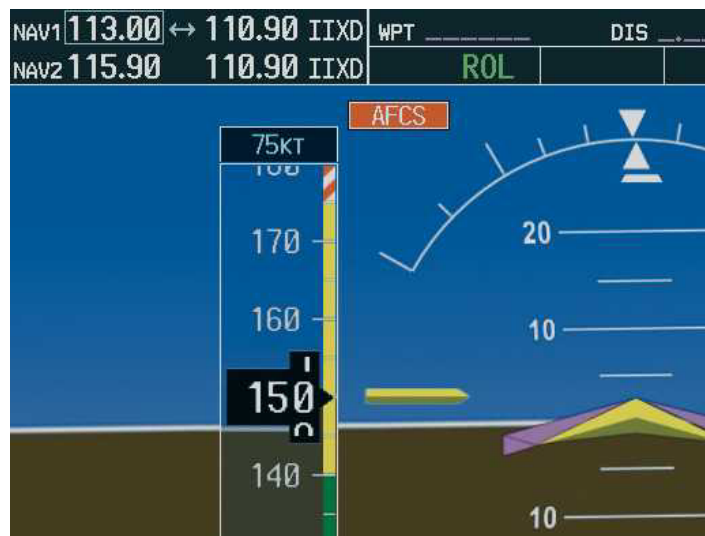
Figure 4-9. AFCS Annunciation Field

The GFC 700 AFCS Annunciation field is located above the airspeed tape on the PFD as shown in Figure 4-9.

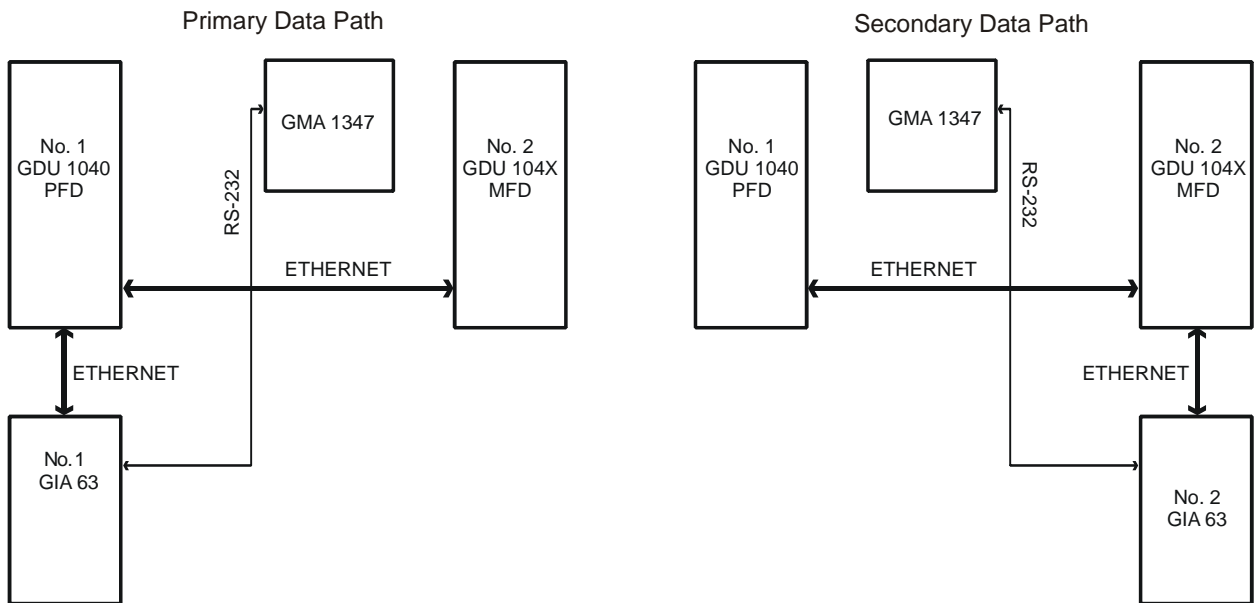
Figure 4-11. Backup Path Alerts

Message	Cause	Solutions
BACKUP PATH – Audio panel using backup data path.	The GMA 1347 is using a backup RS-232 data path.	✓ Ensure the GMA/GIA RS-232 data lines are working properly.

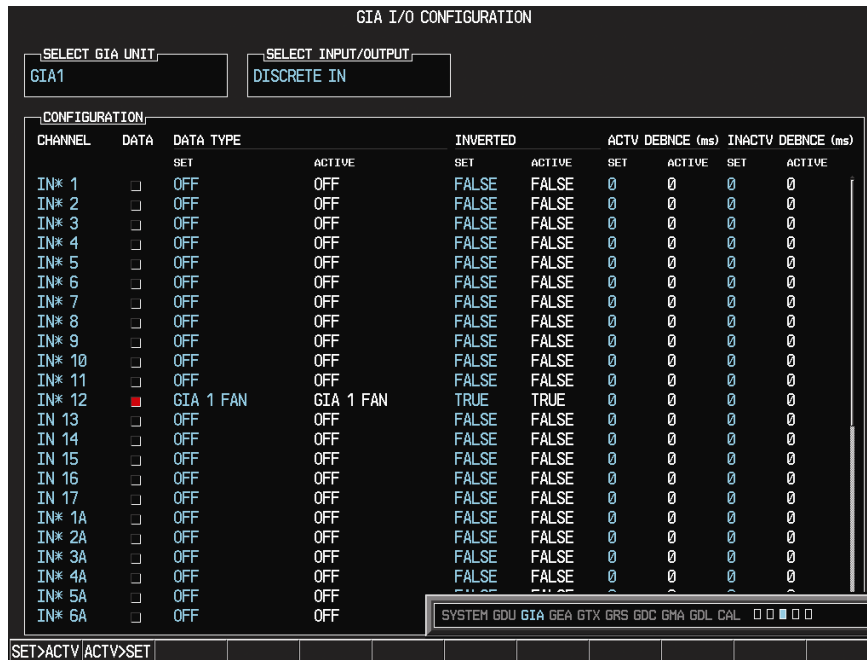
Figure 4-14. GIA I/O CONFIGURATION Page

Discrete and analog input/output channels for GIA 1 and GIA 2 are shown on this page. All settings are pre-established for a particular installation and are loaded from the G1000 Loader Card and should not be changed. The 'GIA1' and 'GIA2' configuration files contain the settings shown on this page.

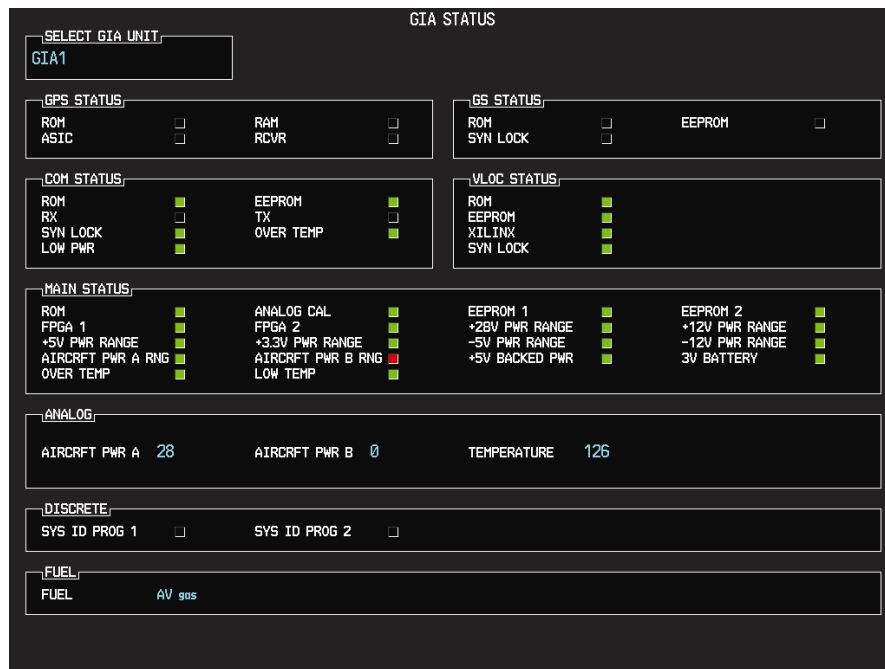
Figure 4-16. GIA STATUS Page

This page shows various items related to the GIA 63 and its operation. The technician can use this page to aid in diagnosis and troubleshooting of the GIA 63 .

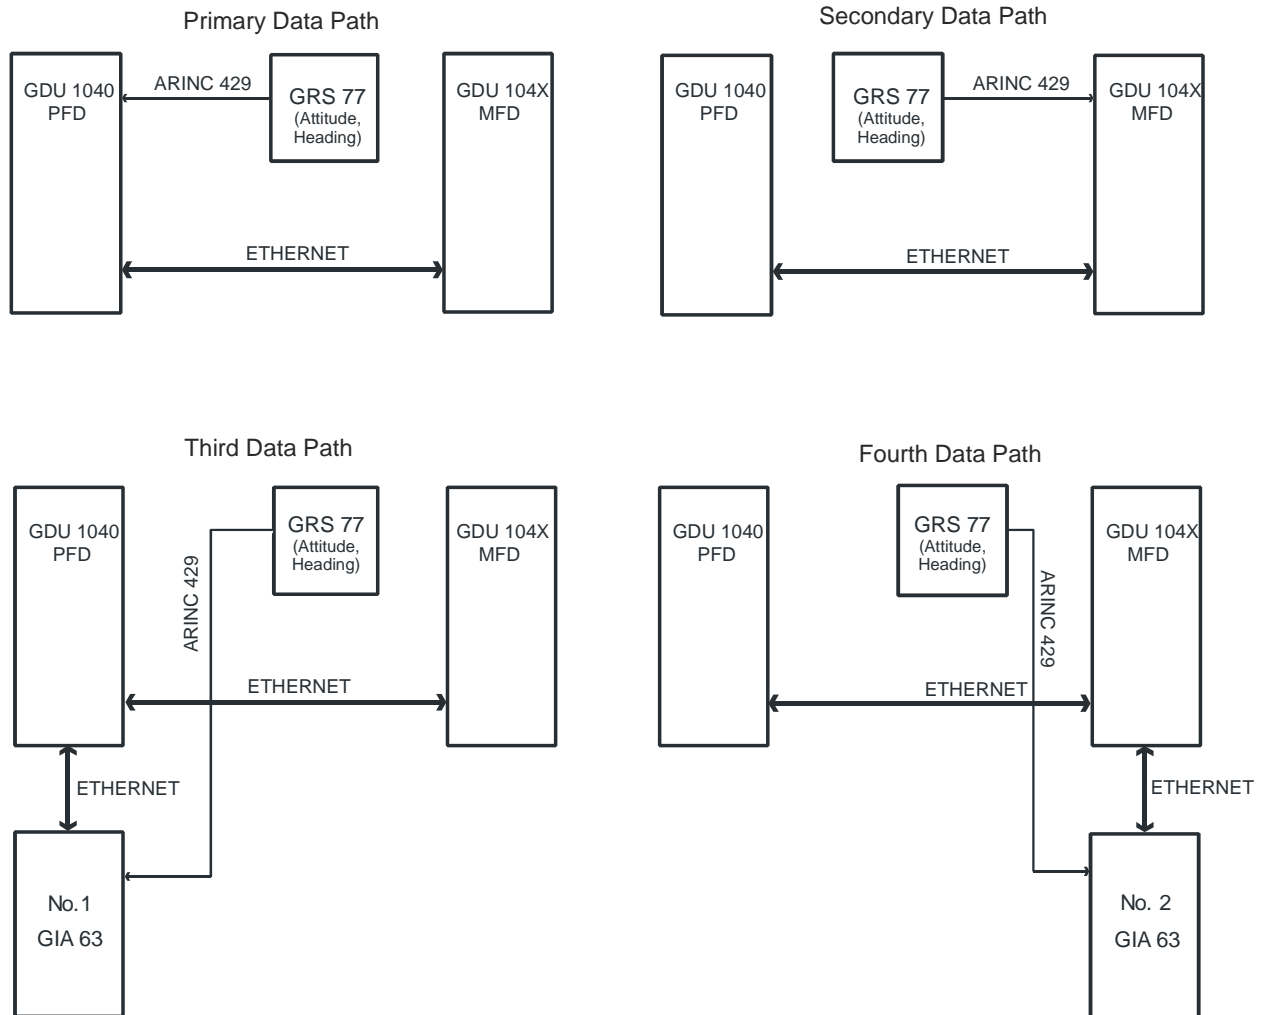
Figure 4-22. GRS 77 Data Paths

Message	Cause	Solutions
BACKUP PATH – AHRS using backup data path.	The PFD is using a backup ARINC 429 data path to receive AHRS data.	<ul style="list-style-type: none"> See 4.9.4 for troubleshooting.

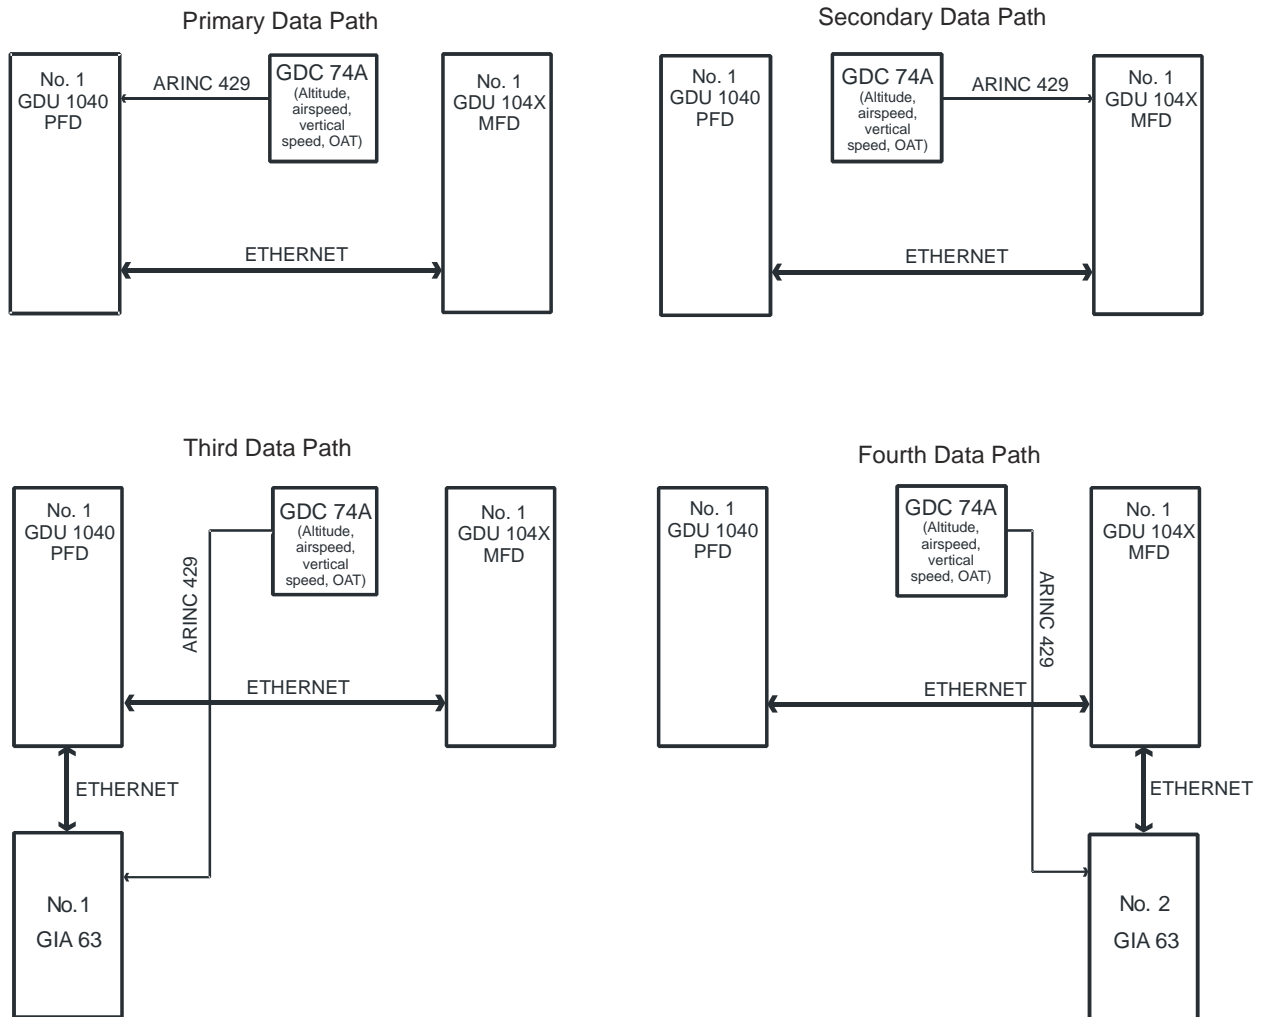
Figure 4-23. GDC 74A Data Paths

Message	Cause	Solutions
BACKUP PATH – Airdata using backup data path.	The GDC 74A is using a backup ARINC 429 data path.	<ul style="list-style-type: none"> See Section 4.10 for troubleshooting.

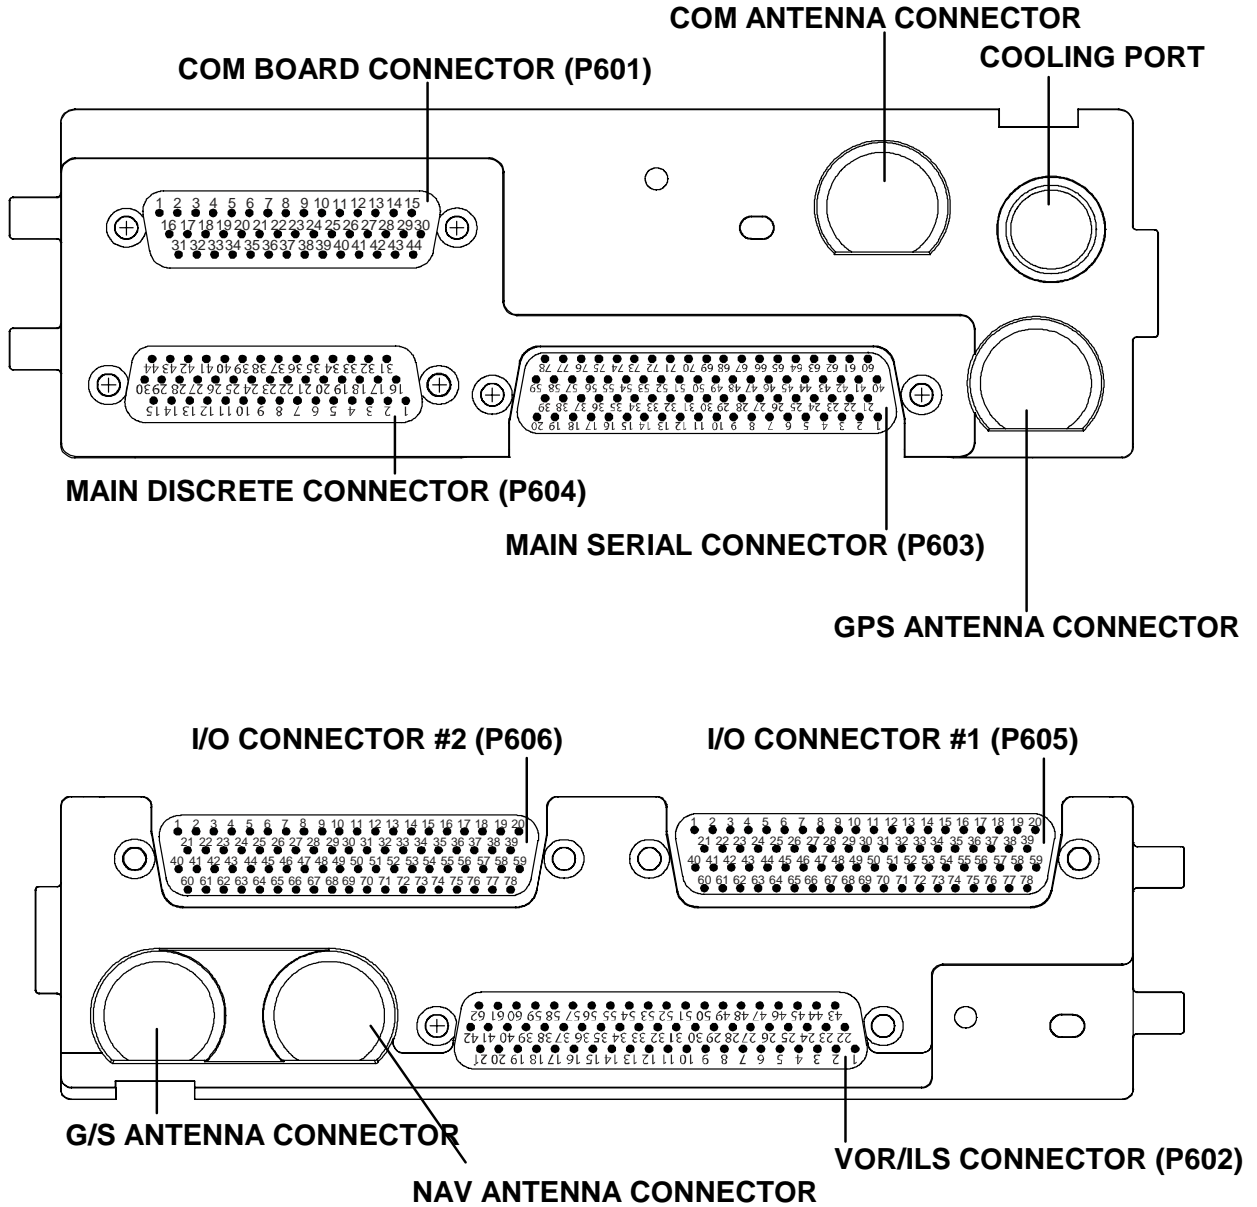
Figure 4-29. GIA 63 Backshell Connectors

The following figures depict the backshell connectors as viewed with the LRU removed.

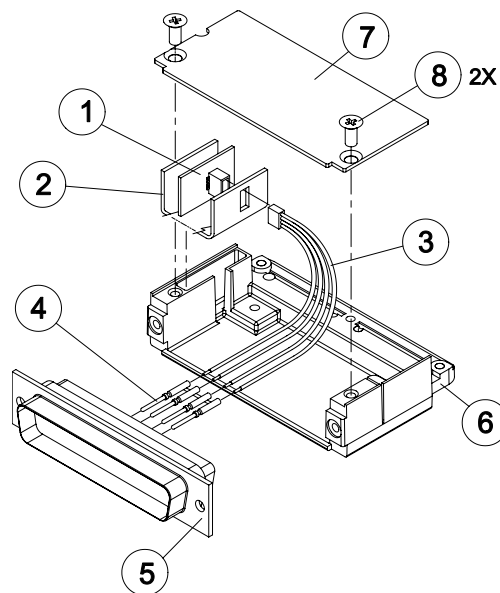
Figure 5-2. Configuration Module Installation

Location of Configuration Modules (Garmin P/N 011-00979-00):

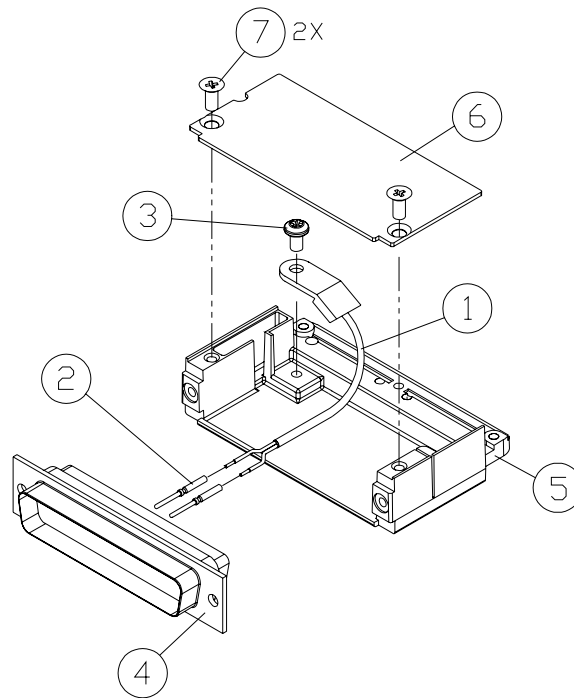
Figure 5-3. GEA Backshell Thermocouple

1. Crimp pins (2) onto each of the thermocouple wires (1). Ensure that pre-stripped wire length is 1/8" prior to crimping.
2. Insert newly crimped pins and wires into the appropriate connector housing location (4) as specified by the 350/400 avionics wiring diagram.
3. Place thermocouple body (1) onto the backshell boss (5). Place the thermocouple as shown in Figure 5-3 so that the wires exit towards the bottom of the backshell.
4. Fasten thermocouple tightly to backshell using the provided screw (3).
5. Fasten cover (6) to backshell using the provided screws (7).

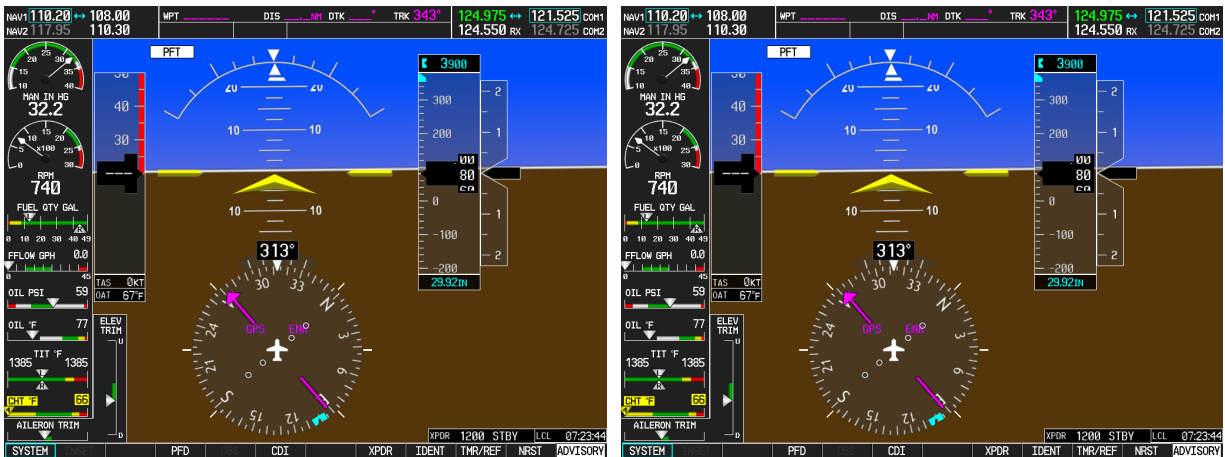
Figure 6-2. G1000 Reversionary Mode Check

3. Push the red display reversion button on the GMA 1347. Verify both displays enter reversionary mode (both should have valid attitude, heading, altitude, airspeed, vertical speed, and engine instruments):

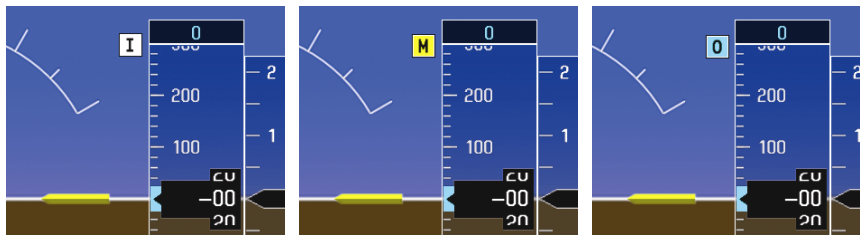
Figure 6-3. Marker Beacon Symbology

Using a ramp tester, simulate the outer marker, middle marker and inner marker signals by following the test equipment manufacturer's instructions. Verify that each marker audio signal is present over the headphones and speaker.

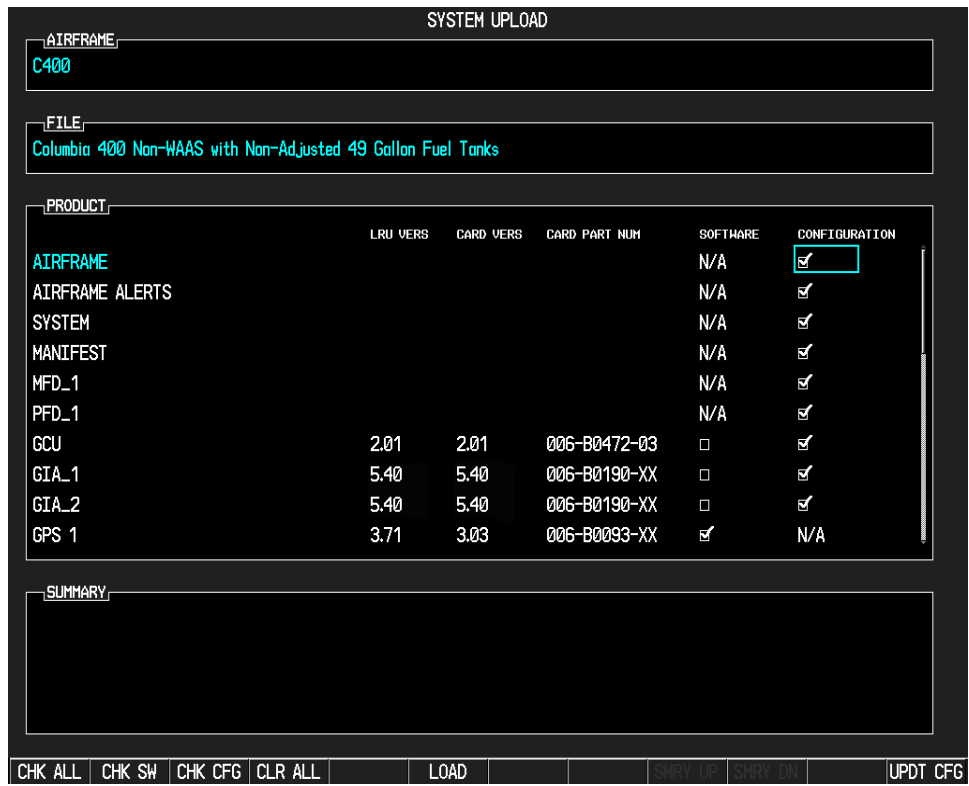
- The PRODUCT window will populate and display software and configuration file information for each G1000 LRU. The LRU VERS column shows the currently loaded software version in the LRU, whereas the CARD VERS column shows the LRU software version stored on the Loader Card. Each check designates a file to be loaded to the G1000.

By default, if an inequality between the LRU and CARD columns exists, the SOFTWARE and CONFIGURATION boxes will be pre-selected (checked).

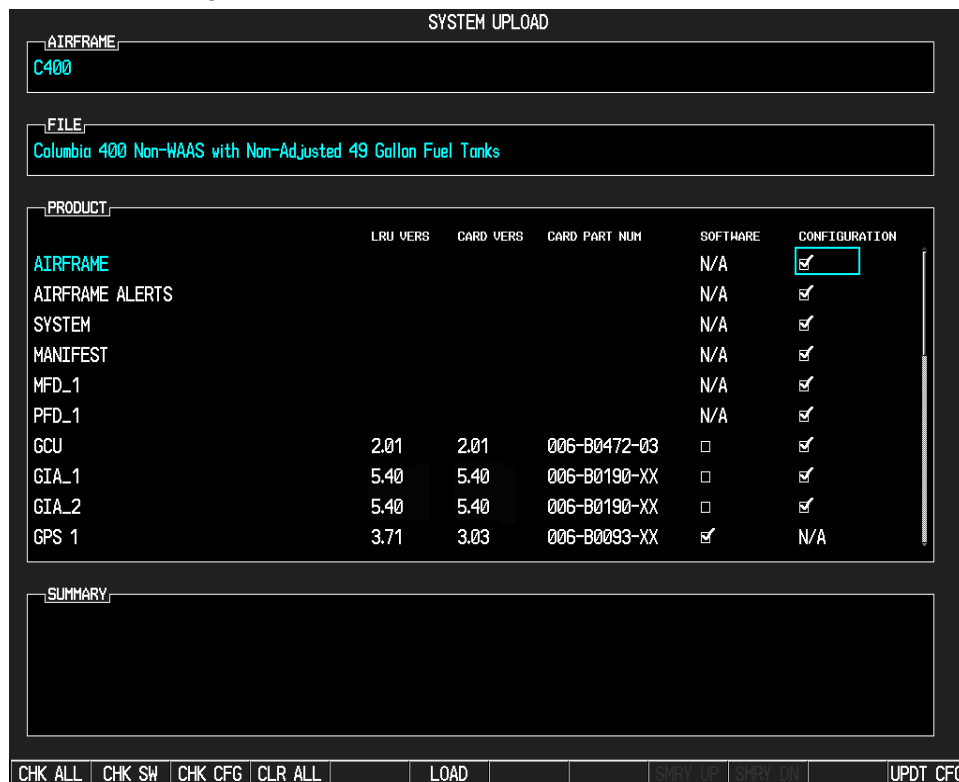
- The PRODUCT window will populate and display software and configuration file information for each G1000 LRU. The LRU VERS column shows the currently loaded software version in the LRU, whereas the CARD VERS column shows the LRU software version stored on the Loader Card. Each check designates a file to be loaded to the G1000.

By default, if an inequality between the LRU and CARD columns exists, the SOFTWARE CONFIGURATION boxes will be pre-selected (checked). By default all of the CONFIGURATION boxes will be pre-selected.
