RECORD OF REVISIONS

Section 5: G1000 Equipment Removal & Replacement

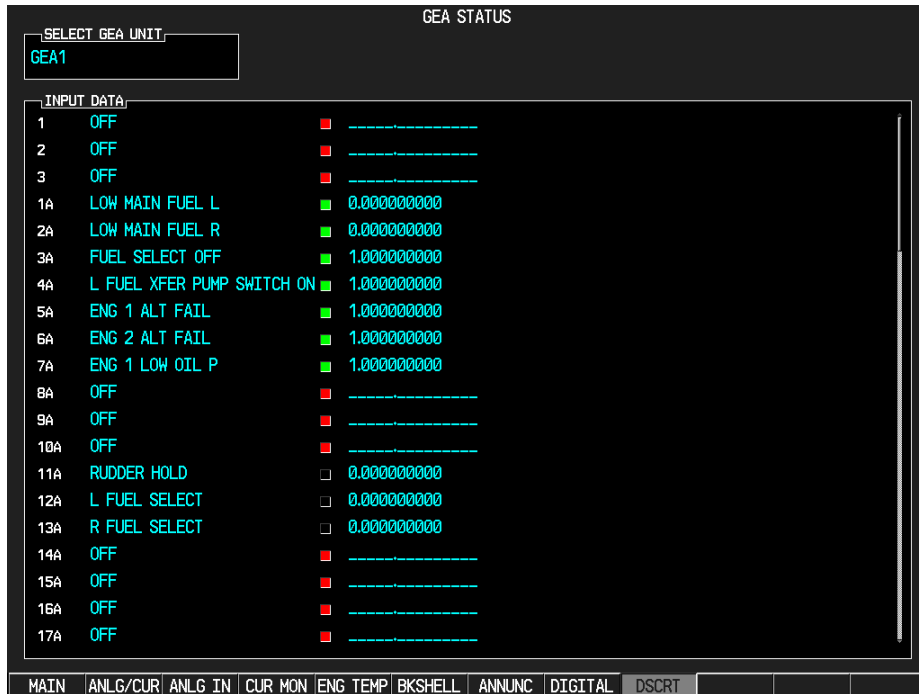
1. Using the large FMS knob, select the GEA STATUS page (2nd page in the GEA page group). GEA 1 will be shown by default.
2. Press the DSCRT softkey to select the Discrete Inputs status page.

Unless specified, the status of other discrete inputs may not match the figure above and does not matter for this portion of the test.

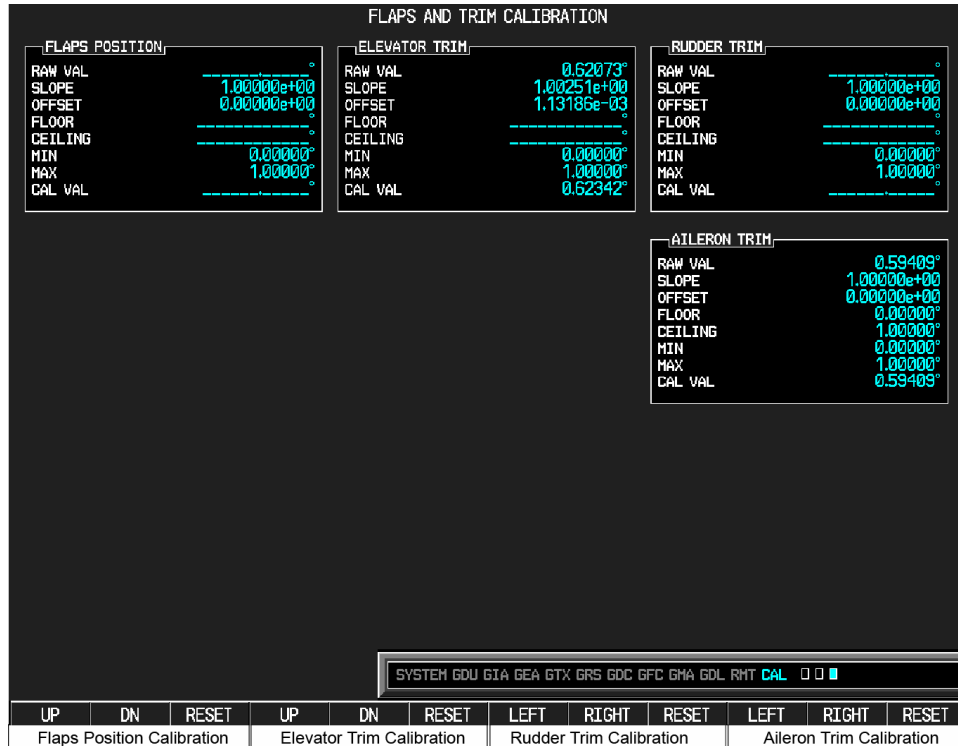
Figure 6-5. Aileron and Elevator Trim Calibration

1. Go to the CAL Page Group on the PFD.
2. Select the Flaps and Trim Calibration page (3rd page in CAL group), shown below:

3. This page is protected and requires a keystroke password to perform the calibration. Press the following softkeys in sequence:
 - a) softkey 1 (Far Left softkey)
 - b) softkey 2
 - c) softkey 3
 - d) softkey 4
4. Press the *Elevator Trim* RESET softkey (see Figure 6-5). Press ENT to acknowledge the following prompt after the RESET softkey is pressed:

5. Use the trim hat switch to run the elevator trim to the FULL UP position.
6. Press the *Elevator Trim* UP softkey on the PFD (see Figure 6-5).
7. Run the elevator trim to the FULL DOWN position. Press the *Elevator Trim* DN softkey on the PFD.

-
8. Run the elevator trim back to the FULL UP position.
 9. Verify that the CAL VALUE in the ELEVATOR TRIM window indicates 1.00000 ± 0.02000 . If it does not, repeat steps 4 to 8 for 4 tries. If calibration can not be achieved, the motor, switch or transducer may have failed. See Columbia maintenance documentation for additional support.
 10. Press the *Aileron Trim* RESET softkey on the PFD (see Figure 6-5). Press ENT to acknowledge the following prompt after the RESET softkey is pressed:

11. Use the trim hat switch to run the aileron trim full RIGHT.
12. Press the *Aileron Trim* RIGHT softkey on the PFD (see Figure 6-5)
13. Use the hat trim switch in the aircraft to run the aileron trim full LEFT. Press the LEFT softkey on the PFD (see Figure 6-5).
14. Run the aileron trim full RIGHT.
15. Verify that the CAL VALUE in the AILERON TRIM window indicates 1.00000 ± 0.02000 . If it does not, repeat steps 10 to 14 for 4 tries. If calibration can not be achieved, the motor, switch or transducer may have failed. See Columbia maintenance documentation for additional support.
16. Calibration is complete.
17. Continue to the GEA71 Test procedure.

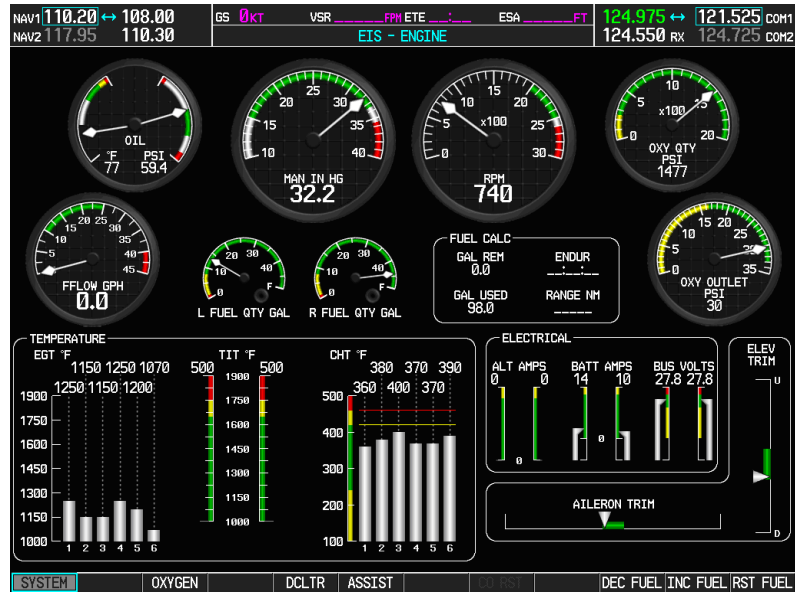
Figure 6-6. G1000/350/400 Engine/Airframe Indicators

Columbia 400 (with Oxygen System Option)

Columbia 350 (without Oxygen System Option)

On the MFD, check the indication for each of the sensor or monitor inputs with the aircraft engine off. Observe the 'Engine' page by using the SYSTEM softkey on the MFD. Observe the following sensor indications (see Figure 6-6):

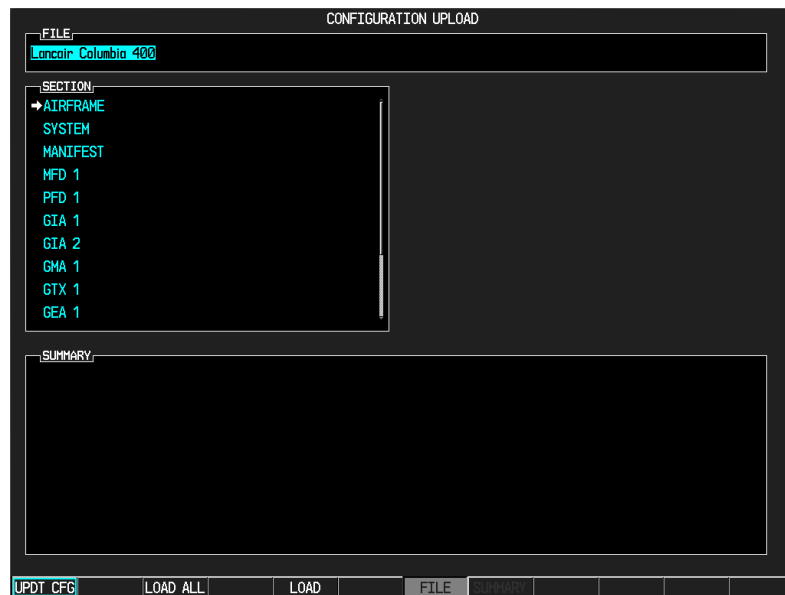
- Insert the correct G1000-Columbia 350/400 Code Loader Card (see Required Equipment List) into the top slot of the PFD.
- Start the G1000 system in Configuration mode.
- On the PFD, go to the Configuration Upload page using the FMS knob:

- Activate the cursor and use the small FMS knob to highlight the airframe type in the FILE field.

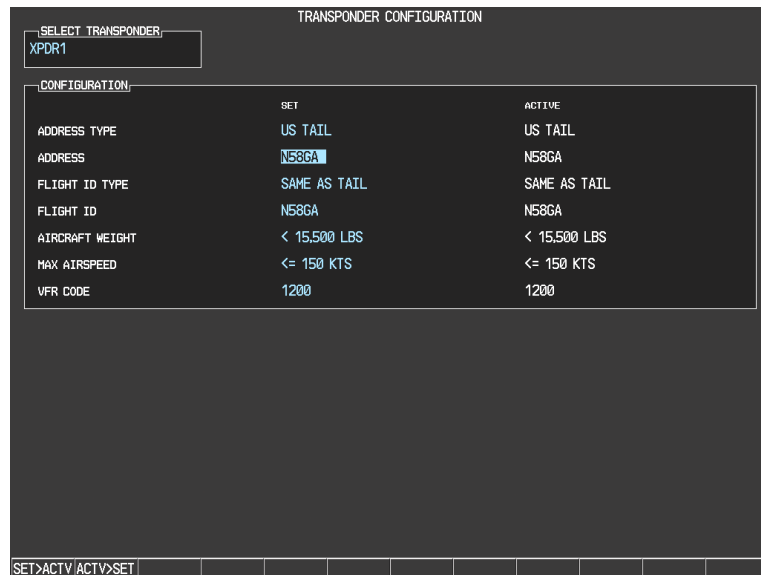
10. View the SUMMARY field and ensure that all items are 'complete', then de-activate the cursor.
11. Select the GTX page group, then select the Transponder Configuration page on the PFD:

12. Ensure that the 'ADDRESS TYPE' is 'US TAIL' under the 'SET' and 'ACTIVE' columns.
13. Activate the cursor and highlight the 'ADDRESS' field. Use the small/large FMS knobs to enter the aircraft registration number.
14. Once the correct registration number is entered, press the ENTER key. The transponder is configured:

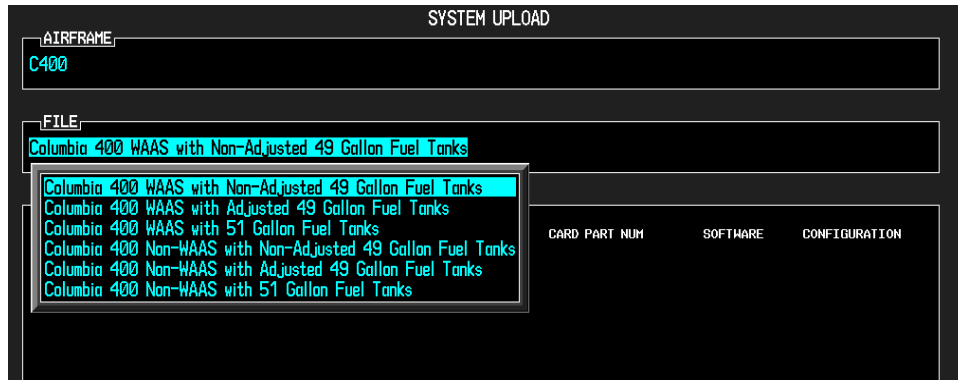
At this step, select to load WAAS or non-WAAS G1000 software.

- The PRODUCT window will populate and display software and configuration file information for each G1000 LRU. The LRU VERS column shows the currently loaded software version in the LRU, whereas the CARD VERS column shows the LRU software version stored on the Loader Card. Each check designates a file to be loaded to the G1000.

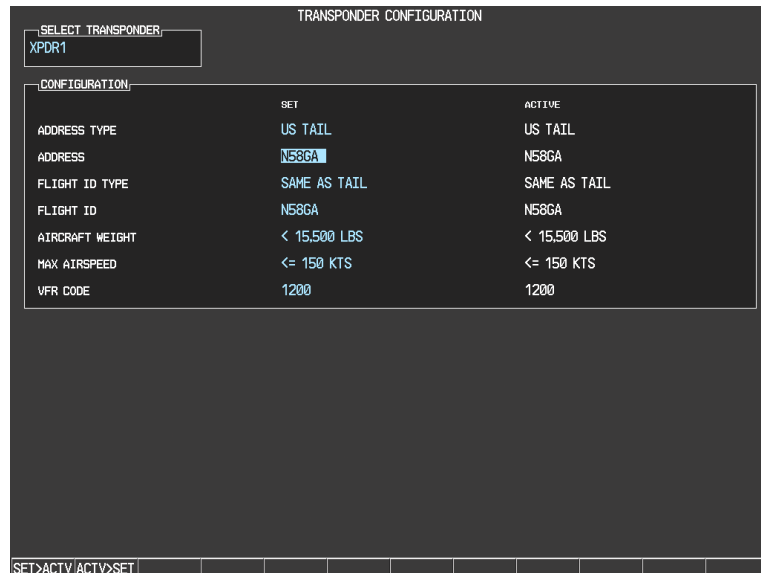
8. Verify that each column indicates PASS in green when the loading process has finished and inspect the SUMMARY window as well to ensure that the load is successful.
9. Select the GTX page group, then select the Transponder Configuration page on the PFD:

10. Ensure that the 'ADDRESS TYPE' is 'US TAIL' under the 'SET' and 'ACTIVE' columns.
11. Activate the cursor and highlight the 'ADDRESS' field. Use the small/large FMS knobs to enter the aircraft registration number.
12. Once the correct registration number is entered, press the ENTER key. The transponder is configured:

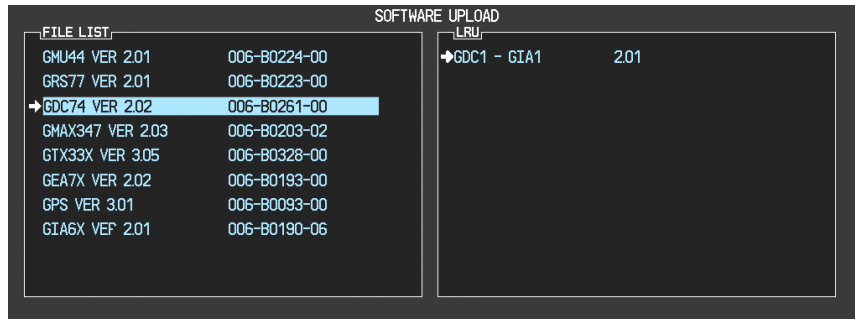
1. Remove the Supplemental Database cards from the bottom slots of each display. Note which card was removed from the MFD so it may be identified later for reinsertion in the MFD when software and configuration loading is complete. It contains a FliteChart or ChartView database which is only used by the MFD.
2. Insert the correct G1000-Columbia 350/400 Code Loader Card (see Required Equipment List) into the top slot of the PFD.
3. Start the G1000 system in Configuration mode.
4. On the PFD, go to the Software Upload page using the FMS knob.
5. Highlight the GDC software file. Ensure that GDC to GIA data path appears in the LRU field as shown:

6. Press the LOAD softkey.
7. Select OK and press the ENT key to acknowledge the following prompt:

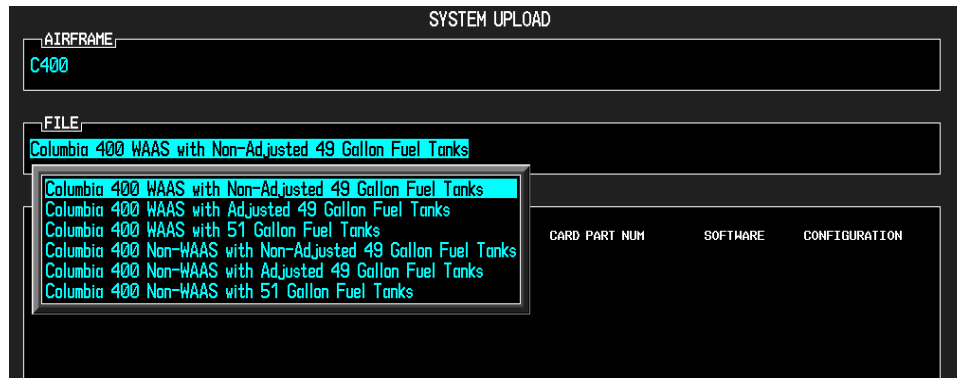
At this step, select to load WAAS or non-WAAS G1000 software.

- The PRODUCT window will populate and display software and configuration file information for each G1000 LRU. The LRU VERS column shows the currently loaded software version in the LRU, whereas the CARD VERS column shows the LRU software version stored on the Loader Card. Each check designates a file to be loaded to the G1000.

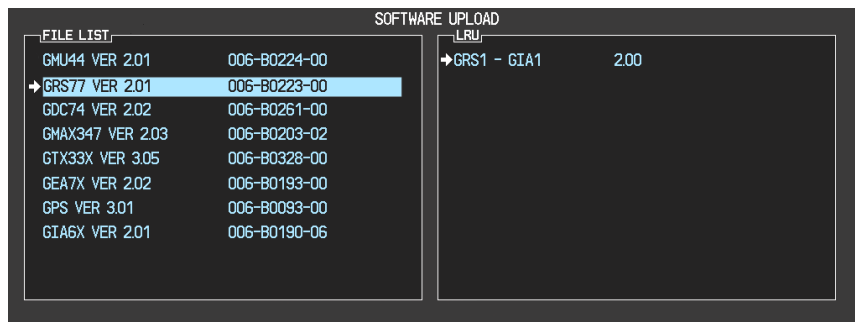
1. Remove the Supplemental Database cards from the bottom slots of each display. Note which card was removed from the MFD so it may be identified later for reinsertion in the MFD when software and configuration loading is complete. It contains a FliteChart or ChartView database which is only used by the MFD.
2. Insert the correct G1000-Columbia 350/400 Code Loader Card (see Required Equipment List) into the top slot of the PFD.
3. Start the G1000 system in Configuration mode.
4. On the PFD, go to the Software Upload page using the FMS knob.
5. Highlight the GRS software file. Ensure that the GRS to GIA data path appears in the LRU field as shown:

6. Press the LOAD softkey.
7. Select OK and press the ENT key to acknowledge the following prompt:

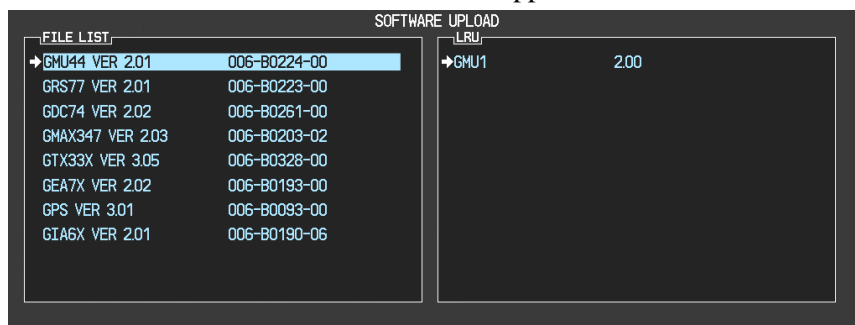
- Remove the Supplemental Database cards from the bottom slots of each display. Note which card was removed from the MFD so it may be identified later for reinsertion in the MFD when software and configuration loading is complete. It contains a FliteChart or ChartView database which is only used by the MFD.
- Insert the correct G1000-Columbia 350/400 Code Loader Card (see Required Equipment List) into the top slot of the PFD.
- Start the G1000 system in Configuration mode.
- On the PFD, go to the Software Upload page using the FMS knob.
- Highlight the GMU software file. Ensure that GMU1 appears in the LRU field as shown:

-
6. Press the LOAD softkey.
 7. Select OK and press the ENT key to acknowledge the following prompt:

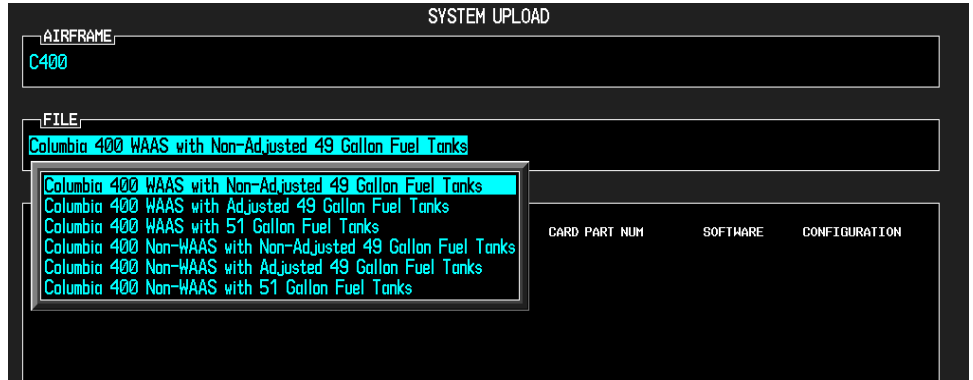
At this step, select to load WAAS or non-WAAS G1000 software.

- The PRODUCT window will populate and display software and configuration file information for each G1000 LRU. The LRU VERS column shows the currently loaded software version in the LRU, whereas the CARD VERS column shows the LRU software version stored on the Loader Card. Each check designates a file to be loaded to the G1000.

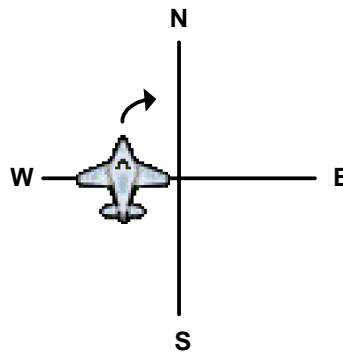
1. Start both displays in normal mode.
2. Start the aircraft engine following the procedures in the Columbia Pilot's Operating Handbook.
3. After aircraft engine startup, taxi the aircraft to a properly calibrated compass rose. At the compass rose, align the aircraft to a heading of magnetic north ($\pm 5^\circ$).

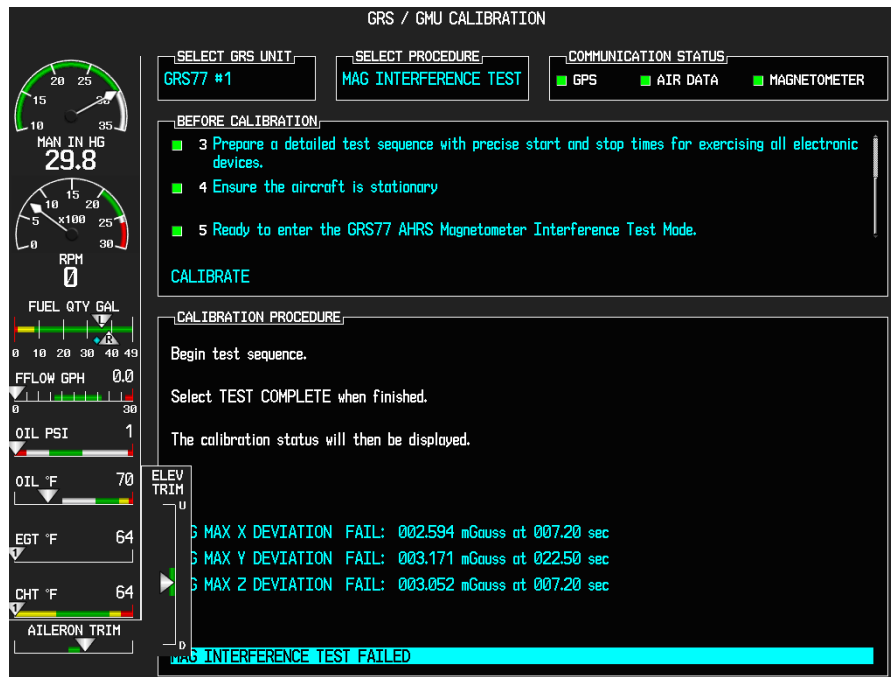
Figure 6-8. Magnetometer Interference Test Complete

-
2. Leave the Navigation lights on for approximately 10 seconds, and then turn them off.
 3. Wait approximately five seconds and then press the ENT key to complete the test.
 4. The PFD informs the operator if the installation has passed or failed the magnetometer interference test. If the test passes, no further action is required.
 5. Press the ENT key on the PFD to conclude this procedure.
 6. If the MAG INTERFERENCE TEST fails but ALL of the deviations are less than the following thresholds ($X < 5$ mGauss, $Y < 5$ mGauss, and $Z < 8$ mGauss), the installation must be verified with a flight test before it is acceptable.

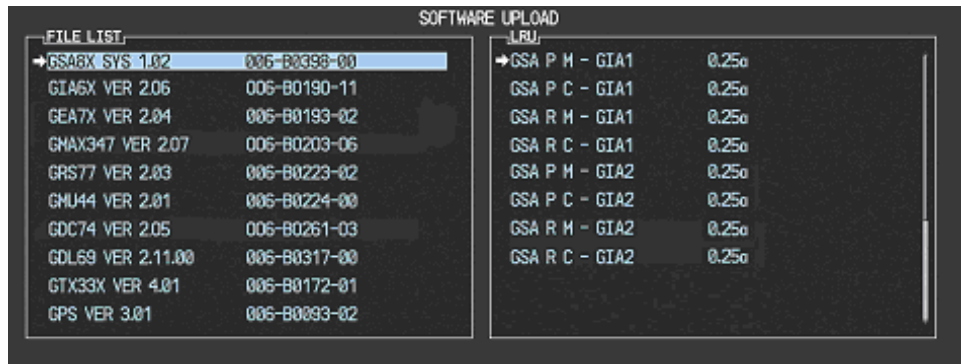
5. Highlight the GSA 8X software file. Ensure that each GSA to GIA data path appears in the LRU field as shown. Each servo axis is identified by the letters 'P' for pitch and 'R' for roll. Each servo consists of a monitor, denoted by the letter 'M', and a controller, denoted by the letter 'C'. Each servo interfaces to GIA1 and GIA2. The current software version is noted next to each LRU.
6. Press the LRU softkey to toggle the cursor to the LRU window.
7. Use the FMS knob to select the LRU to load and press the LOAD softkey.
8. Verify YES and press the ENT key to acknowledge the following prompt:

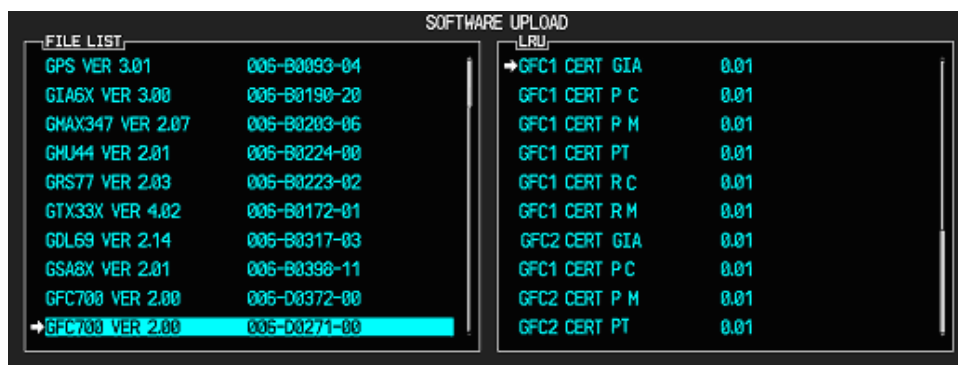
1. Highlight the GFC700 Certification Gains software file. The following GFC1 CERT and GFC2 CERT paths may appear in the LRU field (a sample screen is shown below):

2. Press the LRU softkey to toggle the cursor to the LRU window.
3. Use the FMS knob to select the LRU to be loaded. The pitch and roll servos each require two items to be loaded – monitor (M) and controller (C). The GIA and pitch trim adapter each only require that one item be loaded.
4. Press the LOAD softkey to start loading the selected item.
5. Select YES and press the ENT key to acknowledge the following prompt:

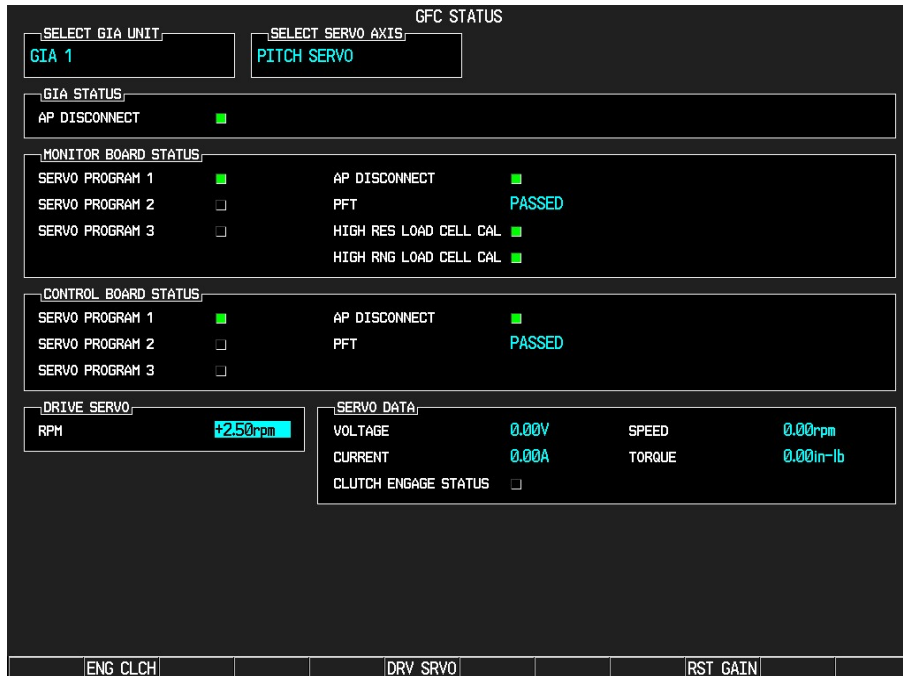
Figure 6-10. GFC Status Page, Pitch Servo

1. Open the PFD and MFD circuit breakers.
2. Turn on power to the G1000 system.
3. While holding the ENT key on the PFD, close the PFD circuit breaker.
4. When INITIALIZING SYSTEM appears on the PFD, release the ENT key. The PFD will be in configuration mode.
5. Repeat steps 3 and 4 for the MFD.
6. Using the FMS knob, navigate to the GFC page group and select the second page in this page group. The title of this page is "GFC STATUS."
7. Change the RPM to +2.50rpm as shown in Figure 6-10. and press the ENT key.

8. Hold the control stick in the full nose-down position.
9. Press the ENG CLCH softkey, followed by the DRV SRVO softkey. The servo will attempt to drive the control stick nose up.
10. While holding the control stick in the full nose down position, a second person should use a cable tensiometer to measure the tension on the pitch bridle cable. The tension should be measured on the portion of the bridle cable that is under tension.
11. Press the STP SRVO and DIS CLCH softkeys to stop driving the servo.
12. Record the tension in Table 6-1.
13. Verify that the tension is less than 35 lbs for the C400 and 72 lbs for the C350.

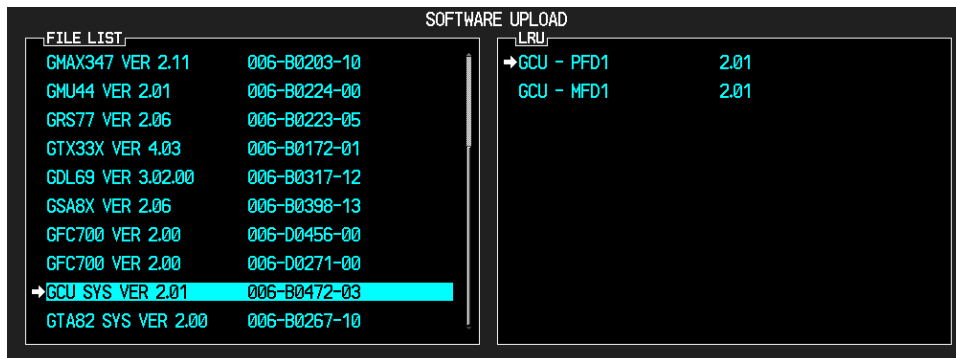
1. Remove the Supplemental Database cards from the bottom slots of each display. Note which card was removed from the MFD so it may be identified later for reinsertion in the MFD when software and configuration loading is complete. It contains a FliteChart or ChartView database which is only used by the MFD.
2. Insert the correct G1000-Columbia 350/400 Code Loader Card (see Required Equipment List) into the top slot of the PFD.
3. Start the G1000 system in Configuration mode.
4. On the PFD, go to the Configuration Upload page using the FMS knob:

5. Highlight the GCU SYS software file. Ensure that both paths to the GCU through PFD1 appear in the LRU field as shown:
6. Press the LRU softkey. Select the GCU – PFD1 to load software. Press the LOAD softkey.
7. Select OK and press the ENT key to acknowledge the following prompt:

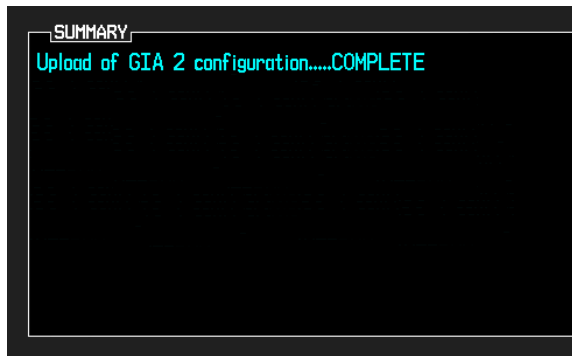
12. View the SUMMARY field and ensure that the item is 'COMPLETE':

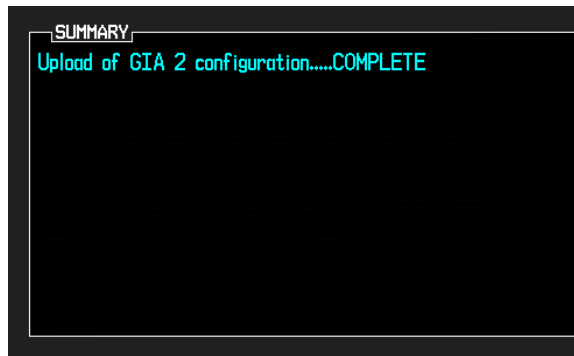
24. View the SUMMARY field and ensure that the item is 'COMPLETE':

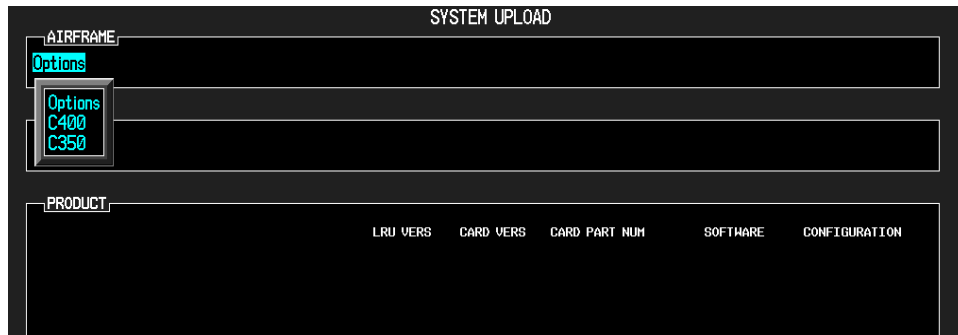
1. On the PFD, go to the System Upload page using the small FMS knob.
2. Activate the cursor and use the small FMS knob to highlight the airframe type in the AIRFRAME field. Select the appropriate aircraft type (C400 or C350) and press the ENT key.

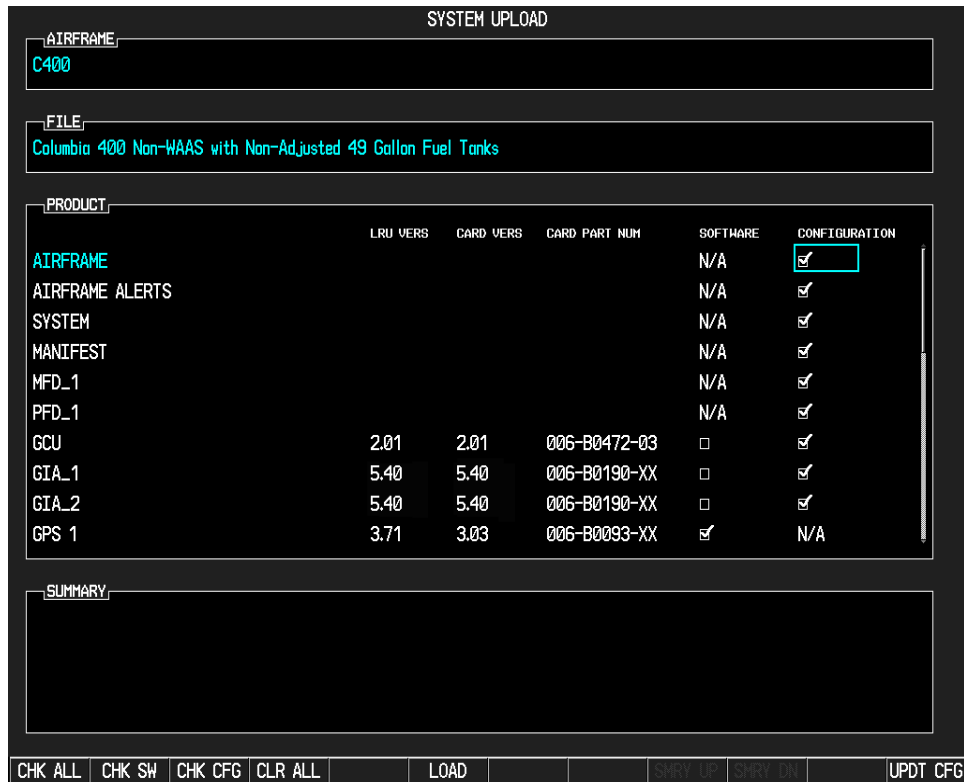
- The PRODUCT window will populate and display software and configuration file information for each G1000 LRU. The LRU VERS column shows the currently loaded software version in the LRU, whereas the CARD VERS column shows the LRU software version stored on the Loader Card. Each check designates a file to be loaded to the G1000.

By default, if an inequality between the LRU and CARD columns exists, the SOFTWARE and CONFIGURATION boxes will be pre-selected (checked).

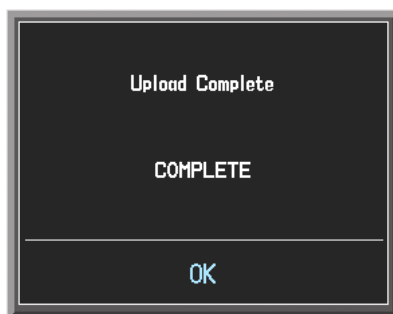
5. After verifying that the desired software and configuration files are checked, press the LOAD softkey. It is acceptable to simply load the pre-selected software and config files. The G1000 system automatically begins loading software and default configuration files to the selected LRUs in the proper order.
6. When the system finishes loading, it prompts the technician accordingly. Press the ENT key to acknowledge that the upload is finished:

7. Verify that each column indicates **PASS** in green when the loading process has finished and inspect the SUMMARY window as well to ensure that the load is successful.
8. After the software and configuration files are loaded, turn off the system and reinsert the Supplemental Database Cards in the bottom slot of each display. Be sure to insert the card removed from the MFD back into the MFD.
