# TLS-3XX Series Consoles

## Troubleshooting Guide

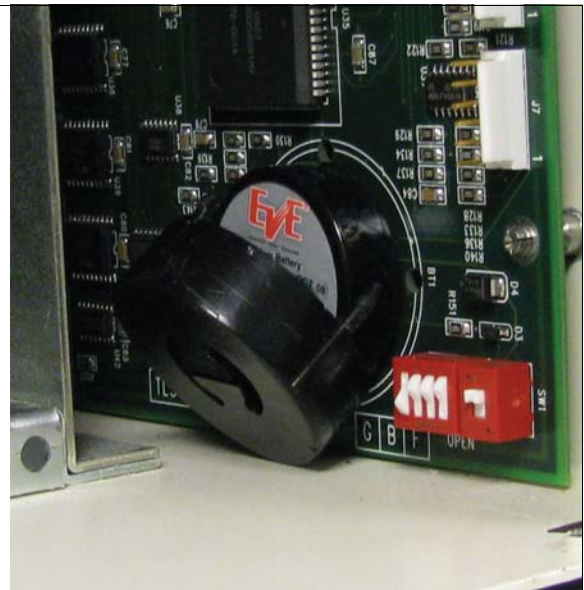
7. Does the volt meter read 3.4 to 3.6 Vdc? If Yes, Do not remove Battery. Battery is not defective do not remove it, go to Step 14. If No, go to Step 8.
8. Using an insulated screw driver, push down and pull away on the battery cover that is attached to the ECPU board. You may want to use your finger tips to help remove the battery cover. Please be careful you don't touch any other circuits on the board (see Figure 2-14, A). After the top of the battery cover has dislodged, you can pull the cover off with you finger tips (see Figure 2-14, B).

**A. Dislodging Battery Cover**

**B. Battery Cover Dislodged****Figure 2-14. Removing Battery Cover**

6. Using an insulated screw driver, push down and pull away on the battery cover that is attached to the CPU board. You may want to use your finger tips to help remove the battery cover. Please be careful you don't touch any other circuits on the board (see Figure 2-14, A). After the top of the battery cover has dislodged, you can pull the cover off with you finger tips (see Figure 2-14, B).
