IBM 3420/3803

Magnetic Tape Subsystem

Reference Guide

This reference guide was created by FE Service Planning to assist in maintaining the 3420/3803 magnetic tape subsystem. It is divided into sections for each major topic. Reference is made to the 3420/3803 MLM, and other publications that are required for effective 3420/3803 maintenance.

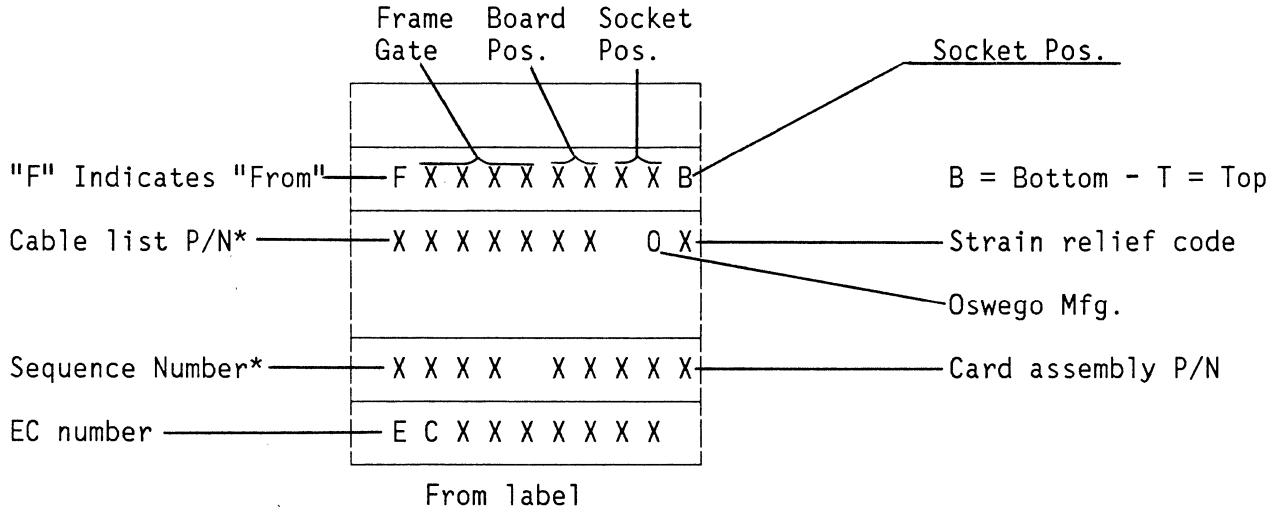
3803 MST FLAT CABLE REPLACEMENT (CONT'D)

* This information is necessary for ordering new cables, and it must be obtained from the label on the "From" end of the cable.

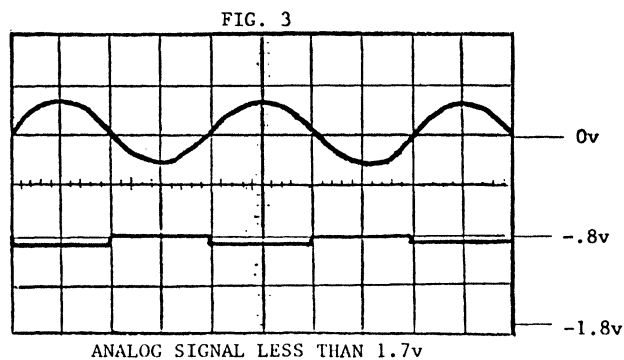
- (5) Using alternate sweep, adjust time base to view 2 cycles of analog data. Adjust track P pot clockwise until a solid square wave is observed. The analog sine wave should be symmetrical and undistorted. (Figure 1)
- (6) Now turn the pot counter-clockwise until the digital signal drop out is observed as a dim horizontal line through the square wave. At this time the analog signal should be 2V +/- .3V. (Figure 2)
If the pot is adjusted too far counter-clockwise, the square wave will disappear. (Figure 3)
- (7) Repeat steps 5 and 6 for all remaining tracks.

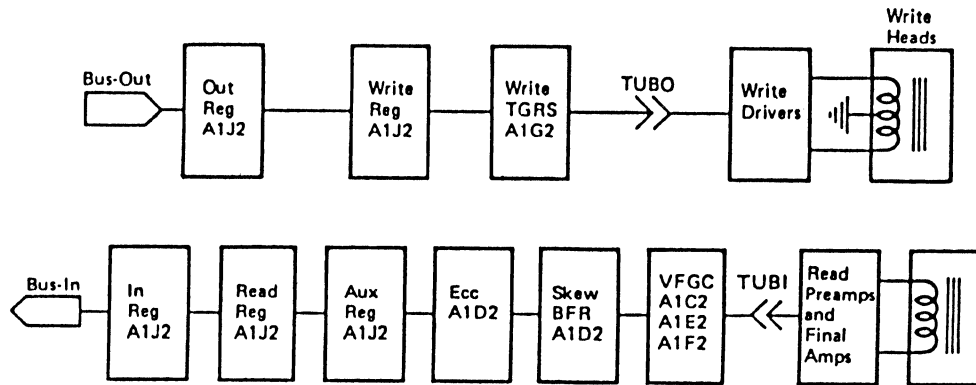
3803 MODEL 1 DATA FLOW

VFCG ZN1	A1C2*	BITS P-0-5
VFCG ZN2	A1E2*	BITS 2-6-7
VFCG ZN3	A1F2*	BITS 1-3-4

* = Interchangeable cards
see notes 3803-1/3420
MLM 19-023

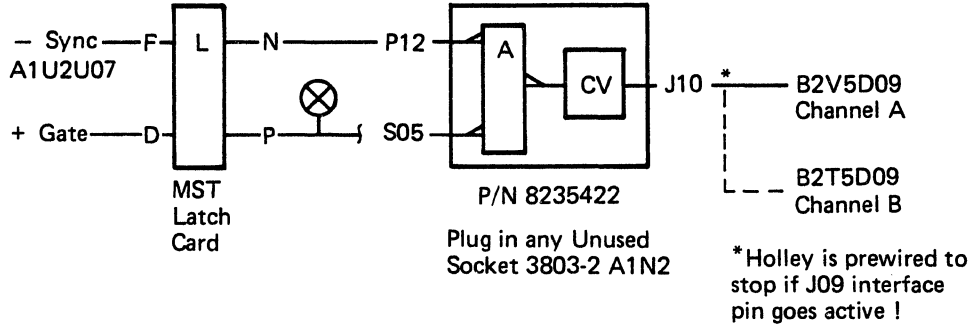
Holley Monitor Trap
3803 Model 1/2

Use Tri-Leads for Backpanel
