**SUBJECT: NEW VEHICLE DEMONSTRATION / DELIVERY HOLD**

**Compliance Recall 19C07 – *Supplement #3***

Certain 2018-2020 Model Year Escape, Explorer, F-150, Superduty, Expedition and Aviator Vehicles Equipped With Manual Reclining Seats  
Manual Recliner Seat Inspection

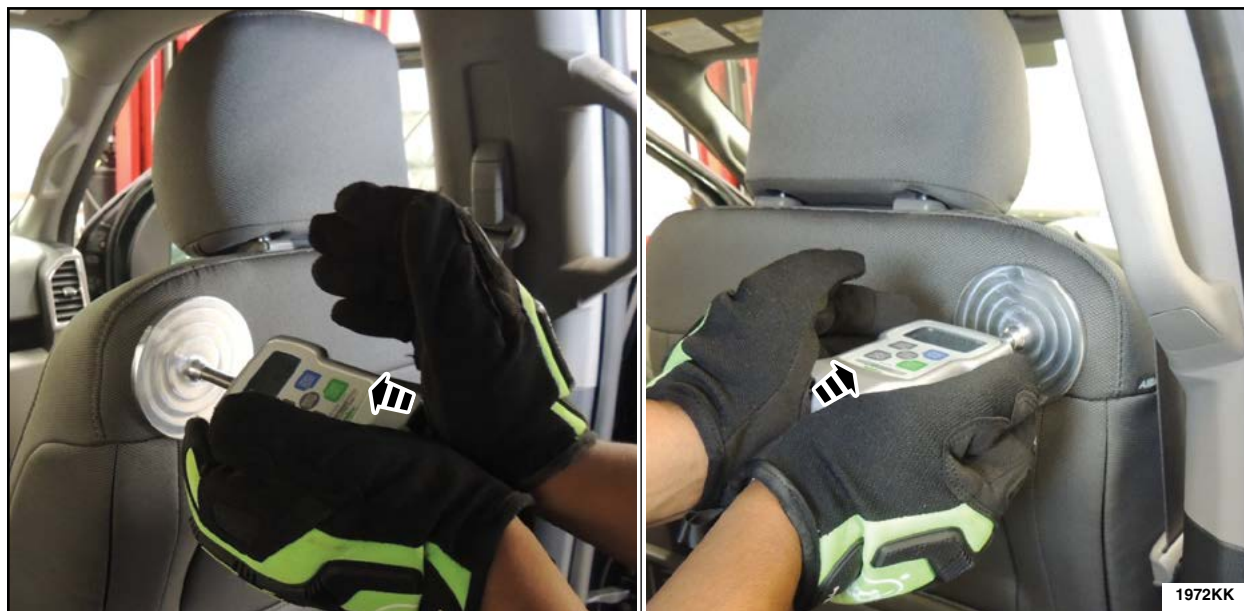
**FIGURE 1**

7. While sitting in the second row seat, place the Force Gauge pressure plate on the upper inboard and outboard sides of the front seat backrest, 1 inch from the top and 1 inch from the side of the backrest, and apply pressure until a minimum of 850N (0.850kN) force is achieved or seat back ratchets forward (If the seat back ratchets there will be an audible noise). See Figure 1.

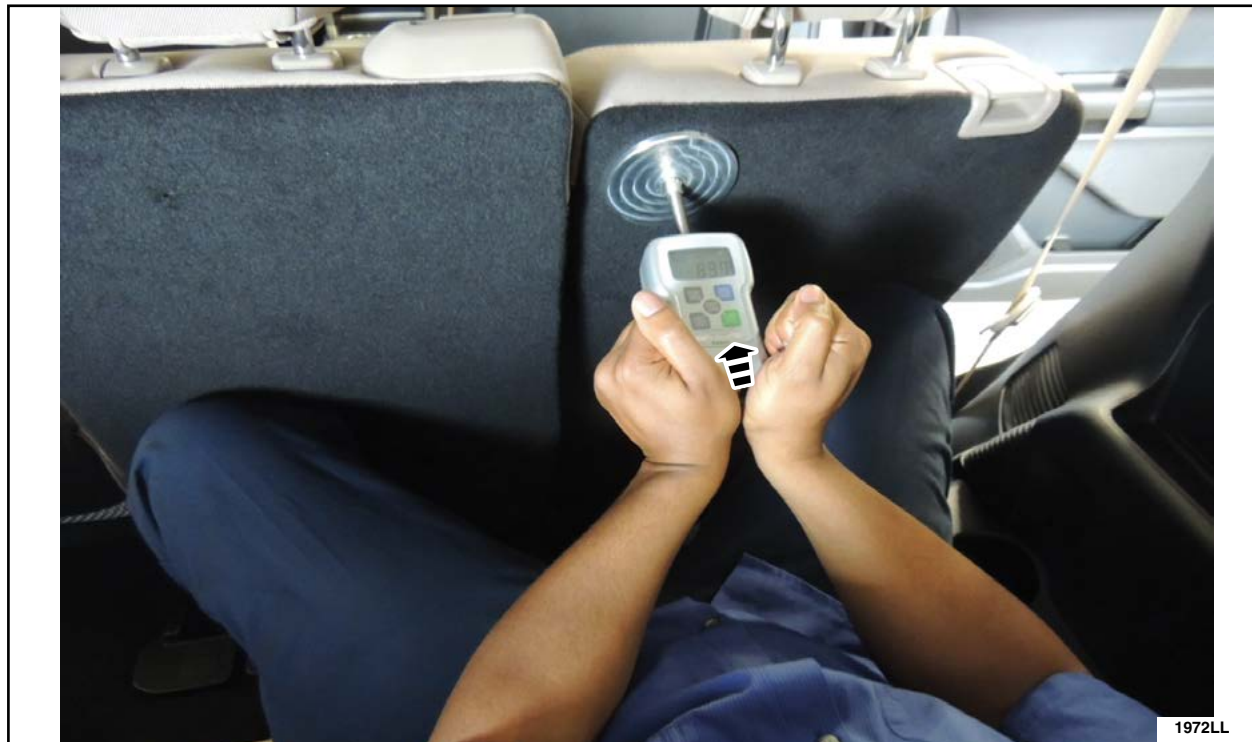
FIGURE 2

6. While sitting in the third row rear seat, place the Force Gauge pressure plate on the upper inboard side of the second row seat backrest, 1 inch from the top and 1 inch from the side of the backrest, and apply pressure until a minimum of 850N (0.850kN) force is achieved or recliner mechanism seat back ratchets forward (If the seat back ratchets there will be an audible noise). See Figure 2.

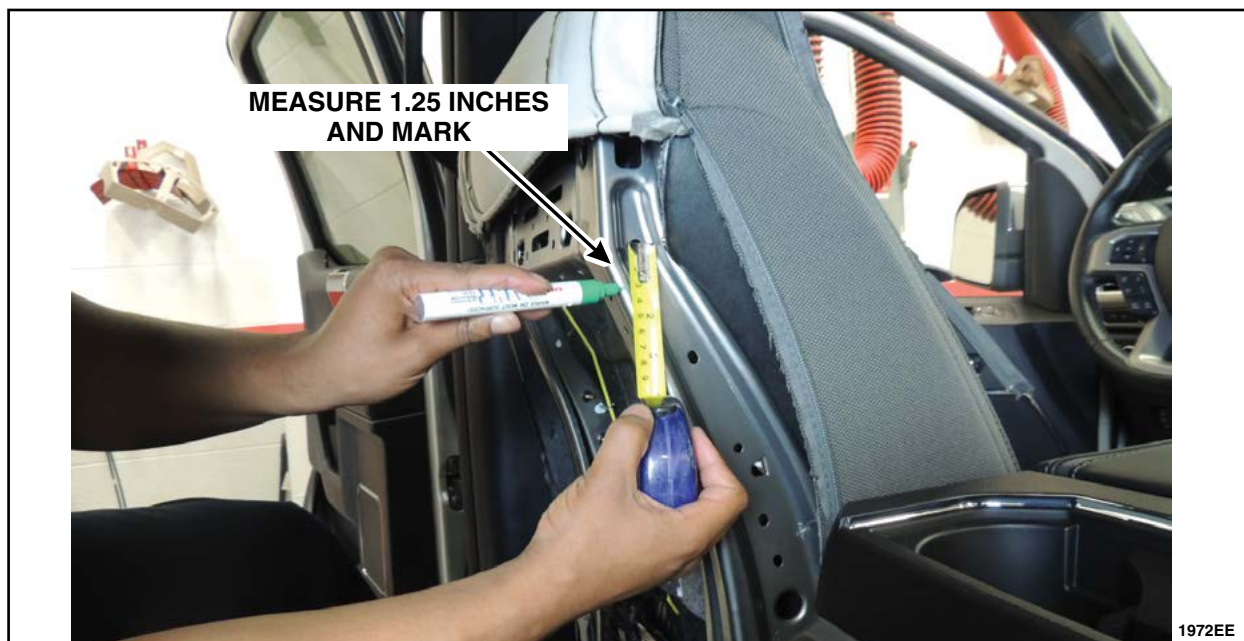
FIGURE 5

6. Measure 1.25 inches (32mm) down from the center of the upper attachment hole shown and mark frame as shown in Figure 5.

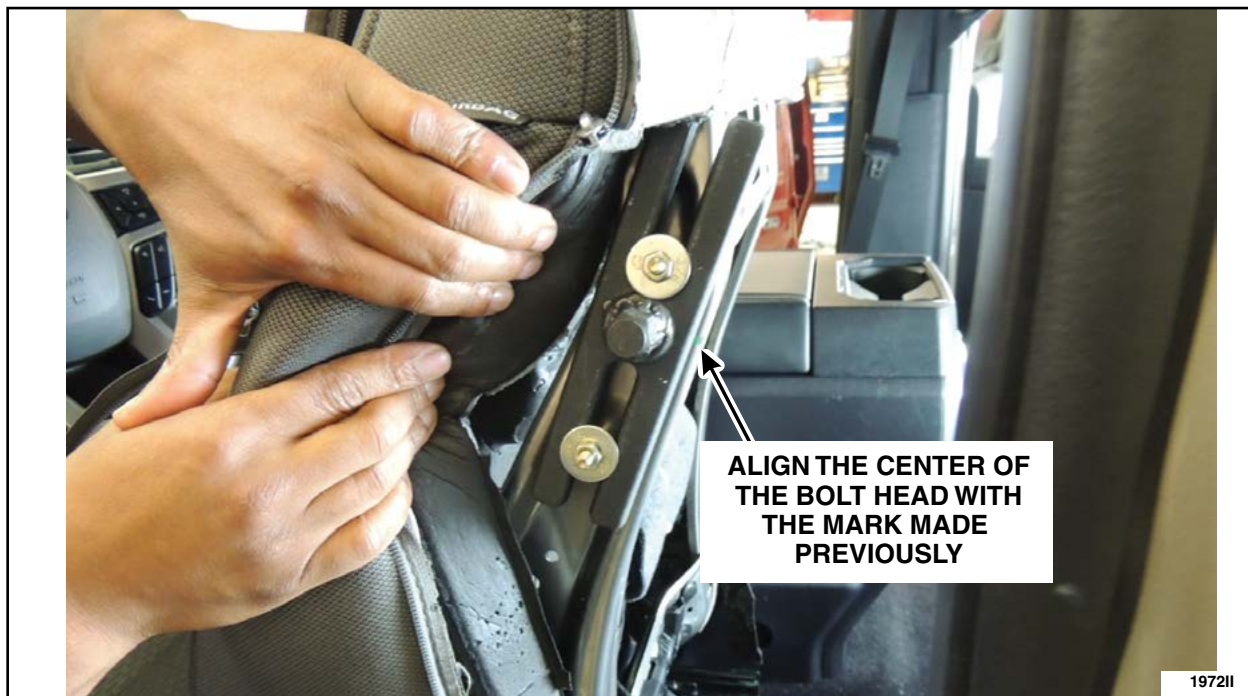
**FIGURE 11**

5. Install Torque Fixture onto the outboard side of the front seat backrest. See Figure 11.
  - a. Position a washer on the 6mm bolt, of suitable length, and install through the lower attachment hole.
  - b. Install a washer and nut onto the lower attachment bolt.
  - c. Position the Torque Fixture onto the lower attachment bolt between the frame and the outer washer.
  - d. Position a washer on the bolt and install through the upper attachment hole.
  - e. Install a washer and nut onto the upper attachment bolt.
  - f. Align the mark made on the backrest to the center of the Torque Fixture bolt.
  - g. Tighten down the Torque Fixture bolts and nuts so that the fixture can not move.

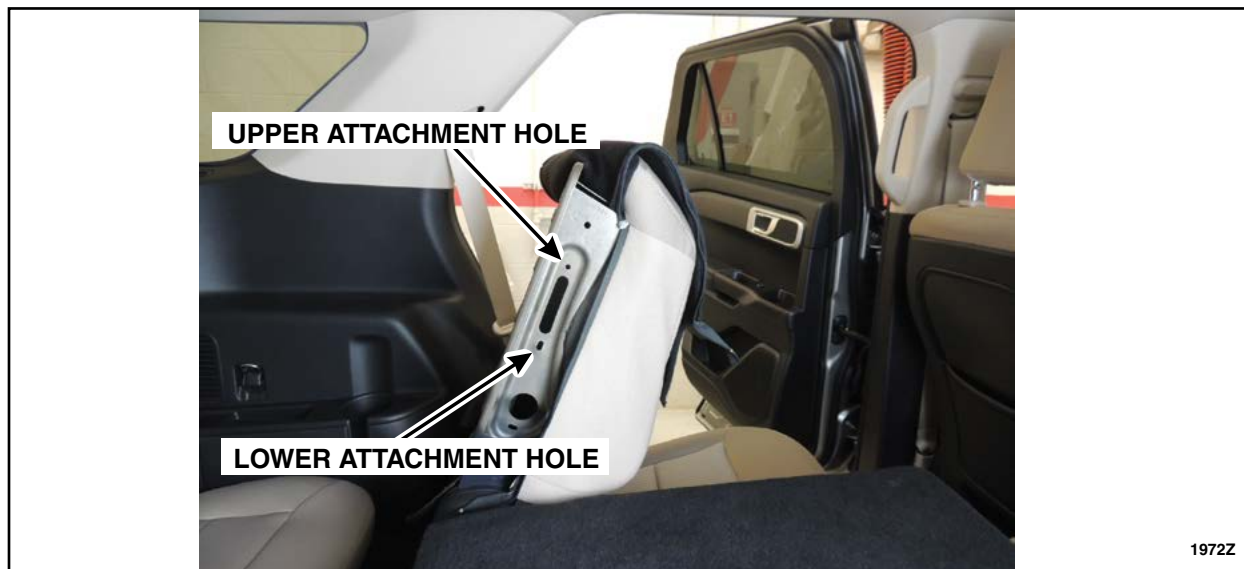
**FIGURE 14**

2. Partially remove the seat backrest cover enough to access the seat frame holes shown in Figure 14. Please follow the procedures within Workshop Manual (WSM) Section 501-10B - Rear Seat Backrest Cover.

3. The Torque Fixture will attach at the locations shown in Figure 14.

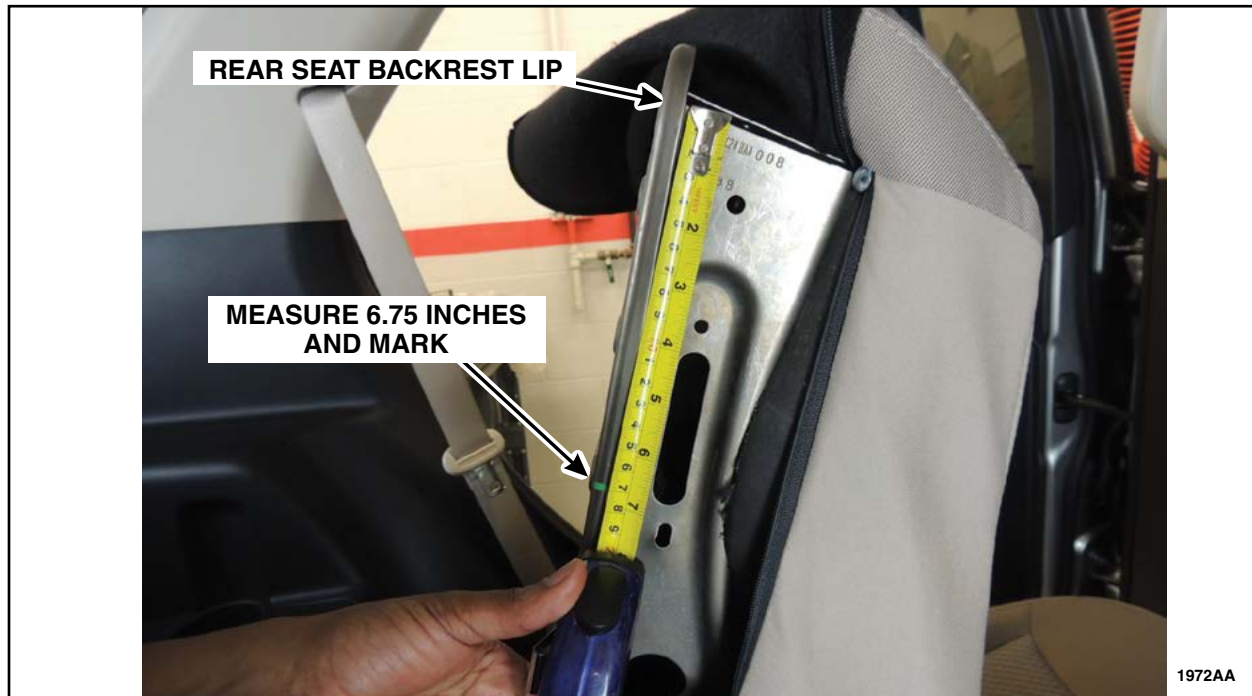
FIGURE 15

4. Measure 6.75 inches (171mm) from the top of the seat backrest frame and mark that measurement on the seat backrest lip for reference later in this procedure. See Figure 15.

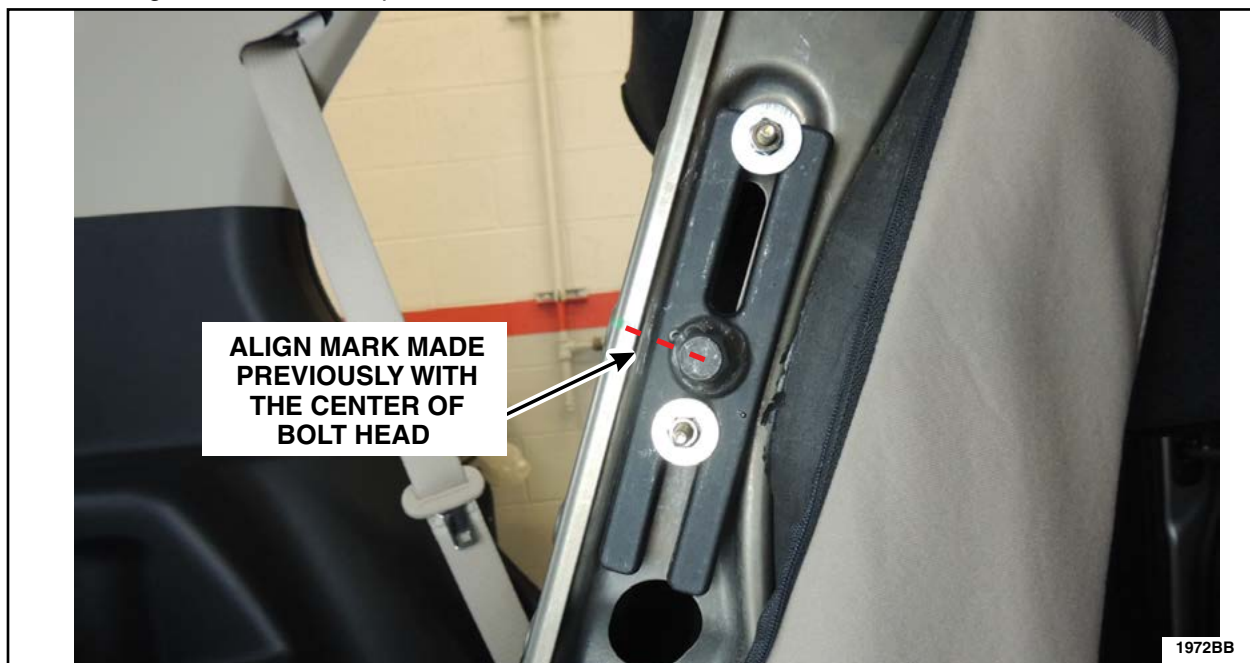
**FIGURE 16**

8. Install Torque Fixture onto the inboard side of the second row seat backrest. See Figure 16.
  - Position a washer on the 6mm bolt, of suitable length, and install through the lower attachment hole.

- Position a washer on the bolt and install through the upper attachment hole.
  - Install a washer and nut onto the upper attachment bolt.
  - Align the mark made on the backrest to the center of the Torque Fixture bolt.

- Tighten down the Torque Fixture bolts and nuts so that the fixture can not move.

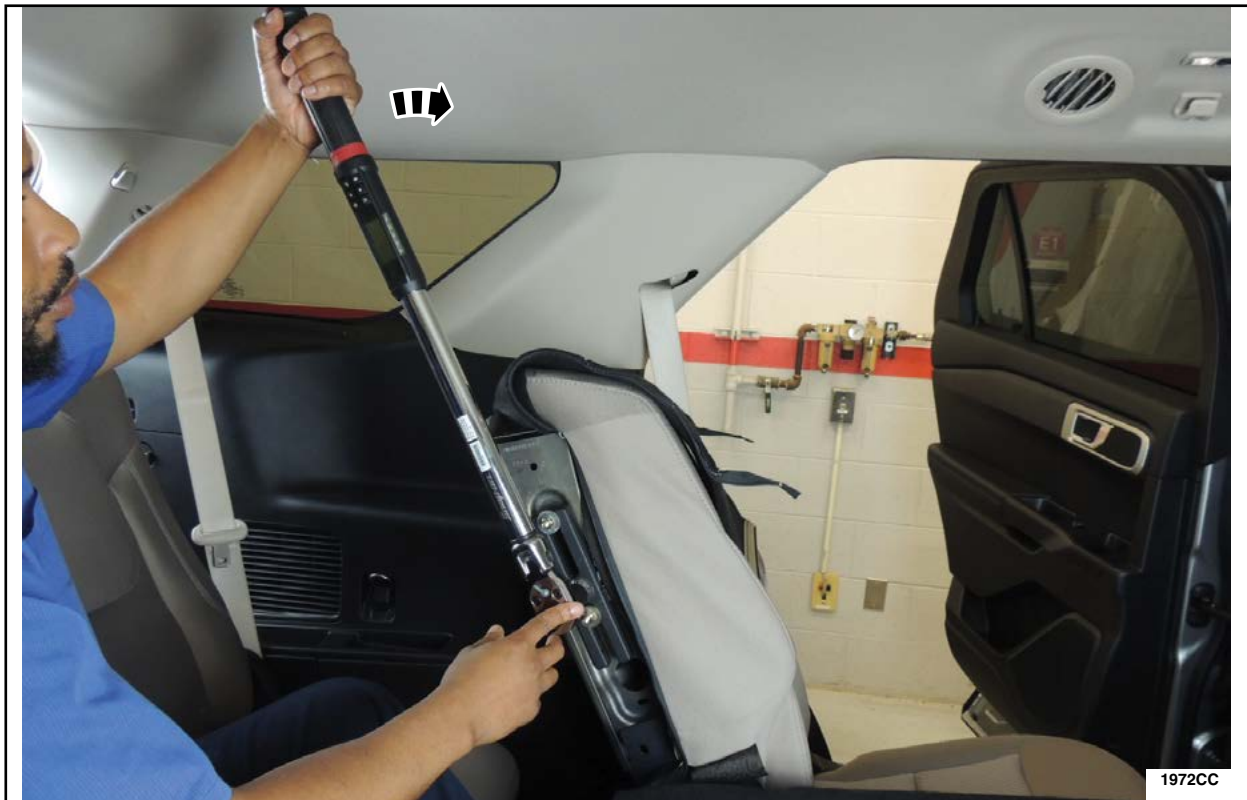
**FIGURE 17**

9. Using a 1/2 inch drive torque wrench, apply a minimum of 199 ft lbs (270 Nm) of force to the seat backrest, stopping when either 199 ft lbs (270 Nm) is achieved or recliner makes a ratcheting noise or ratchets forward. See Figure 17 for starting position of torque wrench.

**NOTE:** The torque wrench should be positioned as close to the angle of the seat backrest as possible without touching the headliner. Place clean shop cloth over handle of torque wrench to protect headliner.

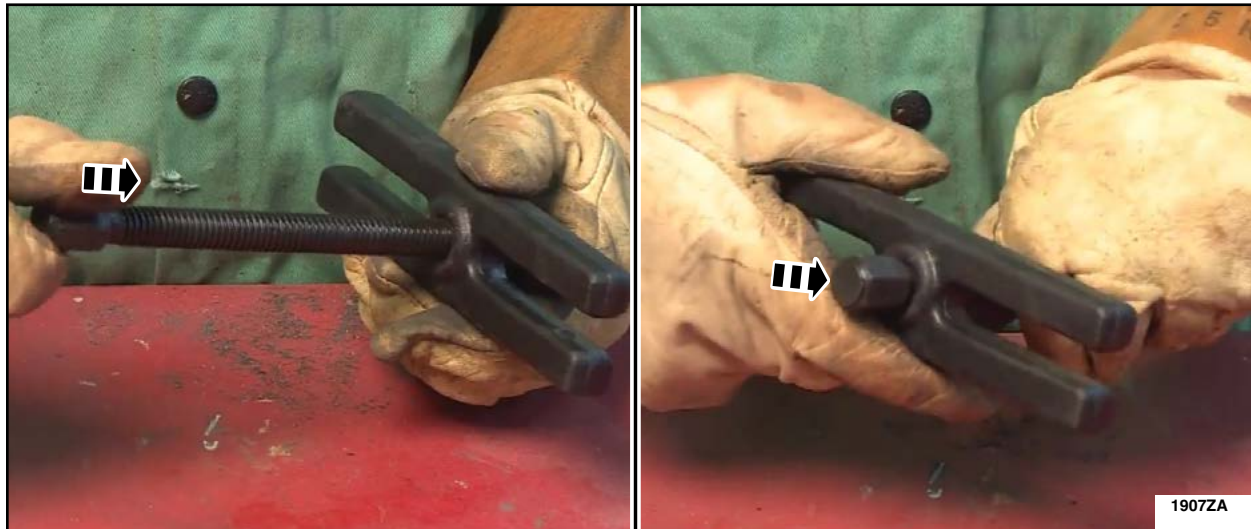
FIGURE 1

1. Screw the bolt fully into the H bar gear puller. See Figure 1.

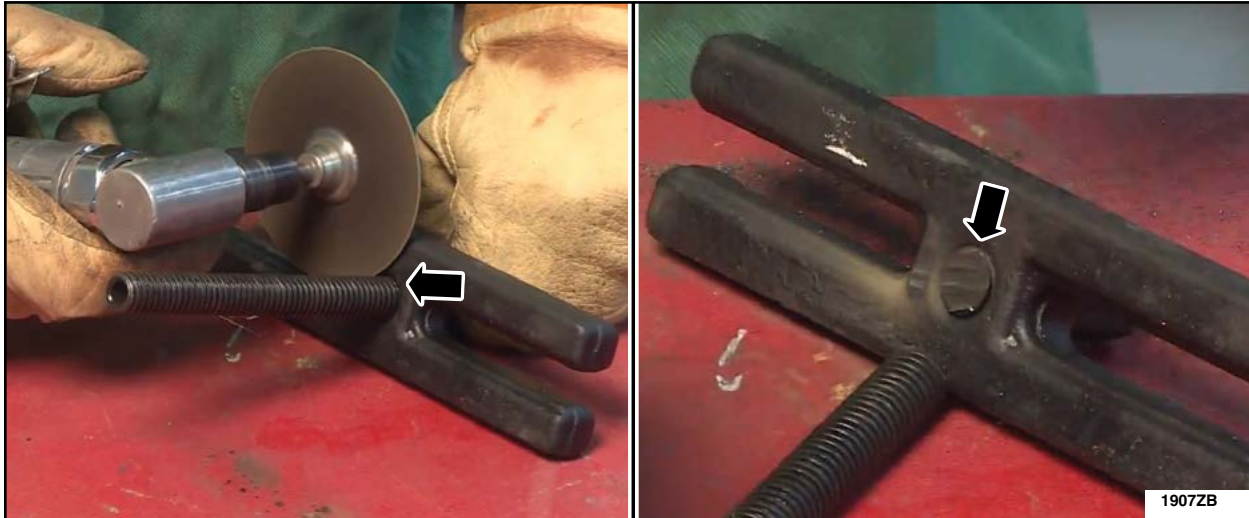
**FIGURE 2**

2. Use a cut off wheel to cut the excess bolt threads off the bottom end of the H bar tool, flush with the bottom of the H bar tool. See Figure 2.

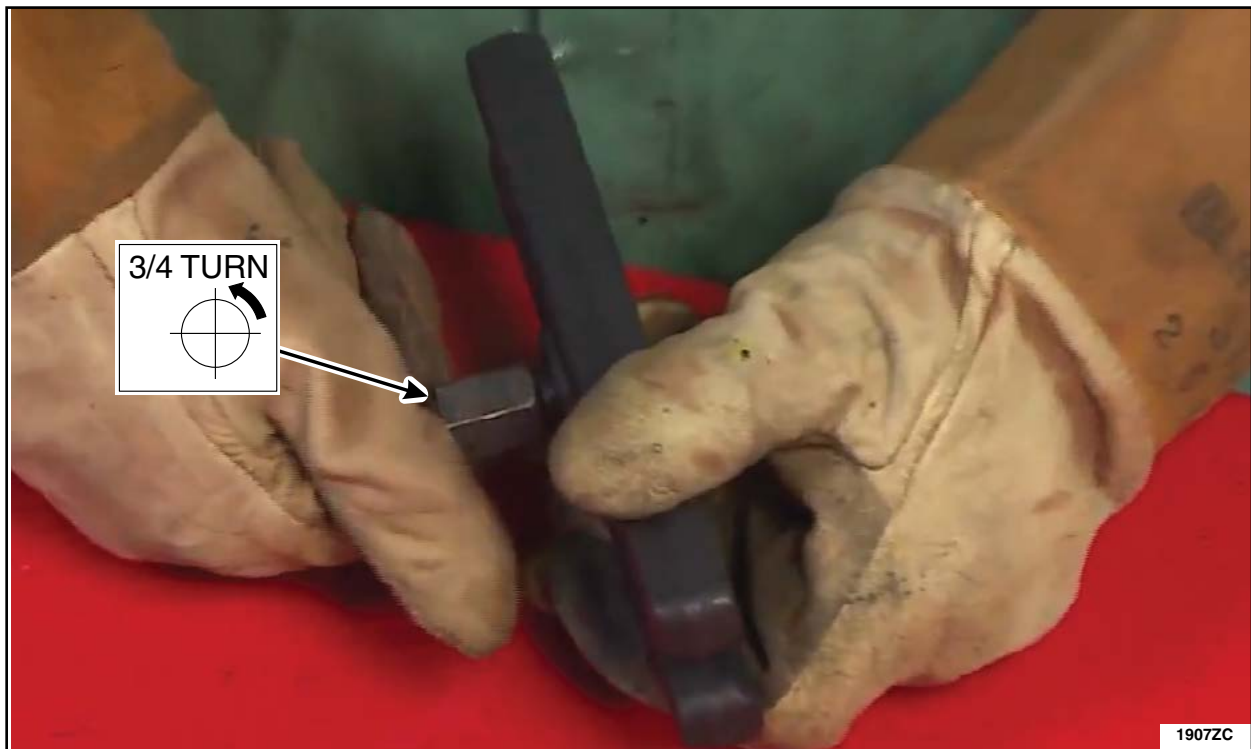
**FIGURE 3**

3. Back off the bolt head 3/4 of a turn to provide room for a good weld bead on both sides of the bolt threads (top and bottom). See Figure 3.

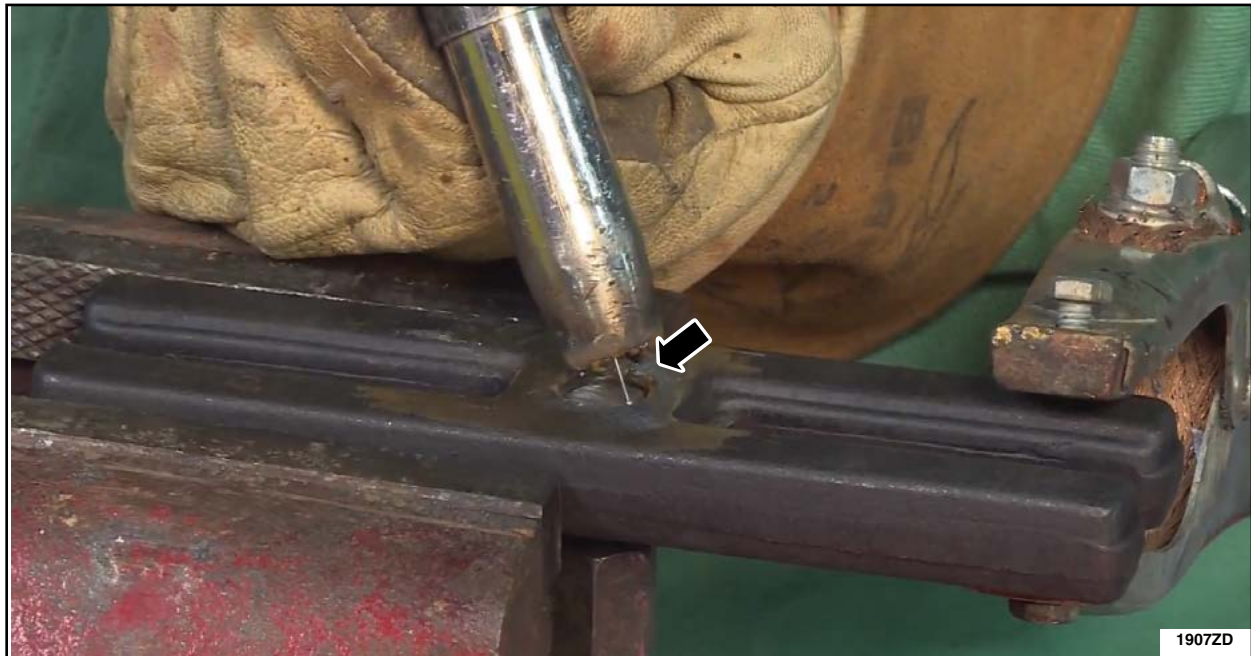
FIGURE 4a

4. Place the H bar tool in a vice. Weld bottom of the bolt threads to permanently secure the bolt in place. Ensure the weld is sufficient to withstand a large amount of torque. See Figures 4a and 4b.

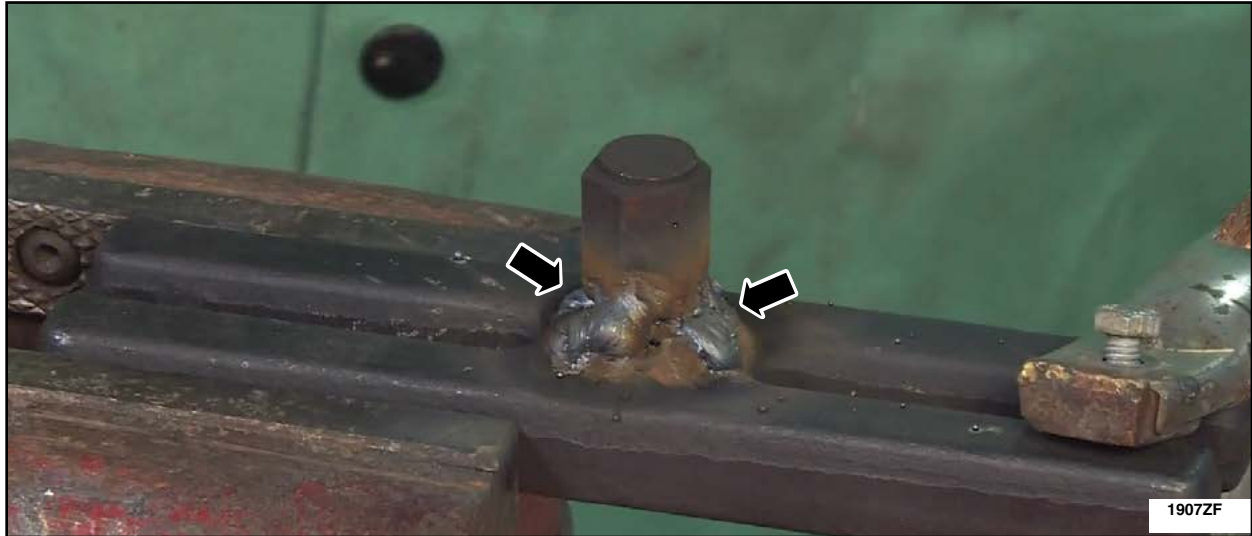
FIGURE 5

5. Turn the H bar tool over, bolt head side up and secure in the vice. Weld bolt threads to the H bar tool to permanently secure the bolt head in place. Again ensure the weld is sufficient to withstand a large amount of torque. See Figure 5.

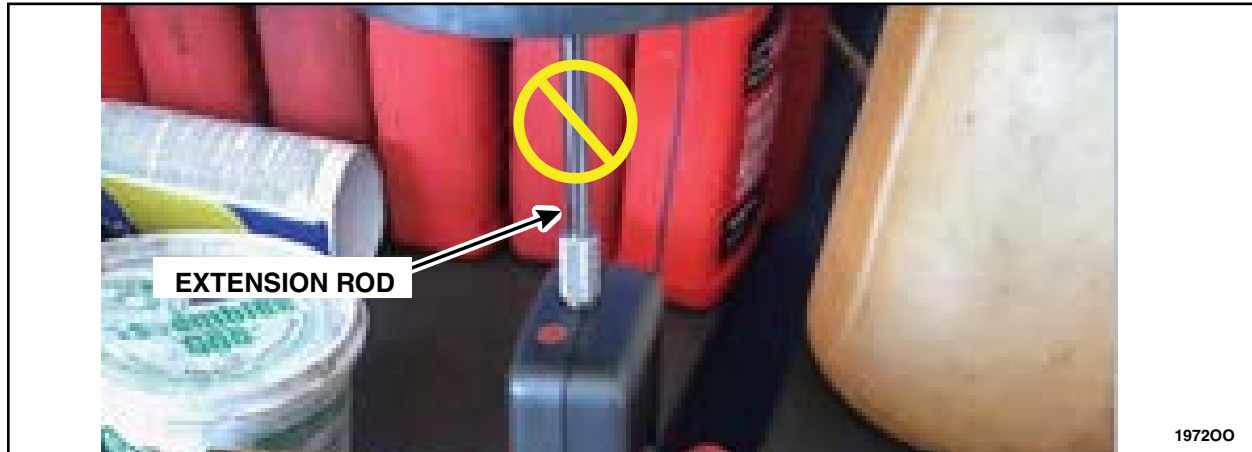
**FIGURE 2**

3. Multiple brands and styles of Force Gauges have been provided to dealers. Extension rods should only be used on Force Gauges that have threaded connections that are under-flush with the Force Gauge housing (currently only models Mecemesin - AFG-1000 and BFG-1000 require the use of an extension rod). See Figure 2.

**NOTE:** The use of extensions on the Force Gauge can contribute to a tech applying excessive side loads on the gauges. Multiple gauges have been broken due to excessive side loads.

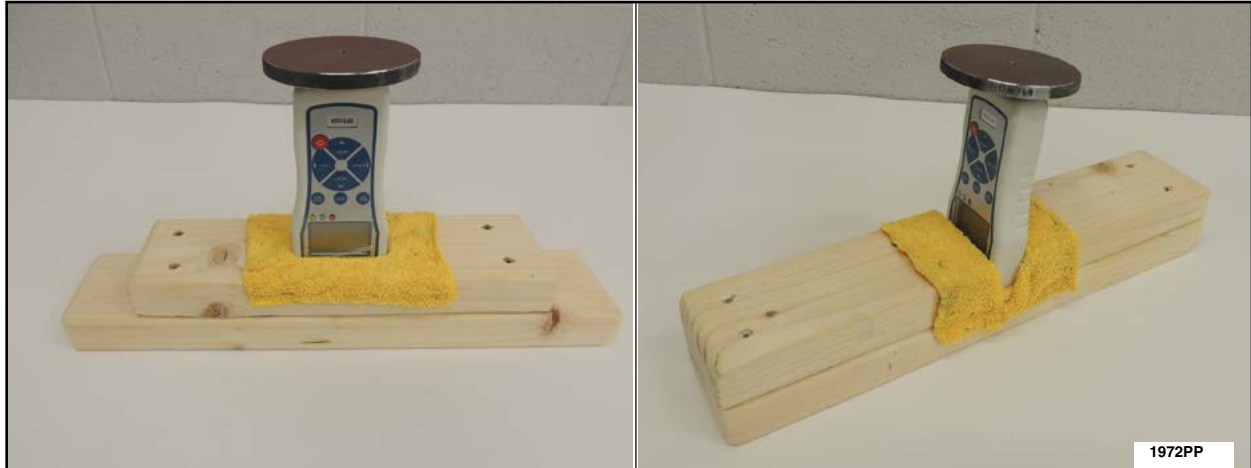
FIGURE 3

- a. Some dealer techs have fabricated simple holding fixtures that allow the tech to have better control of the Force Gauge. These holding fixtures range from a simple assembly of 2x4's to the use of C-Channel or a small I-Beam with through holes drilled and handles welded on. See Figures 3 and 4.

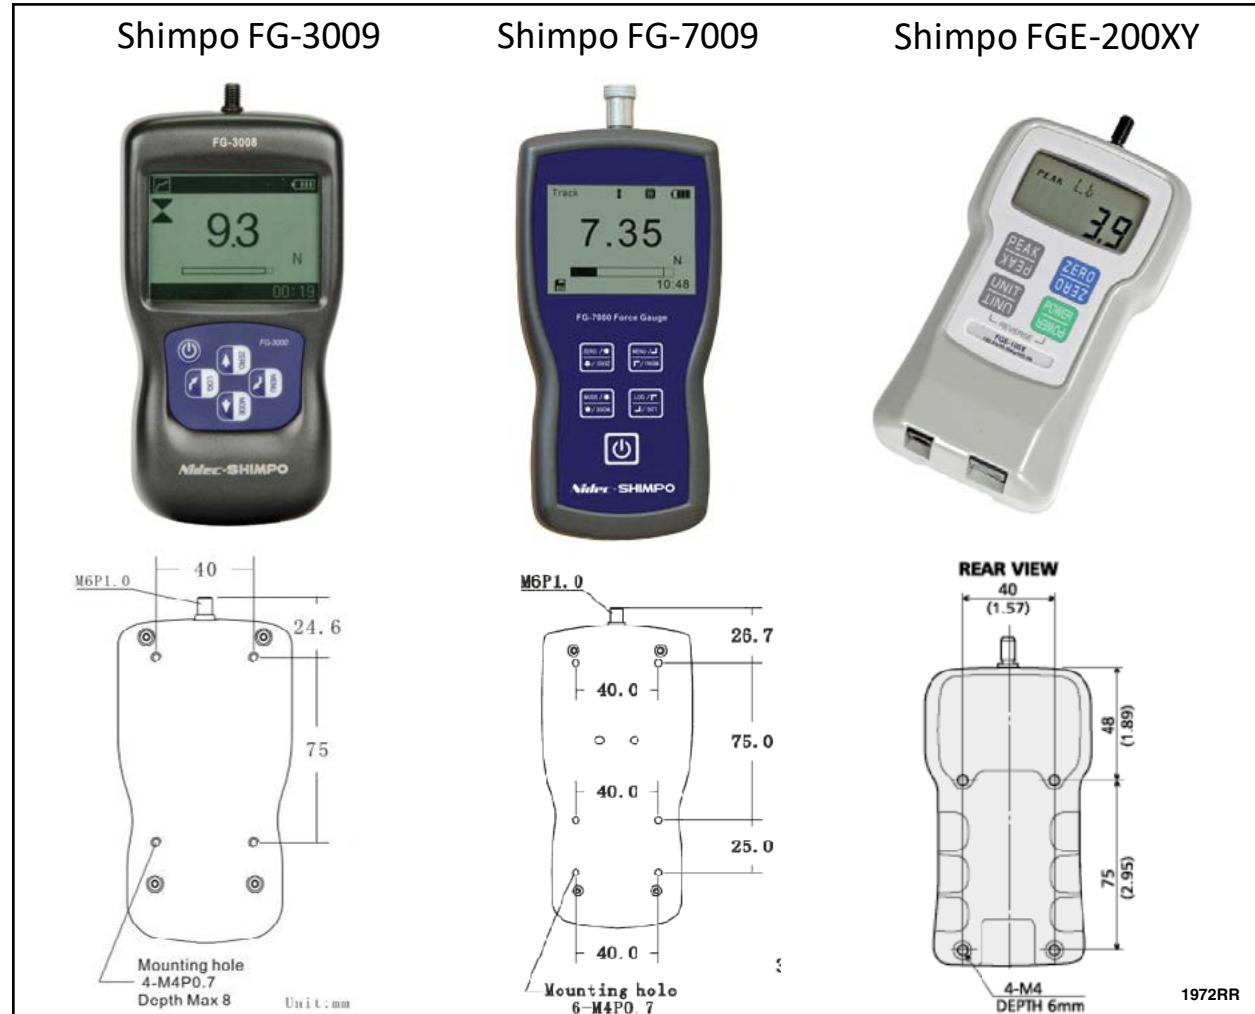
**FIGURE 5**

## FORCE GAUGE MOUNTING LOCATION TO ASSIST IN BUILDING A HOLDING FIXTURE

**NOTE:** Not all force gauges are shown. Please see the user manual for the Force Gauge sent to your dealership.

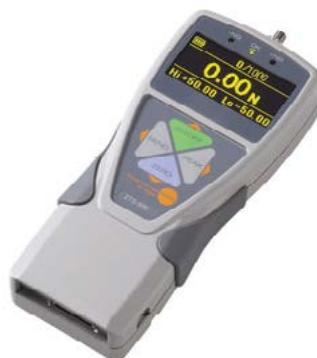
FIGURE 9

Motive  
ZTA-220

1972VV
