**Firmware Version:** 1.20.008  
**Boot Code Version:** 1.00.005  
**Nuclias Portal Version:** 2.2.0.4  
**Published:** Feb. 09, 2021

These release notes include important information about D-Link Nuclias switch firmware revisions. Please verify that these release notes are correct for your switch:

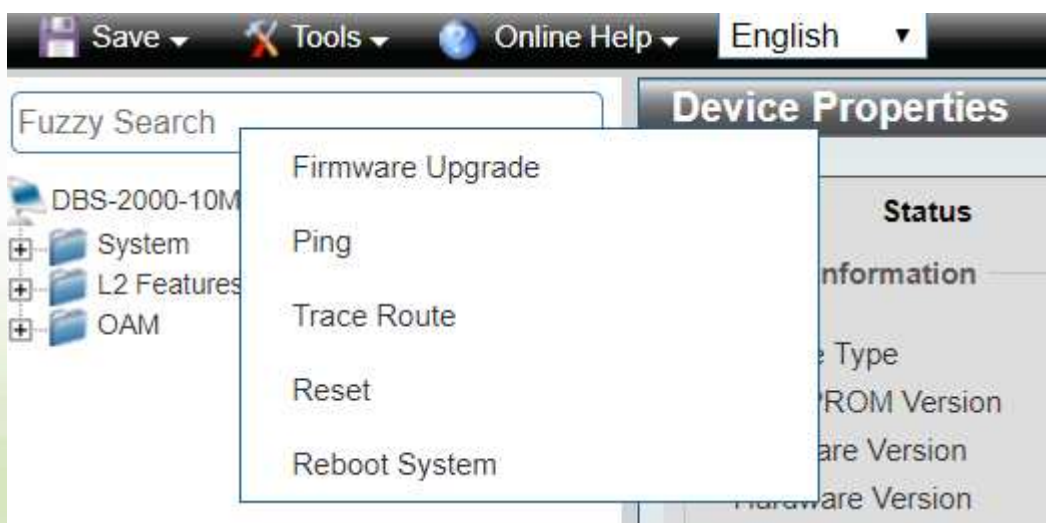
1. Connect a workstation installed with java SE runtime environment to any switch port of the device.
2. Open the web browser from the workstation and enter the IP address of the switch.
3. Enter username and password then press OK to login. The username and password are "admin" and "password" by default.
4. To update switch's firmware or configuration file, select **Tools > Firmware Upgrade** from the banner.

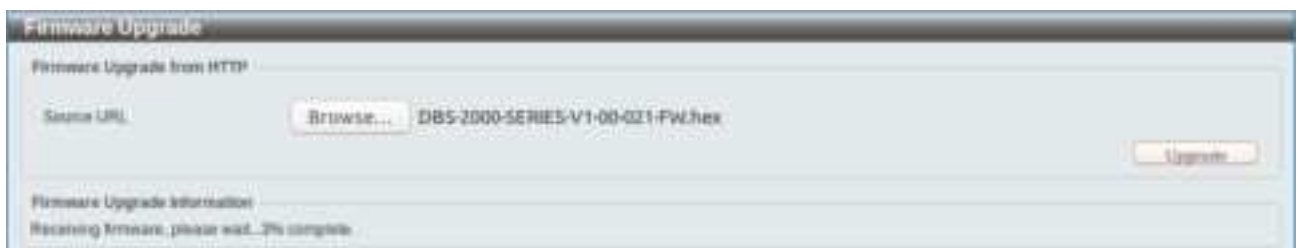
- b. Click **Upgrade** after selecting the firmware file you want to upgrade

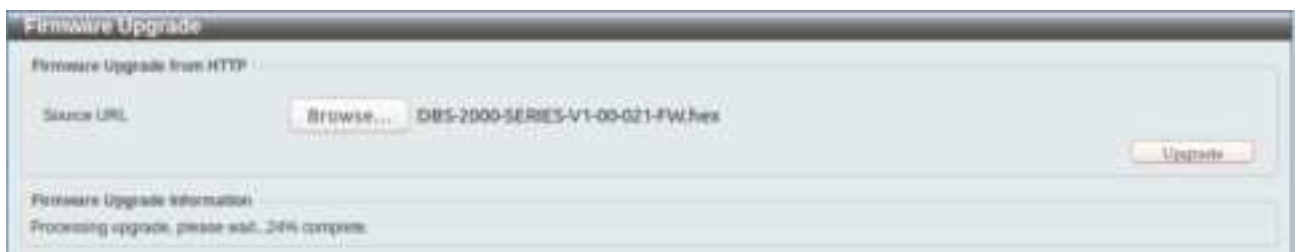
- c. It will be downloading the firmware file to DUT.
- d. When download success, do not power off.

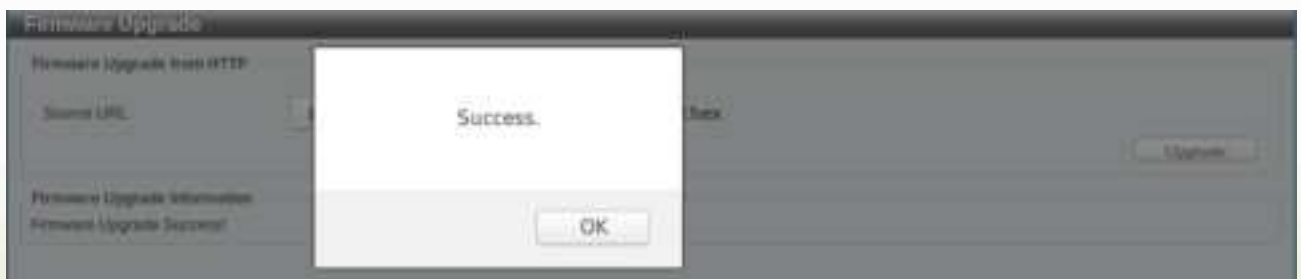
- e. Wait until display the "Firmware Upgrade Success!" message and pops up "Success".
