# Dell™ PowerVault™ ML6000 Maintenance Guide

Document Number: 6-01367-10 Rev A

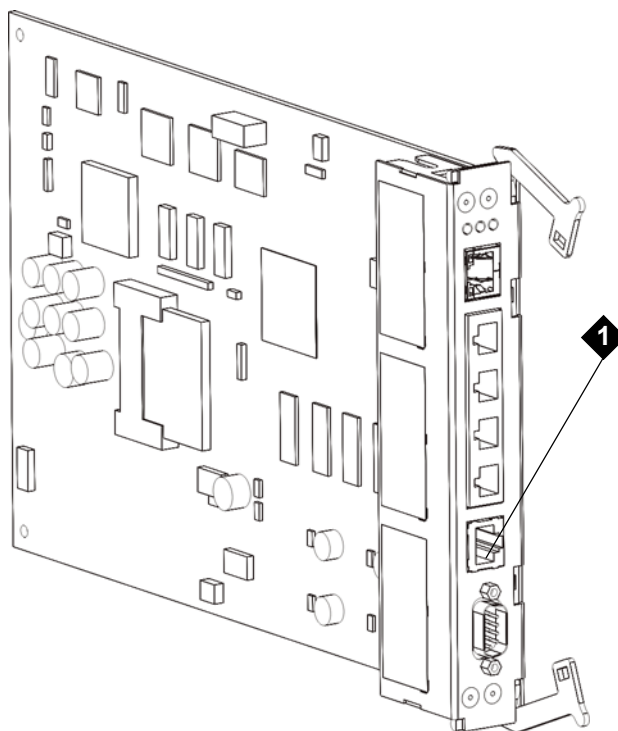
## 1 Service Port

The library control blade (LCB) provides an Ethernet port that is reserved for use by service personnel. When servicing a library, connect your laptop to this port to access the remote Web client.

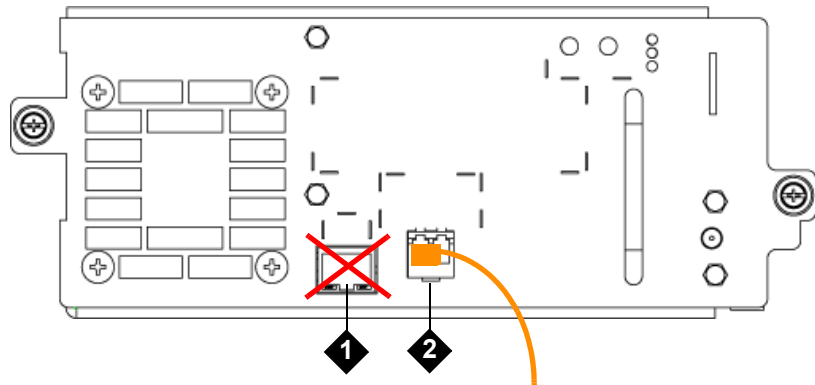
**Figure 1** IBM LTO-5 Single Port Fibre Channel Tape Drive

- 
- 1 Ethernet port - do not use
  - 2 Fibre Channel port - use this port
-

The library handles the Ethernet and data ports on LTO-5 and LTO-6 tape drives differently, depending on the tape drive. See [Figure 1](#) and [Figure 2](#) for details.

LTO-5 and LTO-6 Fibre Channel tape drives can be configured for speeds of up to 8 Gb/s. If they are configured for 8 Gb/s, you should connect them directly to a host or switch and not to an FC I/O blade, because the FC I/O blade only allows speeds up to 4 Gb/s. If you connect an LTO-5 or LTO-6 Fibre Channel tape drive to an FC I/O blade, the speed will autonegotiate to 4 Gb/s.

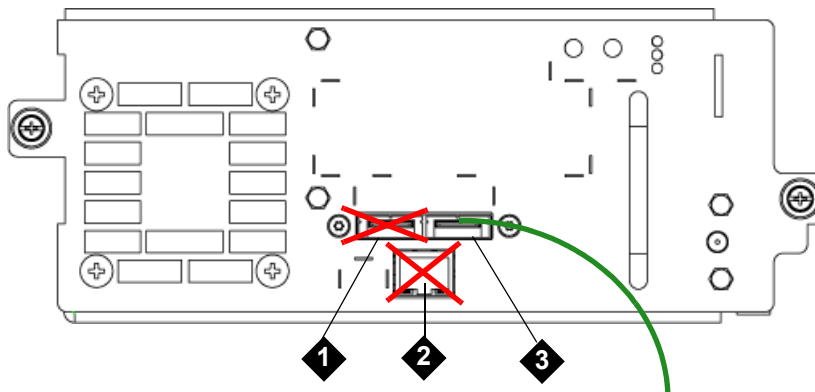
**Figure 2** IBM LTO-5 Dual Port SAS Tape Drive

- 
- 1 SAS port 1 - use this port
  - 2 SAS port 2 - do not use
  - 3 Ethernet port - do not use
-

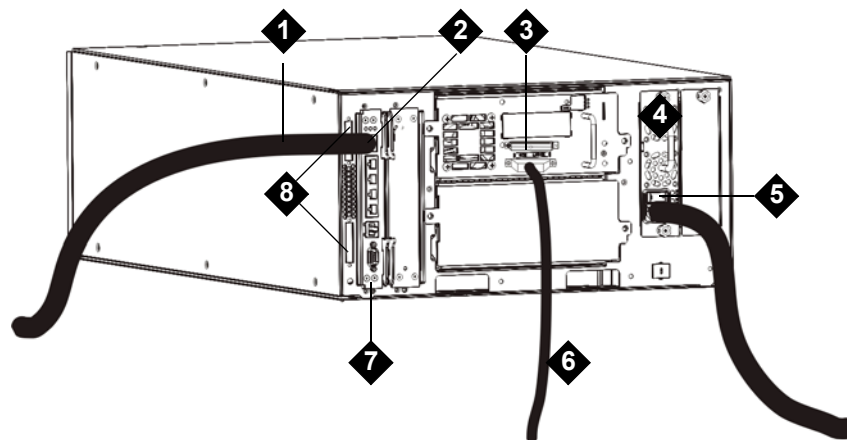
**Figure 3** Stand-Alone 5U Library Control Module SCSI Cabling

| 1 Ethernet cable to customer network | 5 Rear power switch |
| 4 Power supply | 8 Module terminators |

Use this procedure, along with [Figure 3](#) and [Figure 4](#) on page 25, if you are installing a library that includes SCSI tape drives:

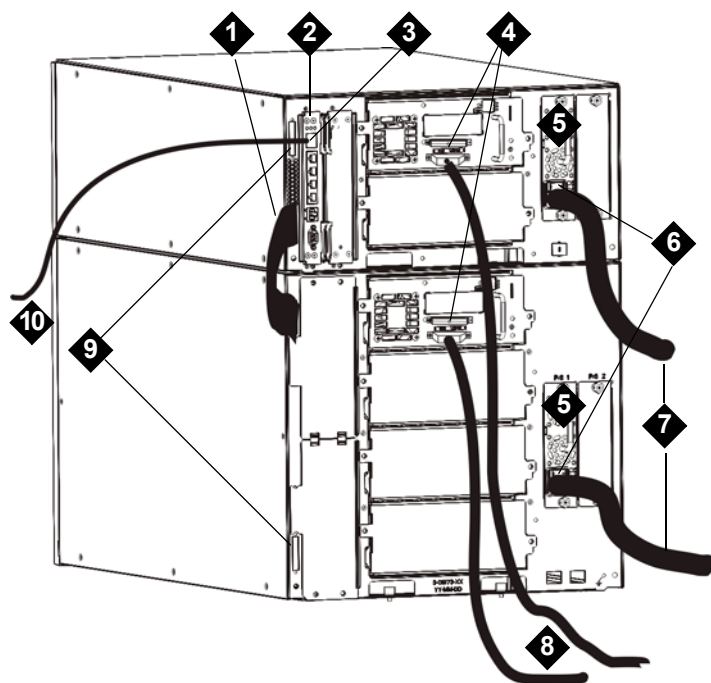
**Figure 4** Multi-Module SCSI Cabling

| 1 | Module-to-module cable | 6 | Rear power switch |
| 2 | Library control blade | 7 | Power cords |

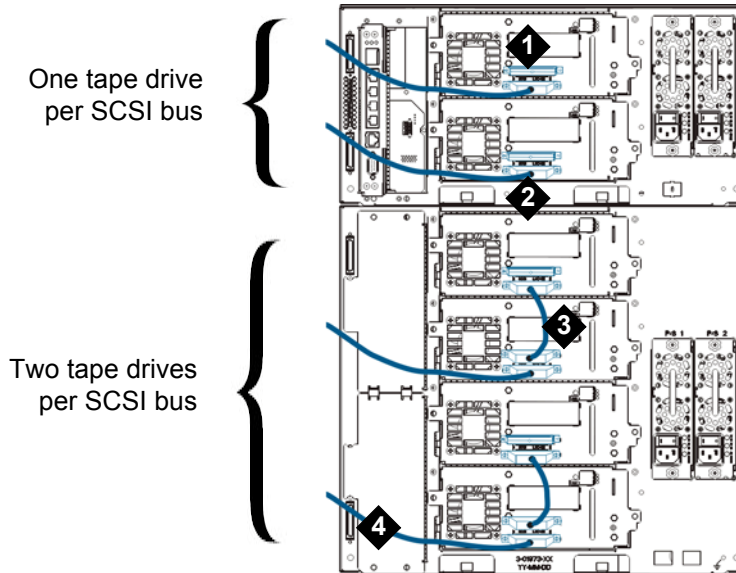
**Figure 5** Cabling One or Two Tape Drives Per SCSI Bus

- a. Connect one end of the SCSI cable to the top SCSI port of the bottom tape drive. Then connect the other end of the cable to the bottom SCSI port of the tape drive above. The SCSI cable connecting the two tape drives should be at least 30 cm in length.
- b. Use another SCSI cable to connect the bottom tape drive of the SCSI bus to your host.
- c. Use a SCSI terminator to terminate the top tape drive of the SCSI bus.

| 1 | SCSI terminator | 3 | SCSI cable connecting two SCSI tape drives |

- 1 If your library is taller than 14U, install it in a rack. See [Using the Rack-mount Kit to Install a Library in a Rack](#) on page 108 for instructions. The instructions include procedures for removing and replacing tape drives.
- 2 Connect the SCSI cables to the tape drives. There are two recommended ways to cable SCSI tape drives: one tape drive per SCSI bus or two tape drives per SCSI bus (see [Figure 5](#)).

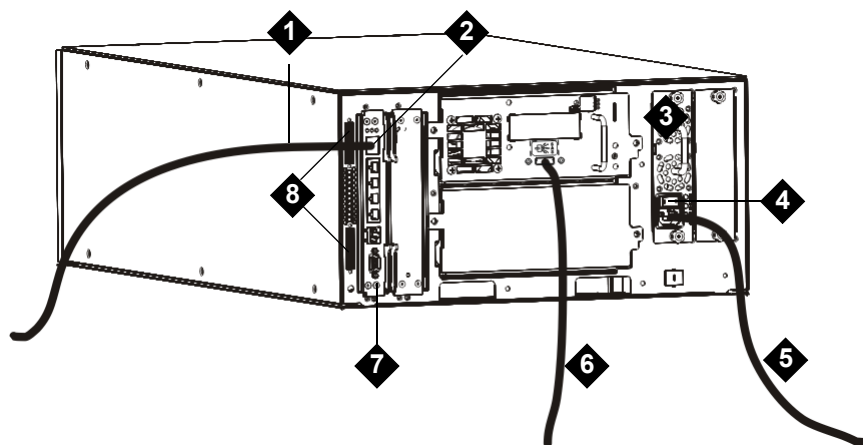
**Figure 6** Stand-Alone 5U Library Control Module SAS Cabling

| 1 Ethernet cable to customer network | 5 Power cord |
| 4 Rear power switch | 8 Module terminators |

Use this procedure, along with [Figure 6](#) and [Figure 7](#) on page 29, to connect SAS cables directly to the host.

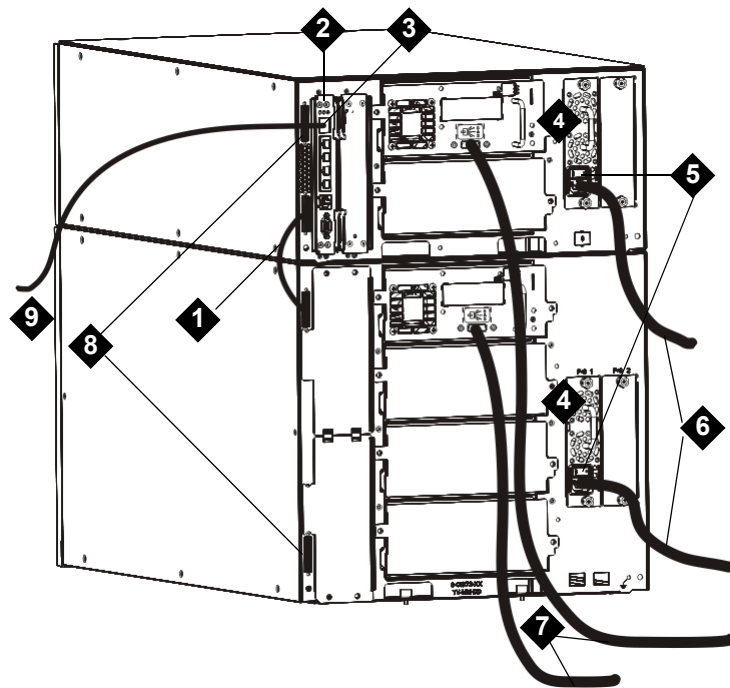
**Figure 7** Multi-Module SAS Cabling

| 1 | Module-to-module cable | 6 | Power cords |
| 2 | Library control blade | 7 | SAS cables to host |

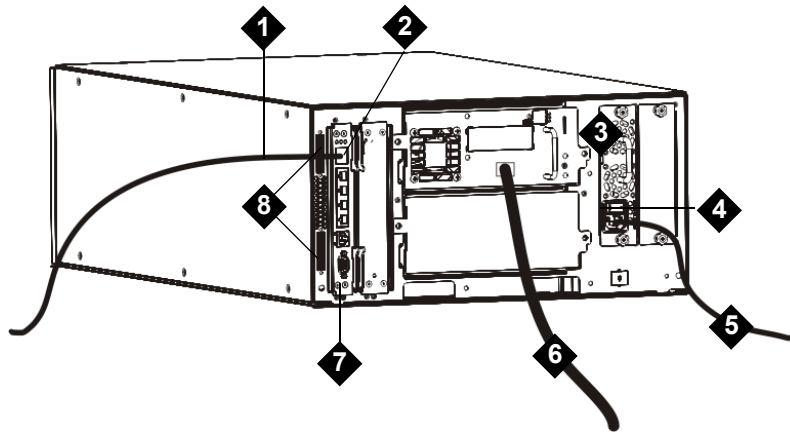
**Figure 8** Stand-Alone 5U Library Control Module Fibre Channel Cabling

| 1 Ethernet cable to customer network | 5 Power cord |
| 4 Rear power switch | 8 Module terminators |

Use this procedure, along with [Figure 8](#) and [Figure 9](#) on page 32, if you are installing a library that includes FC tape drives that are connected directly to a host.

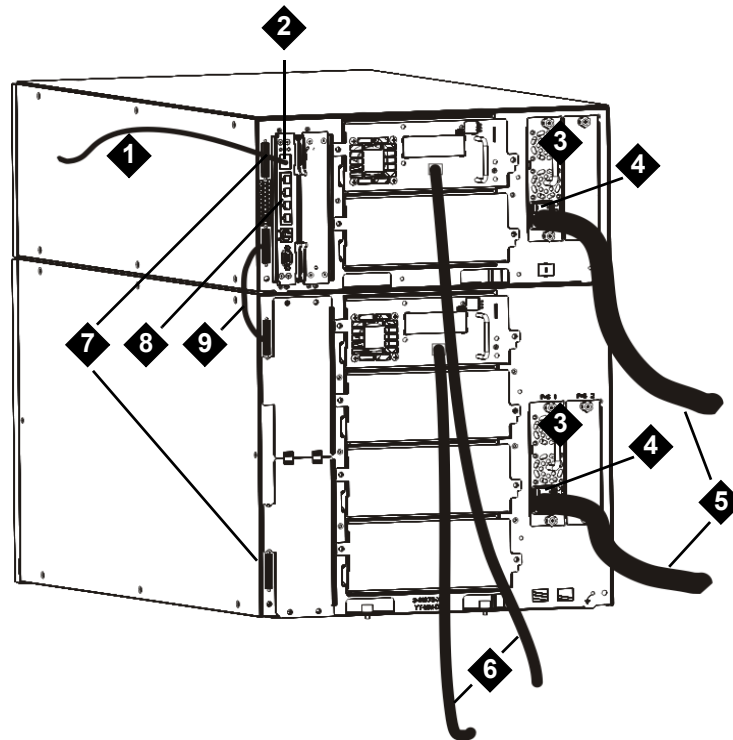
**Figure 9** Multi-Module Fibre Channel Cabling

| 1 Ethernet cable to customer network | 5 Power cords |

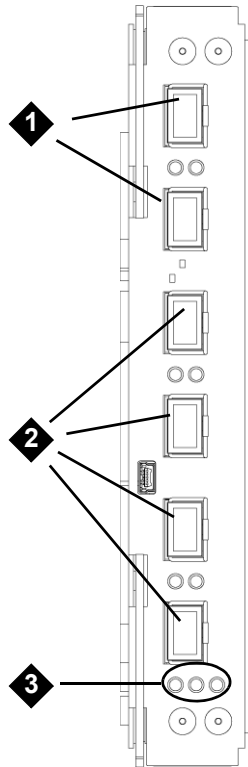
**Figure 10** FC I/O Blade

- 
- 1** Target ports 1 and 2 to host(s)
  - 2** Initiator ports 3 – 6 to drives
  - 3** LEDs (blue, amber, green)
-

- Each expansion module can support up to two FC I/O blades. A maximum of four FC I/O blades can be present in any library configuration. A maximum of four FC drives can be connected to one FC I/O blade.
- Ports 1 and 2 on each FC I/O blade are reserved for connection to hosts. Ports 1 and 2 are always in target mode. The other four ports (3, 4, 5 and 6) are always in initiator mode. See [Figure 14](#) on page 45.
- SAN-ready tape drives that are shipped with FC I/O blades include 24-inch, orange fibre optic cables to connect tape drives to initiator ports on an FC I/O blade.
- Ideally, an installed tape drive should be cabled to a port on the nearest FC I/O blade to eliminate the need to manage excessively long cables. The nearest FC I/O blade is usually located in the same 9U library expansion module as the tape drive.

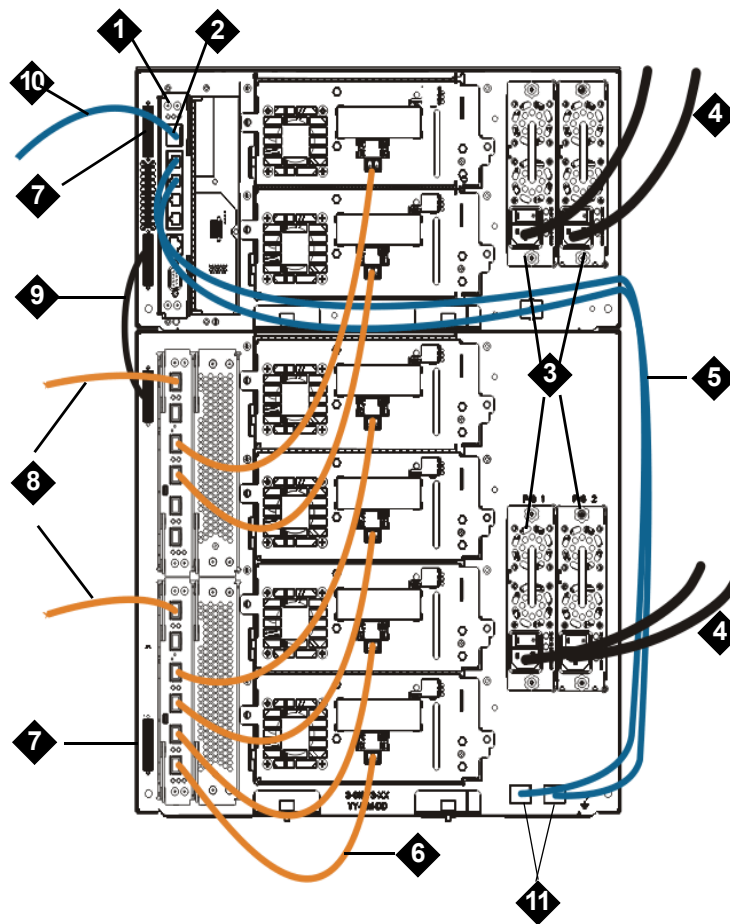
**Figure 11** FC With I/O Blade Cabling

| 1 Library control blade (LCB) | 6 FC cable to tape drive |

Use the following procedure, along with [Figure 11](#), if you are installing a library that includes FC tape drives that are connected to FC I/O blades.

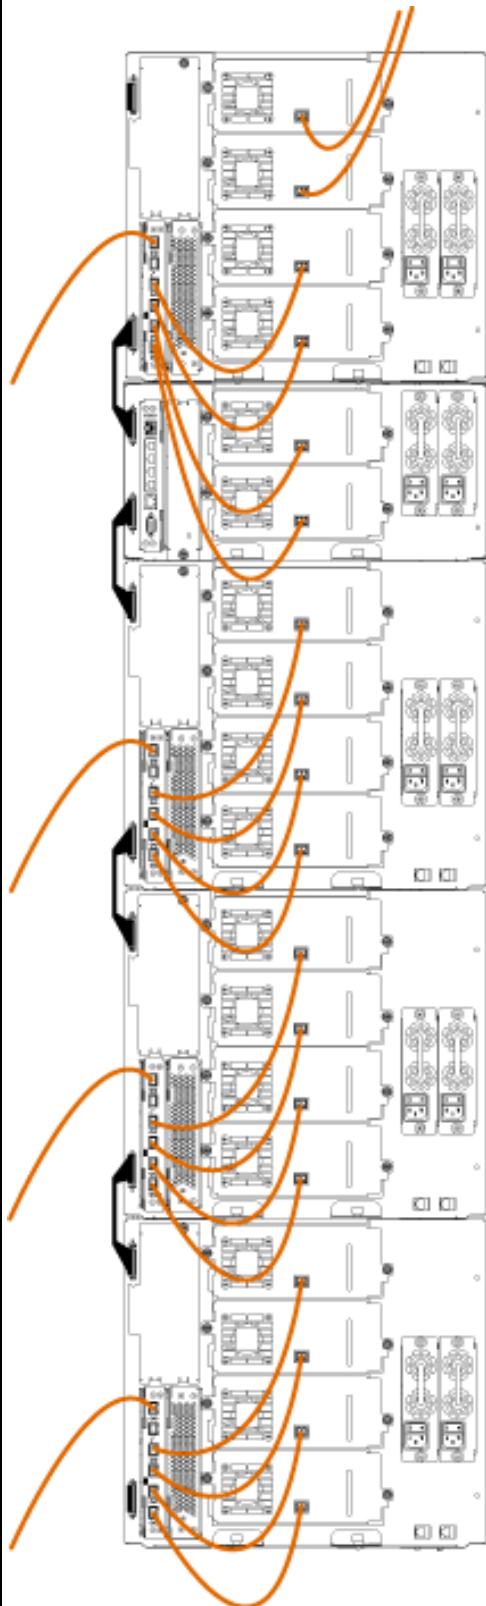
**Table 2** Recommended Fibre Channel Cabling With I/O Blades in Maximum Capacity Library

| Recommended Cabling | Tape Drive | FC I/O Blade | FC I/O Blade Port |
|---|---|---|---|
| <p>The diagram illustrates the recommended fibre channel cabling for a Maximum Capacity Library. It shows a vertical stack of tape drives on the left and FC I/O blades on the right. Orange lines represent the fibre optic cables connecting the drives to the blades. The connections are as follows: Drive [1,1] and [1,2] are direct attached. Drive [1,3] connects to blade [1,2] Port 3. Drive [1,4] connects to blade [1,2] Port 4. Drive [0,1] connects to blade [1,2] Port 5. Drive [0,2] connects to blade [1,2] Port 6. Drive [-1,1] connects to blade [-1,2] Port 3. Drive [-1,2] connects to blade [-1,2] Port 4. Drive [-1,3] connects to blade [-1,2] Port 5. Drive [-1,4] connects to blade [-1,2] Port 6. Drive [-2,1] connects to blade [-2,-2] Port 3. Drive [-2,2] connects to blade [-2,-2] Port 4. Drive [-2,3] connects to blade [-2,-2] Port 5. Drive [-2,4] connects to blade [-2,-2] Port 6. Drive [-3,1] connects to blade [-3,2] Port 3. Drive [-3,2] connects to blade [-3,2] Port 4. Drive [-3,3] connects to blade [-3,2] Port 5. Drive [-3,4] connects to blade [-3,2] Port 6.</p> | [1,1] | N/A (direct attached) | |

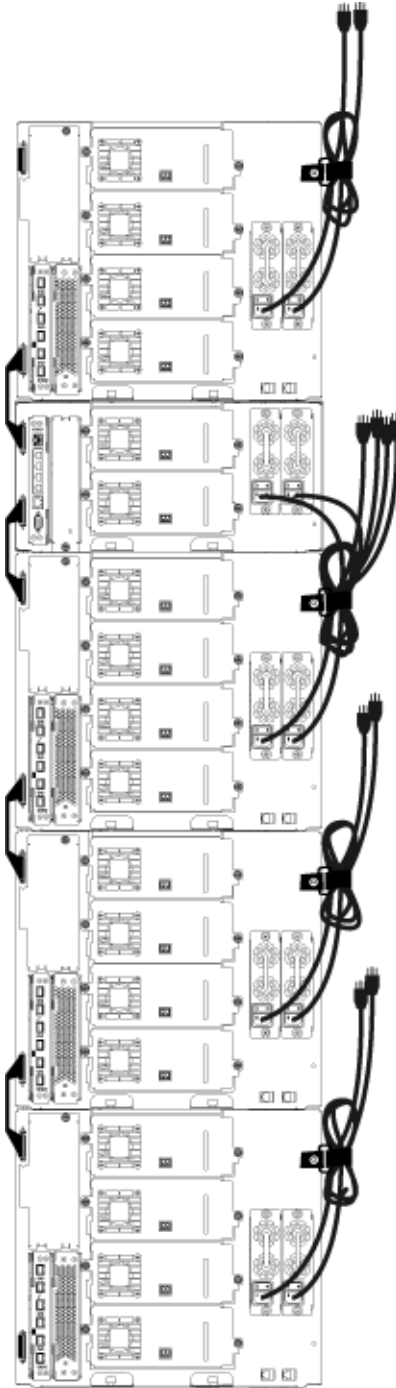
**Figure 12** Power Cord Management

Once complete, power cord management for an ML6030 CM plus two PowerVault ML6000 9U Expansion Modules should look similar to [Figure 12](#) below.

- 1 Facing the rear of the library, locate a specific hole that is drilled into the back of the 9U Expansion Module for the hook-and-loop fastener. This hole is located on the rear of the library, about three inches from the top of the 9U Expansion Module near the right side of the library chassis. See [Figure 12](#) on page 42 for the location of this hole.

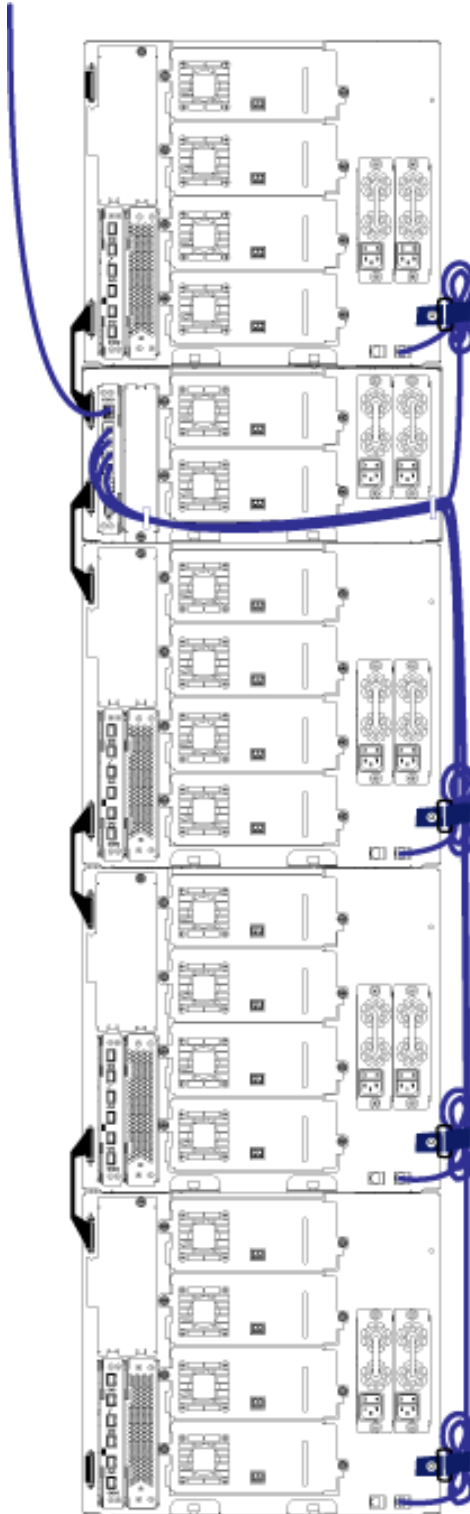
**Figure 13** Ethernet Cable Management

Once complete, the Ethernet cabling for a an ML6030 Control Module plus two PowerVault ML6000 9U Expansion Modules containing four I/O blades should appear similar to the illustration below.

- 1 Facing the rear of the library, install the two push-in wire saddle cable clamps onto the 5U Control Module chassis. Push the rivet of one clip into the hole drilled into the cover plate located to the right of the LCB. Push the rivet of the other clip into the hole located near the extreme right side of the library, below the 5U Control Module's power supplies. See [Figure 13](#) on page 44 for the locations of these holes.

If your 5U Control Module chassis does not have the drilled holes, use the adhesive -backed wire saddle cable clamps in the location shown in [Figure 13](#).

- 2 Locate a specific hole that is drilled into the back of the 9U Expansion Module for the hook-and-loop strap. This hole is located on the rear of the library, about three inches from the bottom of the 9U Expansion Module on the right side of the frame back plane. See [Figure 13](#) on page 44 for the location of this hole.

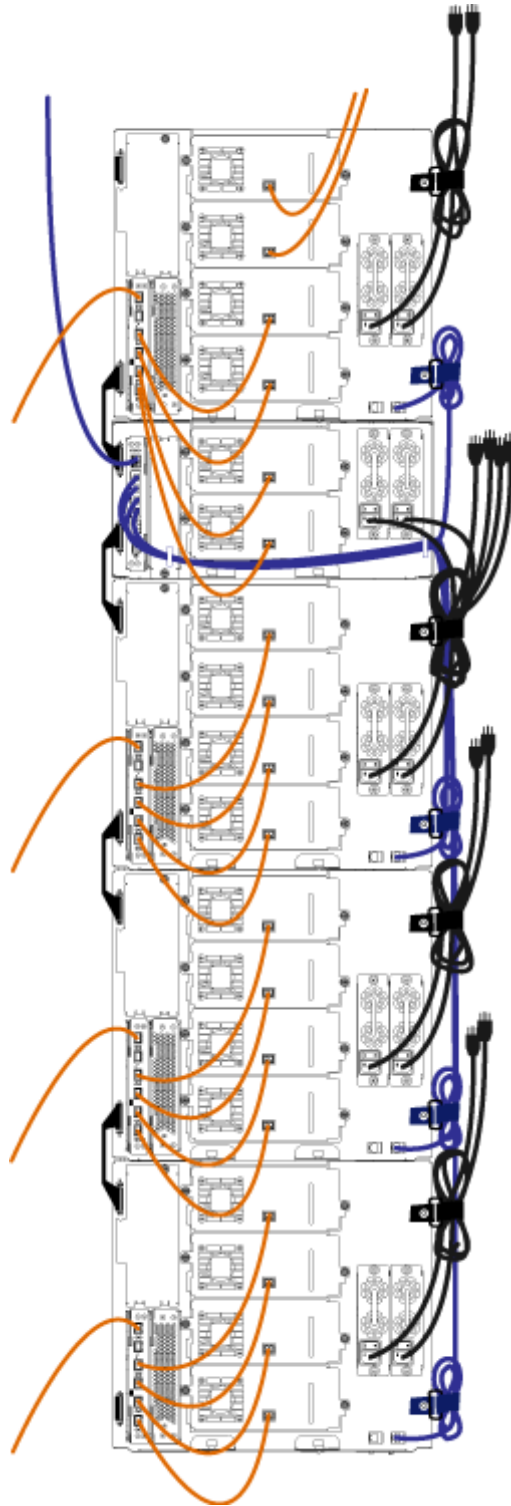
**Figure 14** Cable Management, All Cables, FC I/O Blades Installed

[Figure 14](#) shows how a 41U library with FC I/O blades would appear with power, Ethernet, and fibre cables installed and managed according to these guidelines.

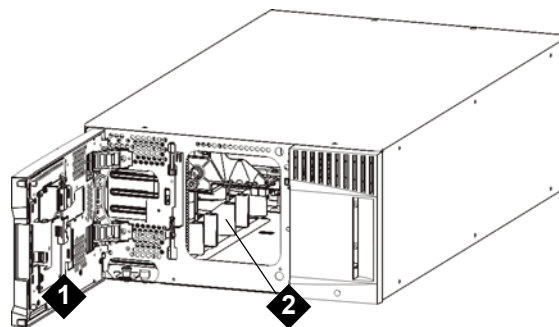
1 access door

2 tape blockers (installed)

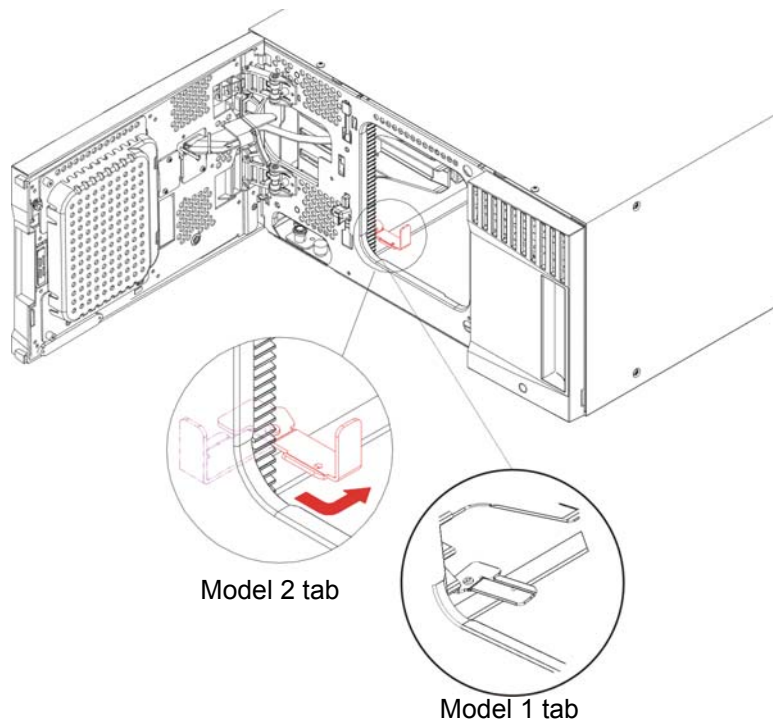
- c. After raising the robot assembly to the approximate middle of the 5U Library Control Module, hold it in place with one hand, and using your other hand, move the parking tab to the "parked" position (**Model 1 parking tab**: swivel toward you; **Model 2 parking tab**: move the parking tab in a counter-clockwise direction). The metal parking tab is located at the bottom of column 1.
- d. Gently release the robot assembly to rest on the parking tab.

Parking tab in “parked” position. Note that your parking tab may look different from the picture.

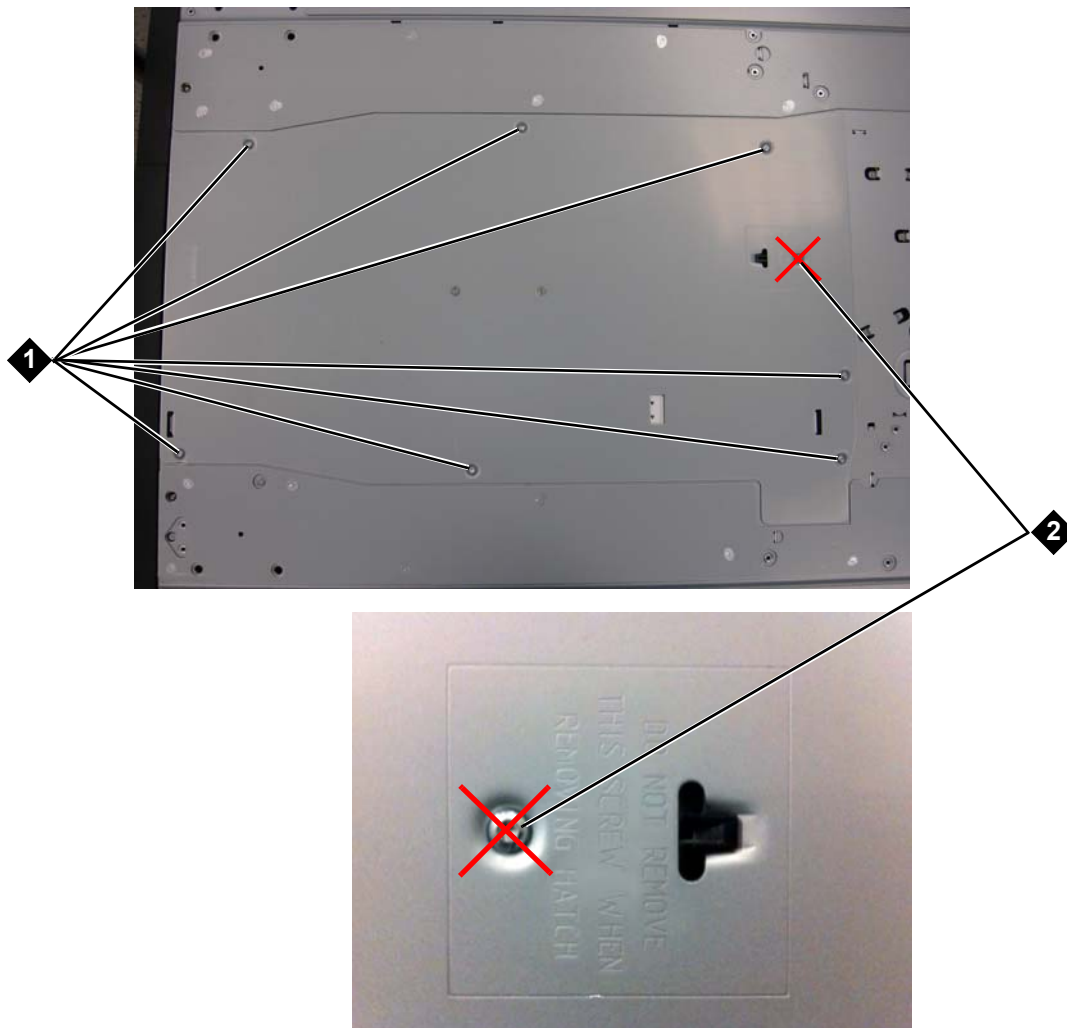
**Figure 15** Cover plate with y-home flag

**1** Screws to remove

- 5 Remove and replace the cover plates, if appropriate. When removing the cover plate, ensure that you do not remove the y-home flag screw, as shown in [Figure 15](#).

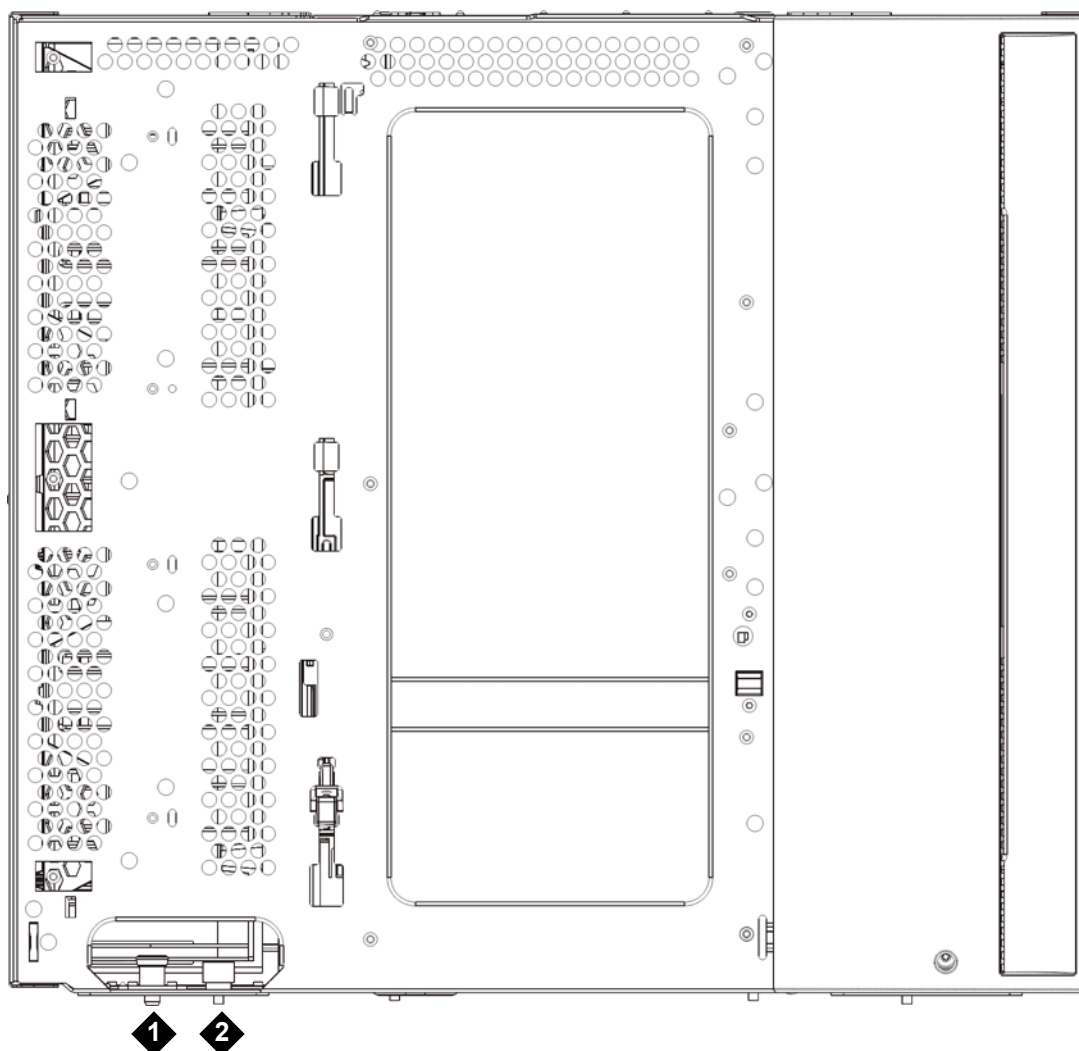
- 1 Open the 9U Expansion Module's access door and raise the guide pin by pulling it up and turning it slightly, as if it were a screw. Otherwise, the guide pin may scratch the front doors of the module on which you are stacking.

| 1 | Guide pin |

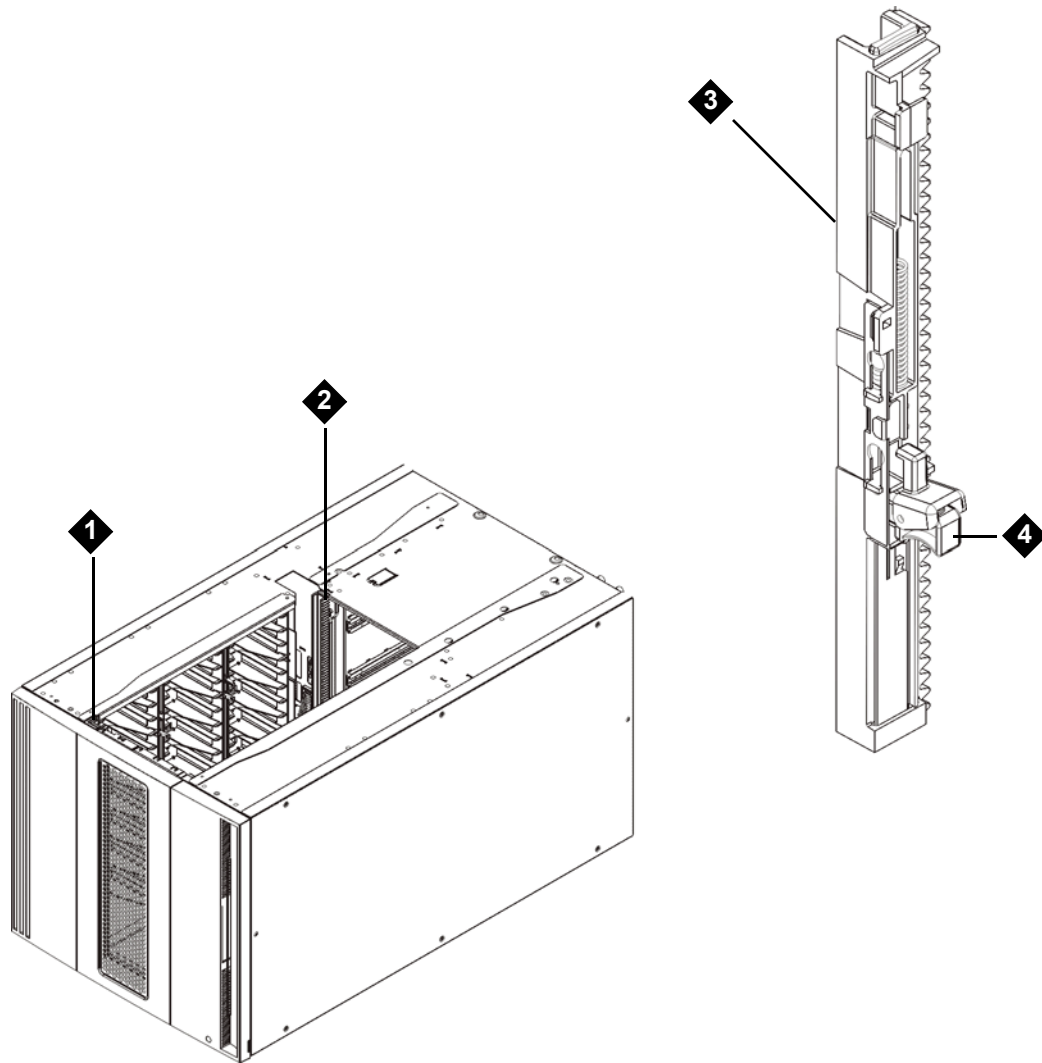
- 6 If stacking the 9U Expansion Module on top of another module, engage the Y-rails of the new module in your library configuration. Ensure that the Y-rails are properly aligned and the thumbscrews are tightened.

| 1 | Front Y-rail | 3 | Y-rail (this end up) |

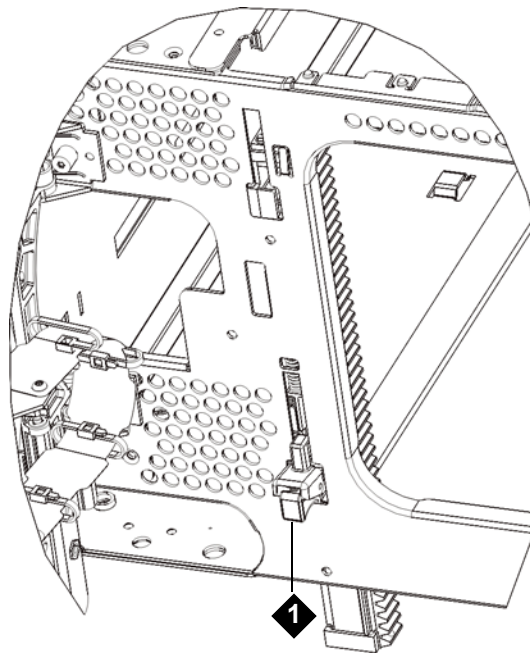
Doing this aligns the Y-rails with the Y-rails of the module beneath it.

**1** Y-rail in unlocked, functional position

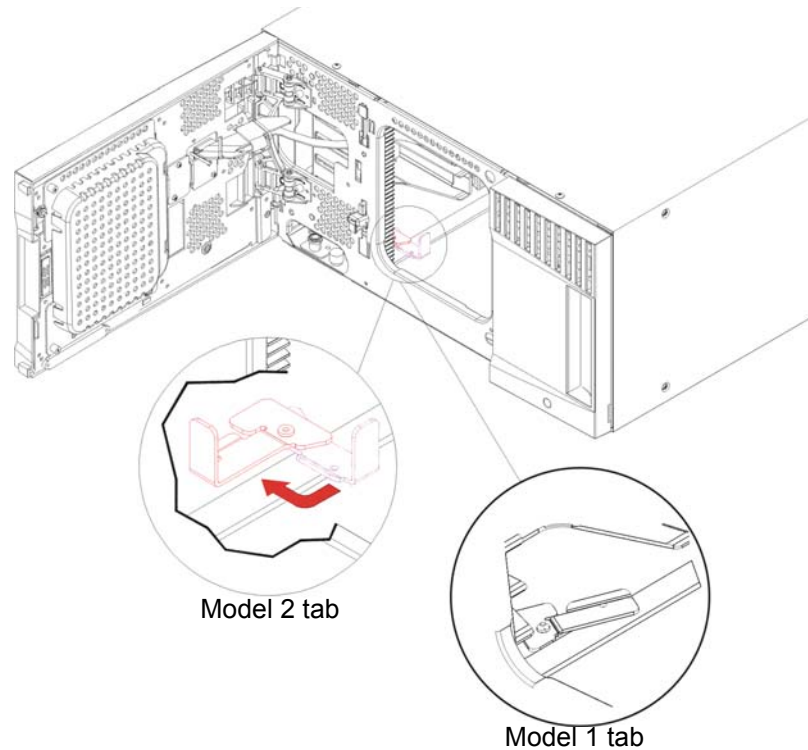
- b. With your free hand, move the parking tab to the "unparked" position so that it is removed completely from the interior of the module (**Model 1 parking tab**: swivel the parking tab away from you; **Model 2 parking tab**: move in a clockwise direction). When replaced correctly, the parking tab will not accidentally swivel into the path of the robot.

- c. Gently release the robot assembly. It will lower to the bottom module of the library.

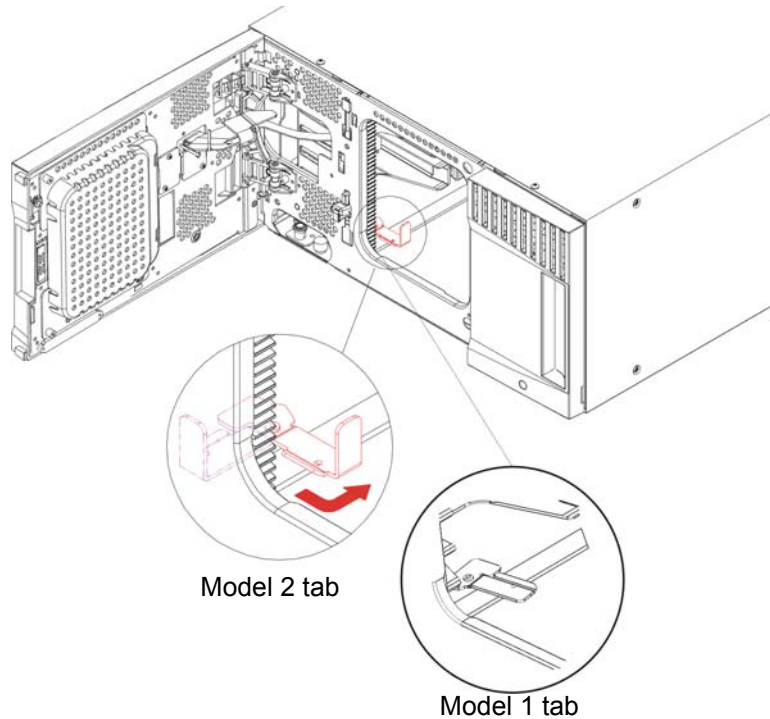
- c. After raising the robot assembly to the approximate middle of the 5U Library Control Module, hold it in place with one hand, and using your other hand, move the parking tab to the "parked" position (Model 1 parking tab: swivel toward you; Model 2 parking tab: move in a counter-clockwise direction). The metal parking tab is located at the bottom of column 1.
- d. Gently release the robot assembly to rest on the parking tab.

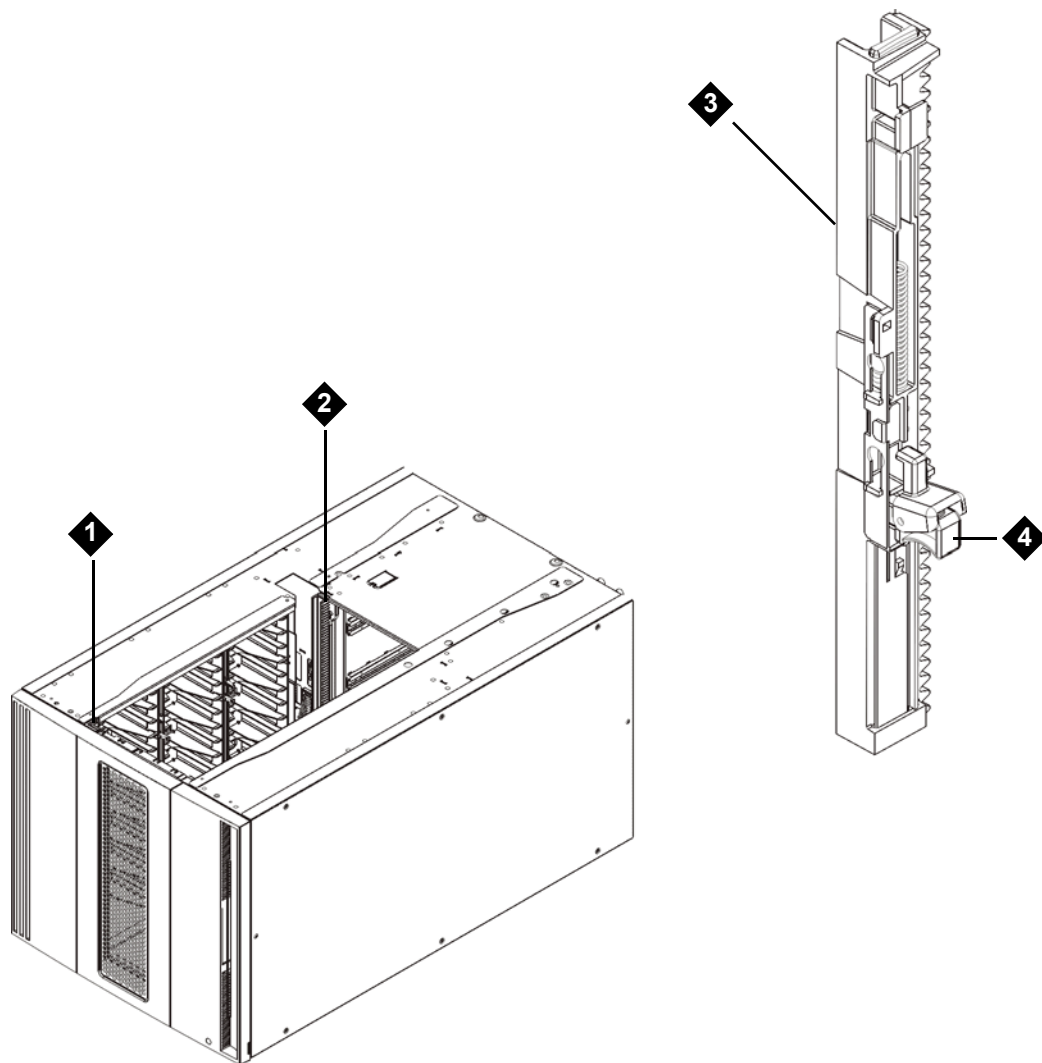
**Note** The rear Y-rail is impossible to lift up with the tape drives installed.

| 1 Front Y-rail | 3 Y-rail (this end up) |
| 2 Rear Y-rail | 4 Squeeze here to release |

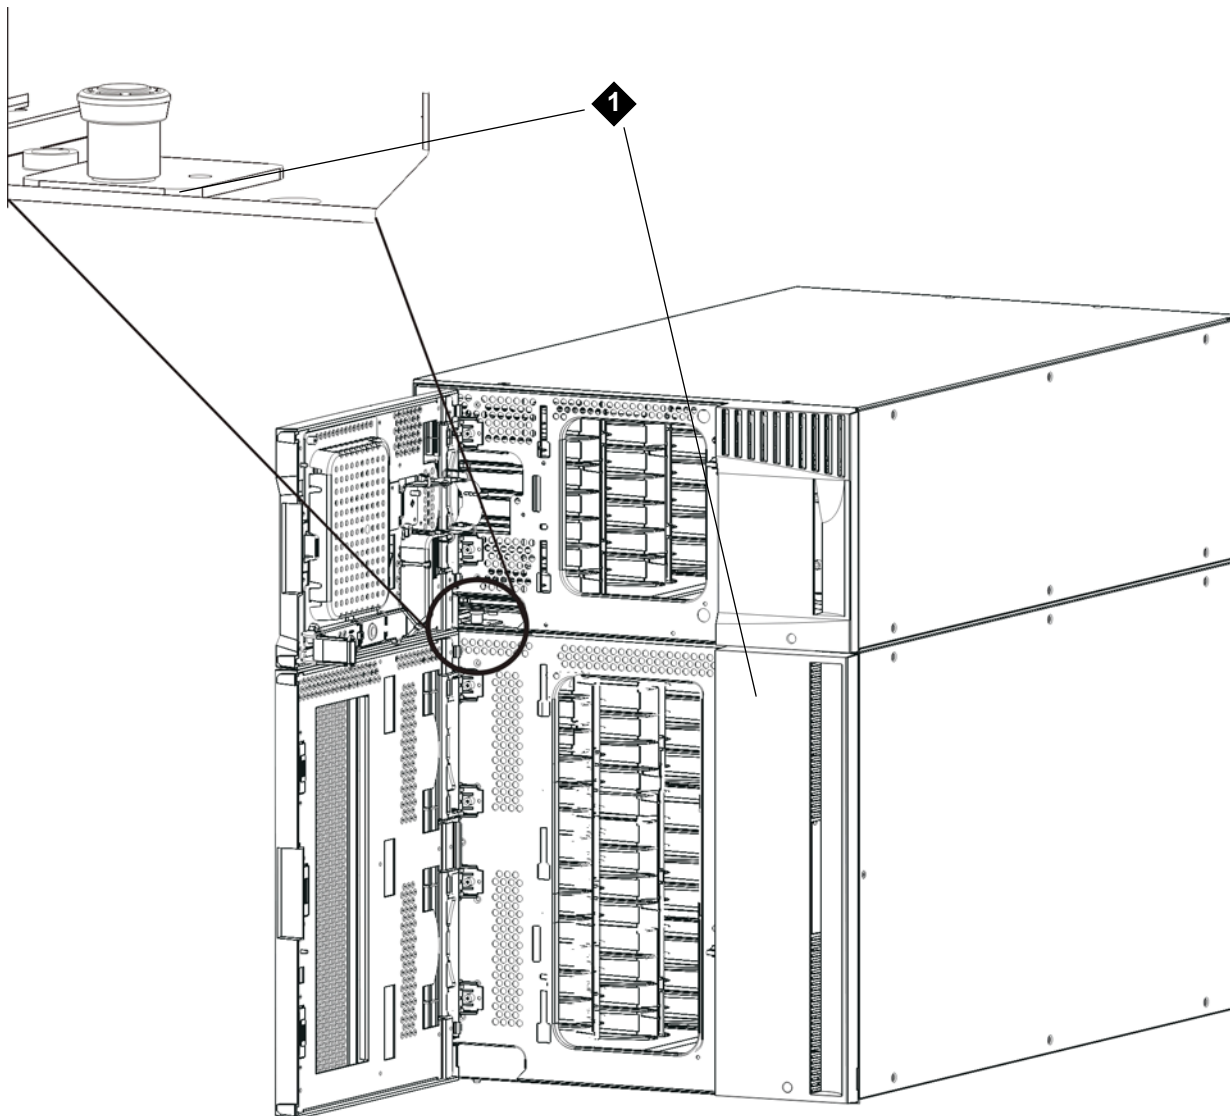
- 3 Remove the rack ears that fasten the module to the rack.
- 4 Loosen the thumbscrews located at the base of the front and rear of the module.

**1** Thumbscrews (behind doors)

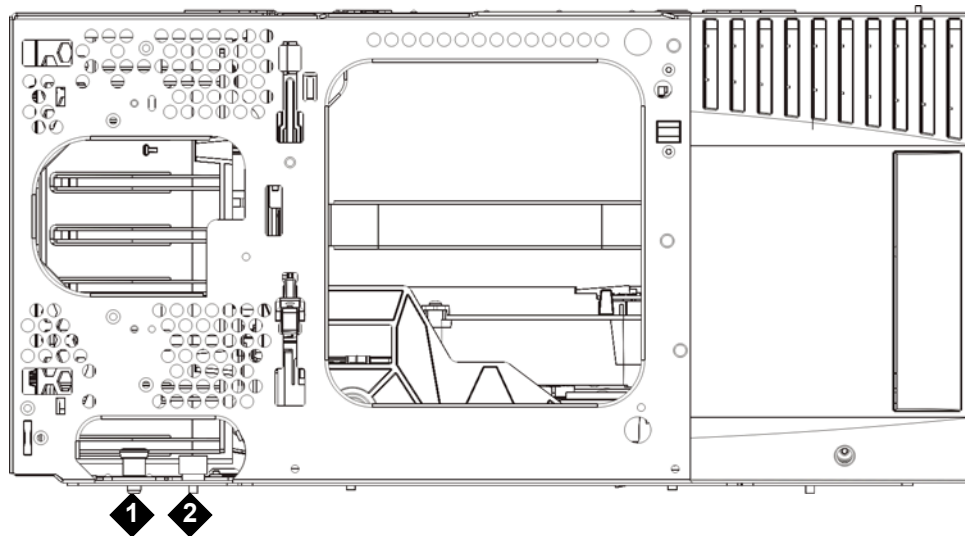
- 5 Open the module's access door and raise the guide pin by pulling it up and turning it slightly, as if it were a screw. Otherwise, the guide pin may scratch the front doors of the module beneath it.

- 
- 1 Guide pin
  - 2 Thumbscrew
-

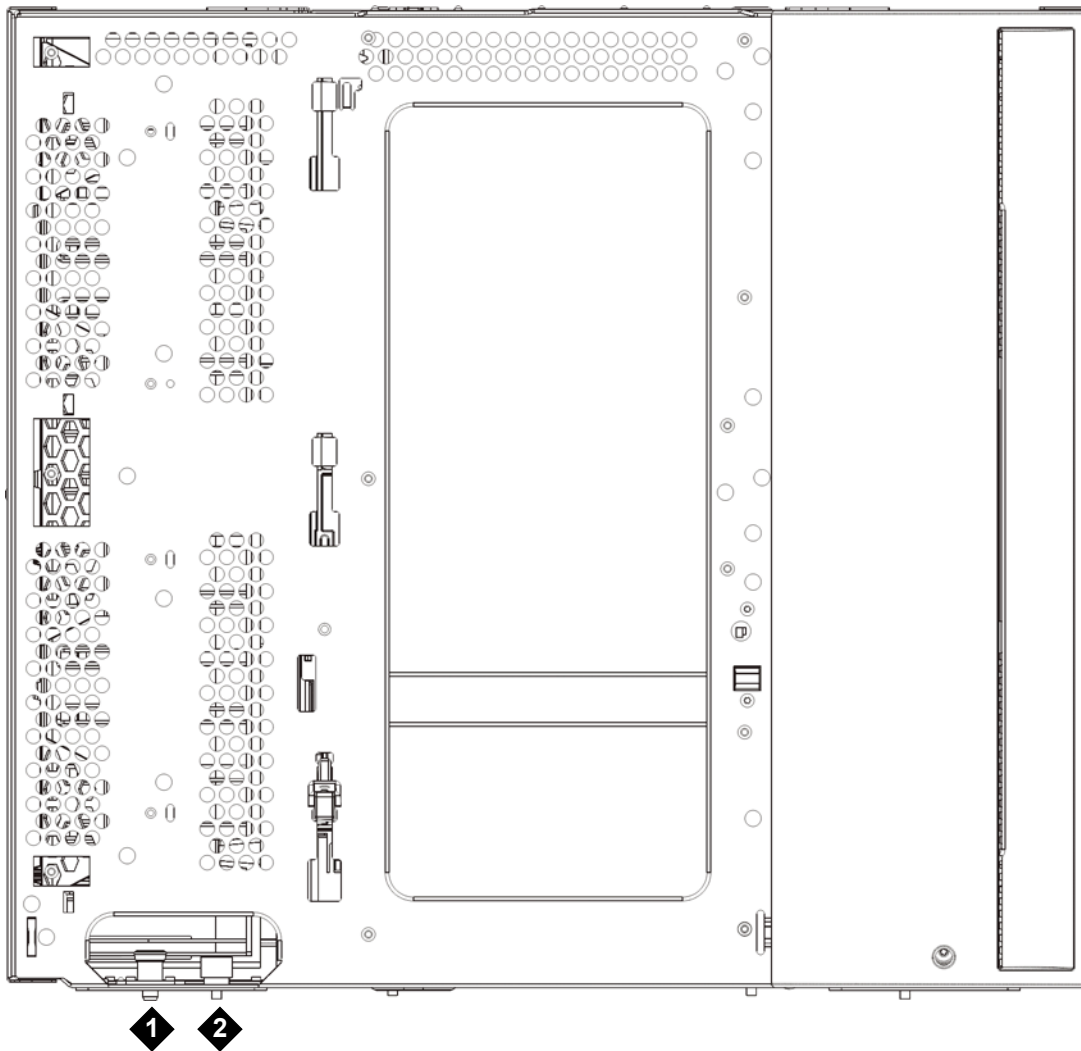
- 3 Open the 9U Expansion Module's access door and raise the guide pin by pulling it up and turning it slightly, as if it were a screw. Otherwise, the guide pin may scratch the front doors of the module on which you are stacking it.

- 
- 1 Guide pin
  - 2 Thumbscrew
-

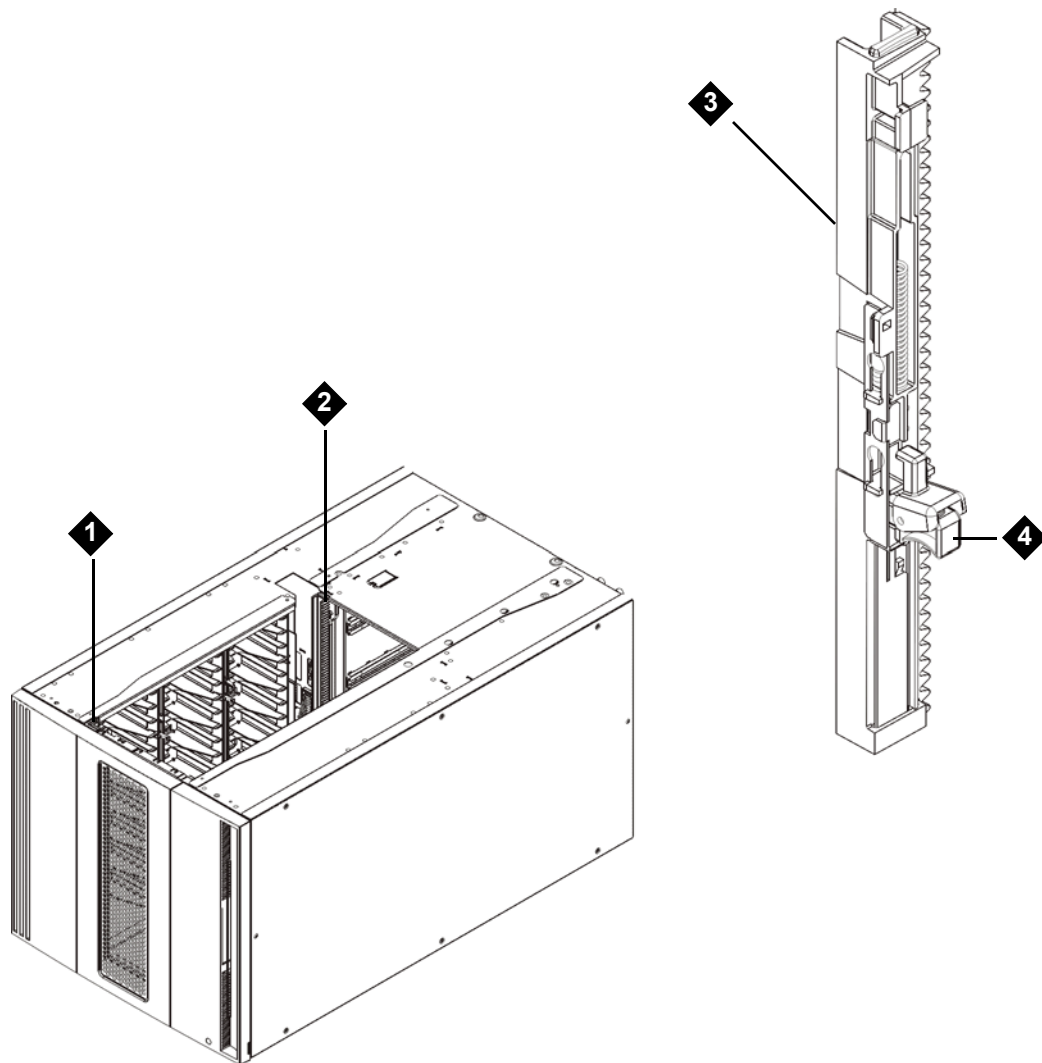
- 8 Engage the Y-rails of the new module in your library configuration. Ensure that the Y-rails are properly aligned and the thumbscrews are tightened.

| 1 Front Y-rail | 3 Y-rail (this end up) |

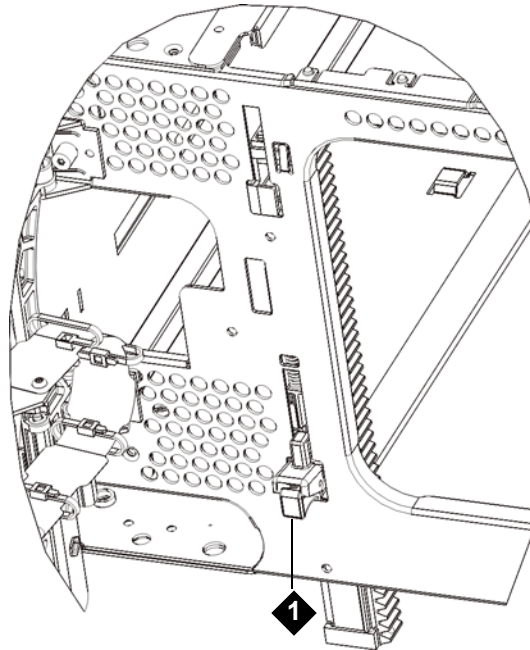
**Check to make sure that there is no gap between the top and bottom Y-rails on both the front and back of the library. If a gap exists, the library cannot mechanically initialize.**

- 
- 1** Y-rail in unlocked, functional position
-

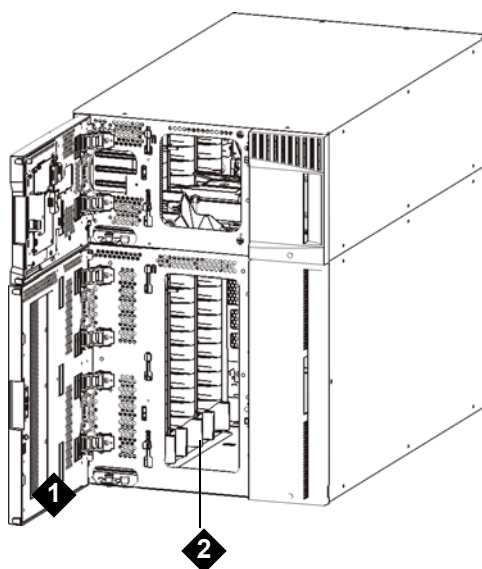
Libraries that have a Model 2 robot installed no longer use tape blockers. If your library contains a Model 2 robot, do NOT install tape blockers. For more information, see [Removing and Replacing the Robot Assembly](#) on page 164 and [How to Determine Which Robot Your Library Contains](#) on page 165.

1 access door
