# Dell™ PowerVault™ ML6000 Maintenance Guide

Document Number: 6-01367-10 Rev A

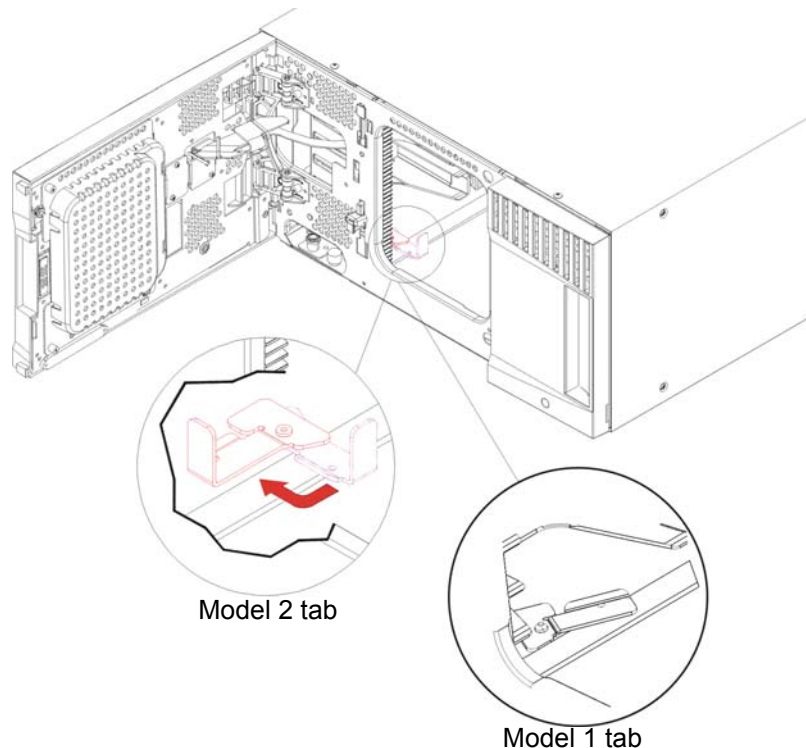
- b. With your free hand, move the parking tab to the "unparked" position so that it is removed completely from the interior of the module (**Model 1 parking tab**: swivel the parking tab away from you; **Model 2 parking tab**: move in a clockwise direction). When replaced correctly, the parking tab will not accidentally swivel into the path of the robot.
- c. Gently release the robot assembly. It will lower to the bottom module of the library.

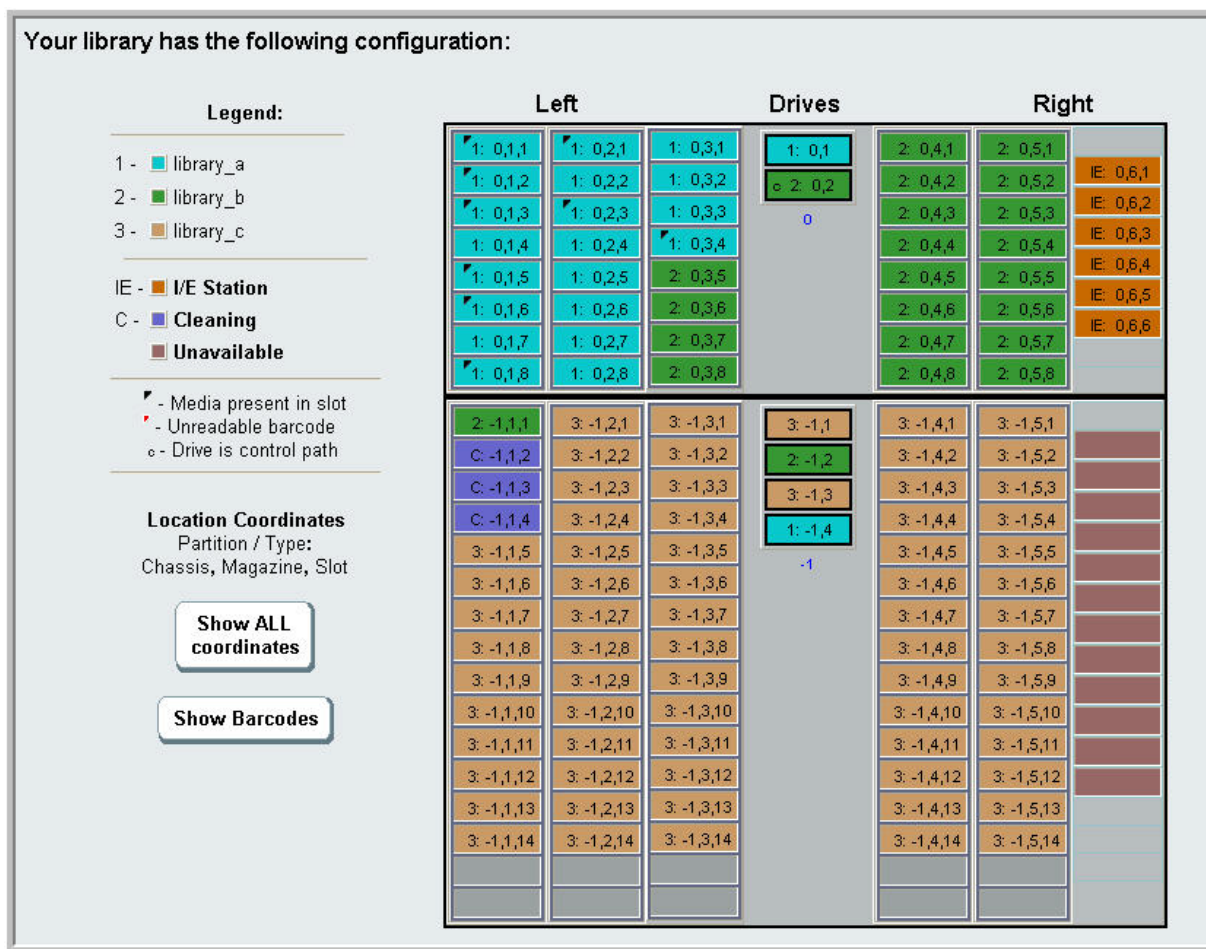
**Figure 16** Library Configuration Example 1

**For example**, in [Figure 16](#), there are three partitions configured. All three partitions share six I/E elements in the 5U Library Control Module. The library is configured for automatic cleaning and has three cleaning slots configured in the 9U Library Expansion Module.

- **Library\_a** includes all storage elements in the 5U Library Control Module, and has one drive configured in the 5U Library Control Module, and one drive configured in the 9U Library Expansion Module.
- **Library\_b** includes most storage elements in the 5U Library Control Module, but references its last storage element in the 9U Library Expansion Module. This partition has one drive configured in the 5U Library Control Module and one drive configured in the 9U Library Expansion Module.
- **Library\_c** includes all storage elements in the 9U Library Expansion Module, and also two drives in this 9U Library Expansion Module.

**For example,** in [Figure 16](#) on page 71, all partitions reference drives in the 9U Library Expansion Modules. In [Figure 17](#) on page 73, Library\_c was deleted, as well as its drive references in the 9U Library Expansion Module. Library\_a and Library\_b still require partition modifications to remove the drive reference and free the 9U Library Expansion Module of all partition resource references.

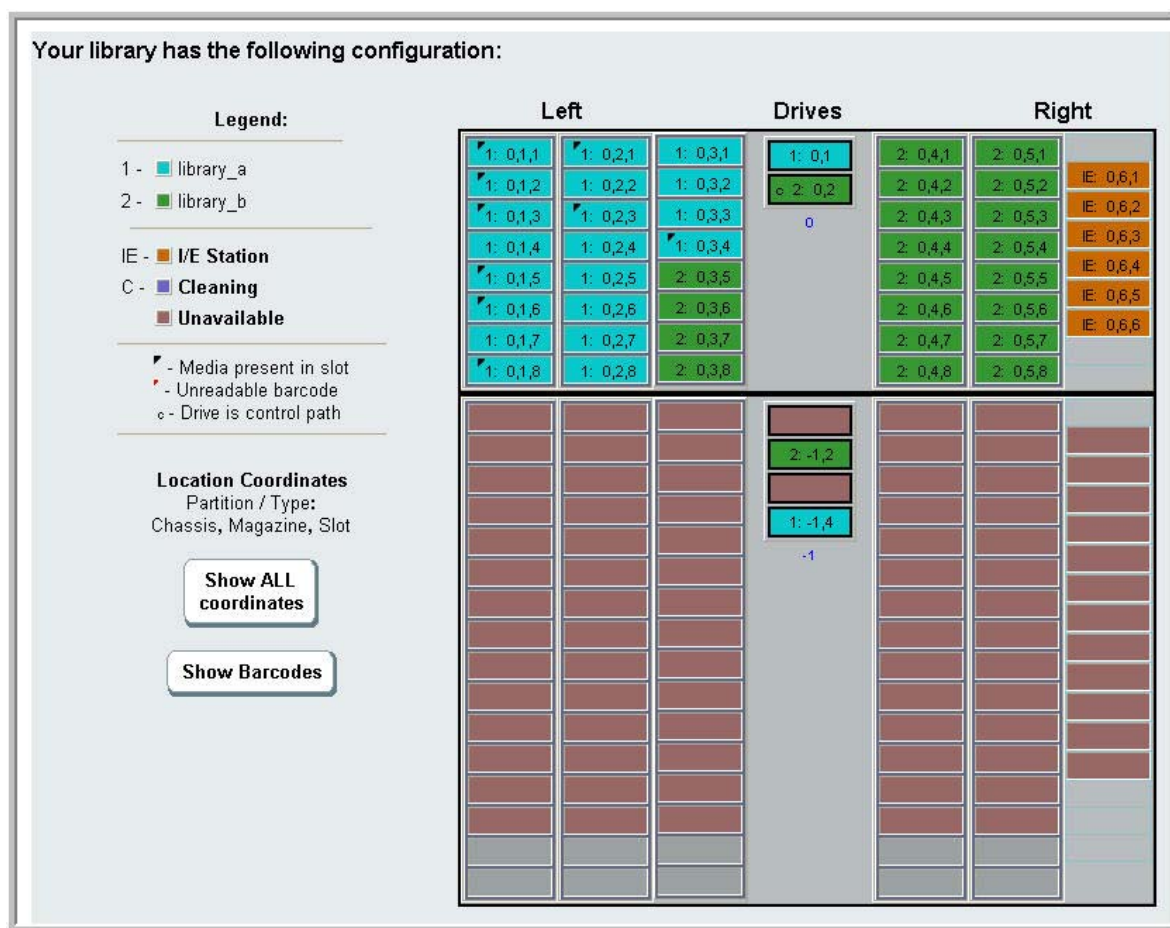
**Figure 17** Library Configuration Example 2

**For example**, in [Figure 17](#), after exporting all affected tape cartridges from the module you are removing, the cleaning slots are deleted, then Library\_c is completely deleted, and Library\_b is modified to reduce its storage slot count by one, since this deletes the storage slot reference in the 9U Library Expansion Module. No storage element modifications are required for Library\_a.

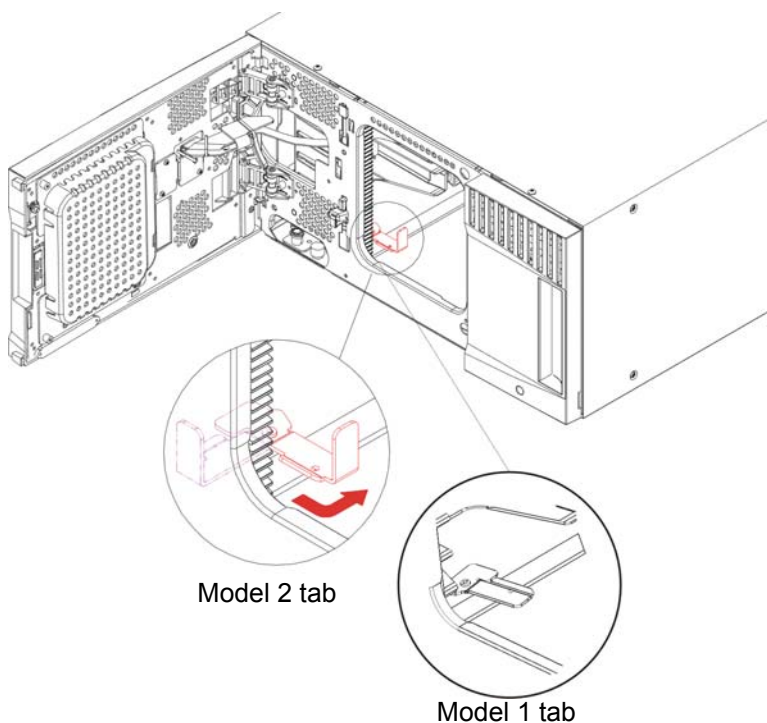
- After raising the robot assembly to the approximate middle of the 5U Library Control Module, hold it in place with one hand and, using your other hand, move the parking tab to the "parked" position (Model 1 parking tab: swivel toward you; Model 2 parking tab: move in a counter-clockwise direction). The metal parking tab is located at the bottom of column 1.
- Gently release the robot assembly to rest on the parking tab.

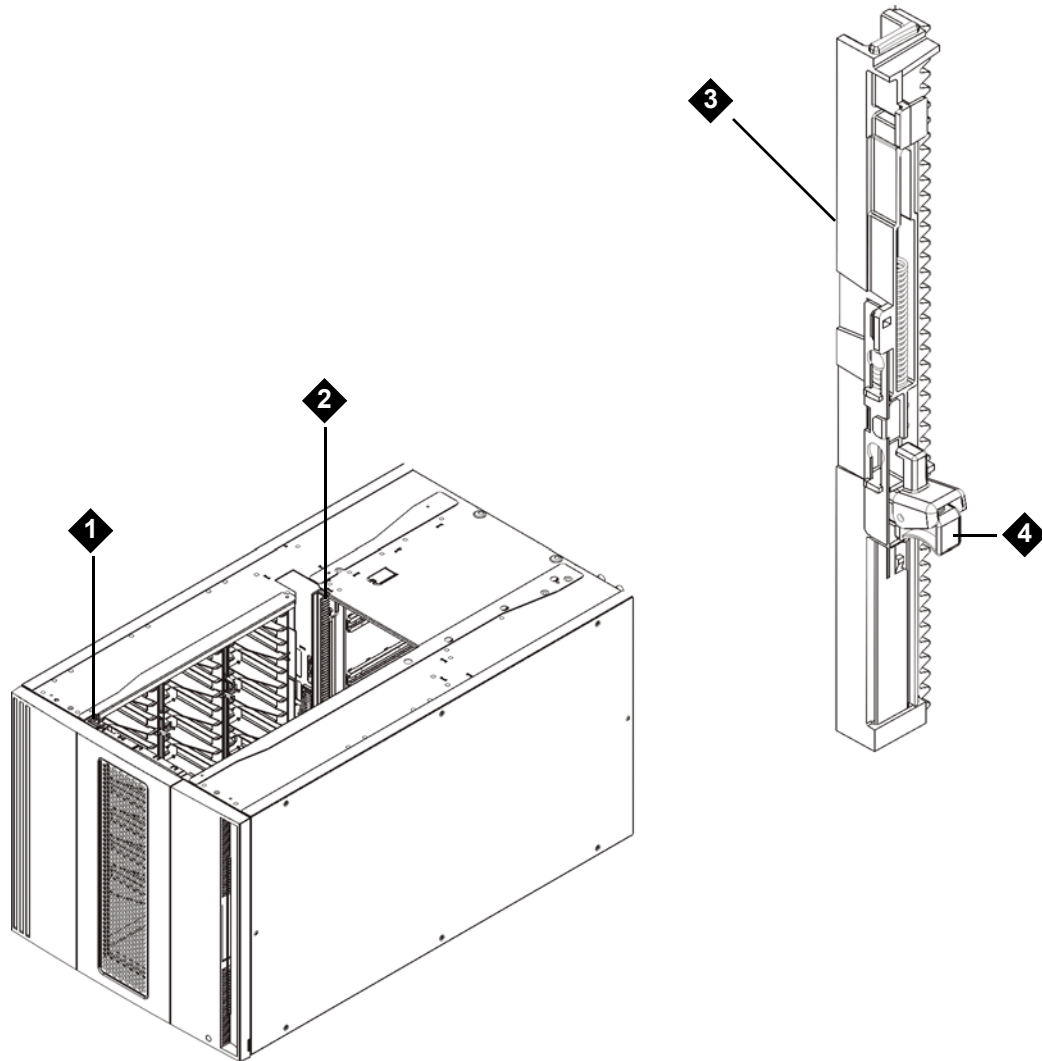
- 3 Disengage the Y-rails so the modules can be unstacked safely.

| 1 Front Y-rail | 3 Y-rail (this end up) |
| 2 Rear Y-rail | 4 Squeeze here to release |

- a. From the front of the library, find the Y-rail release mechanism, which is located on the left side of the 5U Library Control Module. Squeeze the handle of the Y-rail release mechanism, lift it, and release it so that it locks into place.
- b. From the rear of the library, find the rear Y-rail release mechanism located in the interior of the right side of the module. Squeeze the handle of the Y-rail release mechanism, lift it, and release it so that it locks into place.

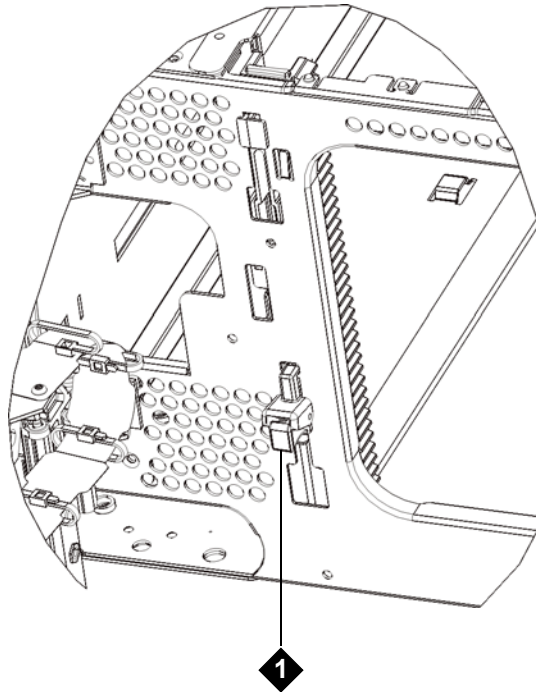
**1** Y-rail in locked, non-functional position

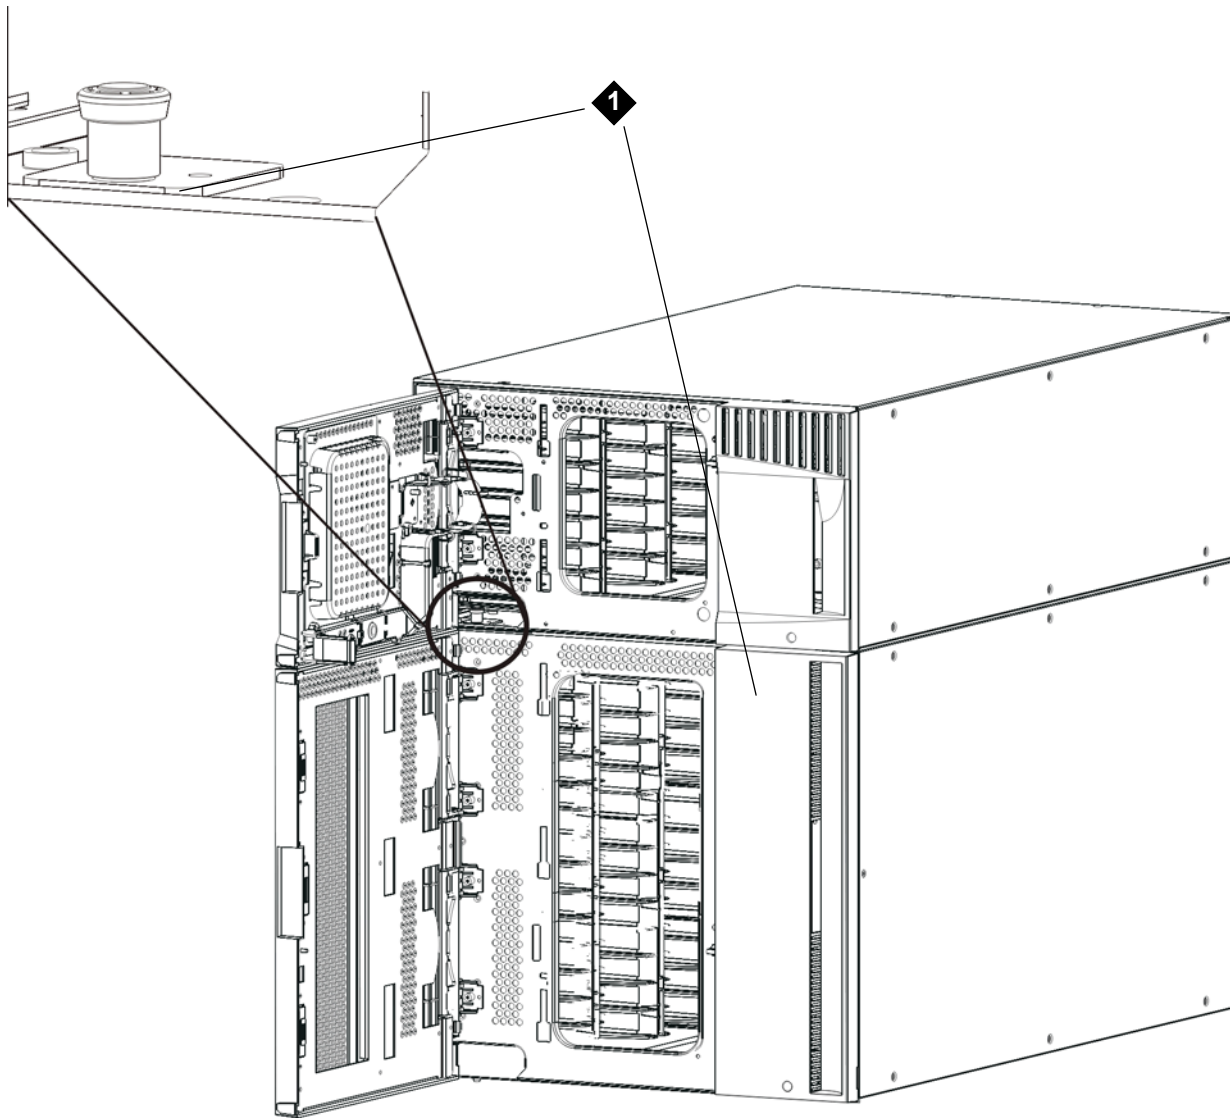
- 5 Loosen the thumbscrews located at the base of the front of the module.

**1** Thumbscrews (behind doors)

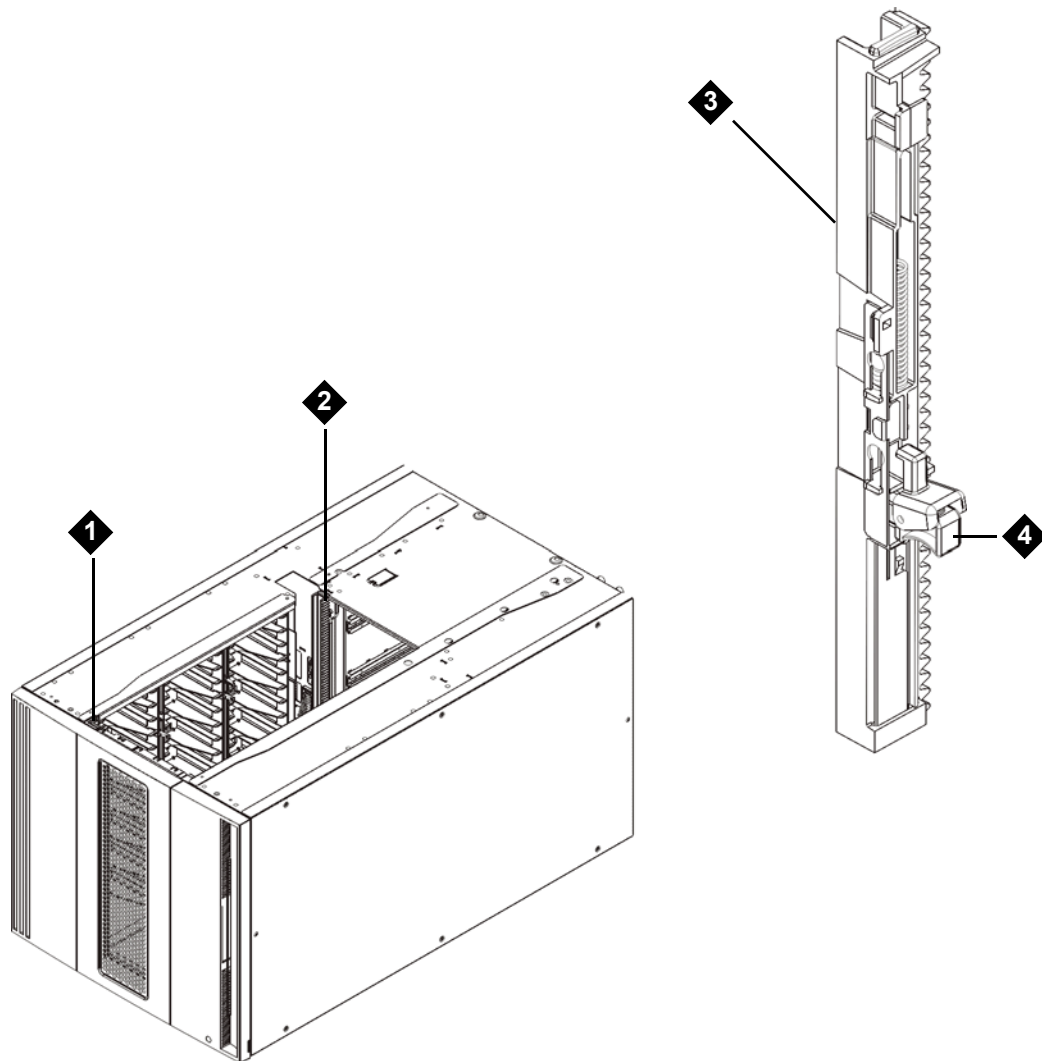
- 1 Ensure that the Y-rails are properly aligned and the thumbscrews are tightened.

| 1 Front Y-rail | 3 Y-rail (this end up) |

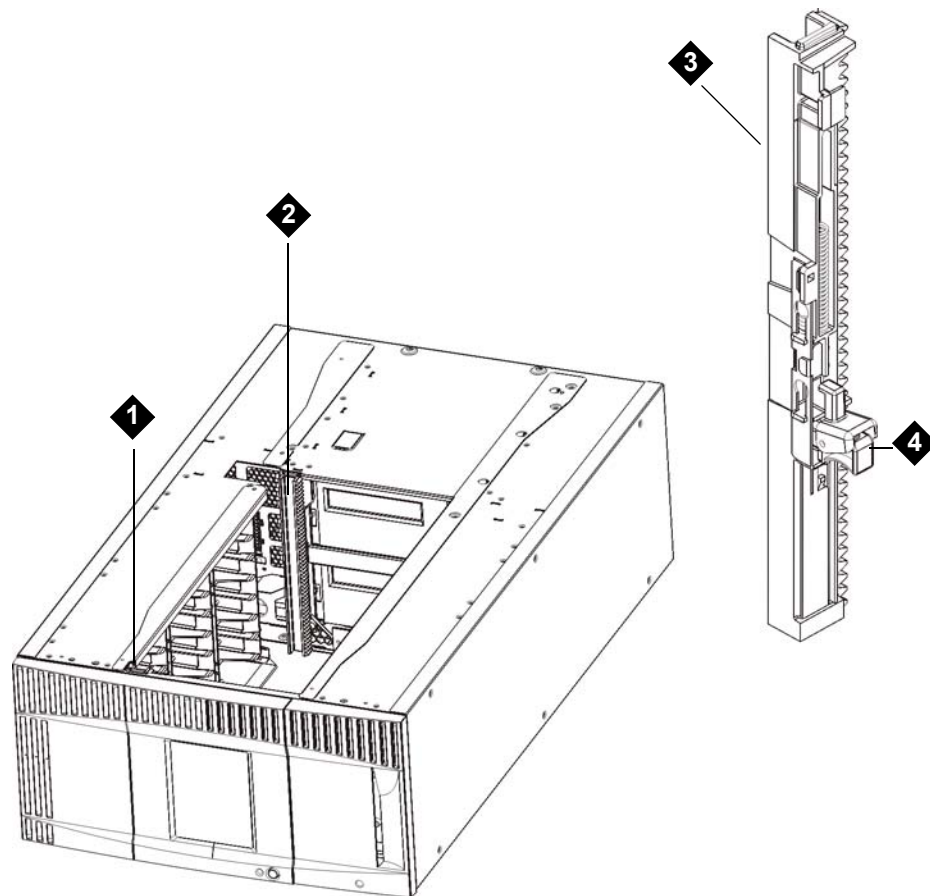
**Note** The rear Y-rail is impossible to lift up with the tape drives installed.

| 1 Front Y-rail | 3 Y-rail (this end up) |

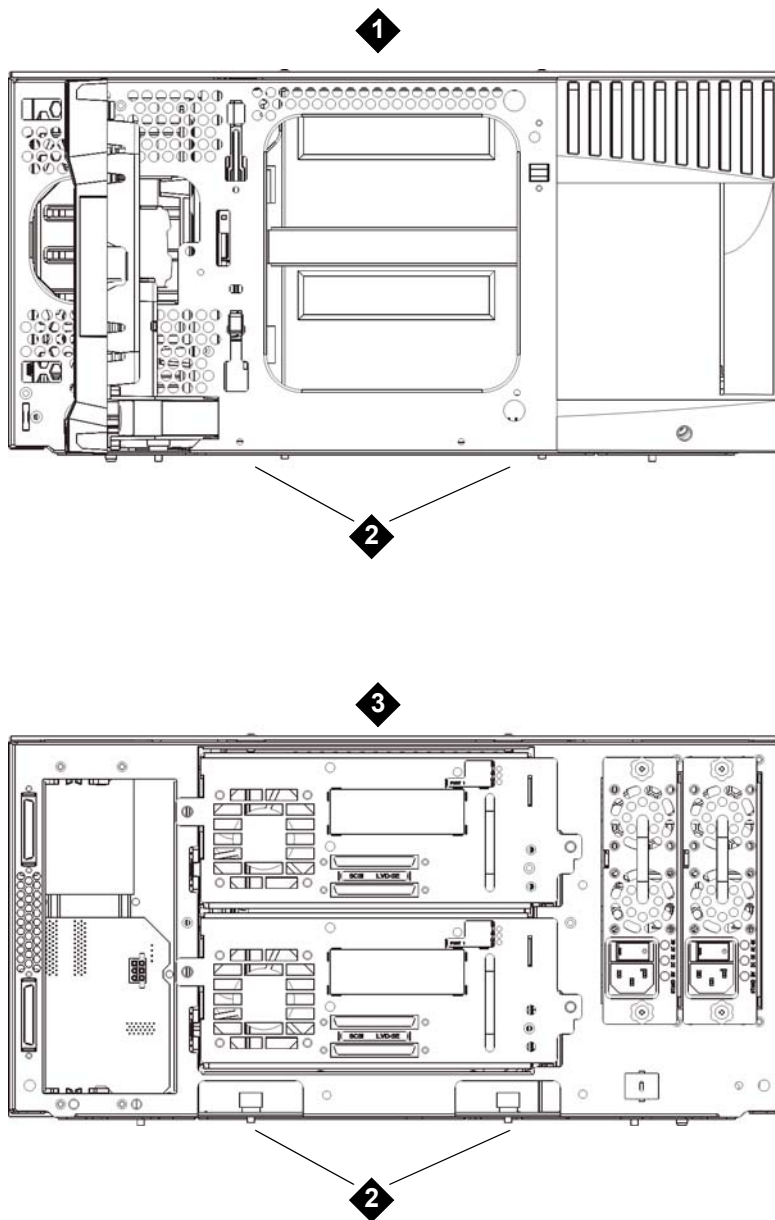
- 5 Loosen the thumbscrews located at the base of the front and rear of the module.

- 
- 1 5U Library Control Module (front)
  - 2 Thumbscrews
  - 3 5U Library Control Module (rear)
-

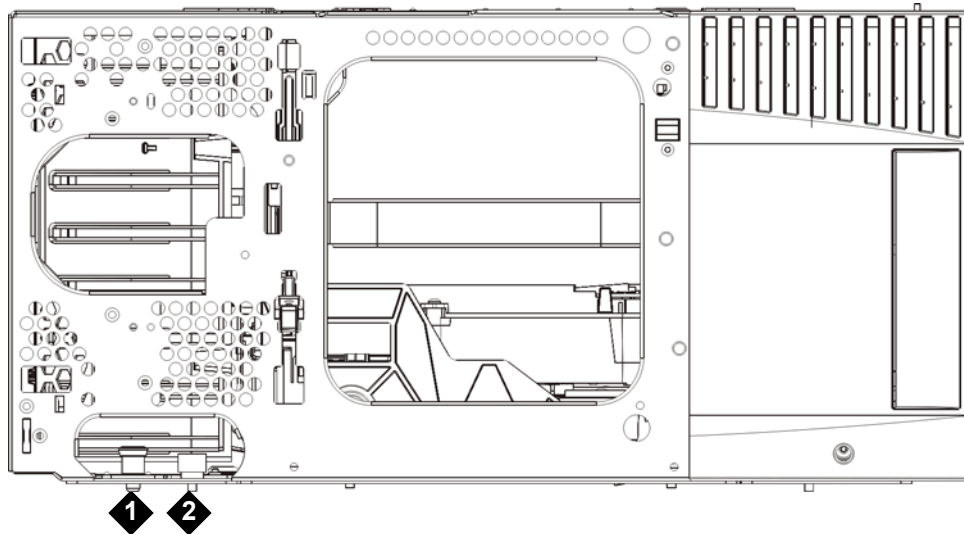
- 6 Open the module's access door and raise the guide pin by pulling it up and turning it slightly, as if it were a screw. Otherwise, the guide pin may scratch the front doors of the module beneath it.

| 1 | Guide pin |

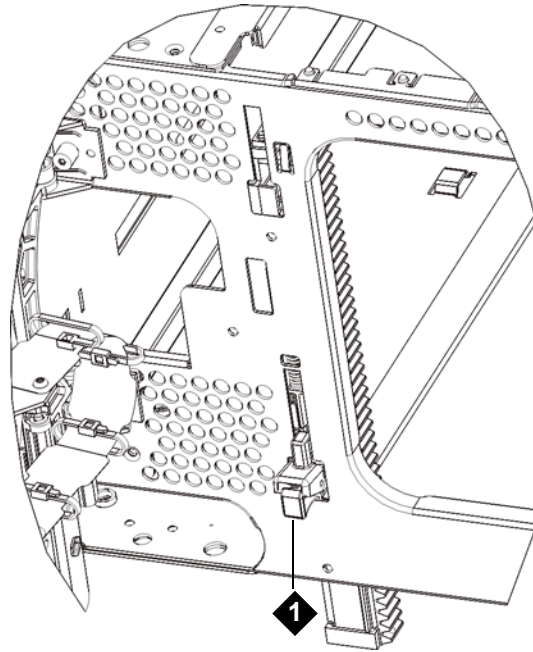
- 9 Engage the Y-rails. Tighten the thumbscrews and lower the guide pin. Doing this aligns the Y-rail with the Y-rail of the module beneath it.
- From the front of the library, open the I/E station and access doors of the 5U Library Control Module. Squeeze the handle of the Y-rail release mechanism, lift it out of its locked position, and slide it downward as far as it will go.

1 Y-rail in unlocked, functional position

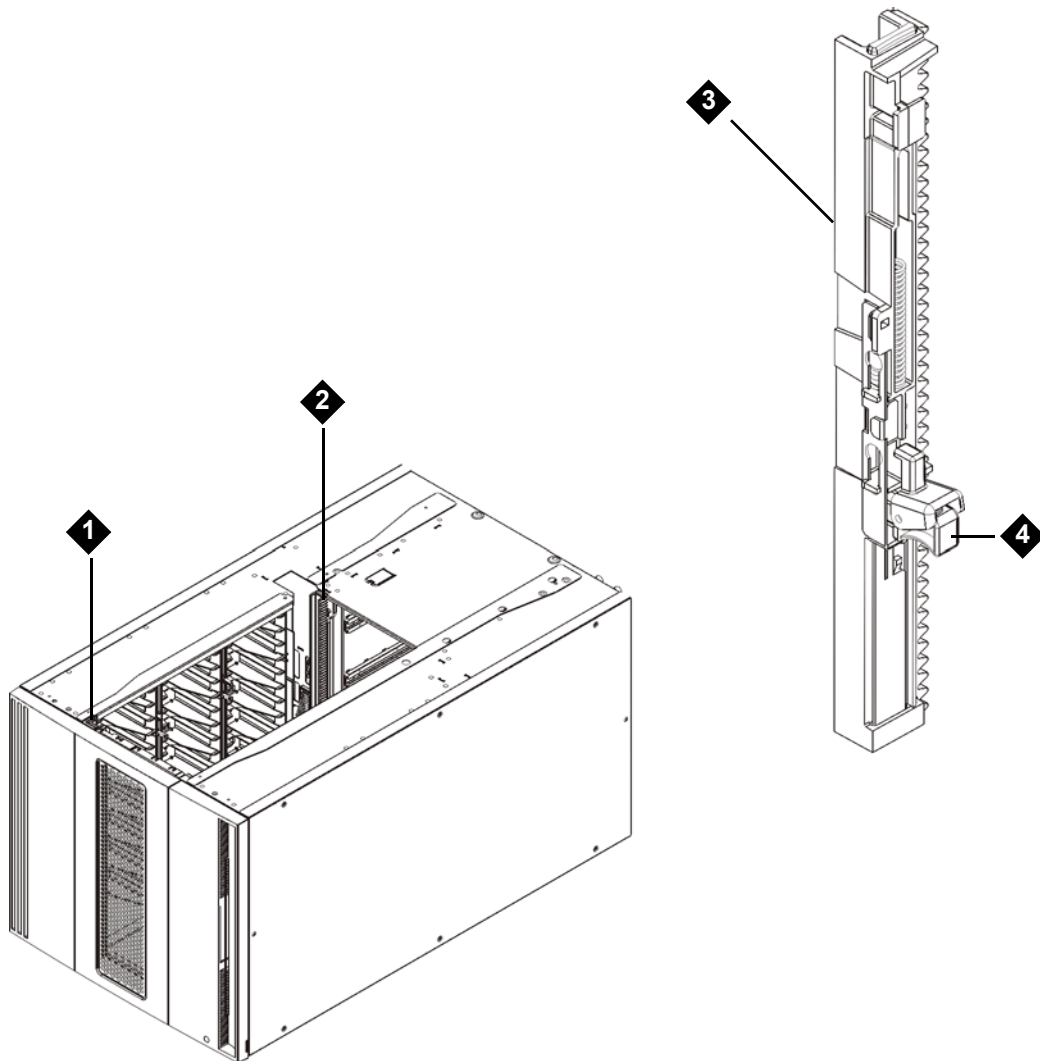
- 3 Disengage the Y-rails so the modules can be unstacked safely.

| 1 Front Y-rail | 3 Y-rail (this end up) |
| 2 Rear Y-rail | 4 Squeeze here to release |

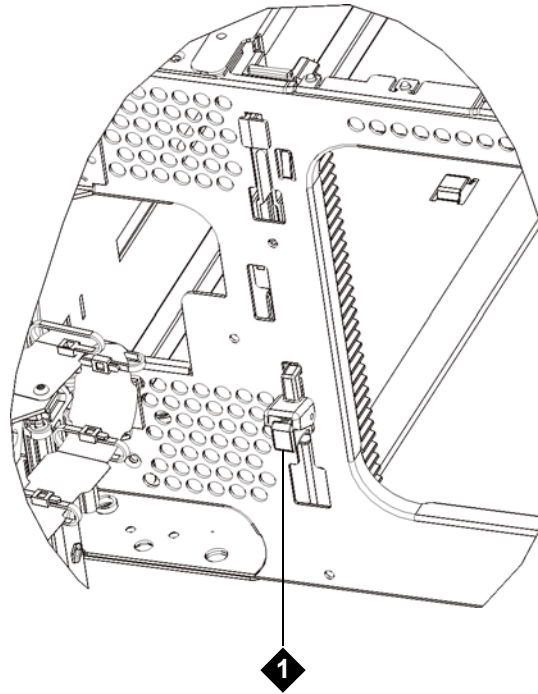
- a. From the front of the library, find the Y-rail release mechanism, which is located on the left side of the 5U Library Control Module. Squeeze the handle of the Y-rail release mechanism, lift it, and release it so that it locks into place.

**1** Y-rail in locked, non-functional position

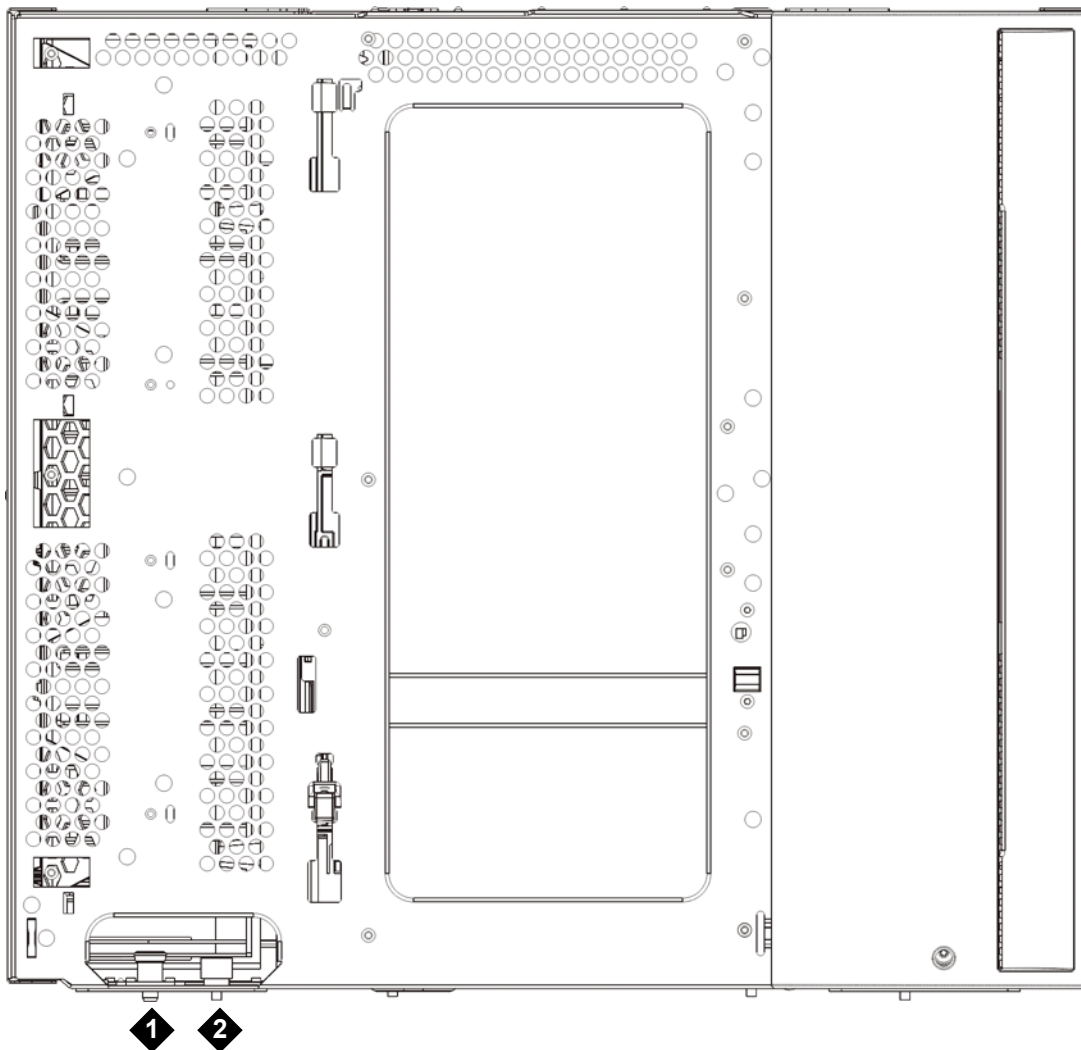
- 1 Remove all tape drives from the 9U Library Expansion Module that you are adding. See [Adding, Removing, and Replacing Tape Drives](#) on page 127 for instructions on removing tape drives.
- 2 Remove the power supplies from the 9U Expansion Module that you are adding. See [Adding, Removing, and Replacing Power Supplies](#) on page 106 for instructions on removing power supplies.
- 3 Open the 9U Expansion Module's access door and raise the guide pin by pulling it up and turning it slightly, as if it were a screw. Otherwise, the guide pin may scratch the front doors of the module on which you are stacking it.

- 
- 1 Guide pin
  - 2 Thumbscrew
-

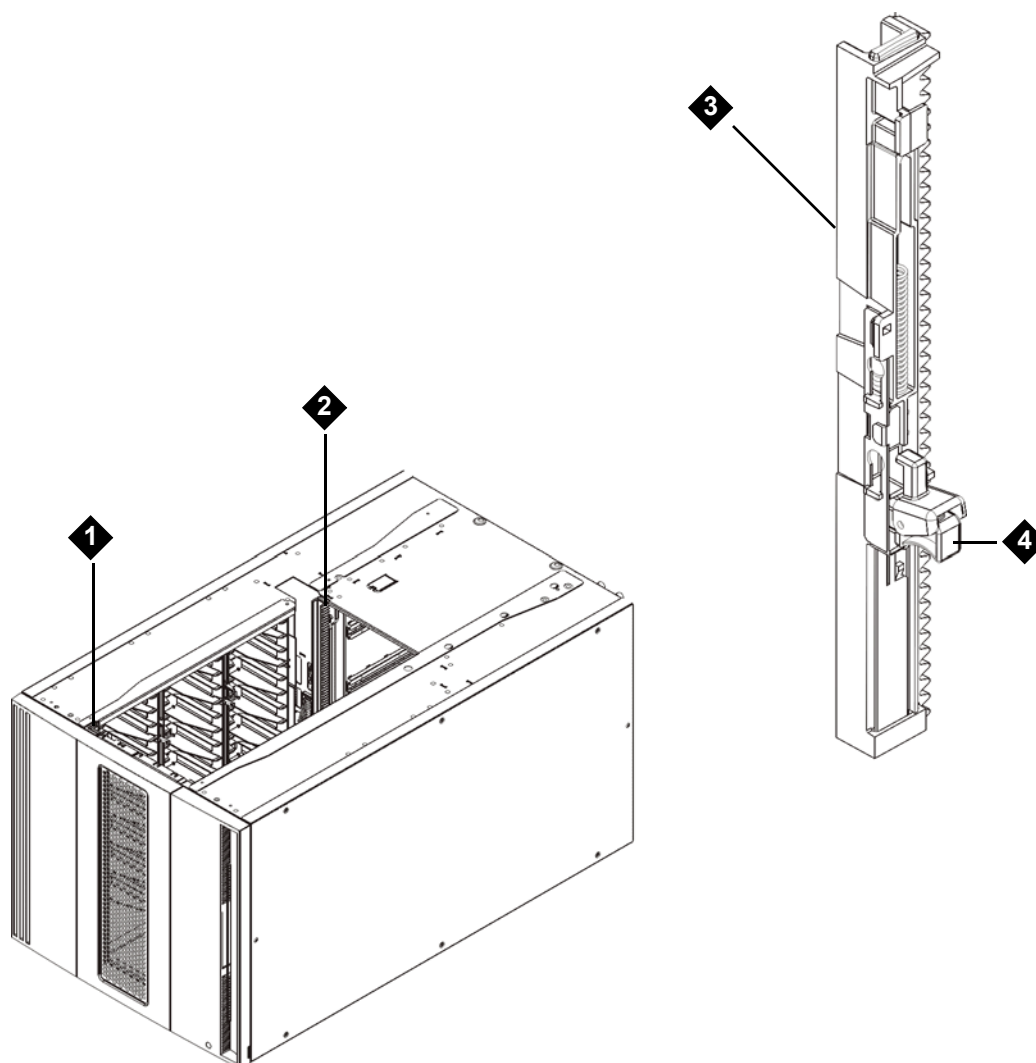
- 8 Engage the Y-rails of each module in your library configuration. Ensure that the Y-rails are properly aligned and the thumbscrews are tightened.

| 1 Front Y-rail | 3 Y-rail (this end up) |
| 2 Rear Y-rail | 4 Squeeze here to release |

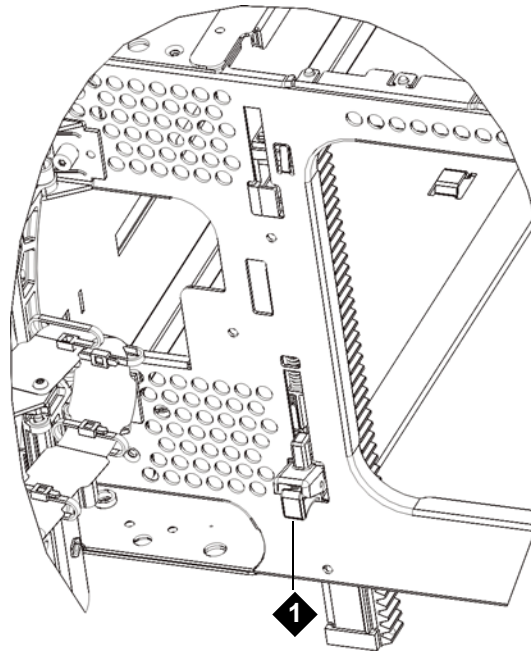
- a. From the front of the library, open the I/E station and access doors of the 9U Expansion Module. Squeeze the handle of the Y-rail release mechanism, lift it out of its locked position, and slide it downward as far as it will go.

**1** Y-rail in unlocked, functional position

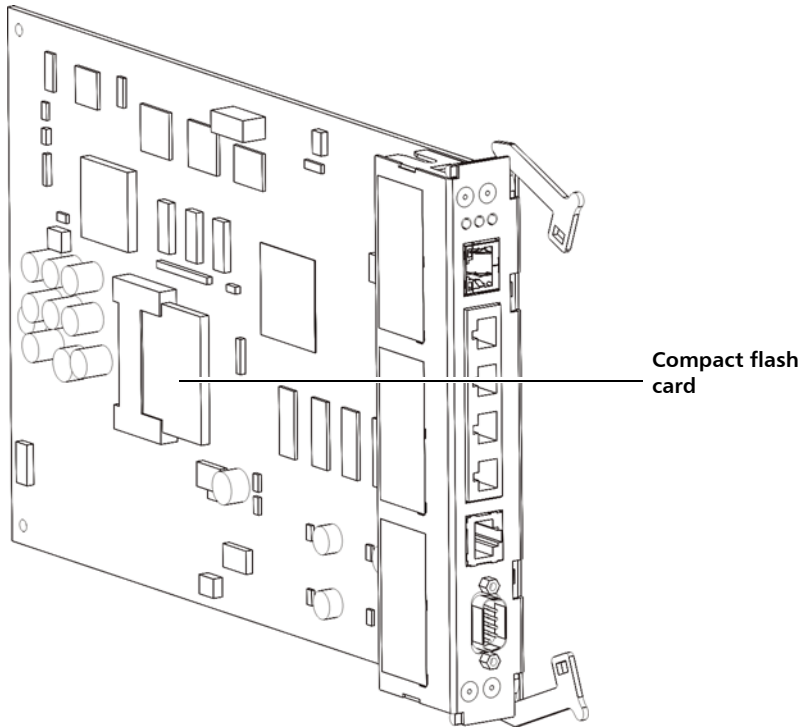
**Figure 18** LCB and Compact Flash Card

To remove the existing LCB, release both of the LCB latch hooks, and using the latch hooks as handles, pull the entire LCB toward you (see [Figure 18](#) on page 103).
- 5 If the new LCB and compact flash card came in separate packages, insert the new compact flash card into the new LCB (or, if replacing the compact flash card only, remove the existing compact flash card and install the new one in the existing LCB). See [Figure 18](#) on page 103.

- 6 Insert the new LCB/compact flash card assembly into library using the internal card guides to properly align the assembly with the backplane connector. Be sure that the LCB LEDs are located at the top of the LCB, and that the latch hooks are on the right side of the LCB. When sliding the new LCB into the slot, there should be no resistance.

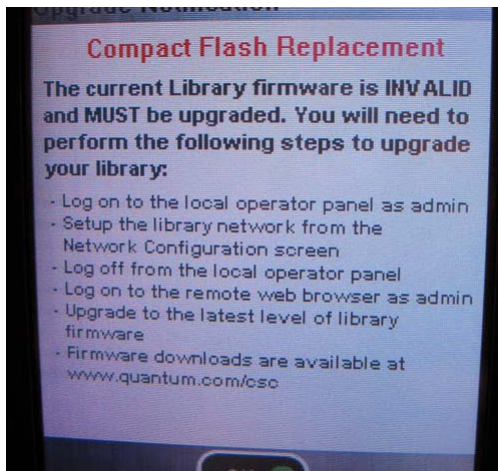
When initialization is complete, the screen will display the "Upgrade Notification: Compact Flash Replacement" screen shown below.

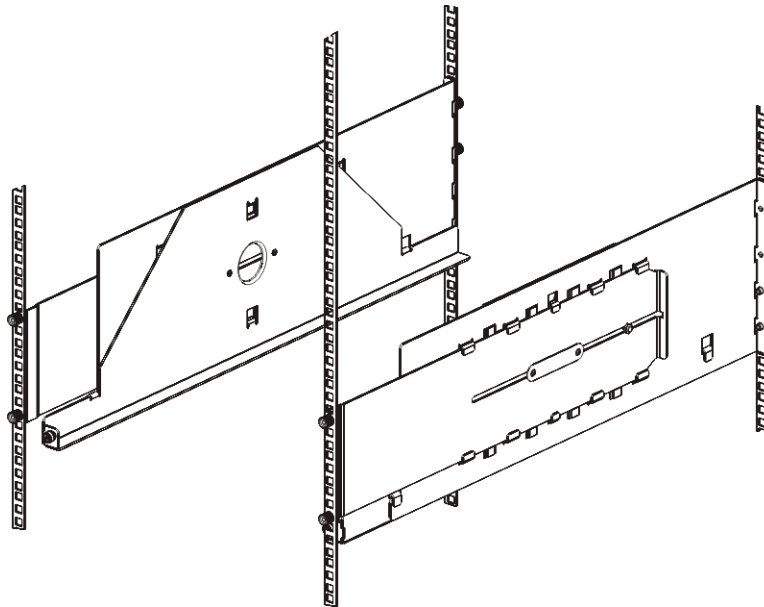
- 3 Install the rack-mount shelves into the rack so that they are level with one another.
  - a. Position the shelf to the appropriate side of the rack (right or left) and align the shelf at the desired height.
  - b. Install the shelf's rear studs in the rack's rear mounting holes.

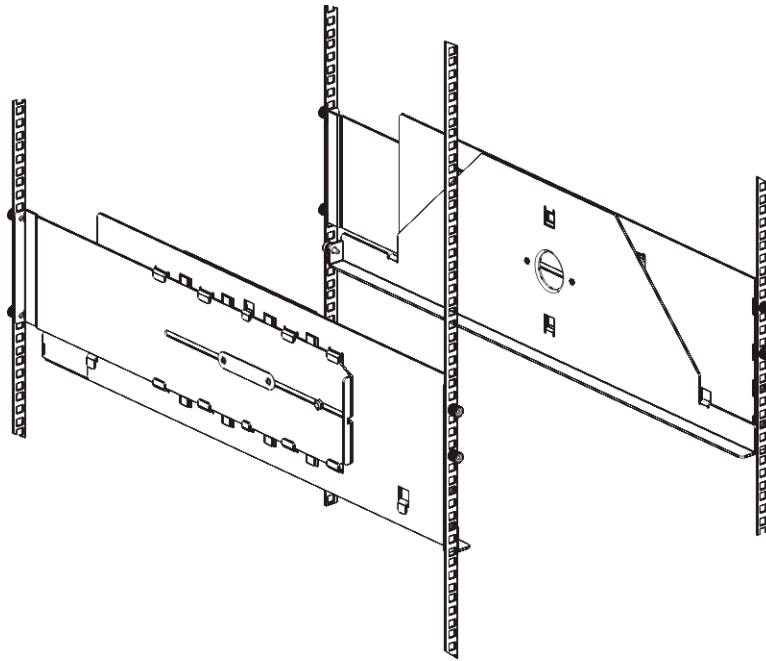
- d. Next, install the shelf's front studs in the rack's front mounting holes.

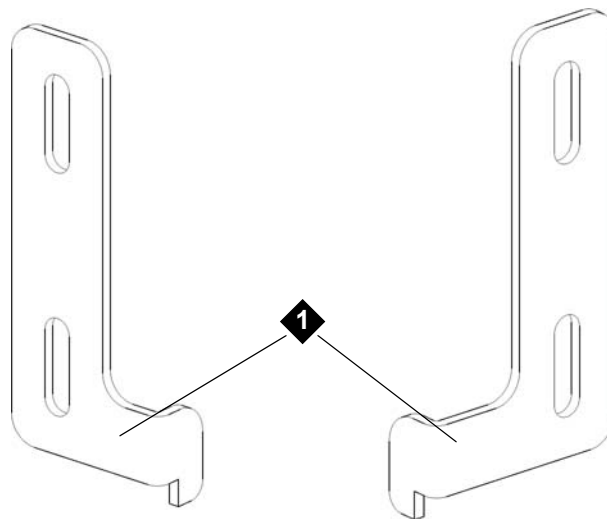
**1** Hinge of rack ears

- 1 Place the desired module (whichever module you want to be the bottom module of the library) onto the rack-mount shelves. From the front of the rack, lift the module onto the shelf and gently slide it into the rack. Slide the module to the back of the rack, so that the front of the module is flush with the mounting holes.
- 2 From the back of the rack, secure the module to the rack-mount shelves by tightening the two silver thumbscrews that are attached to the rear of the rack-mount shelves.
- 3 Install the right rack ear. At the front of the library:
  - a. Open the I/E station door. At the lower right corner of the module is a vertical slot. Insert the hinge of the right rack ear into the slot, and then position the holes of the rack ear flush with the rack rail.

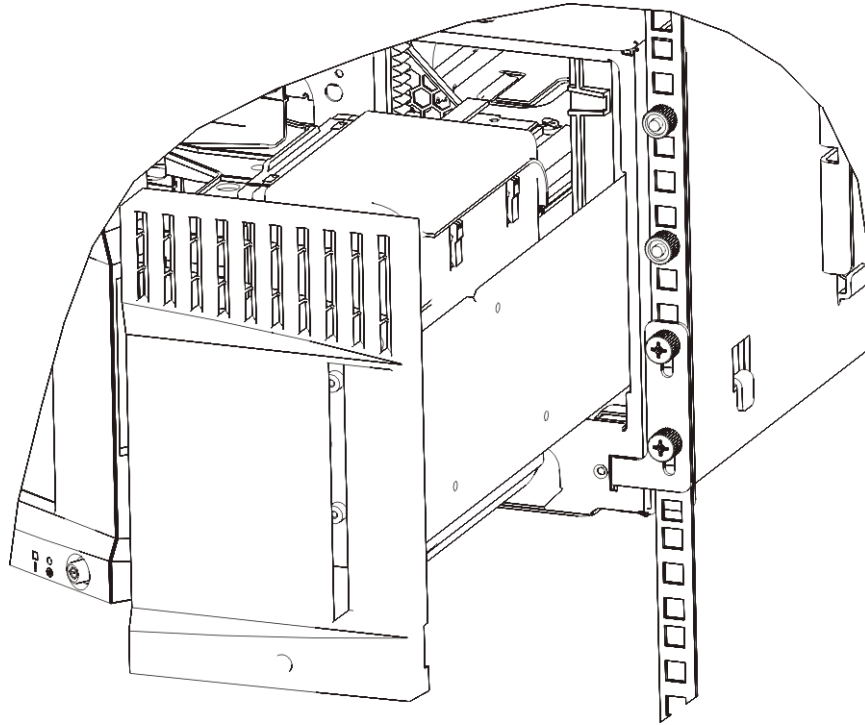
- b. Using two M5 thumbscrews, fasten the rack ear to the rack. The thumbscrews should fasten completely and evenly.

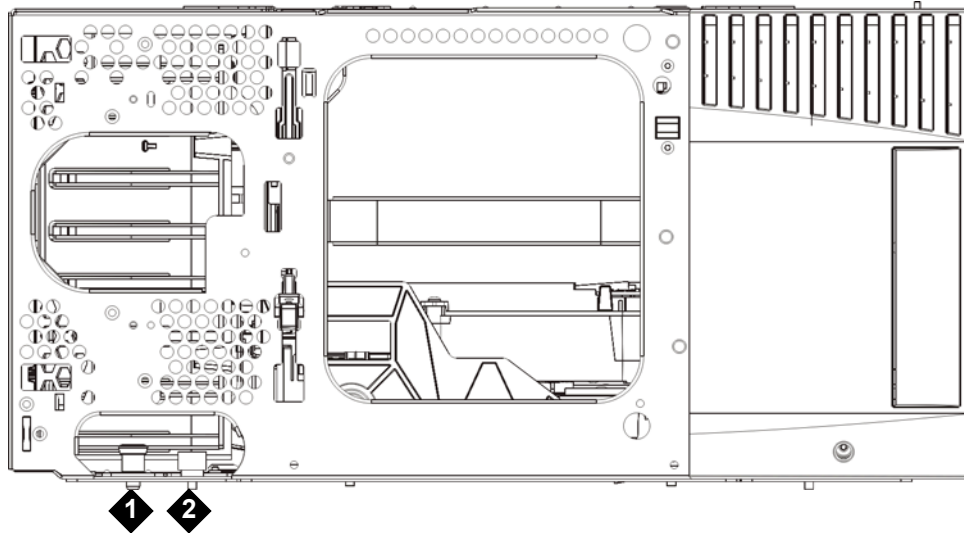
- 
- 1 Guide pin  
2 Thumbscrew
-

- c. Open the module's access door and raise the guide pin by pulling it up and turning it slightly, as if it were a screw. Otherwise, the guide pin may scratch the front doors of the module on which you are stacking it.

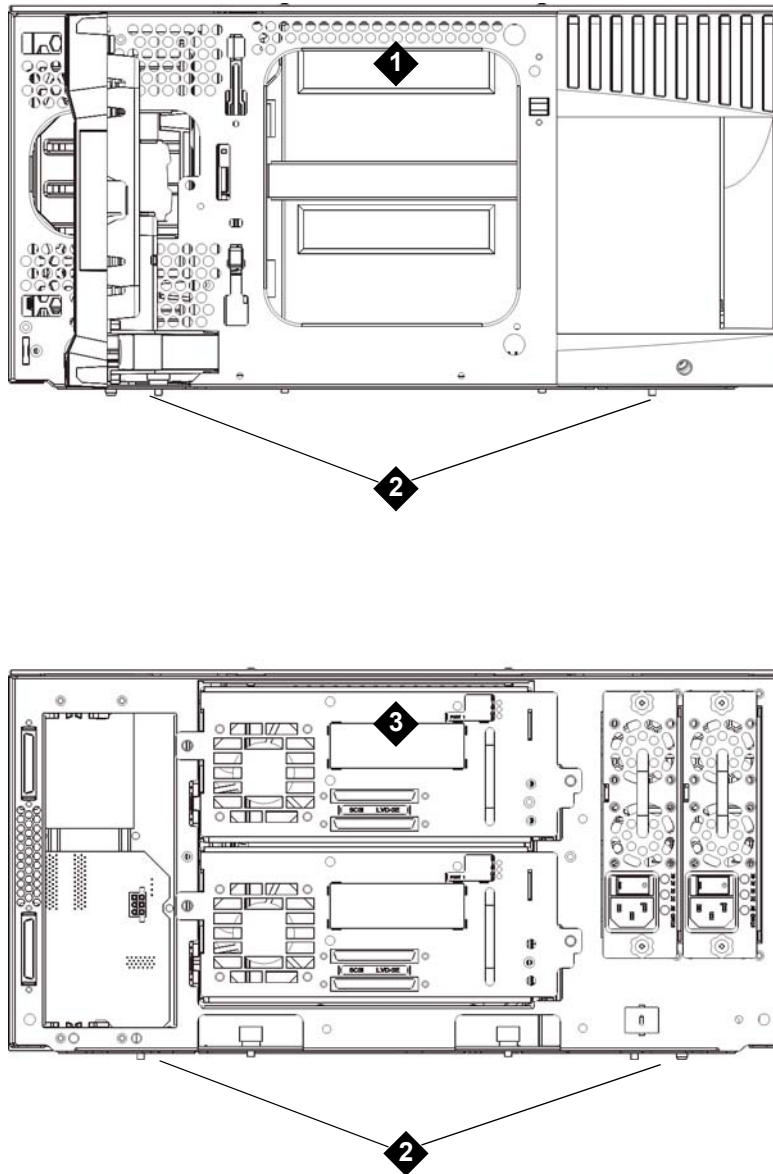
- 
- 1 5U Library Control Module (front)
  - 2 Thumbscrews
  - 3 5U Library Control Module (rear)
-

- 7 Secure the module to the module beneath it by tightening the thumbscrews located at the base of the front and back of the module. Press down the thumbscrew, and then tighten it.

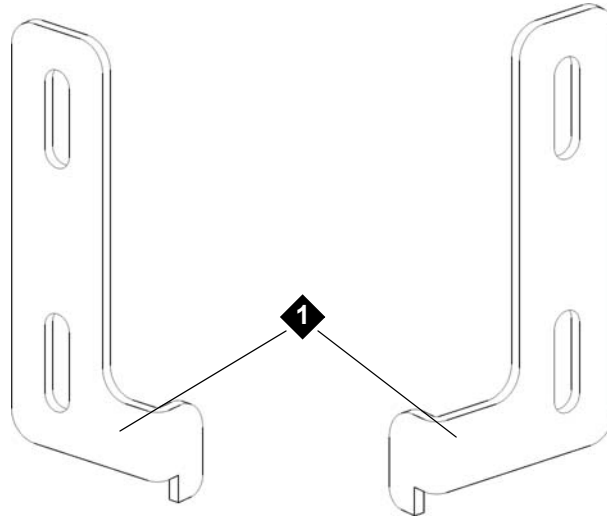
**1** Hinge of rack ears

- a. Open the I/E station door. At the lower right corner of the module is a vertical slot. Insert the hinge of the right rack ear into the slot, and then position the holes of the rack ear flush with the rack rail.

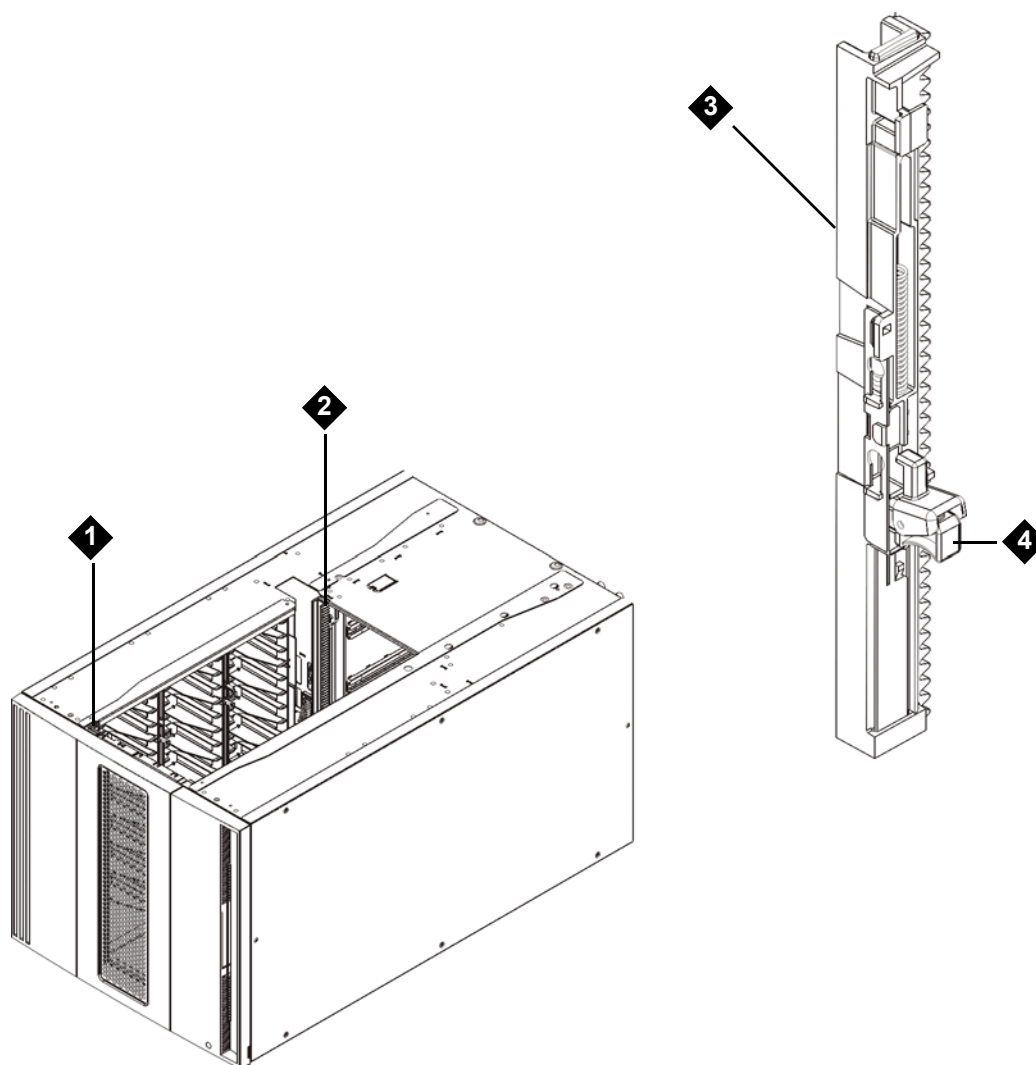
- 10** If the module you are installing is an expansion module, engage the Y-rails of the new module in your library configuration. Ensure that the Y-rails are properly aligned, and the thumbscrews are tightened.

| <b>1</b> Front Y-rail | <b>3</b> Y-rail (this end up) |

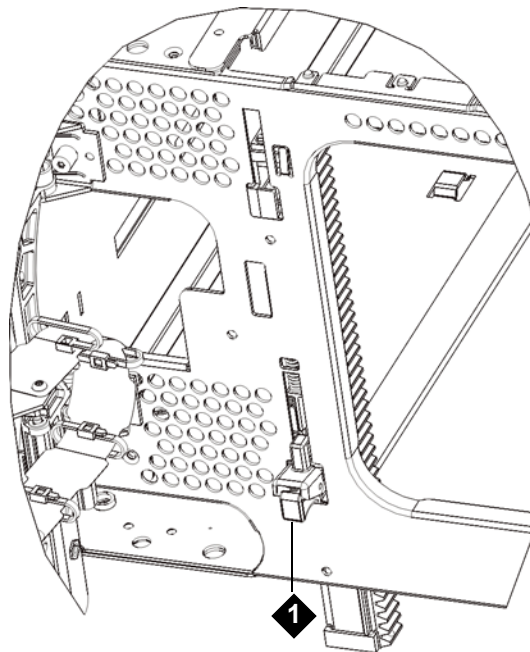
Doing this aligns the Y-rails with the Y-rails of the module beneath it.

**1** Y-rail in unlocked, functional position
