# Dell™ PowerVault™ ML6000 Maintenance Guide

Document Number: 6-01367-10 Rev A

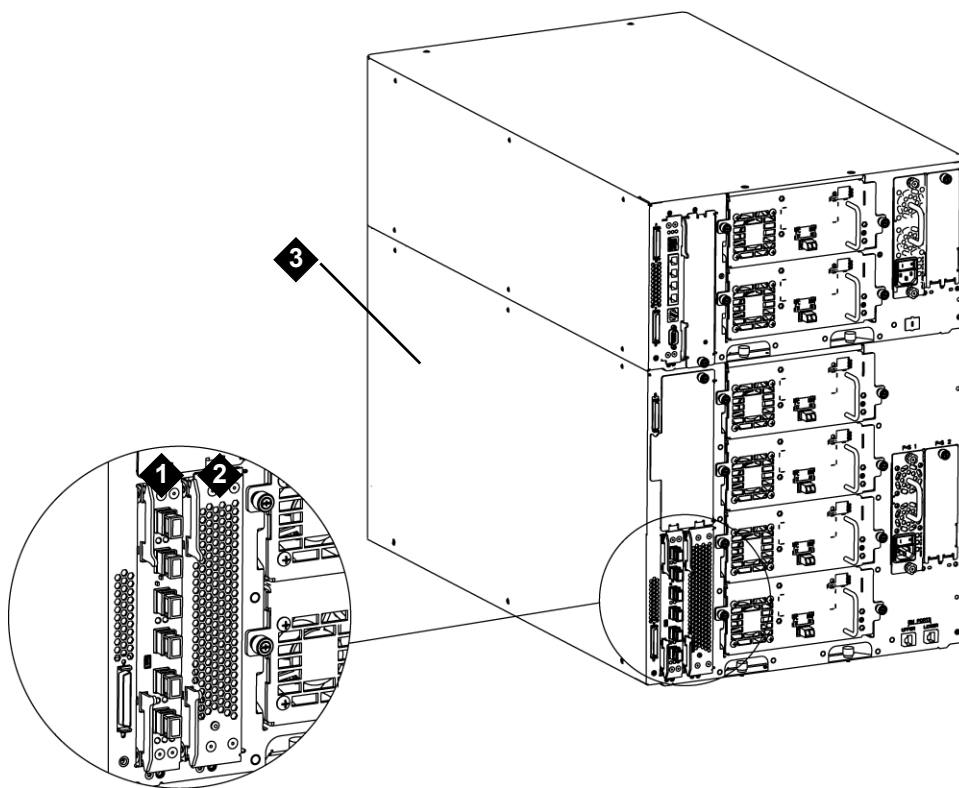
**Figure 19** FC I/O Blade and Fan Blade Bays in Expansion Module

- 
- 1 FC I/O blade
  - 2 Fan blade
  - 3 Expansion module
-

- Each FC I/O blade is accompanied by a fan blade that cools the blade. The fan blade is installed to the right of the FC I/O blade in the expansion module. Each expansion module has four bays and can accommodate two FC I/O blades and two fan blades. [Figure 19](#) shows the FC I/O blade and fan blade installed in the expansion module. For instructions on installing the fan blade fan, see [Adding, Removing, and Replacing the FC I/O Fan Blade](#) on page 137.

[Figure 19](#) on page 131 shows the FC I/O blade and I/O blade fan installed side-by-side in the expansion module.

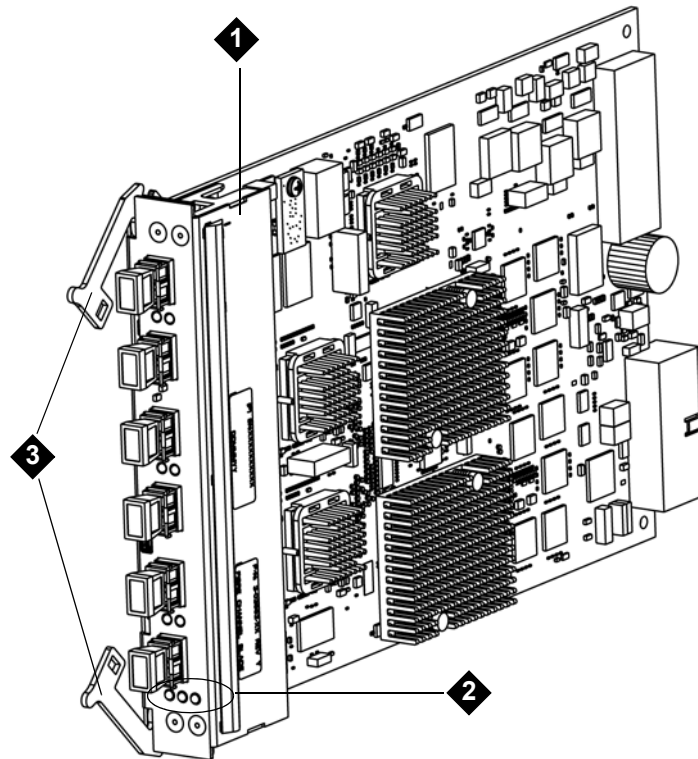
- 2 Remove the cover plate from the appropriate bay.
- 3 Press up and out to open the latch hooks on each side of the I/O blade.

| 1 | I/O blade |

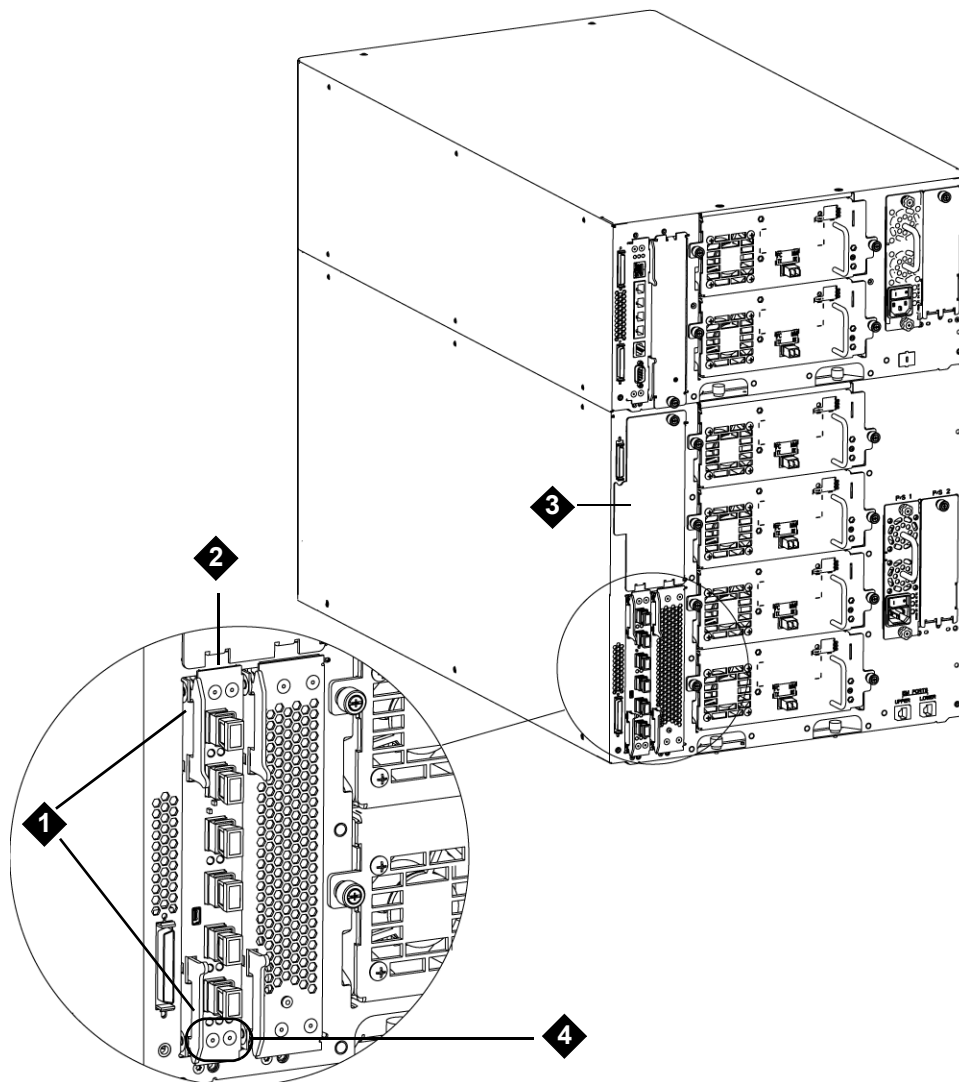
- 6 When you are ready to cable the blade, remove the necessary number of the black rubber protective covers from the ports on the FC I/O blades.

1 Latch hooks, locked

2 FC I/O blade

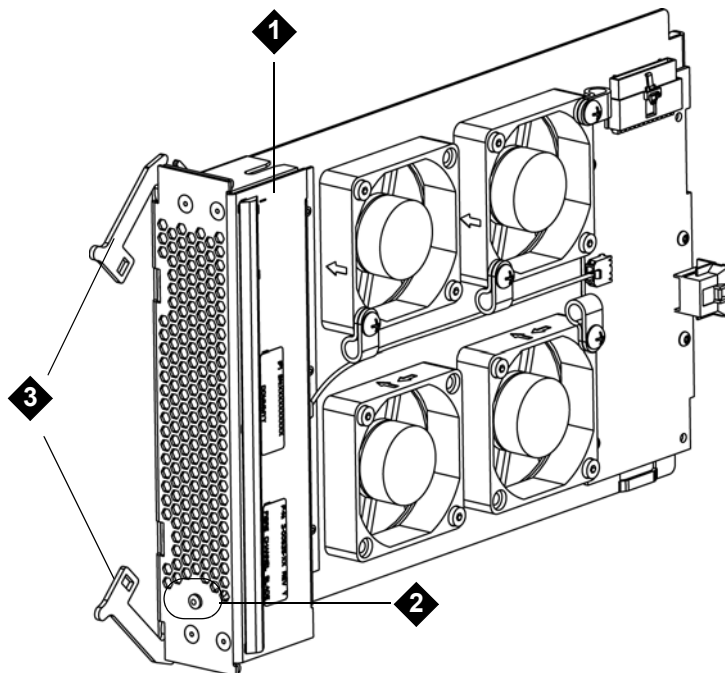
- 3 Press up and out to open the latch hooks on each side of the fan blade. The LED must be at the bottom of the blade.

| 1 | Fan blade |

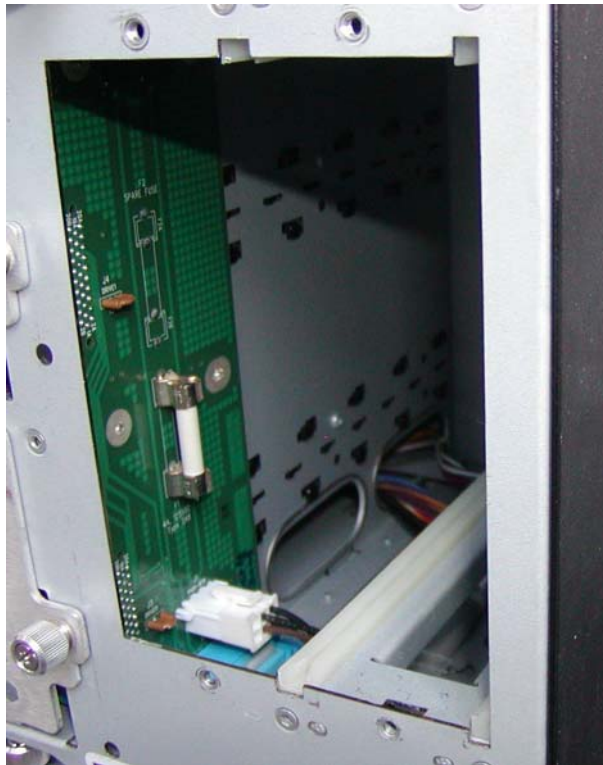
**Figure 20** DSIB Fuse Location, Control Module

- 4 Remove all power supplies from the affected module and set aside.
- 5 Remove any cover plates from empty power supply slots and set aside.
- 6 Using a socket wrench or Torx screwdriver, reach through the power supply opening and remove the two screws that attach the fuse cover to the DSIB board, removing the fuse cover. If it is not possible to access the screws, you may need to remove the library side cover panel as well.
- 7 Using a fuse puller, carefully pull the failed fuse from its two fuse clips, which are attached to the DSIB board, located to the left of the power supply area of the module. See [Figure 20](#) and [Figure 21](#) for fuse location.
- 8 Replace the drive fuse with one of the same amperage and type for the module (see information above). Firmly press the new fuse into the two fuse clips. The fuse will snap into the fuse clips when it is secured.

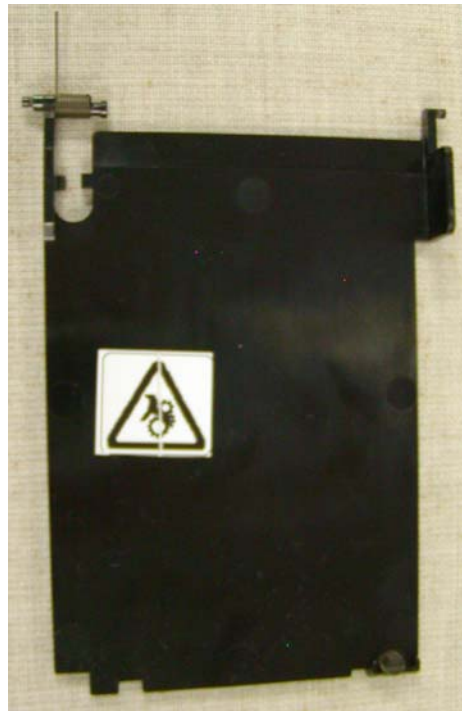
The I/E safety door assembly for the 5U Library Control Module consists of the following parts:

- Plastic door
- Spring

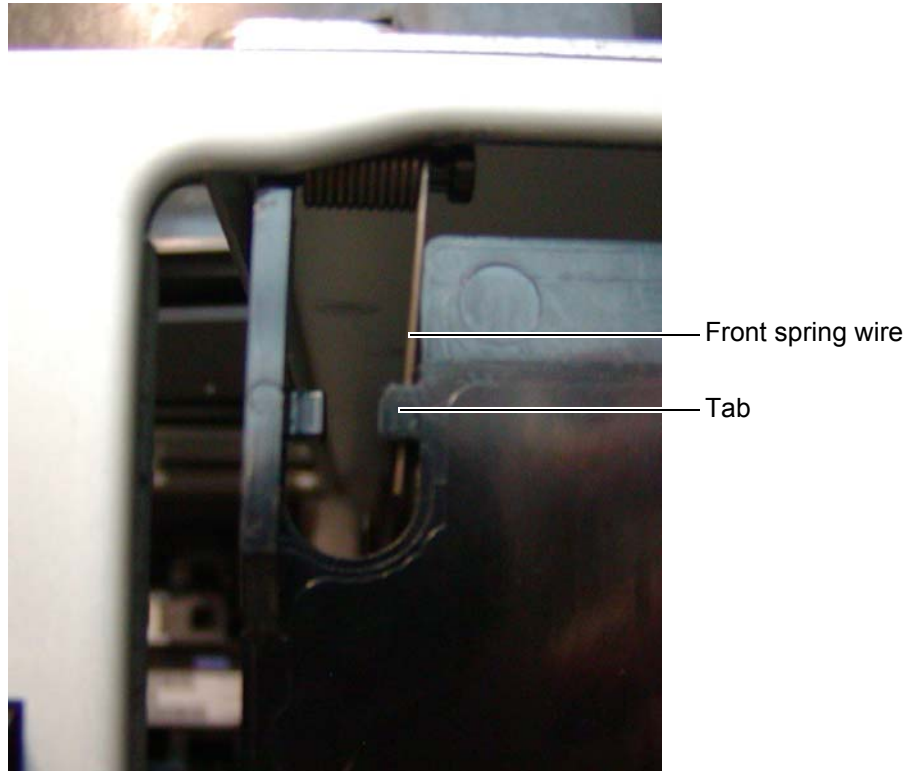
- 3 Unhook the front spring wire from the tab on upper left of the safety door.

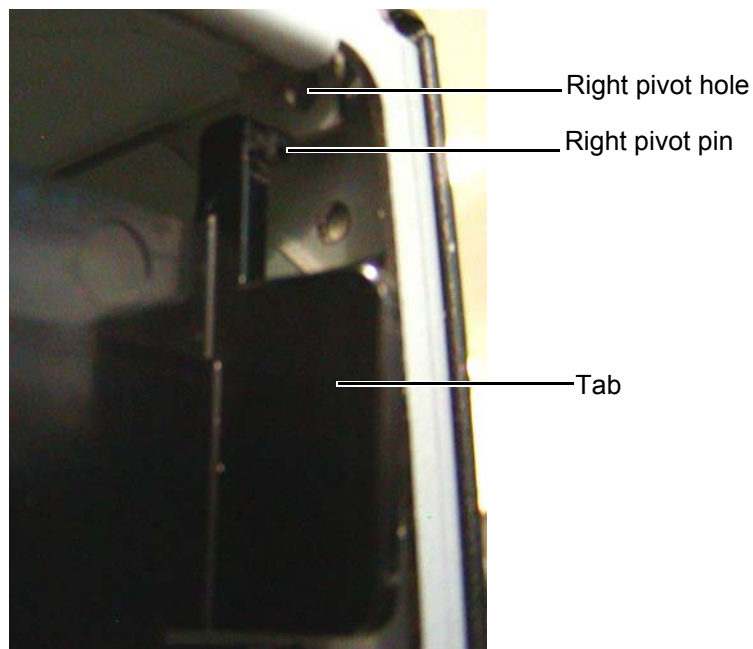
- 4 Remove the right pivot pin from the right pivot hole by pushing the tab to the left. (The tab is located on the upper right of the safety door.).

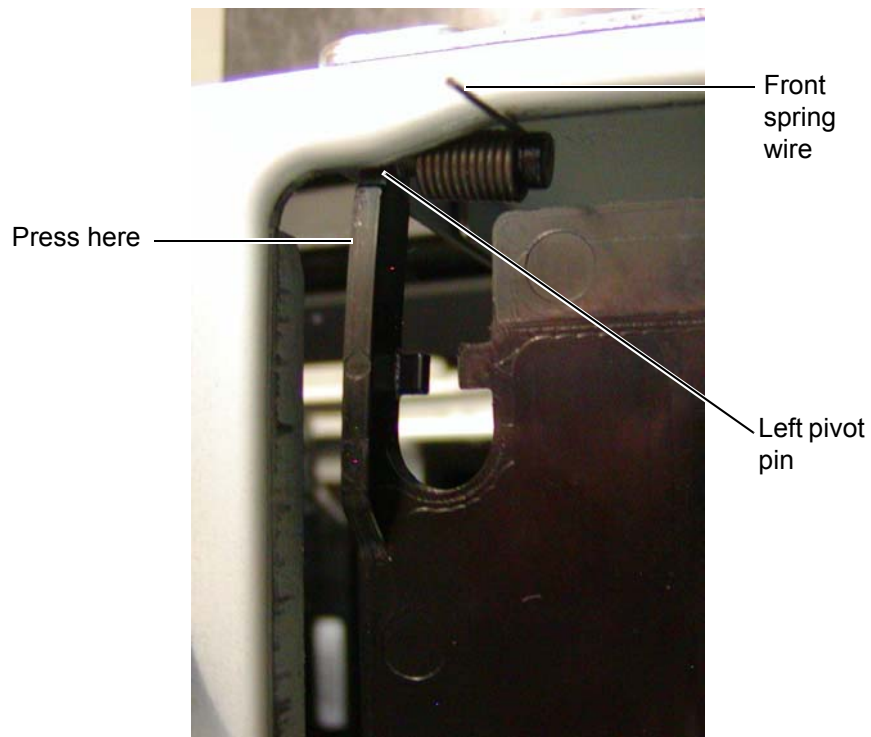
- 5 Remove the left pivot pin from the left pivot hole by pushing the flexible piece of the safety door just beneath the left pivot pin toward the right.

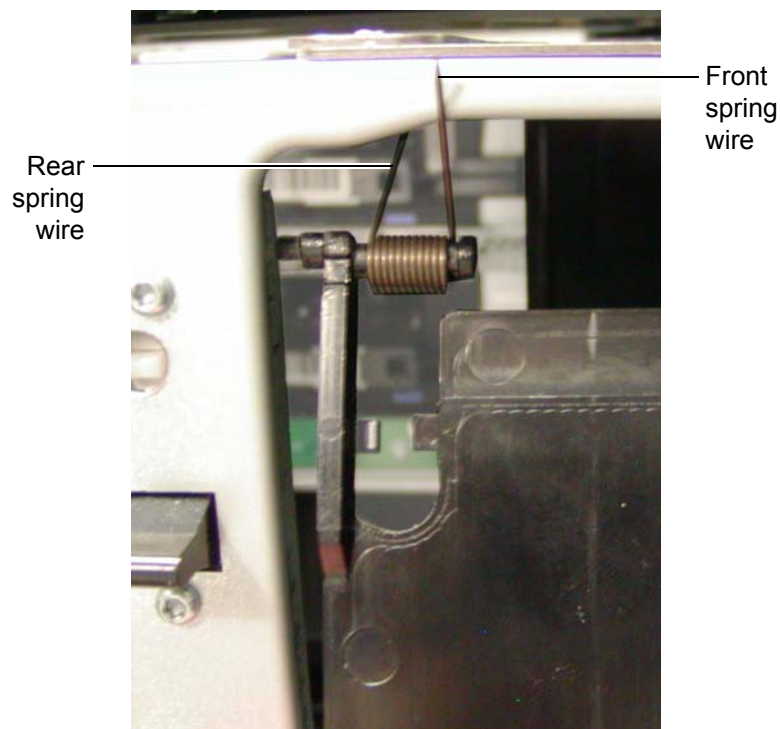
- 6 Remove the safety door from the library.
- 7 To replace the safety door, place the spring on the left pivot pin, and perform the above steps in the reverse order. When installing the safety door, position the spring as shown below.

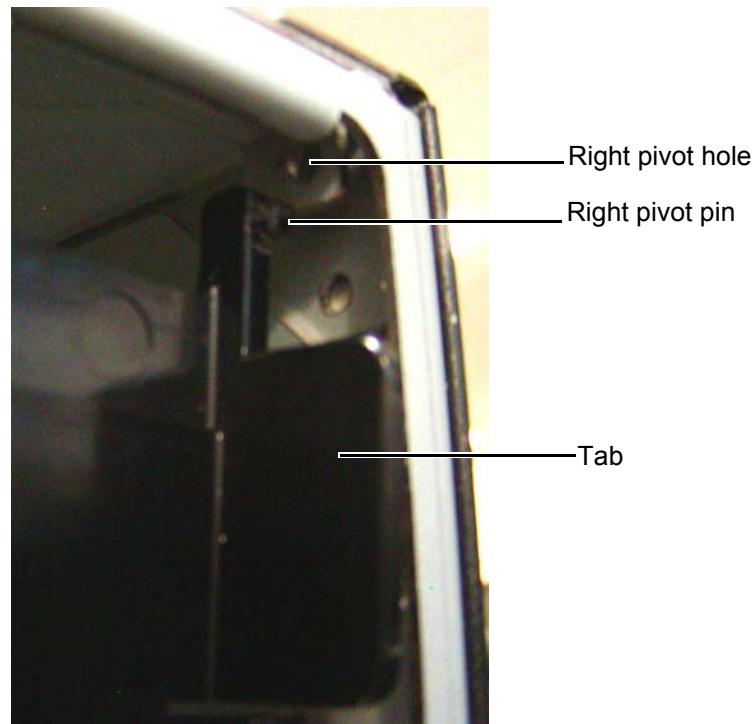
- 3 On the top door, remove the right pivot pin from the right pivot hole by pushing the tab to the left. (The tab is located on the upper right of the safety door.)

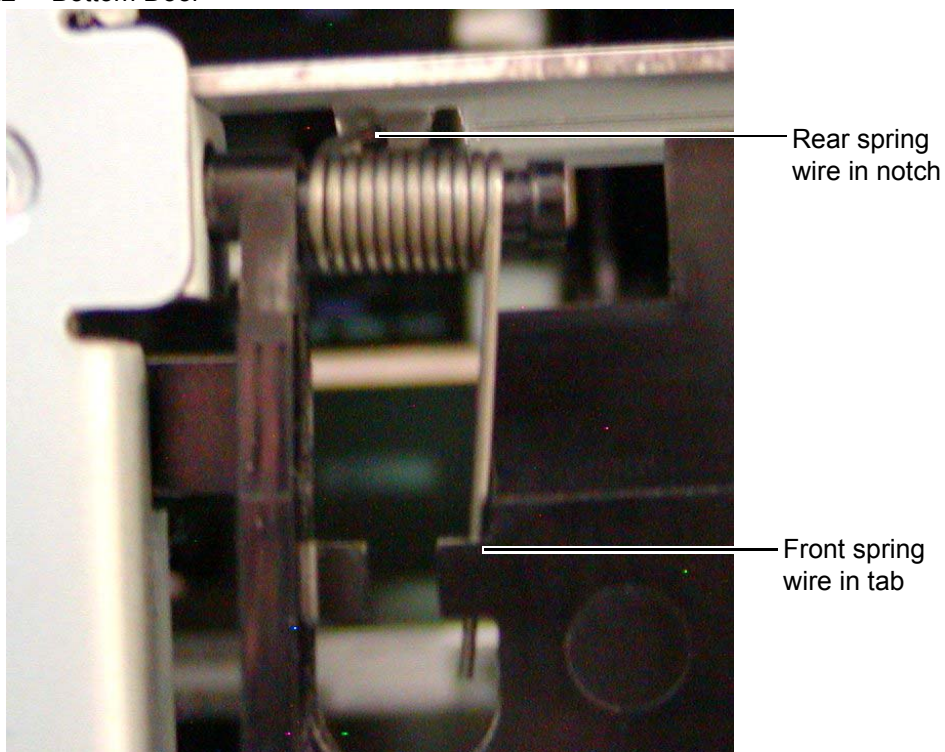
**Figure 22** Bottom Door

- 5 Gently set the top door down inside the library, taking care not to damage the plastic link that connects the two doors.
- 6 On the bottom door, unhook the front spring wire from the tab (see [Figure 22](#)).
- 7 Unhook the rear spring wire from the notch in the frame (see [Figure 22](#)).

If the top door has a spring, remove it as described in steps [Step 6](#) and [Step 7](#) on page 160. On very old libraries, there may not be a notch for the rear spring wire like the one shown in [Figure 22](#) on page 160, but there may be a small hole in the horizontal metal frame which holds the wire. Remove the wire from the hole and make sure, when reinstalling, to push the wire back into the hole.

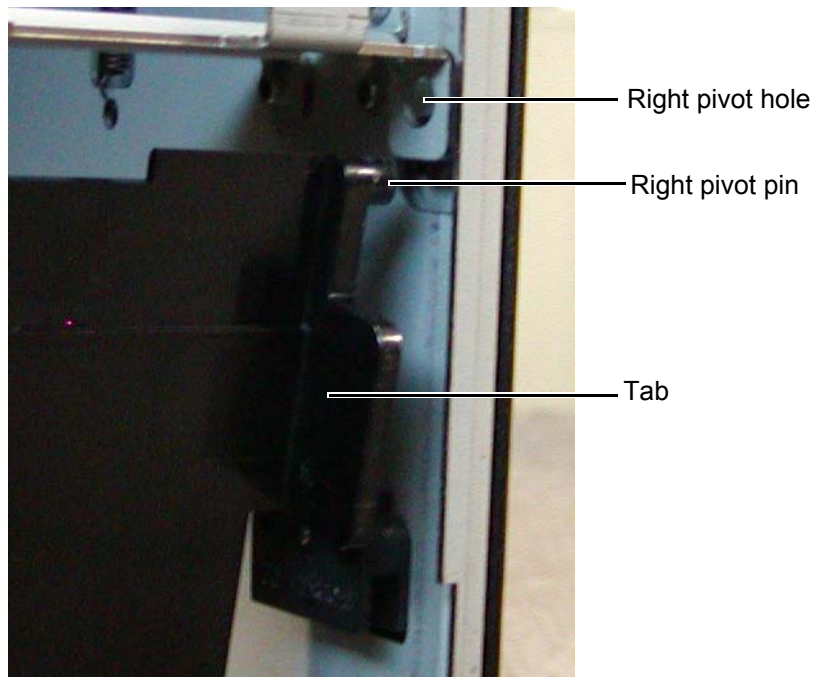
- 8** On the bottom door, remove the right pivot pin from the right pivot hole by pushing the tab to the left. (The tab is located on the upper right of the safety door.)

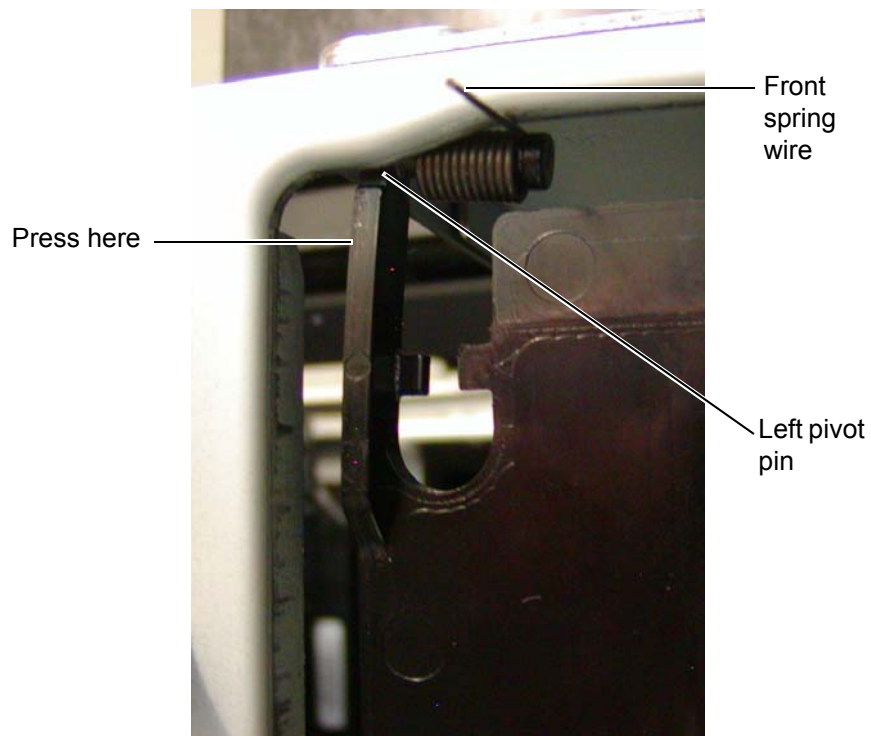
- 9** On the bottom door, remove the left pivot pin from the left pivot hole by pushing the flexible piece of the safety door just beneath the left pivot pin toward the right.

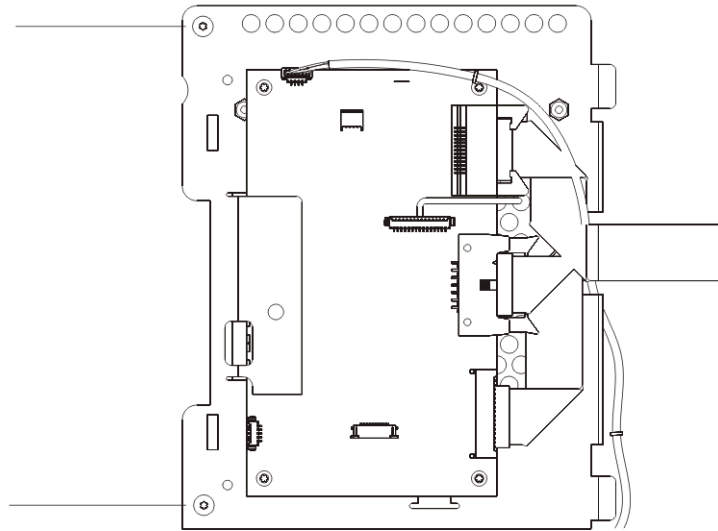
**When removing the final screw, hold the operator panel to ensure it doesn't fall and become damaged.**

Remove  
this  
screw...

...and  
this  
screw

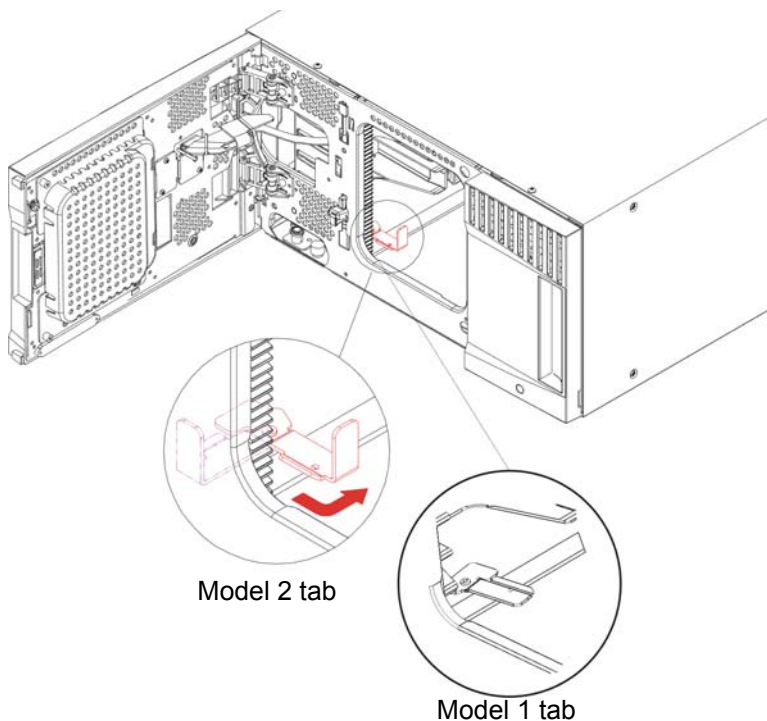
- c. After raising the robot assembly to the approximate middle of the 5U Library Control Module, hold it in place with one hand, and using your other hand, move the parking tab to the "parked" position (**Model 1 parking tab**: swivel toward you; **Model 2 parking tab**: move in a counter-clockwise direction). The metal parking tab is located at the bottom of column 1.
- d. Gently release the robot assembly to rest on the parking tab.

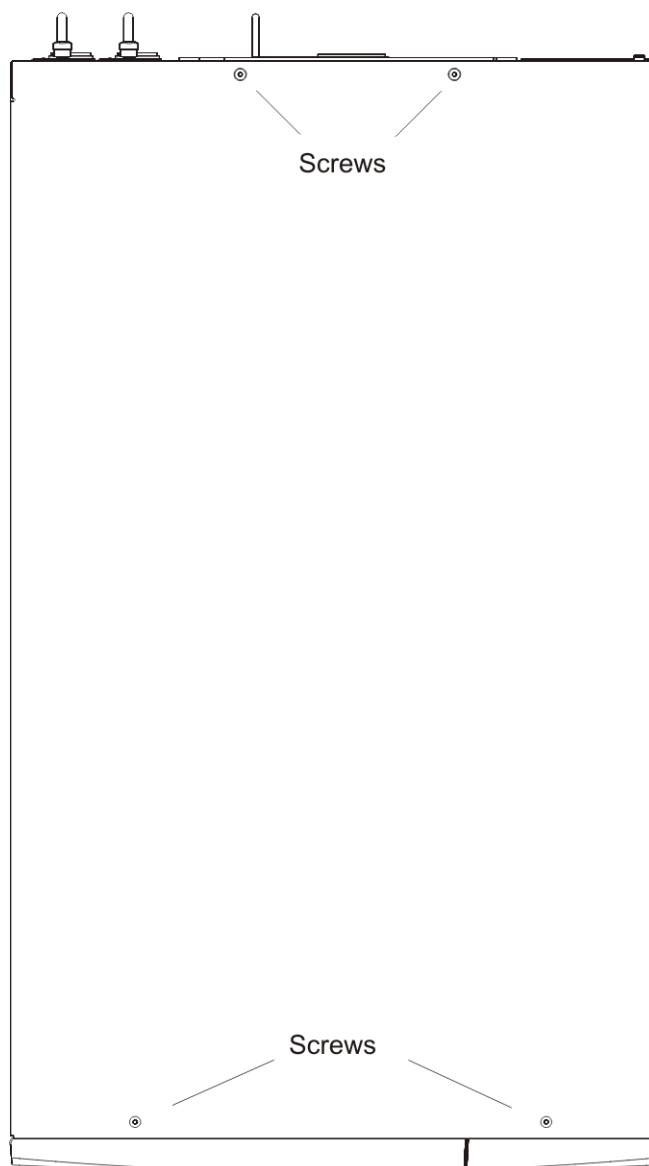
If the 5U Library Control Module's top cover plate is still in place, remove it. Use the Phillips screwdriver to loosen all screws to remove the cover.

On newer versions of the top cover, the screws are retained in the cover. Partially loosen all screws before completely loosening any one screw. Loosening one screw completely while the others are tight can cause the retaining clip of the screw being loosened to come off. In older versions of the top cover, remove the screws and set aside.

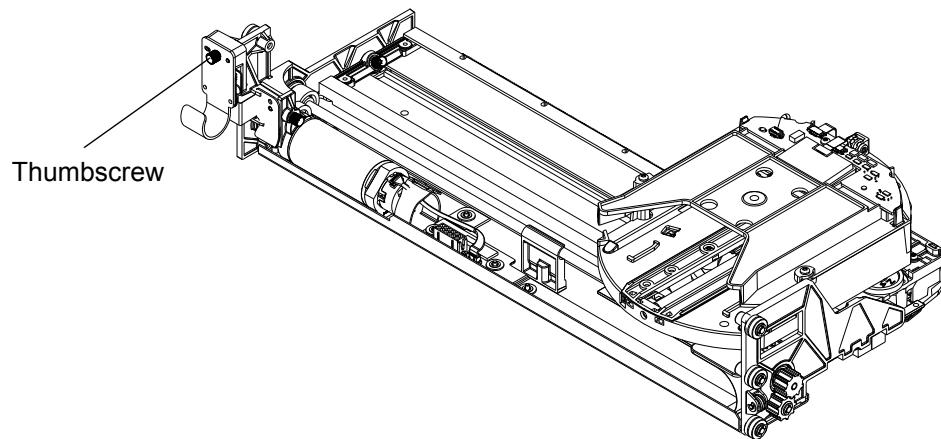
- 8 Unscrew the captive thumbscrew that attaches the cable spool to the robot assembly, and pull the cable spool flex circuit off the assembly.

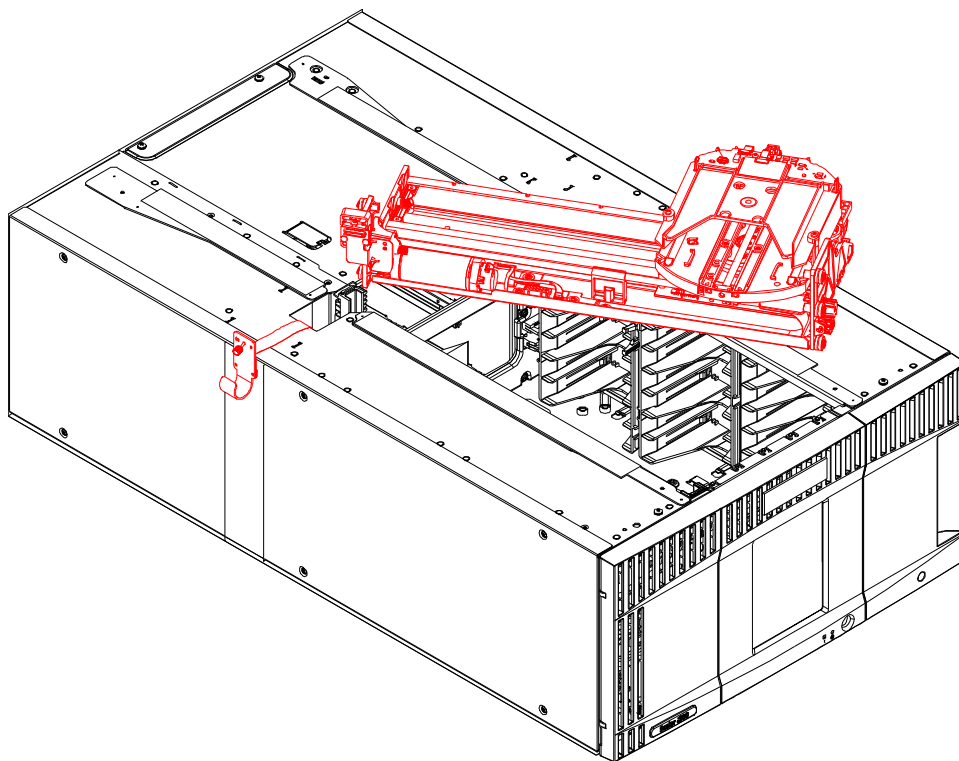
- 1 Place the robot assembly on top of the 5U Library Control Module at an angle, as shown below. This position keeps the cable from kinking when you attach the cable spool in the next step.

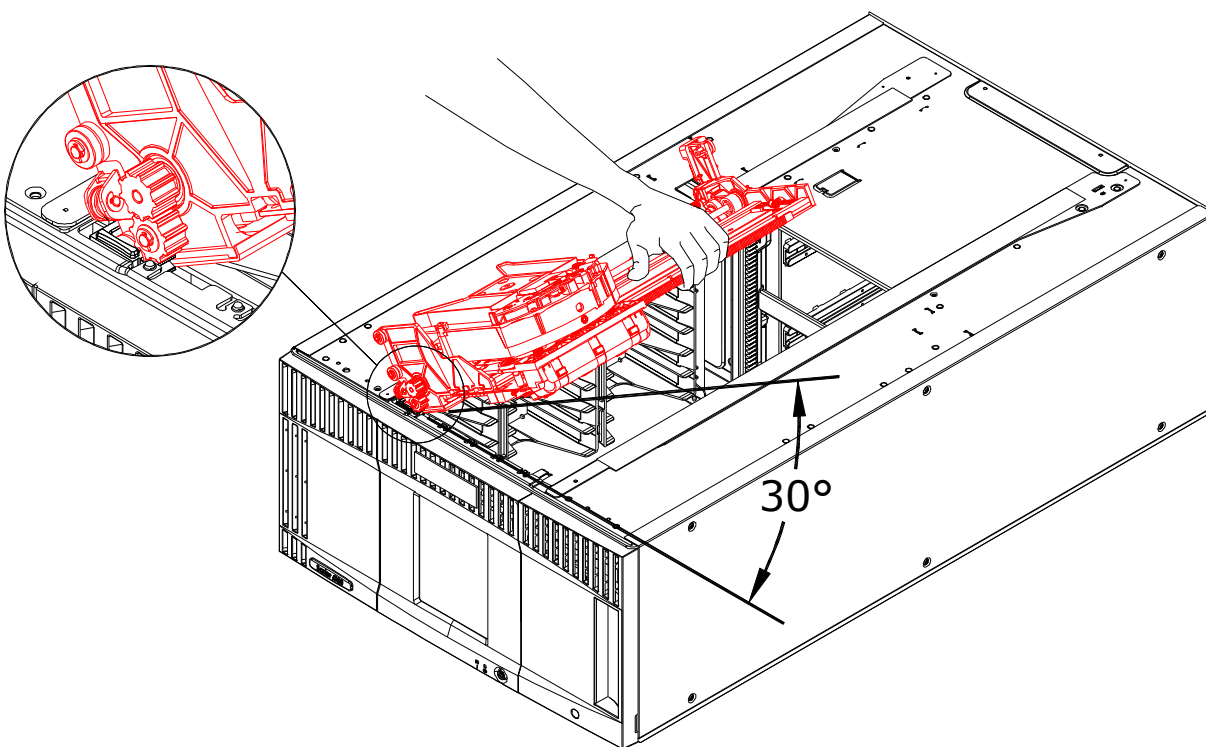
- a. Lift the robot from the center of the tray and hold it at a 30-degree angle to the 5U Library Control Module. Insert the front and rear lower guide rollers into the gear rack on the Y-rail, then lower the robot slightly until both the front and rear gears make contact with the gear rack.

It is very important to hold the robot at a 30-degree angle until both the front and rear gears contact the gear rack on the Y-rail.

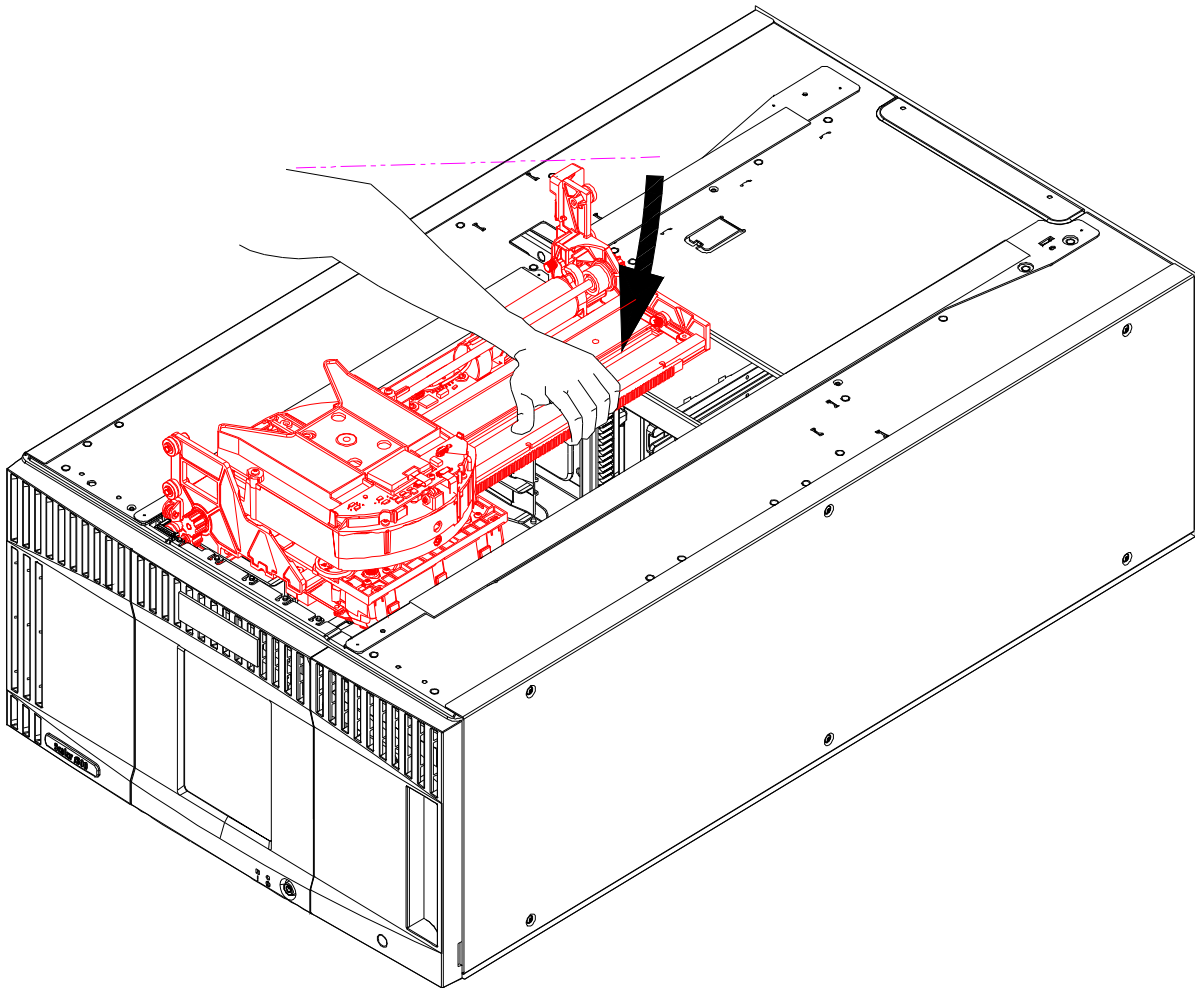
- b. Rotate the robot so that it is level with the library. Do not allow either the front or rear lower guide rollers to exit the gear rack on the Y-rail. As you rotate the robot into the level position, the gears will rotate and engage in the gear rack.

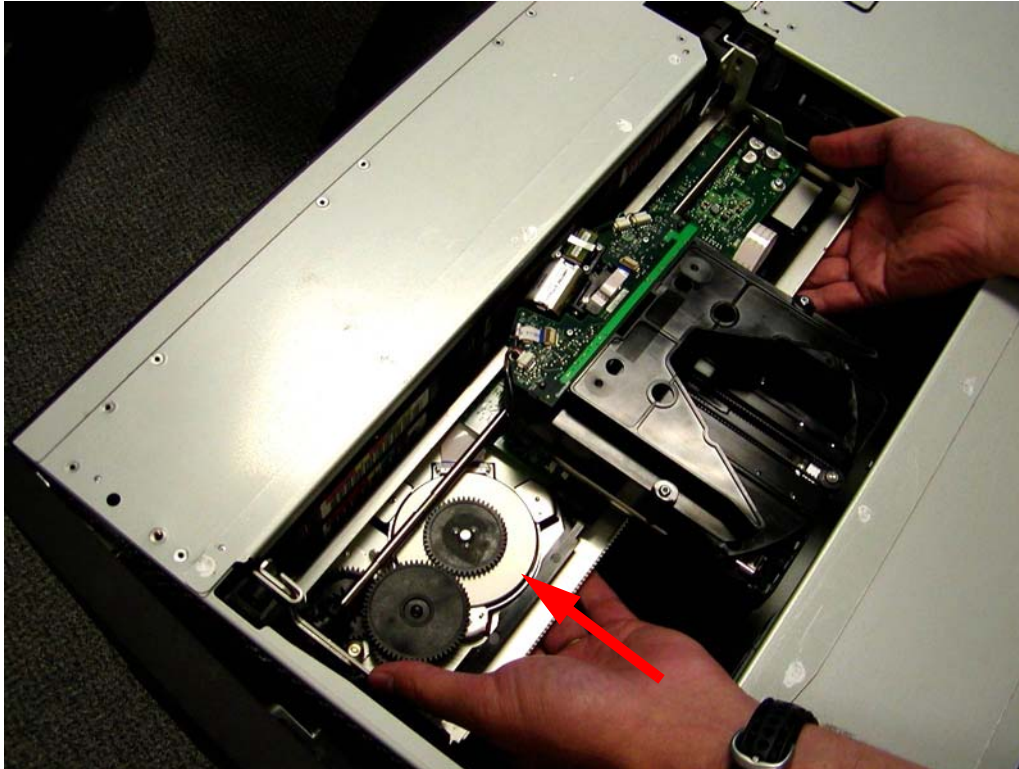
- a. Hold the robot with both hands. Keeping the robot level, insert the front and rear lower guide rollers into the gear rack on the Y-rail, then lower the robot slightly until both the front and rear gears make contact with the Y-gear rack. Do not allow the front and rear rollers to exit the gear rack. Exert slight pressure on the robot toward the left side of the library.

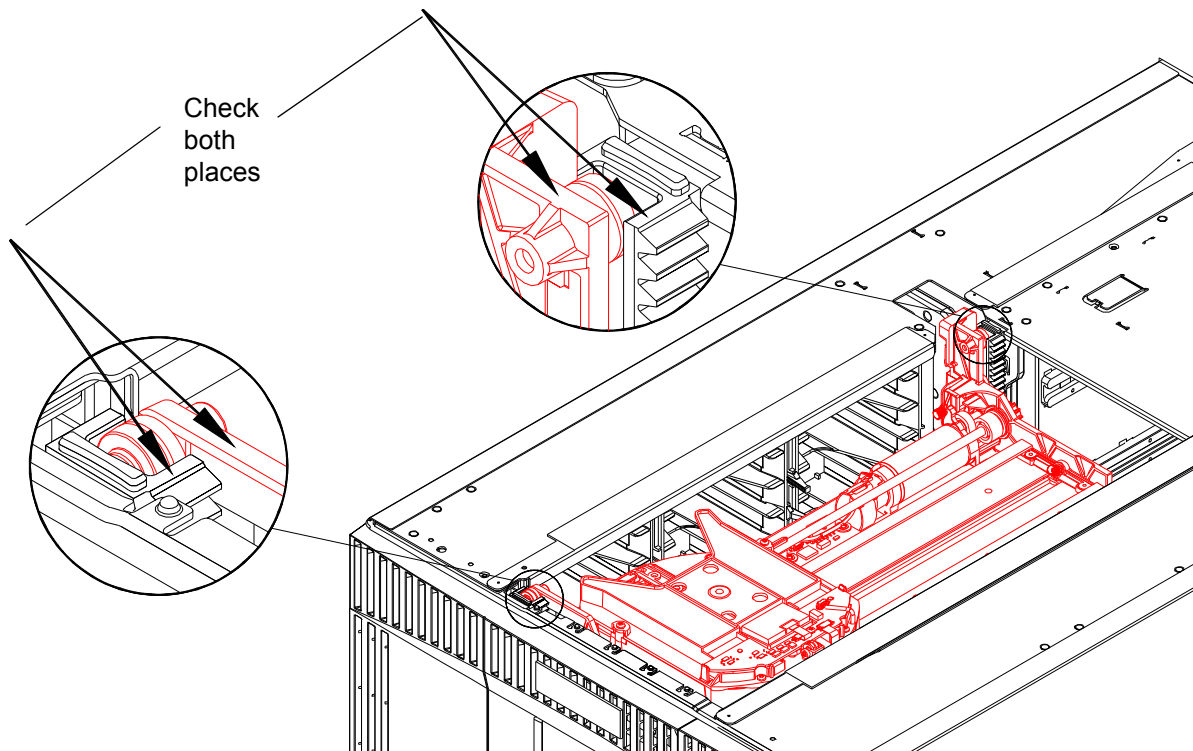
While continuing to hold the robot level, verify that the Y climber rear shelf mount is level with the rear gear rack on the Y-rail. Check both places indicated in the figure below. If it is level, continue to the next step. ***If it is off by more than 2 mm, the robot is NOT LEVEL. Disengage the robot from the gear rack and repeat the previous step.***

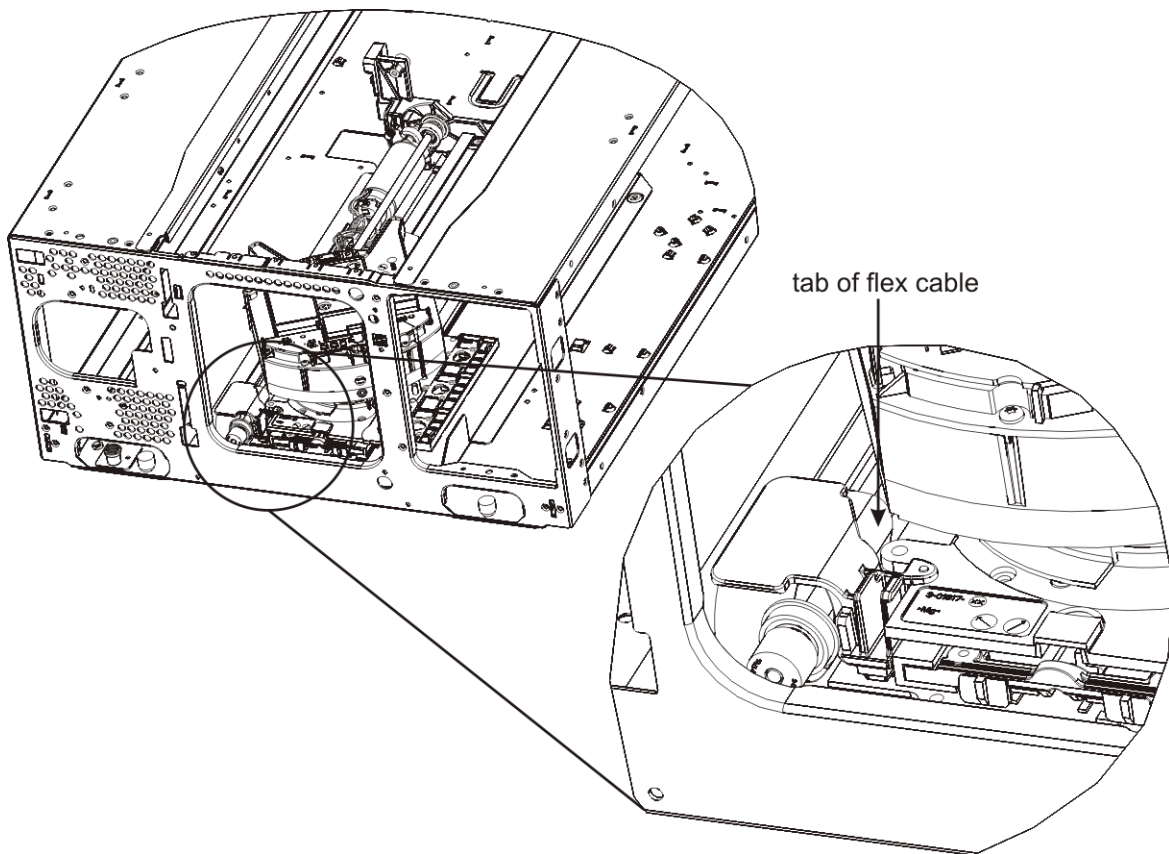
Using your hand, squeeze the tab of the flex cable, and then pull the cable out and up. The other end of the flex cable remains attached.

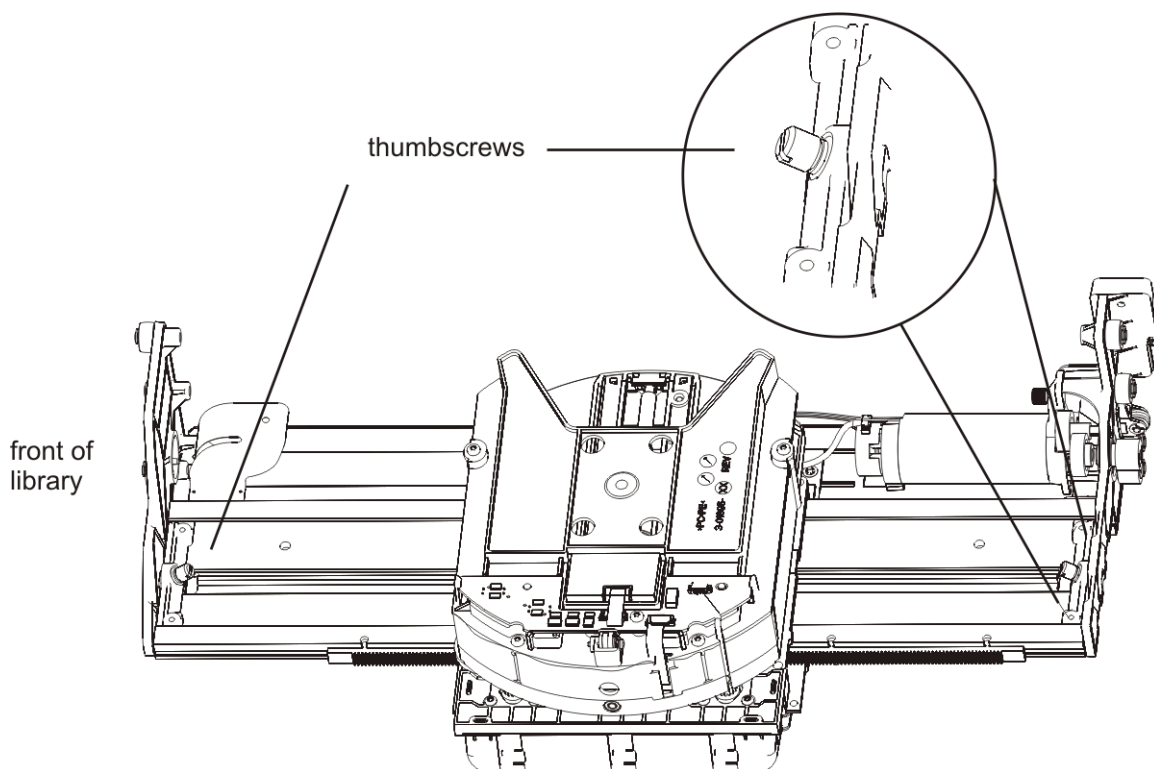
- 5 Using the T10 Torx screwdriver, loosen the thumbscrews located at the front and back of the picker assembly. You may need to slide the picker to access the thumbscrews.

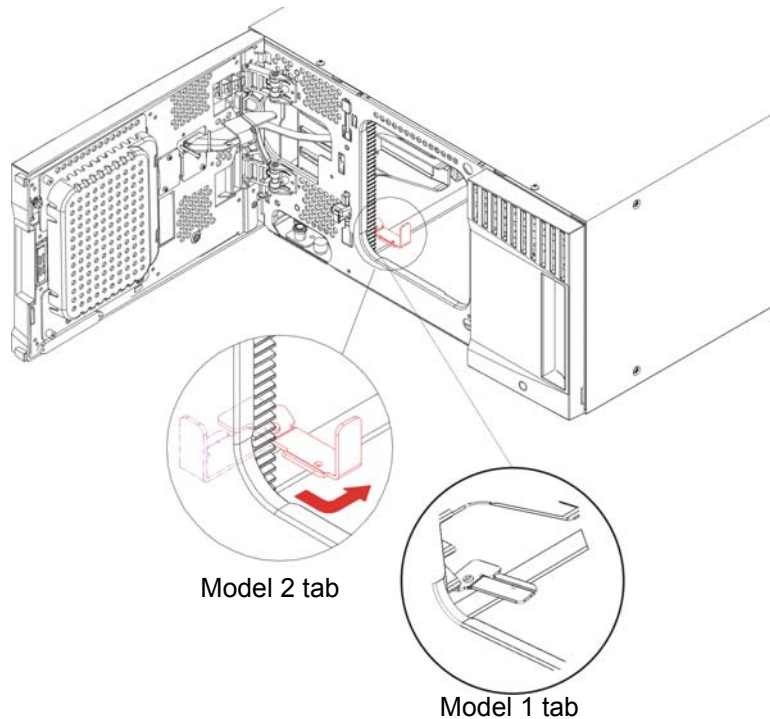
- c. After raising the robot assembly to the approximate middle of the 5U Library Control Module, hold it in place with one hand, and using your other hand, move the parking tab to the "parked" position (**Model 1 parking tab**: swivel toward you; **Model 2 parking tab**: move in a counter-clockwise direction). The metal parking tab is located at the bottom of column 1.

- d. Gently release the robot assembly to rest on the parking tab.

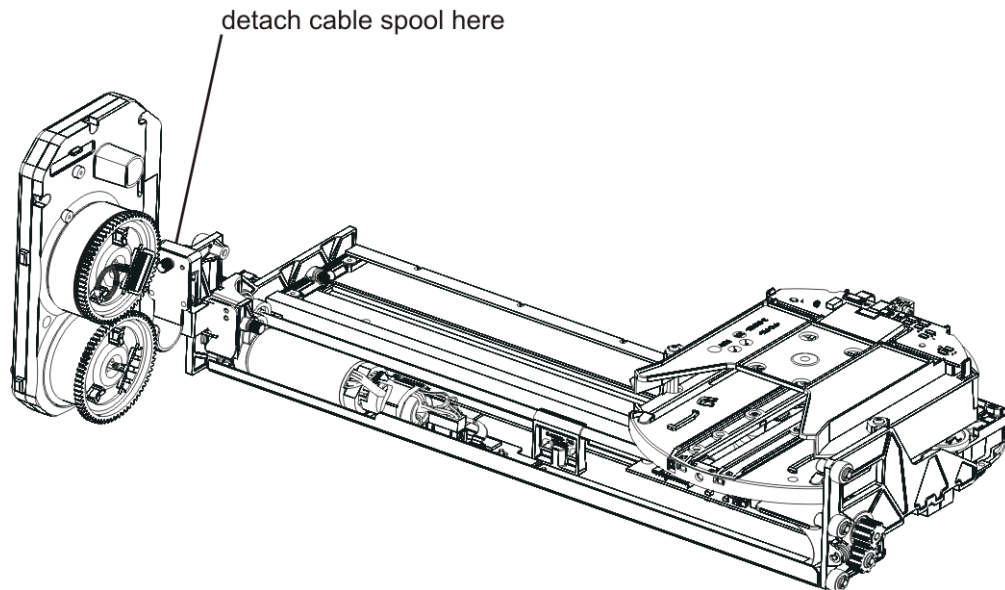
**Note** The figure below shows the Model 1 robot assembly and cable spool. If you are working on a Model 2 robot assembly and cable spool, they will look slightly different, but the way they attach together is the same.

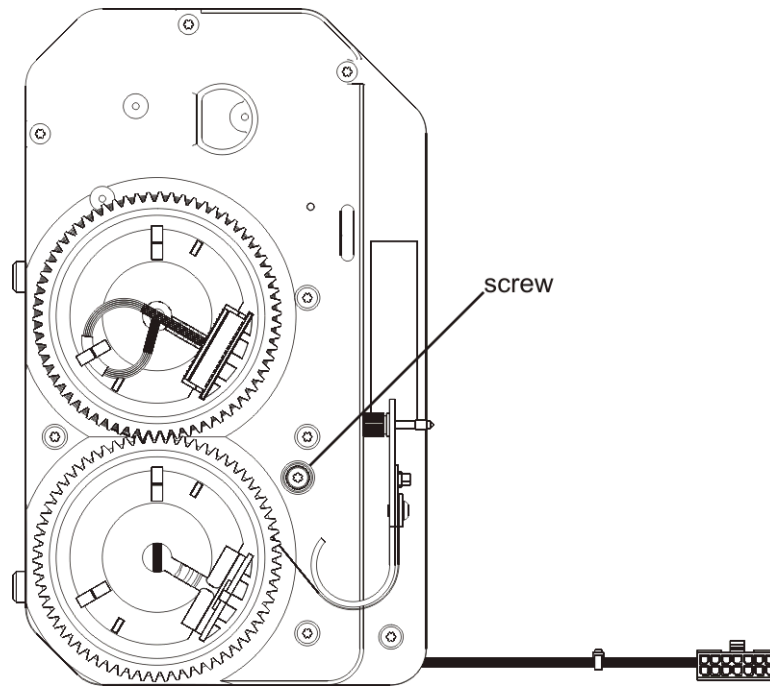
- 4 Using the T10 TORX screwdriver, loosen the screw that secures the cable spool to the chassis.

The external appearance of the cable spool on your library may differ slightly from the one shown in the figure below. However, the fit, function, and location of the screw and cable are the same.

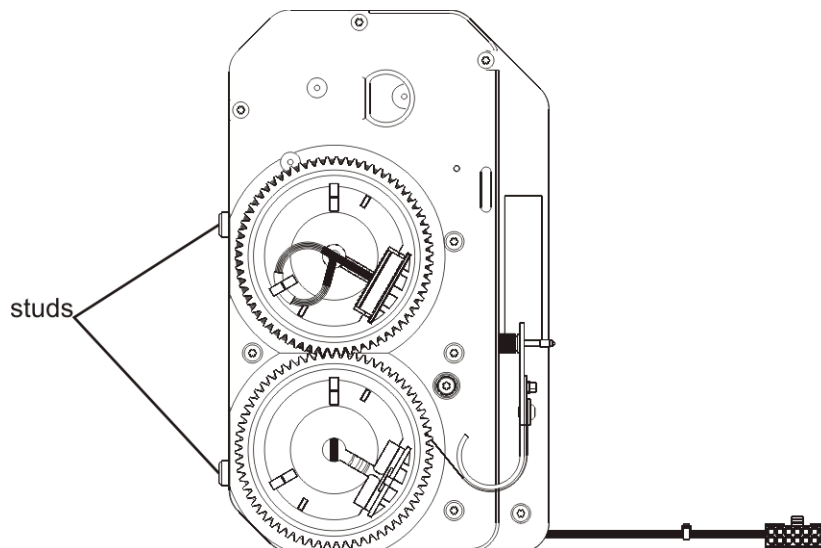
The external appearance of the cable spool on your library may differ slightly from the one shown in the figure below. However, the fit, function, and location of the studs, screw, and cable are the same.

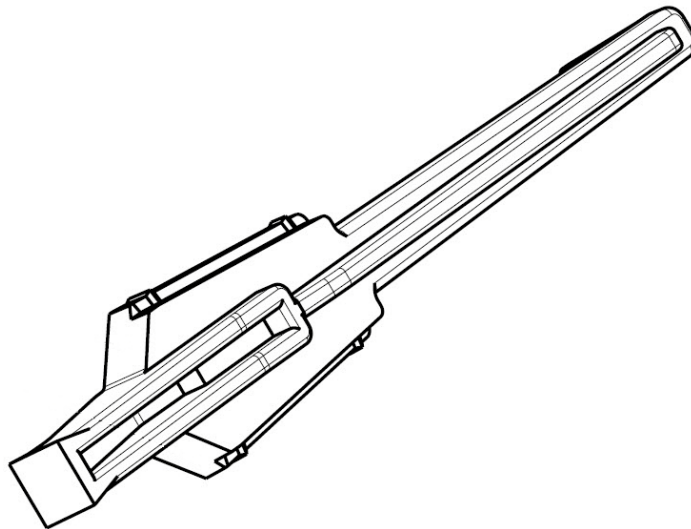
**Figure 23** Fiducial

The fiducial is a removable white plastic part that snaps on to the column in a specific location. The robot scans the fiducials during initialization and other move operations so that it "knows" where tape cartridges belong. If there is a problem with a fiducial, you may need to replace the fiducial. To do this, you need to first remove the column (see [Removing and Replacing Columns](#) on page 189).

- 1 To place a fiducial on a column, slide it into the appropriate slot, and snap the tail of the fiducial over the post on the column.
- 2 See [Figure 24](#) for a drawing of a fiducial. See [Figure 24](#) for the locations of the fiducials in a 5U tape column. See [Figure 25](#) for the location of the fiducials in a 9U tape column.

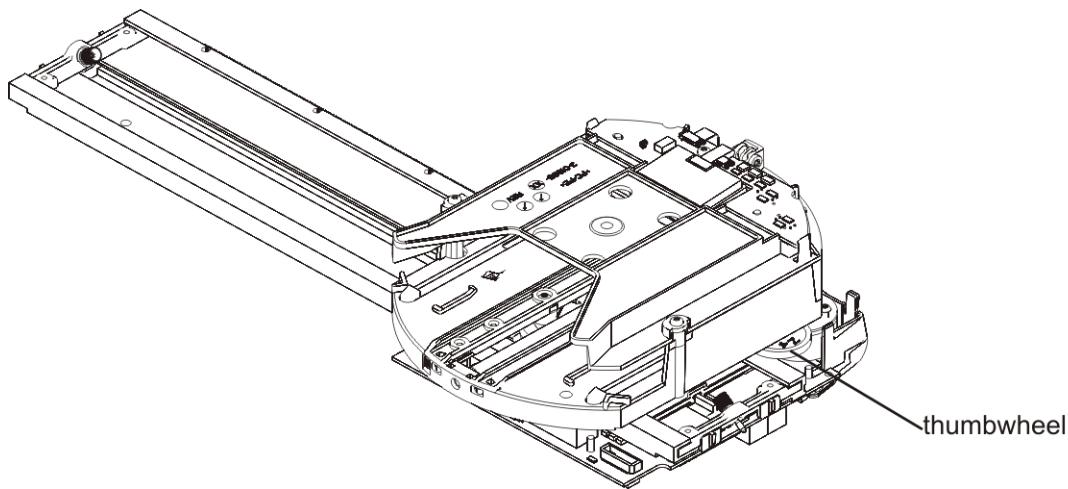
- 1 Take all library partitions offline.
- 2 Open the library main access doors.
- 3 Rotate the picker assembly by hand, so that the opening faces the drives.
- 4 Use the gear thumbwheel in the rear of the picker assembly base to manually slide the tape cartridge out of the picker assembly toward the tape drives.
