# Dell™ PowerVault™ ML6000 Maintenance Guide

Document Number: 6-01367-10 Rev A

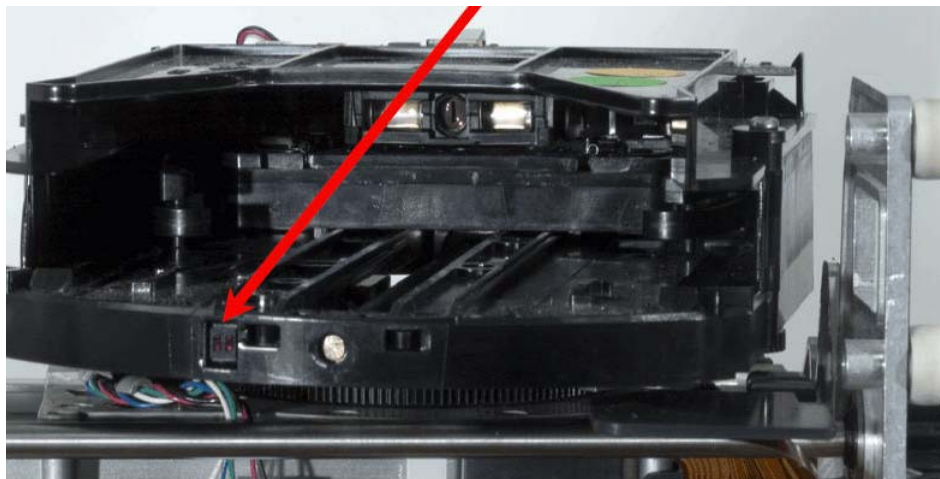
- c. Open and fully extend the bottom I/E station door, then reach through the main access door and locate the picker assembly's recessed calibration sensor in the picker base, just slightly to the right of the picker's center line. Gently wipe the surface of the calibration sensor, using a soft, lint-free cloth.

**Note to Service:** The picture below shows the location of the calibration sensor. If you are guiding a customer by phone, you may want to copy the picture and e-mail it to them.

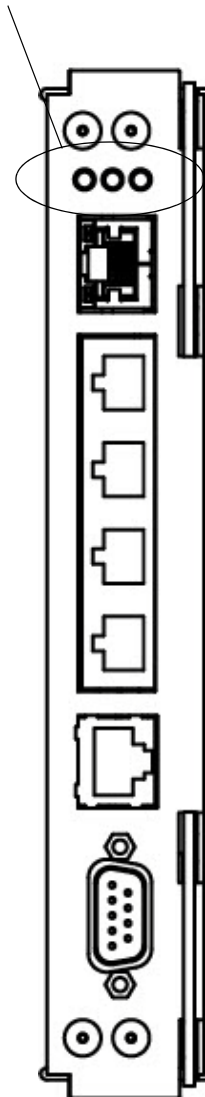
Library Control Blade  
Status LEDs

- Left = Blue
- Middle = Amber
- Right = Green

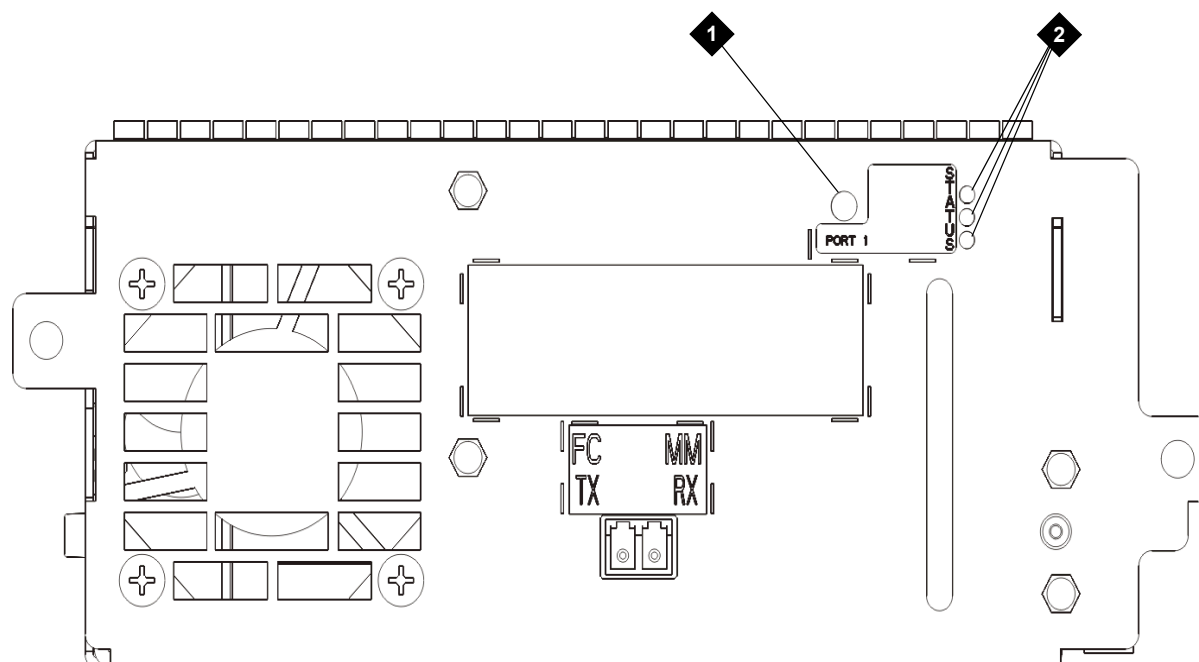
**Figure 29** Location of Tape Drive LEDs

**1** FC port link LED

**2** Tape drive LEDs

[Figure 29](#) shows where the tape drive LEDs and the FC port link LED are located.

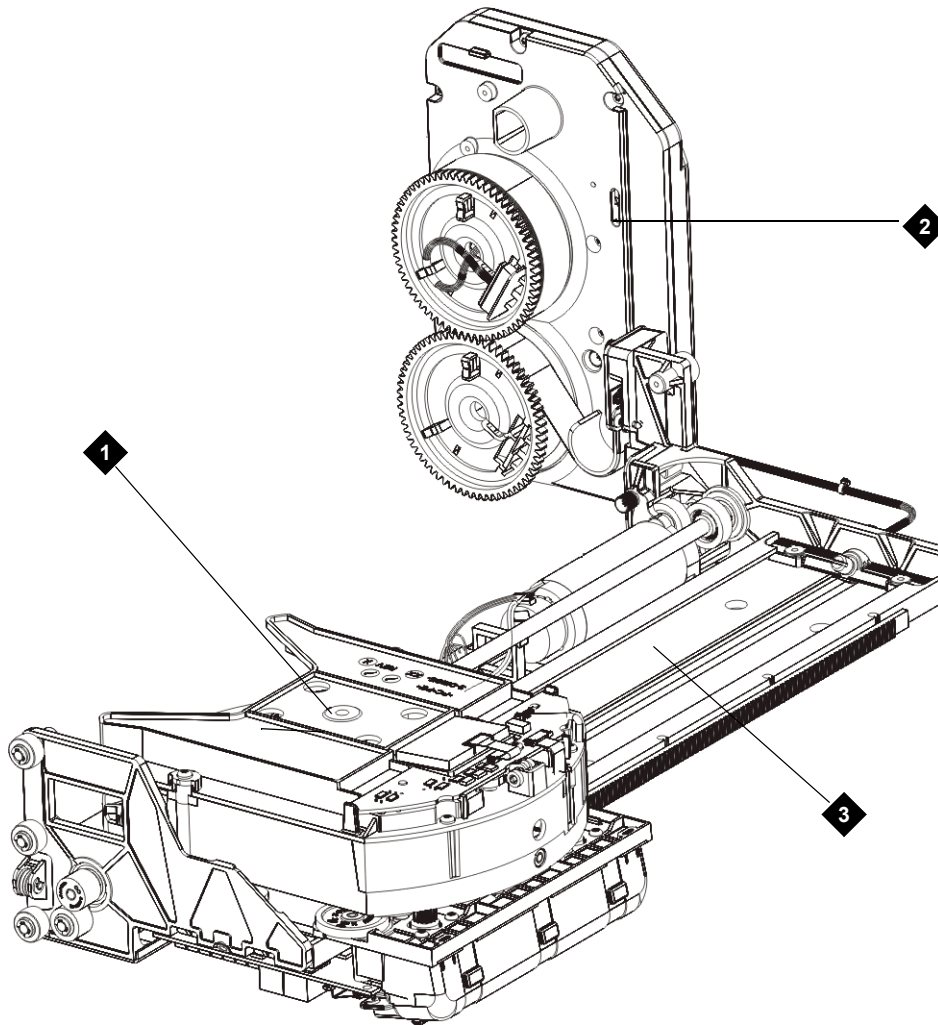
**Figure 40** Model 1 Robot Assembly with Original Cable Spool

Both robot assemblies are shown below. Note that the actual cable spool may look slightly different from the one shown in [Figure 40](#).

**1** Picker

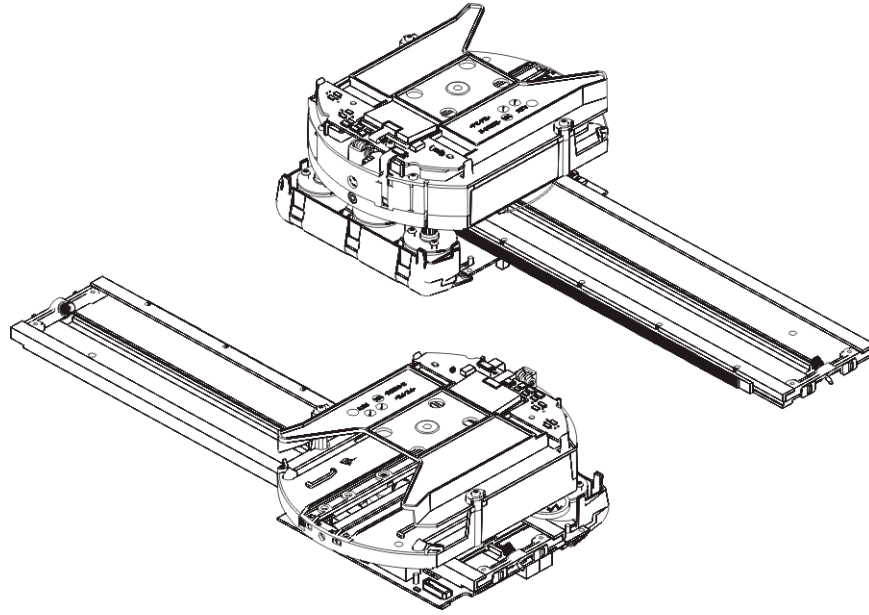
**Figure 42** Model 1 Picker Assembly

As of November 2008, the picker assembly changed as part of the robot change. The two pickers are identified as follows:

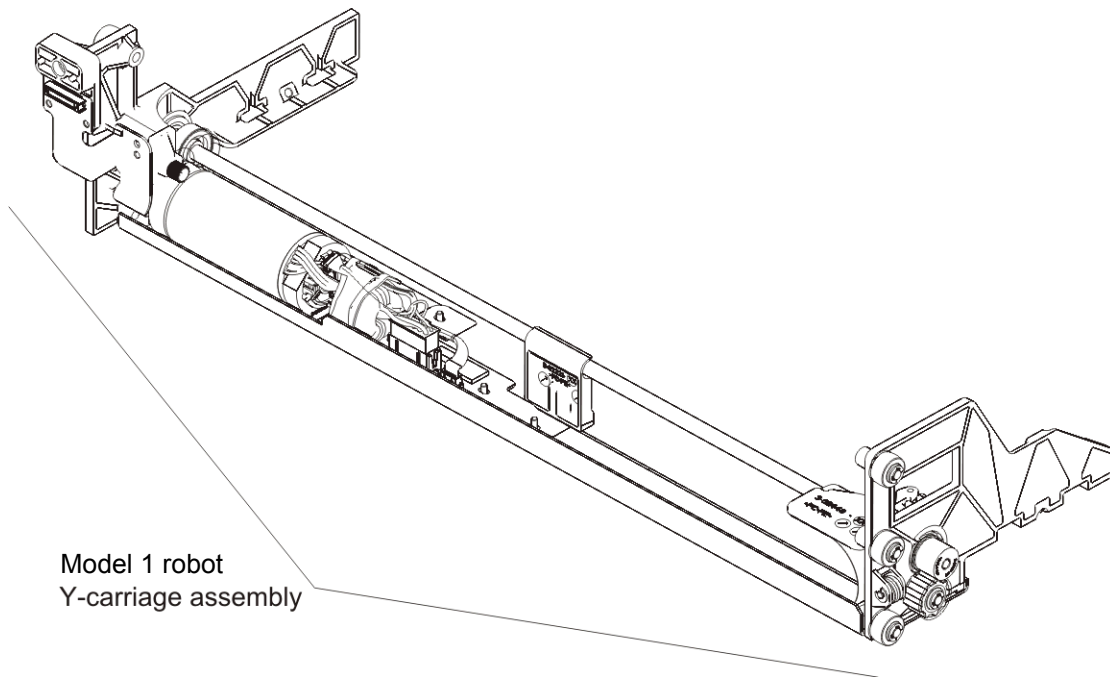
## Model 1 Y-carriage Assembly

As of November 2008, the Y-carriage assembly changed as part of the robot change. The Model 2 Y-carriage assembly is included as part of the Model 2 Robot Assembly (see [Figure 41](#) on page 444).

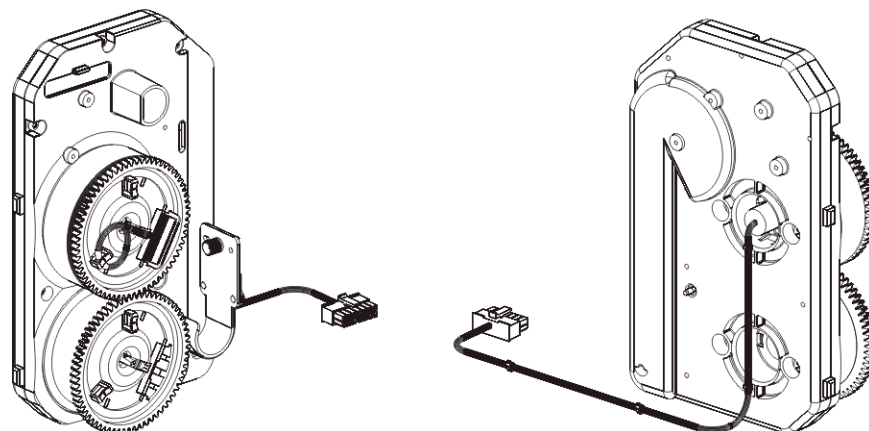
**Figure 44** Original Cable Spool.

On August 27, 2007, the cable spool changed. The cable spools look very similar to each other and function exactly the same way. The gears are different sizes, but the location of the components is the same.

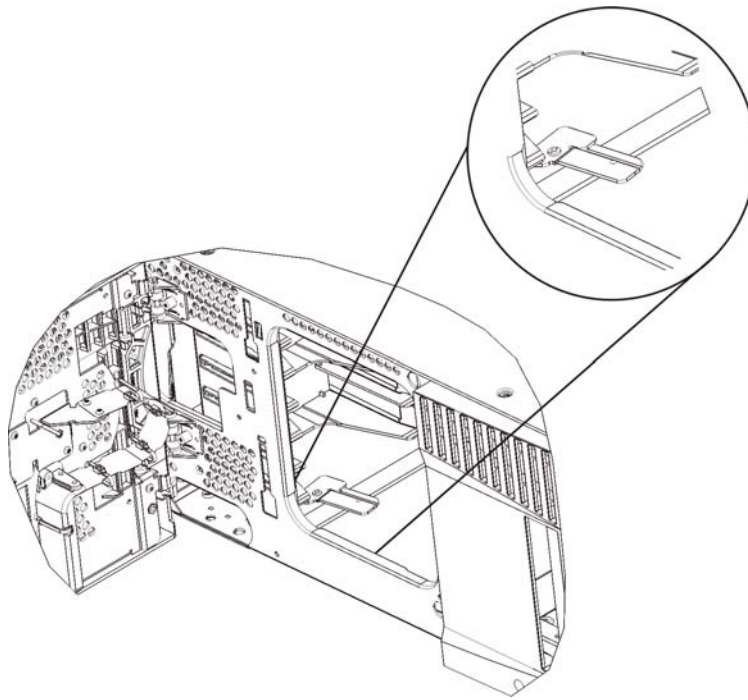
**Figure 46** Model 1 Parking Tab, Parked

As of November 2008, the robot assembly was changed. This change affected the parking tab. The Model 2 robot has spring-loaded roller sliders that extend below the Y-carriage assembly and which could be caught and bent on the lower chassis when removing the control module if the old parking tab was used. The new parking tab sticks up 1 inch vertically and holds the robot up high enough that the roller sliders will not get caught. Also, the tab swivels in the opposite direction. The two parking tabs are identified as follows:

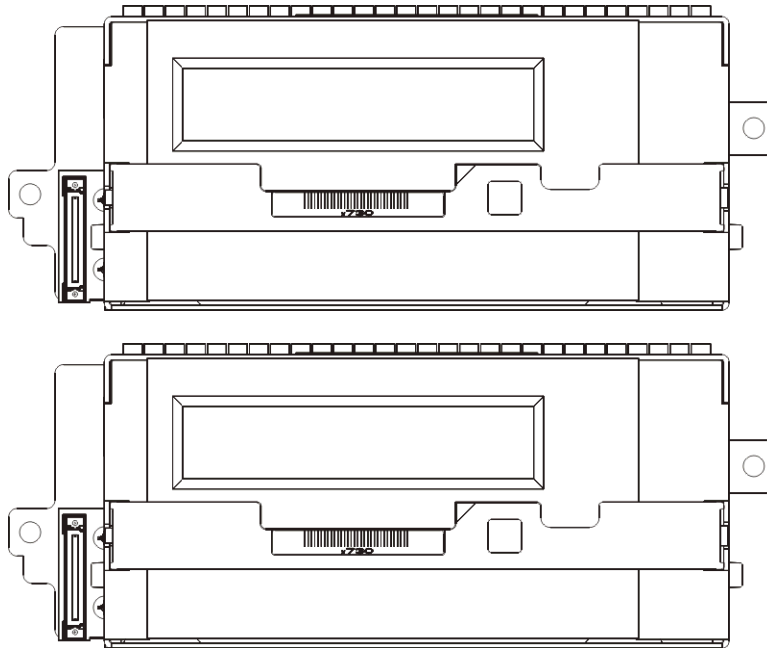
**Figure 51** Tape Drive, Front View

In this document, *tape drive* is used as a collective term to describe the universal drive sled (UDS) and the tape drive itself. The UDS houses the tape drive. The tape drive itself is also sometimes called the *drive brick* to differentiate it from the *drive sled*.
