| Document class | Release Note |
| Document ID | 1MRS759126 |

## Firmware update release 1.2.0.B5 for 630 series product version 1.2 protection relays

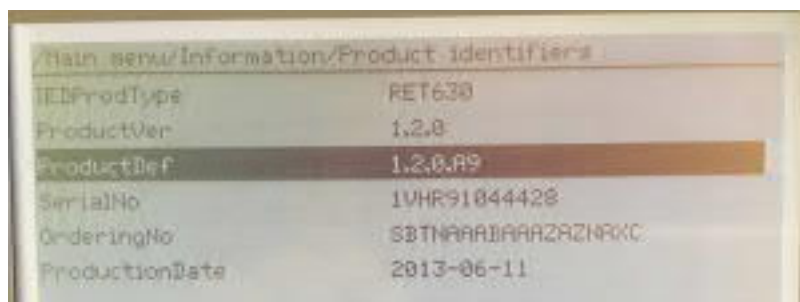
To identify the current firmware revision of 630 series relays, please note the parameter **ProductDef**, refer to Figure 2.

*Fig. 2 Current firmware revision of the 630 series protection relay*
