# **Intel® Visual Compute Accelerator 2 (Intel® VCA 2)**

## ***Product Specification and Hardware Guide***

A reference document for server OEMs providing an overview of product features, integration requirements, and validation guidelines.

**Rev 1.7**

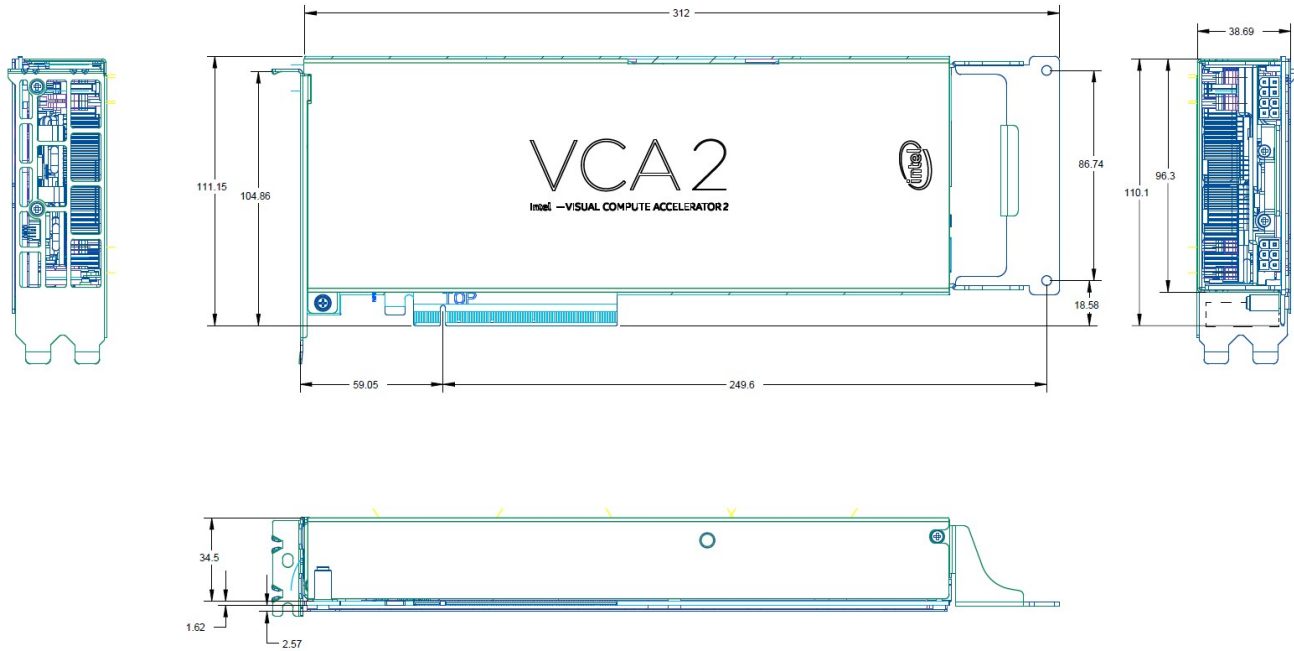
**Figure 2. Intel® VCA 2 dimensions**

Intel® VCA 2 is a “near” full-length, full-height, double-width PCIe\* 3.0 x16 add-in card. It includes a bracket that extends the card to full length for systems that fully support the PCIe specification.

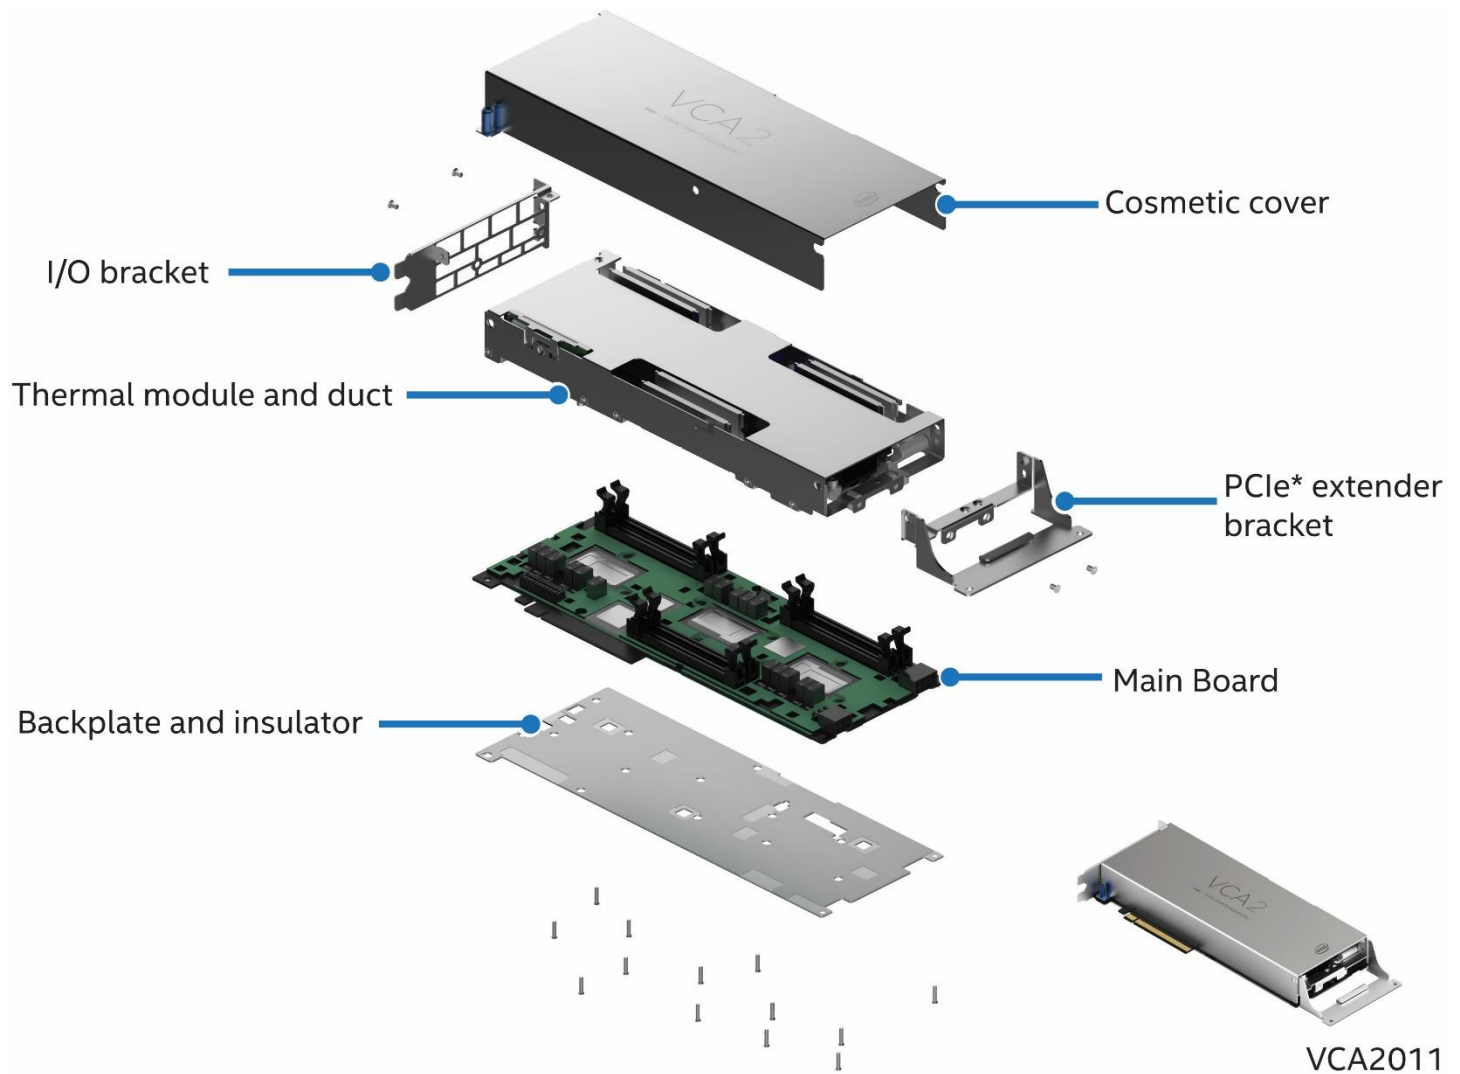
**Figure 3. Intel® VCA 2 detachable components**

The Intel VCA 2 assembly consists of several detachable components to allow for card configuration and serviceability. Figure 3 displays the full card assembly.

**Advisory Note:** Intel VCA 2 must have the provided mechanical support bracket (or other custom support bracket) mounted to the card to ensure proper support when installed in the system. Failure to properly support the installed card may cause serious damage should the system be exposed to any level of shock or vibration or is transported to the end user location.

When in operation, the card temperature will rise. The cosmetic cover, thermal module, and duct must be in place to allow for proper airflow over and through the card assembly. Failure to have the card covers installed results in overheating which may impact performance or proper operation of the card.

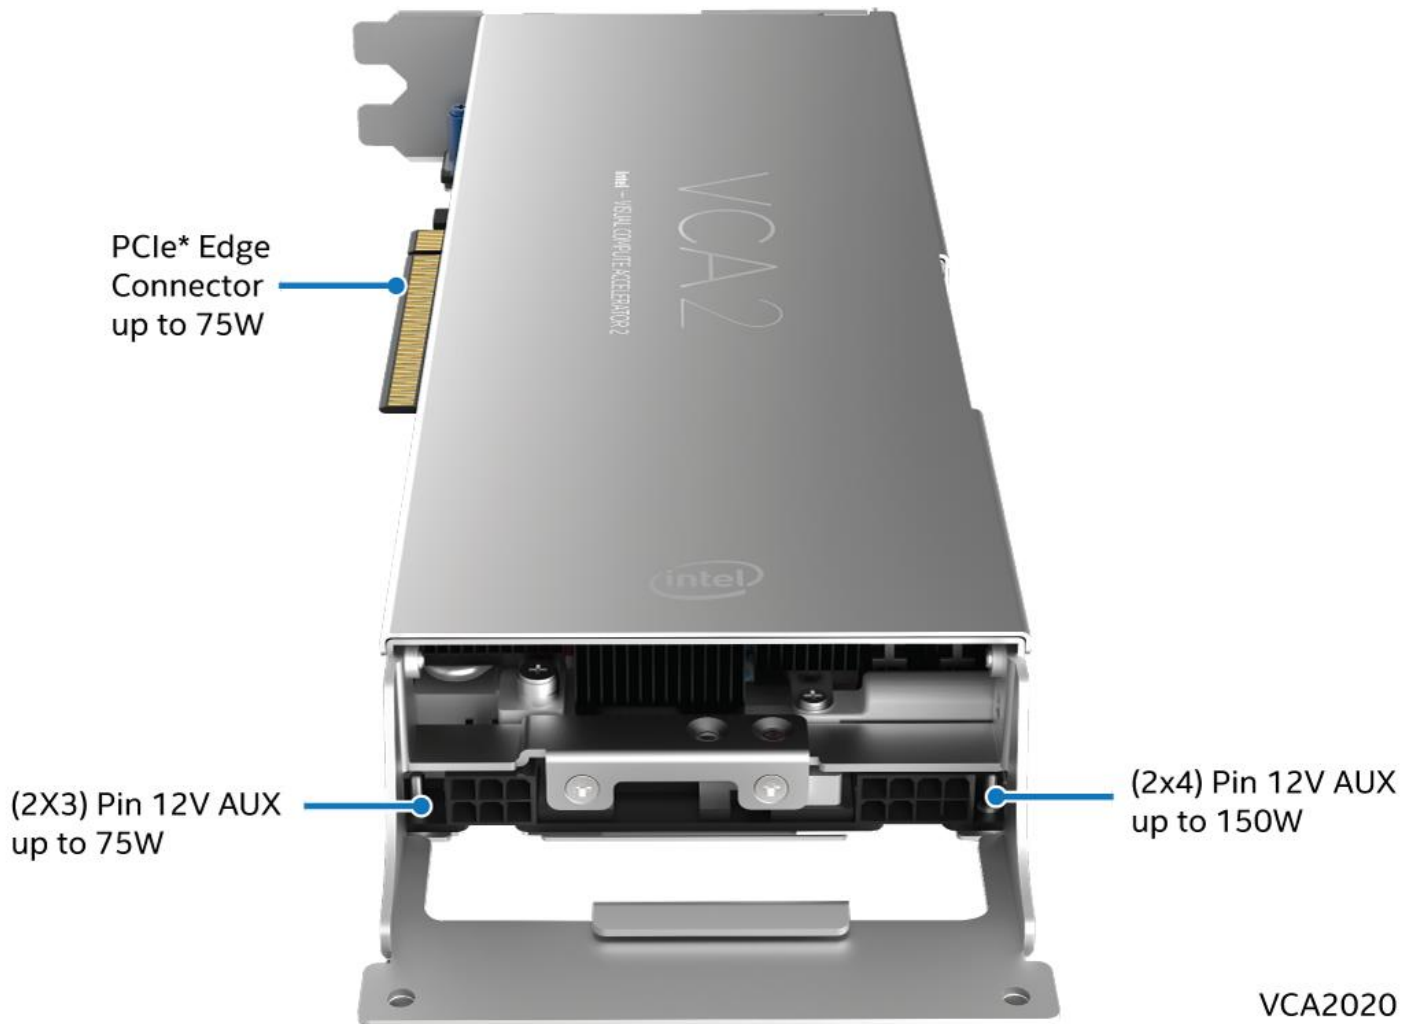
Figure 6. Intel® VCA 2 card power connectors

Intel VCA 2 has a maximum TDP of 235 W. per the PCIe specification, the PCIe x16 connector can support up to 75 W. The remaining power to the card must be supplied via the 2x3 (75 W) and 2x4 (150 W) 12 V AUX power connectors on the card as shown in Figure 6.

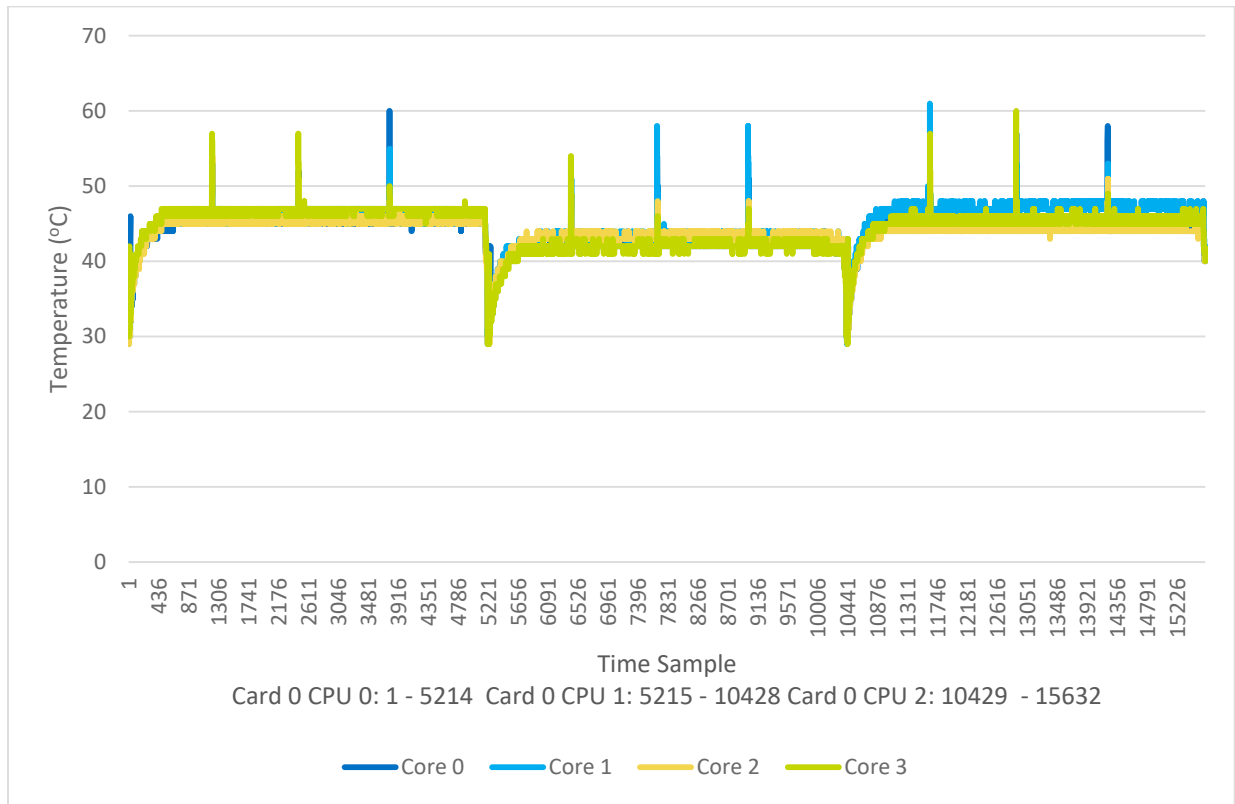
**Figure 14. Temperature profile while transcoding**

The temperature while booted in idle mode is ~35 °C. Temperature during workload is expected to reach ~60 °C. During transcoding workload, the script runs the load more times to ensure frame rate achieved is correct. Also longer input file is used during temperature profile. Temperature values from the VCA nodes are captured for every 10ms during the avc\_benchmark script in a log file (avc\_benchmark\_temp\_log.txt) and sorted along the Card and CPU in log file (avc\_benchmark\_sorted\_temp.txt). Each VCA node has 4 cores and each core temperature is captured. If the average temperature is captured is higher than ~60 °C, the possible cause of temperature is CFM requirements may not be met. Check the fan settings in BIOS. For example, on Intel® Server Board S2600WT based systems, this can be enabled in BIOS setup by configuring the following two options on the PCI Configuration screen.

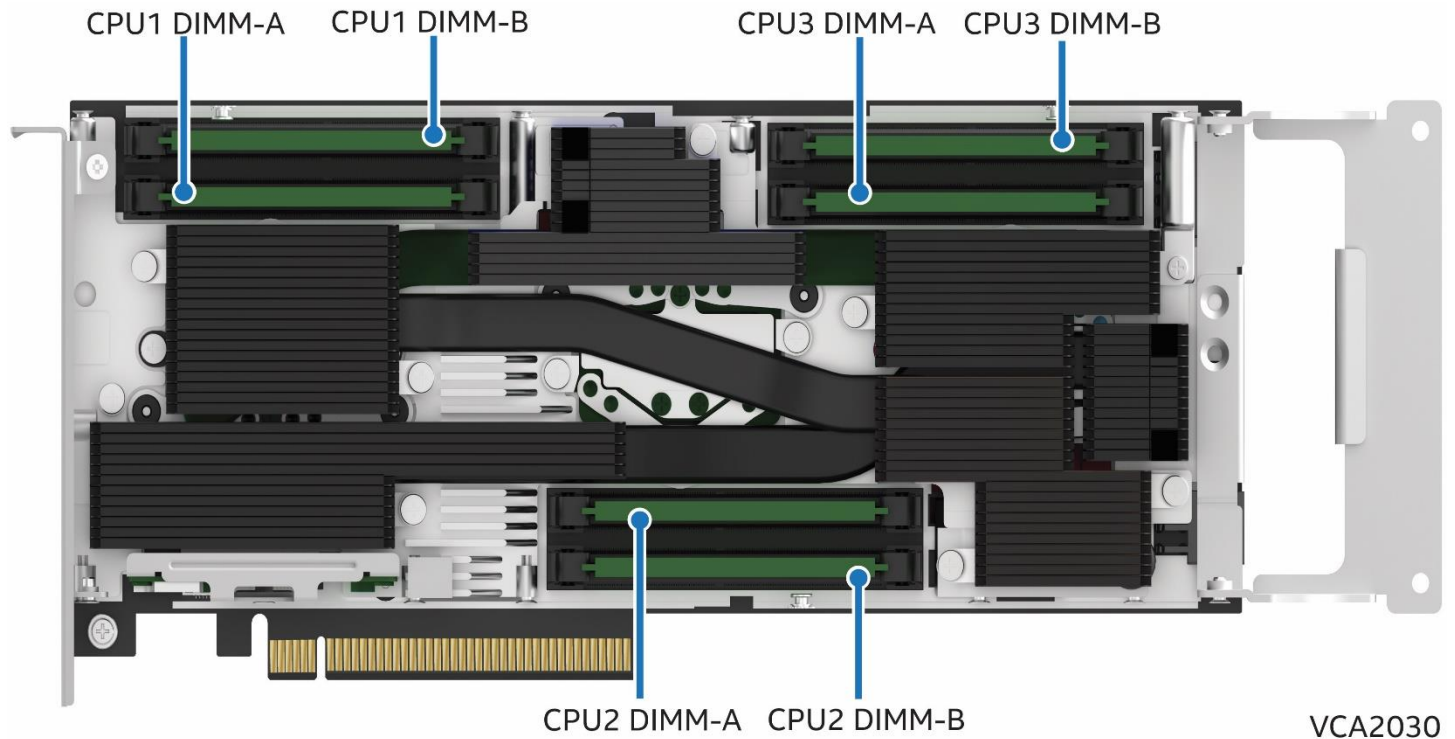
Figure 15. Intel® VCA 2 card DIMM slots

Intel® VCA 2 includes three processors identified as CPU 1-3. Each of the three processors includes two memory channels identified as A and B. Each memory channel supports one SODIMM socket. Each processor can support up to 64 GB of memory. Figure 15 below identifies the SODIMM sockets for each processor.

- All DIMMs must be DDR4 DIMMs.
- All processors must have at least one DIMM installed.
- To get better performance, it is recommended to install both DIMMs (e.g.: instead of 1 16GB DIMM, install 2 8GB DIMMS)
- DIMM slots for each processor must be installed in order, beginning with DIMM Slot A.
- When only one DIMM is installed for any given processor, it must be populated in the DIMM A slot.
