Technical Bulletin

Bulletin No: TCH-008-043

Subject: Recommended Purge Valve Repair Kit

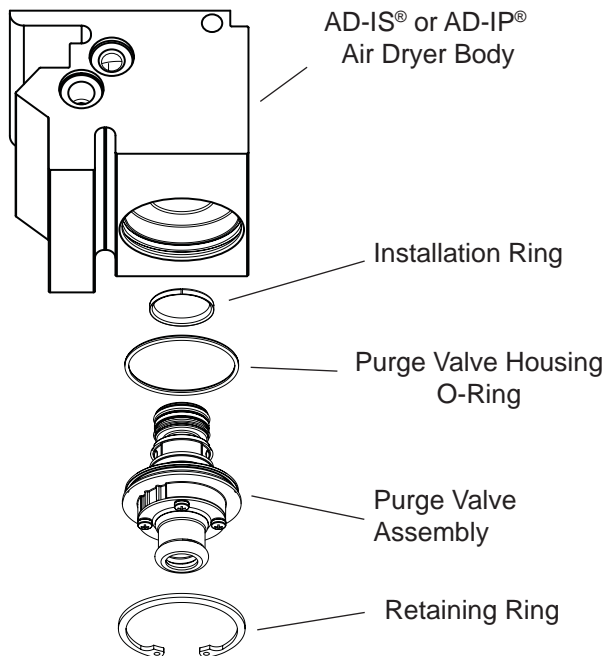
Purge Valve Repair Kit Contents:

The contents of the Purge Valve Repair Kit piece number K022105 are shown here for reference. Installation Instructions are included with each kit to ensure proper servicing.

Qty.	Description
1	Large O-ring
1	Small O-ring (installed)
1	Lubricant (not shown)
1	Retaining Ring
1	Purge Valve Assembly (with protective cap)
1	Installation Ring

Bendix has developed a Purge Valve Repair Kit, part number K022105, for use on Bendix® AD-IS® and AD-IP® air dryers that experience the valve sticking issue described in Technical Bulletin TCH-008-039. This new repair kit should be used in place of the lubrication maintenance kit, part number 5018313, shown in bulletin TCH-003-039.
