COMMANDO SERVICE NOTES

SERVICE NOTES ON THE NORTON COMMANDO

Covering all models up to and including Mk. III

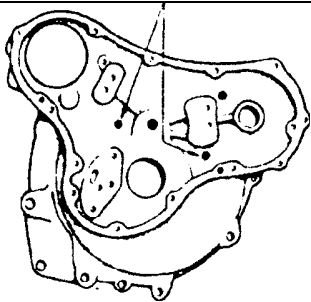
Diagram 4, Timing side crankcase showing holes for 850 breathing, See page 14.

DRILL 3/8 Holes
HERE

The 830 breather is much better than both earlier systems, but really you need 830 cases to make it work, so that you get good oil return from the sump and a filter, but you can get good results by fitting a pipe of about 1/2 in bore into the back of the timing chamber where the magneto used to go (in the days when Lucas ignition systems were guaranteed for two years, including points wear). The pipe should stick through the case about ;in and slope downwards, so that oil running down the inside of the case doesn't get carried up the pipe with the air going out. Oil runs down from the inlet valve as well as sloshing about from the timing gear. How you fit the pipe is up to you; you can't just buy the bits and slap them in. It is also necessary to drill holes in the timing side crankcase-try and get a look in an 830 timing cover and copy the size and position and I don't recommend drilling the holes without dismantling the engine; no Malcolm, put that brace and bit down immediately! See Diagram 4, page 12
