PHASER 3200MFP WORKCENTRE PE220

SERVICE MANUAL

708P88744

April 2007

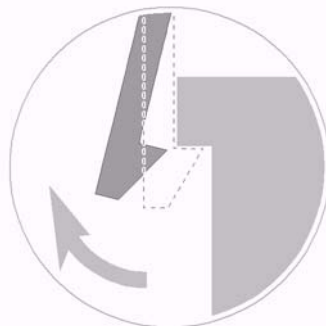
Figure 1

Many of the parts are held in place with plastic latches. The latches break easily; release them carefully.

To remove such parts, gently pull the hook of the latch away from the part which it is latched on to.
