September 16, 2015

02025 Version 3

## Safety Recall: Driver's Airbag Inflator Can Be Over-Pressurized

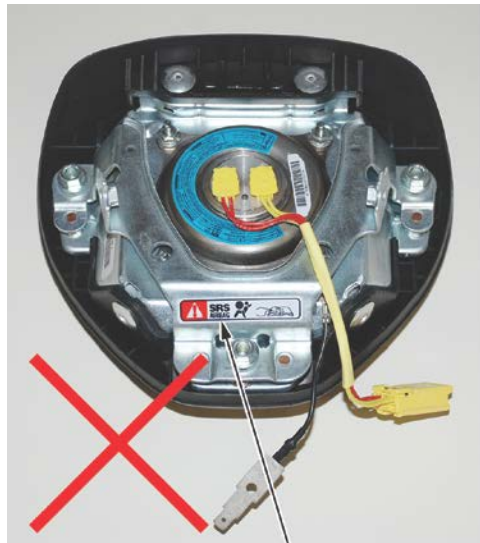
NON-STANDARD  
SAFETY LABEL

- If there are any unusual markings, like an incorrect label or a model year written in marker, the airbag and inflator may not be the correct airbag and/or inflator for the vehicle or it may be a counterfeit part. For more information about counterfeit airbags, you can refer to [safercar.gov](http://safercar.gov), enter keywords **MANAGING COUNTERFEIT**, and select **Recommended Dealer Guidance for Managing Counterfeit Air Bags** from the list. **If you suspect that the airbag or inflator is counterfeit, do not continue this procedure.** Contact your DPSM for assistance.

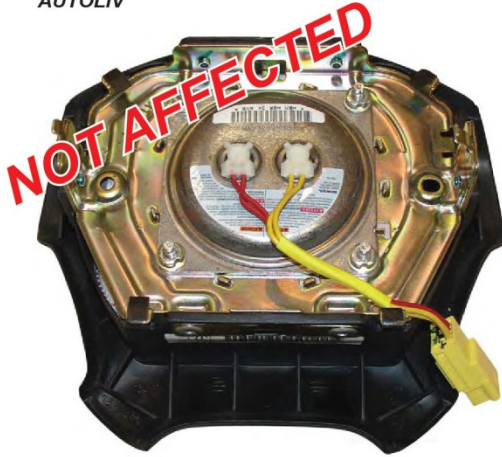
AUTOLIV

6. **Civic only** - Determine if the airbag is made by Autoliv or Takata by comparing the inflators to those in the images below.

NOTE: The Autoliv serial number label is different from the Takata label; the Autoliv has 11 characters, the Takata has 9.

- If the airbag is made by Autoliv, the airbag is OK. Reinstall the airbag using new Torx bolts. Torque the bolts to **9.8 N·m (7.2 lb-ft)**. If you already received a replacement inflator, return the unopened kit to American Honda.
- If the airbag is made by Takata, go to step 7.

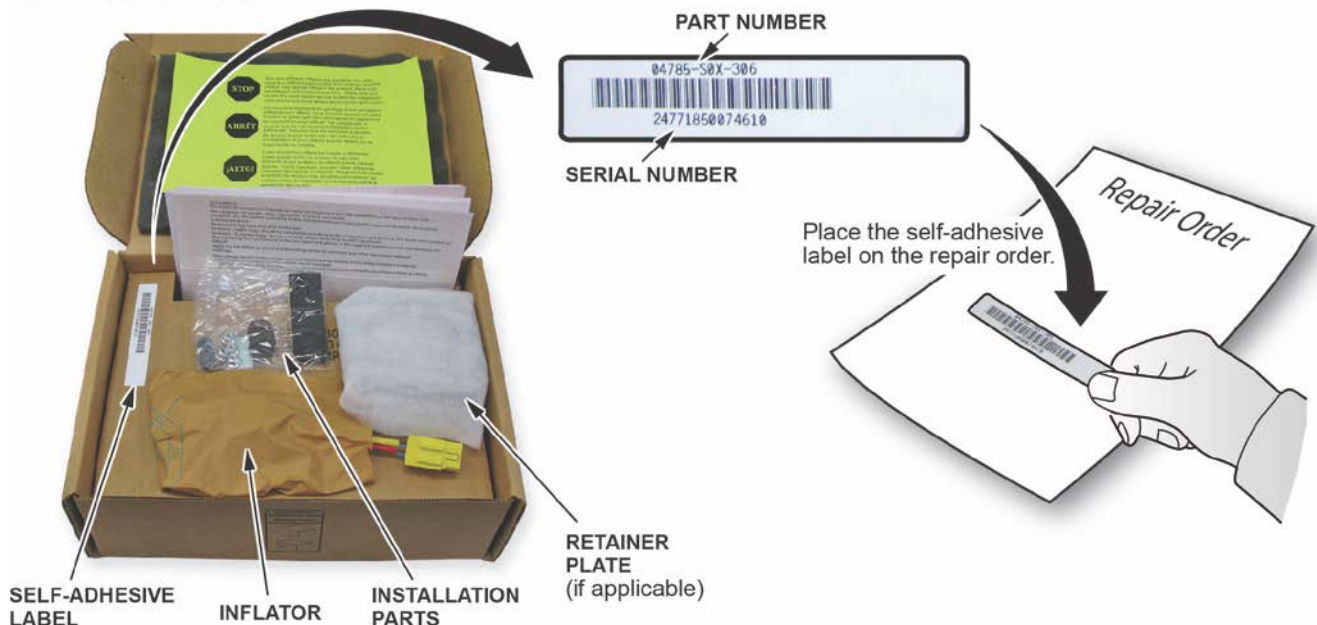
**INFLATOR PARTS BOX**

7. Peel the label located inside the inflator box from its backing and attach it to the RO. For the warranty claim to be paid, the **replacement inflator part number that you received** must be included in the warranty claim.

- The replacement part number is printed on the top part of the label and the serial number is printed on the bottom. **Make sure you attach the label to the RO and give it to the warranty clerk.**
- There may also be a colored sticker located in the kit, ignore it because it is not used.
- Not all inflator kits have a label included. In those cases, write the serial number and part number from the side of the inflator box on the RO. The part number always starts with 047.

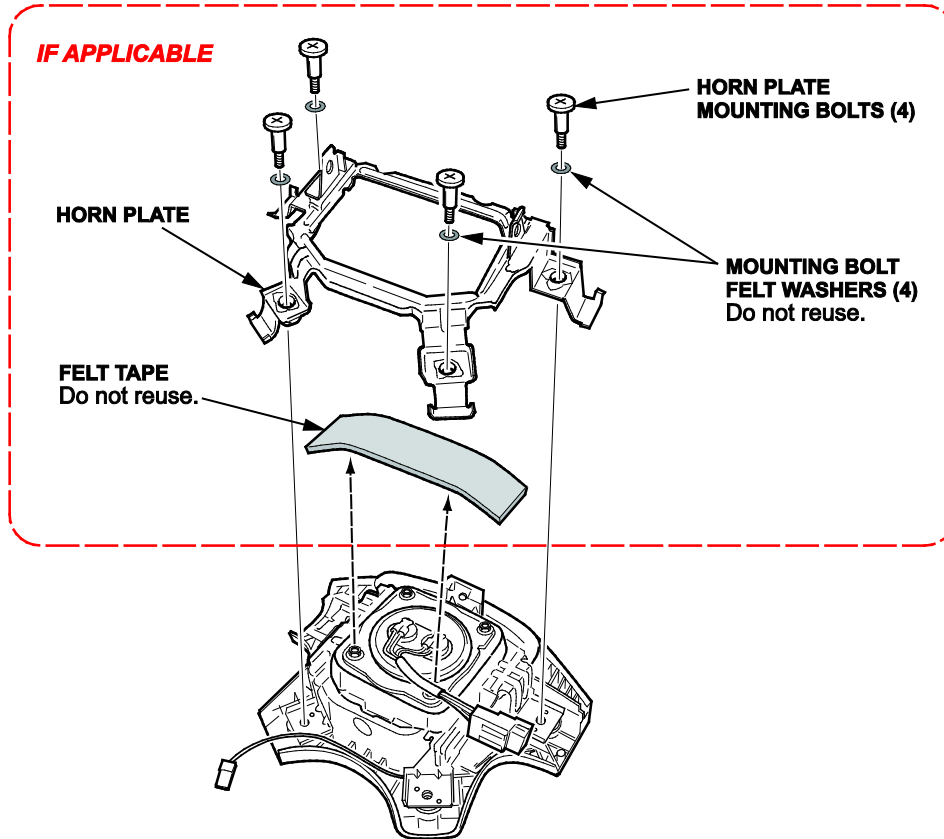
8. If there is no horn plate installed, go to step 9. If there is a horn plate installed, remove the four horn plate mounting bolts, the mounting bolt felt washers, the horn plate, and remove the felt tape covering the lower two inflator locknuts. The felt washers and felt tape will not be reused.

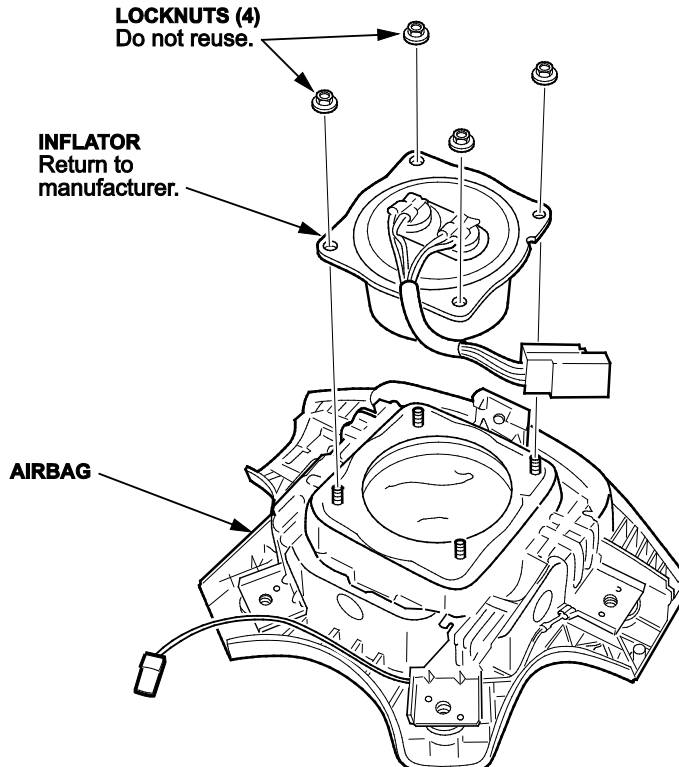
9. Using needle-nose vise grips or a 3/8 in. 6-point socket, remove the four locknuts from the inflator. The locknuts will not be reused.

NOTE: Do not remove the inflator from the airbag until you complete step 10.

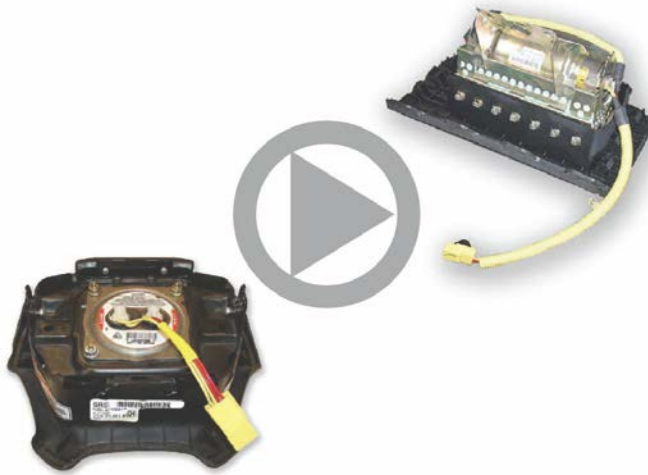
Click on the image below for a short video about the different variations of the driver's and front passenger's replacement inflators involved with the recalls related to Takata inflators. While both the driver's and front passengers inflators are shown in the video, this is informational only. Replace inflators only as directed by the iN VIN status inquiry.

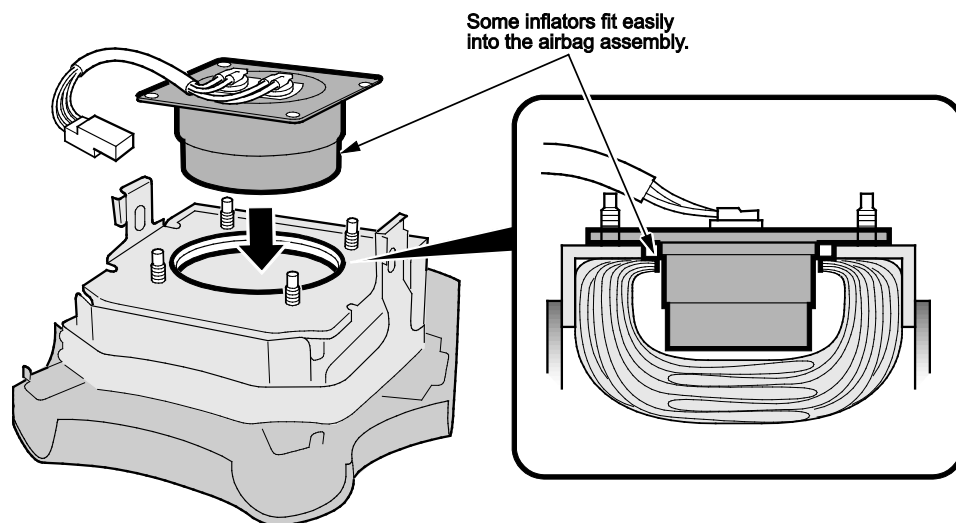
Refer to **Driver's Inflator Type 1** in the video.

- Insert the inflator into the opening.

NOTE: Make sure the inflator wires are positioned toward the bottom of the airbag. If you install the inflator incorrectly, you may not be able to reconnect the SRS airbag harness.

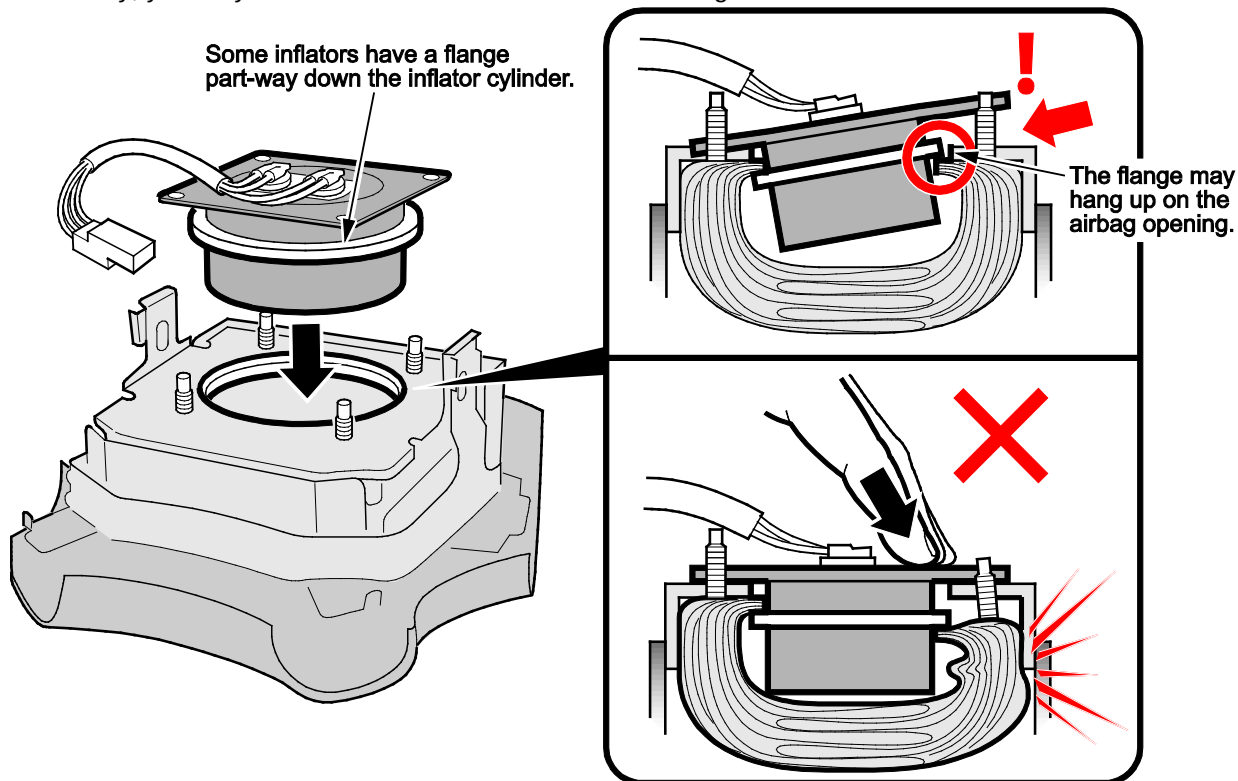
Refer to **Driver's Inflator Type 2** in the video.

- Insert the airbag inflator into the opening. Do not force it into the airbag module.

NOTE: Make sure the inflator wires are positioned toward the bottom of the airbag. If you install the inflator incorrectly, you may not be able to reconnect the SRS airbag harness.

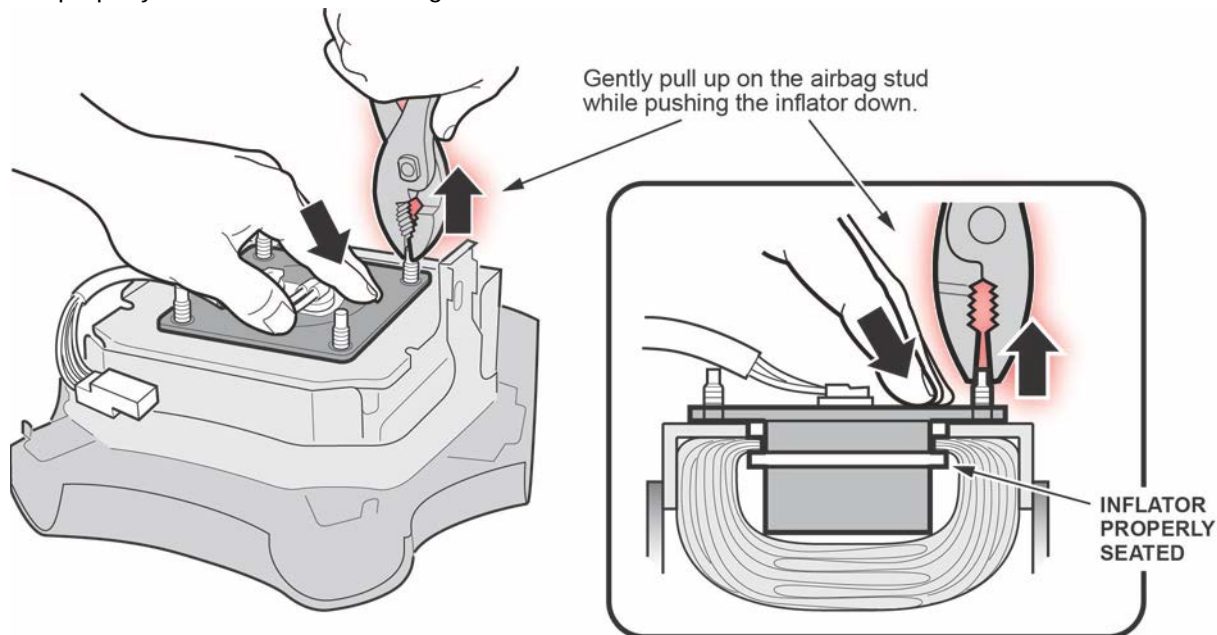
- Using a pair of pliers, gently pull up on each stud up while pushing the inflator module down until the airbag is properly seated within the airbag module.

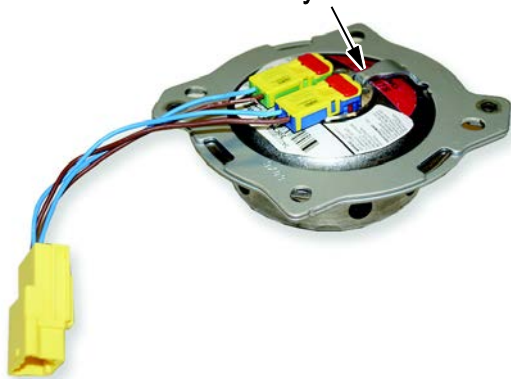
The inflator is held down by a directional retainer that is keyed to the inflator.

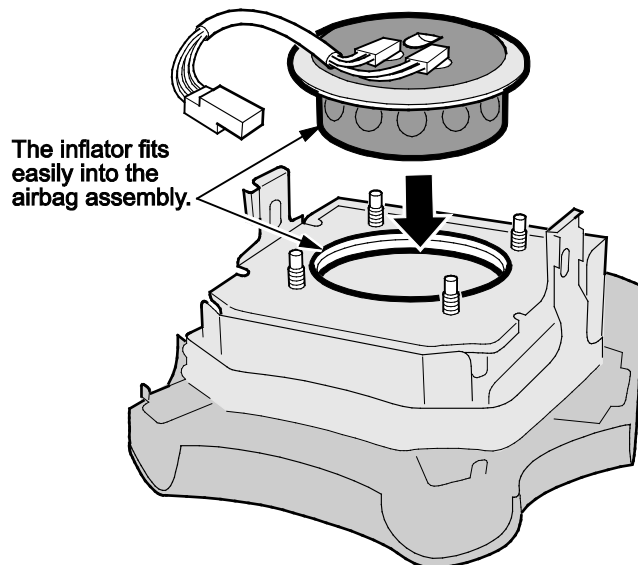
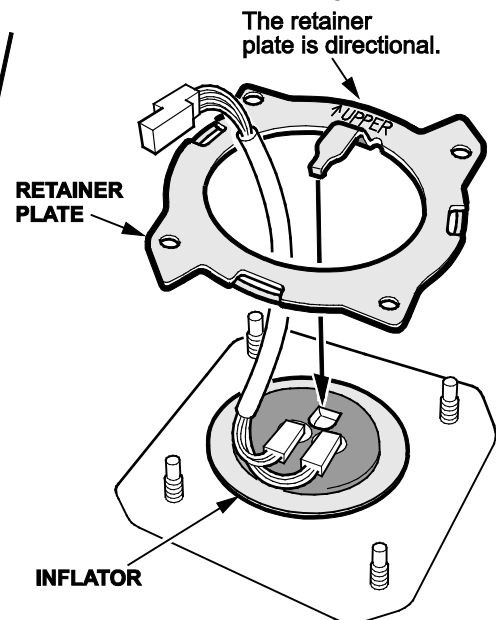
- Place the inflator into the opening with the inflator harness toward the bottom of the airbag.

- Install the bracket onto the studs. Make sure the locator tab fits into the locator hole as shown.  
NOTE: Make sure the harness comes out through the center opening. Do not install the bracket over the harness wires.

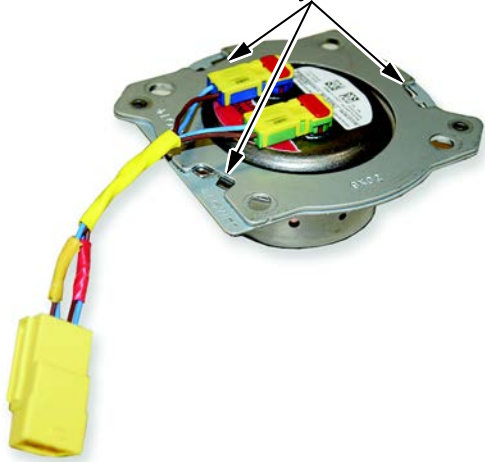
The inflator is held down by a directional retainer that is keyed to the inflator.

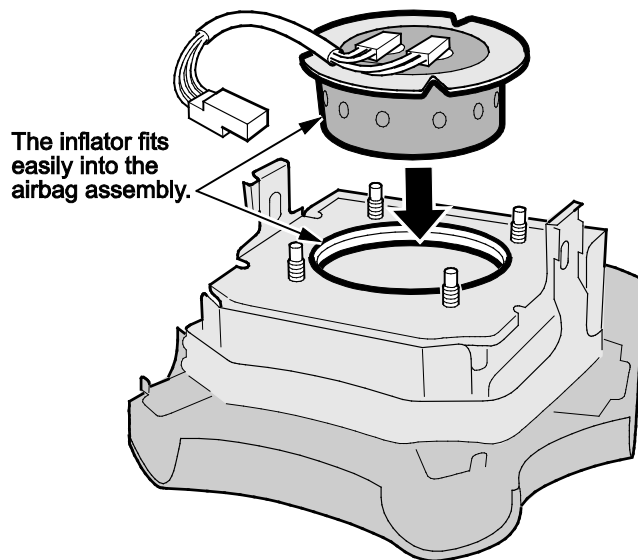
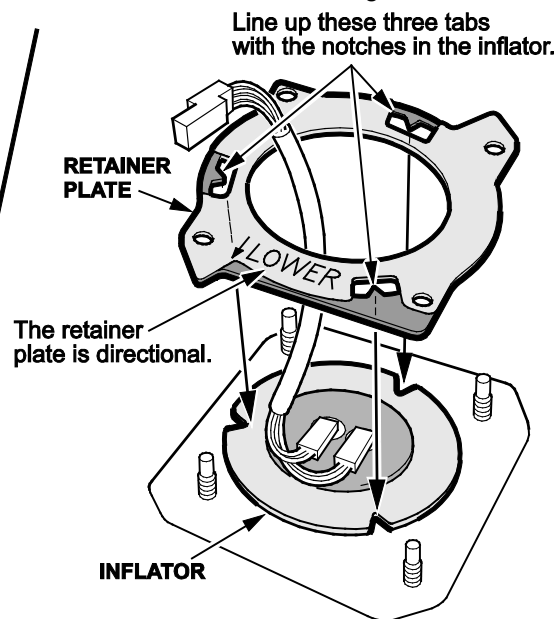
- Place the inflator into the opening with the inflator harness toward the bottom of the airbag.

- Install the bracket onto the studs with the stamp **LOWER** at the bottom of the airbag.
- Make sure the three tabs and notches are properly aligned.

- The tabs and notches are designed to align in one direction only. If the tabs and notches are not aligned, the inflator and bracket are not installed correctly.
- Make sure the harness comes out through the center opening. Do not install the bracket over the harness wires.
