David J. Johnson
 Director
 Service Engineering Operations
 Ford Customer Service Division

SUBJECT: **Safety Recall 19S01 – Supplement #1**
 Certain 2005-2014 Mustang, 2005-2006 GT, 2007-2011 Ranger, 2006-2012 Fusion and MKZ/Zephyr, 2006-2011 Milan, and 2007-2010 Edge and MKX Vehicles
 Passenger Airbag Inflator Replacement

REASON FOR THIS SAFETY RECALL

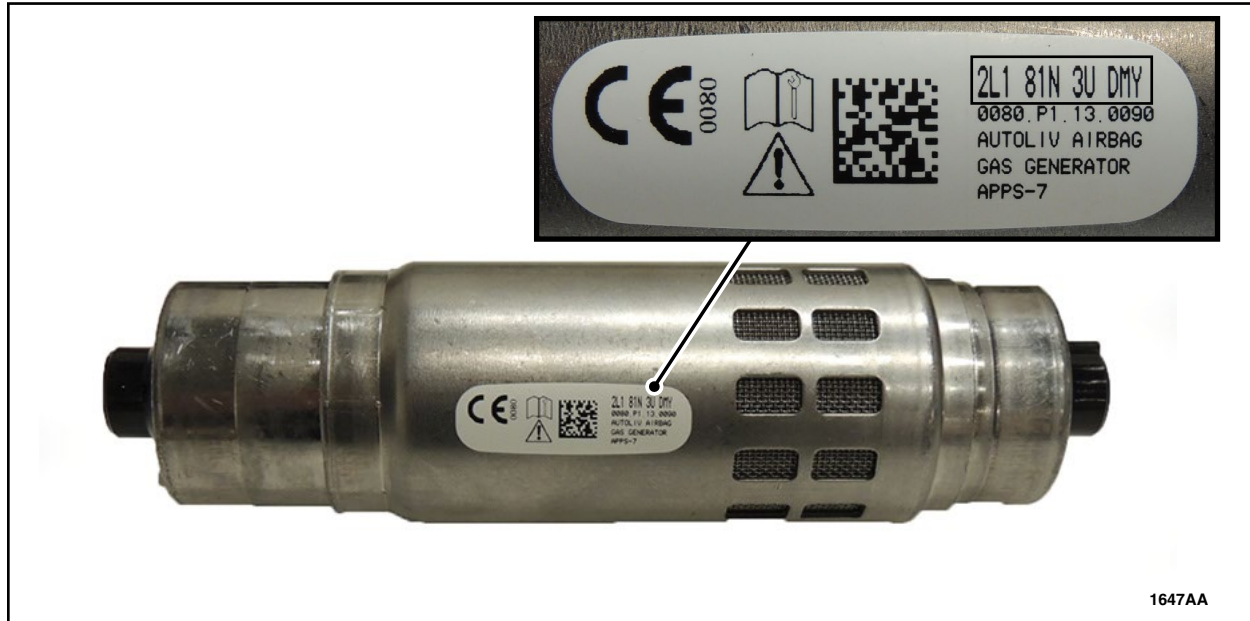
FIGURE 7

9. Record the 11 character serial number of the *new* airbag inflator on the repair order. See Figure 7.

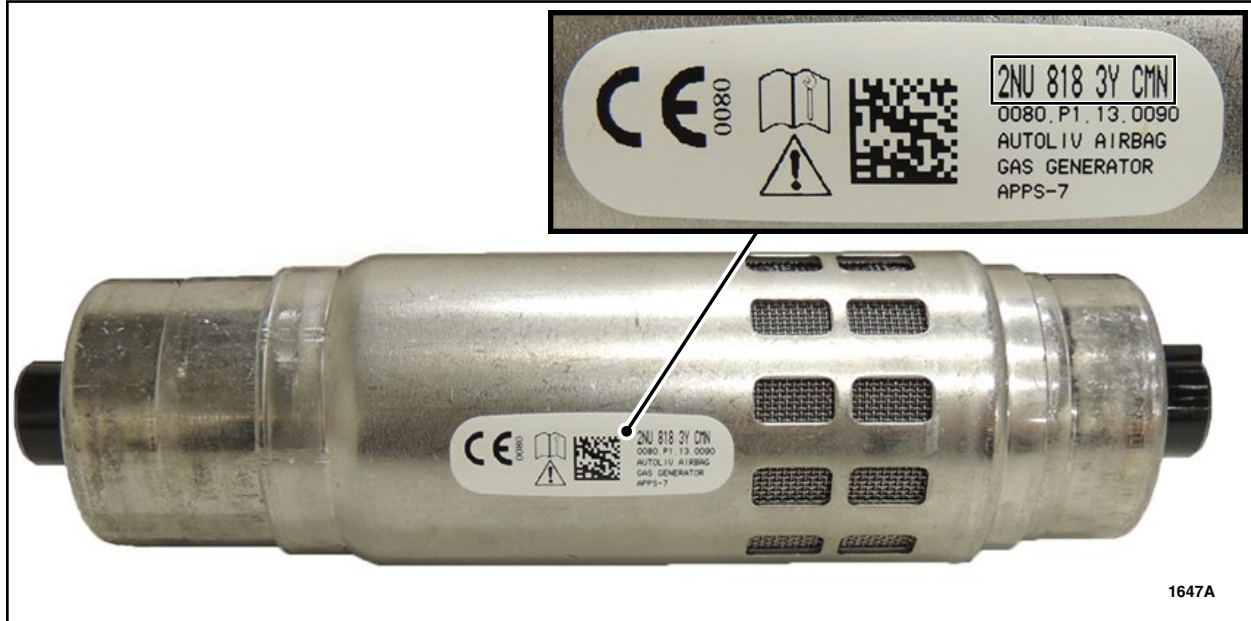
FIGURE 7

9. Record the 11 character serial number of the *new* airbag inflator on the repair order. See Figure 7.

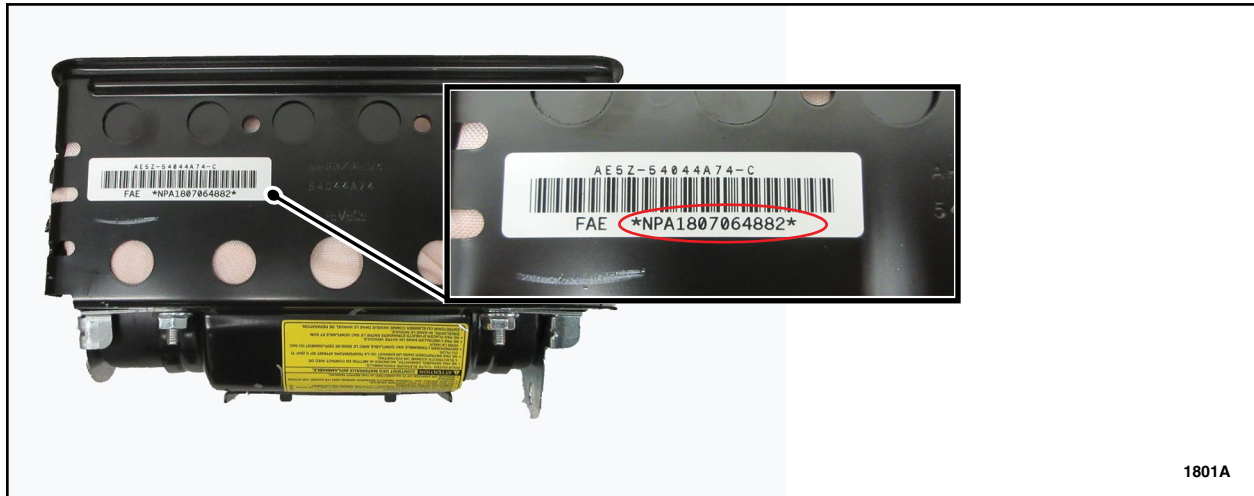
FIGURE 1

1. Record the 13 character serial number of the new airbag module on the repair order. See Figure 1.
