Warranty Extension: MIL Comes On With DTCs P0301 thru P0304Supersedes 13-081, dated June 13, 2018, to revise the information highlighted in **yellow**.**AFFECTED VEHICLES**

Year	Model	Trim	VIN Range
2011-13	Odyssey	ALL	Check the iN VIN status for eligibility.

REPAIR PROCEDURE B - PISTON CLEANING AND RING REPLACEMENT

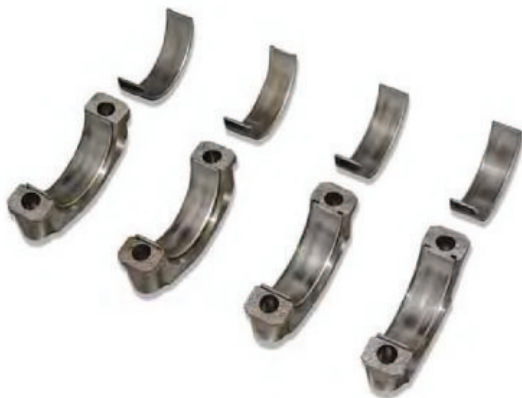
50. Visually inspect all the connecting rod bearing for signs of damage.

- If your fingernail catches on a scratch or groove in the bearing, replace it. Pictured are normal reusable rod bearings after about 35,000 miles. Some discoloration is normal and does not require replacement.
- If the bearings look like they must be replaced, contact your DPSM for authorization.

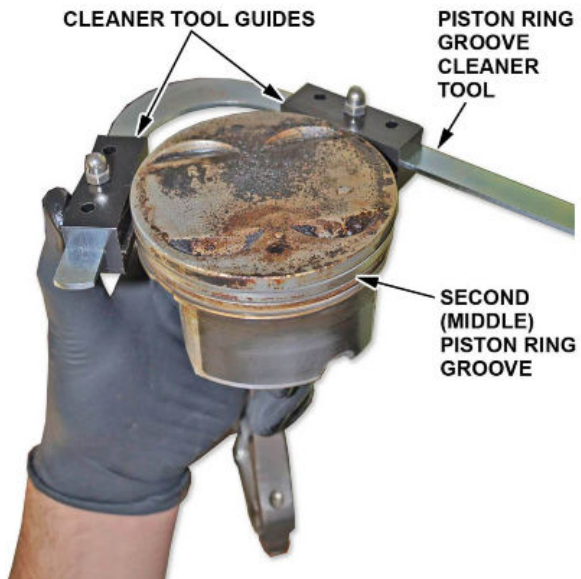
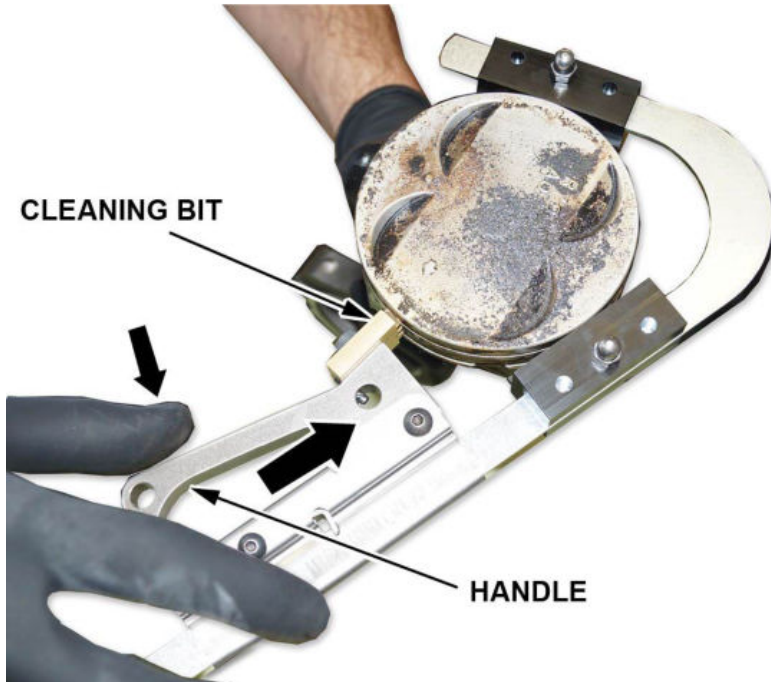
2. Spray the piston head and piston ring grooves thoroughly with Honda throttle plate cleaner.
3. While holding the piston upright in your left hand, take the piston ring groove cleaner tool in your right hand and line up the cleaner tool guides with the second (middle) piston ring groove.

4. Press the handle on the piston ring groove cleaner tool and slide the cleaning bit onto the appropriate piston ring grooves.

5. Once the cleaning bit is in the appropriate ring grooves of the piston, make sure the tool handle clicks in to place.

There is only one notch on the tool for the handle to engage.

6. Hold the piston steady and rotate the tool counter-clockwise five to six times to remove any carbon deposits in the piston ring grooves. **Do not** rotate the tool clockwise.

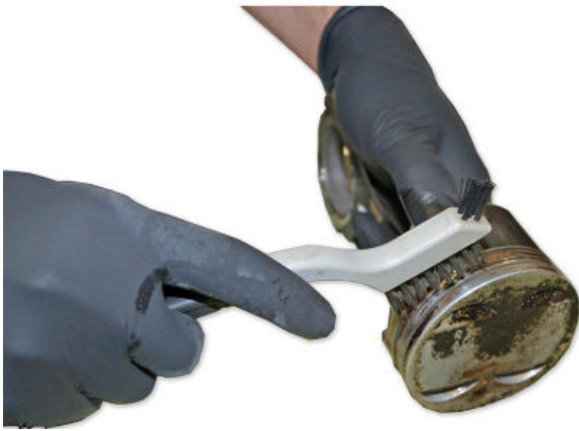
8. Finish cleaning the piston with throttle plate cleaner and the nylon brush. Do not use a steel wire brush.
