Manual TP-0445

# Parts Failure Analysis

# Service Notes

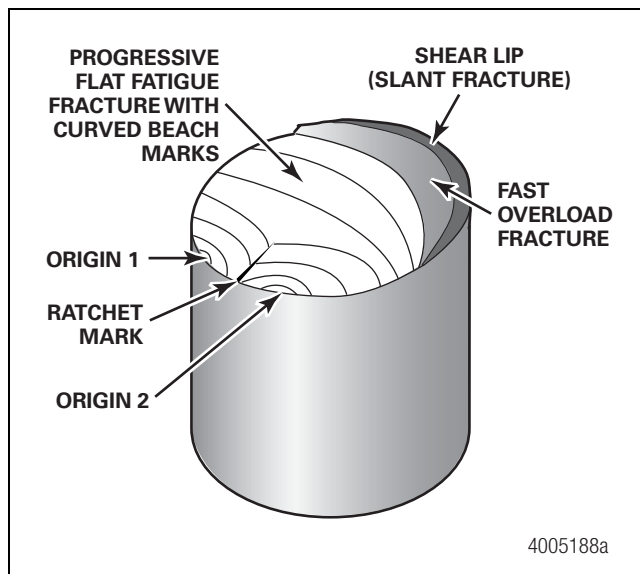
**Figure 3.1**

Beach marks represent fatigue cycles that occurred before the component failed completely. Visually, beach marks are often compared to the rippling effect of a stone thrown into calm water. Figure 3.1.

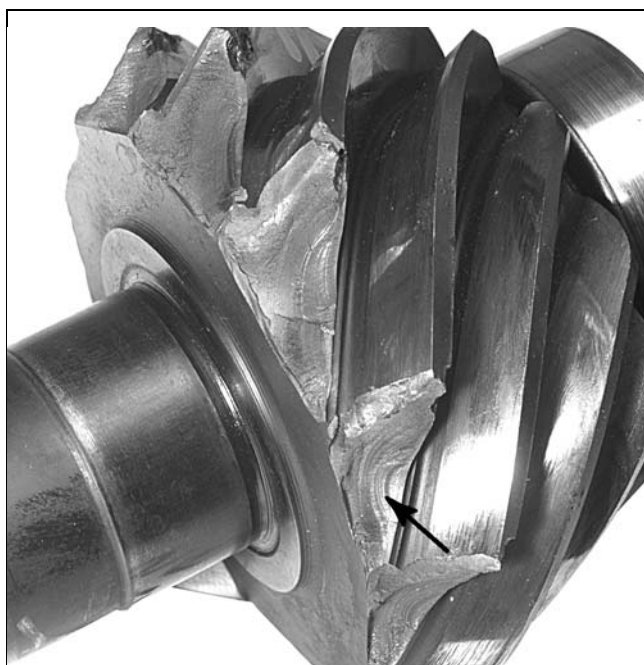
Bending fatigue also causes gears to change position, which affects tooth contact patterns. Figure 3.3 shows concentrated loading at gear teeth corners instead of over the entire surface. Figure 3.4 shows two tooth patterns on the ring gear, because bending fatigue caused the gear to change position.

TEETH BROKEN DUE TO FATIGUE AT HEEL END

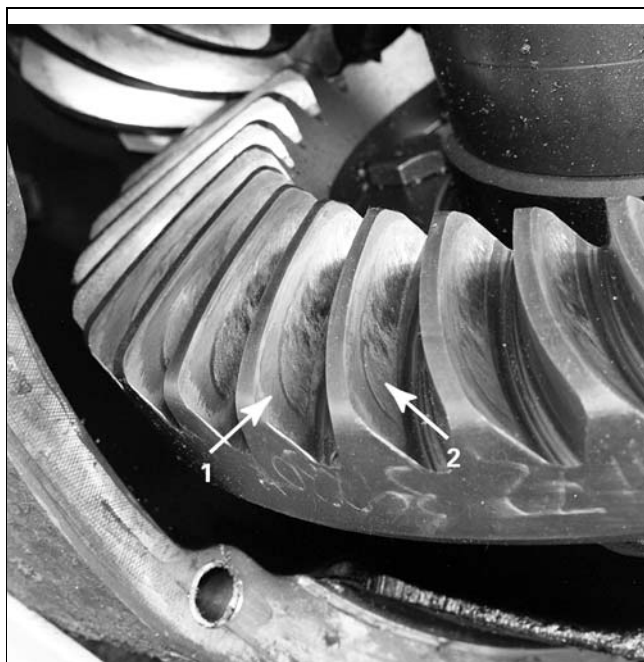
Figure 3.4

1 ORIGINAL PATTERN  
2 SECONDARY PATTERN

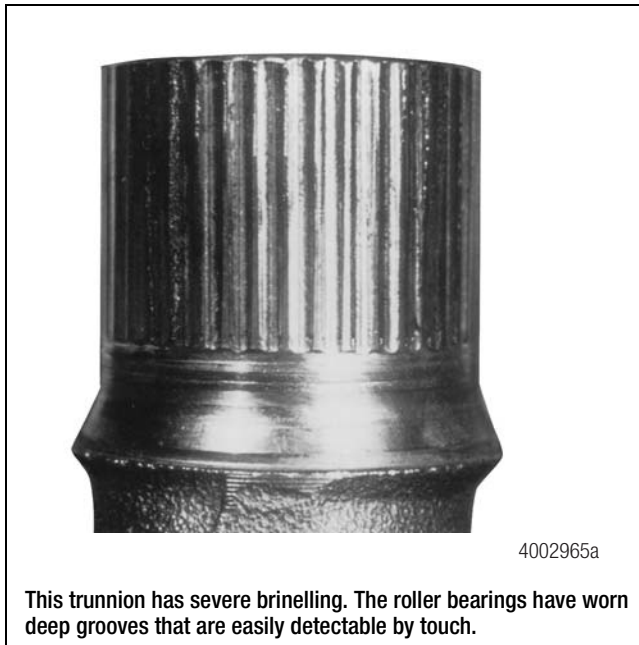
**Figure 3.6**

Brinelling is a type of surface fatigue that causes bearing rollers to wear deep grooves into the mating surface. Figure 3.6. Brinelling of a u-joint usually occurs when load applications exceed the vehicle's rating, which can also cause parts to spall from uneven load application.

Brinelling can also be caused by overloads on undersized u-joints and by a breakdown of lubricant between the needle rollers and trunnion. To determine if the condition you see is brinelling, check the trunnions with your fingertips. Do you feel deep grooves? If so, brinelling has occurred.

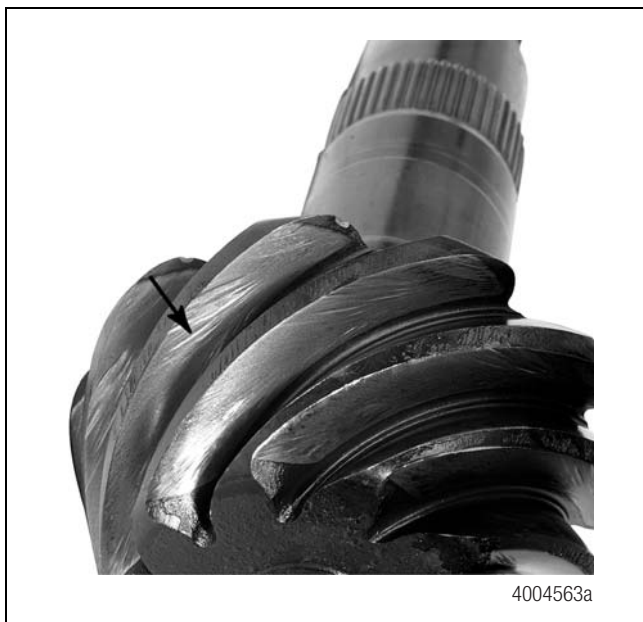
Crow's footing is a type of surface fatigue that runs lengthwise on hypoid and amboid bevel gear teeth. Crow's footing occurs when the vehicle operates with insufficient or incorrect lubricant. Metal-to-metal contact occurs, which causes friction to damage parts. Figure 3.9 and Figure 3.10.

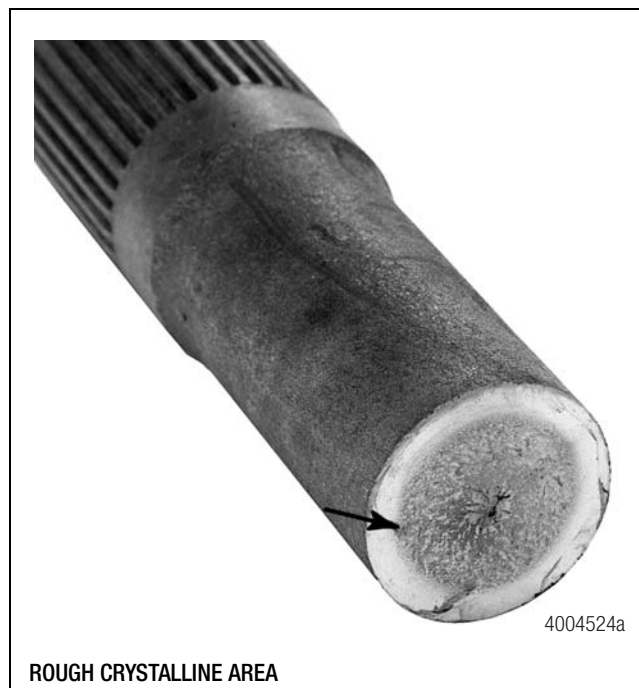
Figure 3.11

When a sudden, severe impact load occurs, the wear pattern that forms on the surface of the part resembles crystal facets. Figure 3.11.

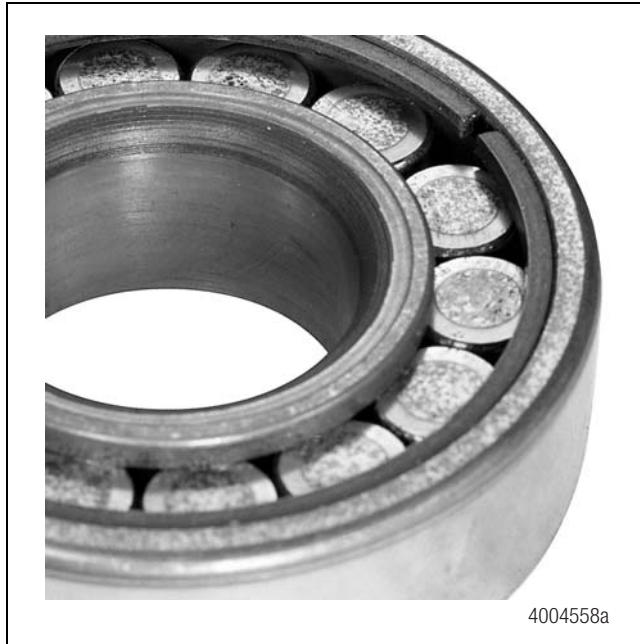
**Figure 3.12**

Water in lubricant damages bearing races and cups, and causes the hypoid gear set to wear prematurely. Figure 3.12 shows corrosion on the spigot bearing roller ends. Figure 3.13 shows etching damage on the bearing rollers, non-contact surfaces and bearing cage windows.

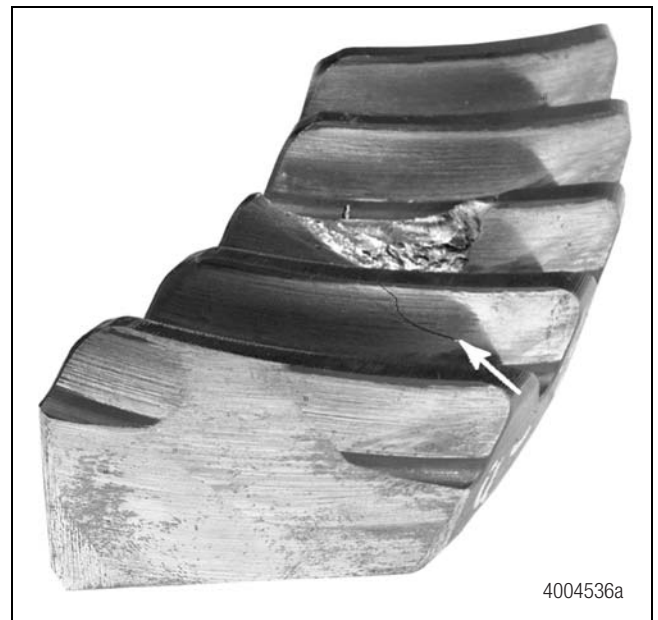
**Figure 3.14**

Flank cracking is a type of surface fatigue that's similar to spalling, because it causes metal to break into chips or fragments. When flank cracking occurs, initially cracks form along the length of the gear tooth. Once flank cracking appears, the tooth begins to crumble, and failure rapidly occurs. Figure 3.14.

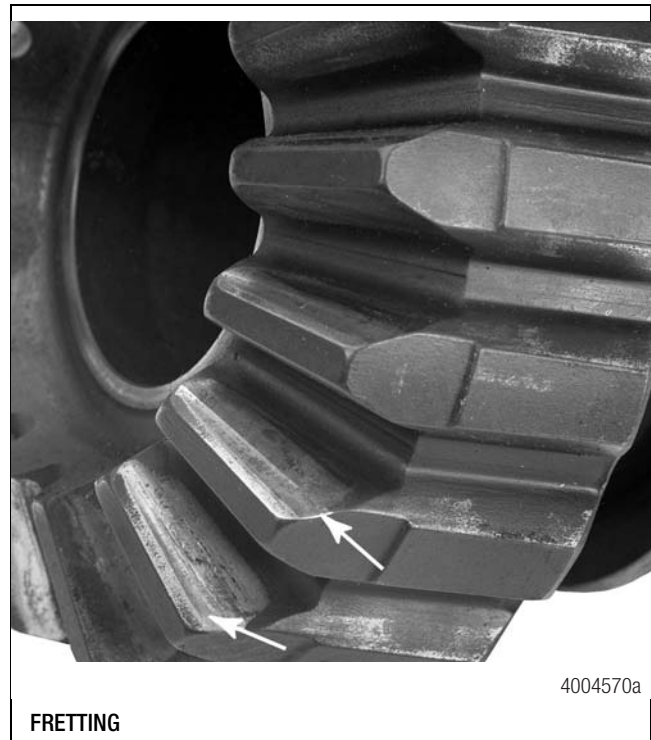
**Figure 3.16**

Inspect the back of the gear teeth on the forward drive axle carrier. If you find a contact line on the rear side of the gear teeth on the forward drive axle carrier, fretting has occurred. Figure 3.16.

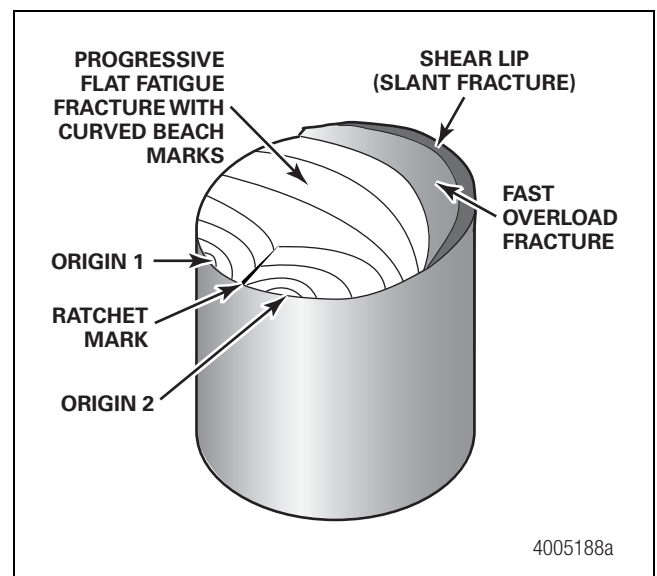
**Figure 3.23**

When more than one fatigue fracture occurs, beach marks form and create a raised, rough "ridge" between the origins of the fractures. This ridge is called a "ratchet mark." In this figure, you can see the ratchet mark between the first fracture, (Origin 1), and the second fracture, (Origin 2). Figure 3.23.

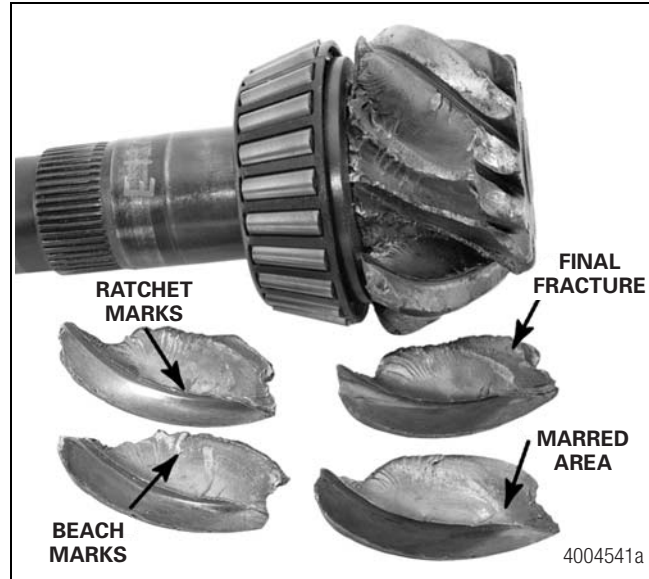
**Figure 3.25**

Figure 3.25 shows a less common root beam fatigue fracture that occurred when shock load was strong enough to crack the tooth, but not to break the entire tooth.

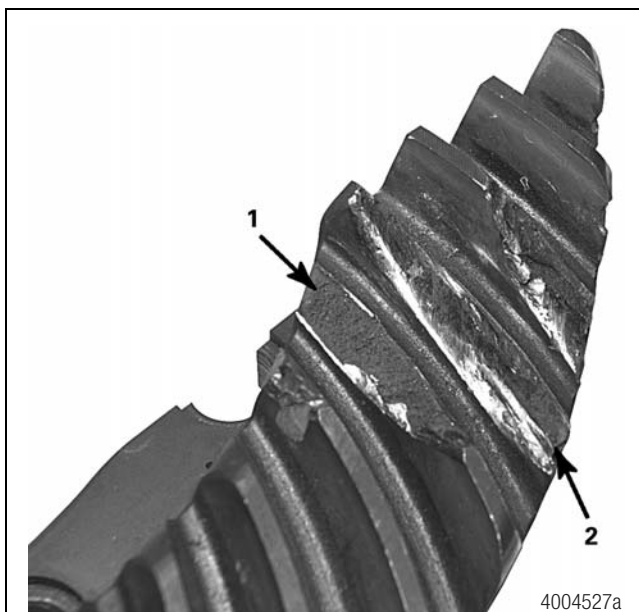
Figure 3.27 shows a hypoid gear seat damaged by shock load. Typically, the first tooth breaks at the heel, the second tooth breaks completely, and the third tooth breaks at the toe. The figure shows how two of the teeth were damaged by the pinion rubbing against the area where the teeth broke.

- 1 ROUGH CRYSTALLINE AREA
- 2 SMEARED AREA

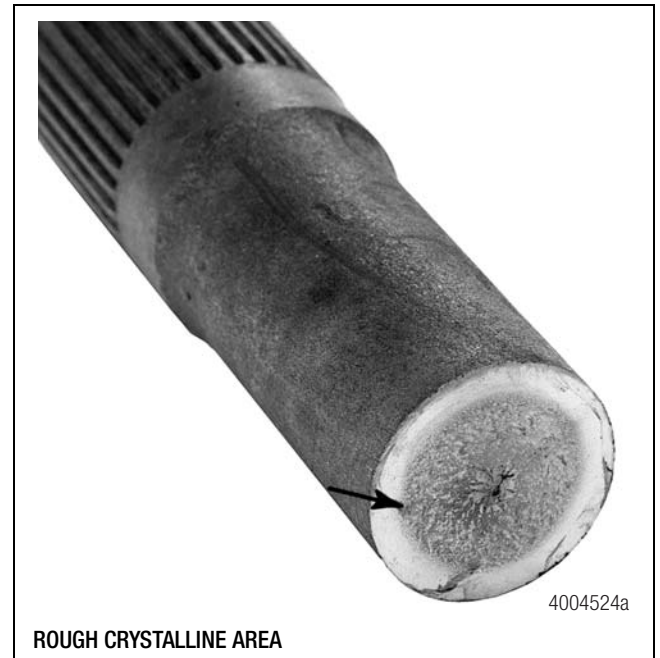
**Figure 3.28**

Figure 3.28 and Figure 3.29 show an axle shaft damaged by shock load that fractured perpendicular to its centerline, which caused a rough, crystalline surface to form on the shaft. This type of failure is also called "torsional shear." If the fracture is at a 45-degree angle to the centerline, the damage is called "torsional tensile" failure.

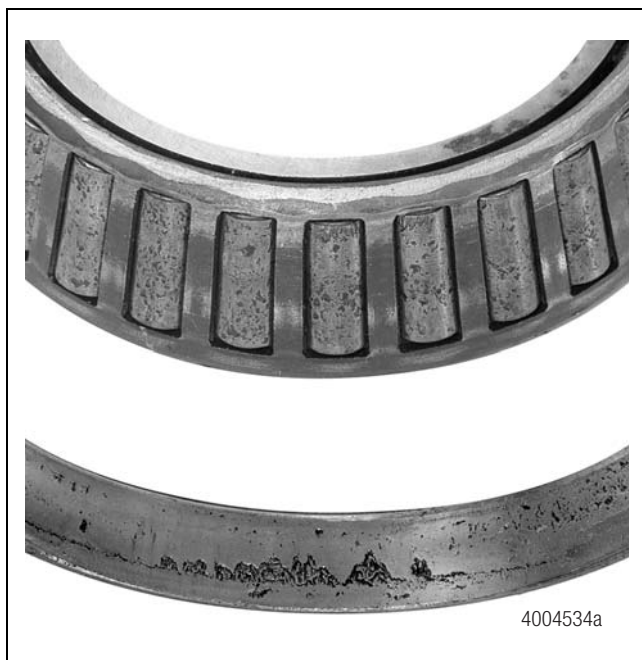
Some causes of spalling are prolonged stress from excessive load applications; or the components operate with no lubricant or a lubricant that doesn't meet the correct specification. Spalling can also occur when components are operated beyond the maximum mileage range. Figure 3.30 and Figure 3.31.

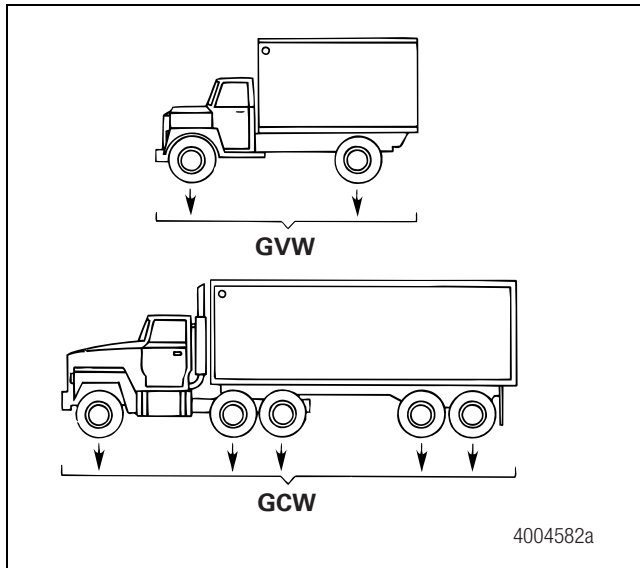
Figure 4.1

Axles operated under conditions that exceed their design capacity can wear prematurely. Fatigue, which can result from load cycles that exceed a carrier's gross vehicle weight rating (GVWR) or gross combined weight rating (GCWR), can cause an axle to fail. Figure 4.1.

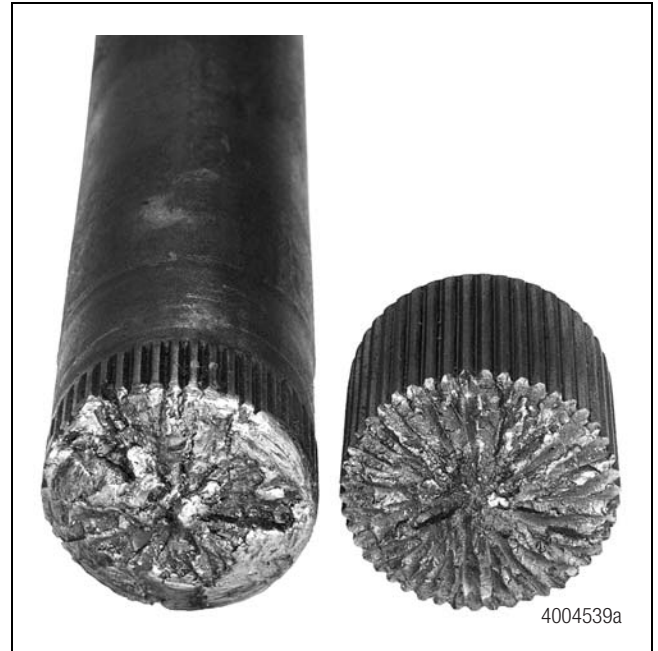
Figure 4.5 shows a shaft damaged by torsional fatigue. As the splines continued to weaken, the metal formed a star-shaped radial pattern, eventually breaking the shaft at the center.

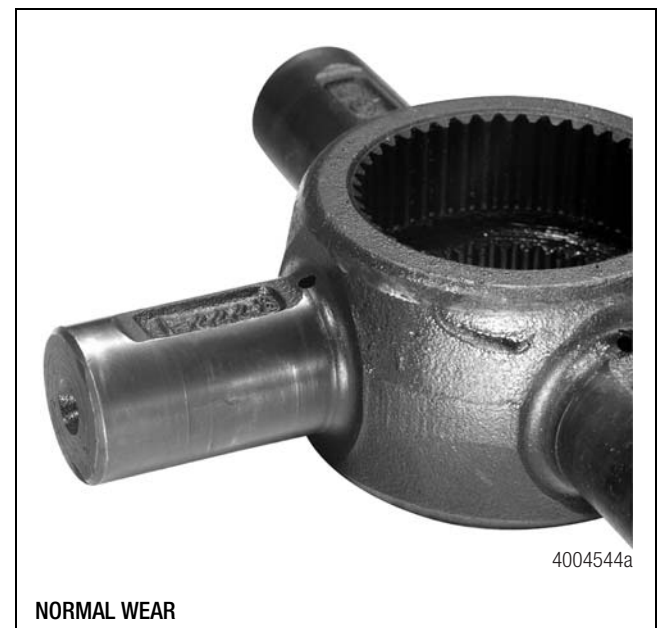
**Figure 4.12**

Figure 4.12, Figure 4.13, Figure 4.14, Figure 4.15 and Figure 4.16 show how spinout caused a pinion cross to fail. Damage progresses from normal wear, to moderate premature wear, and then to heavy wear; and finally, the pinion cross fails.

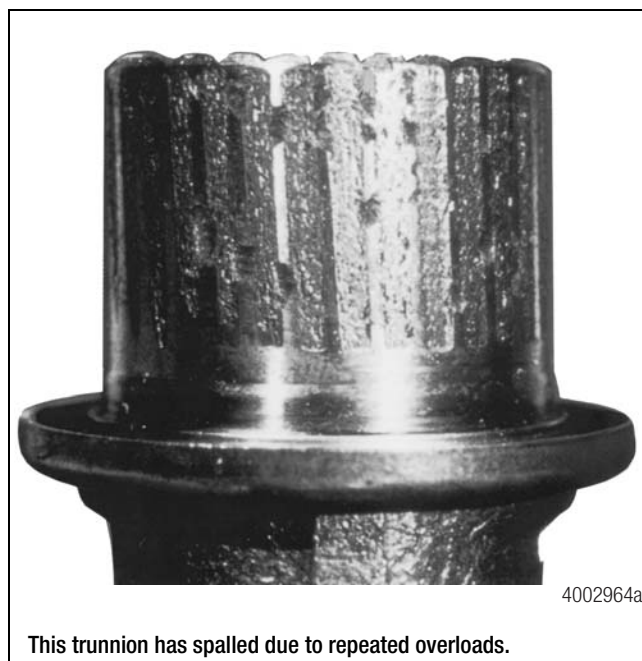
This trunnion has spalled due to repeated overloads.

Operate a vehicle within its approved application and weight limits. Follow recommended maintenance practices.

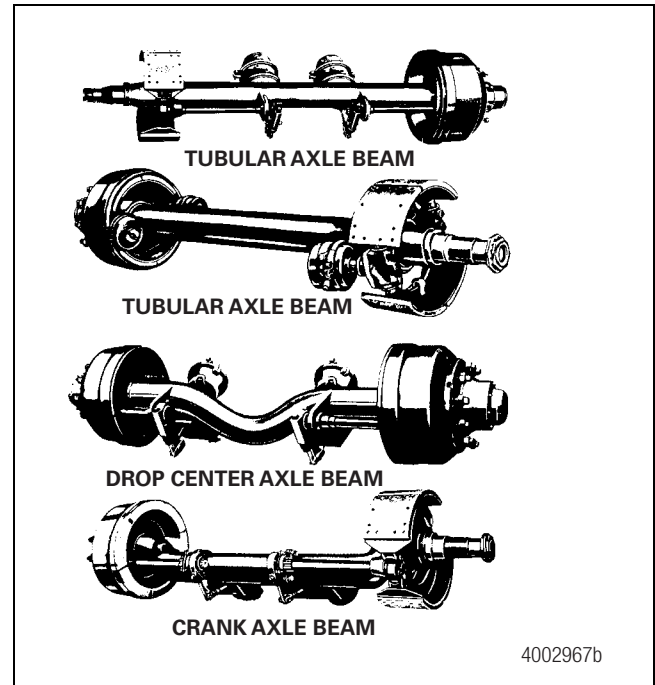
Figure 6.1

Meritor trailer axles are available in a variety of sizes and configurations, and are designed and rated for specific load applications. Figure 6.1. The gross axle weight rating (GAWR) specifies the maximum load limit for a trailer. Trailer axles that are operated above their GAWR can be damaged by torsional fatigue and bending fatigue.

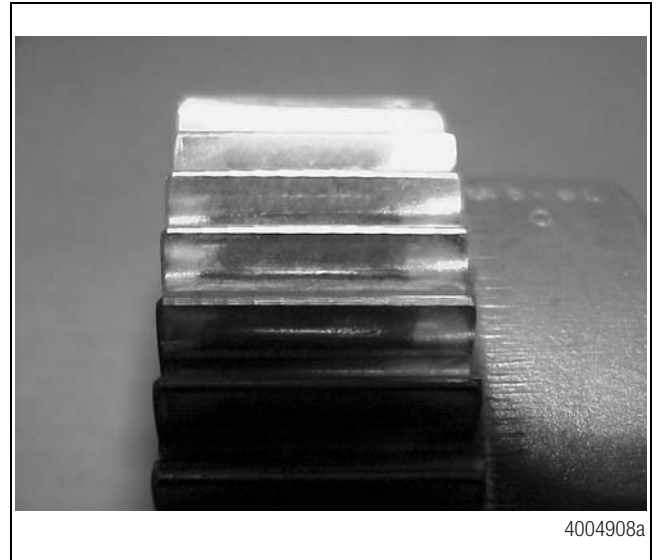
Figure 9.8

No action is required. Frosting is a normal wear condition on spur gear teeth that does not affect performance or gear life. As the gear continues to operate, sliding friction eventually removes frosting. If frosting is the only wear you see on spur gears, do not replace the gears.

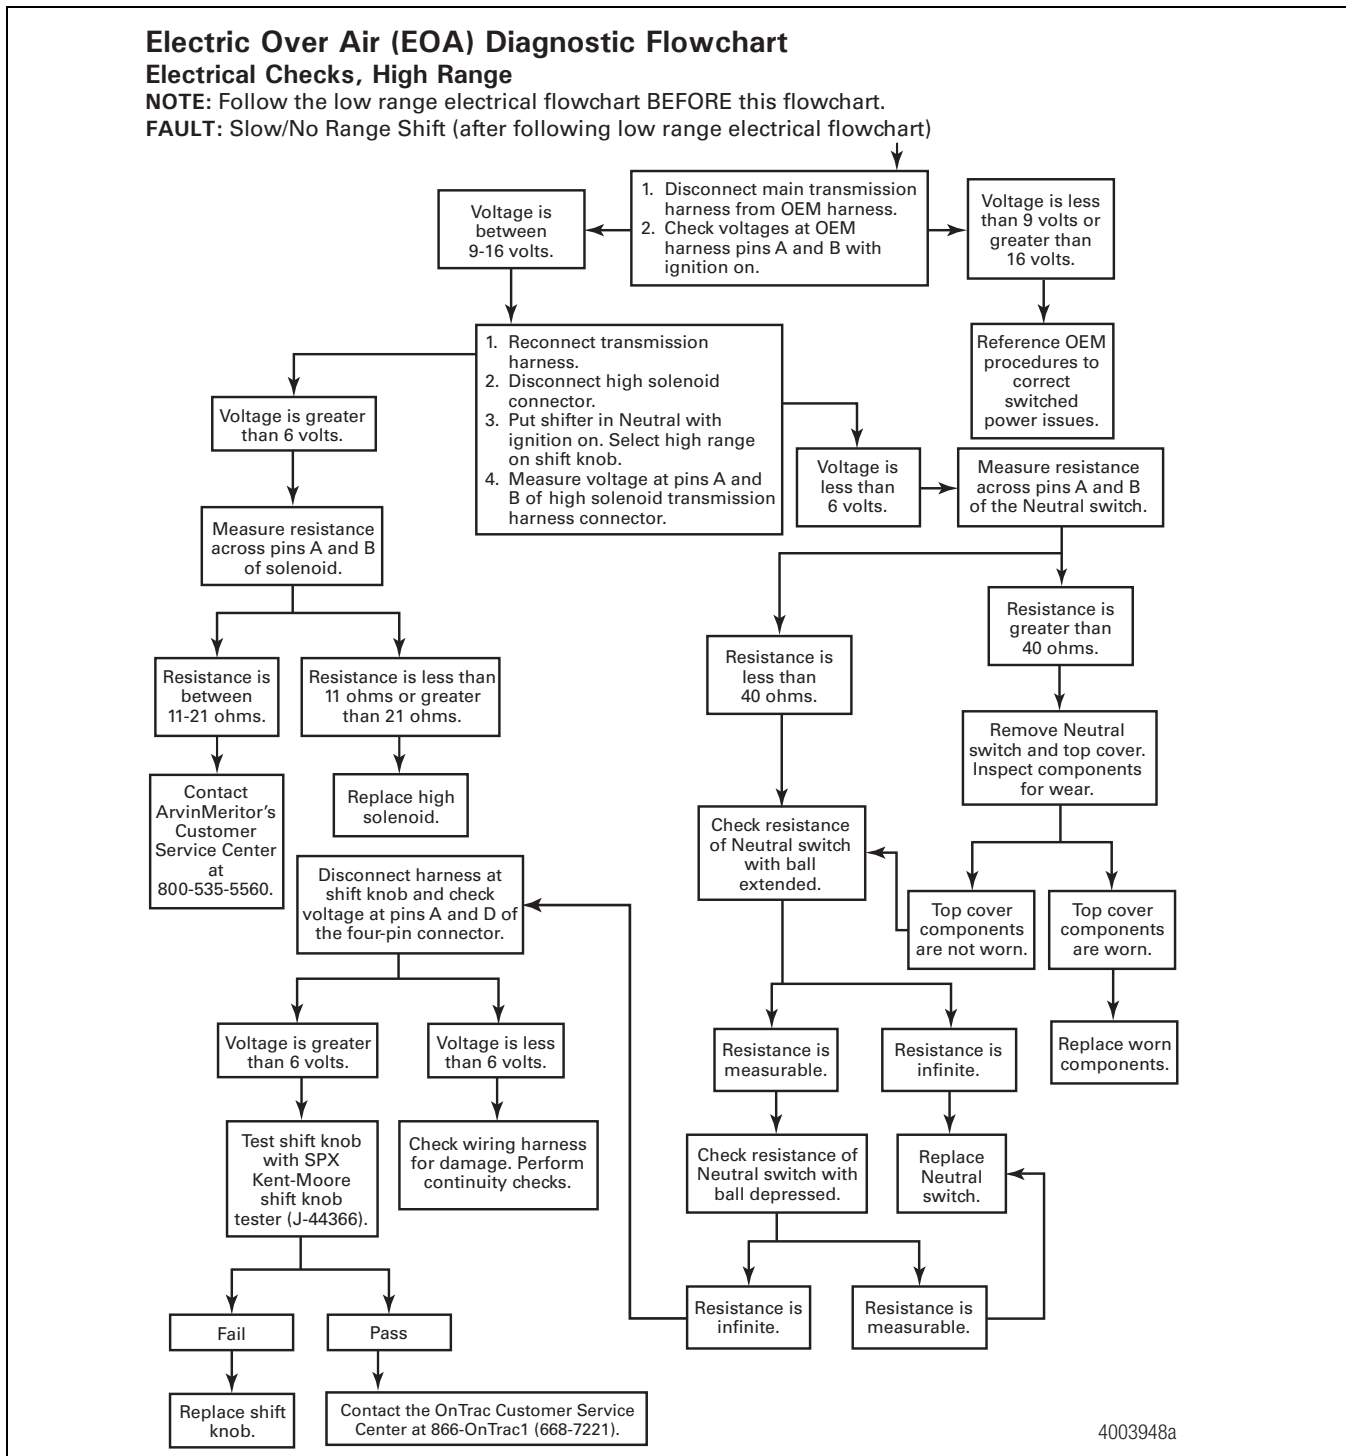
Figure 9.57

3. High Range Electrical Checks — Follow the high range electrical checks flowchart to verify that the high range electrical system functions correctly. Perform high range electrical checks AFTER mechanical checks and low range electrical checks. Figure 9.57.
