# Product Safety Recall

## A182202370 Lower Control Arm Weld

**Release Date:** June 2019

| <b>Condition</b> | General Motors has decided that a defect which relates to motor vehicle safety exists in certain 2017-2019 model year Chevrolet Trax and Tracker vehicles. In some of these vehicles, a joint in one or both front lower-control arms may have been improperly welded. Over time and in rare cases, an improperly welded joint can fatigue and break, causing the lower-control arm to partially separate from the vehicle. |

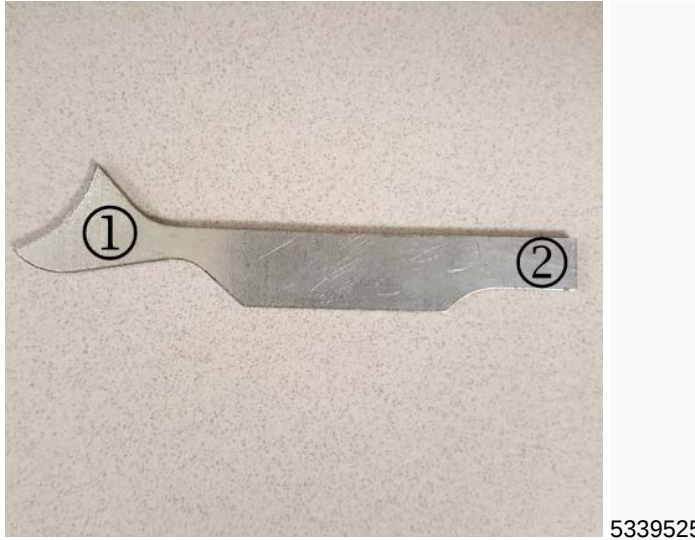
1. Lift the vehicle. Refer to *Lifting and Jacking the Vehicle* in SI.
2. Locate your inspection gauge and identify sides 1 and 2 as shown below.

Photograph of the Inspection Gauge. Use the gauge to measure two weld gaps on the lower control arm. Use the number one (1) side of the gauge to measure the weld gap in step 4 and the number two (2) side of the gauge to measure the weld gap in step 5.

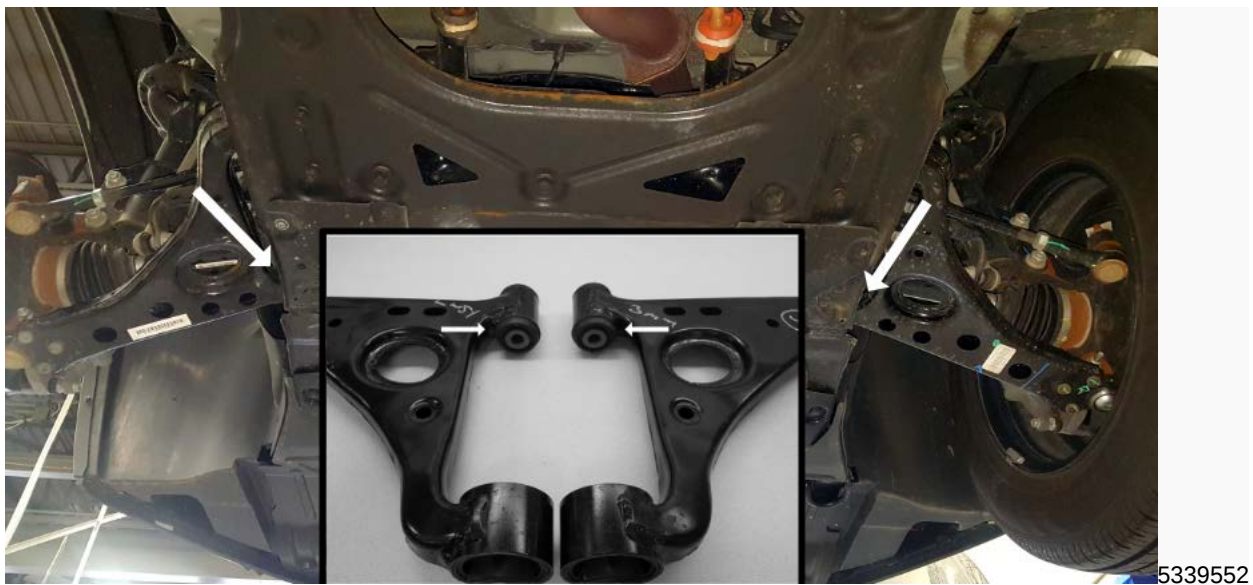
Photograph of Gap 1 (between the welds, red) and Gap 2 (between the control arm body and bushing barrel, purple).

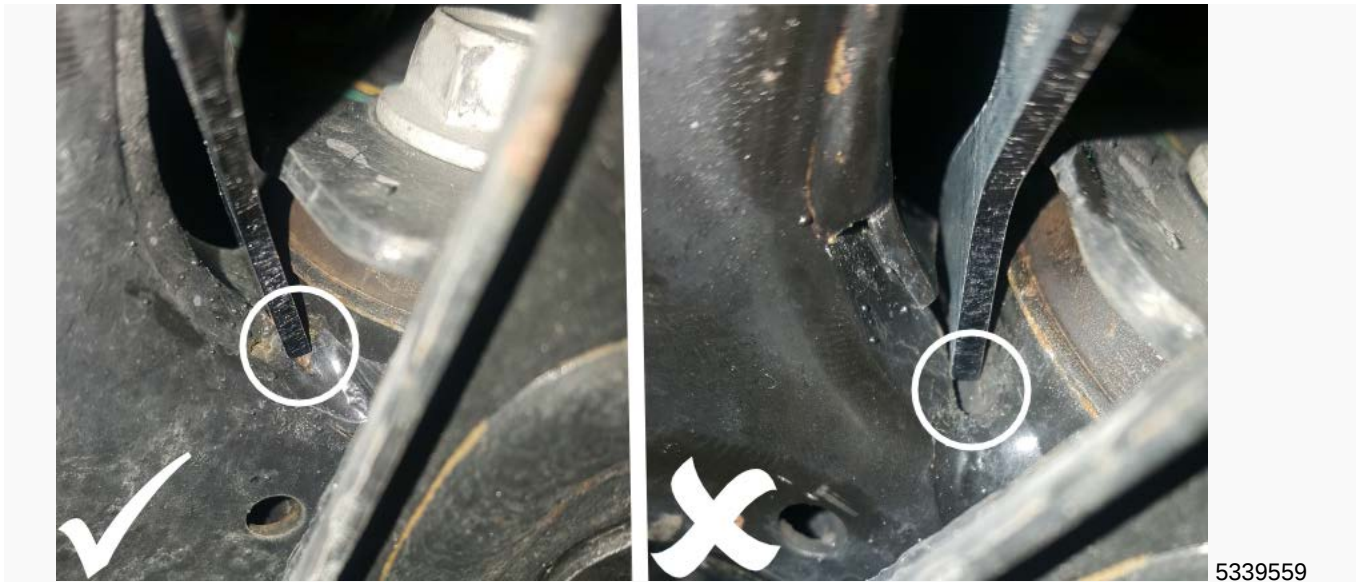
3. Inspect the welds on the rearward side of the driver's side front control arm bushing barrel using the provided gauge.

4. Inspect the Gap (1) in the weld using the number one (1) side of the gauge. With the gauge oriented as shown, slide the top of the tool along the barrel of the bushing until it contacts the upper weld. Then, pivot the bottom of the gauge in while holding the top against the upper weld until the bottom of the tool is also contacting the bushing barrel or weld.

- If the inspection gauge does **not** fit in the gap between the welds (check mark), the control arm is good.
- If the inspection gauge **does** fit in the gap between the welds (X), the control arm is bad and must be replaced.

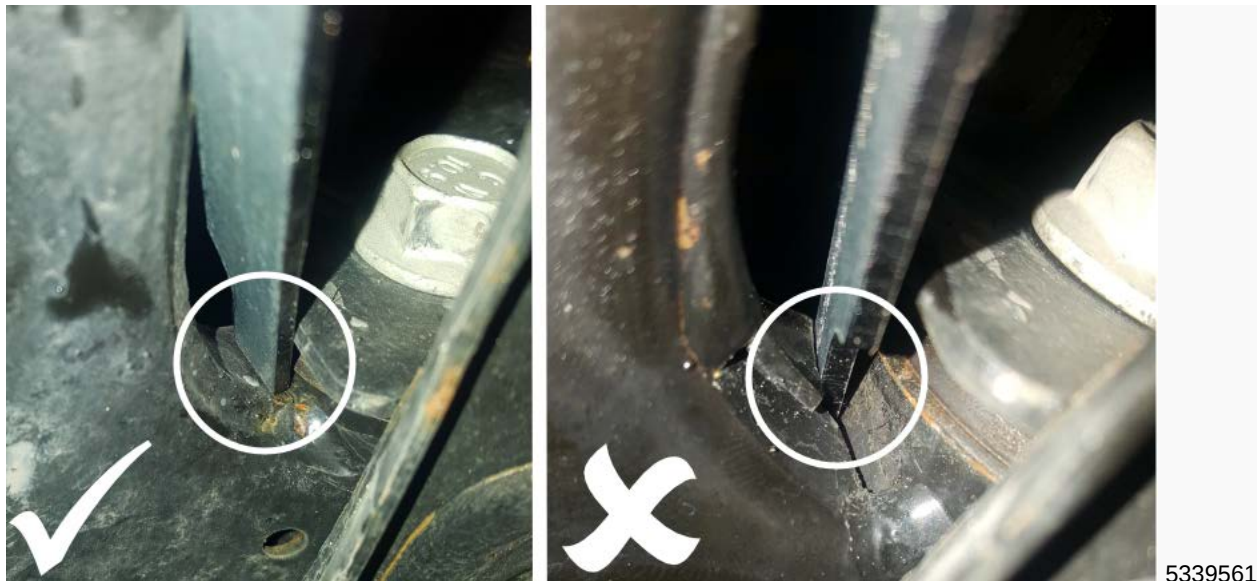
5. Inspect the gap (2) between the control arm bushing barrel and the control arm using the rear number two (2) of the inspection gauge.

- If the 2nd side of the gauge does **NOT** fit between the bushing barrel and the control arm (check mark), the control arm is good.
- If the 2nd side of the gauge **does** fit in the gap between the bushing barrel and control arm (X), the control arm is bad and must be replaced.
- Repeat the process again starting at step 3 on the passenger's side control arm.

- If all control arms passed the gauge inspection, no further action is required on that vehicle. Proceed to step 7.
6. Replace any front control arms that failed inspection. Refer to *Lower Control Arm Replacement* in SI.
  7. Lower the vehicle. Refer to *Lifting and Jacking the Vehicle* in SI.
