Service Bulletin

Bulletin No.: 09-06-04-026R

Subject: Identifying Non-GM (Aftermarket) Engine Calibrations for Gasoline Engines Using

Tech 2® or GDS 2 (U.S. and Canada)

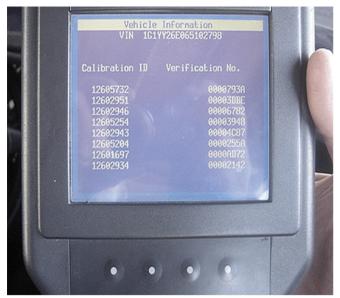
2278650

- Two examples of the Tech 2® Vehicle Information - (Engine) Calibration ID and Verification No. screens are shown.
- The Tech 2® Vehicle Information -Calibration ID and Verification No. screen will differ slightly depending on vehicle and model year.
- Take a CLEAR digital picture(s) of the Tech 2® Vehicle Information screen showing the entire VIN, (Engine) Calibration ID and Verification No. (Number/CVN) and save it in .jpg format.

Notice: It is recommended that an electronic copy of the Tech 2® screen photograph(s) also be saved.

Retain the printout information and the Tech 2® screen photograph(s) with the repair order.

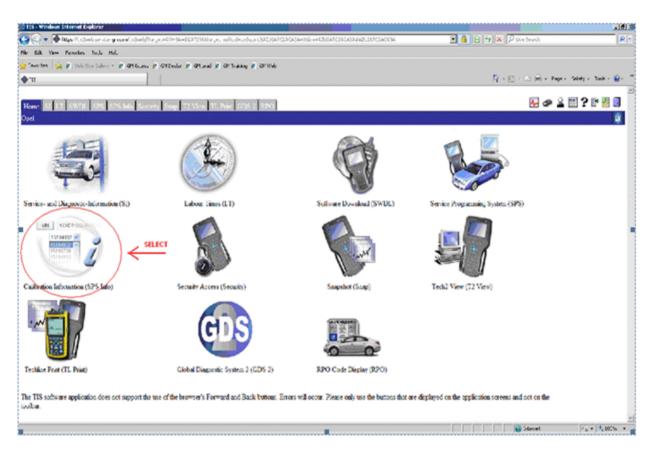
1. Go to: TIS2WEB Home Page.

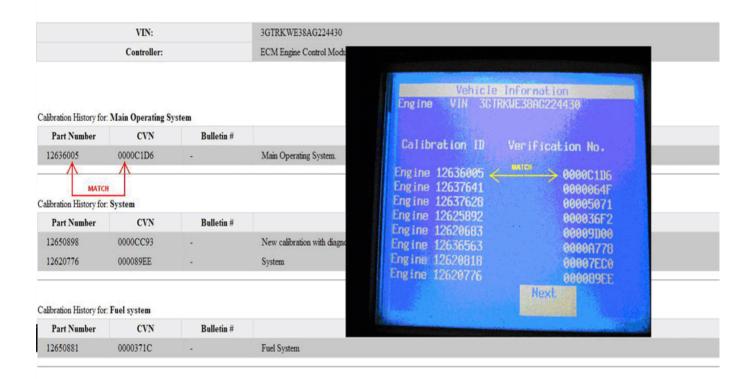
Compare each: Calibration ID Part Number and Verification No. (Number/CVN) from your Tech 2® photo to the corresponding Calibration ID Part Number and Verification No. (Number/CVN) listed in the TIS2WEB GM Vehicle Calibration Information screen of TIS2WEB to ensure that they are ALL an EXACT MATCH.

⇒ If ANY of the Calibration ID Part Number and Verification No. (Number/CVN) when COMPARED to the Calibration ID Part Number and Verification No. (Number/CVN) listed in the TIS2WEB GM Vehicle Calibration Information screen, DO NOT MATCH, then non-GM calibrations may be present and you should follow the procedure in Section: 10. Procedure for All Service Agents for E-mailing .jpg or JPEG Files to the Calibration Group at — TACCVN@gm.com in order to e-mail your findings to the Calibration Group, who will then document your information with the appropriate Brand Quality Manager in the Brand Quality Team.
