## AR-3 Crossover Schematics

During its production cycle, AR modified the AR-3 crossover schematic several times. This note attempts to catalog those changes based on detailed information available in Tom Tyson's files. At some point a complete description of the AR-3 will be written [TT]; at that time this should become an appendix within that document.

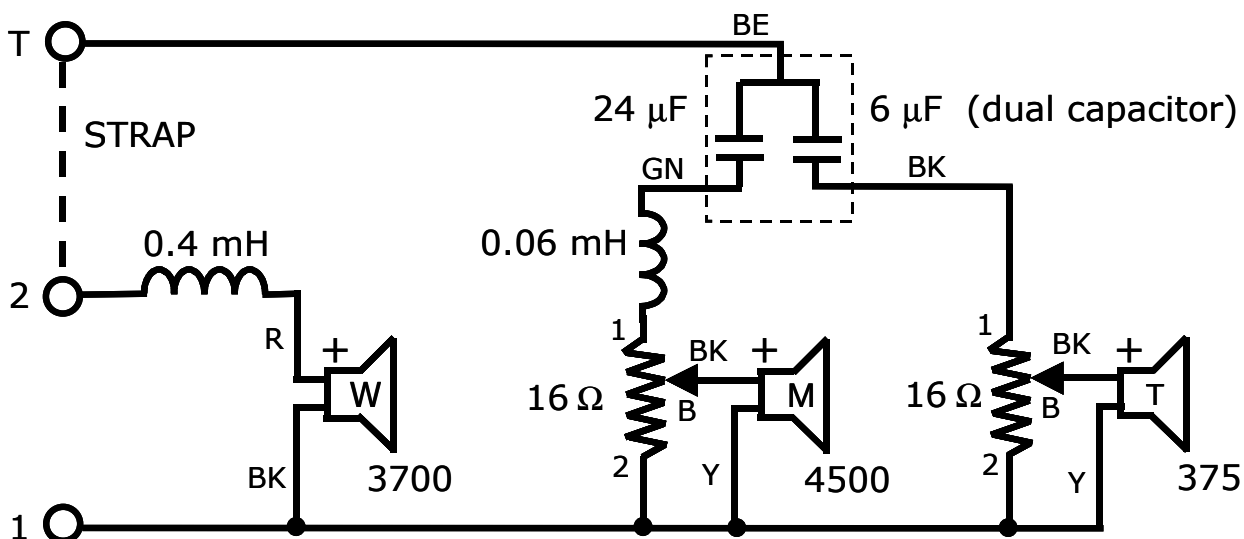
The schematic shown here; dated 13 March 1959 and initialed by EMV, is the original AR-3.

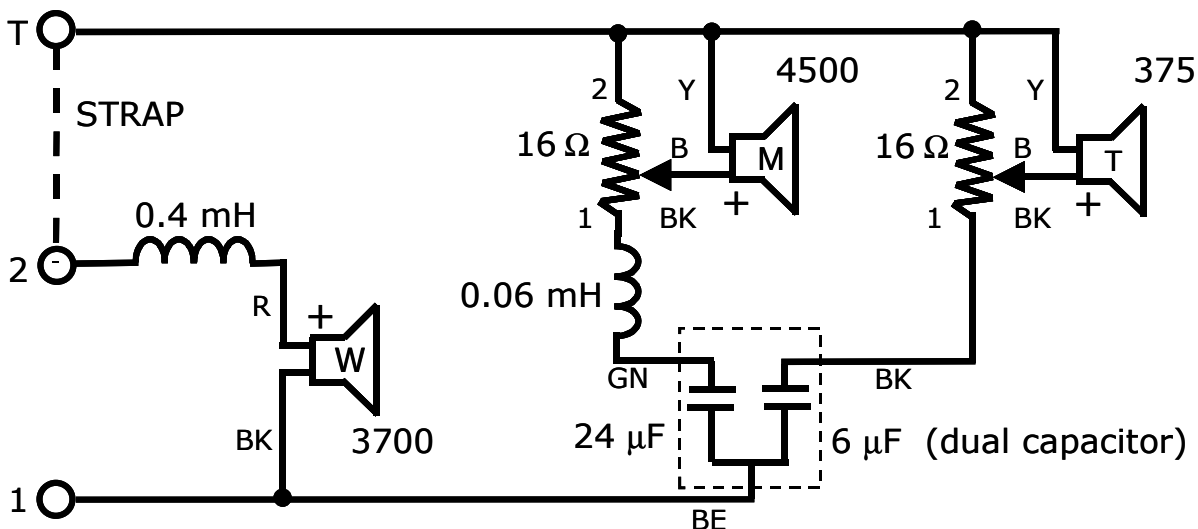
In 1960 the crossover was changed to reverse the phase of the mid-range and tweeter with respect to the woofer [1]. This was the only change made at this point in production.

[1] Phase reversal was initially done manually by reversing the midrange/tweeter wiring with respect to the woofer. At some point, AR either reversed magnet polarization or internal coil wiring to change this phase internally. It is a daunting task to determine whether or not a particular AR-3 is in-phase or out-of-phase. The acoustically measured effect is only *slightly* noticeable and only barely audible—*not* to a great extent. Quite frankly, room-acoustic artifacts can have a much greater influence on the output of the AR-3 than the simple dc phasing reversal. If your AR-3 has never been opened or modified or repaired, it is almost assured that the dc phasing is correct for that speaker, so do not worry about attempting to change it. On the other hand, if a replacement driver of unknown pedigree was installed, then all bets are off. In order to determine exactly the phase relationship, the speaker must be electrically measured with a sine-wave oscillator and oscilloscope or with response measurements at the crossover frequencies, but this is quite difficult to determine accurately without professional test equipment. In the end, its probably best not to worry about the phasing. If the speaker sounds too bright around the midrange crossover frequency (around 1000 Hz), and it is noticeable, you may reverse the lead-in wires from the midrange driver to the terminal strip (thus reversing the polarity of the midrange driver on the tweeter terminal strip on the front speaker baffle board under the grill). Since nearly all AR-3s used aluminum wire from the tweeters, soldering the aluminum lead-in pigtails requires AlumiSol aluminum solder to properly bond, so care must be used when unsoldering and re-soldering to insure a proper solder joint. An alternative technique for joining aluminum to copper by a crimp connection is described in the AR restoration document.

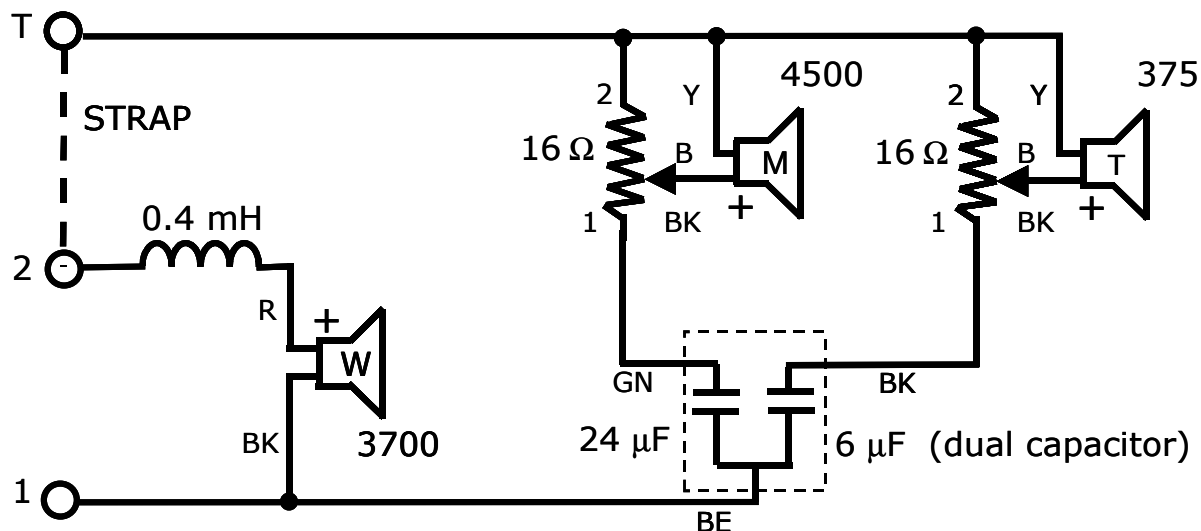
The crossover was modified on 25 Aug. 1965 by removing the 0.06-mH (51-turn) coil in the mid-range crossover.

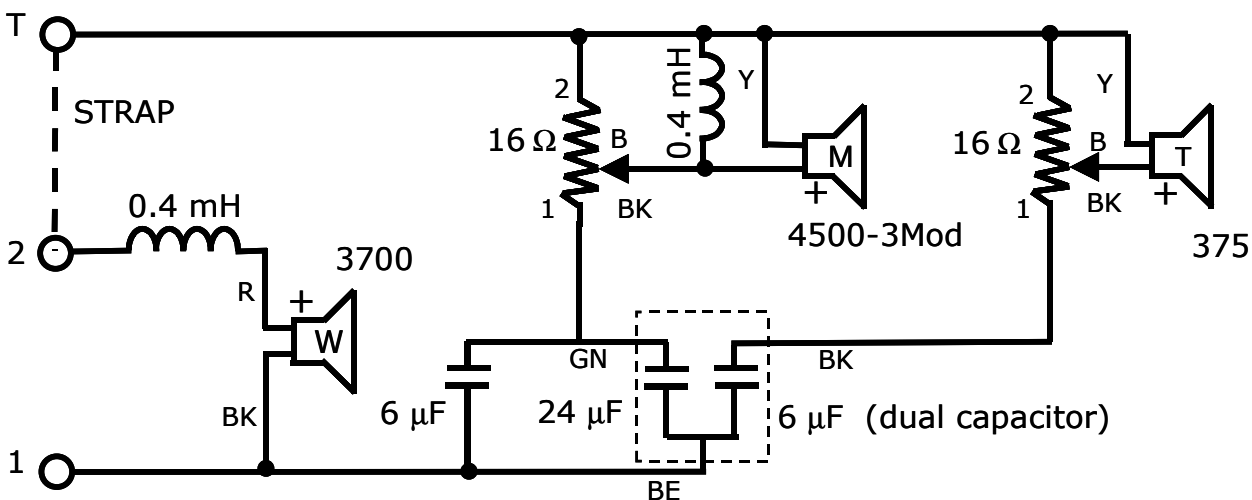
On 13 May 1970, AR ran out of the original phenolic-dome mid-range. This required the use of a version of the AR-3a mid-range identified by part number 4500-3MOD and later identified as part number 200010-AR-3 or 200019-3. (These are Fig's. A.9 and A.10, respectively, in *Restoring the AR-3a*.) This required a crossover change, as the AR-3 and AR-3a did not have the same woofer-mid-range crossover frequency. This crossover change consisted of the addition of a 6-μF capacitor in parallel with the 24-μF (to make a total of 30 μF) and the addition of a 0.4-mH (143-turn) coil across the mid-range driver. These changes are illustrated below.

After the original mid-range supplies were exhausted, the new driver described in Section D was used for both production and service replacement. *So it is possible that an Internet-purchased speaker contains a service replacement mid-range.* Service replacement was not straightforward, as the crossover had to be changed to that shown in Section D. Thus, speakers with serial numbers of C19467 and lower needed to have their 51-turn coil removed before the parts for the new service replacement were added. Speakers with serial numbers greater than C70228 would not have needed the crossover modification, since the new style mid-range was installed when originally assembled.
