Cover Pages for Property Disclosure Package for:

2531 Princeton Dr San Bruno, CA 94066

Inspection Address: 2531 Princeton Drive, San Bruno, CA 94066
Inspection Date/Time: 3/12/2018 10:00 am to 11:30 am

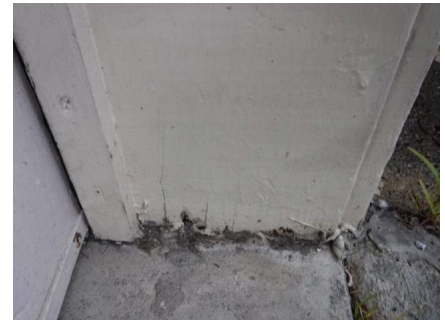
Photo 1

1. The main garage door jamb and/or trim shows evidence of water damage. We recommend the services of a licensed general contractor and/or structural pest control company regarding repairs. (See Photo 1)

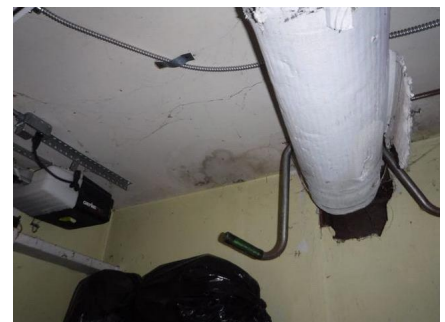
Photo 15

2. Water stains were noted on the ceiling of the garage. This is usually an indication of past plumbing or roof leaks. This area should be further evaluated by the appropriate trades. (See Photo 15)

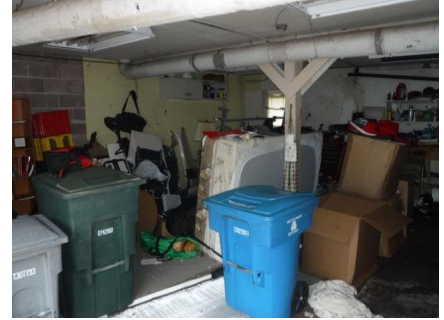
Photo 14

4. Personal storage was blocking access to the interior of the garage. Therefore, the area is considered inaccessible and was not fully inspected. With access and an opportunity for complete inspection, conditions in need of attention may be discovered. Ideally, the personal belongings should be removed so the area may be inspected. (See Photo 14)

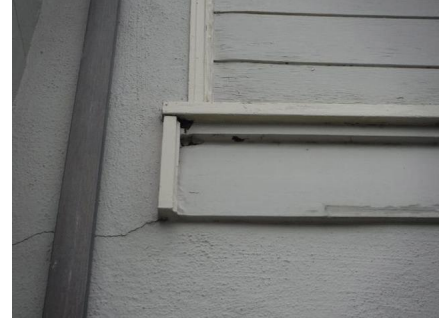
Photo 6

5. Water damage was observed to the exterior trim at various areas. We recommend the services of a licensed general contractor and/or structural pest control company. (See Photo 6)

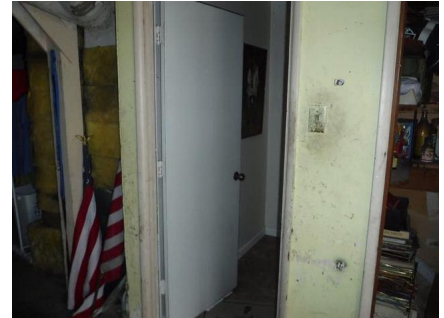
Photo 12

6. The door between the garage and the interior of the house should be a fire rated door as per local codes. Hollow core, windowed or interior grade doors do not meet this requirement. We recommend this door be replaced with a approved door for this location. (See illustration 6F) (See Photo 12)

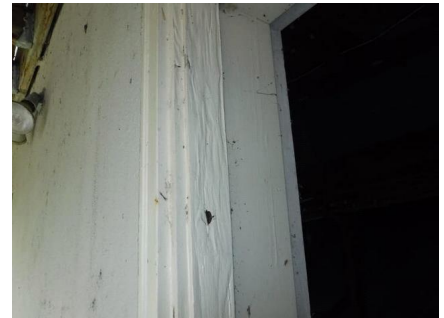
Photo 3

7. The basement door jamb is water damaged. We recommend the services of a licensed general contractor and/or structural pest control company. (See Photo 3)

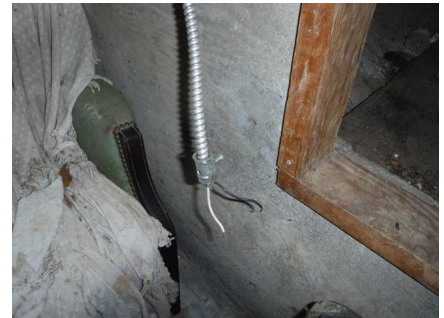
Photo 8

8. Abandoned wiring was noted in the garage. We recommend the wiring be disconnected at its source or terminated in an approved manner in a covered junction box. (See Photo 8)

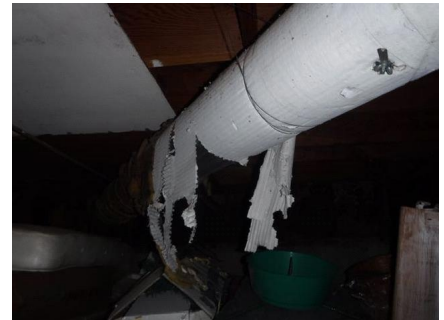
Photo 16

- 10. The insulation on one or more of the heating ducts in the garage are missing or loose. We recommend repair to minimize heat loss. (See Photo 16)

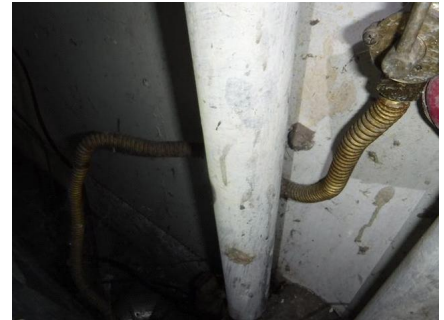
Photo 11

- 11. The gas line/connector at the laundry room is flexible and made of brass. Brass is no longer approved for this use because it is prone to deterioration. We recommend the gas line/connectors be replaced with a line/connector meeting present standards (See Photo 11)

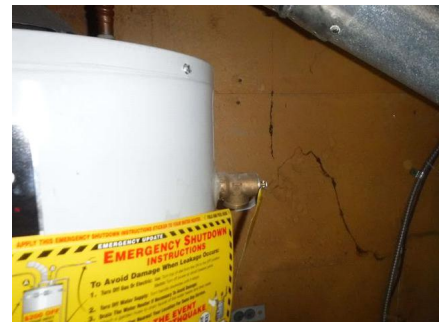
Photo 10

- 12. The temperature and pressure relief valve for the water heater lacks a proper discharge pipe. We recommend the installation of approved piping to an approved location. (See Photo 10)

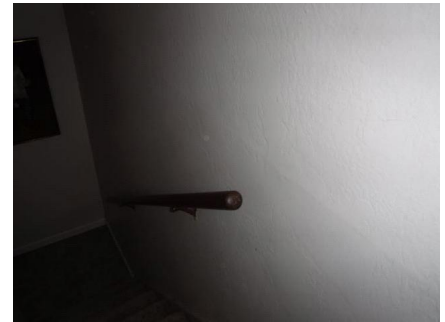
Photo 17

- 14. The ends of the railing at the main stair case should return or connect to the wall, this will eliminate any loose clothing or straps from hanging up on the ends of the railing. It is recommended that this condition be corrected for improved safety. (See Photo 17)

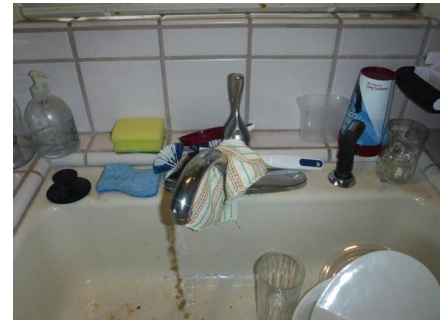
Photo 18

- 15. The dishwasher lacks an air gap device. Air gaps are standard equipment to assure a separation between supply and waste water of the dishwasher. It is advised that one be installed. (See Illustration 4E) (See Photo 18)

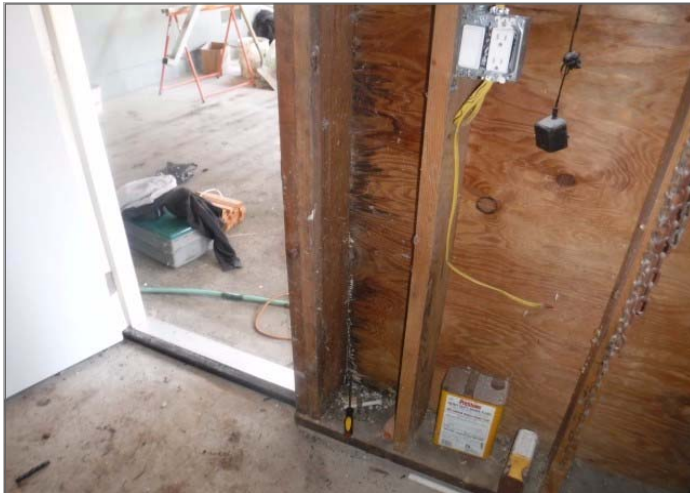
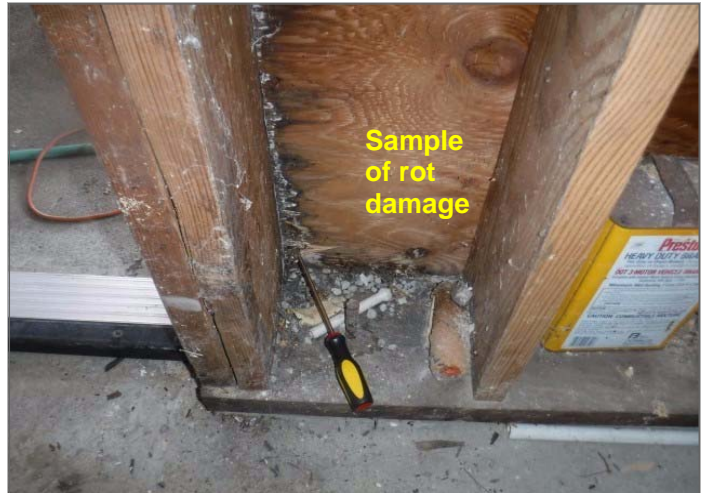
3.9 - There is evidence of rot damage to the wall sheathing in the storage crawl space. We suggest contacting a qualified contractor for any corrective work needed. Please see the NBI Structural Pest Control report for further information.

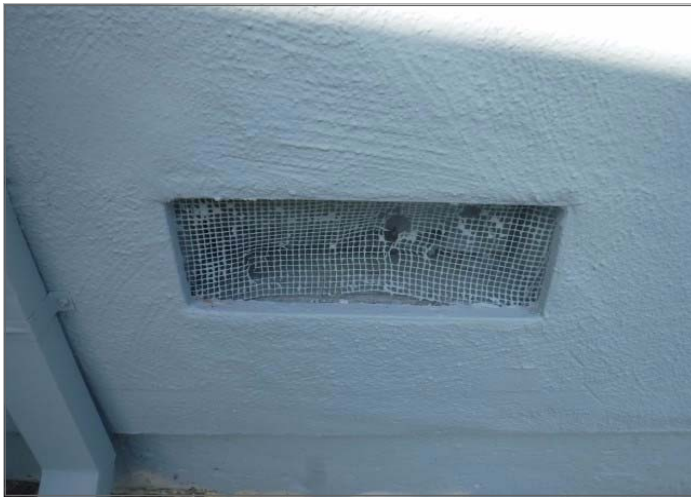
4.4 - Screened subarea vents on the left side of the structure are in disrepair which may allow rodents to enter the substructure. We recommend keeping screened vents repaired as part of routine maintenance.

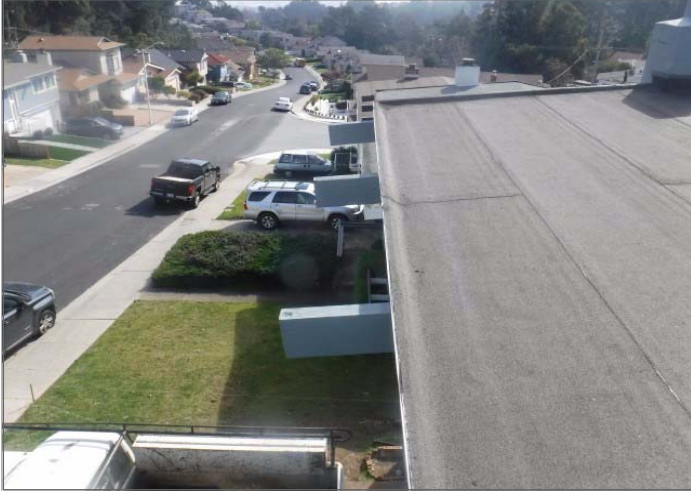
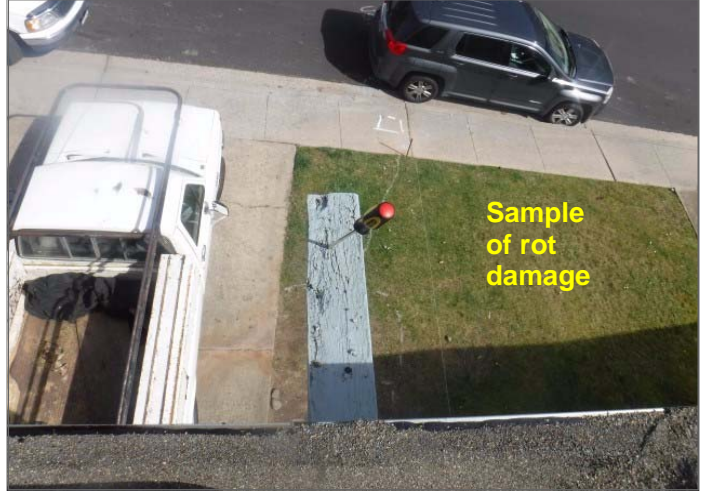
5.4 - Rot damage was noted to the exposed framing members at the left front of the structure. We suggest contacting a qualified contractor for any corrective work needed.

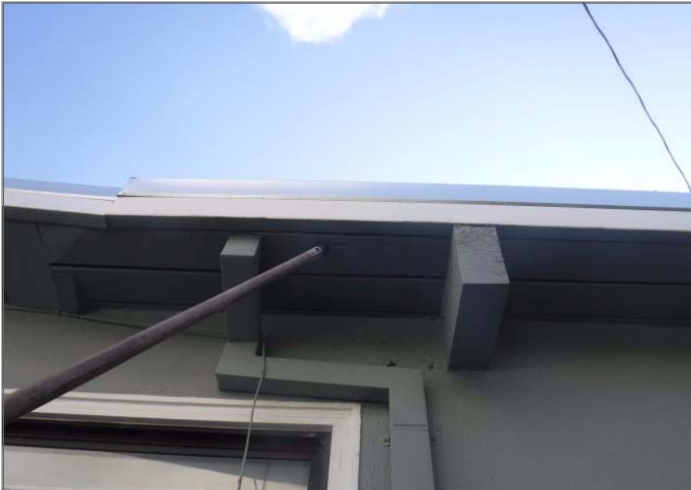
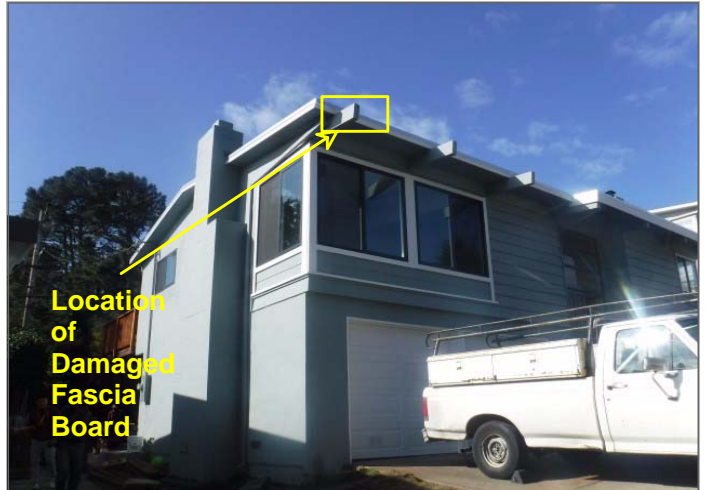
5.5 - Rot damage was noted to the eaves at the right of the structure and to the fascia board at the left front of the structure. We suggest contacting a qualified contractor for any corrective work needed.

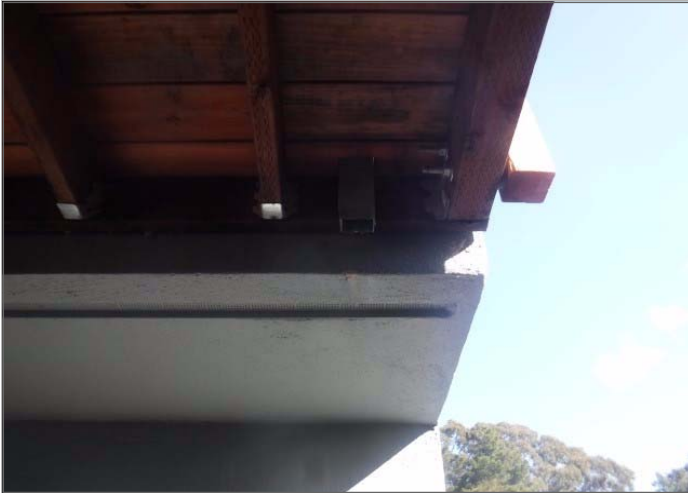
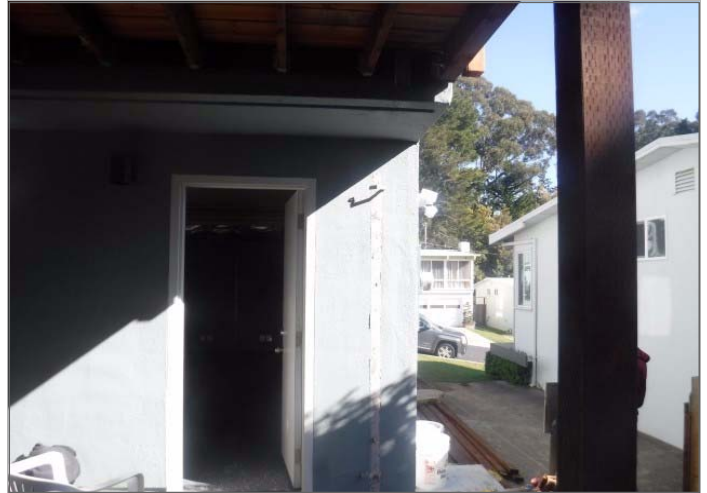
5.8 - The downspout at the left rear of the structure is missing. We suggest having new one(s) installed to assist in adequate control drainage at the roof.

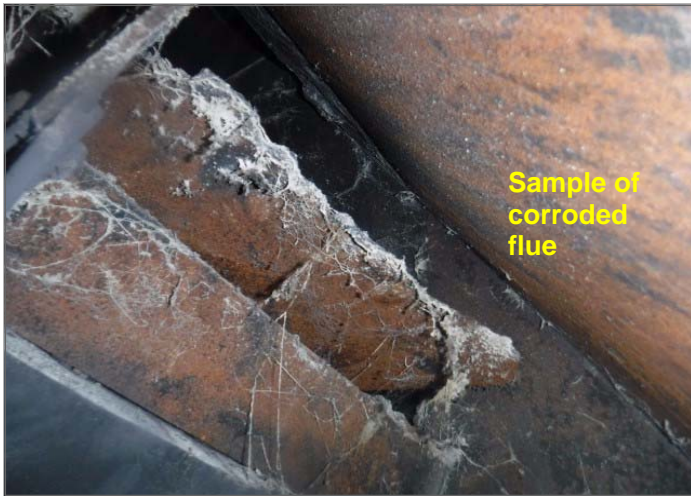
6.3 - The smoke damper is not considered serviceable in its present condition due to heavy corrosion. We suggest having this condition properly corrected to ensure proper fireplace operation.

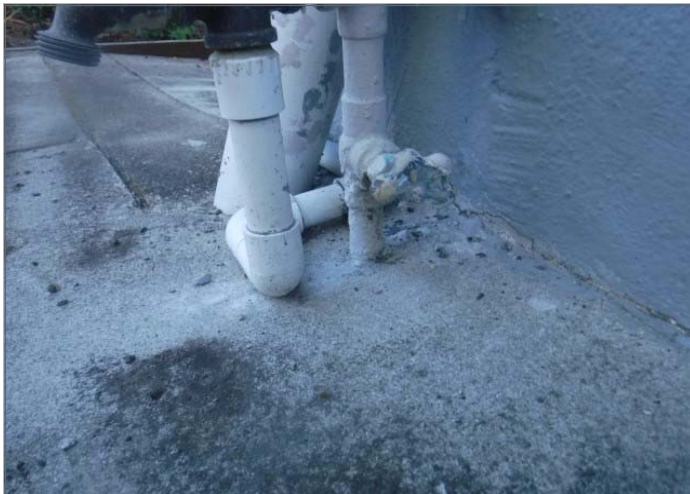
8.4 - The water line at right side of building runs through concrete without a protective sleeve. Due to the rigidity of the concrete, failure of the water line could occur from settlement/movement of the concrete and/or seismic activity; therefore, we recommend having the concrete removed from around the pipe and a protective sleeve be installed.

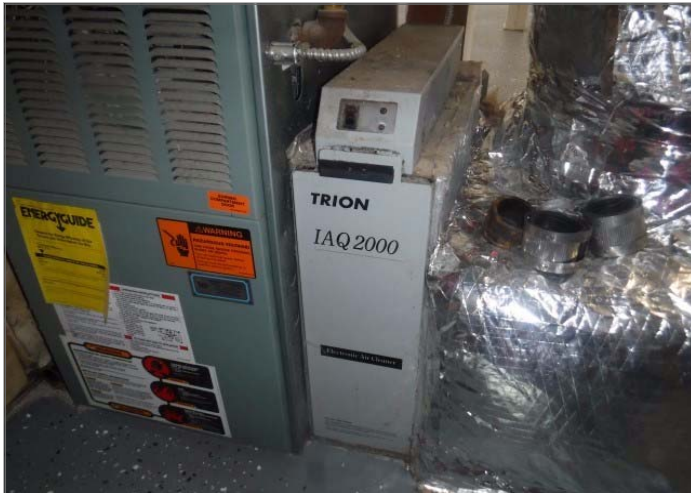
9.3 - There is an electronic air cleaner with the heating unit. It is beyond the scope of this inspection to substantiate its proper operation. We suggest consulting with a qualified specialist for evaluation of serviceability.

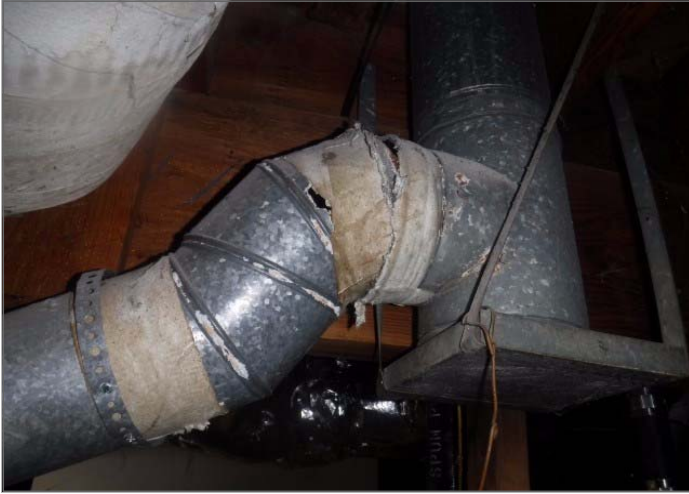
9.5 - The flue is substantially corroded. We recommend it be repaired or replaced.

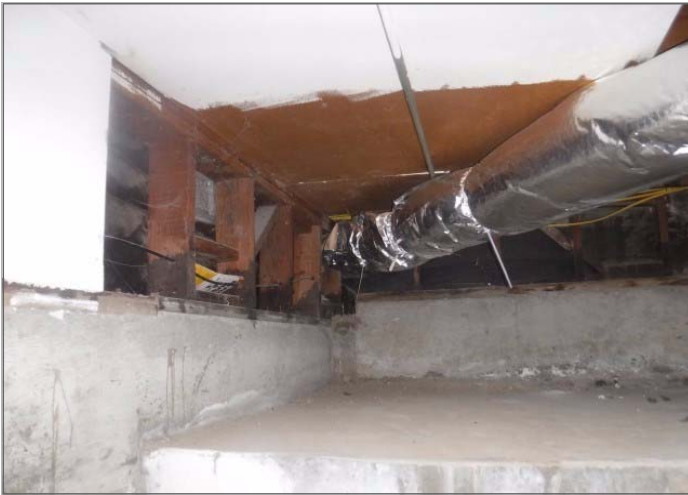
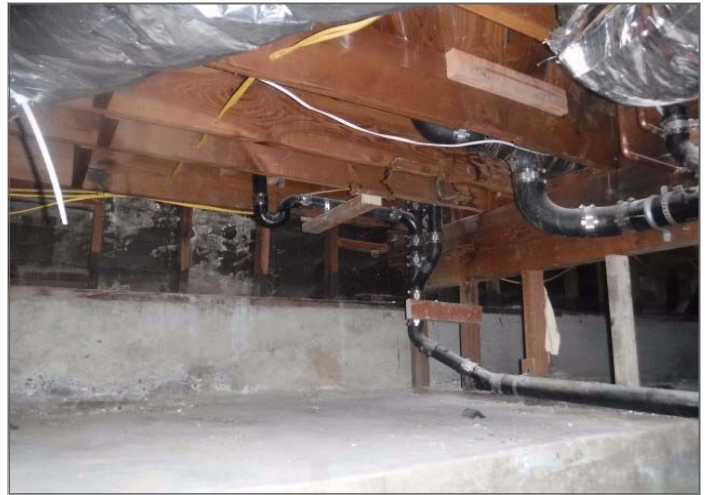
18.3 - The sheetrock is missing from the firewall at the area above the storage platform, which should be rectified to provide maximum fire protection.

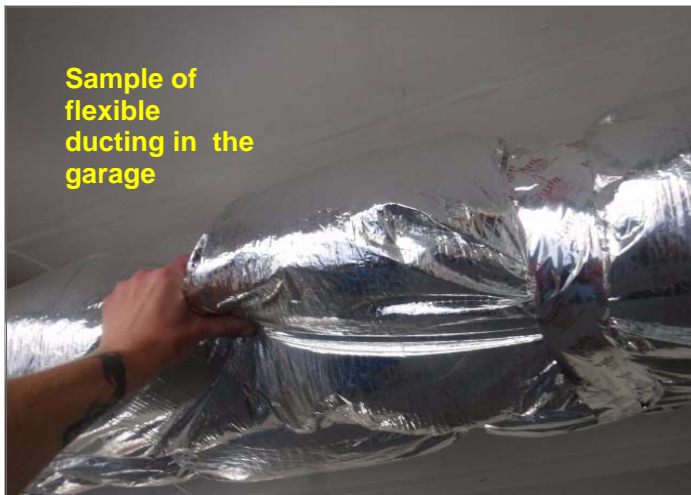
18.4 - Under "current" building standards, air ducts that penetrate the garage firewall should be metal. Portions of the ducting in the garage are comprised of flexible ducting, which does not meet this requirement. We recommend upgrading this condition for maximum fire protection and safety.

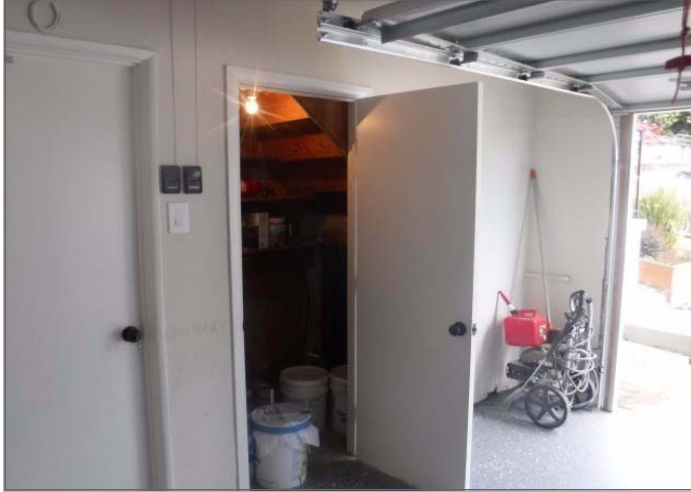
18.5 - The door connecting the garage and the crawl space below the entry should be a solid-cored fire-rated door with an automatic closing device. The existing door is not fire-rated and has no automatic closing device. This should be properly rectified to provide maximum fire protection.
